FIRE-RESISTANCE STUDIES OF THE CONVAIR-340 POWER PLANT

Technical Development Report No. 266

**CIVIL AERONAUTICS ADMINISTRATION
TECHNICAL DEVELOPMENT AND
EVALUATION CENTER
INDIANAPOLIS, INDIANA**

June 1955

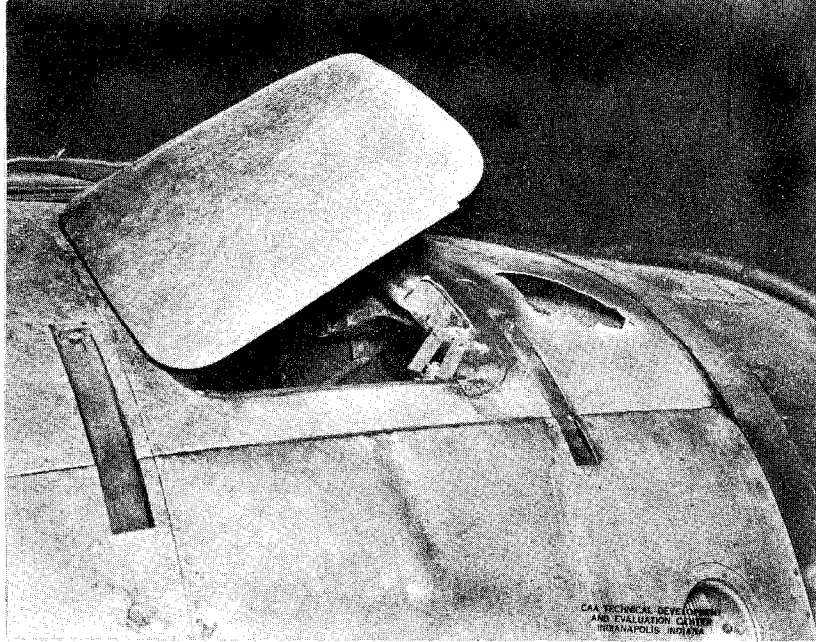
Fig. 3 Hole Burned in Cowling by Fire Leaving Cowl-Flap Port

When a fire of 20 seconds duration was started high in Zone 1 near the partially open cowl flaps, the flames hugged the skin aft of the flaps and burned through the duraluminum outer skin. The damage is shown in Fig. 3. The port was also damaged, but the inner skin of the cowling remained intact because it was fabricated of stainless steel. The flames extended beyond the cowl hinge line, which marks the location of the fire wall, and impinged on the duraluminum skin covering Zone 3. Since there is no protective inner lining for Zone 3, stainless steel was used during the tests to cover this area to prevent its being penetrated by fires.

4. Fire passing through cowl flaps which are partially open will impinge on the metal ports and on the downstream skin.
5. The top-wing exhaust arrangement reduces fire-ignition hazards.

3. Exterior nacelle surfaces downstream of flaps be protected with materials which are more fire-resistant than aluminum alloy.
4. The seals around the oil cooler be fabricated of materials having a maximum of fire resistance together with the necessary degree of flexibility.
