TECHNICAL DEVELOPMENT REPORT NO. 327

INVESTIGATION OF FIRES ORIGINATING
FROM AN AIRCRAFT OXYGEN SYSTEM

Paul R. Dierdorf

October 1957

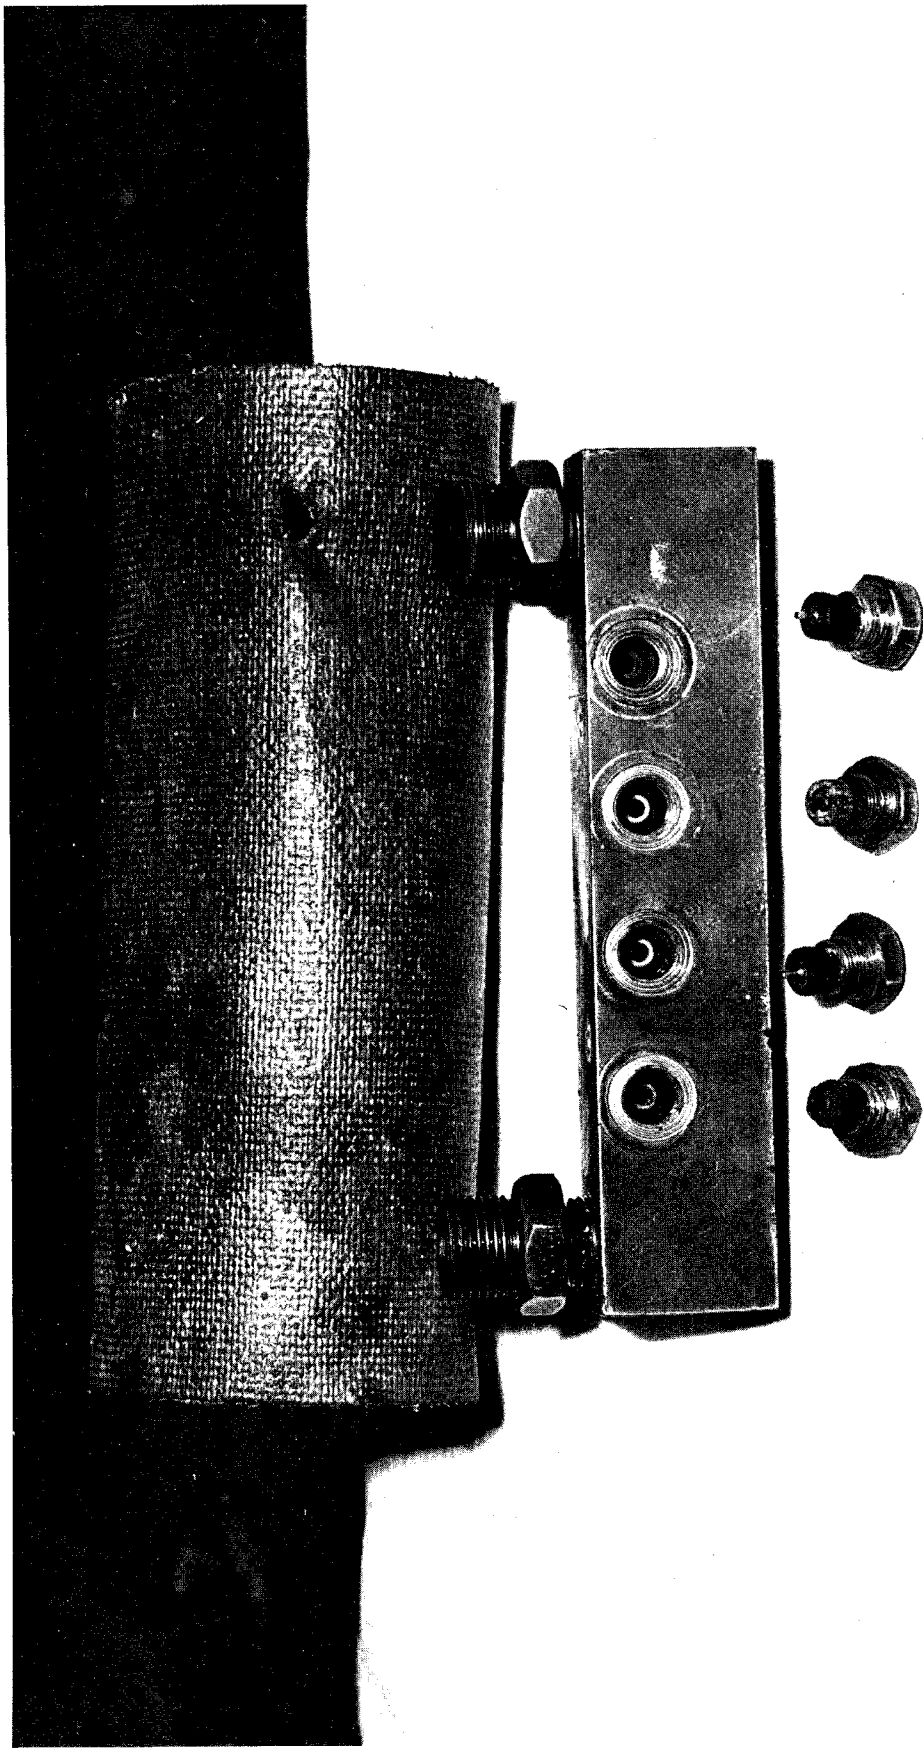
in the shield. Difficulty was encountered, however, in getting the fire to burn through the outlet connection. In several tests the cotton inside the manifold and the check-valve seat at the oxygen inlet were consumed but the cotton outside the manifold was not ignited. In one test, ignition outside the manifold did occur and the fire which consumed the cotton was of sufficient intensity to burn a 1/2-inch diameter hole through the shield. This is shown in Fig. 4.

FIG. 4 DAMAGE TO MANIFOLD SHIELD
