A STUDY OF AIR TRANSPORT PASSENGER CABIN FIRES AND MATERIALS

TECHNICAL REPORT

National Aviation Facilities Experimental Center

TECHNICAL REPORT
ADS-44

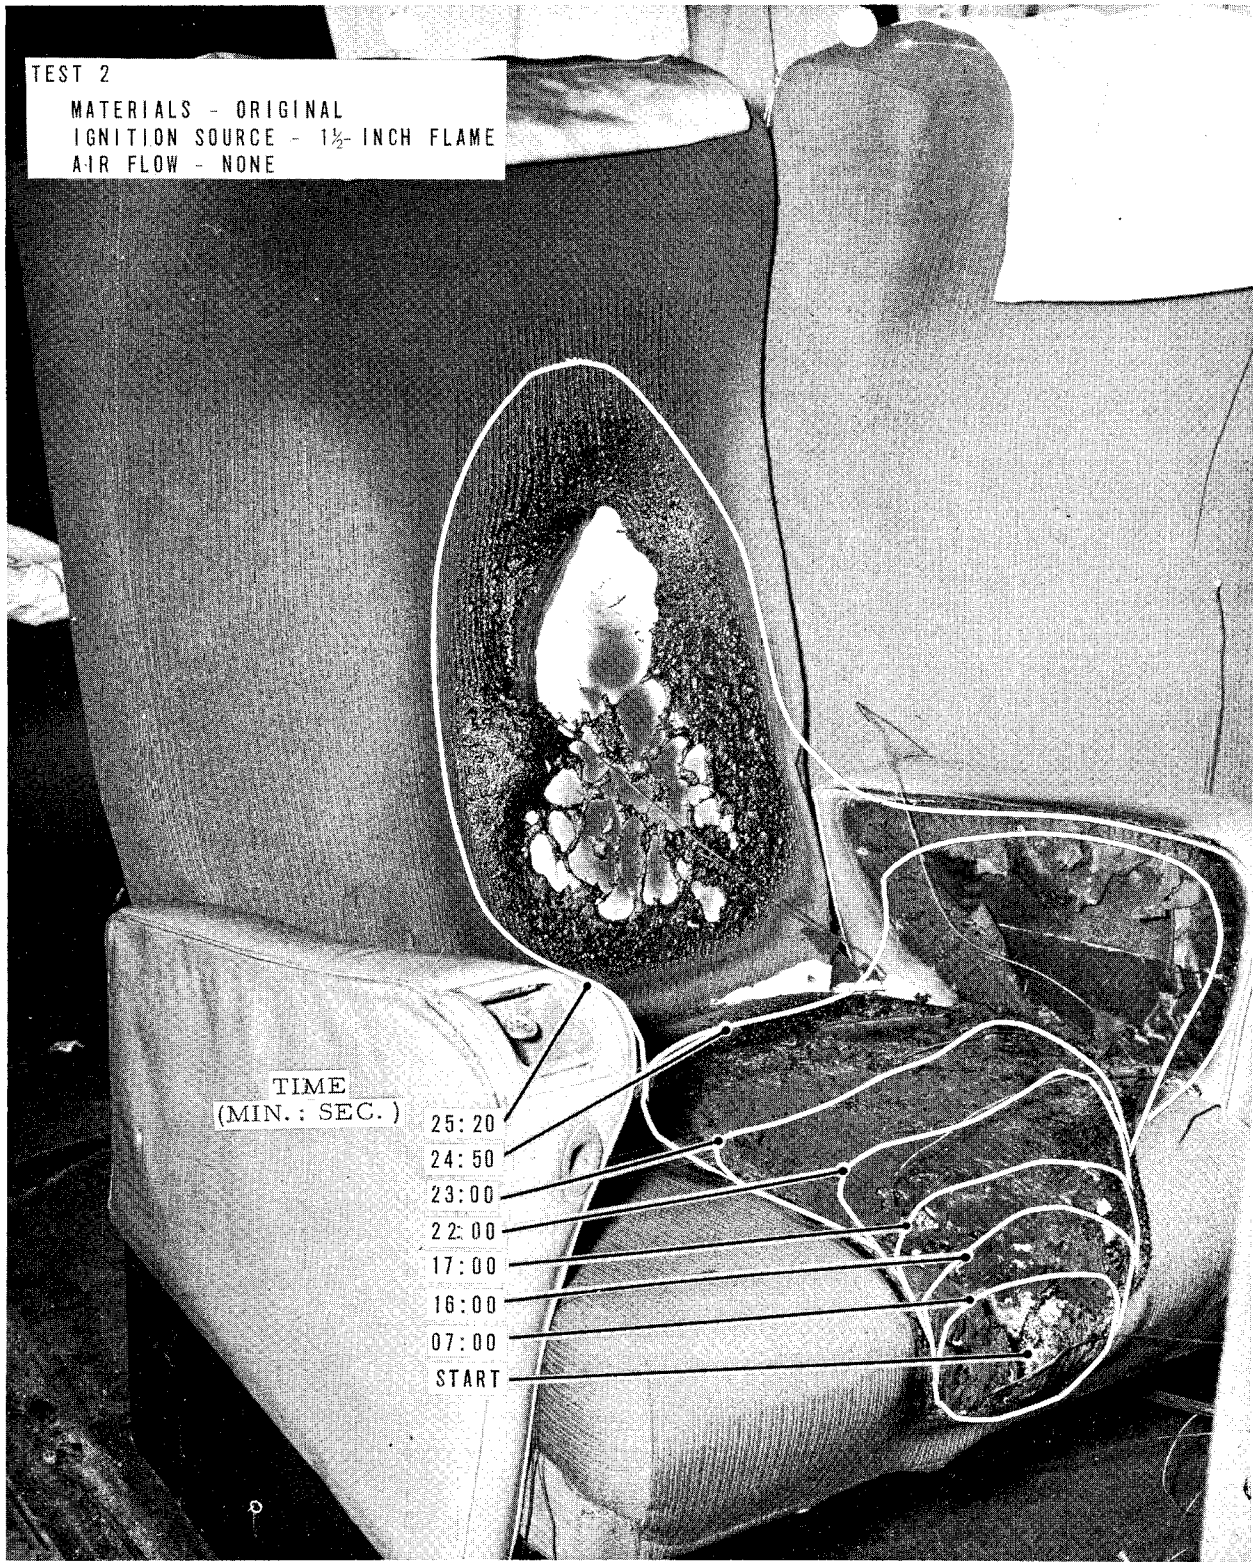
FIG. 2 WOOL/LATEX SEAT CUSHION FLAME PATTERN AND FIRE DAMAGE

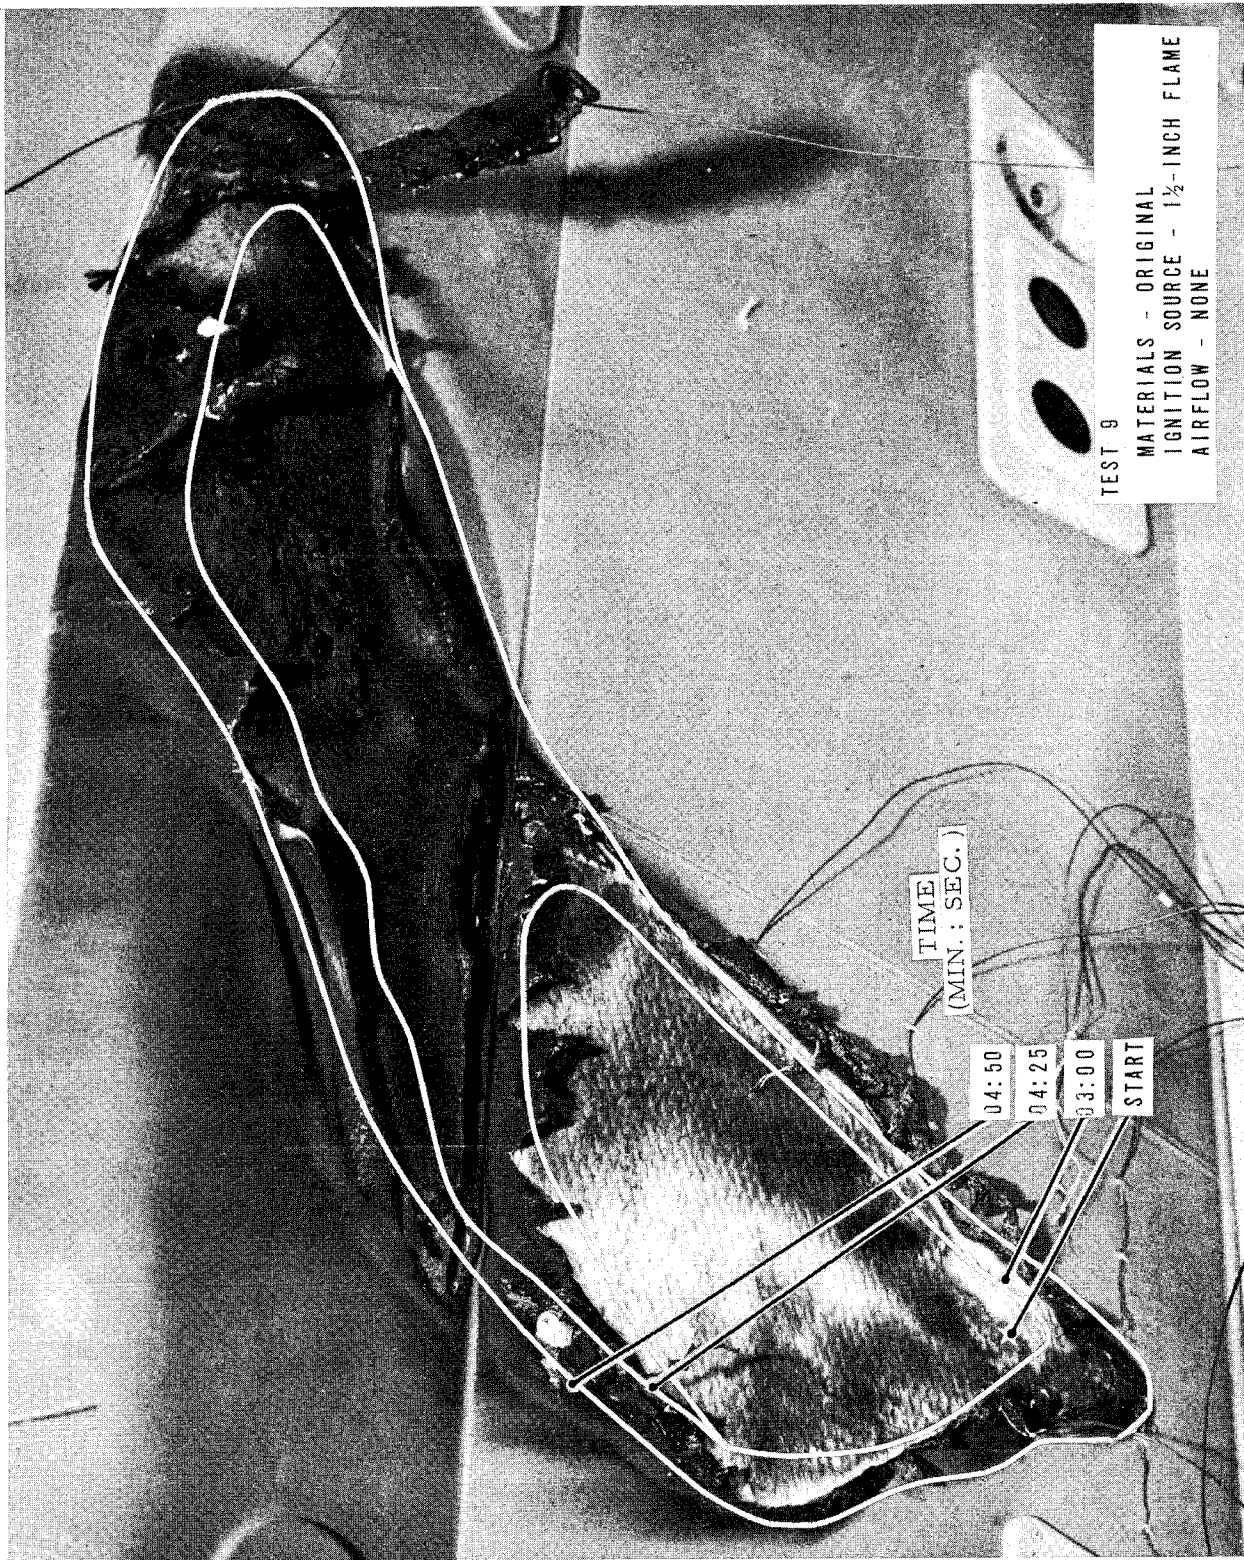
FIG. 3 HATRACK FLAME PATTERN AND FIRE DAMAGE

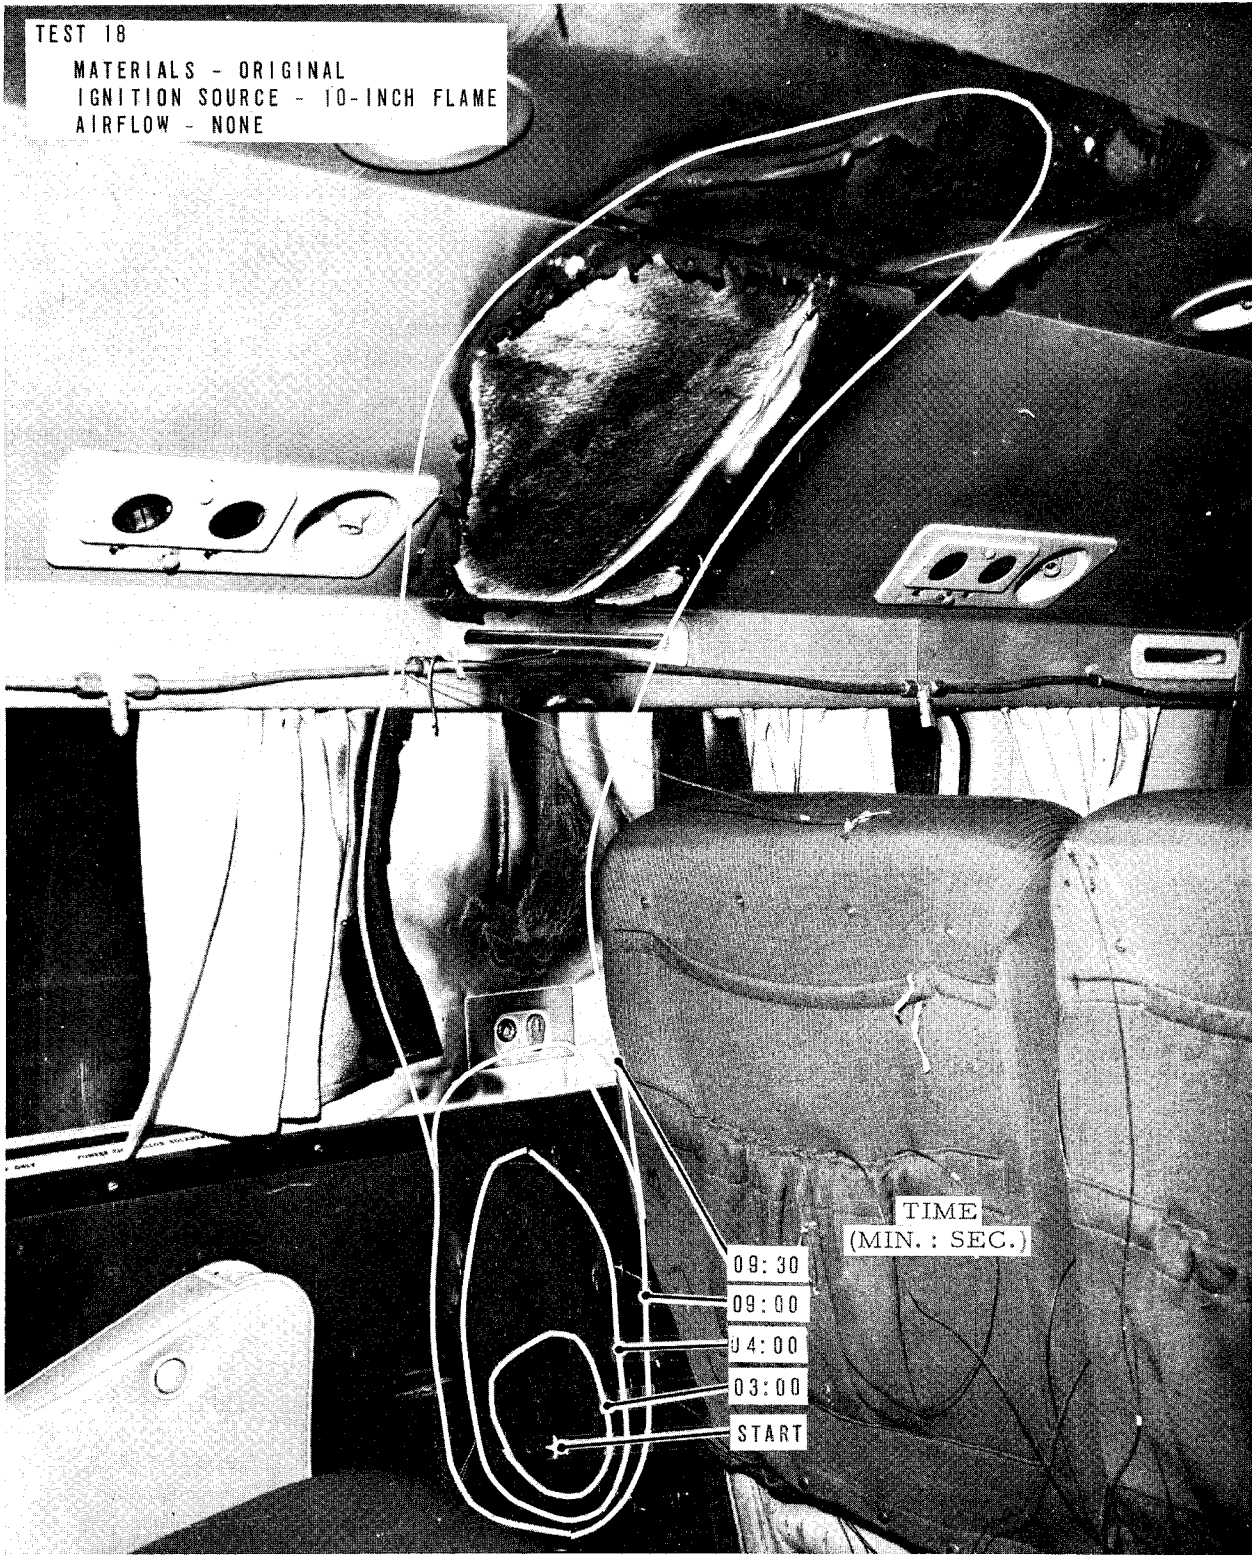
FIG. 4 SIDEWALL FLAME PATTERN AND FIRE DAMAGE

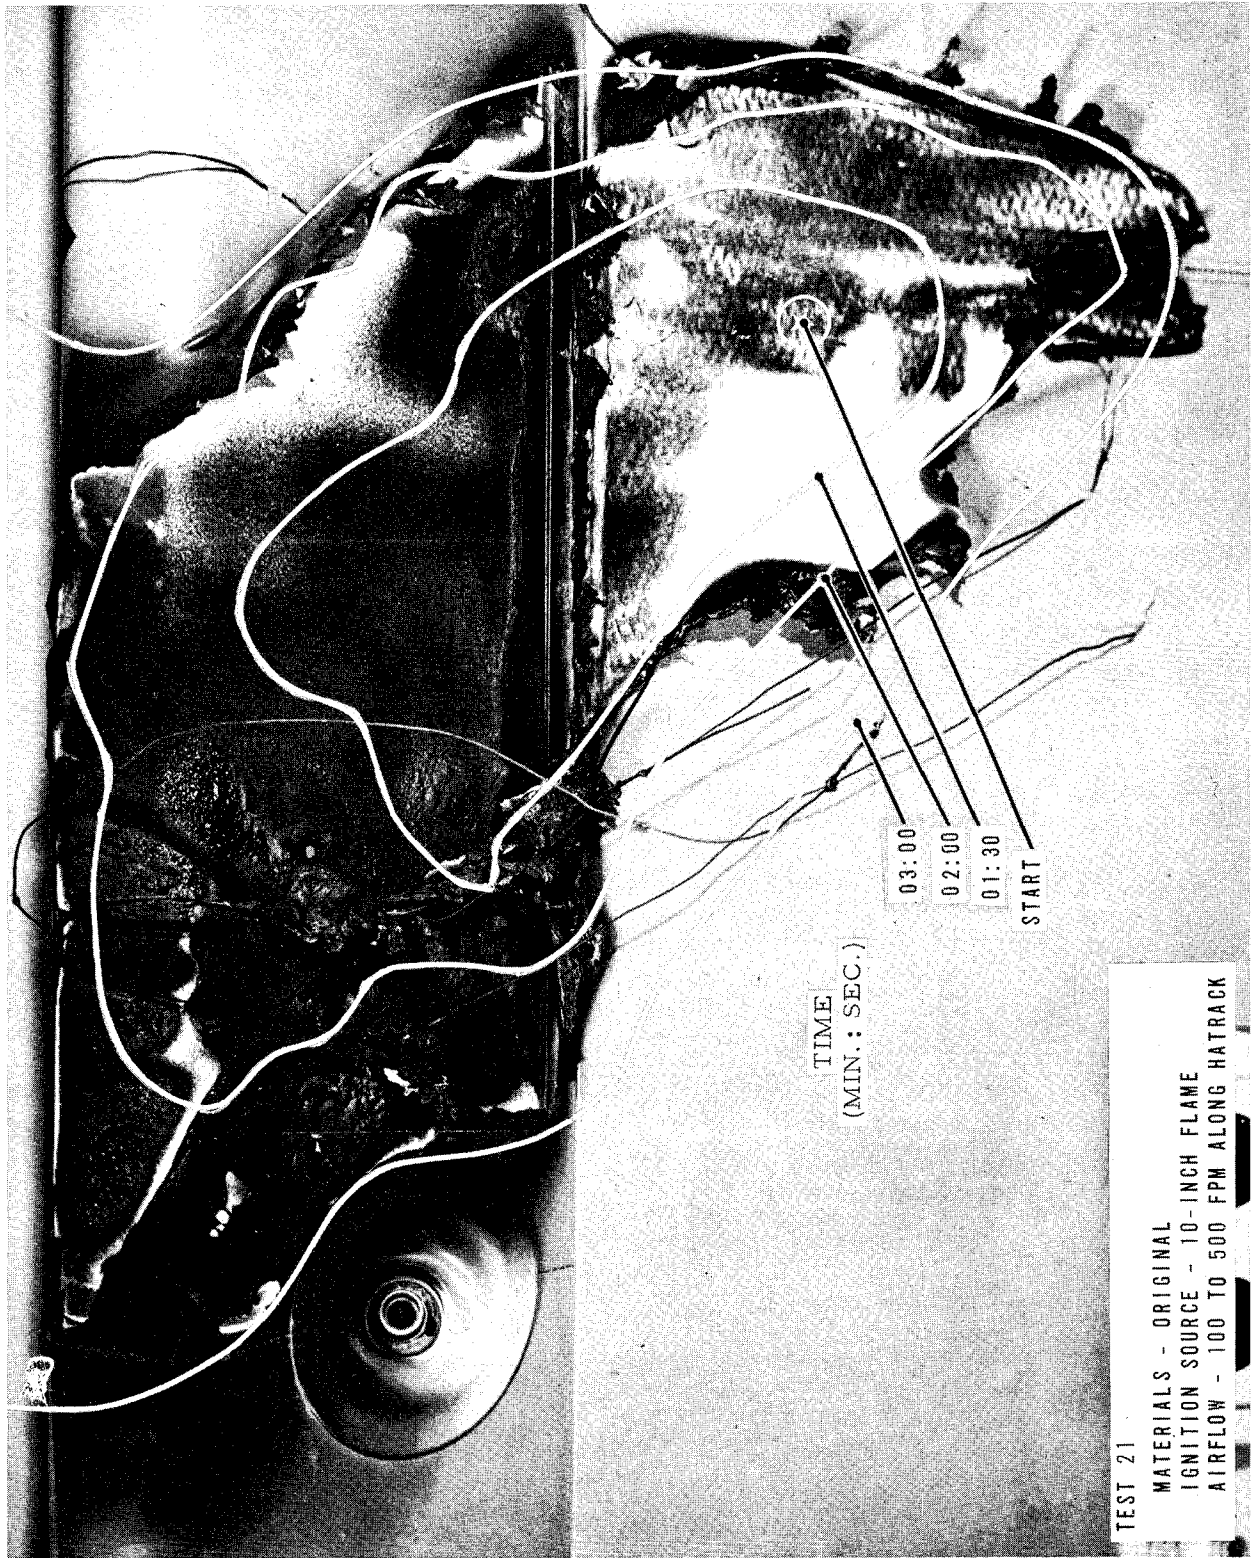
FIG. 5 HATRACK FLAME PATTERN AND FIRE DAMAGE WITH AIR FLOW

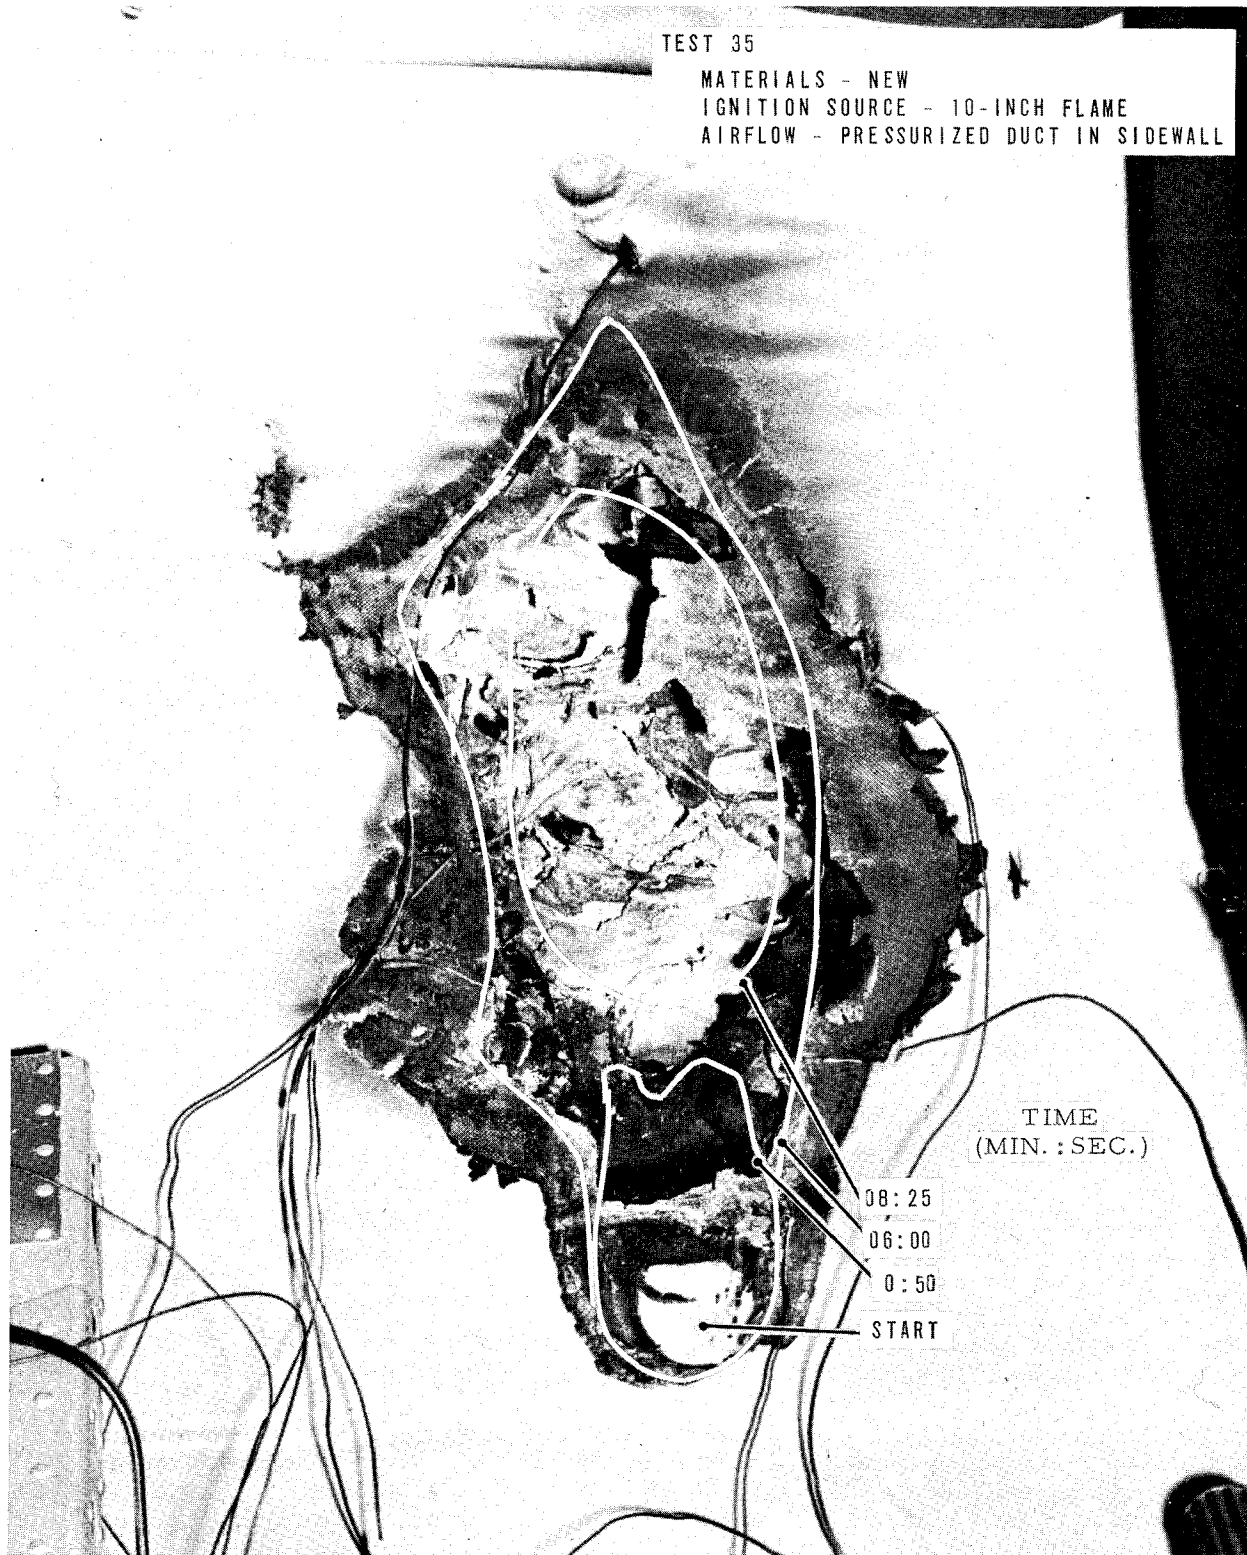
FIG. 6 PRESSURIZED SIDEWALL FLAME PATTERN AND FIRE DAMAGE

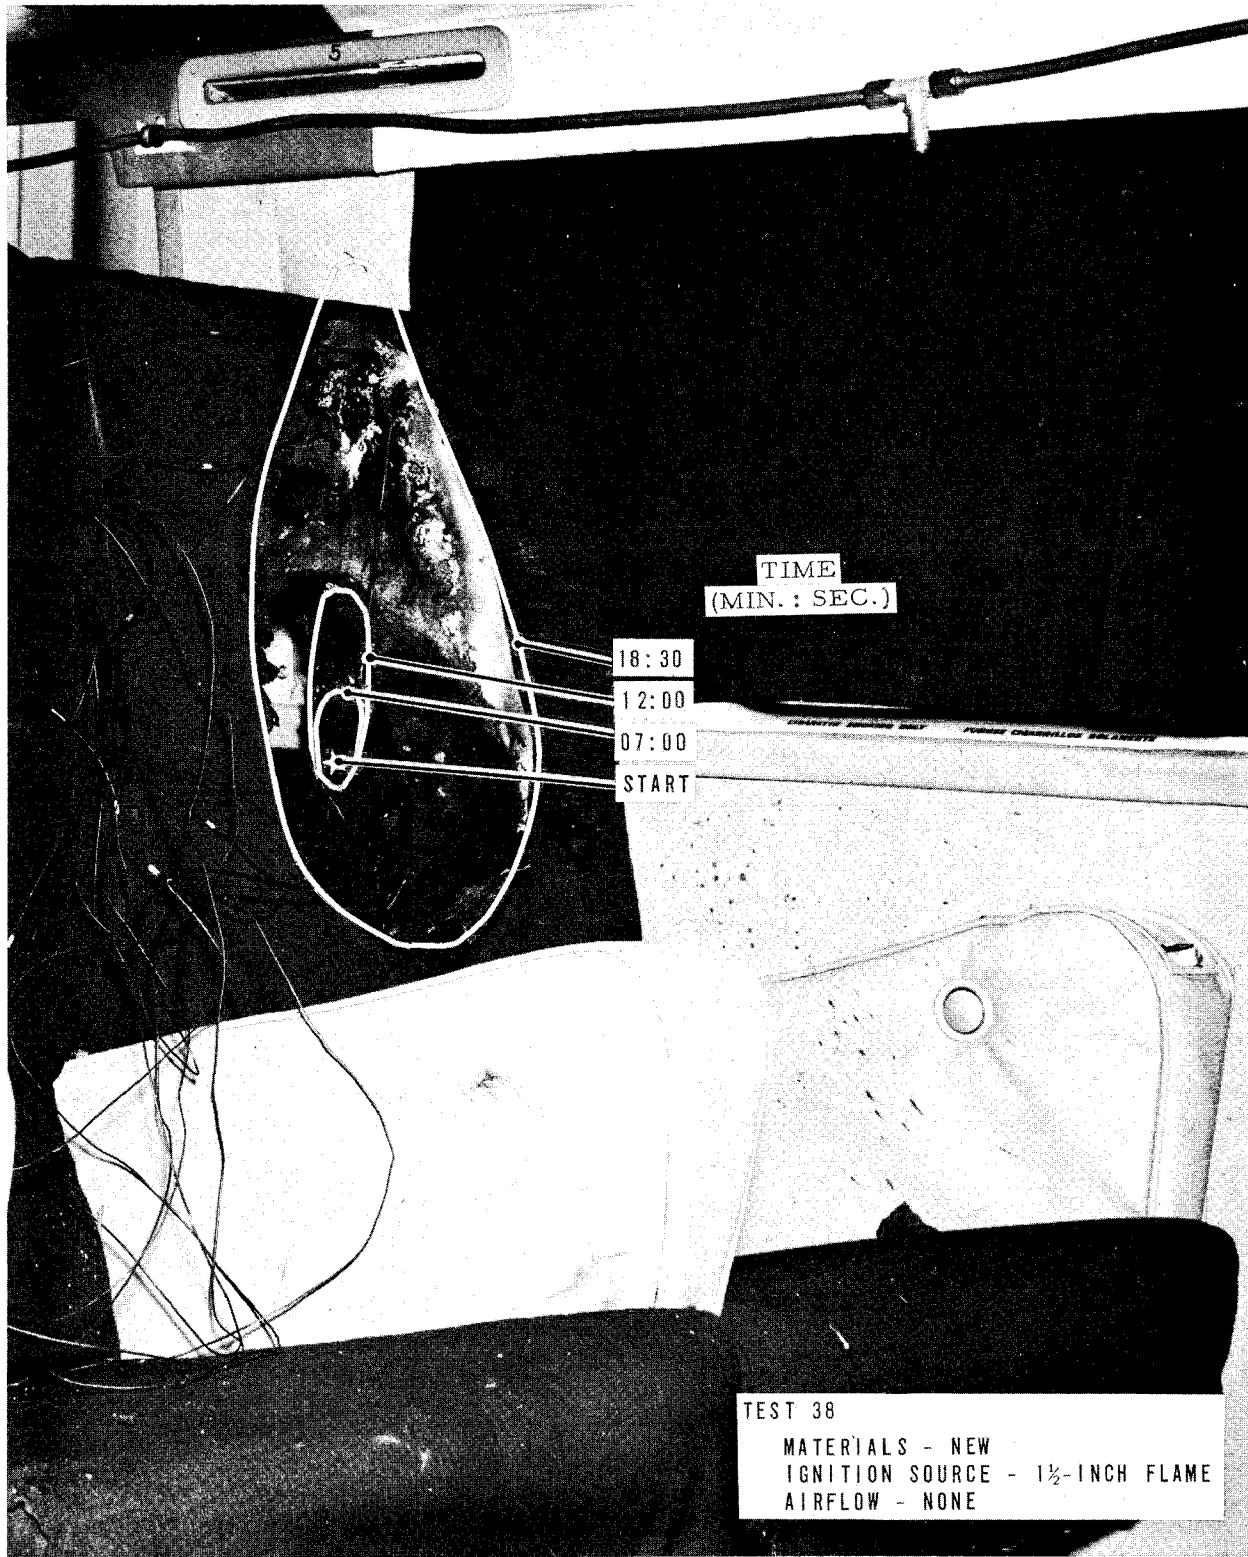
FIG. 7 MODACRYLIC/POLYURETHANE SEAT CUSHION FLAME PATTERN AND FIRE DAMAGE

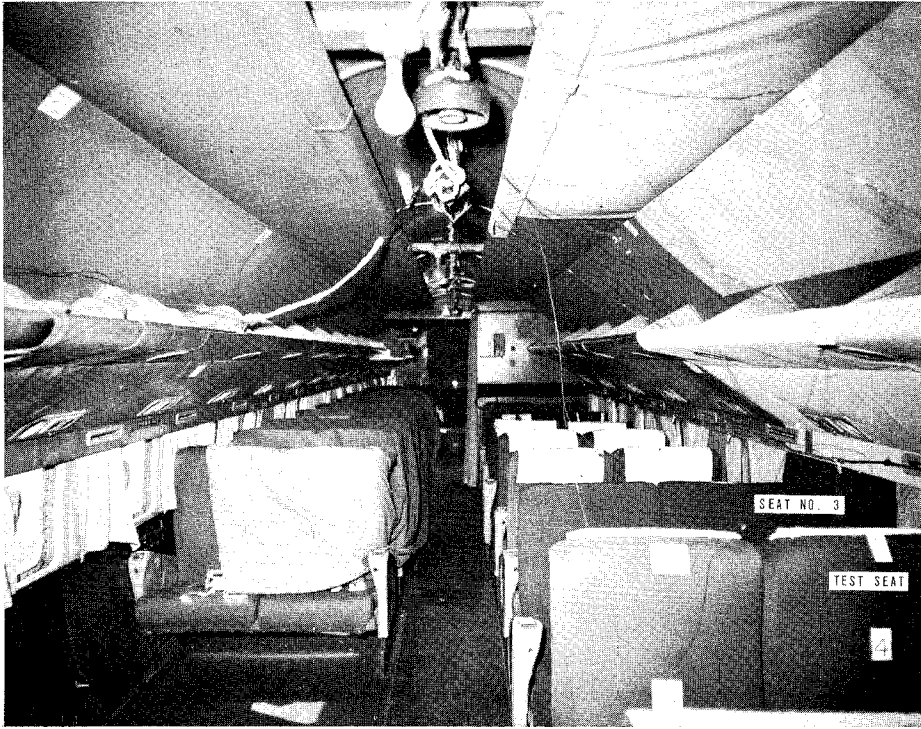
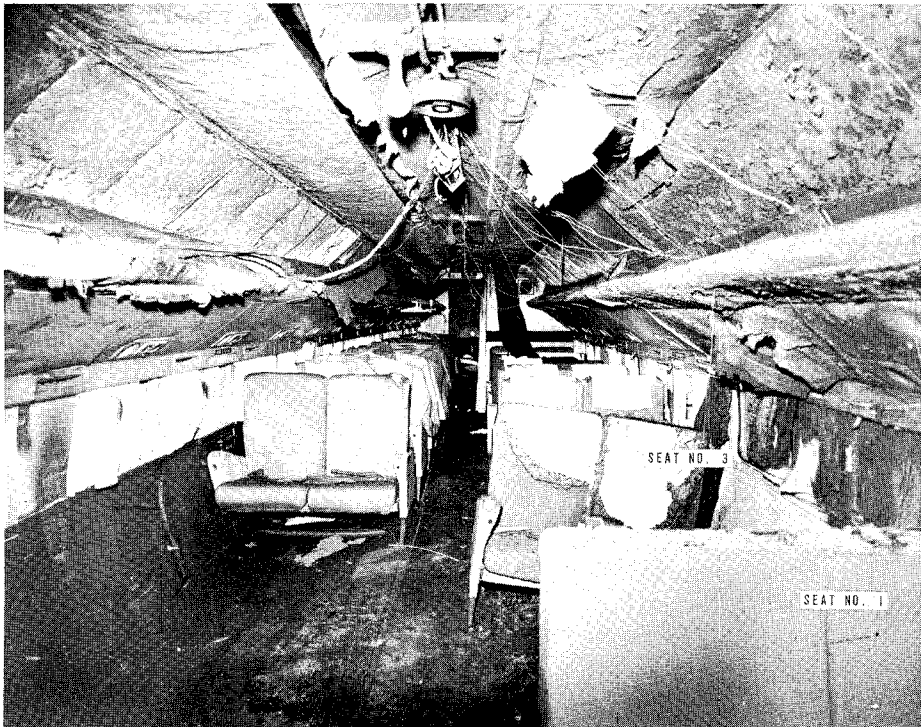
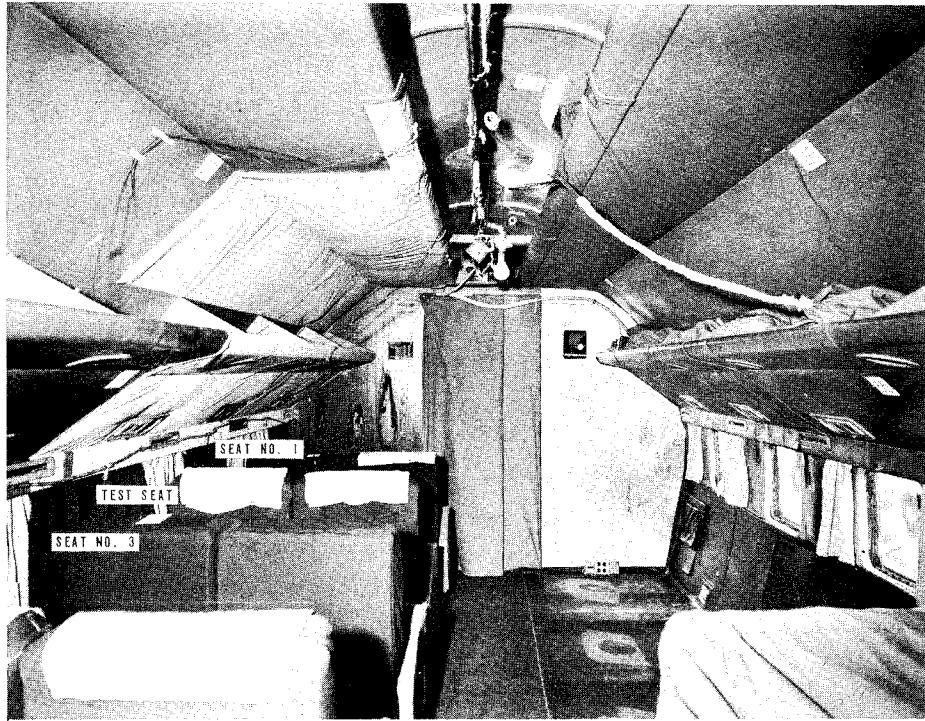
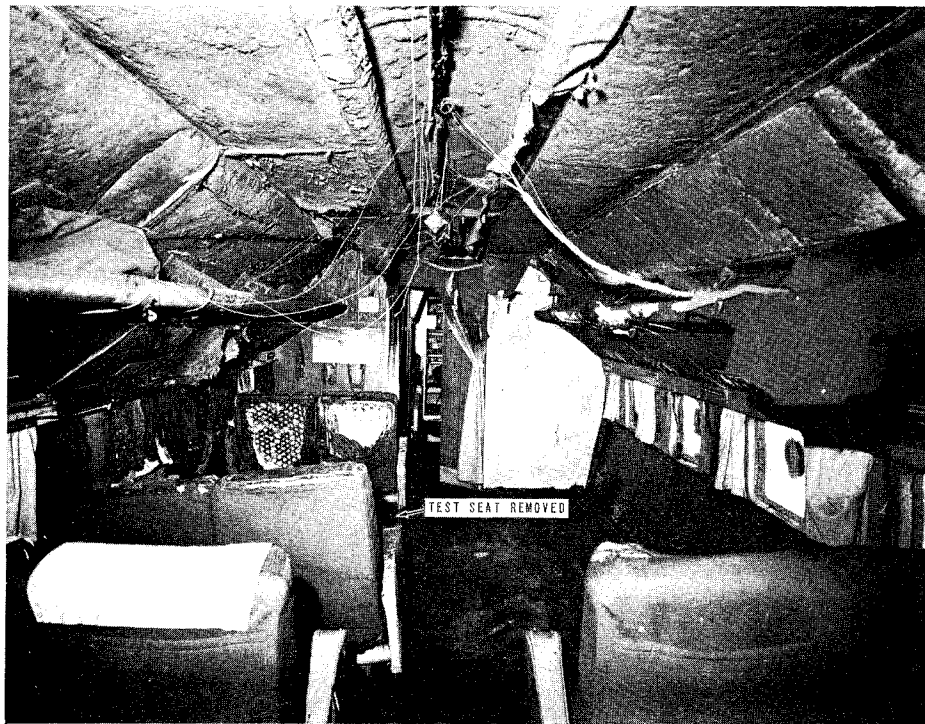
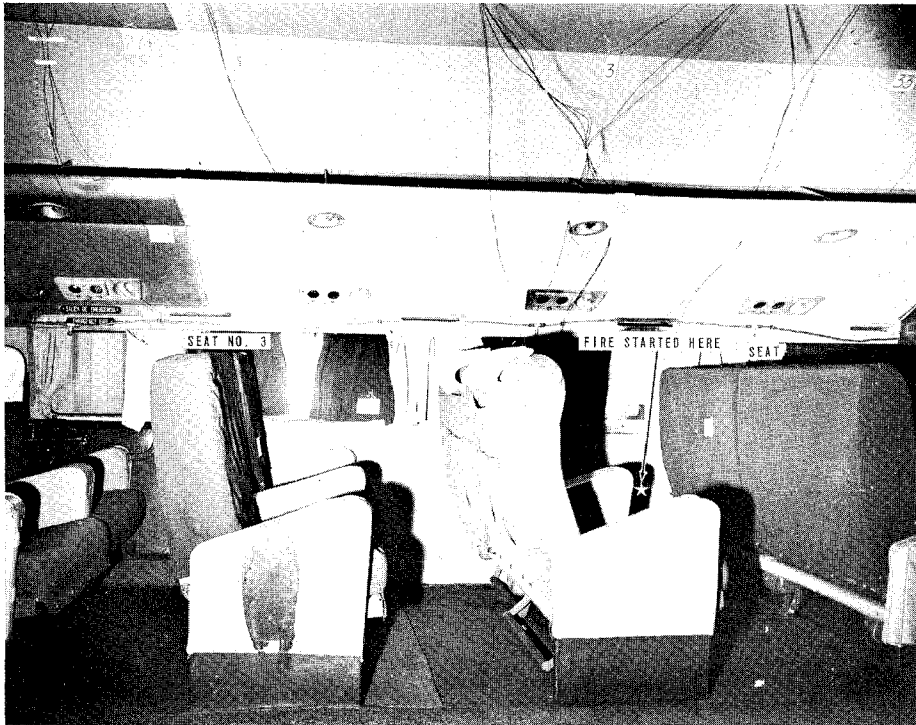
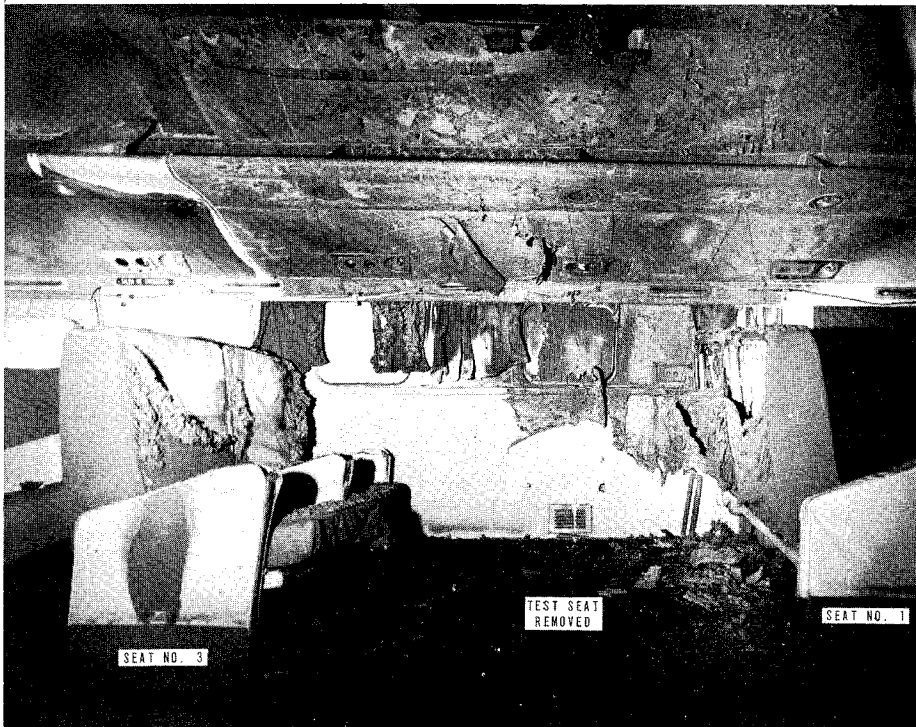
The fire damage was extensive along the ceilings, upper sidewalls and the immediate area surrounding the seat that was set on fire for the test as shown by the photographs in Figures 10, 11 and 12. The modacrylic fabric curtains were completely charred by the severe fire and radiant heat exposure while the wool curtains were only partially charred. From this experience, it appears that self-extinguishing synthetic materials which are difficult to burn by a small ignition source may burn equally as well as the more flammable natural fiber materials when both are subject to a severe fire. The hatrack portion directly above the fire was severely damaged. The vinyl fiberglass fabric for the most part resisted flame penetration and provided considerable protection to the hatrack. The modacrylic fabric used on seat Nos. 1 and 3, adjacent to the seat that was set on fire (Seat No. 2), was severely charred (Figure 10). However, the exposed back of the cushion of seat No. 1 was only slightly charred (Figures 11 and 12). The modacrylic fabric on the front side of seat No. 3 was completely charred. The vinyl foam for this seat protected by a fiberglass cover underneath the modacrylic fabric showed no signs of fire damage. The wood paneling was slightly charred near the ceiling level. No damage, other than a slight puckering of the carpet near the test fire, was noticed. There was no discoloration of its vinyl cover from heat. The mohair rug did not show any visible signs of fire damage. The acrylic windows in the immediate fire area had been protected by a thin aluminum sheet and only showed slight damage (frosting). Smoke damage was extensive throughout the cabin. A greasy film was found deposited on the surfaces left undamaged by fire, especially on the metal surfaces and floor apparently from a condensation of volatiles and water vapor.

FIG. 10 TEST 41 - REAR VIEW OF CABIN INTERIOR
BEFORE AND AFTER LARGE-SCALE FIRE

FIG. 11 TEST 41 - FRONT VIEW OF CABIN INTERIOR
BEFORE AND AFTER LARGE-SCALE FIRE

FIG. 12 TEST 41 - SIDE VIEW OF CABIN INTERIOR
BEFORE AND AFTER LARGE-SCALE FIRE

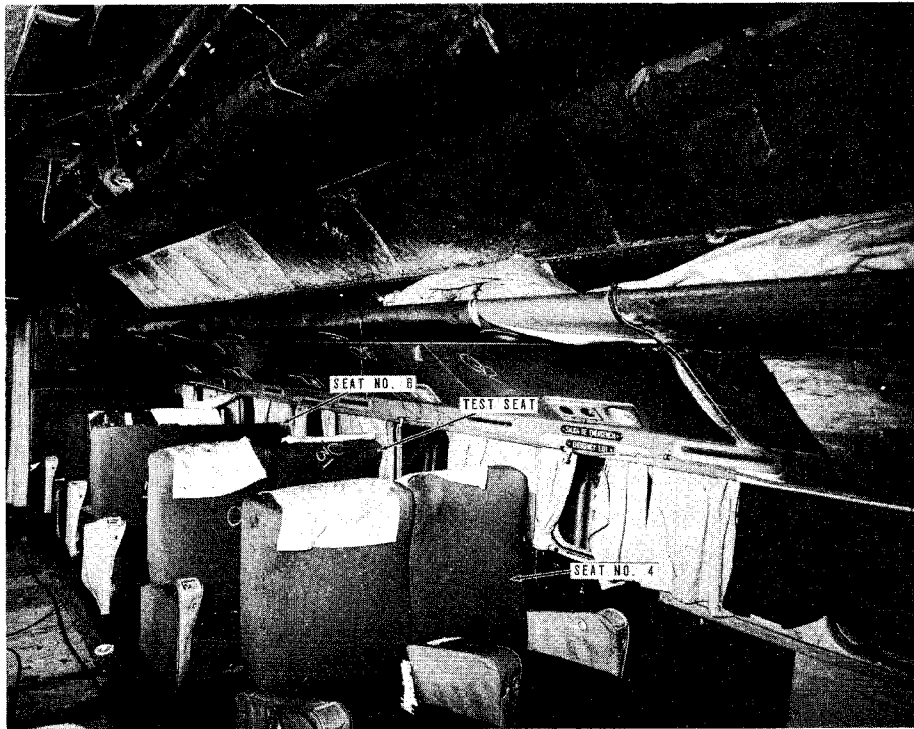
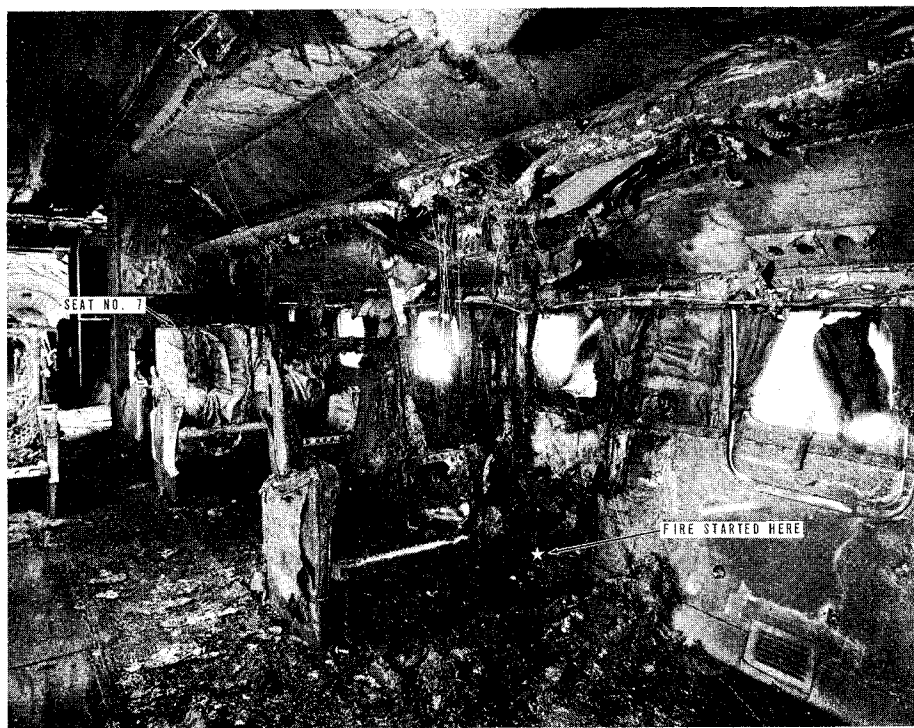
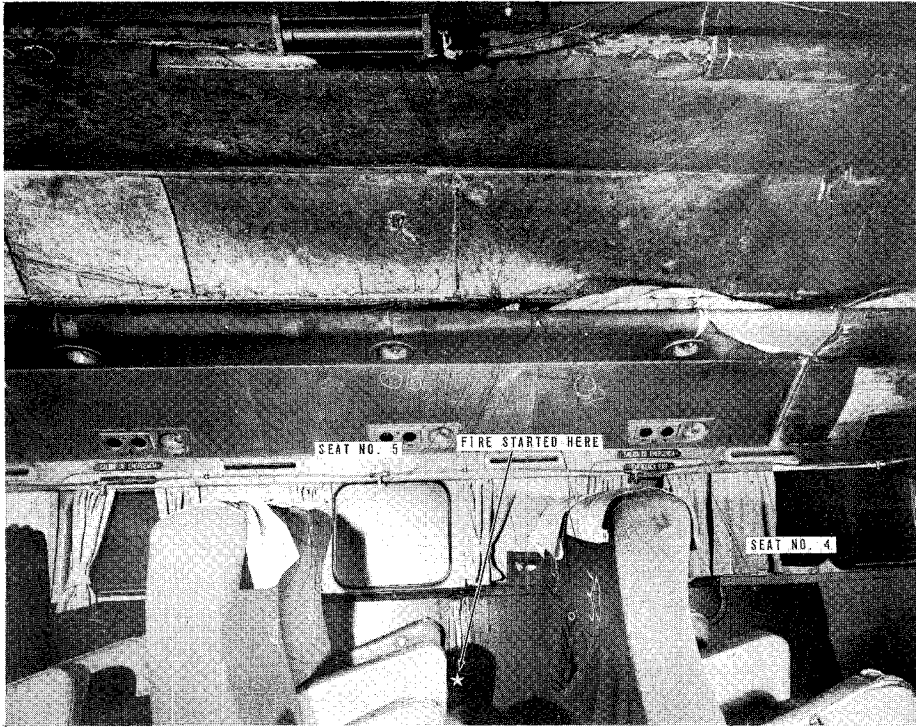
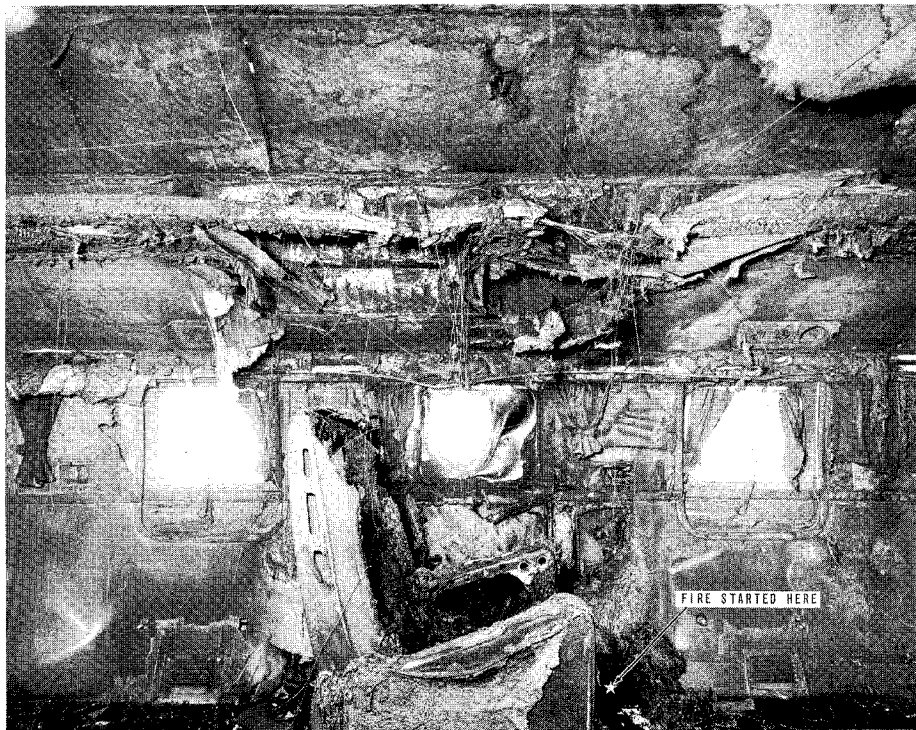
Both carbon dioxide and water were used in large quantities to extinguish the fire. After about two hours, it was possible to safely re-enter the cabin to remove seats that were still smoldering. Damage due to delay in attempting to control the fire was much more extensive than in the previous test as seen in Figure 17 and 18. The intensity of the fire was so severe as to destroy the part of the hatrack above the fire and melt down the aluminum supports. The ceiling also suffered severe damage sufficient to melt the aluminum panel in the center section. Mineral wool insulation in the ceiling adjacent to the test fire showed severe deterioration. Both the modacrylic and wool curtains were completely charred by the fire. Seat upholstery utilizing modacrylic and wool were almost completely destroyed in the center area of the fire. Wood paneling showed extensive charring over the upper part of the side-walls and along the galley ceiling. However, only the thin veneer sheeting of the panel which tended to peel off was affected by the heat. All the acrylic windows showed some frosting due to heat melting the material. The window next to the fire burned through one layer of acrylic pane although protected by a thin aluminum sheet. Adjacent unprotected windows did not suffer any burn throughs. The portion of the hatrack

and sidewall reupholstered with vinyl fiberglass fabric did not show any further deterioration from that in Test No. 41. Very little damage was experienced by the floor materials. The wool/latex cushions of the test seat were completely destroyed in the fire as shown in the photographs of fire damage in Figures 17 and 18. Seats shown missing had been removed from the cabin after the test to control the still smoldering fire in the latex foam. The seat behind the test seat (Figure 17) shows the destruction of the modacrylic upholstery. However, the fiberglass covering for the back cushion remained virtually intact and the vinyl foam padding was not affected by fire. Note that damage shown to the bottom cushion resulted from previous localized fire tests.

FIG. 17 TEST 42 - REAR VIEW OF CABIN INTERIOR BEFORE AND AFTER LARGE-SCALE FIRE

FIG. 18 TEST 42 - SIDE VIEW OF CABIN INTERIOR BEFORE AND AFTER LARGE-SCALE FIRE
