DOT/FAA/AR-95/49

A Study of the Continued Fire Worthiness of Aircraft Seat Cushion Fire-Blocking Layers

March 1997

Final Report

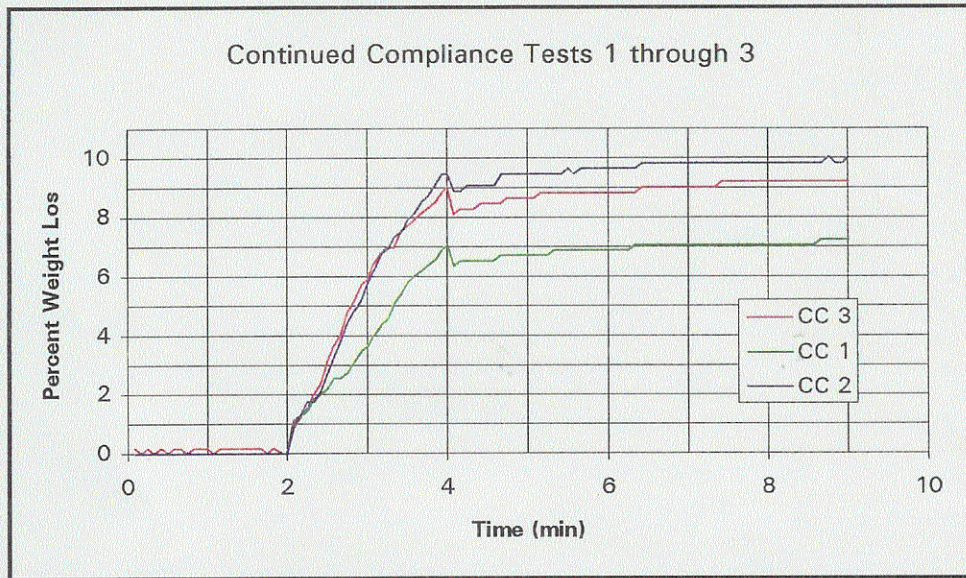
Stock Test Results. The weight loss profiles of the stock tests are shown in figures 1 and 2. The eight stock tests resulted in five tests exceeding 10 percent weight loss. The stock cushion tests did result in several instances where burn lengths exceeded the 17 inch (43.2 cm) requirement. In either case, the standard pass/fail criteria has no relevance in the stock configuration tests, which are expected to have higher test values. The data scatter was wide for both stock test series A and B, as seen in tables 4 and 5. Excluding test number five, no unusual fire behavior was observed during the testing.

FIGURE 1. PERCENT WEIGHT LOSS PROFILES, TESTS 1 THROUGH 3

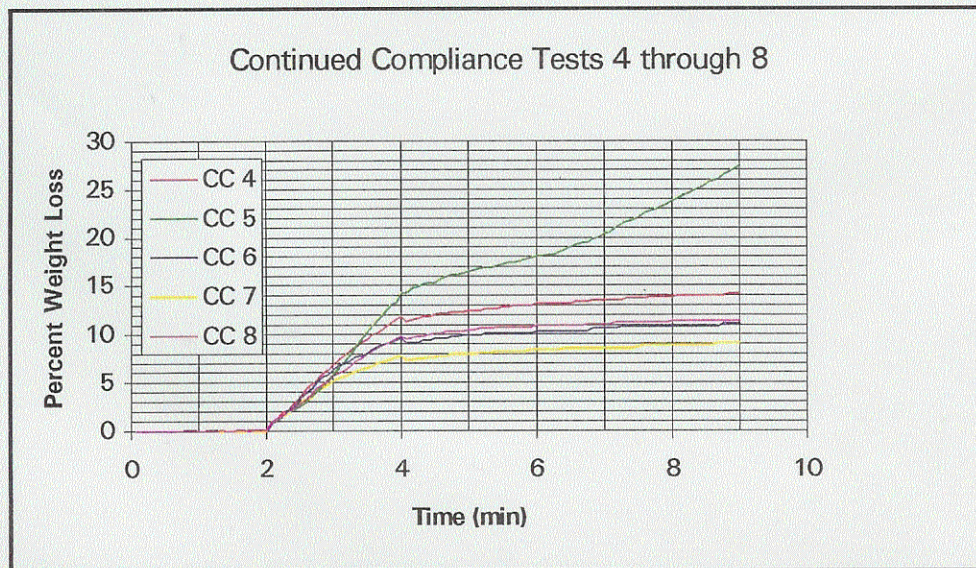
FIGURE 2. PERCENT WEIGHT LOSS PROFILES, TESTS 4 THROUGH 8

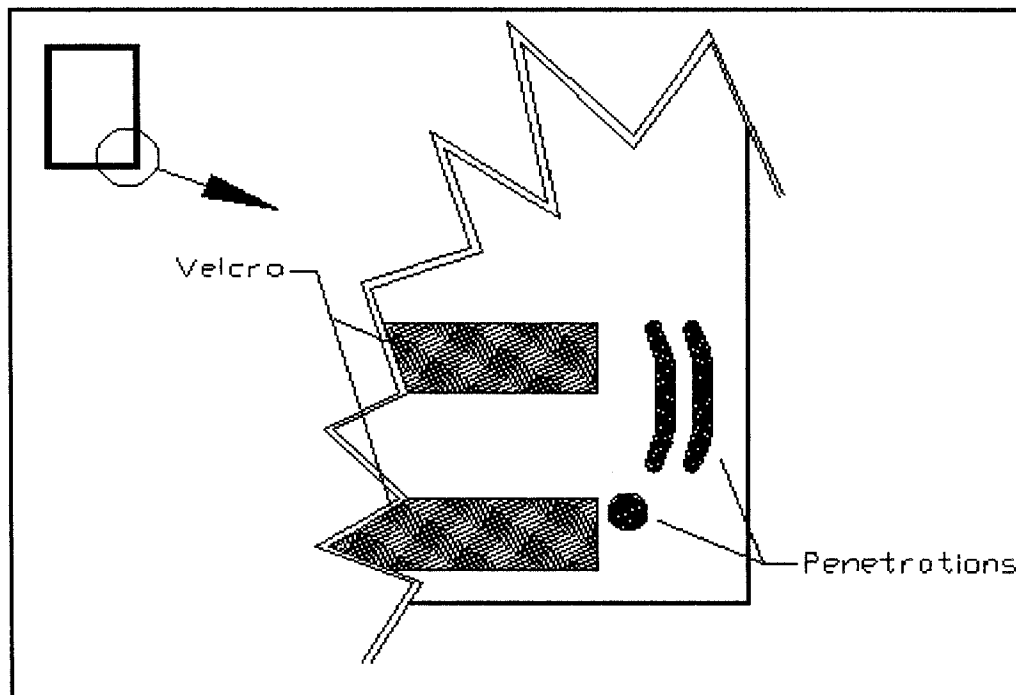
Test number five resulted in a weight loss of 27.47 percent. Excessive damage resulted from penetrations in the vertical cushion FBL. The three penetrations were located on the back side bottom corner closest to the burner (see figure 3). They consisted of two, four-inch by one-half-inch (10.2-cm by 1.27-cm) vertical, parallel slashes with a separation of one inch (2.54-cm); and a one-inch (2.54-cm) -diameter hole located approximately two inches (5.08 cm) below and one inch (2.54 cm) to the side, opposing the burner, from the vertical slashes. During the portion of the test when the oil burner was turned off, burning originated from the backside of the cushion. This behavior was solely due to the FBL penetrations.

FIGURE 3. TEST NUMBER FIVE FIRE-BLOCKING LAYER PENETRATIONS
(vertical cushion, cutaway view of rear facing corner closest to burner cone)

Test number five demonstrated the effect of FBL penetrations. The two, four-inch by one-half-inch (10.2-cm by 1.27-cm) slashes plus the one-inch (2.54 cm) -diameter circle, provide a total penetration area of 4.78 square inches (30.8 square centimeters). Several other cushions also had penetrations in differing spatial orientations which negated propagational behavior as seen in test number five. These penetrations, found in cushions tests 9, 11, and 33, were characterized as one-inch (2.54-cm) or less diameter holes being mechanically created by vibration and friction

from contacting rivet heads or other such features in the stock seat frame. The orientation of the burner flame to the penetration played the obvious factor regarding fire development.

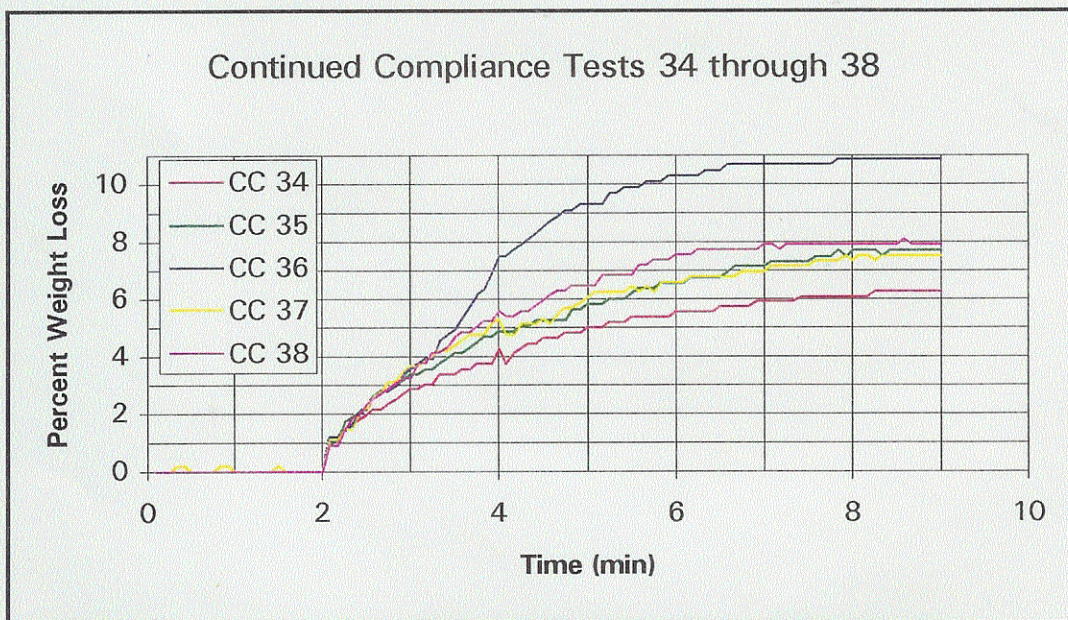
The percent weight loss was 10.87 for test number 36. This test was one of the final four tests performed which had reused vertical cushions. In review of this test, the final weight loss was mainly affected by the involvement of the reused vertical cushion. Had the vertical cushion been in an untested condition, the entire cushion set would have been expected to pass in the same manner as the other 29 tests.

FIGURE 9. PERCENT WEIGHT LOSS PROFILES, TESTS 34 THROUGH 38

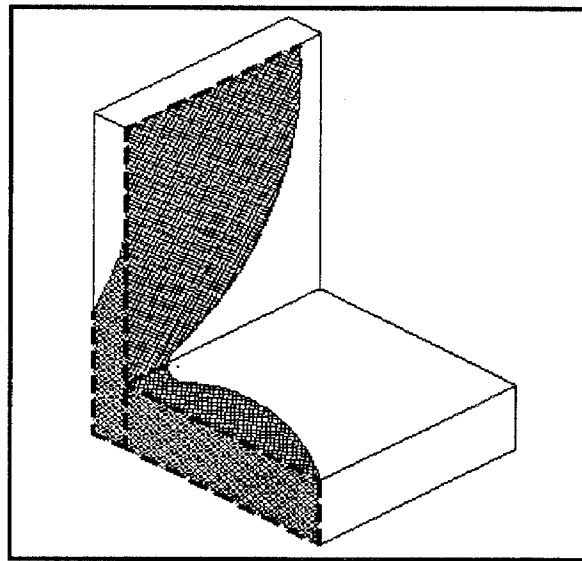
The seat cushion tests, for the most part, followed a generic sequence of events. Upon flame impingement, the vertical edge of the horizontal cushion facing the burner lost its dress cover due to combustion. The flame also contacted the upper and lower horizontal cushion surfaces of the horizontal cushion near the burner cone. The burner flame also tracked in an upward arc across the front, vertical face of the vertical cushion. The arc started from the intersection of the horizontal and vertical cushions, close to the burner, and swept upward further away from the flame source. A typical burn pattern is shown in figure 16.

FIGURE 16. TYPICAL BURN PATTERN RESULTING FROM SEAT TEST
(typically damaged areas are cross-hatched)

The dress cover material was consumed in these areas as well. The fire-blocking materials subjected to the oil burner flame were only affected in the flame contact zone and the immediate vicinity of the burner jet. The FBLs underwent a thermal degradation which resulted in a black, charred, brittle state. In many instances, a crack formed on the vertical cushion edge which received the direct flame contact. This crack had no further negative effect in the combustion of the cushion. Excluding the vertical edge facing the burner cone, the mechanical integrity of the FBL materials were never compromised due to flame impingement.
