DOT/FAA/AR-95/54

Transport Water Impact and Ditching Performance

March 1996

Final Report

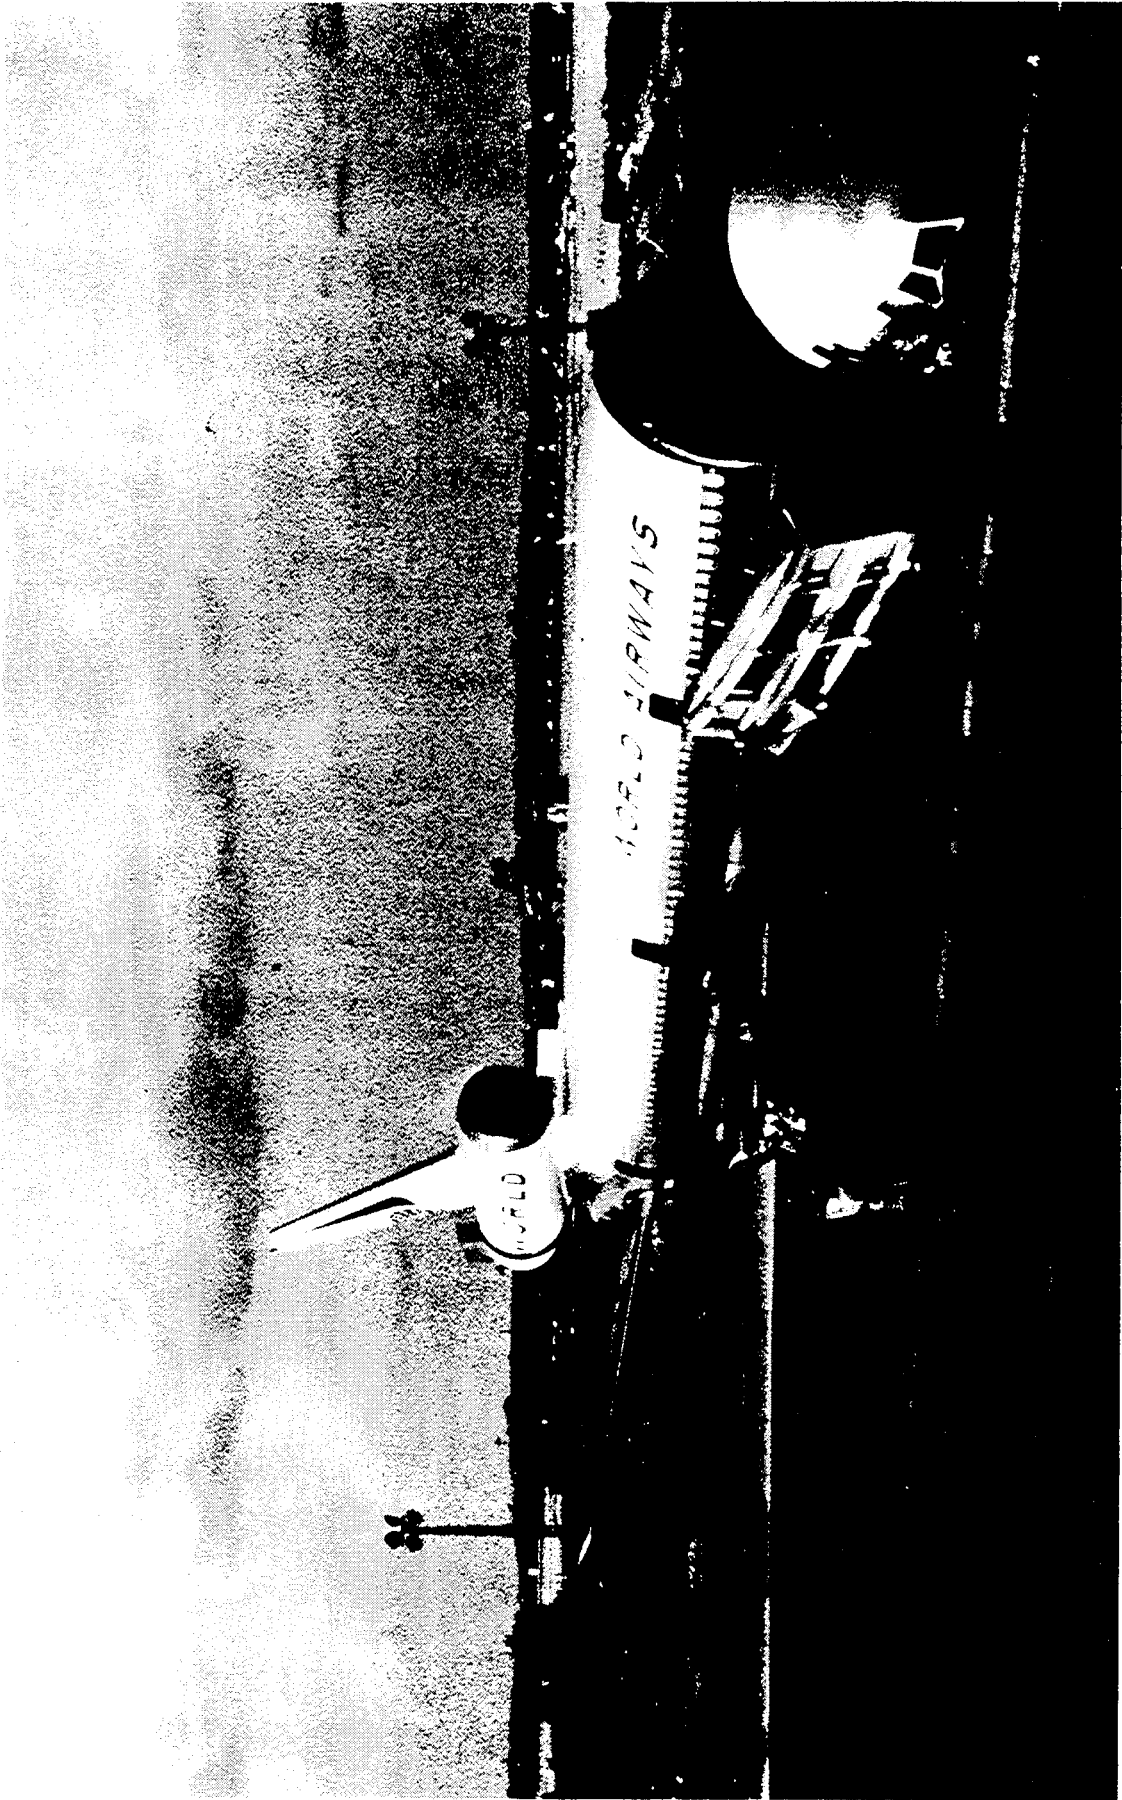
Upon crossing the end of the runway, the airplane came to rest with a slightly nosedown attitude in water which came up to the wings. A section of the nose up to the first row of the cabin seats separated along a fracture line (figure 1) and remained attached to the fuselage only by control cables and electric wire bundles. The pressure bulkhead was crushed along the fuselage bottom centerline, and the main cabin floor beams from fuselage station (FS) 392 to 475 failed due to the downward displacement. The pressure bulkhead at the forward end of the nose gear was crushed as well, leading to the failure of the extended nose gear. The main landing gear were extended and remained undamaged. The airplane's three engines remained attached to their respective pylons, although the No. 3 engine's rear mount was broken. There was no substantial mechanical damage to the engine.

The overall impact forces experienced by the passengers as the aircraft came to rest in the water did not jeopardize occupant survival except in the area of the fuselage separation. The failure of the main cabin floor beams in this area led to floor displacement and subsequent seat track fractures. Three seat modules in the first passenger row, consisting of three left, two center, and three right seats, separated from the floor. This led to the disappearance and presumed death of two of the three passengers seated in this row. The third passenger seated in this row was able to climb back into the main cabin. The cabin aft of the structural separation remained intact.

FIGURE 1. WORLD AIRWAYS DC-10 AFTER COMING TO REST IN BOSTON HARBOR

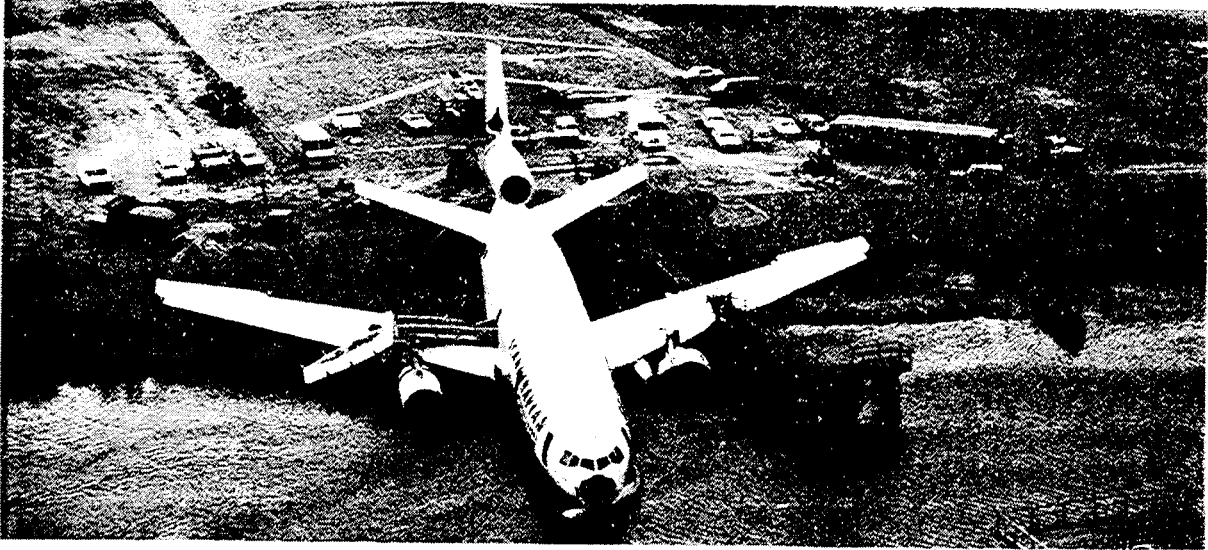
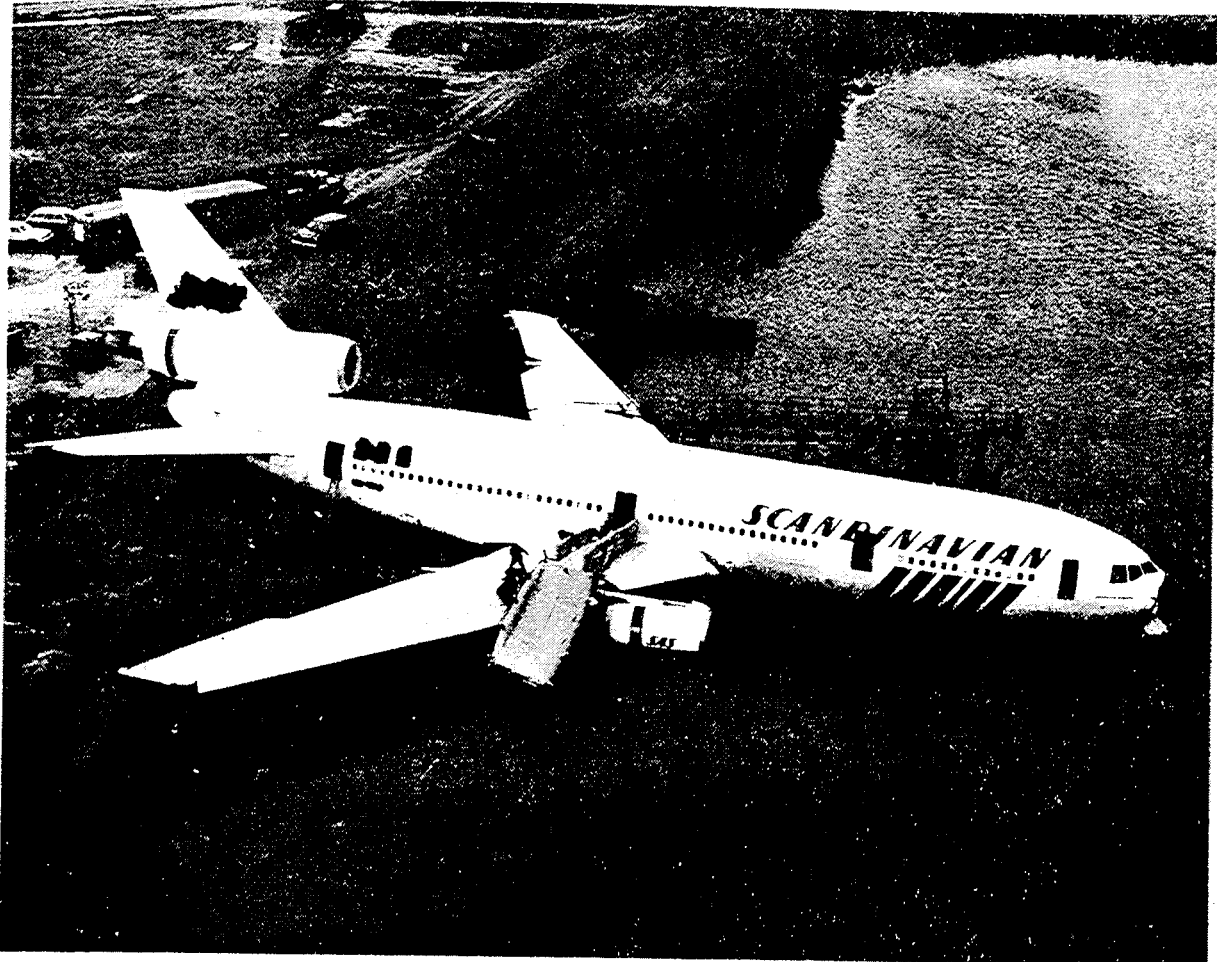
The nose of the airplane came to rest in the tidal waterway approximately 160 feet from the end of the runway overrun area (figure 2). The leading edge of the left wing was embedded in a wooden pier structure which supported the approach lighting system. The aft section of the airplane remained generally intact, however there was major damage to the lower nose area, to the radome, and to the forward pressure bulkhead at fuselage station (FS) 275. The damage was caused by hydrodynamic pressure generated during impact with the water.

The interior of the forward fuselage area was deformed. The wings, leading edge, and flaps sustained moderate damage from impact with the wooden pier. Several floor beams beneath the galley were fractured. The nose gear collapsed and its drag braces fractured and separated from their attachment fittings. Wing engines Nos. 1 and 3 sustained impact and salt water damage. The No. 1 engine pylon structure was also buckled and twisted. The No. 2 engine sustained no impact damage.

FIGURE 2. JOHN F. KENNEDY AIRPORT RUNWAY GRADUAL SLOPE TO WATER

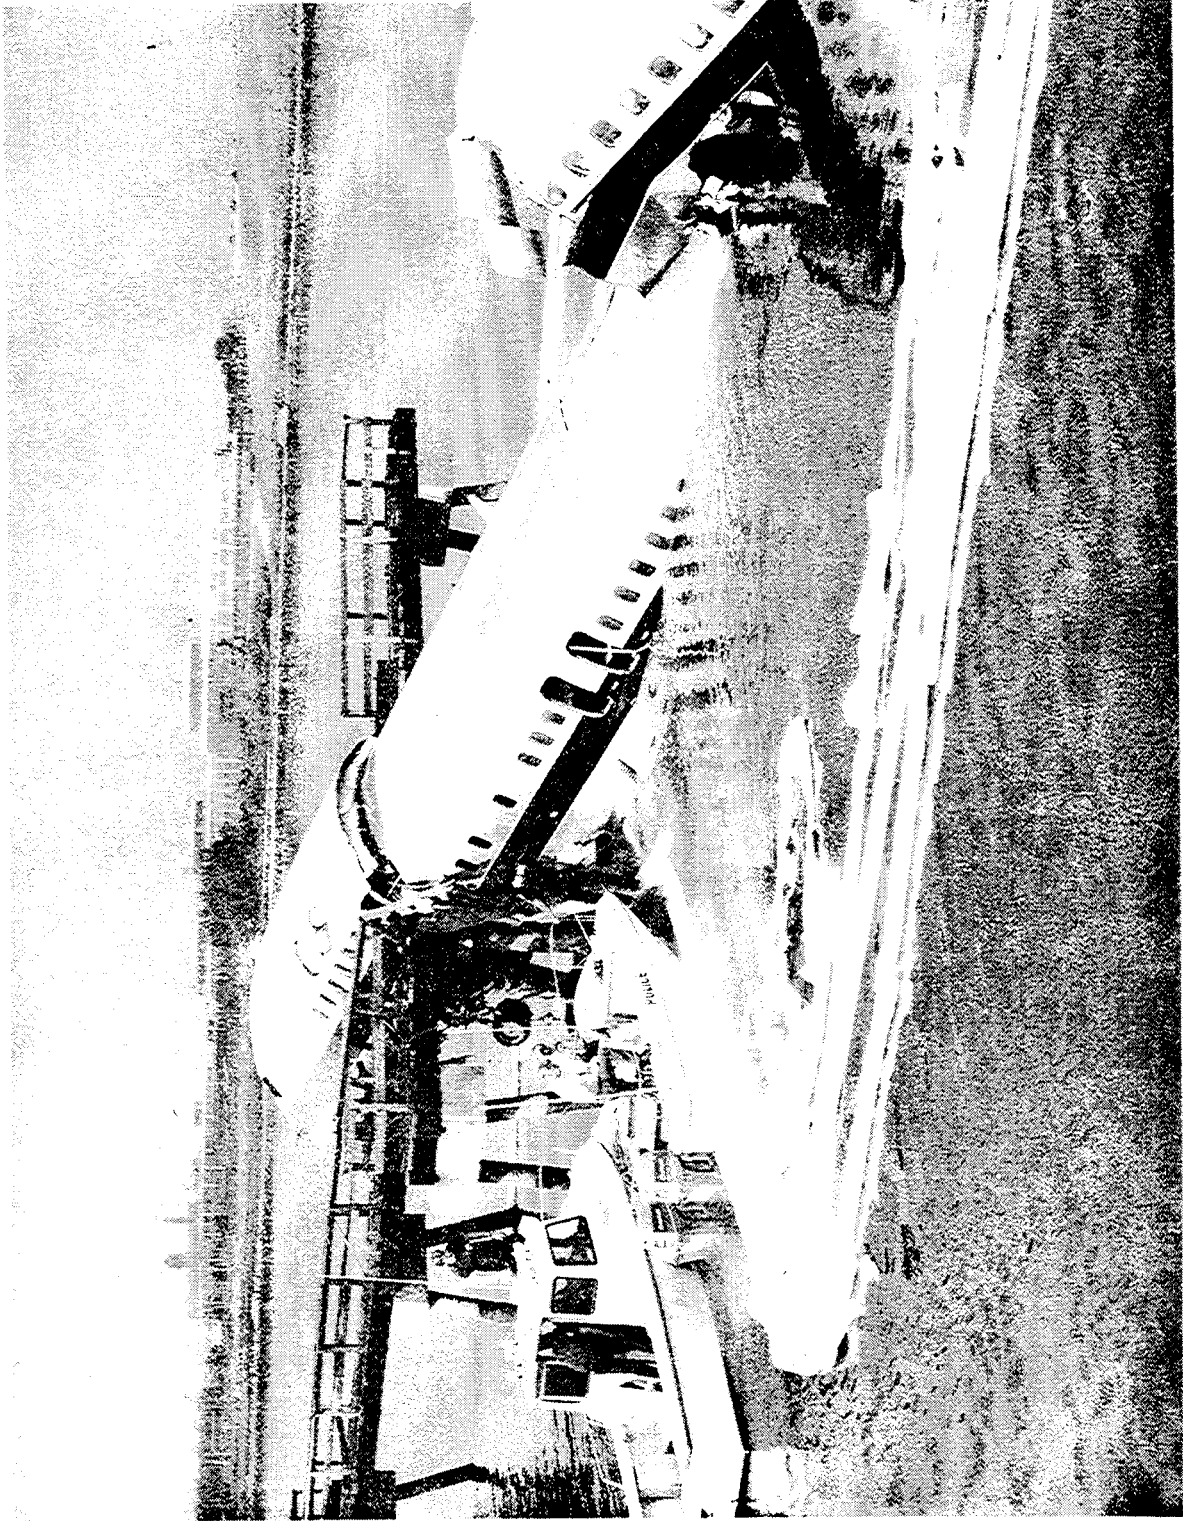
Decelerative forces were not great enough to cause any seat dislocations or seat belt/shoulder harness separations. The only seat damage was caused by fuselage crush and subsequent floor displacement.

Floor displacement was the primary cause of two fatalities. Timber from the wooden approach light pier structure penetrated the fuselage and forced the floor section and surrounding seats upwards, crushing four passengers against the ceiling. Two passengers in row 21 were killed by asphyxia caused by compression of the chest and two passengers in row 22 sustained serious multiple injuries. A piece of wood also penetrated the forward cockpit bulkhead, but did not produce any seat dislocations and caused only minor injury to the captain. The airplane was equipped with eight exits (figure C-3): the L-1 main boarding door, the L-2 aft entry door, the R-1 forward galley door, the R-2 aft galley door, and four overwing exits. All exit doors, with the exception of the L-1 and L-2, were used during evacuation. The L-1 door could not be opened by the lead flight attendant, and the L-2 door was closed when water began entering the cabin. The R-1 slide was successfully deployed. The flight attendant disarmed the R-2 slide before the door was opened to prevent the slide from blocking the exit area. Both the left and right overwing exits operated successfully during evacuation.

FIGURE 3 US AIR B737-400 AFTER COMING TO REST ON LIGHTING STANCHION IN BOWERY BAY

NTSB made the following recommendations to the Port Authority of New York and New Jersey. Survey the 1,000 by 500 foot surface area contiguous to the departure ends of the runways at the LaGuardia Airport in order to minimize hazards to airplanes that do not stop on the runways.

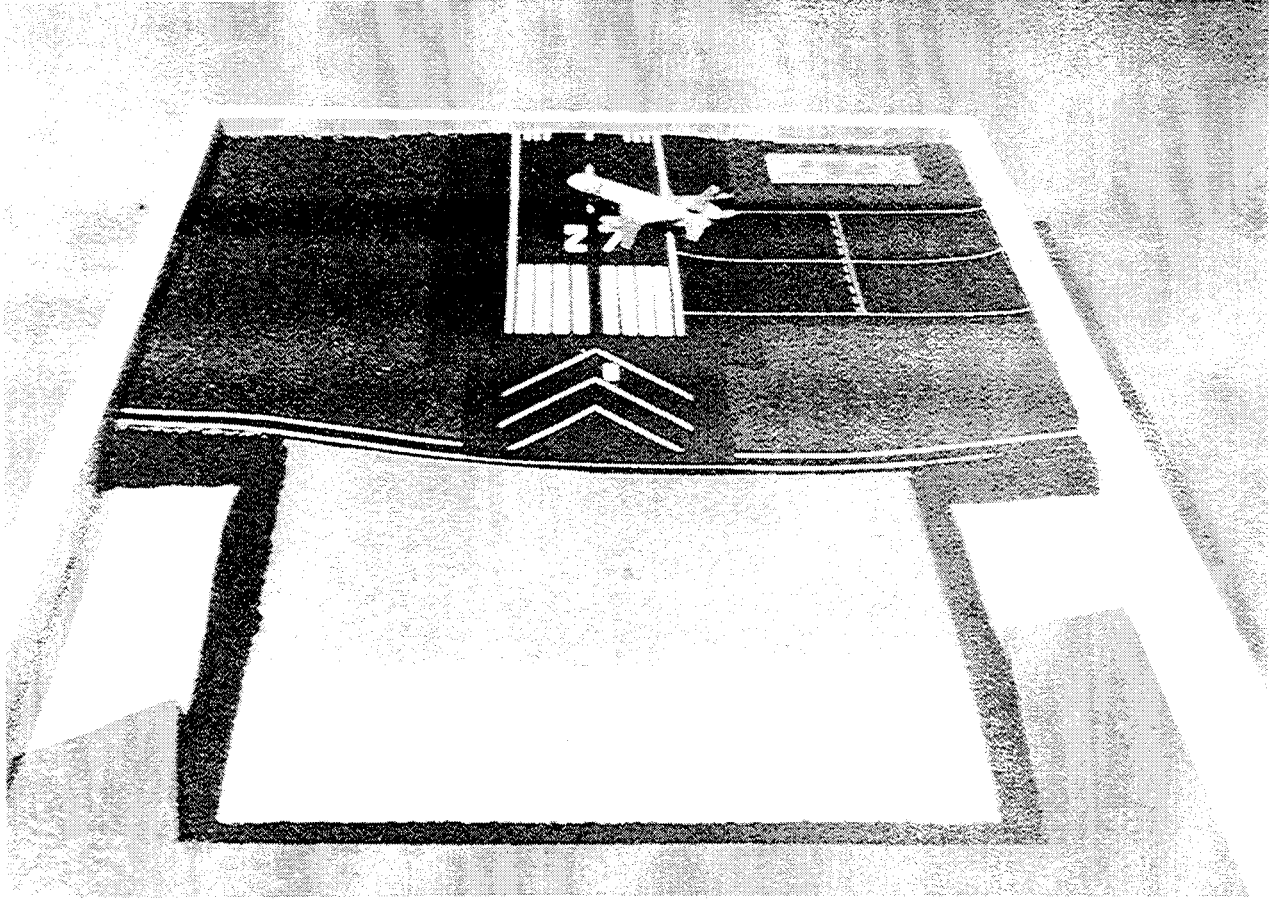
Allowing the airplane to gradually slide into water, as in the JFK accident, should result in minimal aircraft damage and a successful emergency evacuation of all occupants using the available flotation devices. Runway overrun areas leading into water which avoid sudden drop-offs and allow for a smooth transition into the water can reduce impact forces and prevent fuselage separations. Evidence to support this is provided by both the FAA and airport engineers. As stated in FAR Part 139.307 (a)(1), "No slope from the edge of the full-strength surfaces downward to the existing terrain shall be steeper than 2:1," thus preventing vertical drop-offs. Boston-Logan Airport Engineers have looked into the feasibility of developing sloped runway safety areas that decelerate the aircraft through the use of gravel. The model of such a sloped overrun area, developed by Boston-Logan Airport Engineers, is shown below in figure 4.

FIGURE 4. INCLINED SAFETY AREA (ISA) MODEL DEVELOPED BY BOSTON-LOGAN AIRPORT ENGINEERS

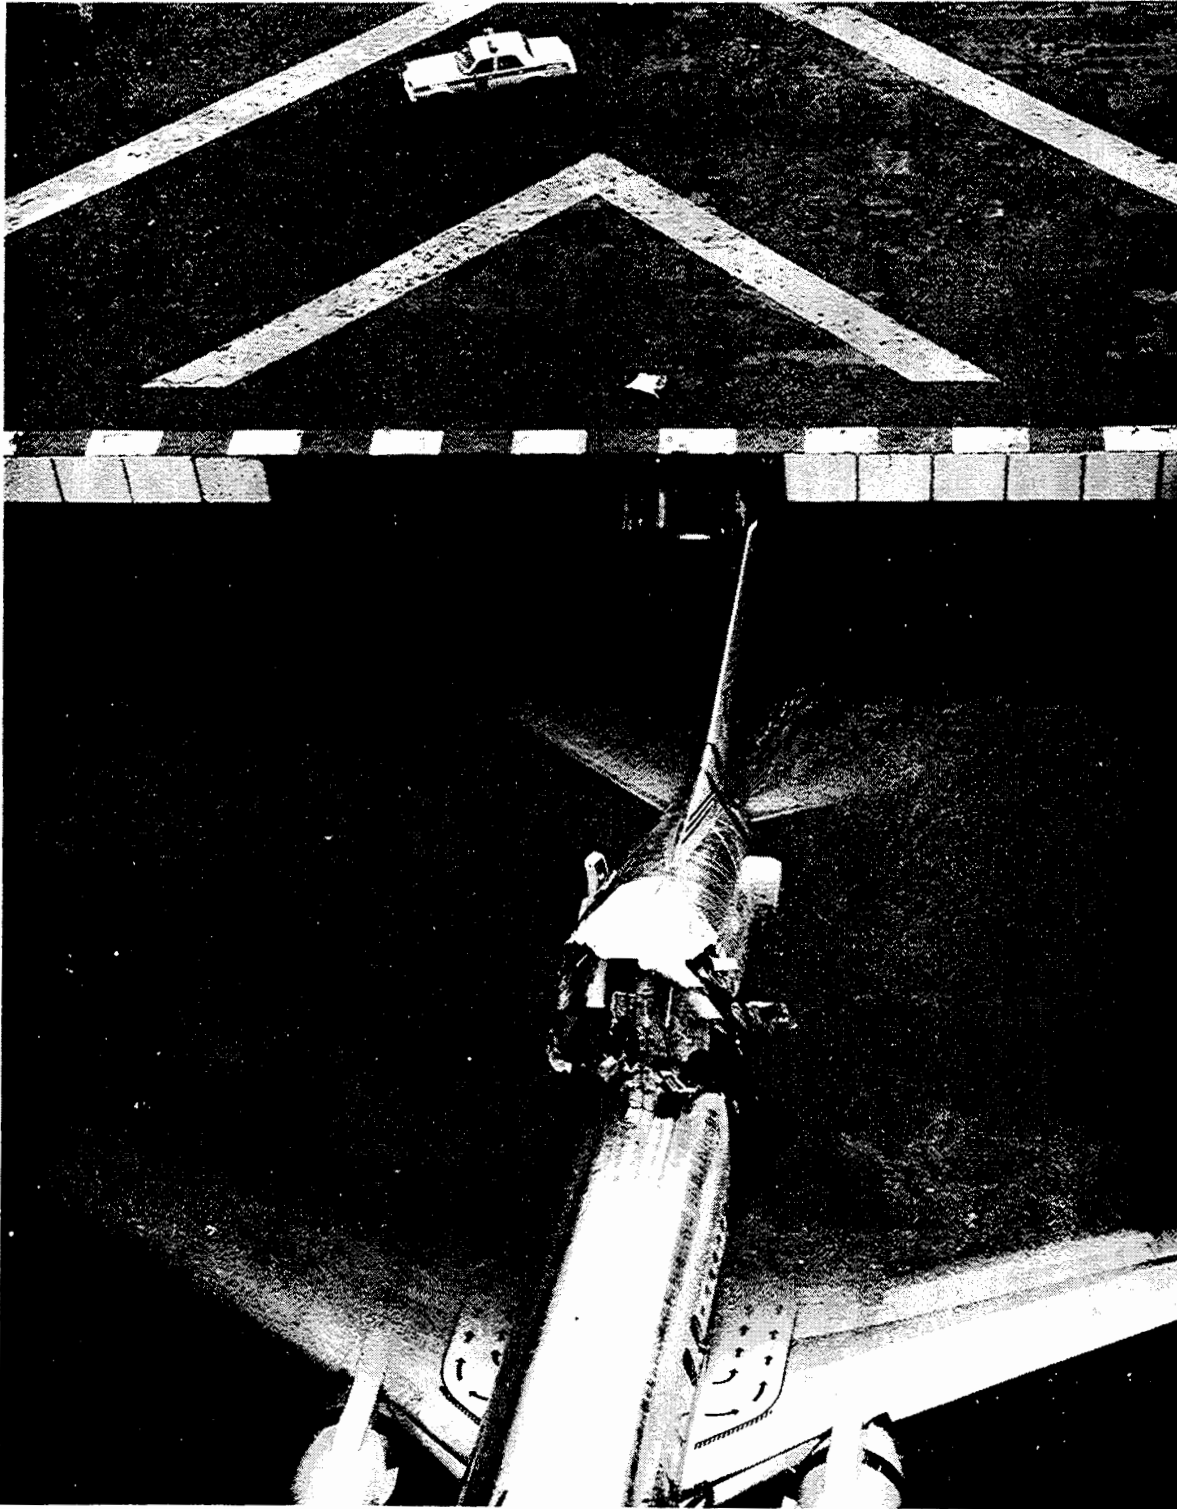
FIGURE 5. LAGUARDIA AIRPORT RUNWAY DROP-OFF TO WATER
