DOT/FAA/AR-96/48

Fuel Fire Penetration Test and Destruction of a Transport Aircraft

December 1996

Final Report

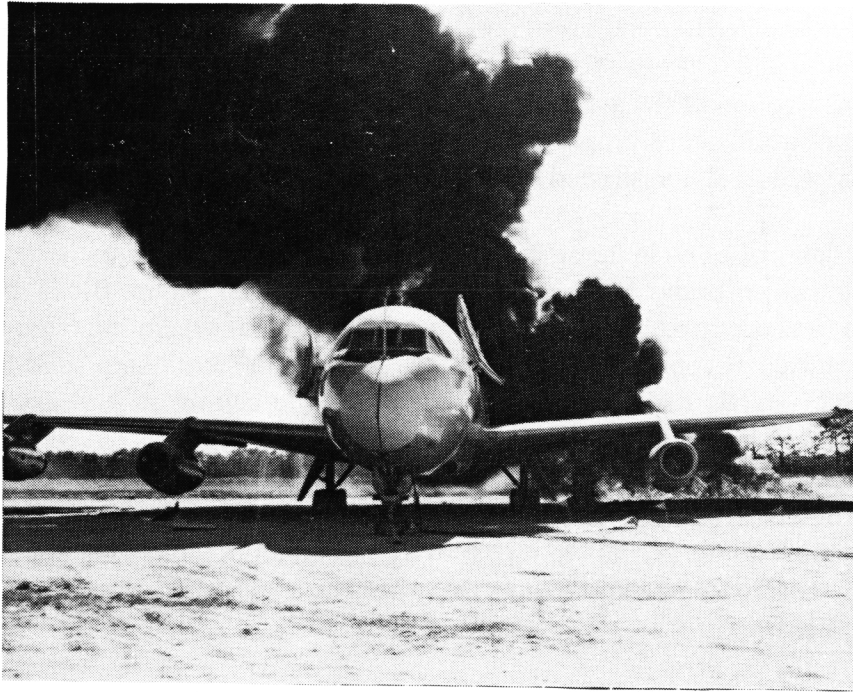
The external fuel fire burned steadily for 8 minutes and did not self-extinguish from lack of fuel until 11 minutes 15 seconds had elapsed. The fire plume was blown by the 12-knot wind against and over the rear fuselage (figures 4 and 5). However, long before the pool fire was out, the interior of the aircraft supported a self-sustaining cabin fire. Two minutes twenty-five seconds after the pool ignition a visible seat fire was observed in the main cabin. Two minutes thirty seconds into the test, heavy black smoke was observed pouring from the starboard rear service door. A small fireball erupted from the starboard rear service door at 2 minutes 47 seconds.

FIGURE 4. FULLY DEVELOPED FUEL FIRE, FORWARD VIEW, 20 SECONDS AFTER IGNITION

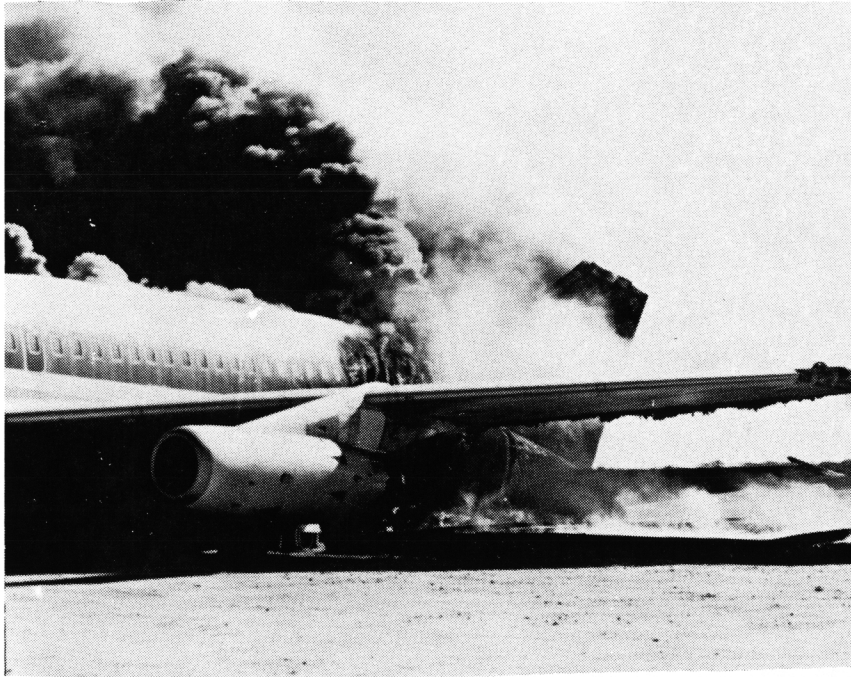
The port side windows burned through from the inside at stations 973 and 1011 at the 10-minute mark (figure 8).

FIGURE 8. INTERNAL FIRE PROGRESSES FORWARD TO STATION 933,
10 MINUTES AFTER IGNITION

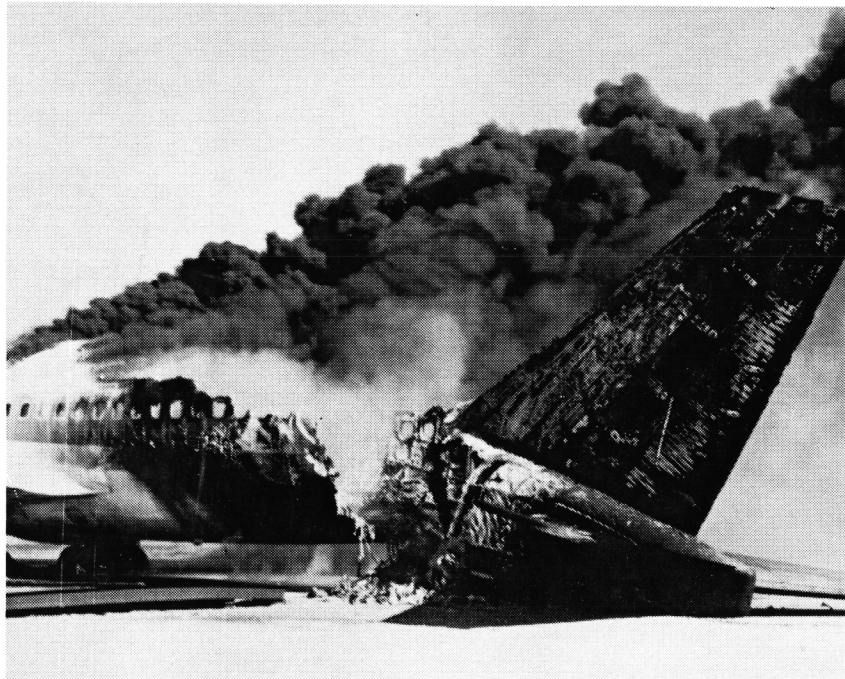
The top of the fuselage began to turn brown at stations 749 and 603, and by 20 minutes 12 seconds, the entire top of the fuselage from station 749 aft is burned through (figure 9). Flames penetrated the top of the fuselage at station 508 at 21 minutes 45 seconds. The entire top of the fuselage from station 479 aft was consumed by the fire at 23 minutes 20 seconds. By 24 minutes 50 seconds, this had progressed to station 342 (figure 10). At 27 minutes 55 seconds, all combustibles aft of station 758 were consumed, the fuselage was burned down to the window level, and the fire continued to burn in the first-class cabin. By 29 minutes 30 seconds, the fire in the first-class cabin and the cockpit began to die down as all remaining combustibles were consumed.

FIGURE 9. THE TOP OF THE FUSELAGE IS BURNED THROUGH FROM STATION 749 AFT, 20 MINUTES 12 SECONDS AFTER IGNITION

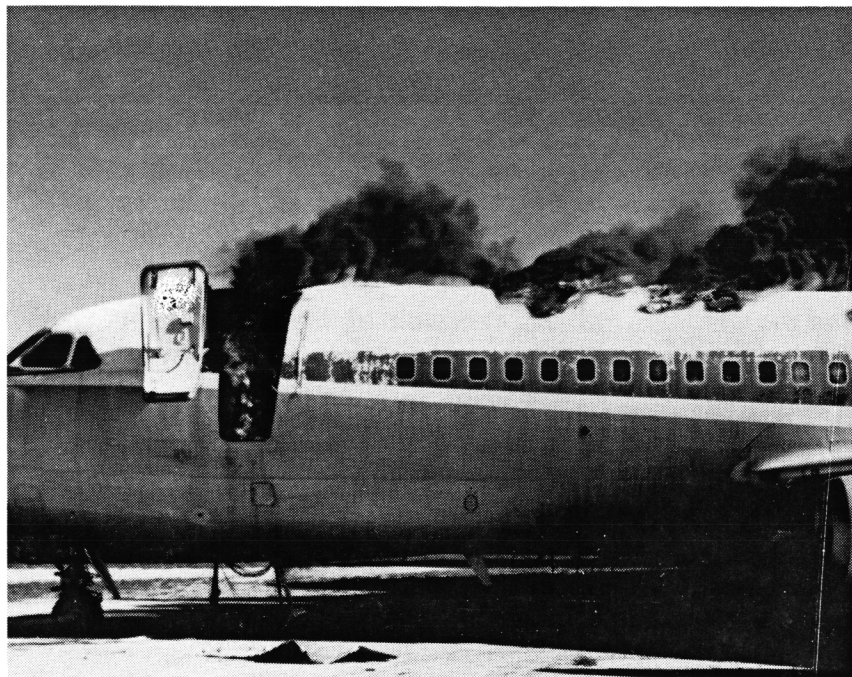
FIGURE 10. FIRST-CLASS CABIN IS COMPLETELY ENGULFED IN FLAMES, 24 MINUTES 50 SECONDS AFTER IGNITION

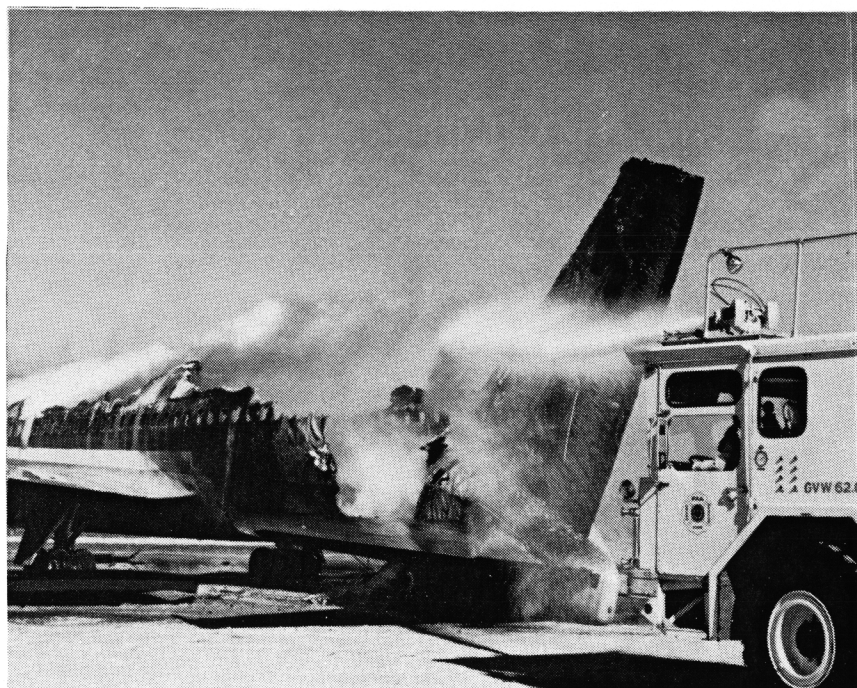
At 33 minutes, the remaining smoldering fire was extinguished by the Airport Fire Service (figure 11).

FIGURE 11. REMAINING FIRE IS EXTINGUISHED BY AIRPORT FIRE SERVICE, 33 MINUTES AFTER IGNITION

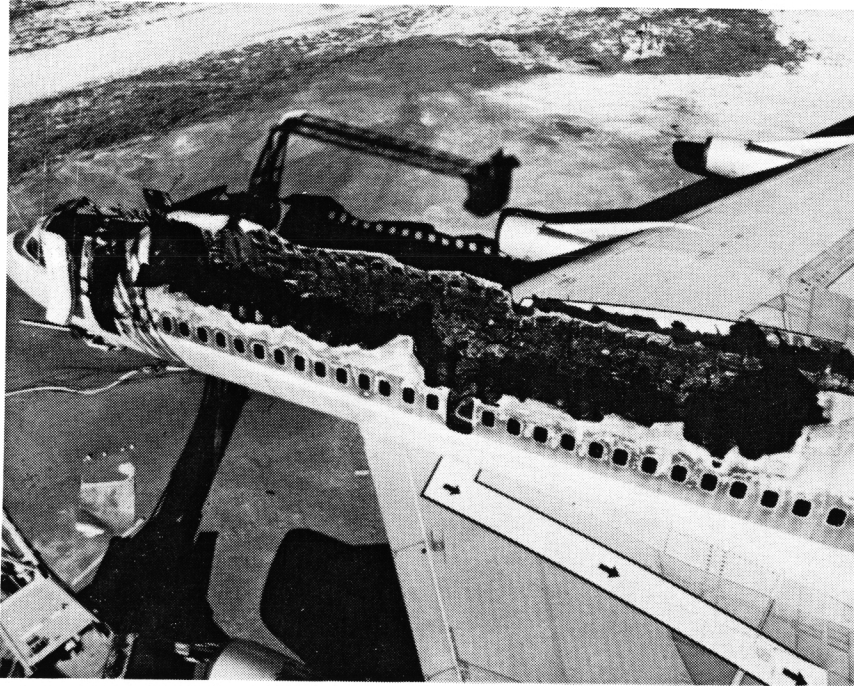
The entire interior of the aircraft was completely gutted. There were no recognizable interior furnishings. All of the windows, with the exception of those on the flight deck, were consumed. The top of the fuselage was burned down to just above the windows (figures 12 and 13). The entire empennage assembly was separated from the fuselage at station 1264 (figure 14). The cabin floor was consumed aft of the main wing spar. Forward of the main wing spar, the floor was intact as well as the forward cargo compartment. The remaining floor support beams were weakened, twisted, and sagging.

FIGURE 12. AERIAL VIEW OF CABIN FORWARD AFTER FIRE

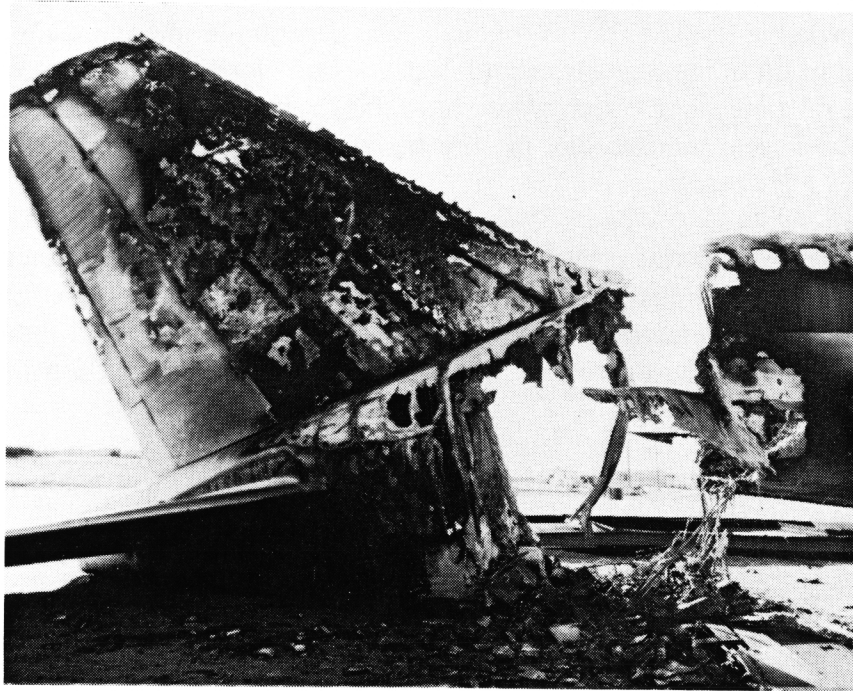
The skin on both sides of the leading edge of the vertical stabilizer and the port horizontal stabilizer was perforated. The starboard side of the vertical stabilizer was heavily coated with soot (figure 16). The starboard horizontal stabilizer was soot coated but relatively undamaged. The tail cone was lightly soot coated but undamaged to the naked eye.

FIGURE 16. STARBOARD SIDE OF VERTICAL STABILIZER HEAVILY COATED WITH SOOT

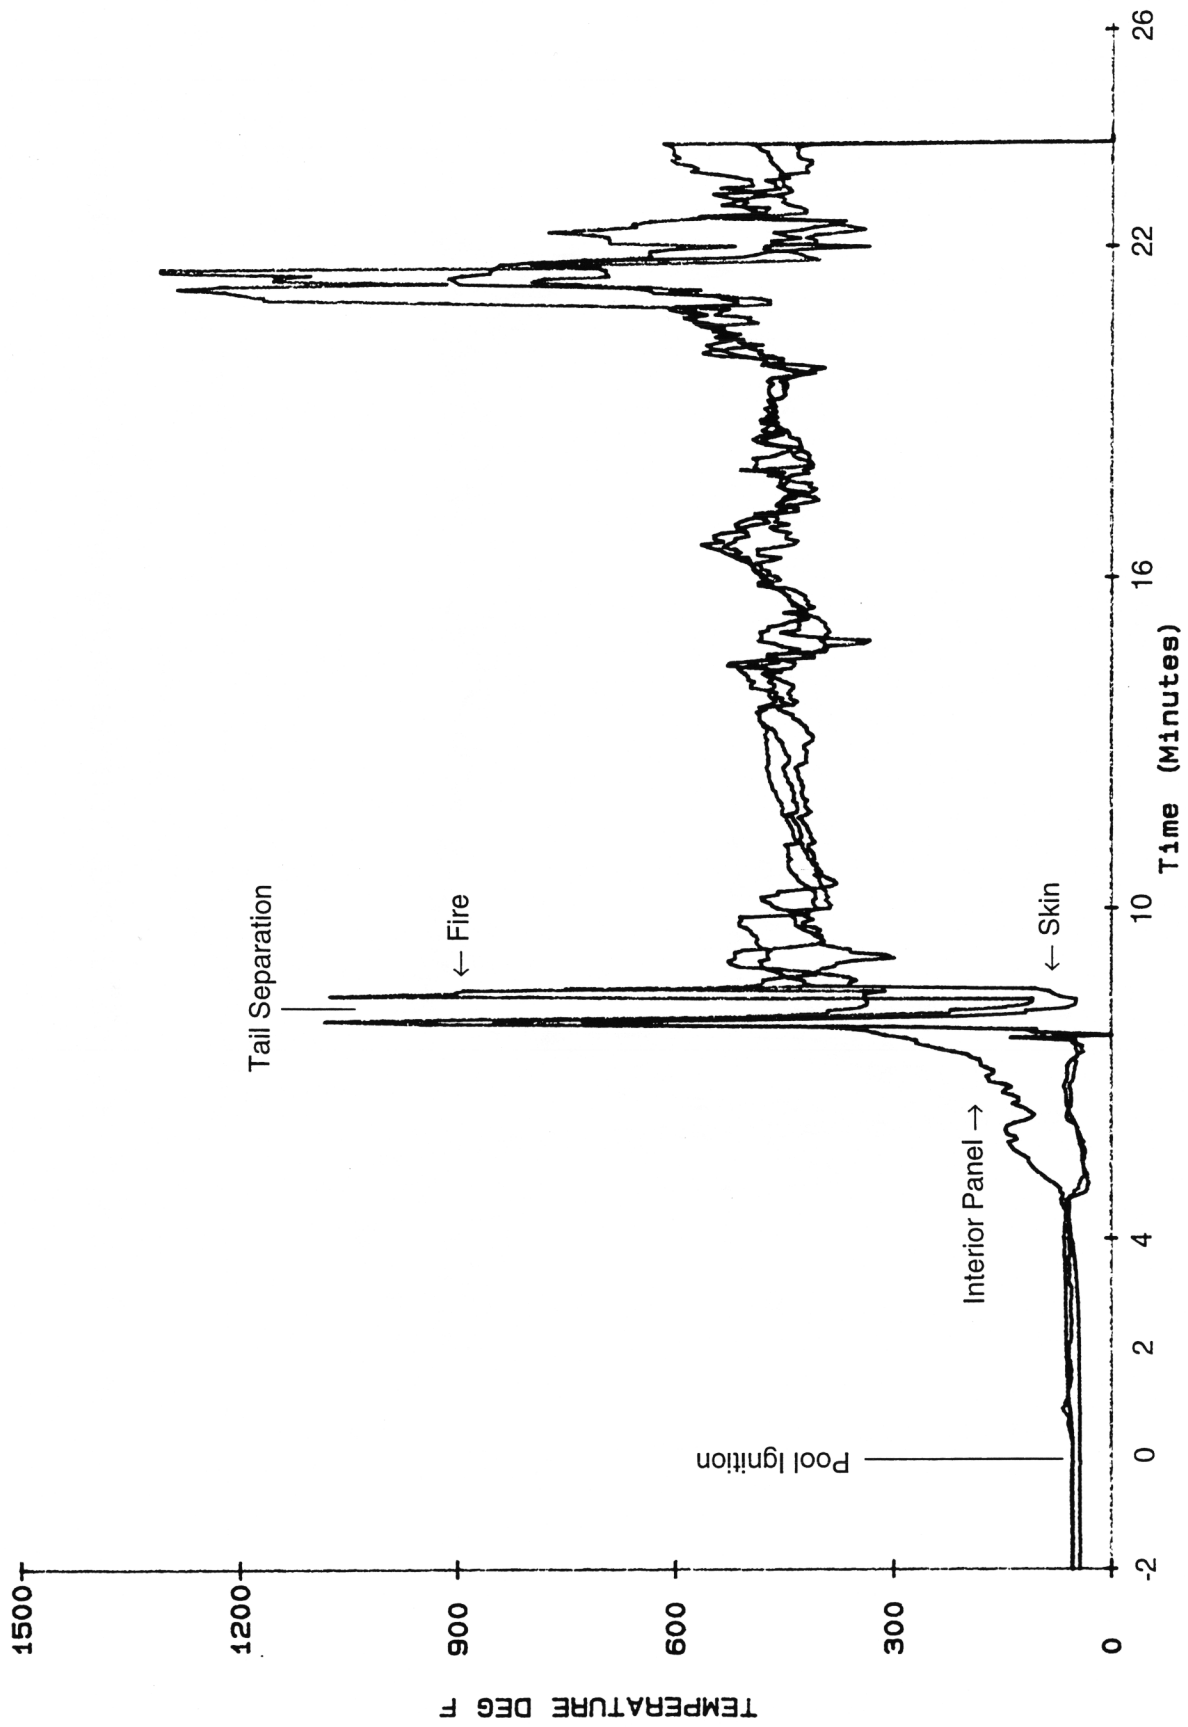
FIGURE B-5. TEMPERATURE PROFILE THROUGH FUSELAGE SKIN AT STATION 1192, BELOW WINDOW, STARBOARD SIDE

Figure B-5 is the temperature profile through the hull just below the window on the starboard side. The area was not exposed to the exterior pool fire. The temperature of the interior sidewall panel began to rise at 5 minutes. This is an indication of the interior cabin fire and not burnthrough as can be seen by the lower skin temperature.

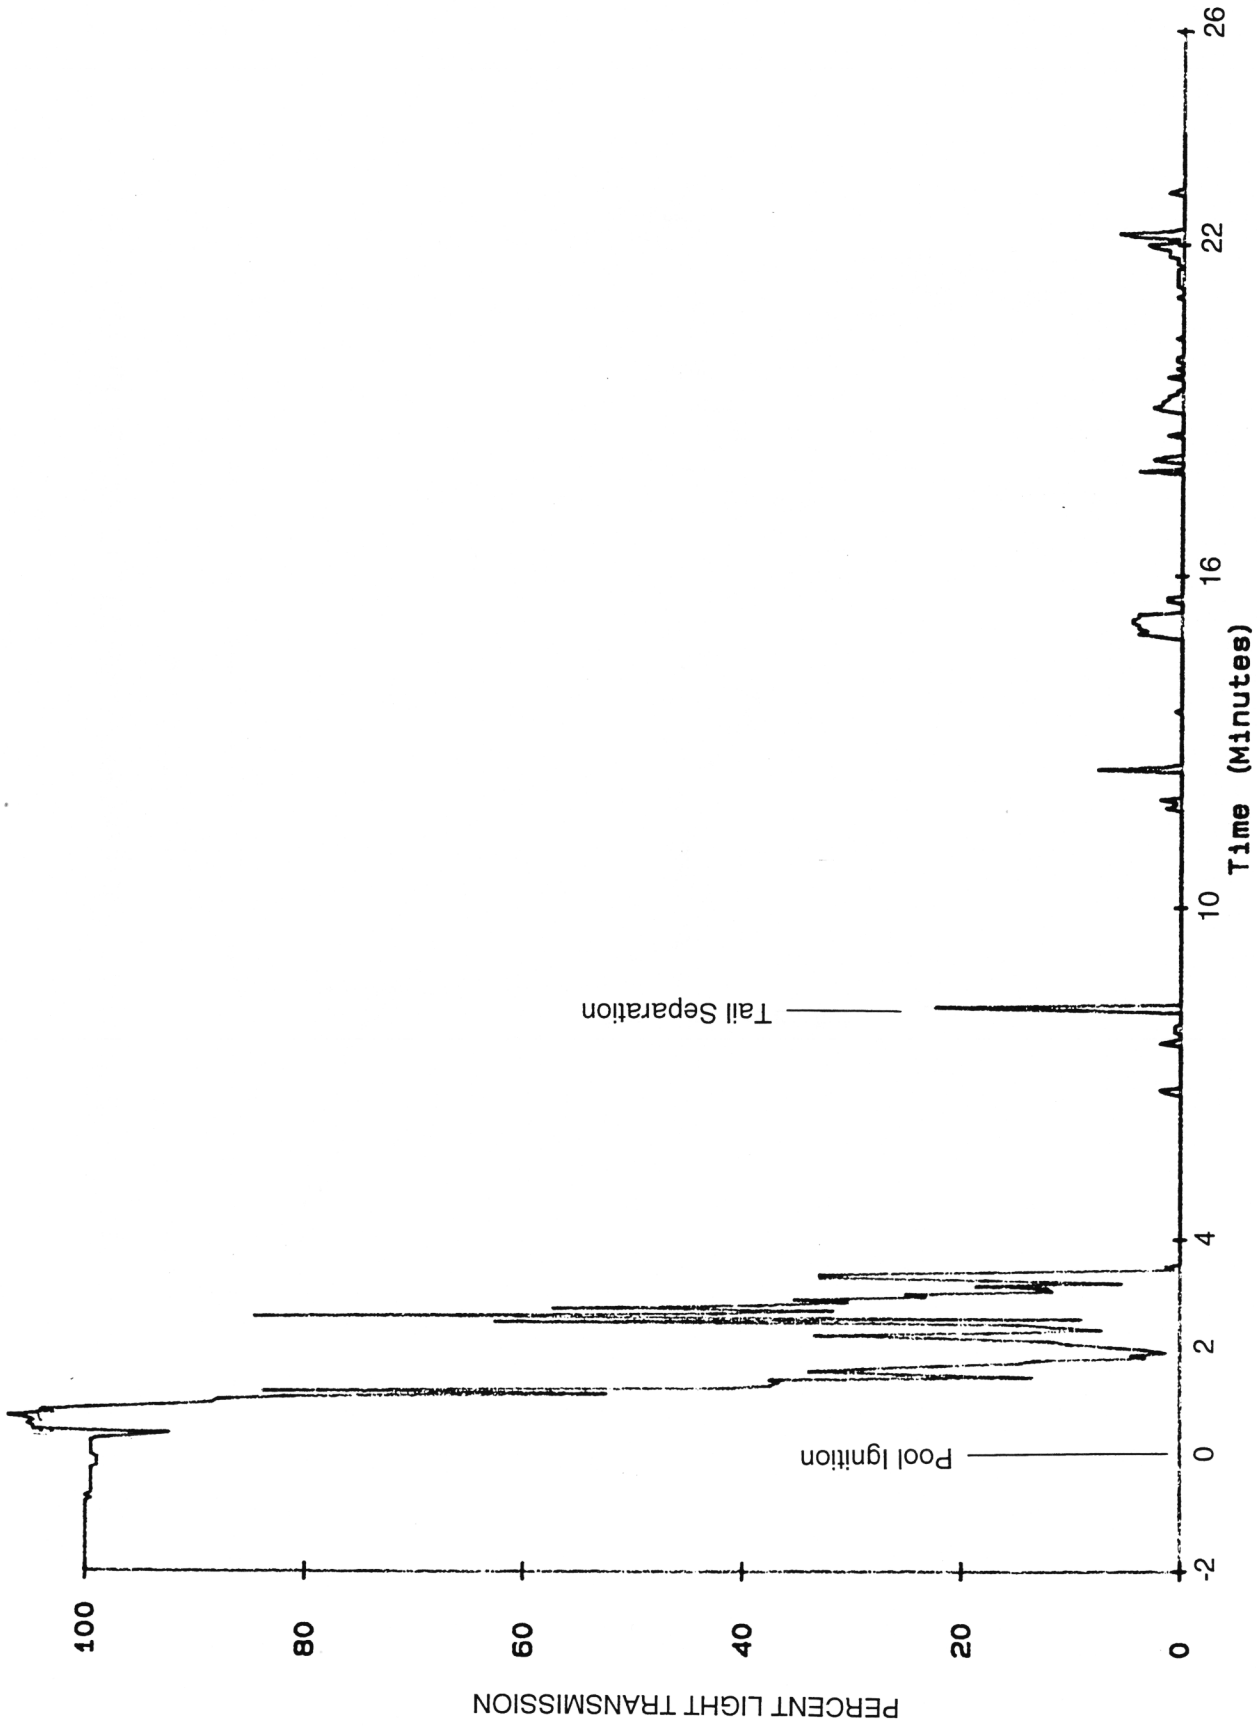
FIGURE B-12. SMOKE DENSITY AT STATION 1280

Figures B-12, B-13, B-14, and B-15 are percent light transmission measurements obtained 48 inches above the floor. The smoke meter for figure B-12 was located in the rear of the aircraft at station 1280. This figure shows a steep drop in light transmissibility beginning 1 1/2 minutes after the pool fire was ignited or only 19 seconds after the first flame penetration was observed in the main cabin at station 1220.

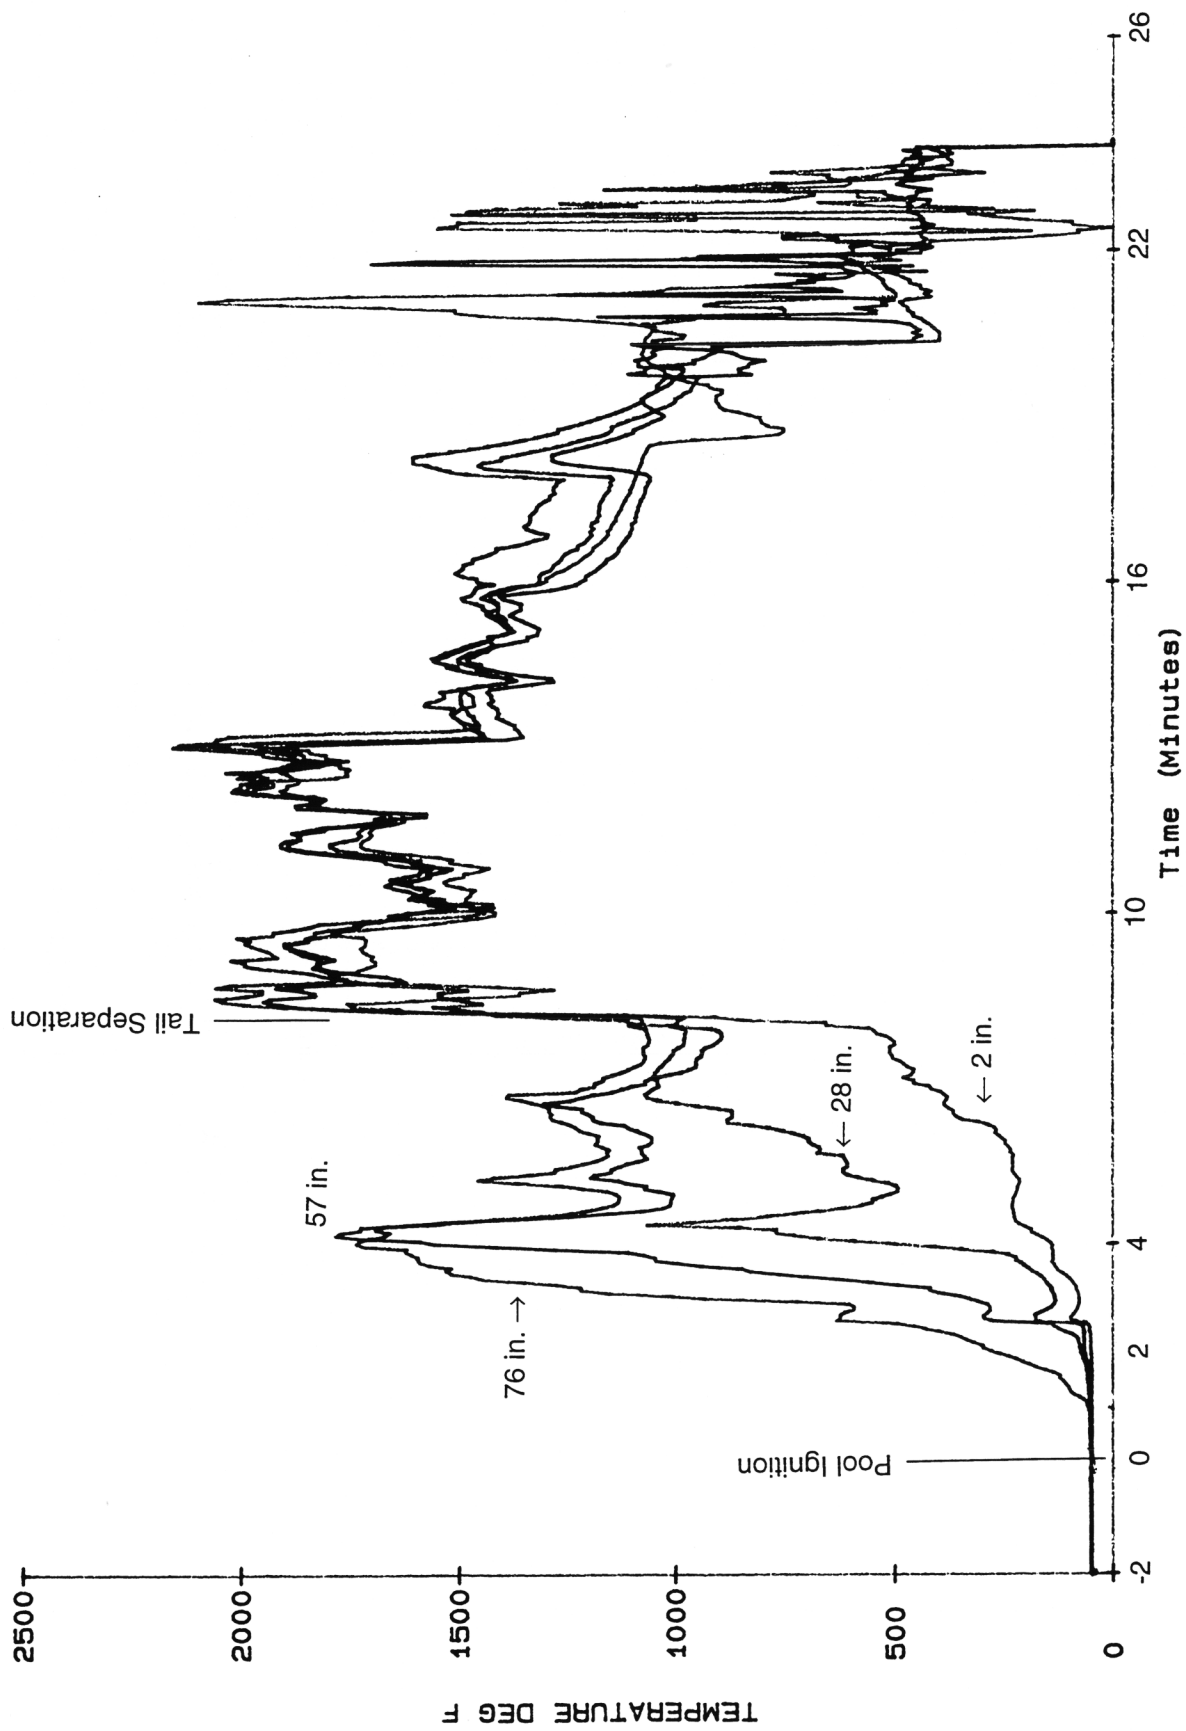
FIGURE B-16. THERMOCOUPLE TREE 1 AT STATION 1280

Figure B-16 shows a vertical air temperature profile at station 1280 across from the starboard rear service door. The ceiling temperature began to rise a few seconds after the burnthrough at station 1220, approximately 1 minute 20 seconds after the pool was ignited. The ceiling temperature indication peaked at 1750°F at about 4 minutes and then dropped off to 1200°F. The temperature peaked again at 2000°F when the tail separated from the aircraft.

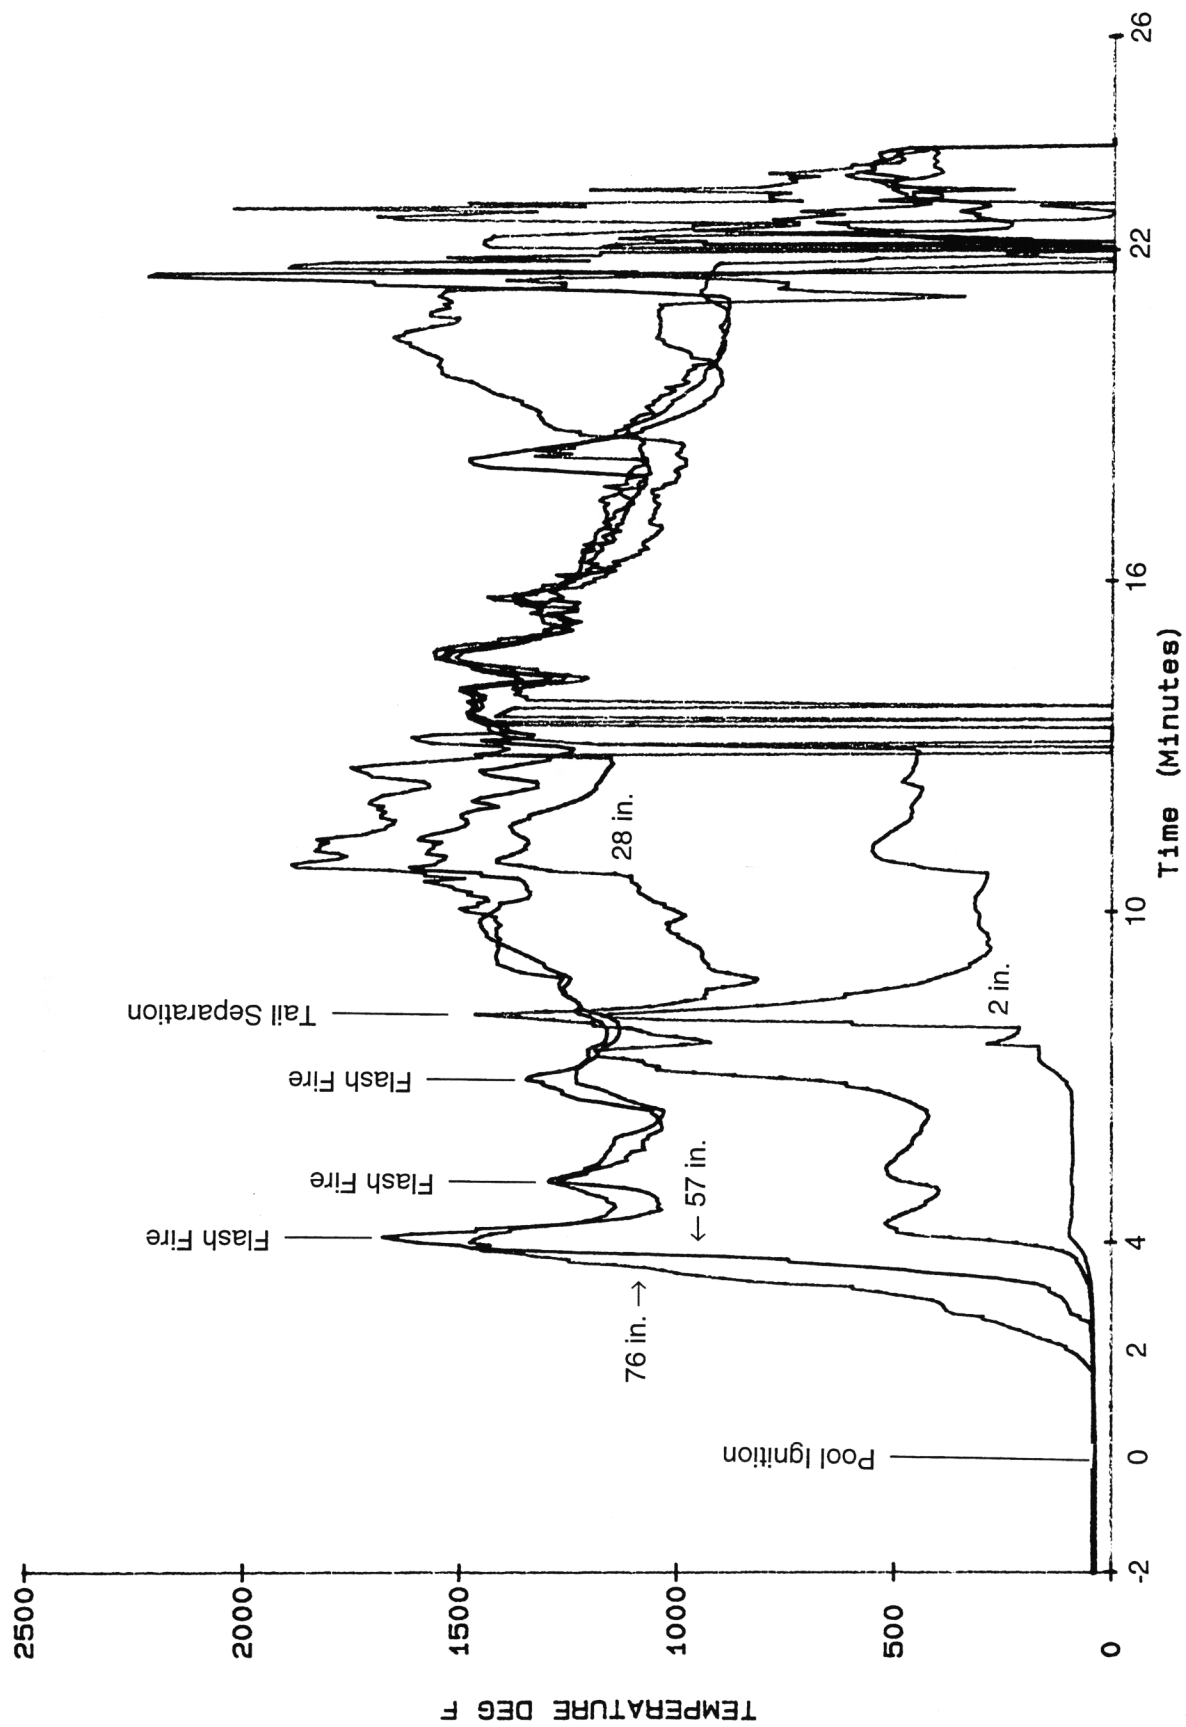
FIGURE B-17. THERMOCOUPLE TREE 2 AT STATION 1106

The thermocouple tree at station 1106 was located 10 feet forward of the initial burnthrough at station 1220 (figure B-17). The ceiling temperature began a rapid rise 2 minutes after the pool fire was ignited or just 50 seconds after the burnthrough. The ceiling temperature peaked at 1700°F at 4 minutes after pool ignition.

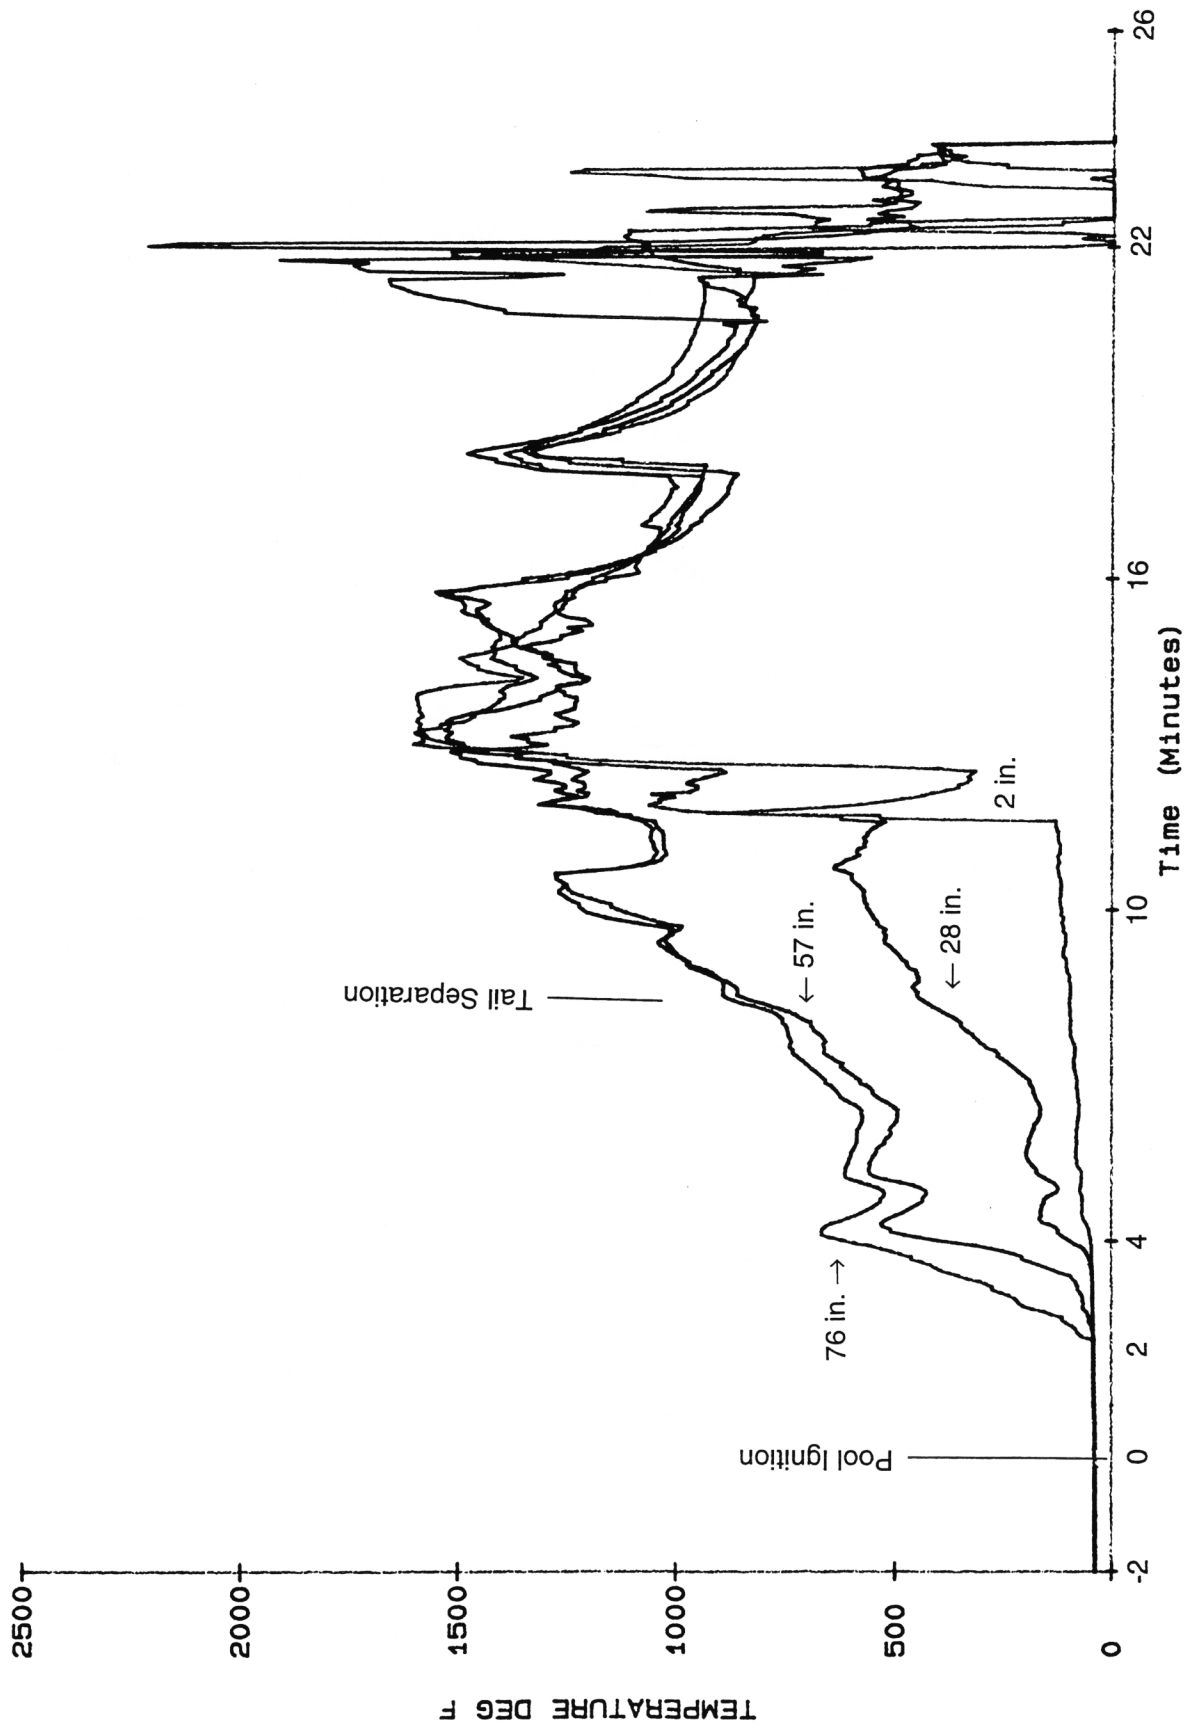
FIGURE B-18. THERMOCOUPLE TREE 3 AT STATION 669

The thermocouple tree at station 669 measured a far less severe rise in the air temperature due to its distance from the initial burnthrough and resultant interior fire (figure B-18).

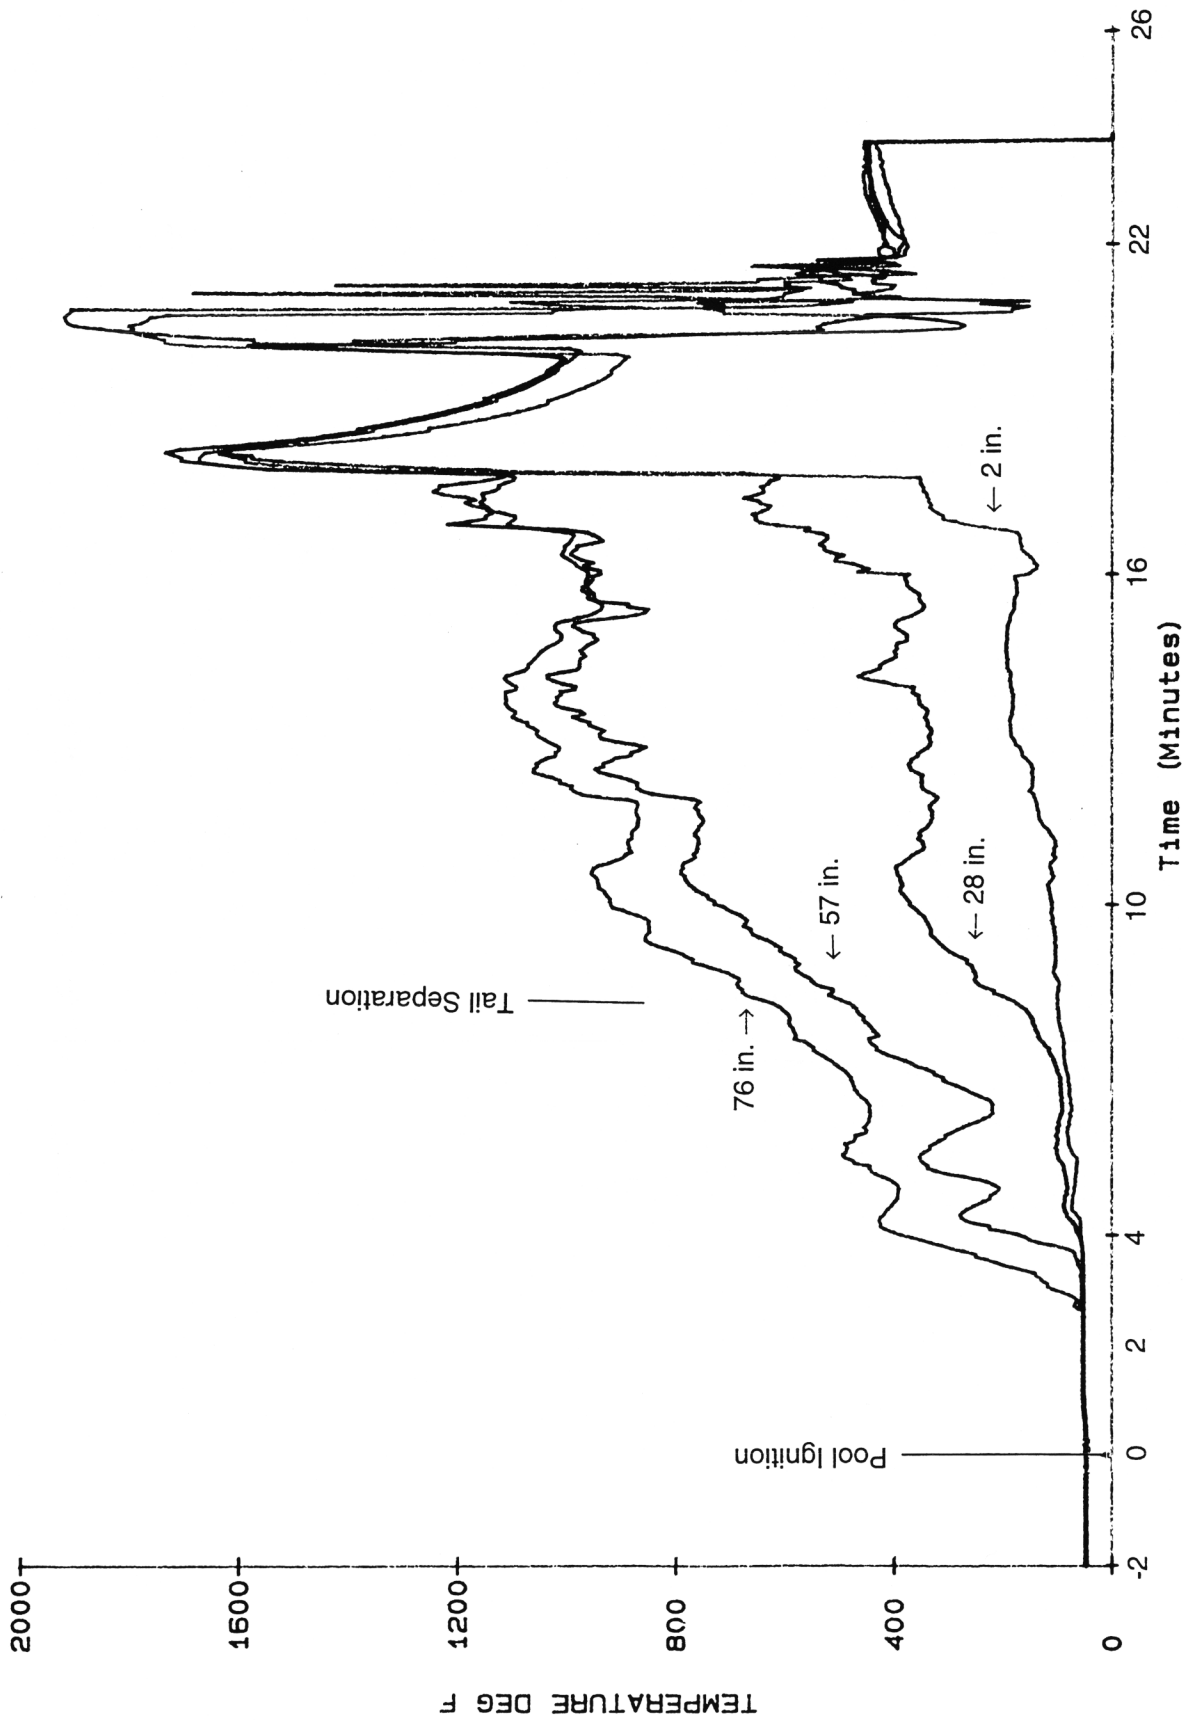
FIGURE B-19. THERMOCOUPLE TREE 4 AT STATION 498

The thermocouple tree located at station 498 measured the temperature profile in the first-class cabin (figure B-19). This area was the farthest away from the initial burnthrough.
