FIRE-RESISTANCE STUDIES OF THE CONVAIR-340 POWER PLANT

Technical Development Report No. 266

**CIVIL AERONAUTICS ADMINISTRATION
TECHNICAL DEVELOPMENT AND
EVALUATION CENTER
INDIANAPOLIS, INDIANA**

June 1955

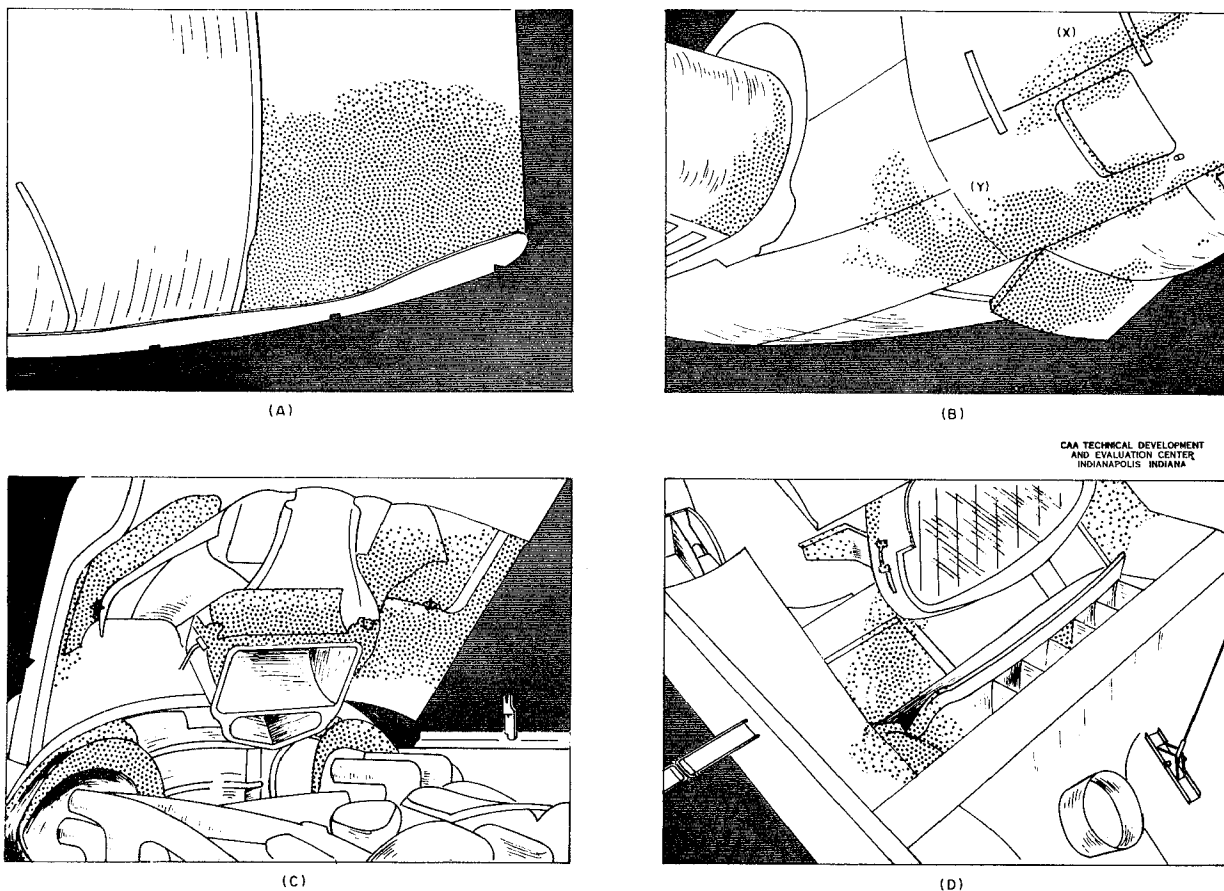
Fig. 2 Dye Deposition on Internal and External Surfaces of the Nacelle During Air-Flow Studies

There were indications that the air flow reversed in direction under certain conditions and indications that leakage occurred through seals which were designed to be leak-proof. Color photographs of the dye deposits facilitated this study. The sketches in Fig. 2 are reproduced from the photographic indications of dye deposition. Figure 2A shows the inside surface of the left side-cowl panel. The pattern was produced when the dye was introduced forward of the engine cylinders on that side. This pattern indicates that part of the air passing between the cylinders reversed, came forward, and spilled over the front of the lower left portion of

the cowling. Figure 2B shows the dye pattern on the outside surface of the nacelle as viewed from the right, near the propeller. This test was conducted with closed cowl flaps. The dye stain at the upper right corner, X, of the sketch was not caused by leakage through the seals between the horizontal mating surfaces. This stain was produced by the dye which first entered Zone 1, then passed between the inner and outer skin of the bottom cowl panel by leaking around the scupper drainpipe in the bottom of the cowling. The dye traveled thence to a hole in the horizontal mating surface, where it emerged at the outside surface. The loose fit of the scupper drain at the inner liner of the cowling would have gone unnoticed except for the dye. Such a loose fit is a potential hazard because flammable fluids and explosive gases can collect in the interior space of the cowl panel. The dark stain immediately below, at Y, was produced by the dye which passed through the scupper drain itself. Although the dye adhered to the skin that encloses Zone 3, there is little reason to believe that fire at the exit of the scupper drain would cause damage in this area. Tests have indicated that such a fire would be wiped off immediately by the air stream.

Inside Zone 1, dye was deposited on the bell-mouths of the augmentor tubes and on the closed cowl flaps. There was also a heavy deposit on the forward side of the carburetor intake duct, as shown in Fig. 2C.

Dye introduced at the intake to Zone 2 was deposited mainly at the lower right side, as shown in Fig. 2D. The left interior of Zone 2 was comparatively free from dye deposits. There was a large deposit of dye on the right side of the Zone 2 access door but no penetration of the seal around this door into Zone 3.

2. The dye deposit indicated a reverse air flow in Zone 1 between the 4- and 6-o'clock positions as viewed from the propeller end and indicated an unsymmetrical flow in Zone 2.

1. The injection of liquid dye mixture into the stream of air entering the various nacelle zones be given consideration as a practical method of determining the effectiveness of seals and the tightness of fire walls in new or reworked nacelles and as an aid in the study of air flows through nacelles.

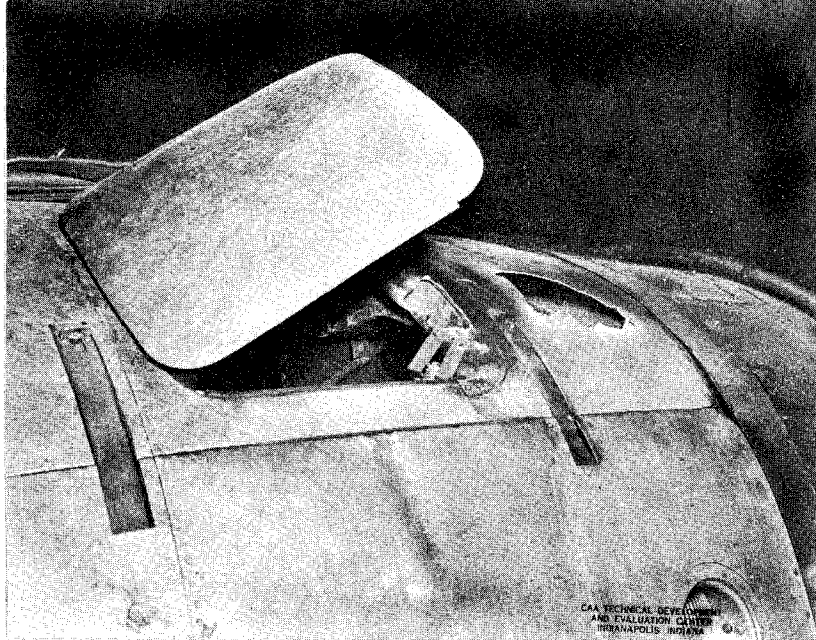
Fig. 3 Hole Burned in Cowling by Fire Leaving Cowl-Flap Port

When a fire of 20 seconds duration was started high in Zone 1 near the partially open cowl flaps, the flames hugged the skin aft of the flaps and burned through the duraluminum outer skin. The damage is shown in Fig. 3. The port was also damaged, but the inner skin of the cowling remained intact because it was fabricated of stainless steel. The flames extended beyond the cowl hinge line, which marks the location of the fire wall, and impinged on the duraluminum skin covering Zone 3. Since there is no protective inner lining for Zone 3, stainless steel was used during the tests to cover this area to prevent its being penetrated by fires.

4. Fire passing through cowl flaps which are partially open will impinge on the metal ports and on the downstream skin.
5. The top-wing exhaust arrangement reduces fire-ignition hazards.

3. Exterior nacelle surfaces downstream of flaps be protected with materials which are more fire-resistant than aluminum alloy.
4. The seals around the oil cooler be fabricated of materials having a maximum of fire resistance together with the necessary degree of flexibility.
