**CIVIL AERONAUTICS ADMINISTRATION  
TECHNICAL DEVELOPMENT CENTER  
INDIANAPOLIS, INDIANA**

TECHNICAL DEVELOPMENT REPORT NO. 327

INVESTIGATION OF FIRES ORIGINATING  
FROM AN AIRCRAFT OXYGEN SYSTEM

October 1957

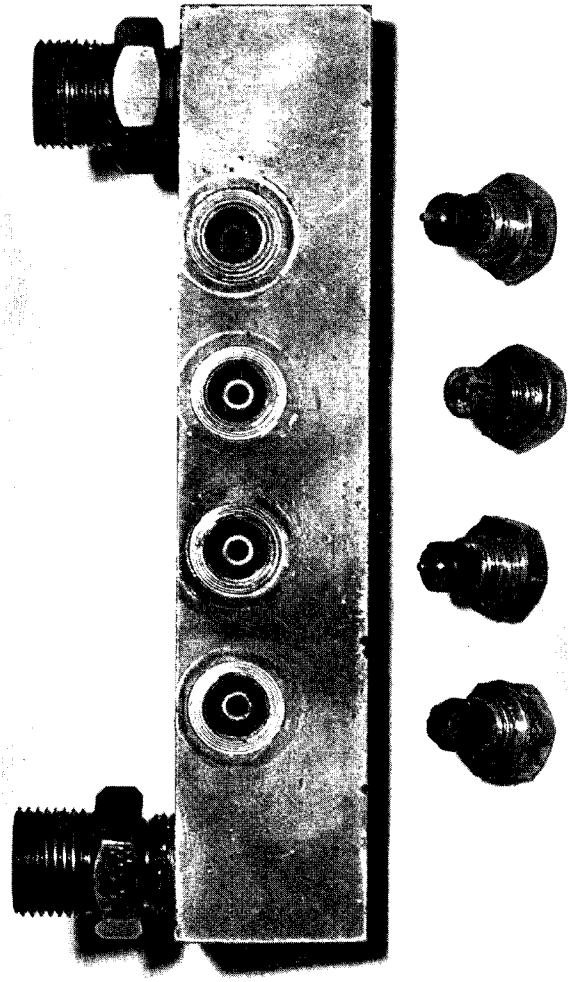
In the second series of tests, the oil-soaked cotton and the check-valve seat at the oxygen inlet were consumed, but the fire was not of sufficient intensity and duration to burn through the manifold block. Figure 3 shows the manifold block after it had been subjected to these tests. The damaged check-valve seats were replaced when necessary prior to each test.

FIG. 3 VIEW OF THE MANIFOLD AFTER TESTS DURING WHICH VALVE SEATS WERE DESTROYED

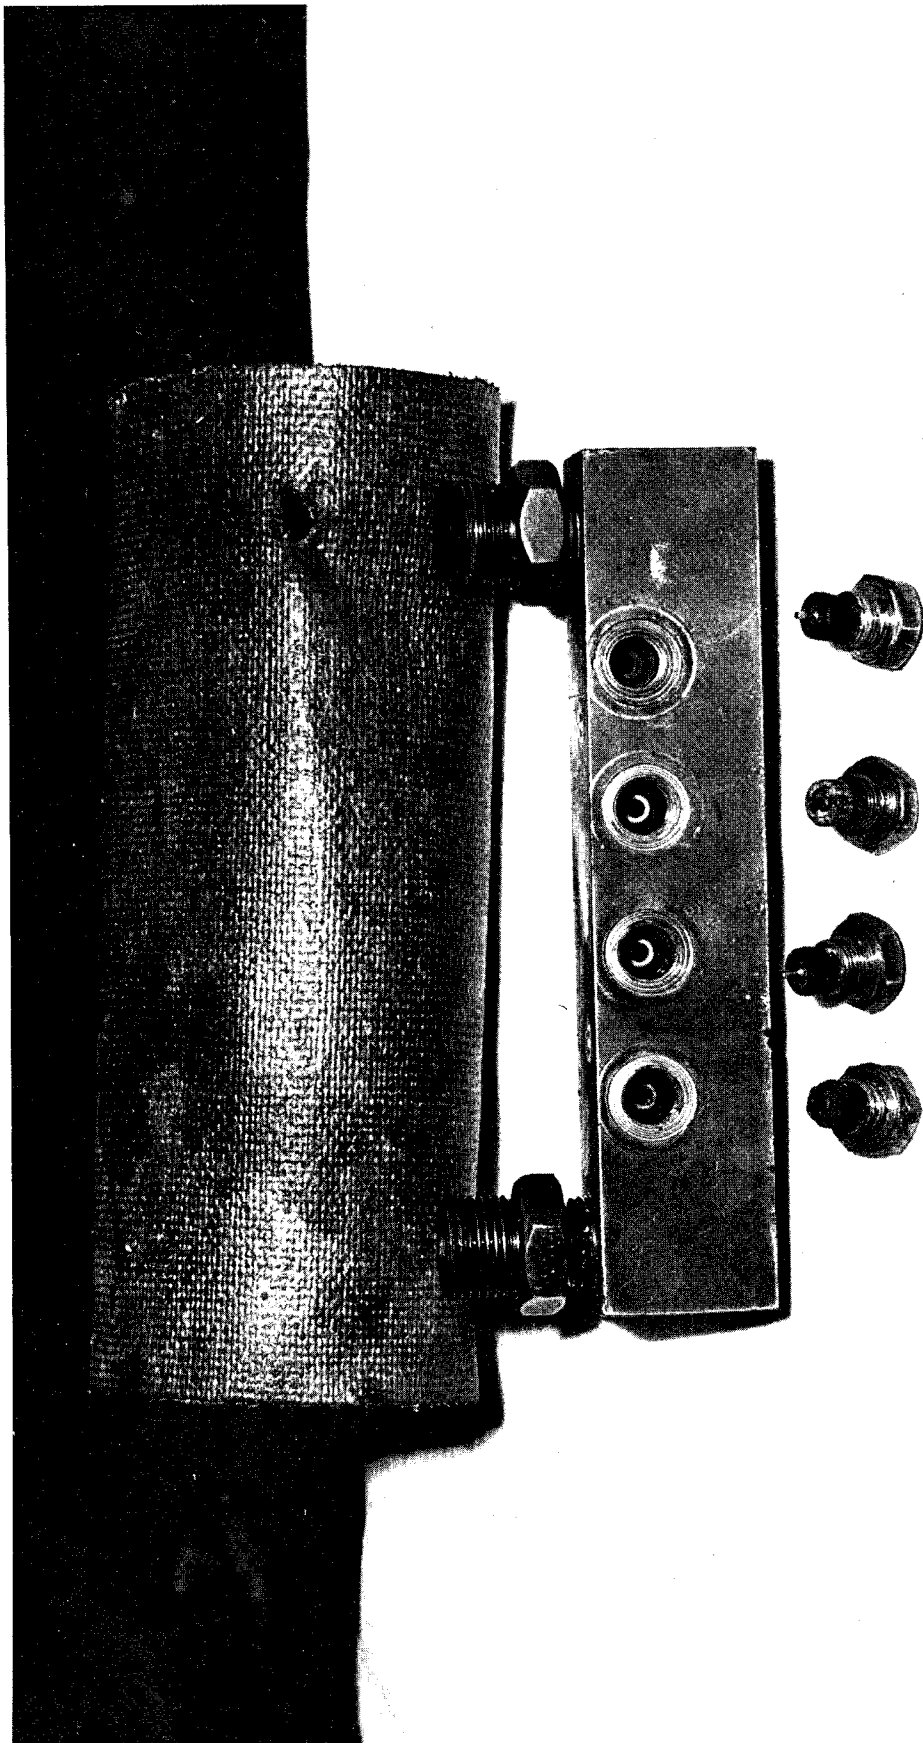
in the shield. Difficulty was encountered, however, in getting the fire to burn through the outlet connection. In several tests the cotton inside the manifold and the check-valve seat at the oxygen inlet were consumed but the cotton outside the manifold was not ignited. In one test, ignition outside the manifold did occur and the fire which consumed the cotton was of sufficient intensity to burn a 1/2-inch diameter hole through the shield. This is shown in Fig. 4.

FIG. 4 DAMAGE TO MANIFOLD SHIELD

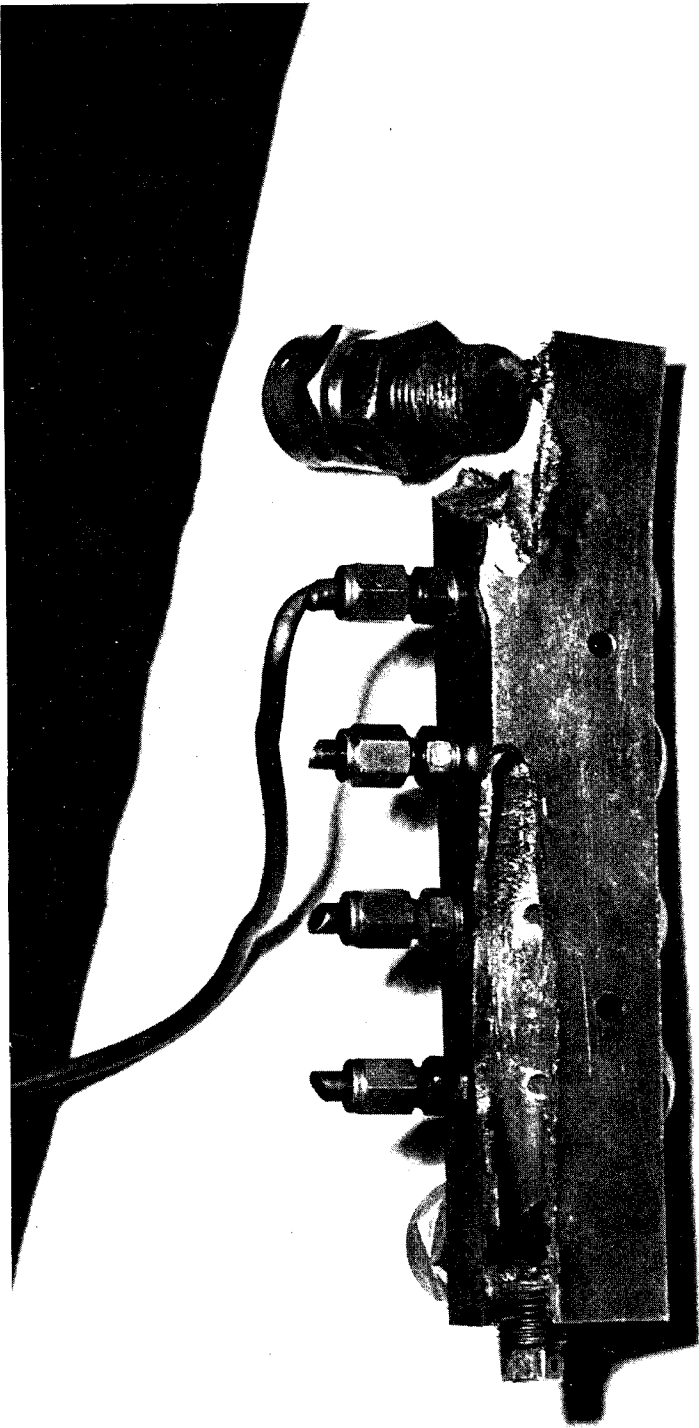
A final test was conducted in this series using a full cylinder of oxygen and a new manifold block. Oxygen was allowed to leak slowly from the outlet connection. The first time the cotton was ignited it burned for only a short time before going out. The cotton again was ignited and very shortly after the cylinder valve was opened, a loud explosion occurred. The manifold was blown off the support bracket and was found on the ground about 35 feet from its original position. One of the regulator outlet fittings was found a few feet from the manifold. The manifold was ruptured along most of the length of the main passage as shown in Fig. 5. The aluminum was melted around the oxygen inlet to the main passage and there was some indication that the fire may have burned through the manifold before the explosion occurred. The check-valve seats were still in good condition and were not damaged by the fire as may be seen in Fig. 6.

FIG. 5 DAMAGE TO MANIFOLD AFTER EXPLOSION

3. Replacement of the aluminum manifolds with manifolds of stainless steel or other material having a high melting point is recommended.

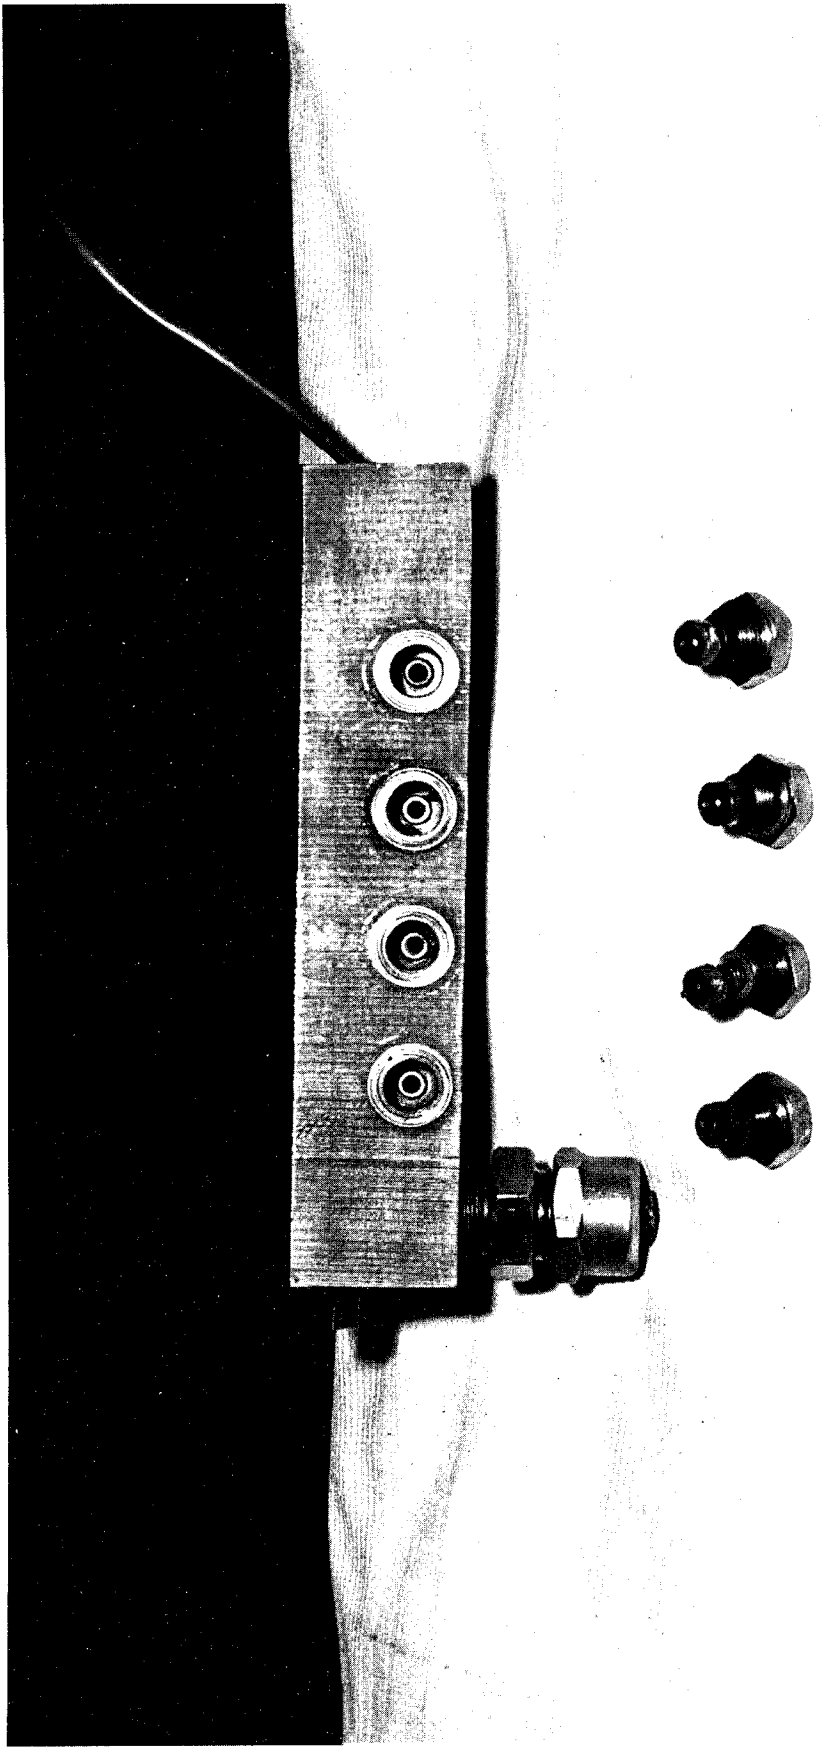
FIG. 6 CONDITION OF CHECK VALVE SEATS
