ALPA CLEVELAND FIRE TEST RESULTS

Captain Don Heine, NOR, Member
ALPA Rescue & Fire Committee

Mr. Jim Brennerman
Fire Protection Engineer, UAL

Presented at the Thirteenth
ALPA Air Safety Forum
October 4-5, 1966

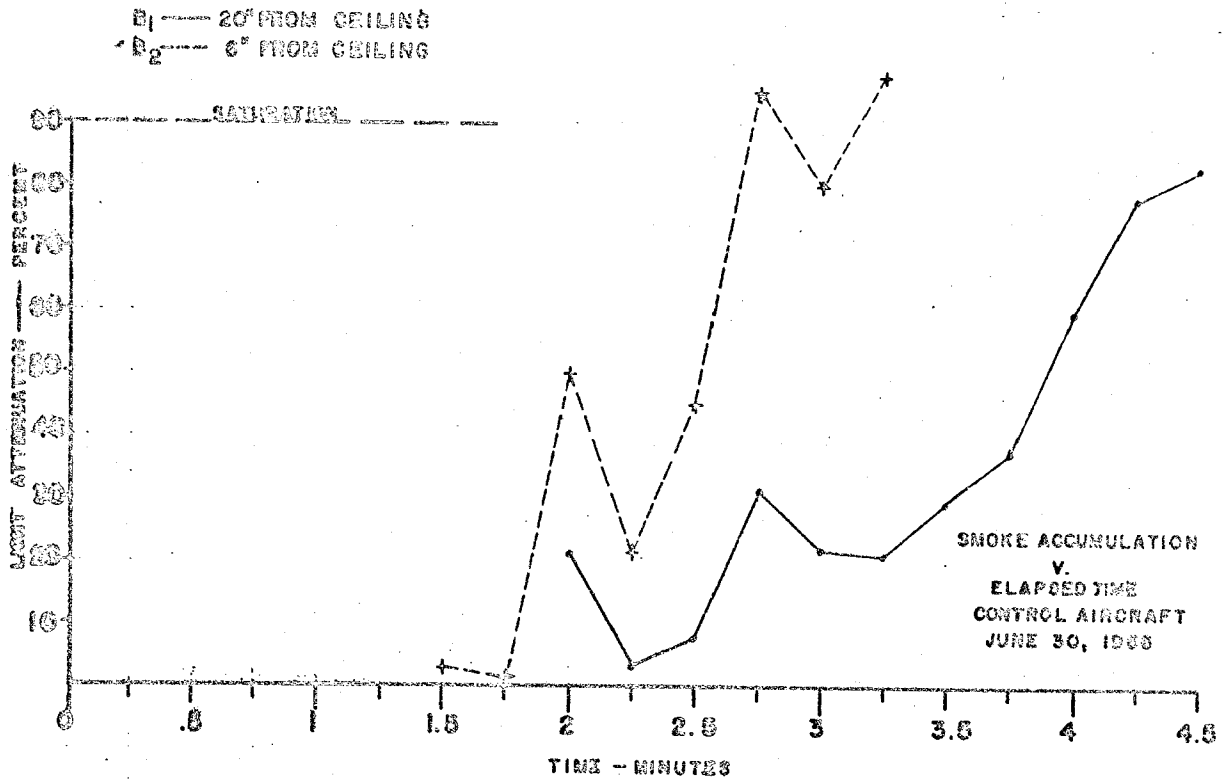
Figure 4.

The initial burn-through of the fuselage skin occurred in the area at the left rear of the mock-up section, approximately two feet above the cabin floor. The skin thickness at this point was .035 inches, and skin failure occurred at 1:03. The first indication of smoke in the cabin was at 1:30 (See Figure 4), and the first temperature rise occurred at 1:40 at the cabin ceiling. At approximately 2:45, the smoke detector located 6 inches from the ceiling indicated smoke saturation. At the same time, the detector located 14 inches lower indicated only 30 per cent indicating extreme stratification in smoke density (Figure 4). At 2:30, the ambient center cabin ceiling recorded 200°F and at this time no other stations had recorded a significant temperature rise. At 4:30, the center cabin ceiling had reached a temperature of 570°F., while at seat height indication was 150°F. At approximately 5:30, the ceiling temperature had risen to 650°F., while at seat height it was 200°F. At about 7:40, the ceiling temperature had risen to 760°F and the seat height temperature to 300°F., while the cockpit temperature was still ambient. At this point, the recorder tapes indicate a flash-over of the entire cabin and within seconds the temperatures soared to the 1700°-2000°F. range. The test was allowed to continue until the test section of the aircraft was totally destroyed, although no additional significant data was obtained.

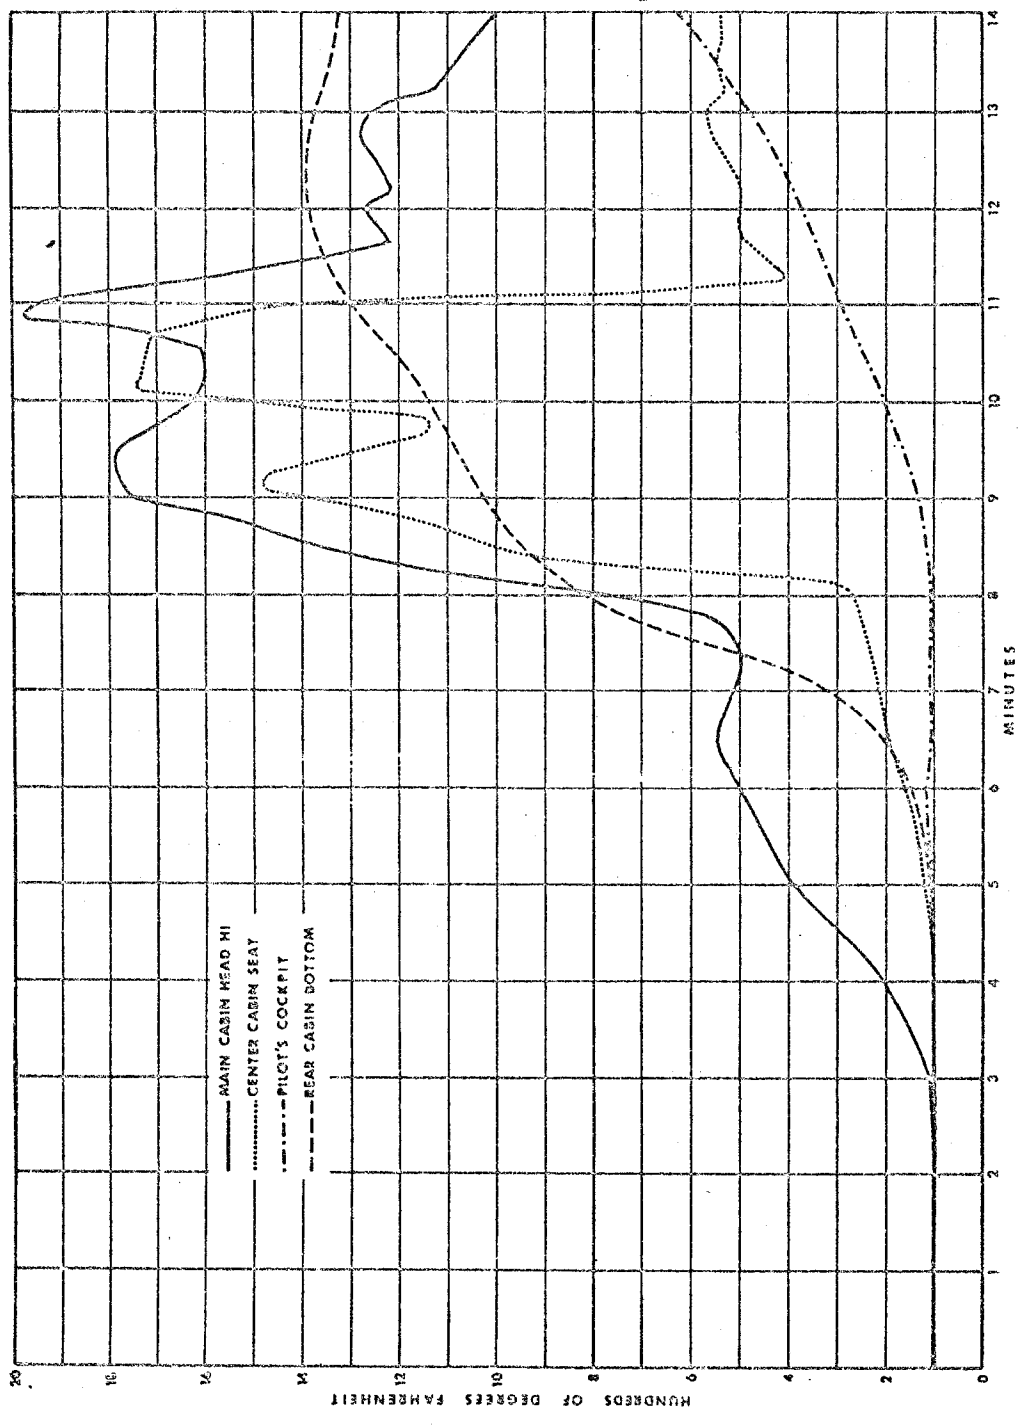
Figure 5.

As previously stated, four of the twelve thermocouples in each aircraft were completely shielded in copper spheres. These shielded radiometers measured only radiant heat, whereas the other eight were exposed directly to the flames, measuring ambient heat. The temperature chart (Figure 5) was made from readings taken from the shielded radiometers. Temperatures referred to in the text are from the unshielded instruments.

Although the temperature curves for both types of instruments would be similar in appearance, Figure 5 will show slower temperature reactions than those outlined in the text, because of the shielding.

Test #1 - Shielded Radiometers

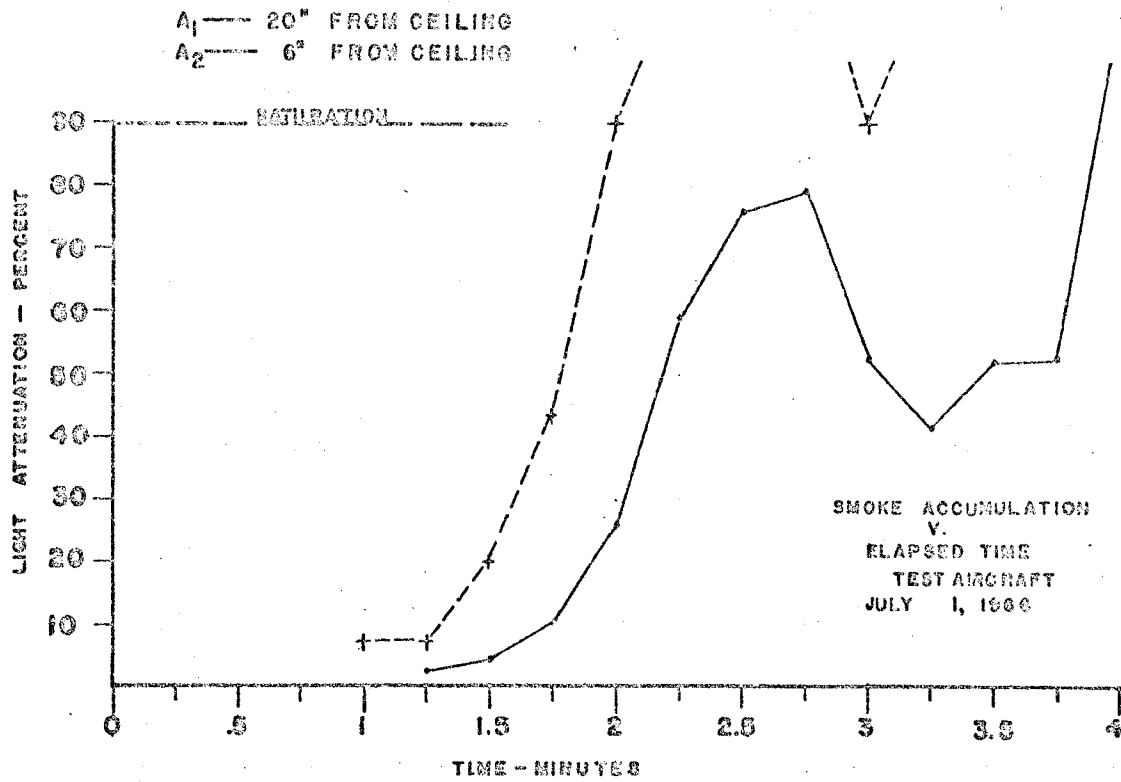
Figure 6.

The initial burn-through of the fuselage skin occurred in the vacant section of the fuselage, aft of the mock-up cabin, and progressed through the aft cabin bulkhead which consisted of a melamine laminate (Formica) bonded to aluminum sheet and aluminum honeycomb material. The actual time of this burn-through was not precisely detected. In this test, the first indication of smoke in the cabin occurred at 1:15, and at 2:00 the smoke detector 6" from the ceiling indicated smoke saturation. At the same time, the lower detector indicated 26 per cent showing almost the same stratification as Test #1 (See Figure 6). At 2:30, the foam generator was turned on and allowed to run for a period of 45 seconds. Because there was no foam readily apparent, it was restarted at 3:20 and allowed to run an additional 45 sec. The first indication of a temperature rise was recorded at 2:00 on an ambient thermocouple, although at 3:00 the center cabin ceiling temperature had risen only 20° above ambient. At 4:10, the ceiling temperature was 125°, and at 4:50 had reached 200°. At 4:50, the thermocouple at seat height had reached only 130° and did not reach 200° until 5:35. At about 6:10, the temperatures at various stations started rising very rapidly and reached over 1500° at 7:00, when the test was discontinued.

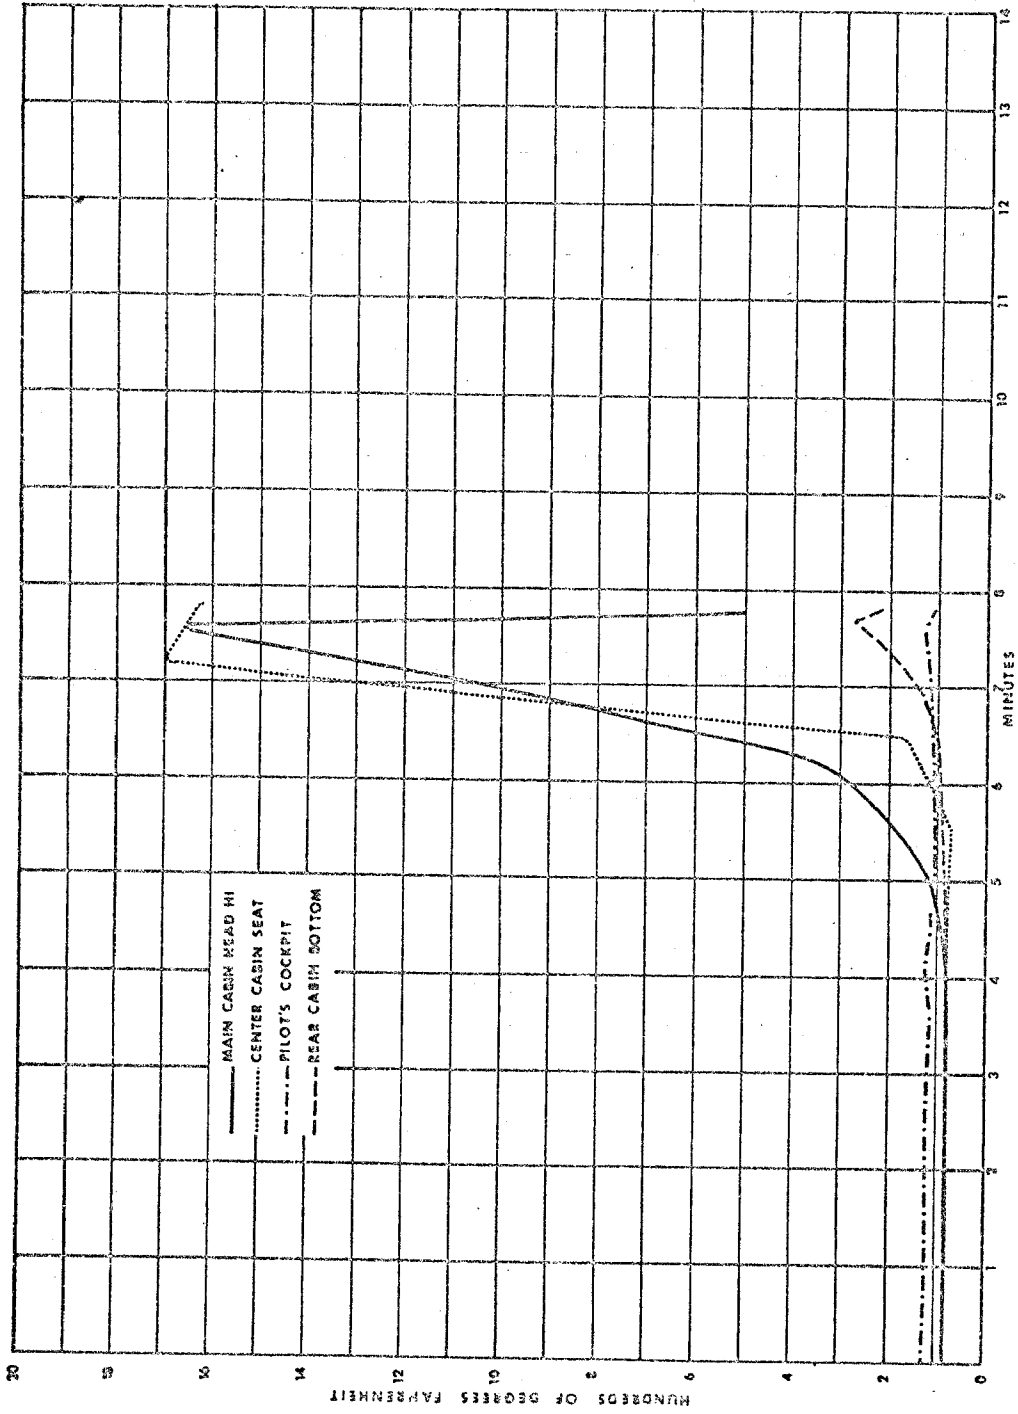
Figure 7.

As with Test #1, the temperature chart for the second test (Figure 7) depicts readings from shielded radiometers, while temperatures referred to in the text are from unshielded instruments.

Test #2 - Shielded Radimeters
