Aging and Contamination Evaluation Status

Insulation Blanket Films

Boeing Commercial Airplanes
Material & Process Technology

November 19th, 2003

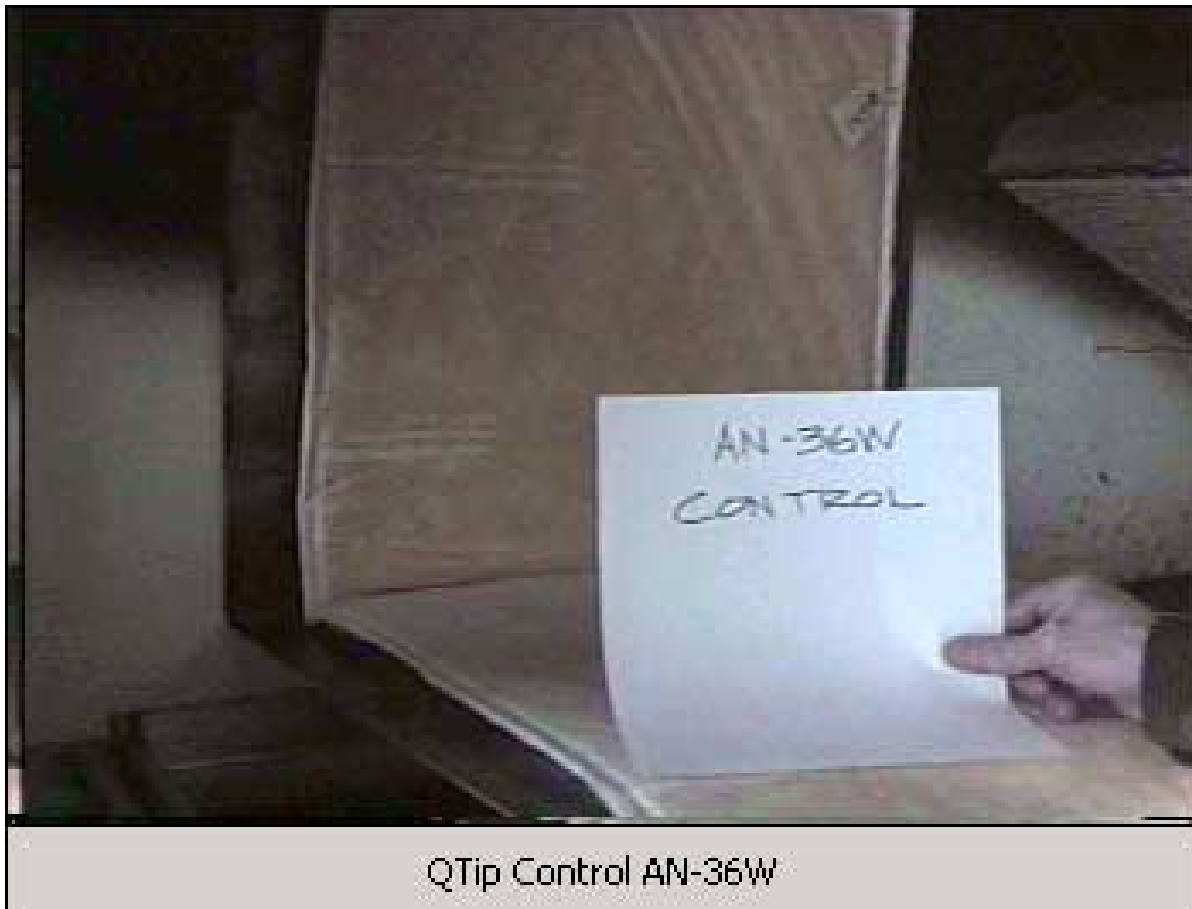
CONTROL: Orcon AN-36W – Current BMS 8-142 Class 00 PET; The Q-tip test is a Boeing requirement for qualification of new products. It is not a FAA requirement, but is more discriminating than Bunsen Burner.

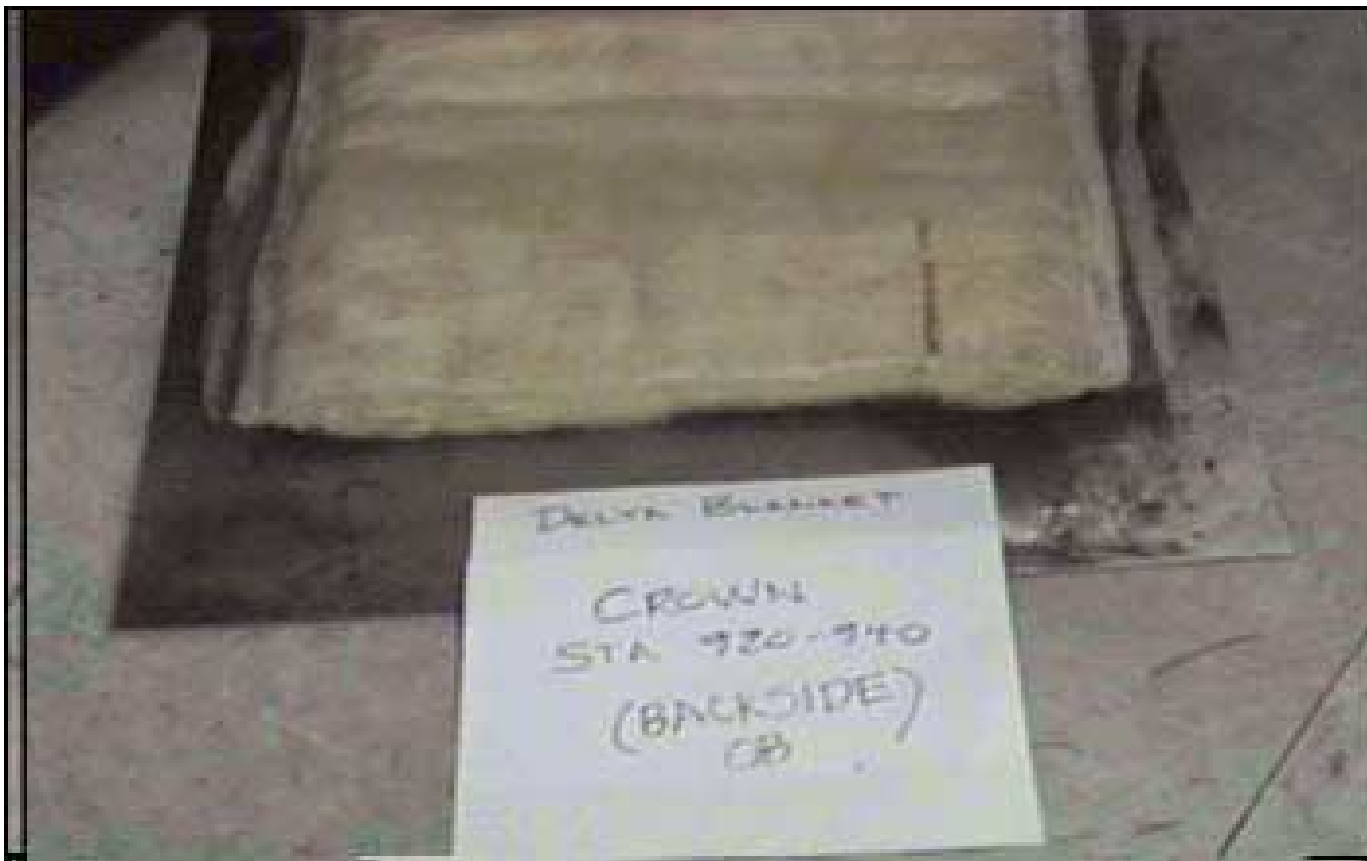
Crown STA 920, OB Surface

IN-SERVICE SAMPLE: Orcon AN-26 In-Service PET Blanket; BMS 8-142 Class 00;
B757-200, delivered 6/85, Crown blanket, STA 920-940, Outboard surface tested.

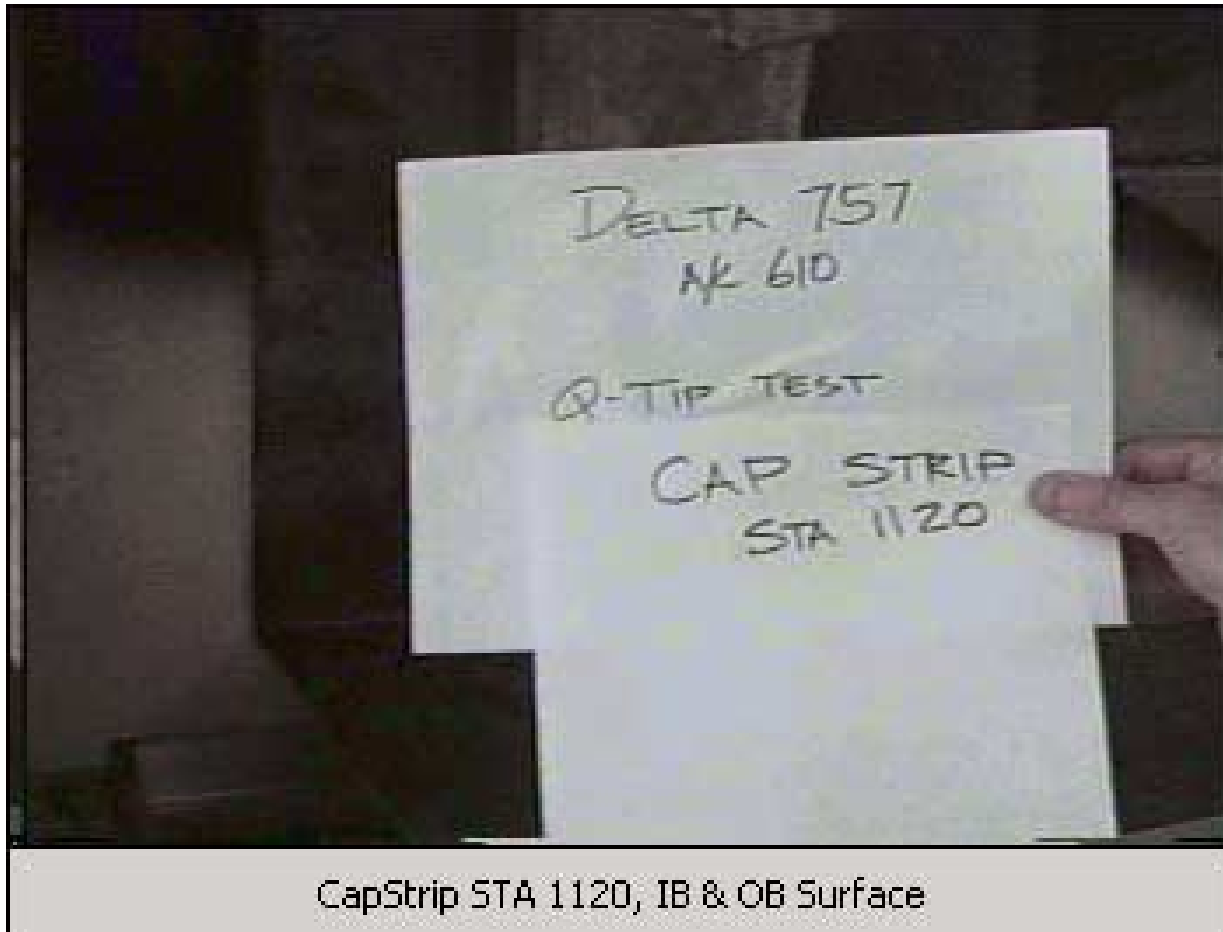
IN-SERVICE SAMPLE: Orcon AN-26 In-Service PET Blanket; BMS 8-142 Class 00; B757-200, delivered 6/85, Cap Strip Blanket, Inboard & Outboard surfaces tested.

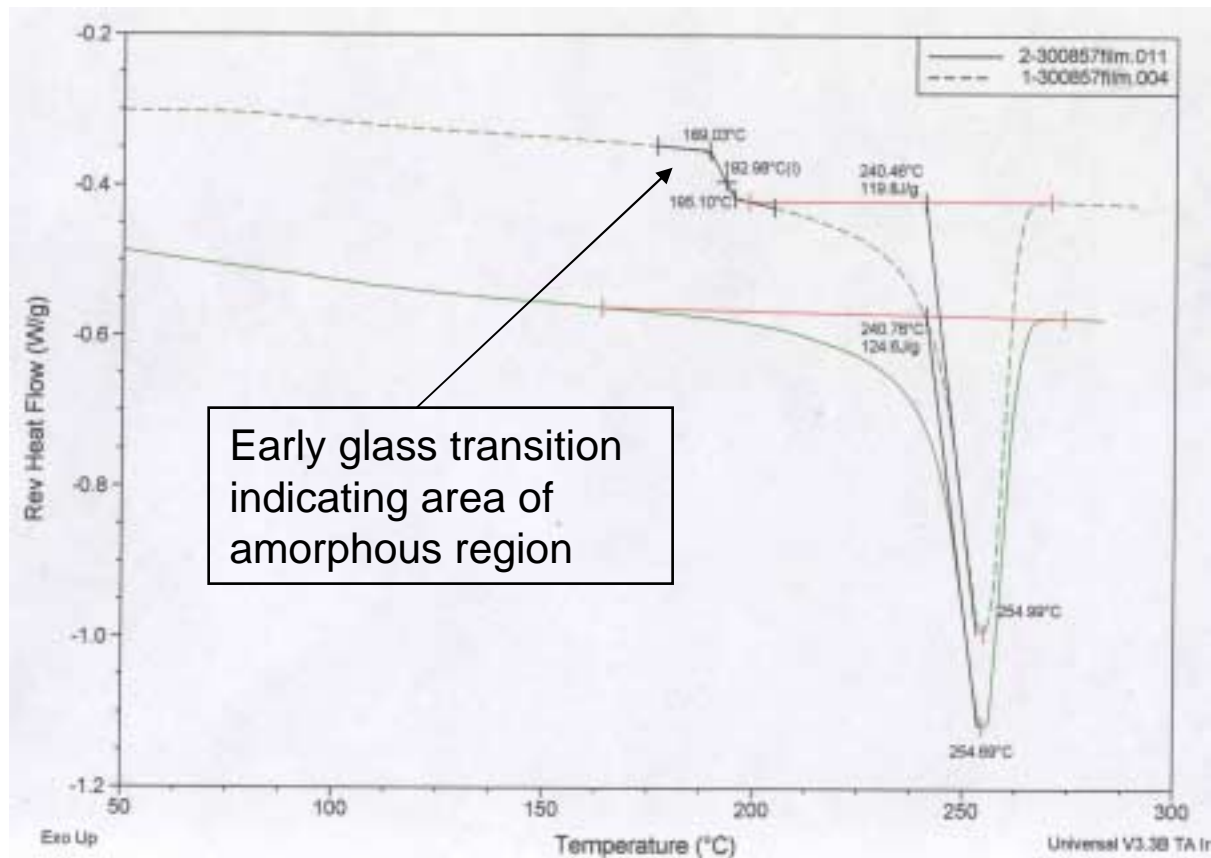
Early glass transition
indicating area of
amorphous region

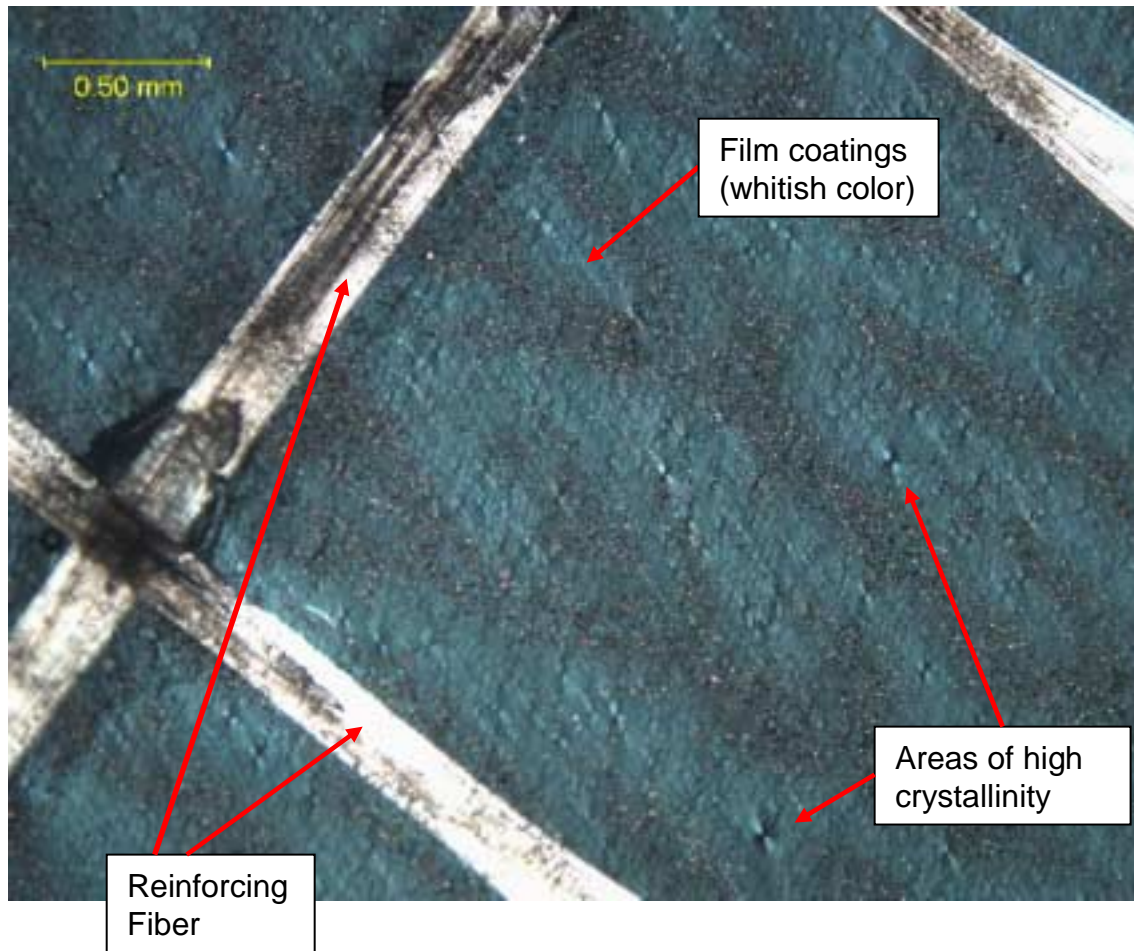
AN-36W New

Polarized
Microscopy
illustrating the
crystallinity
across the PET
film. (4X)

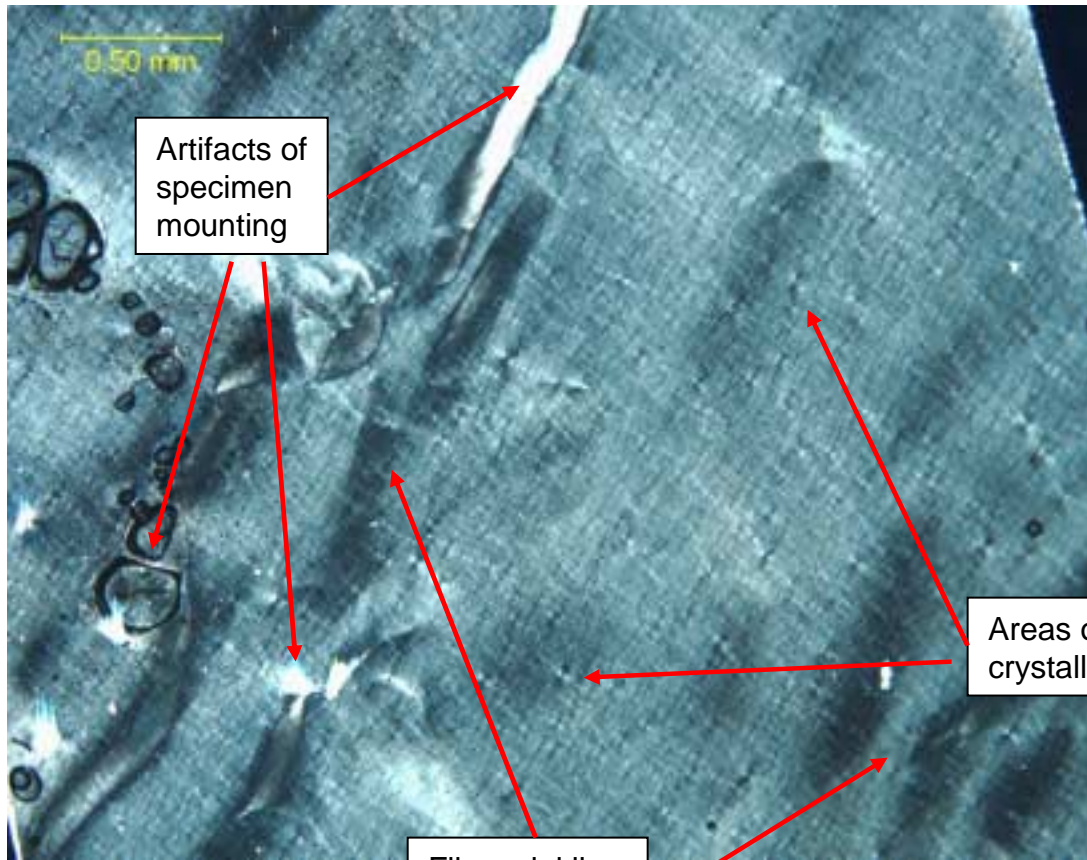
AN-26 In-service

Polarized Microscopy illustrating the crystallinity across the PET film. (4X)
Note: Reinforcing fibers were removed to improve mounting flatness.

Film wrinkling
of in-service
material

Areas of high
crystallinity

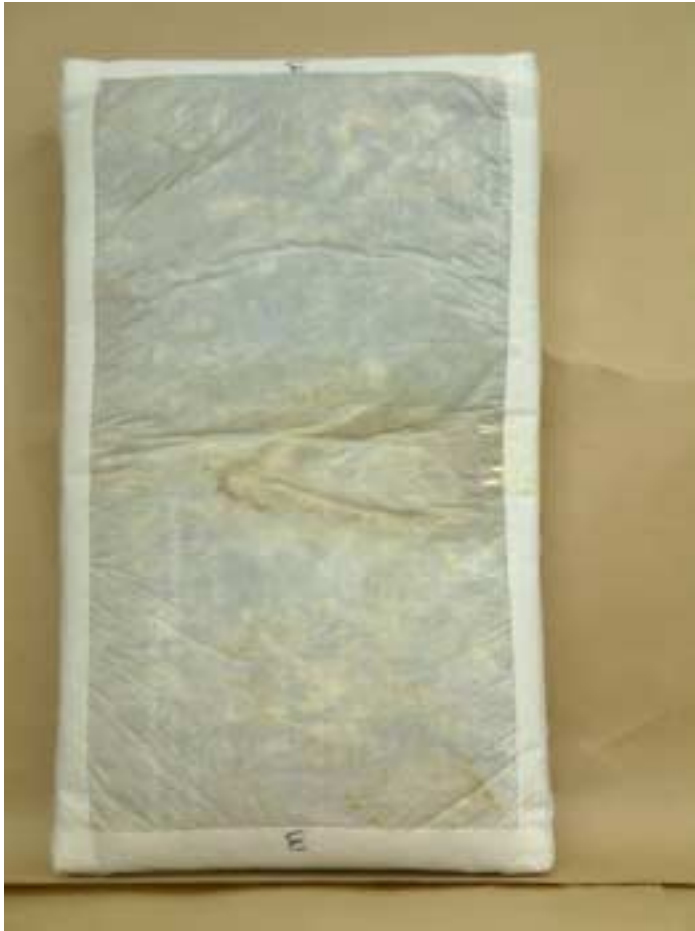
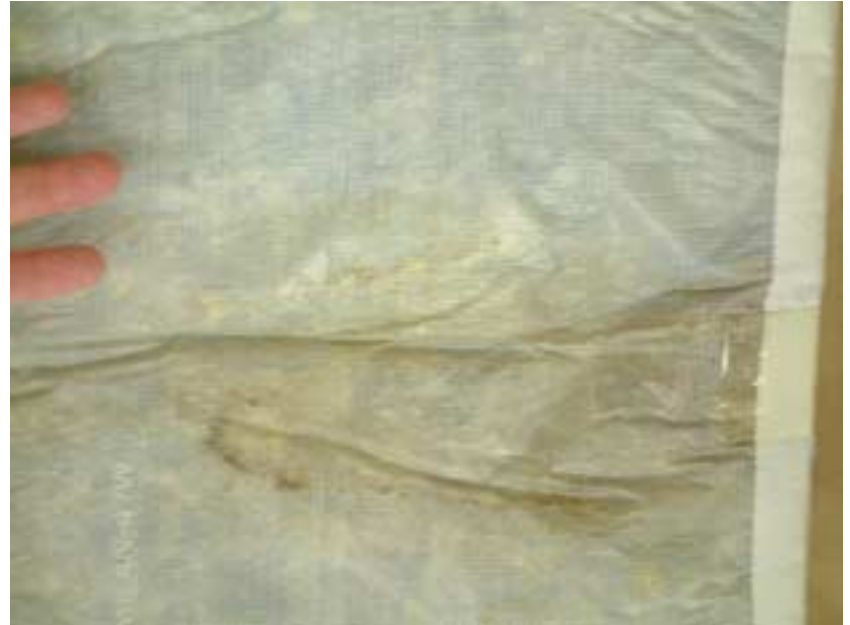
Staining on the inside of the film. Could be glass batting sizing.

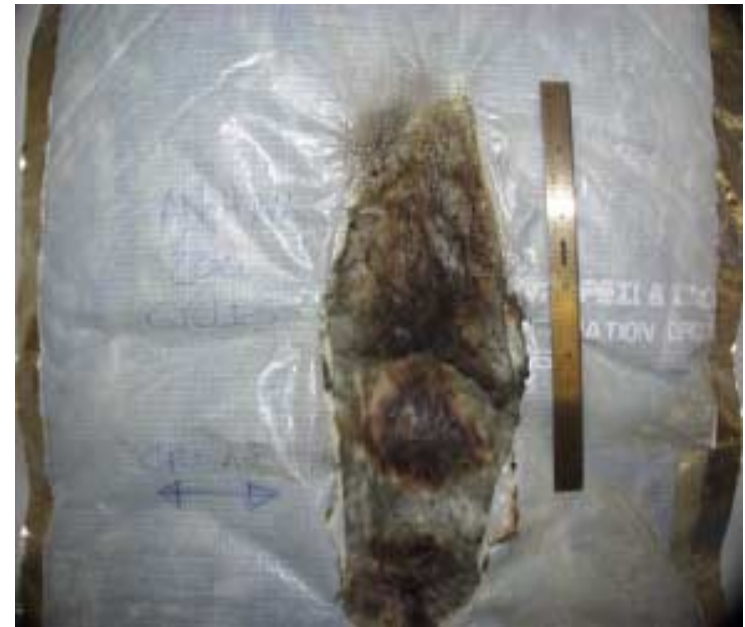
AN-47W
1200 thermal cycles

Film appears to stick
to glass batting.
