FINAL REPORT

Contract No. FA67NF-210  
Project No. 520-003-01X  
Report No. NA-68-22  
(DS-68-10)

METALLURGICAL EVALUATION OF AIRCRAFT  
EXHAUST SYSTEM COMPONENTS FAILED DURING  
GROUND TEST PROGRAM

April 1968

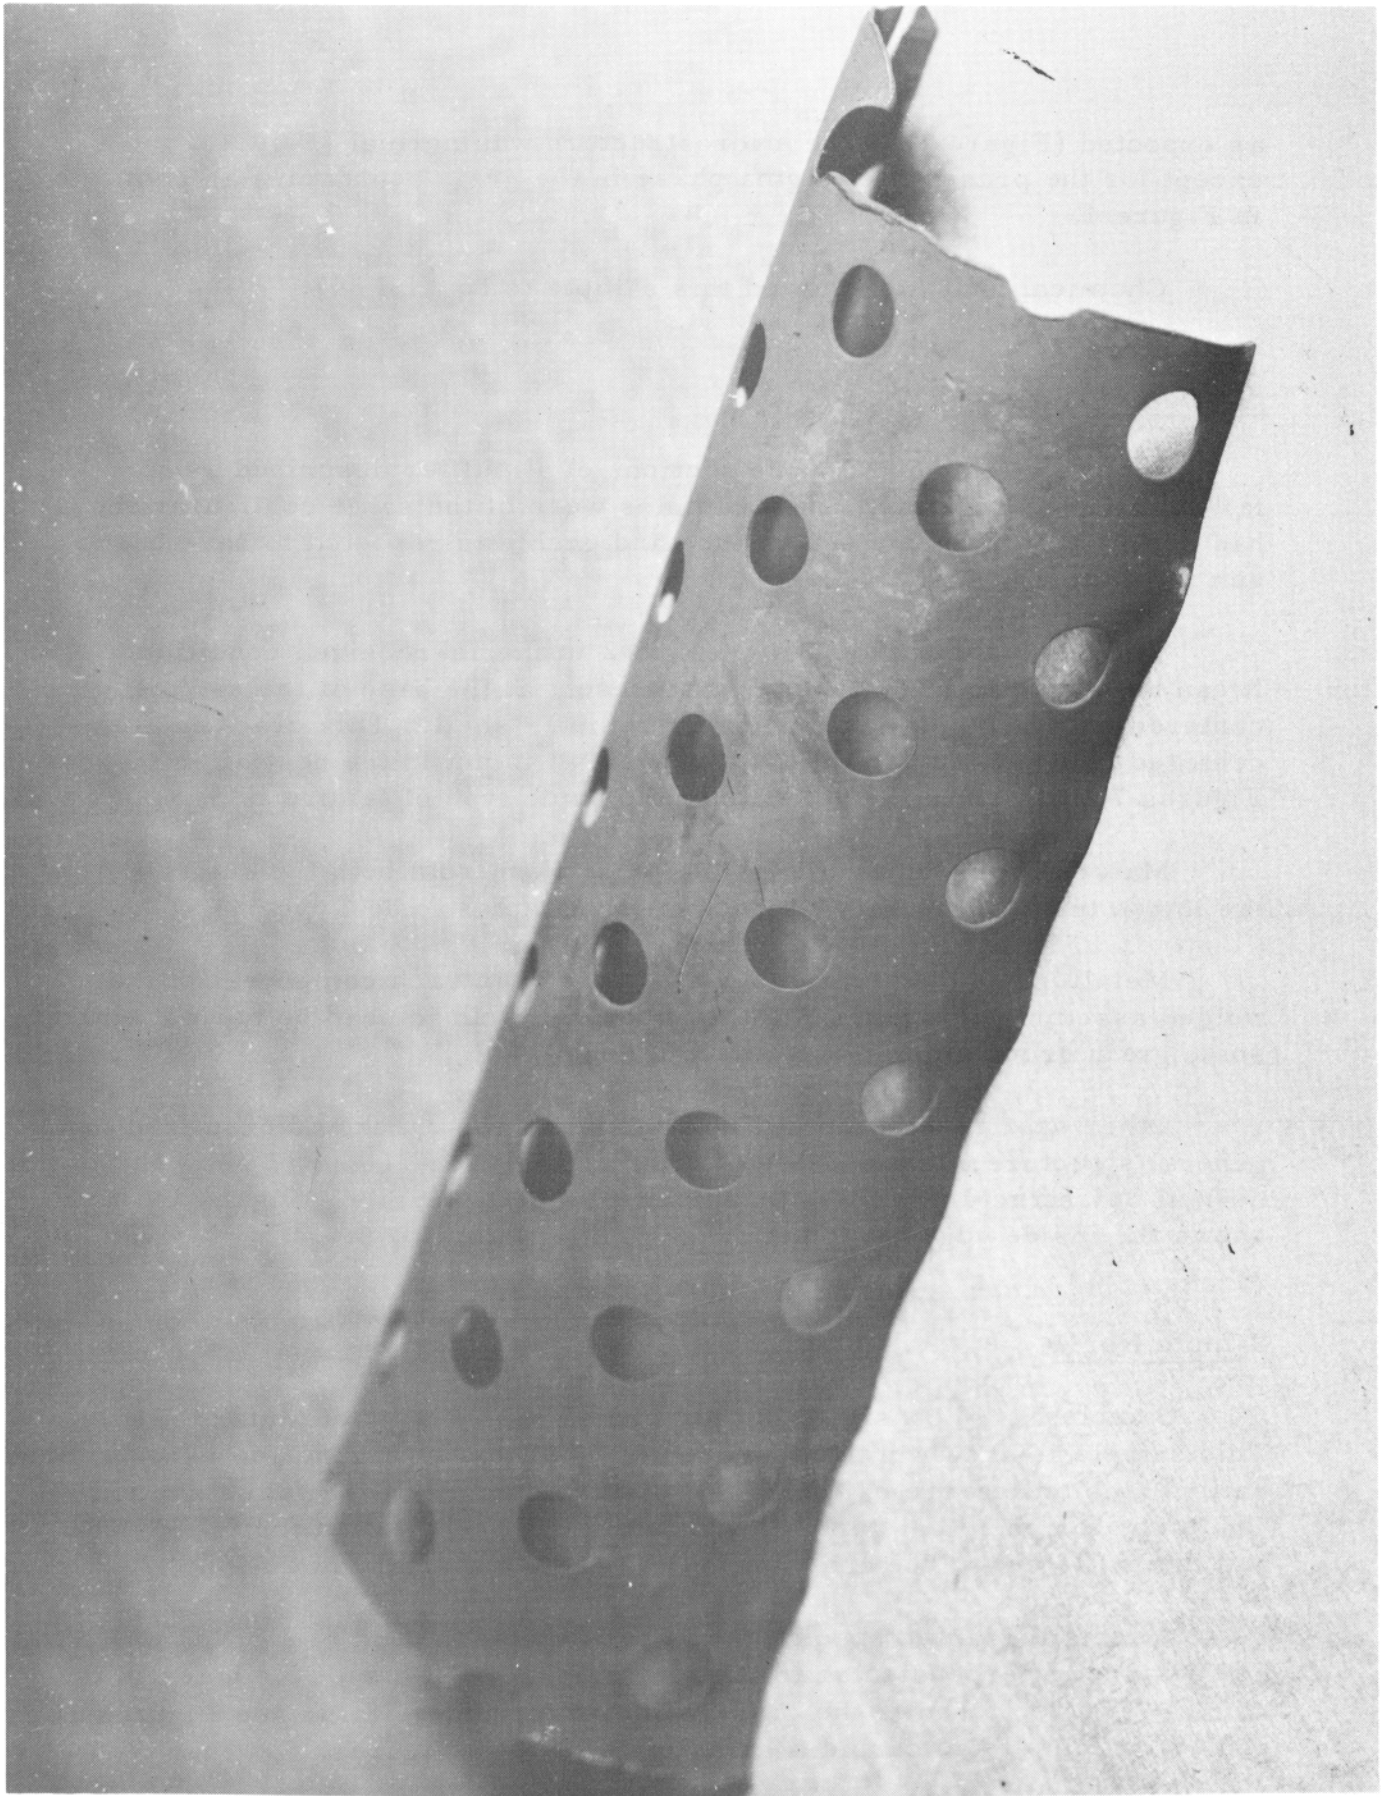
Figure 1. Sample No. 1 - Muffler Baffle, 43 Test Hours

Sample No. 1 is a section of a failed Muffler Baffle as shown in Figure 1. Test data stated that this component was run for 43 test hours. The entire sample showed evidence of oxidation and was somewhat distorted. The end at which the failure occurred was severely oxidized and eroded, suggesting exposure to higher temperatures than the opposite end. Comparative measurements at several locations also showed slight evidence of material thinning near the failed area.

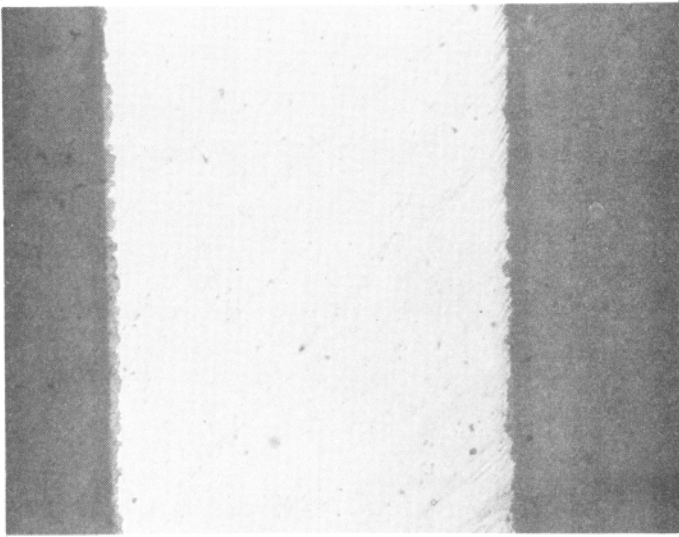
Figure 2

Metallographic specimens were cut from the edge of the burned area. Penetration of oxidation was observed to be greater on the inside surface,

Showing both surfaces as polished.  
(Outside surface at right)

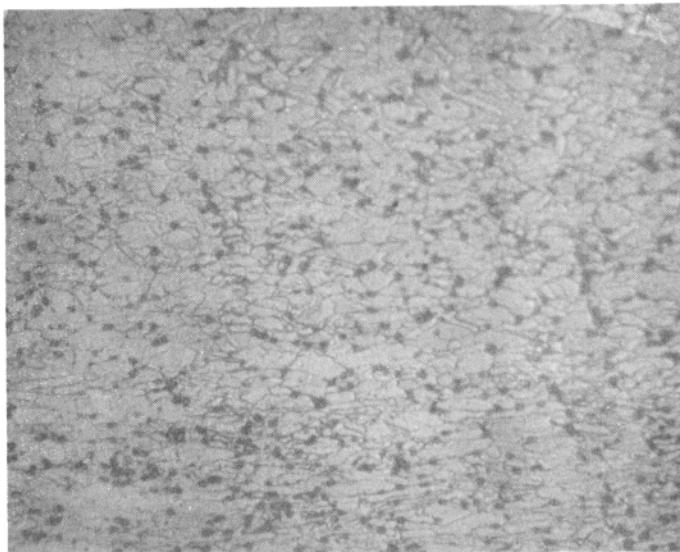
Figure 4

as expected (Figure 2). The microstructure was normal (Figure 3) except for the presence of sigma phase in the grain boundaries as shown in Figure 4.

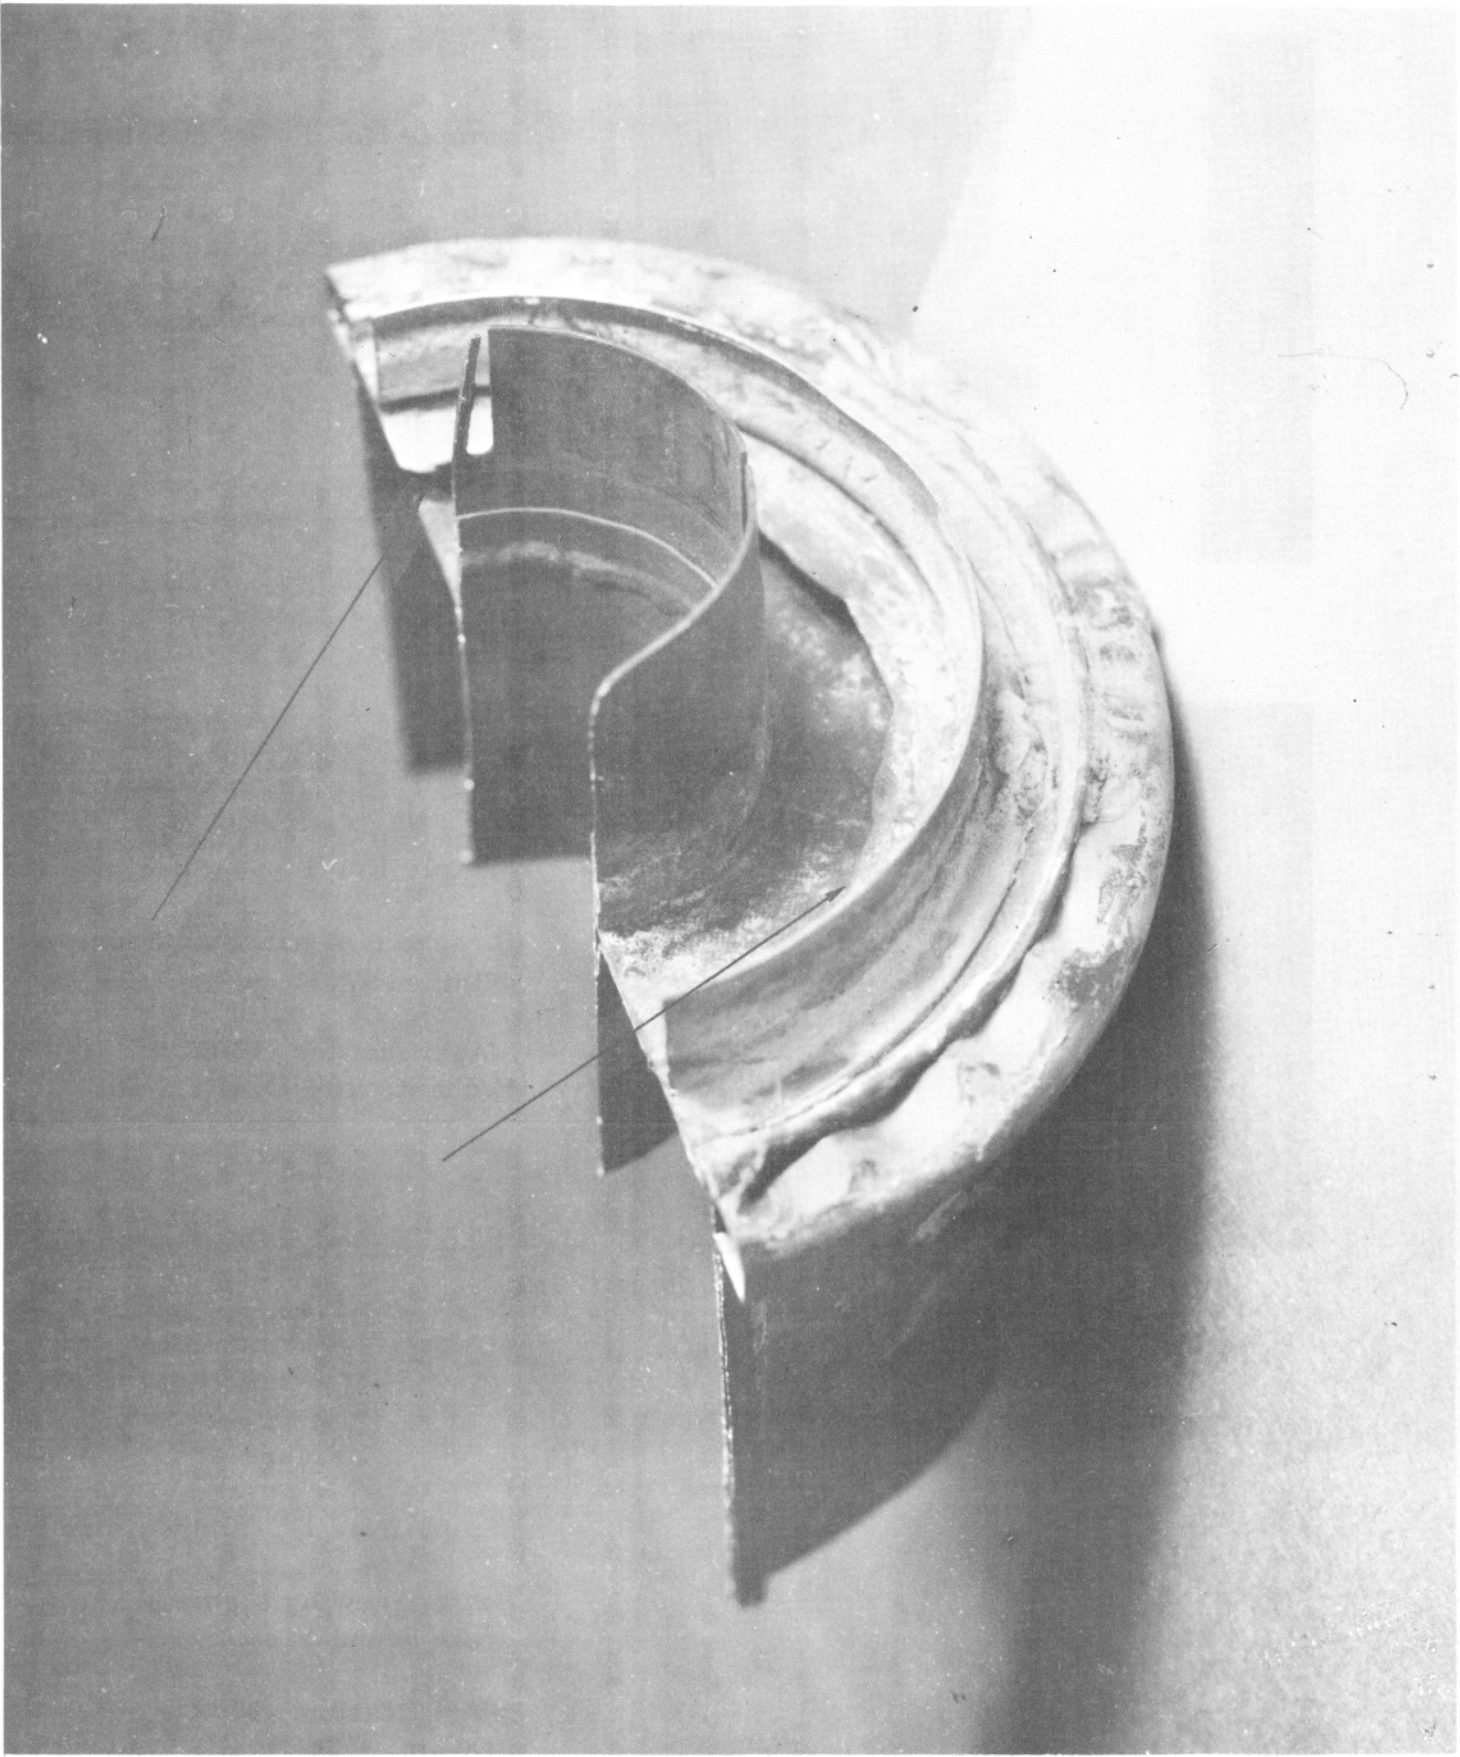
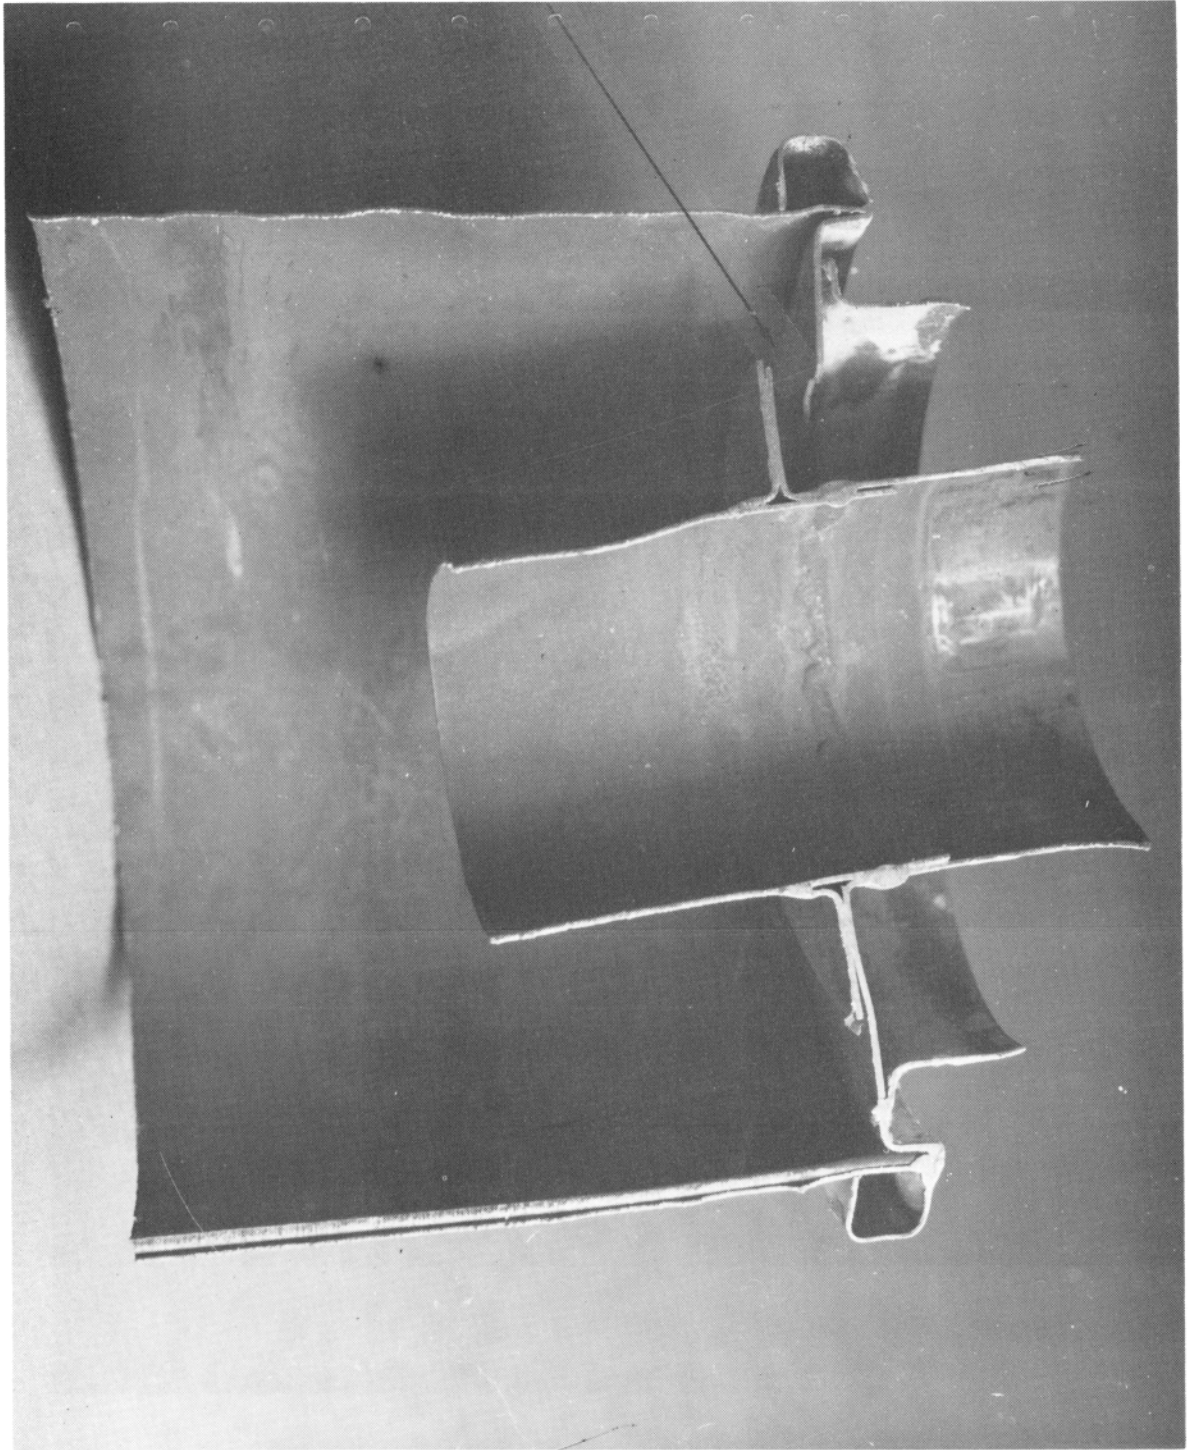
Figures 5 and 6 show Sample No. 2 in the as-received condition. It can be seen that a severe crack is present at the base of the sample centered between the intake tube and the outer shell. This crack is almost centered between the two welds, however, it is not in the heat affected zone. Figures 7 and 8 show almost exactly the same type of failure in Sample No. 3.

Figure 5. Sample No. 2 - Muffler End Plate, outside, 43 Test Hours  
Arrows indicate extent of crack in sample.

Figure 6. Sample No. 2 - Muffler End Plate, inside, 43 Test Hours  
Arrow indicates crack in sample.

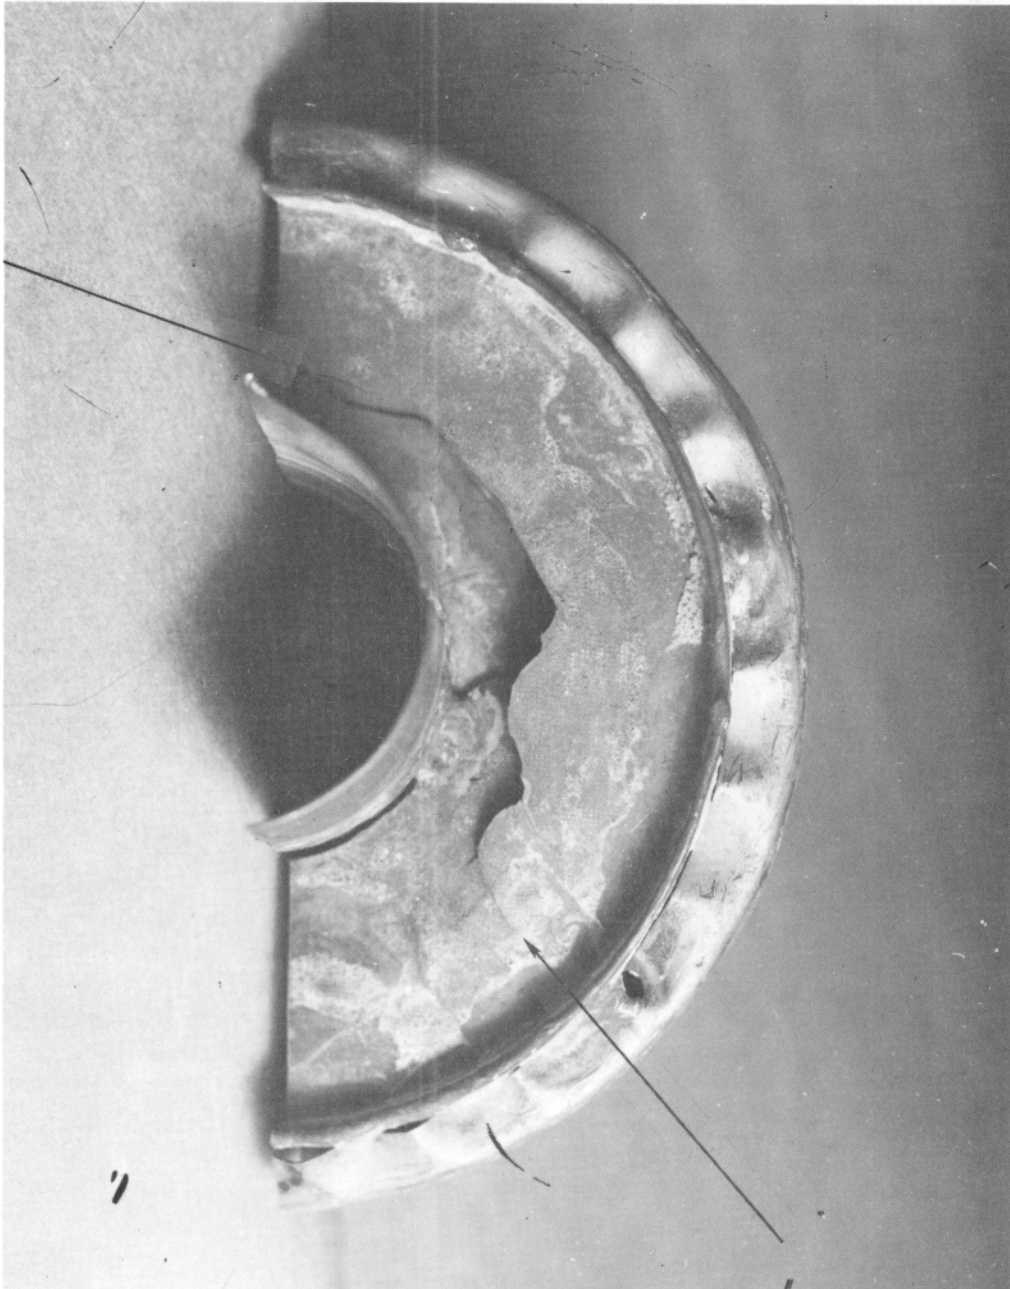
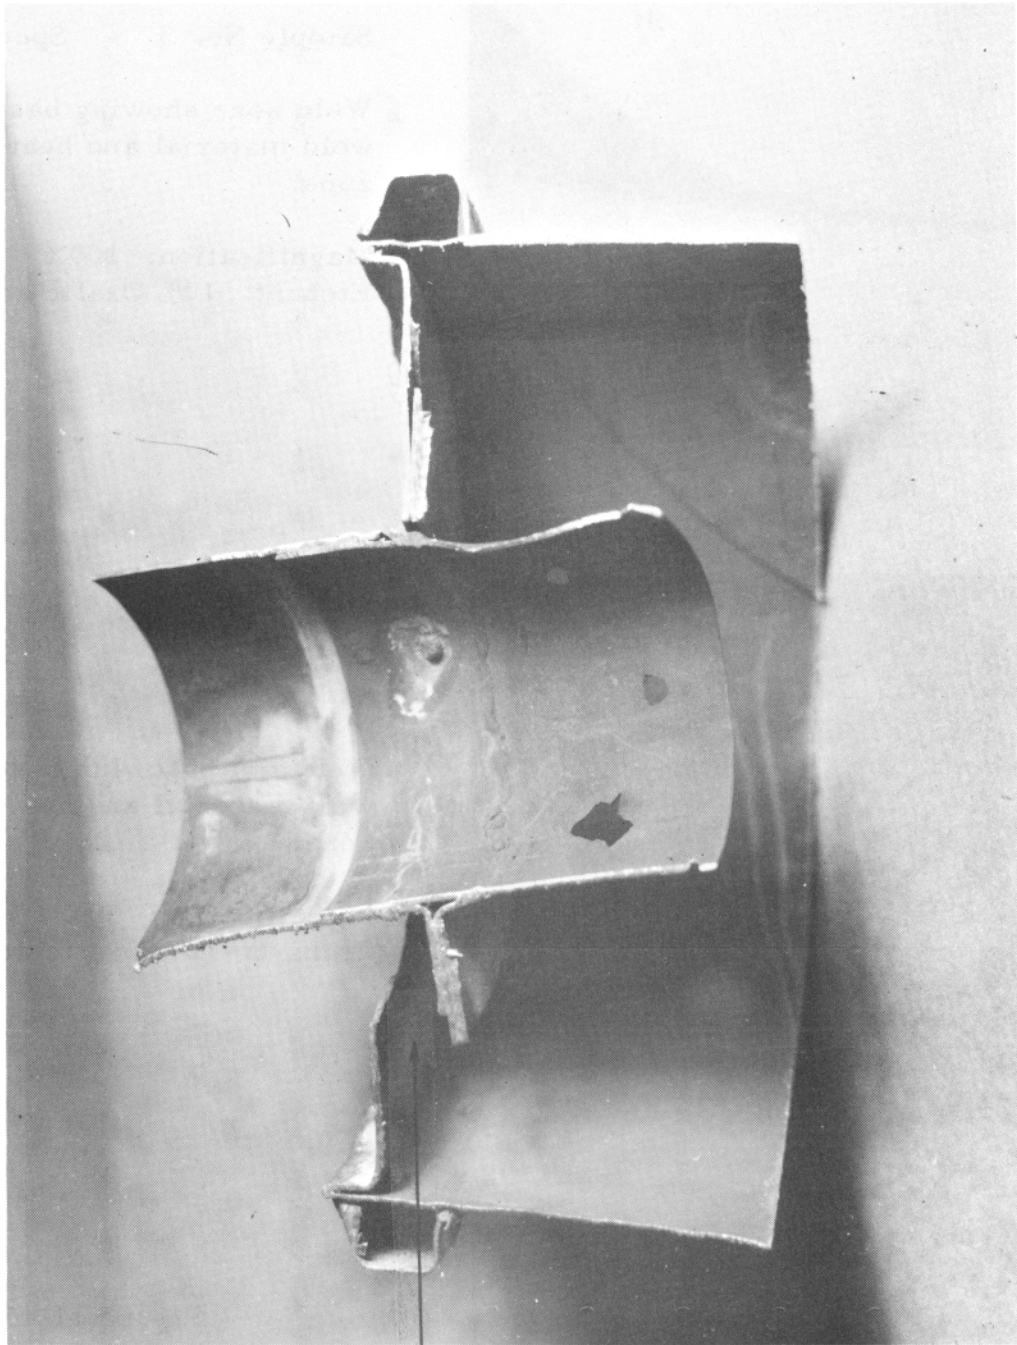
Figure 7. Sample No. 3 - Muffler End Plate, outside, 43 Test Hours  
Arrows indicate extent of crack in sample.

Figure 8. Sample No. 3 - Muffler End Plate, inside, 43 Test Hours  
Arrow indicates crack in sample.

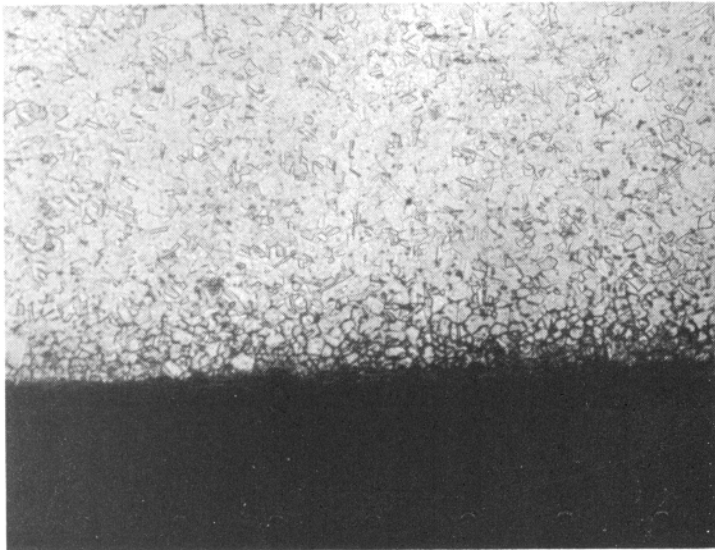
Other specimens were cut on one side of the crack and examined for general structure and the cause of failure. Figures 11 and 12 show the normal 347 structure with some evidence of delta ferrite. Figure 13 shows the inside edge along the crack in Specimen No. 3.

General structure around crack.

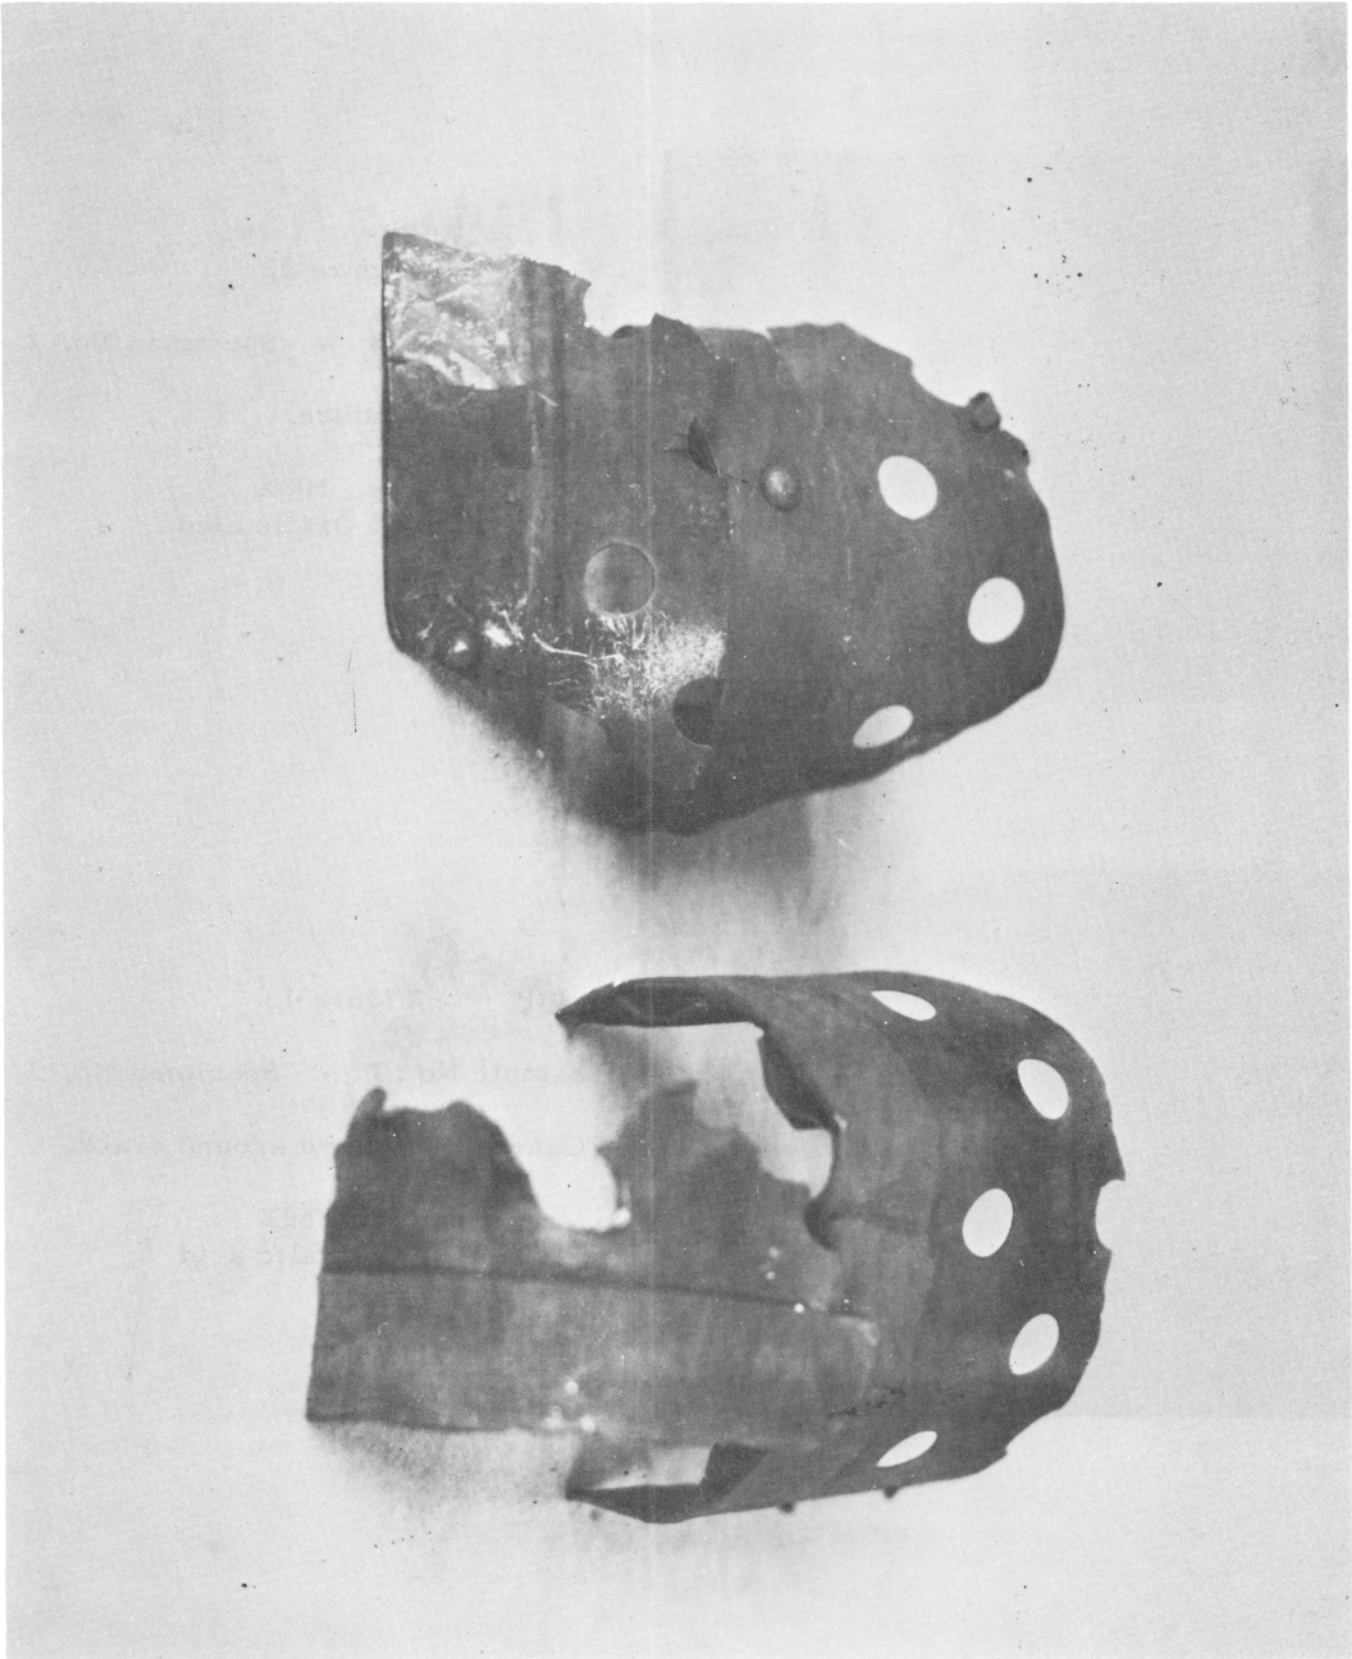
Figure 14. Sample No. 4 - Muffler Baffle, 160 Test Hours

Sample No. 4 consisted of four pieces of a section of Muffler Baffle. This sample is shown in the as-received condition in Figure 14. The baffle exhibited severe oxidation and distorted edges at the failed section. The piece for chemical analysis was taken midway between the failed area and the baffle end. The analysis indicated the material to be AISI 347.

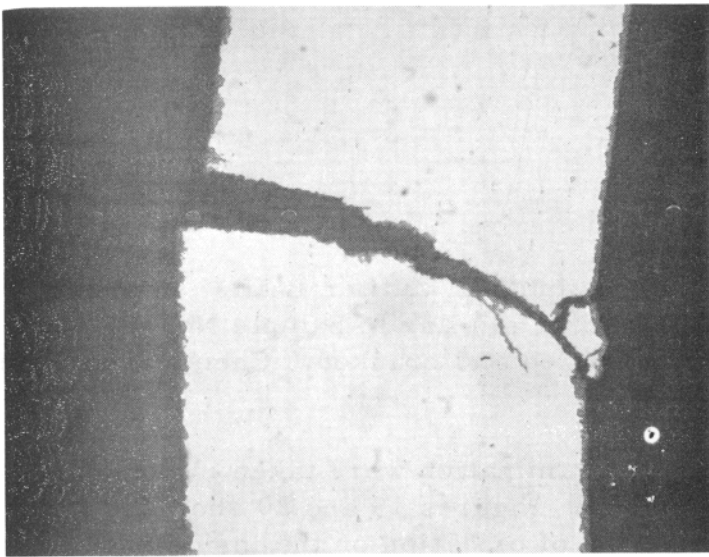
A metallographic specimen was cut to view the end of a crack which had developed perpendicular to the circumference of one of the holes in the baffle. Figure 15 shows the crack with two branches, (also see Figures 16 and 17). Columbium carbides are visible in these figures.

Showing end crack in shell and  
columbium carbides.  
As polished.

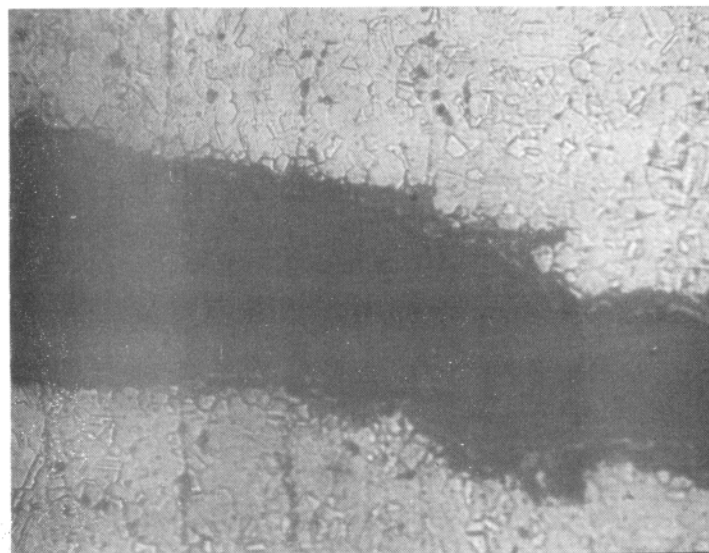
Figure 17

Showing grain structure around  
crack.

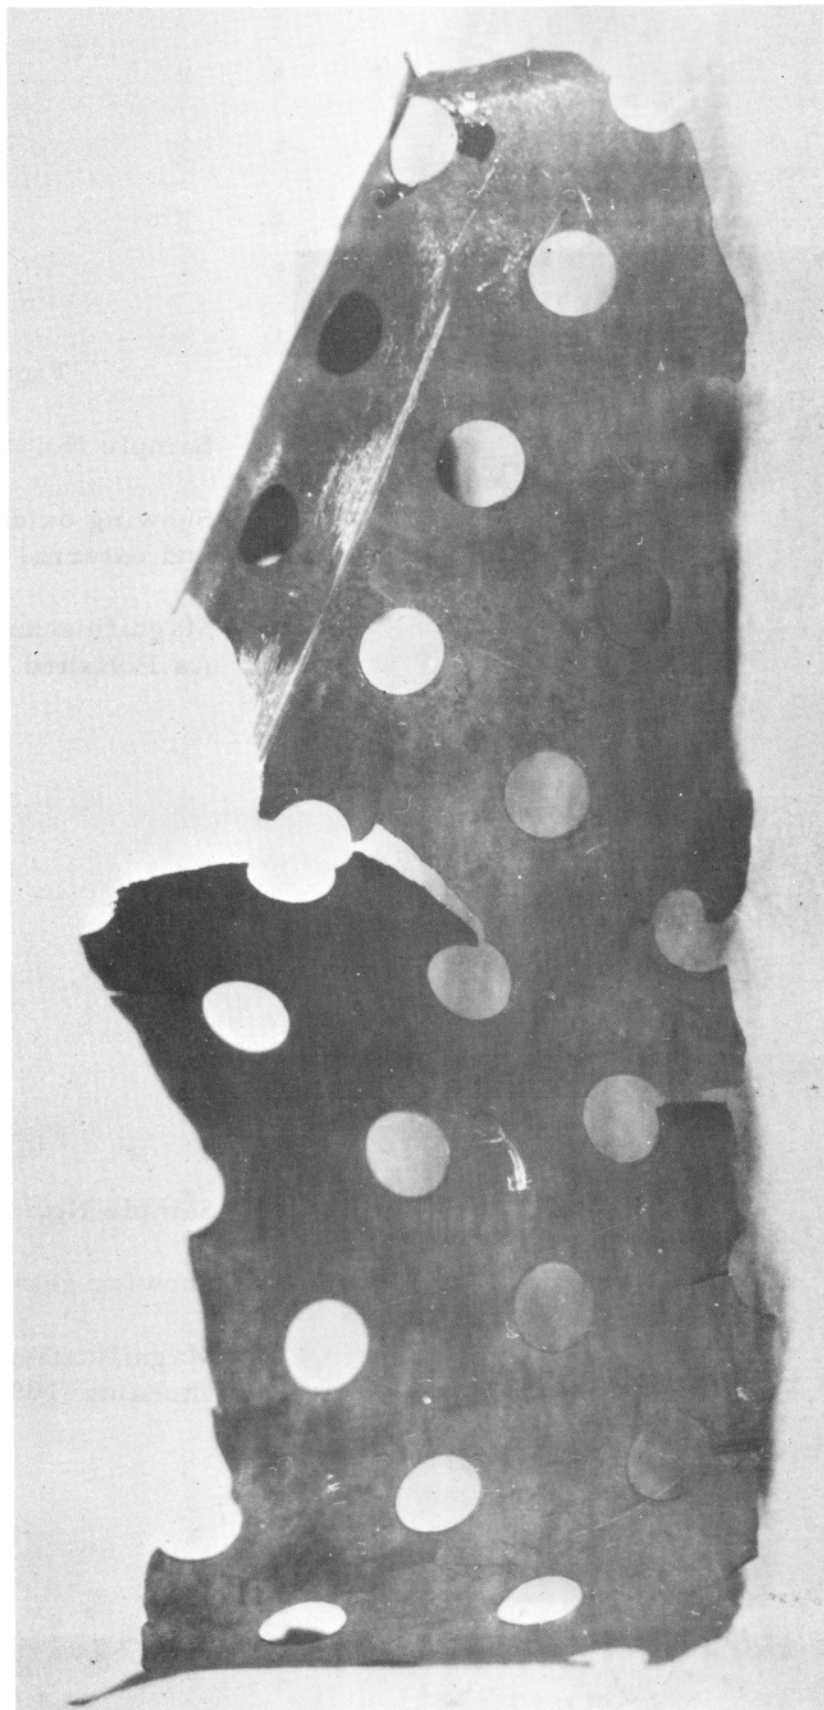
Figure 18. Sample No. 5 - Muffler Baffle, 160 Test Hours

Sample No. 5 (see Figure 18) is another Muffler Baffle. The test conditions and former configuration were similar to Sample No. 4. This sample as-received was twisted, oxidized and cracked. Chemical analysis indicated the material to be AISI 347.

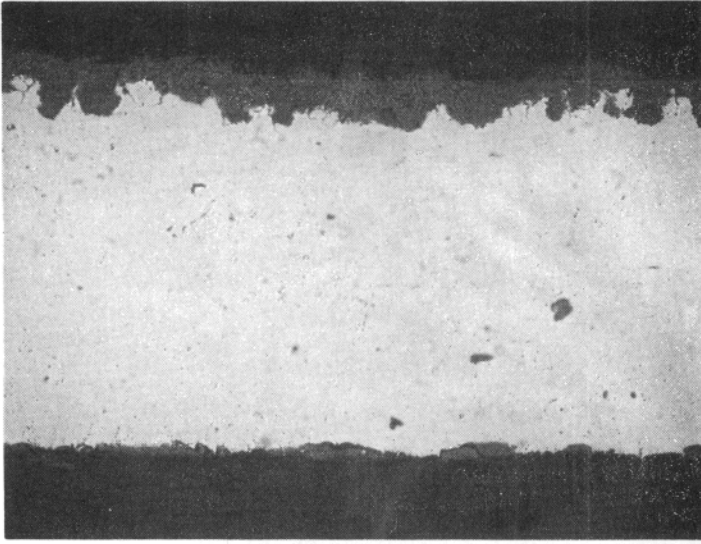
Figure 19

Specimens for metallographic examination were taken in both the longitudinal and transverse directions. Figures 19 and 20 show the general structure and comparative penetration of oxidation on the inside and outside surfaces. The structure revealed grain growth on the outside and inside portion and a finer structure in the middle. This condition is probably due to the higher operating temperatures experienced at these edges.

Showing oxidation on both internal  
and external surfaces.

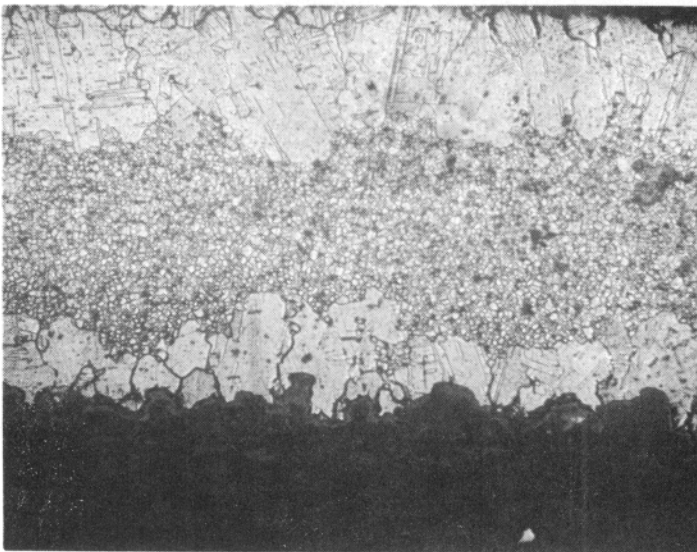
Figure 20

Showing grain growth.

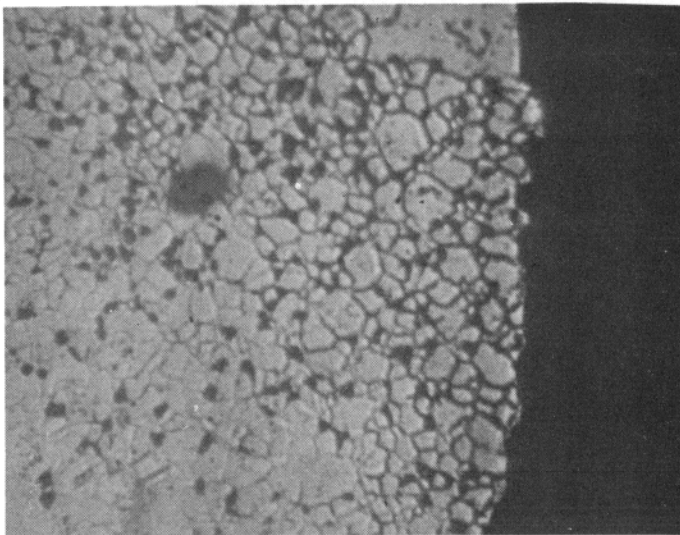
Figure 22

The second metallographic specimen was taken in a transverse direction at the end of a crack through one of the baffle holes, (see Figure 21). Examination of the grain structure showed intergranular corrosion (see Figures 22 and 23).

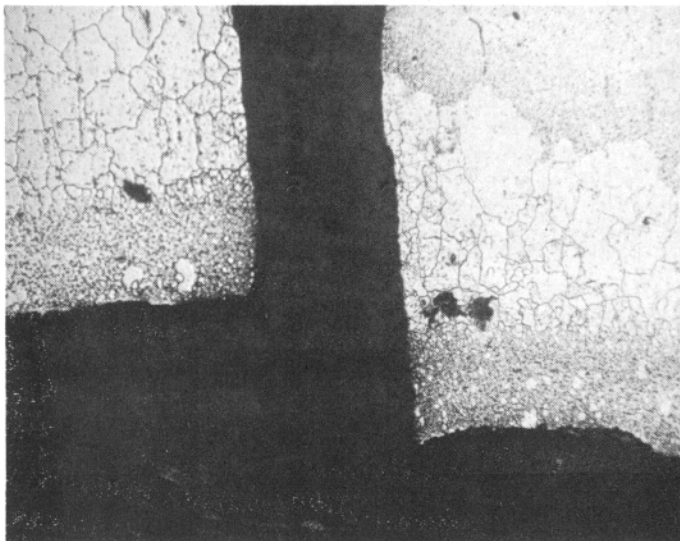
Figure 23

Showing general microstructural  
appearance of crack.

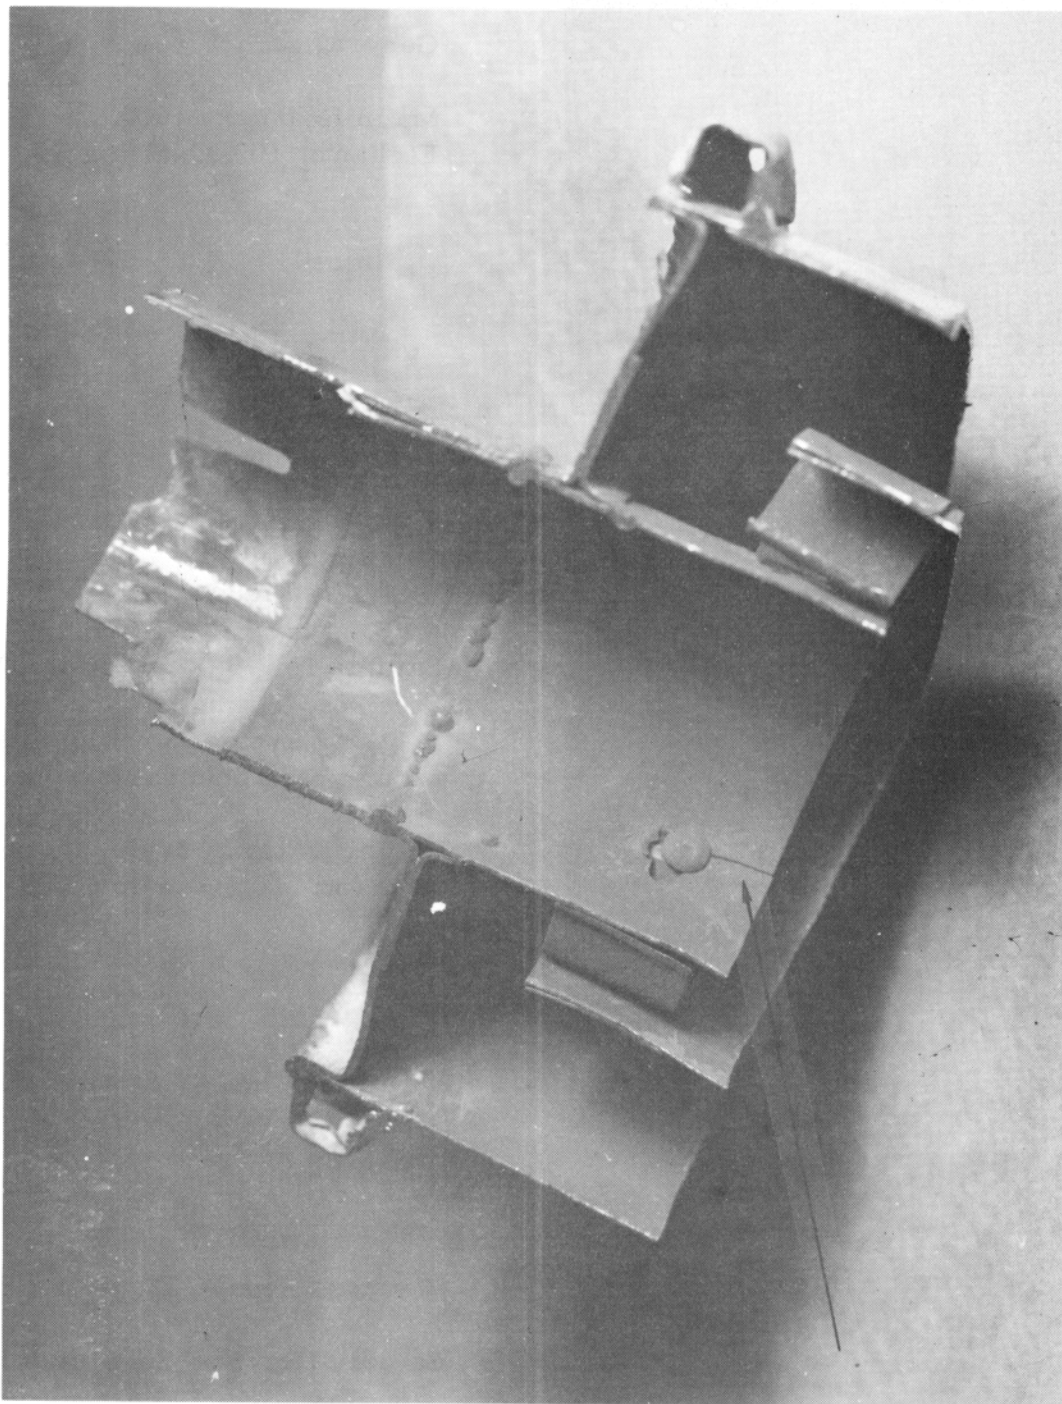
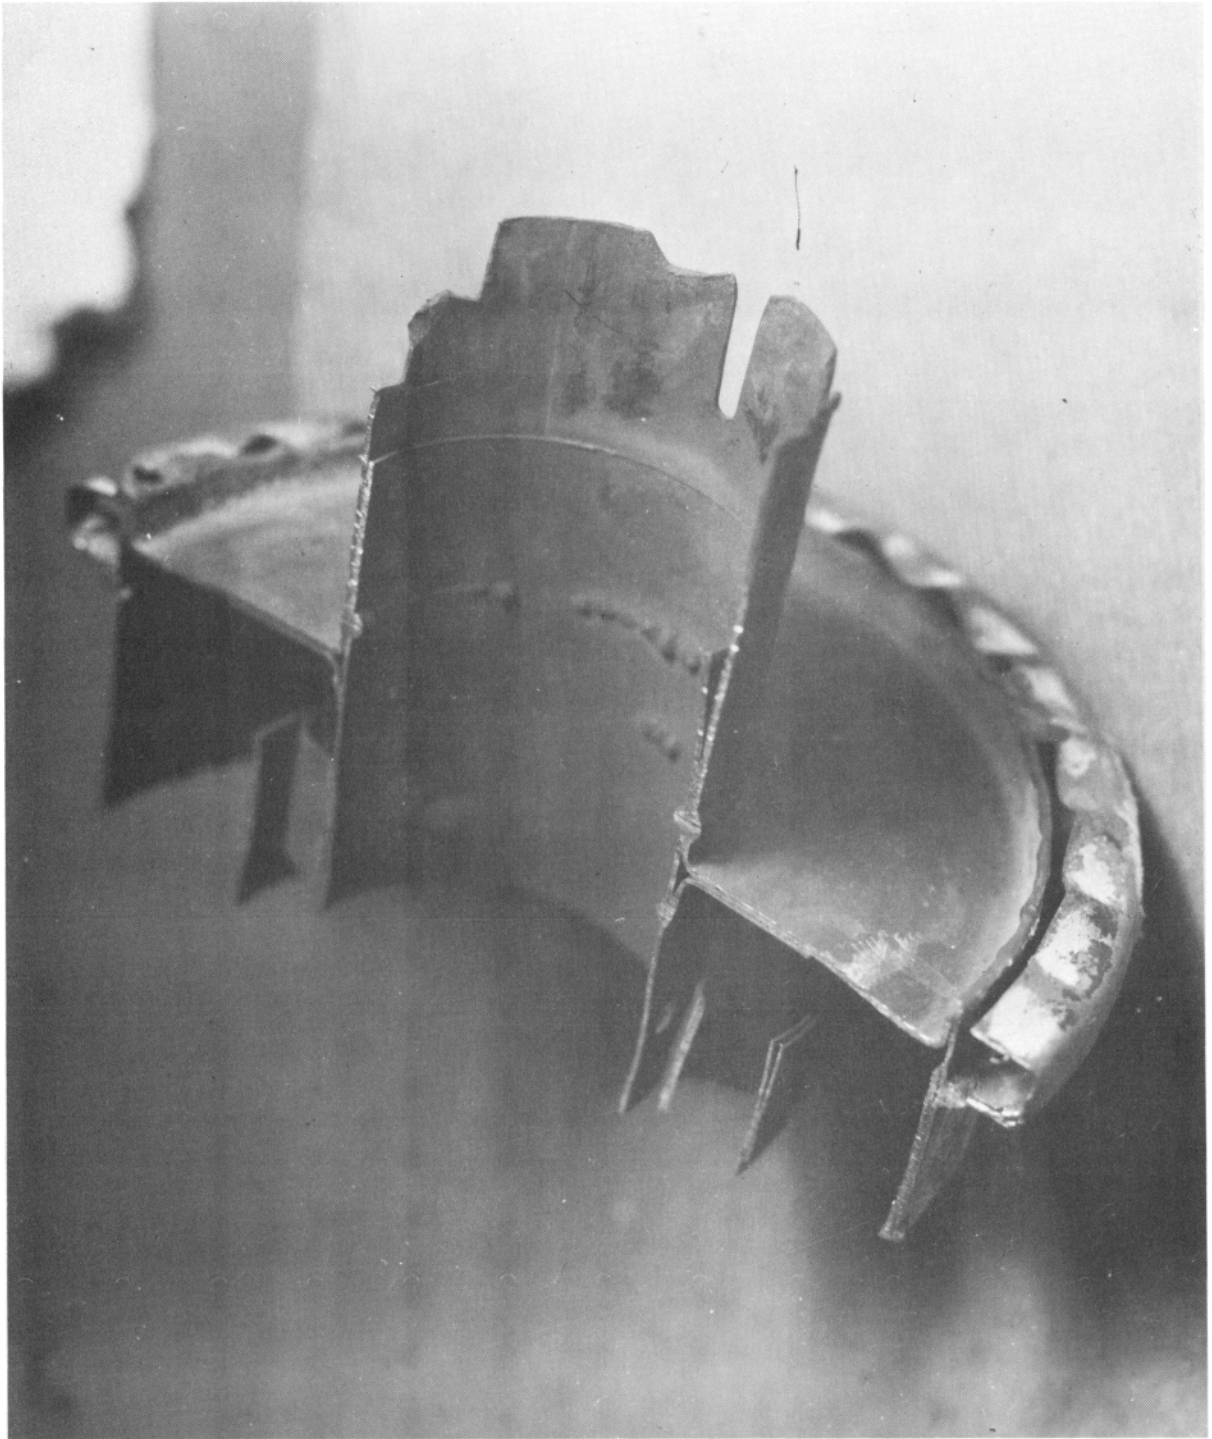
Visual examination showed some oxidation internally and externally along with some distortion and bulging near the intake tube. It is also noted that one of the two rivets holding the internal baffle to the joint was completely sheared off and the metal was cracked adjacent to the other rivet.

Figure 24. Sample No. 6 - Joint, Muffler to Manifold, inside, 490 Test Hours

Figure 25. Sample No. 6 - Joint, Muffler to Manifold, outside, 490 Test Hours

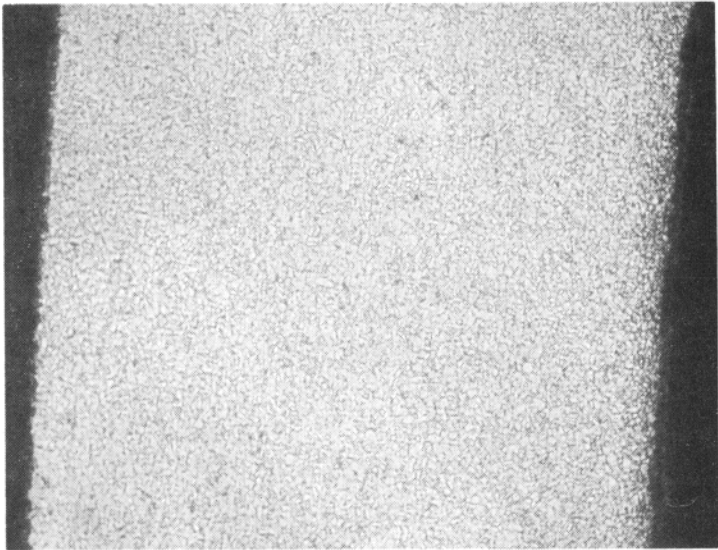
Figure 26 shows the general structure of the sample and the deeper penetration of oxidation in the inside surface.

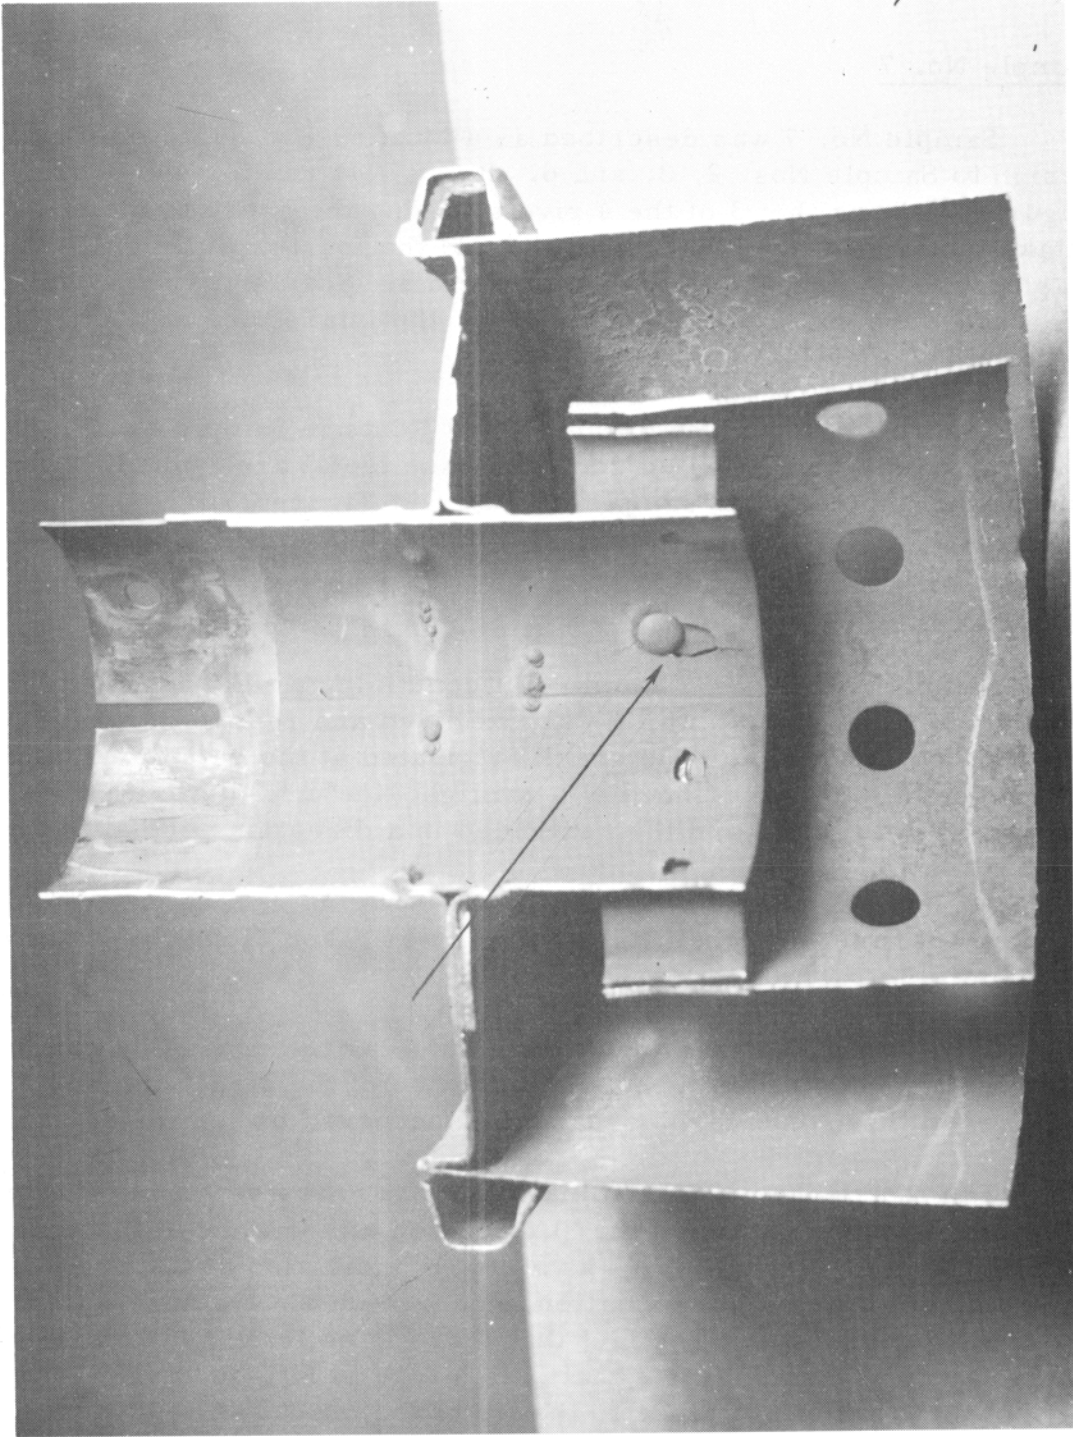
Figure 27. Sample No. 7 - Muffler End Plate, 448 Test Hours

Sample No. 7 was described as a Muffler End Plate similar in design to Sample Nos. 2, 3, and 6. It was test run for 448 hours. Figure 27 shows that 3 of the 4 rivets joining the baffle to the end plate intake tube were completely sheared and the fourth, while still intact, was cracked and weakened by lost material. Specimens for chemical analyses were cut from the outer shell, the intake tube and the internal baffle. The material was Type 347.
