FINAL REPORT

Contract No. FA67NF-210  
Project No. 520-003-01X  
Report No. NA-68-22  
(DS-68-10)

METALLURGICAL EVALUATION OF AIRCRAFT  
EXHAUST SYSTEM COMPONENTS FAILED DURING  
GROUND TEST PROGRAM

April 1968

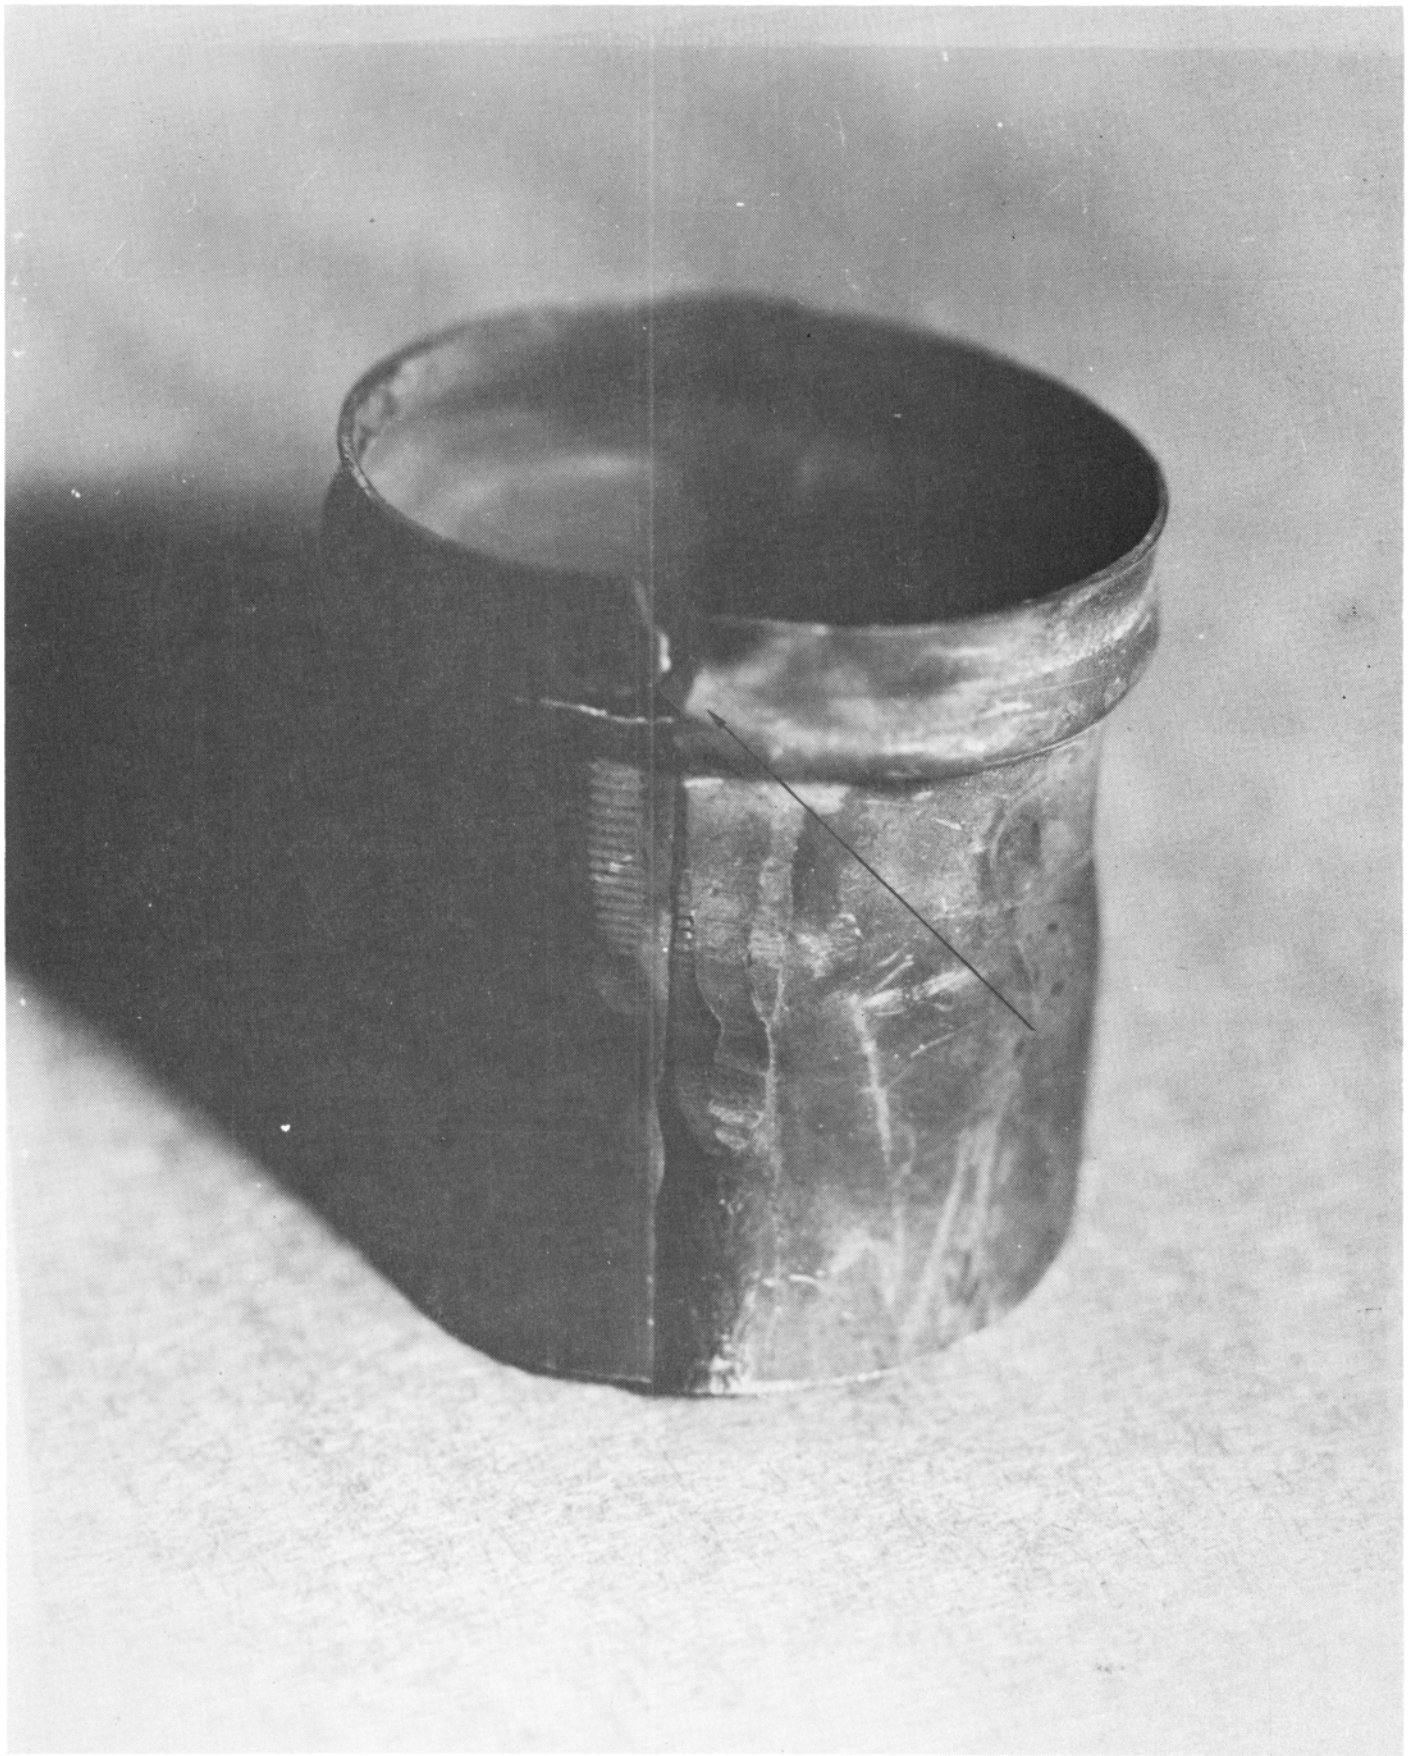
Figure 30. Sample No. 8 - Stack Joint, 112 Test Hours

Sample No. 8 was a Stack Joint containing a weld as shown in Figure 30. The sample was lightly oxidized and reported to have been test run for 112 hours. The crack originated at the outside edge of the tube near the weld, continued in a straight line until it reached the curved portion of the sample and then extended in a direction normal to the original path.

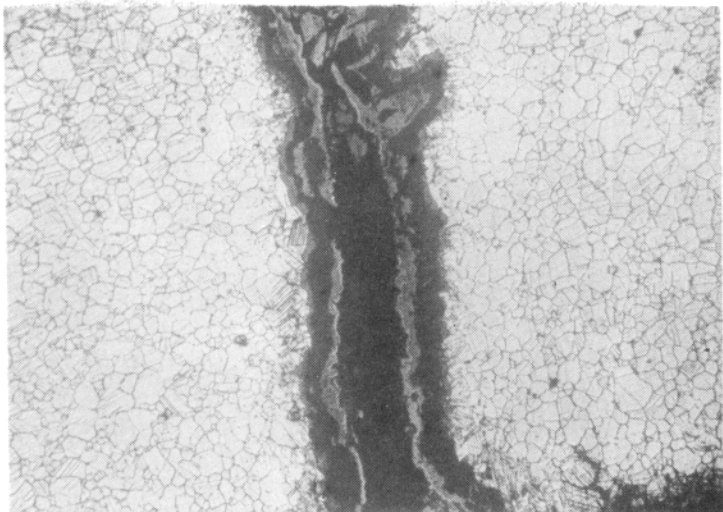
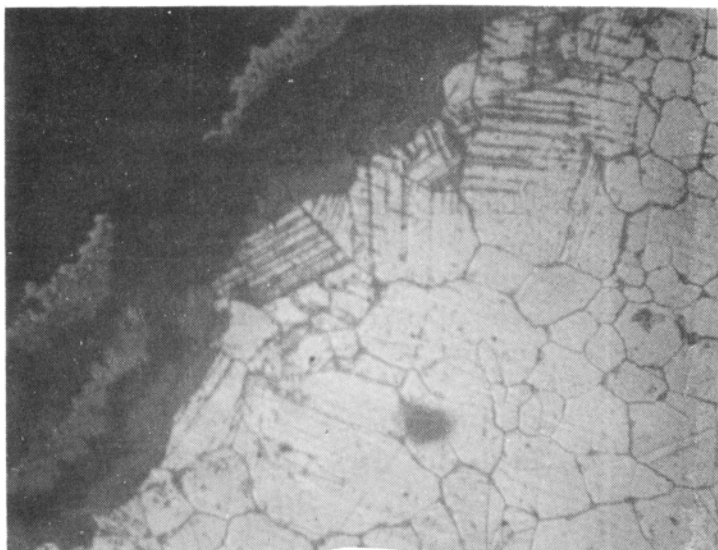
The metallographic examination of the cross section of the crack revealed heavy oxidation on the surfaces on either side of the crack (see Figures 32 and 33). This is a strong indication of the progressive nature of the crack since oxidation occurred on the fracture surface as the crack progressed. The fact that there is no thinning of the metal at the fracture also suggests that it is a type of fatigue crack. Figure 34 shows the structure close to the tip of the crack. The slip bands are typical of a condition created at the tip of a fatigue crack.

Showing oxidation on crack surface.

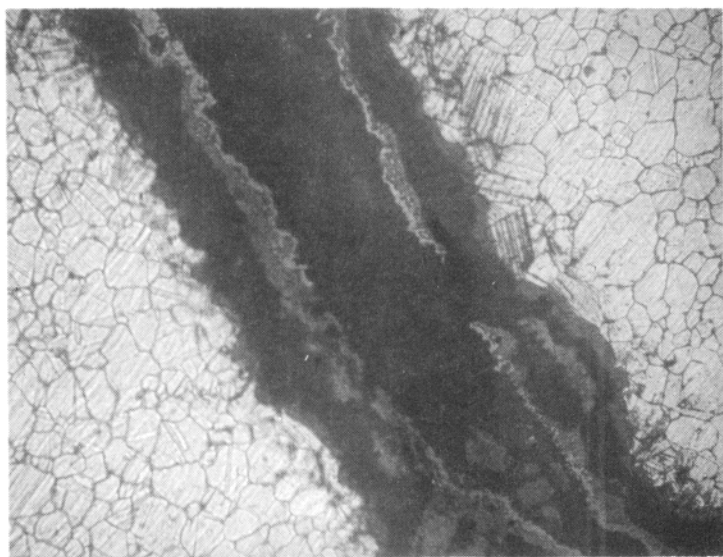
Figure 34

End of crack. Note slip bands adjacent to edge of crack.

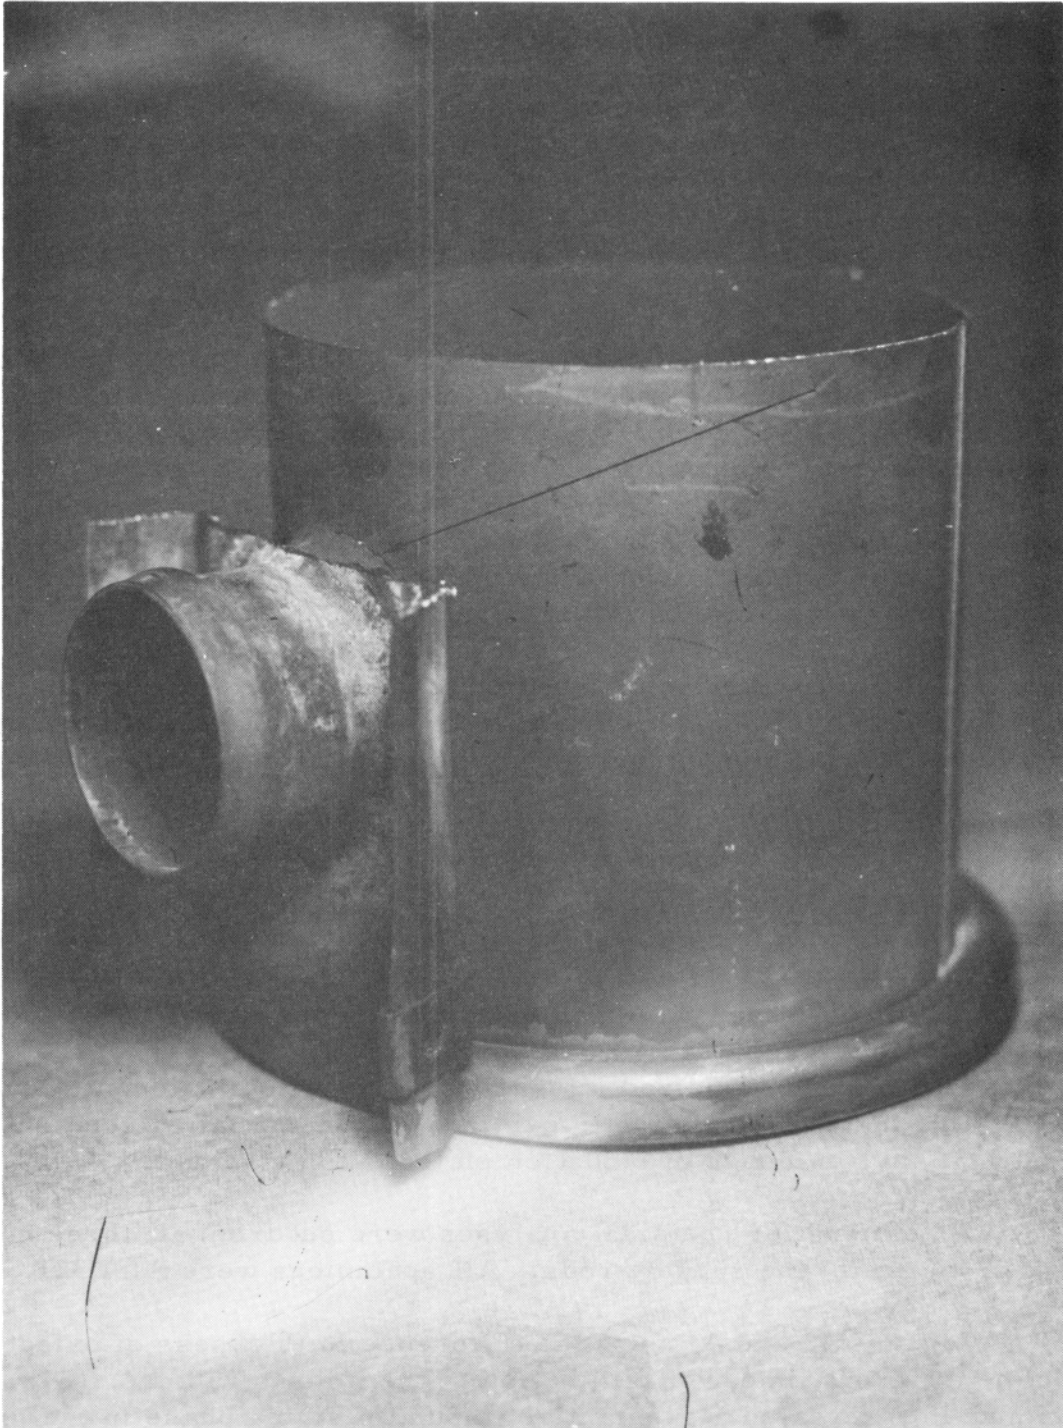
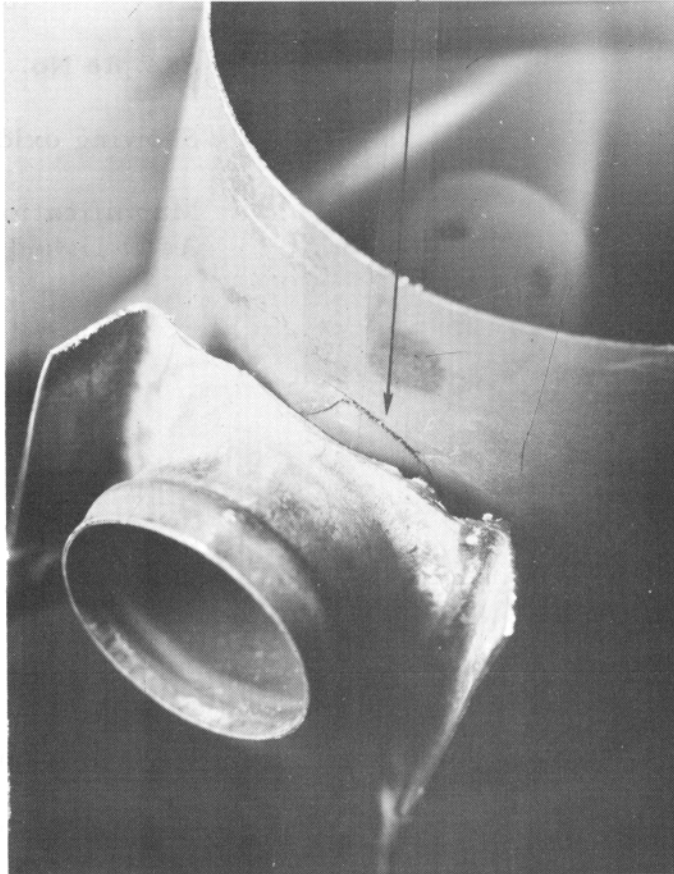
Sample No. 9 was described as a Muffler Wall, Heat Exchanger Surface. The sample was heavily oxidized on both the inside and outside surfaces. Figures 35 and 36 show the part in the as-received condition. There was a crack in the shell above the tube. Specimens for chemical analyses were cut from the shell, the tube and the support piece. All were Type 321. The sample was test run for 555 hours.

Figure 35. Sample No. 9 - Muffler Wall, Heat Exchanger Surface,  
555 Test Hours

Figure 36. Sample No. 9 - Muffler Wall, Heat Exchanger Surface,  
View of crack, 555 Test Hours

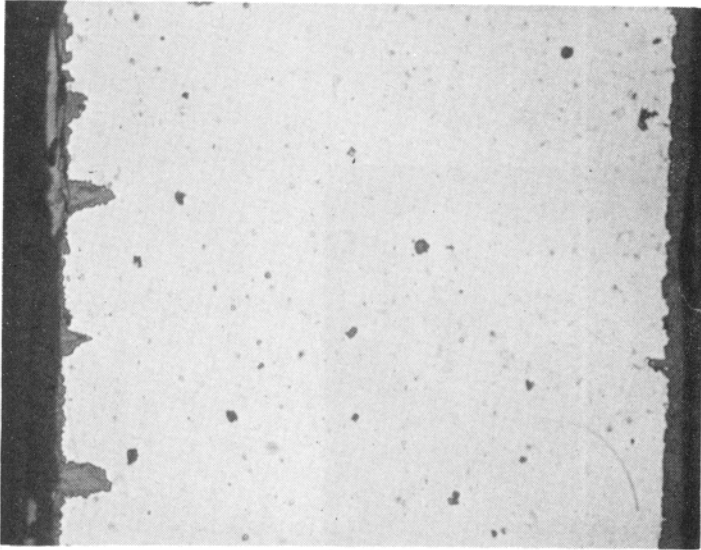
Figure 37

Metallographic specimens were cut at the end of the crack and at the opposite end of the shell. Examination of the polished surface showed a thick layer of oxidation on the inside surface. Figures 37 and 38 show the heavy oxidation. The outside surface showed deeper penetration at various locations along the surface. It is considered significant that the oxidation corrosion penetrates in some areas in a sharp pointed manner. Thus, creating points of stress concentration from which fatigue cracks can originate.

Showing oxidation at surfaces.

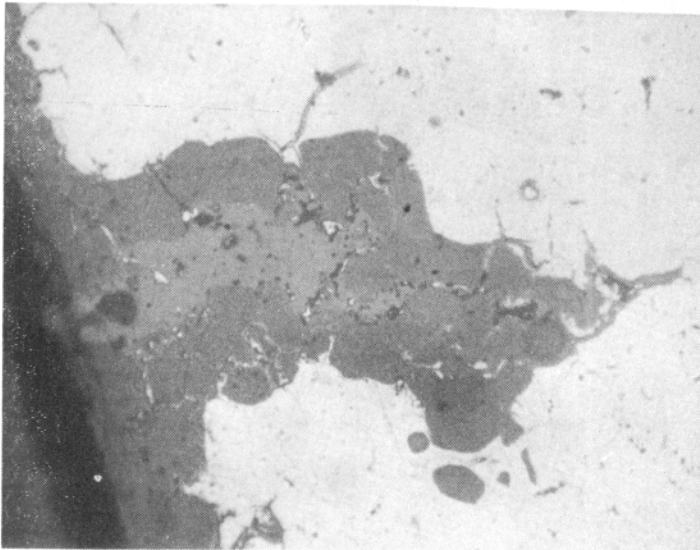
Figure 38

Deeper penetration at various  
locations on outside surfaces.

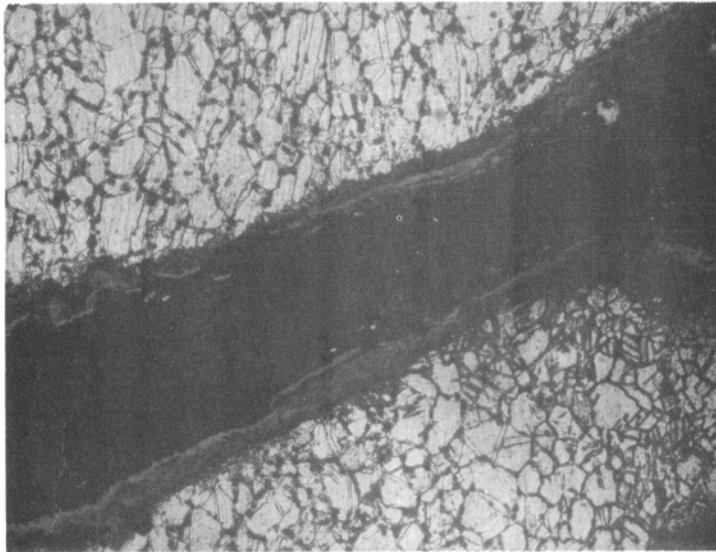
Figure 40

The microstructure at the two locations after etching are shown in Figures 39 and 40. The structure around the crack contained sigma phase distributed discontinuously in the grain boundaries, and severe oxidation.

Showing structure about crack  
and sigma phase in the grain  
boundaries.

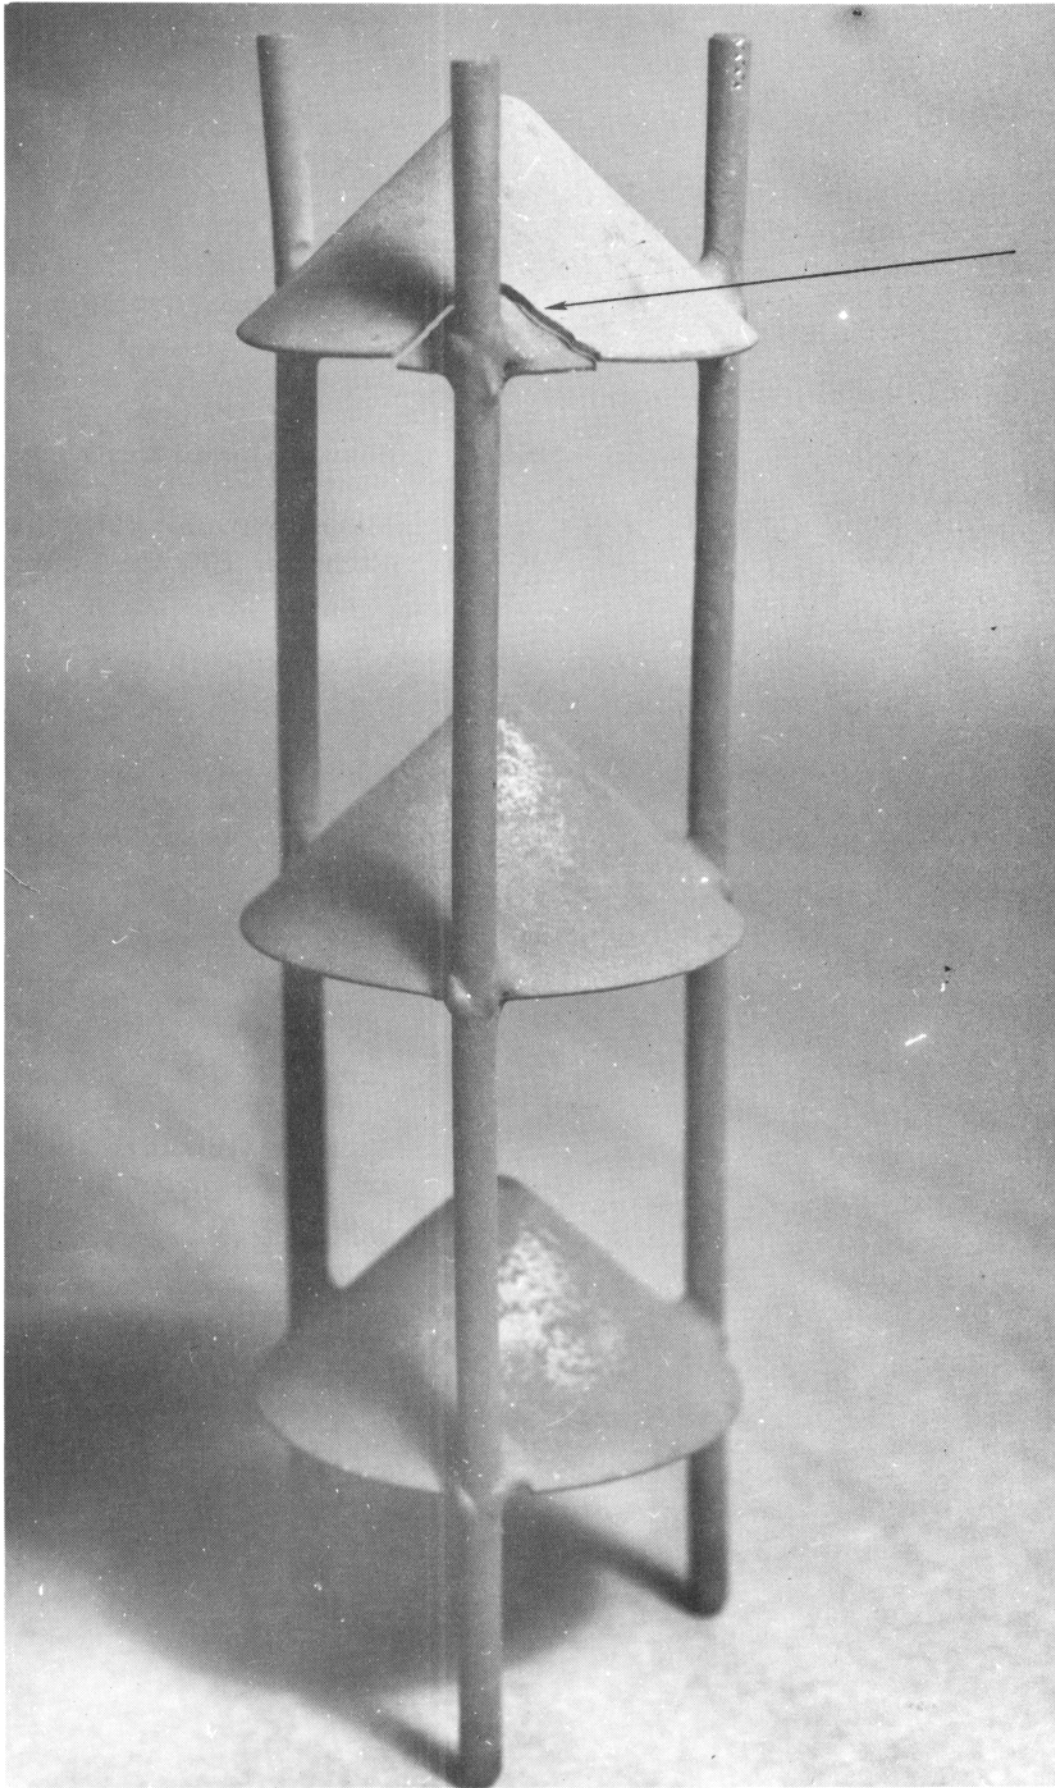
Figure 41. Sample No. 10-11 - Muffler Diffuser Cone, 600 Test Hours

Sample No. 10-11 was identified as a failed Muffler Diffuser Cone. Figure 41 shows a crack occurred around one of the support rods completely separating a section of the top cone. All of the three cones were heavily oxidized internally. The bottom two cones, which were still intact, were slightly oxidized, while the failed cone showed little, if any, evidence of oxidation on the outside surface.

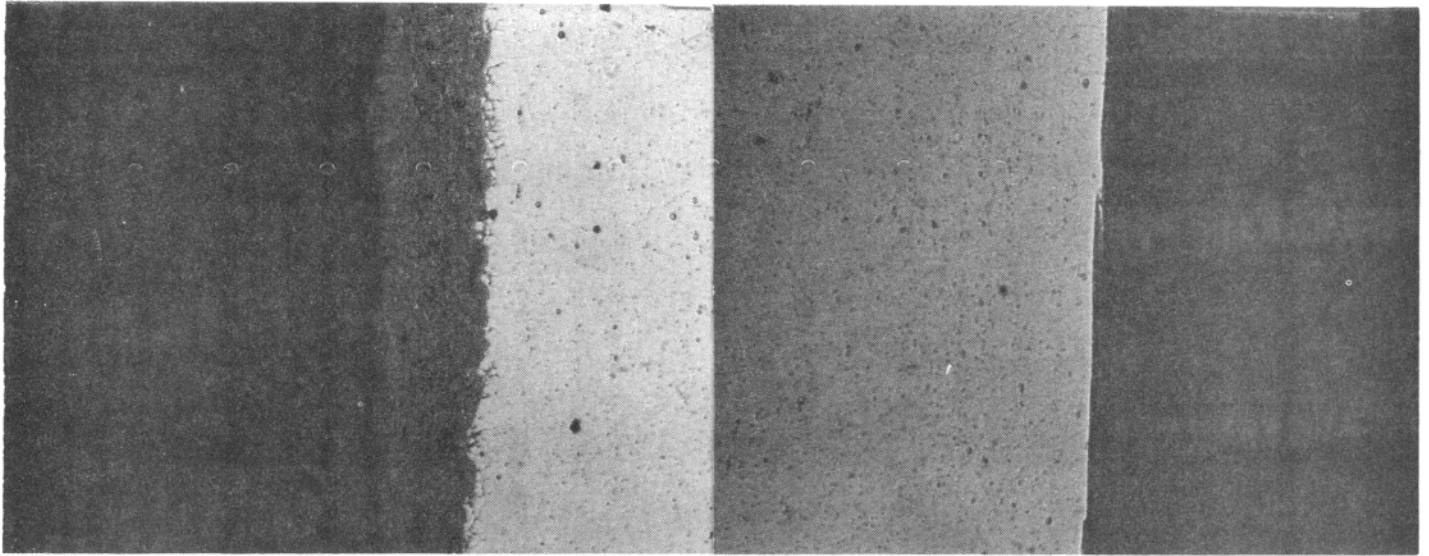
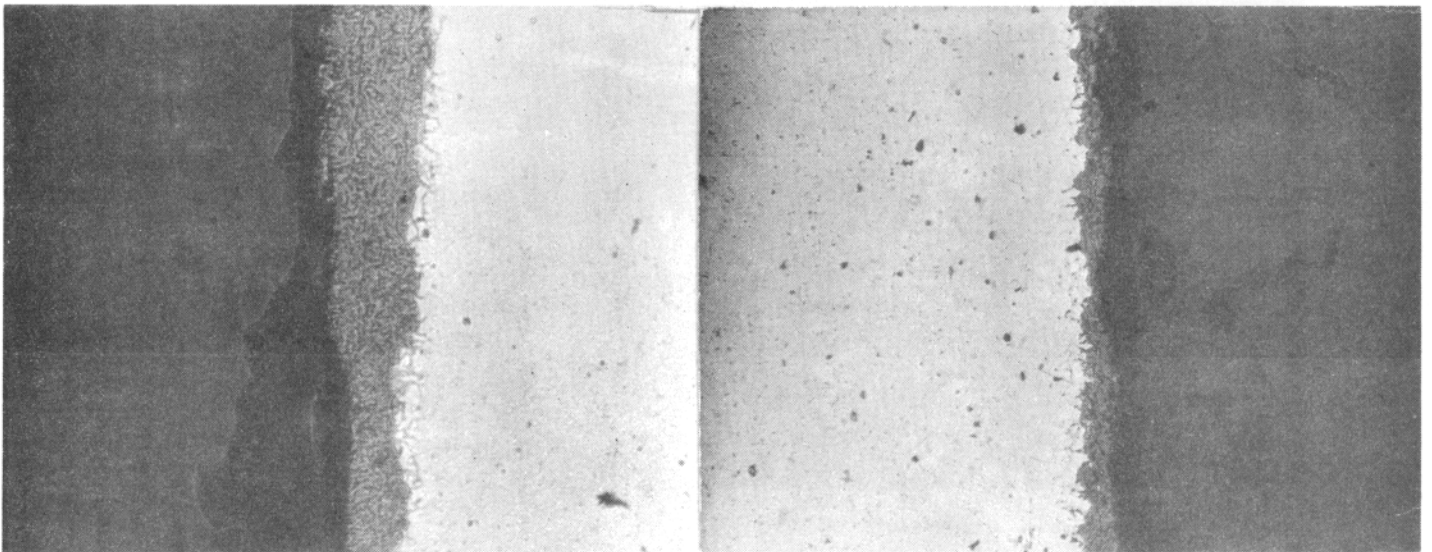
Figures 42 and 43 show the difference in thickness of oxidation on the different cones. Examination of the microstructure, (Figures 44 and 45), revealed a substantial amount of sigma phase in the grain boundaries and some within the grains.

Figure 42. Showing extent of Oxidation on Top Cone of Sample No. 10-11.  
Magnification: 100X As Polished

Figure 43. Showing extent of oxidation on Middle Cone of Sample No. 10-11.  
Magnification: 100X As Polished

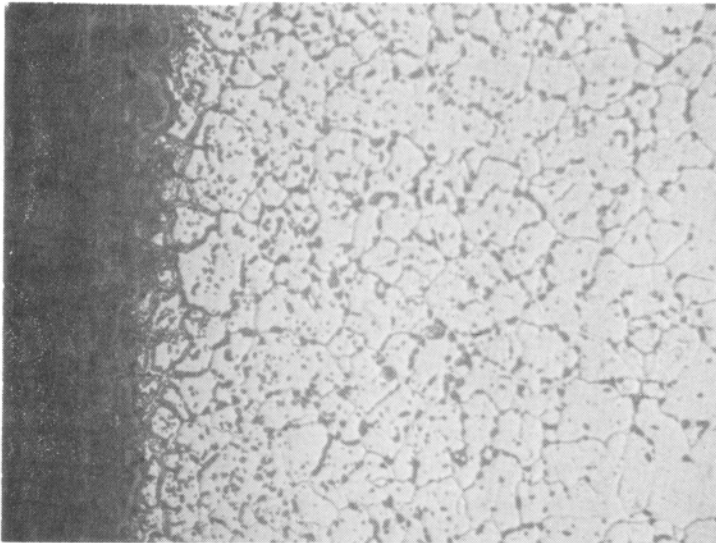
Figure 45

Showing sigma phase and  
intergranular corrosion.

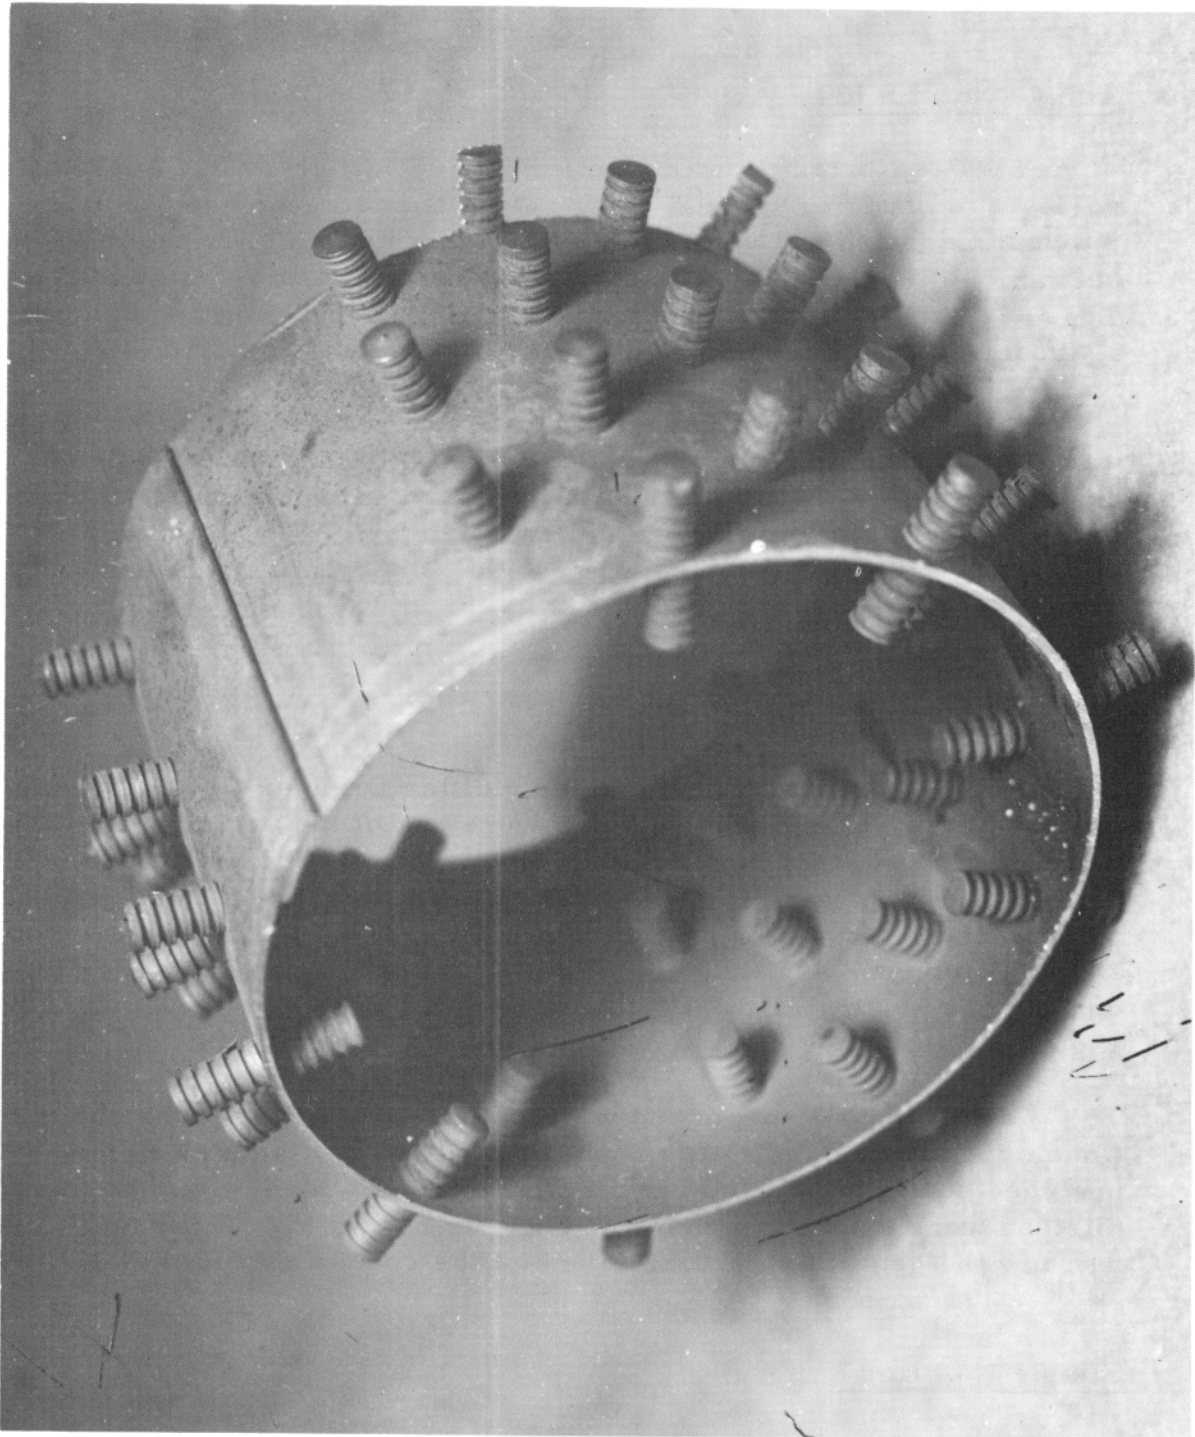
Figure 46. Sample No. 12-13 - Muffler Wall, 600 Test Hours

Sample No. 12-13 was identified as a Muffler Wall. There was no observed failure. Visual examination showed evidence of some internal oxidation and very little external oxidation. The studs were heavily oxidized. Chemical analyses showed the entire sample to be Type 321. The sample, which was test run for 600 hours, is shown as-received in Figure 46.

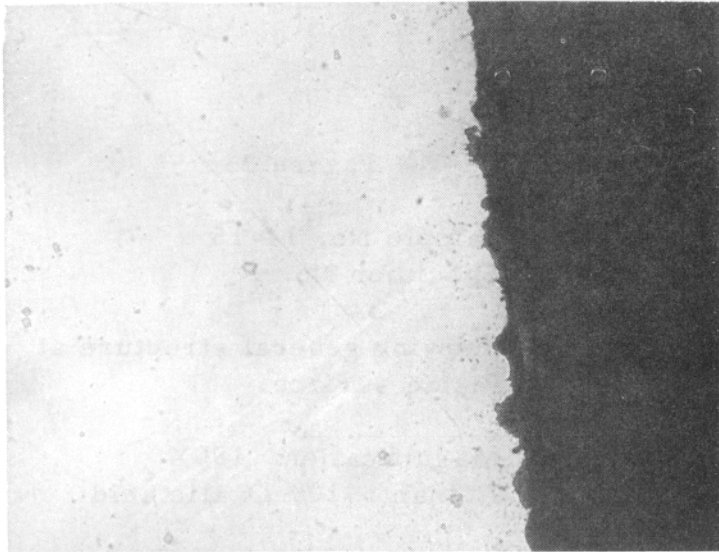
Figure 51

Metallurgical specimens were cut from all of the three cones (Incoloy Alloy 800). The microphotographs of the samples in the unetched condition showed very little oxidation. Many titanium cyanonitrides were evident as shown in Figures 51 and 52. Figures 53 and 54 show the general structure of one of the cones from Sample No. 14-15.

Inside surface showing oxidation  
and titanium cyanonitrides.

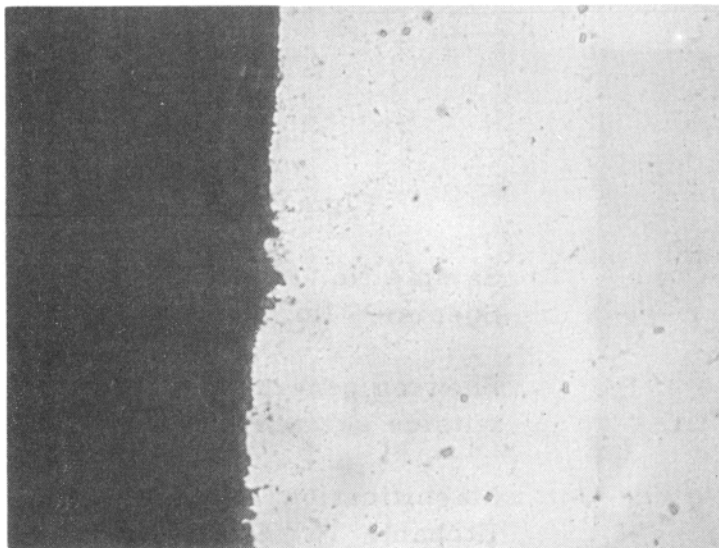
Figure 52

Outside surface showing oxidation  
and titanium cyanonitrides.

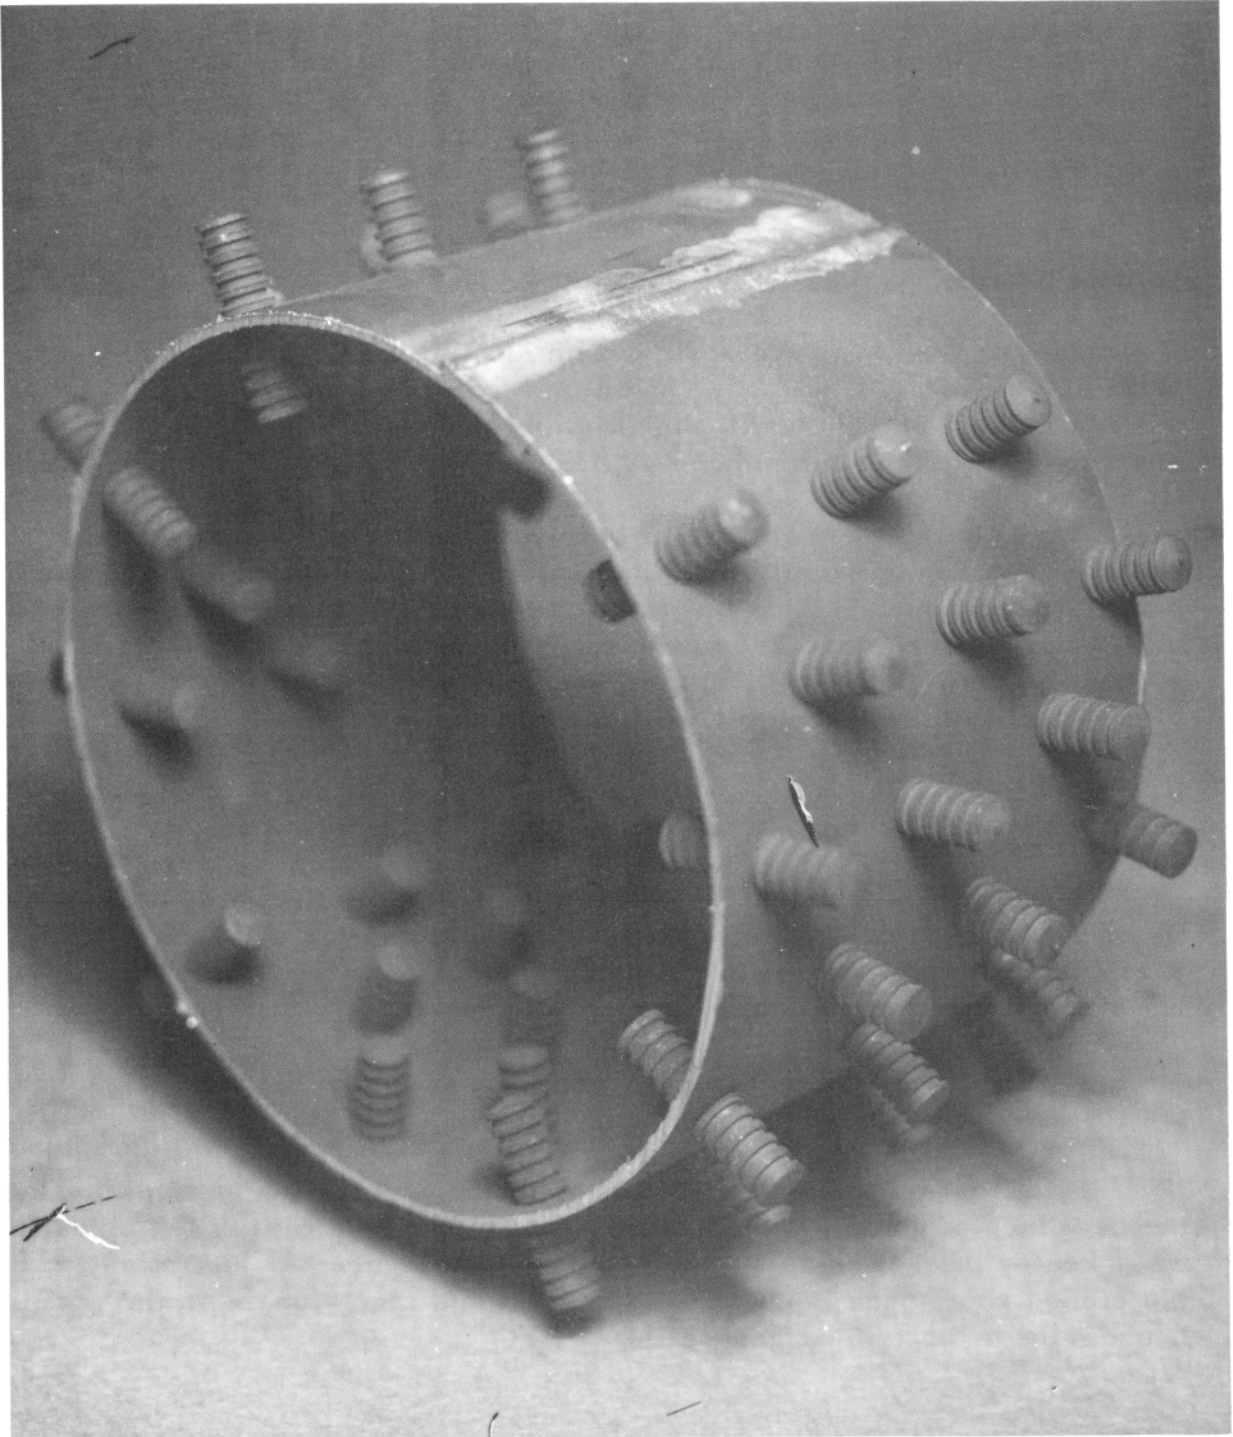
Figure 55. Sample No. 16-17 - Incoloy 800 Muffler Wall, 600 Test Hours

Sample No. 16-17 was a section cut from a Muffler Wall. The sample was identical in configuration to Sample No. 12-13. The description did not specify the amount of test hours. It was determined to be 600. Chemical analyses showed the sample to be Incoloy Alloy 800 with the exception of the studs which were Type 321. As in Sample No. 14-15, there was a conspicuous absence of oxidation except on the studs. Figure 55 shows the sample as-received.

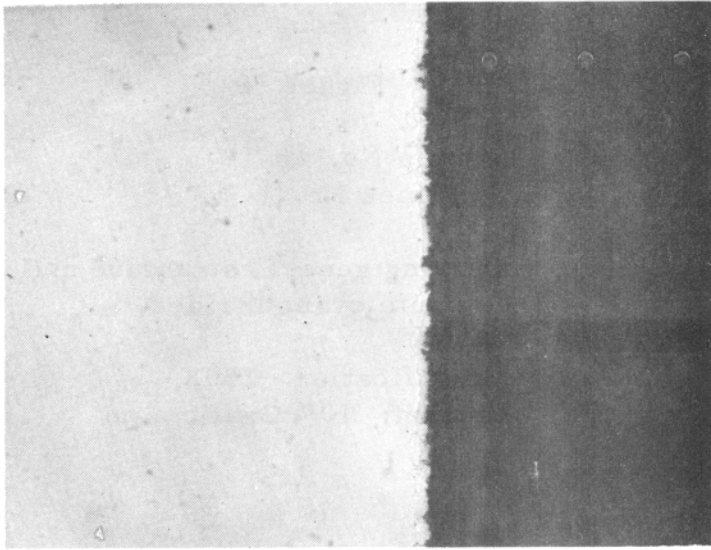
Figure 56

Metallurgical specimens were taken from the wall and the stud. Figures 56 and 57 compare the extent of oxidation on the inside edge of the AISI 321 stud and the Incoloy Alloy 800 wall. The general structure and titanium cyanonitrides are shown in Figures 58 and 59.

Showing extent of oxidation on the  
inside surface of the Incoloy Alloy  
800 muffler wall.

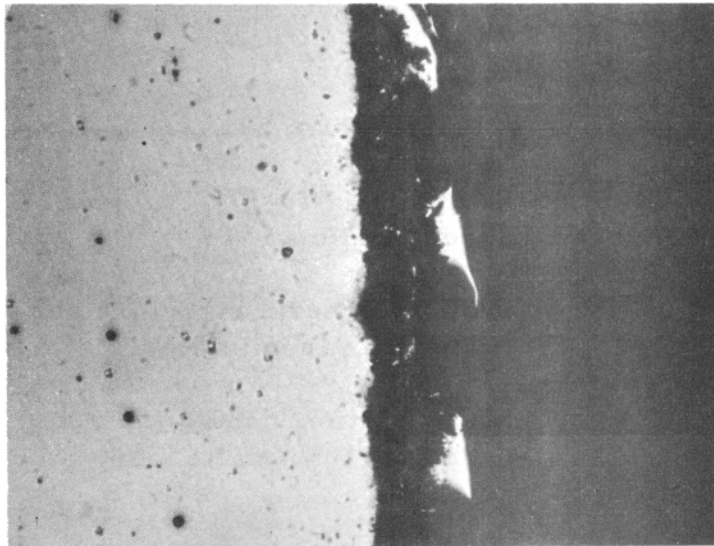
Figure 57

Showing extent of oxidation on the  
inside surface of AISI 321 stud.

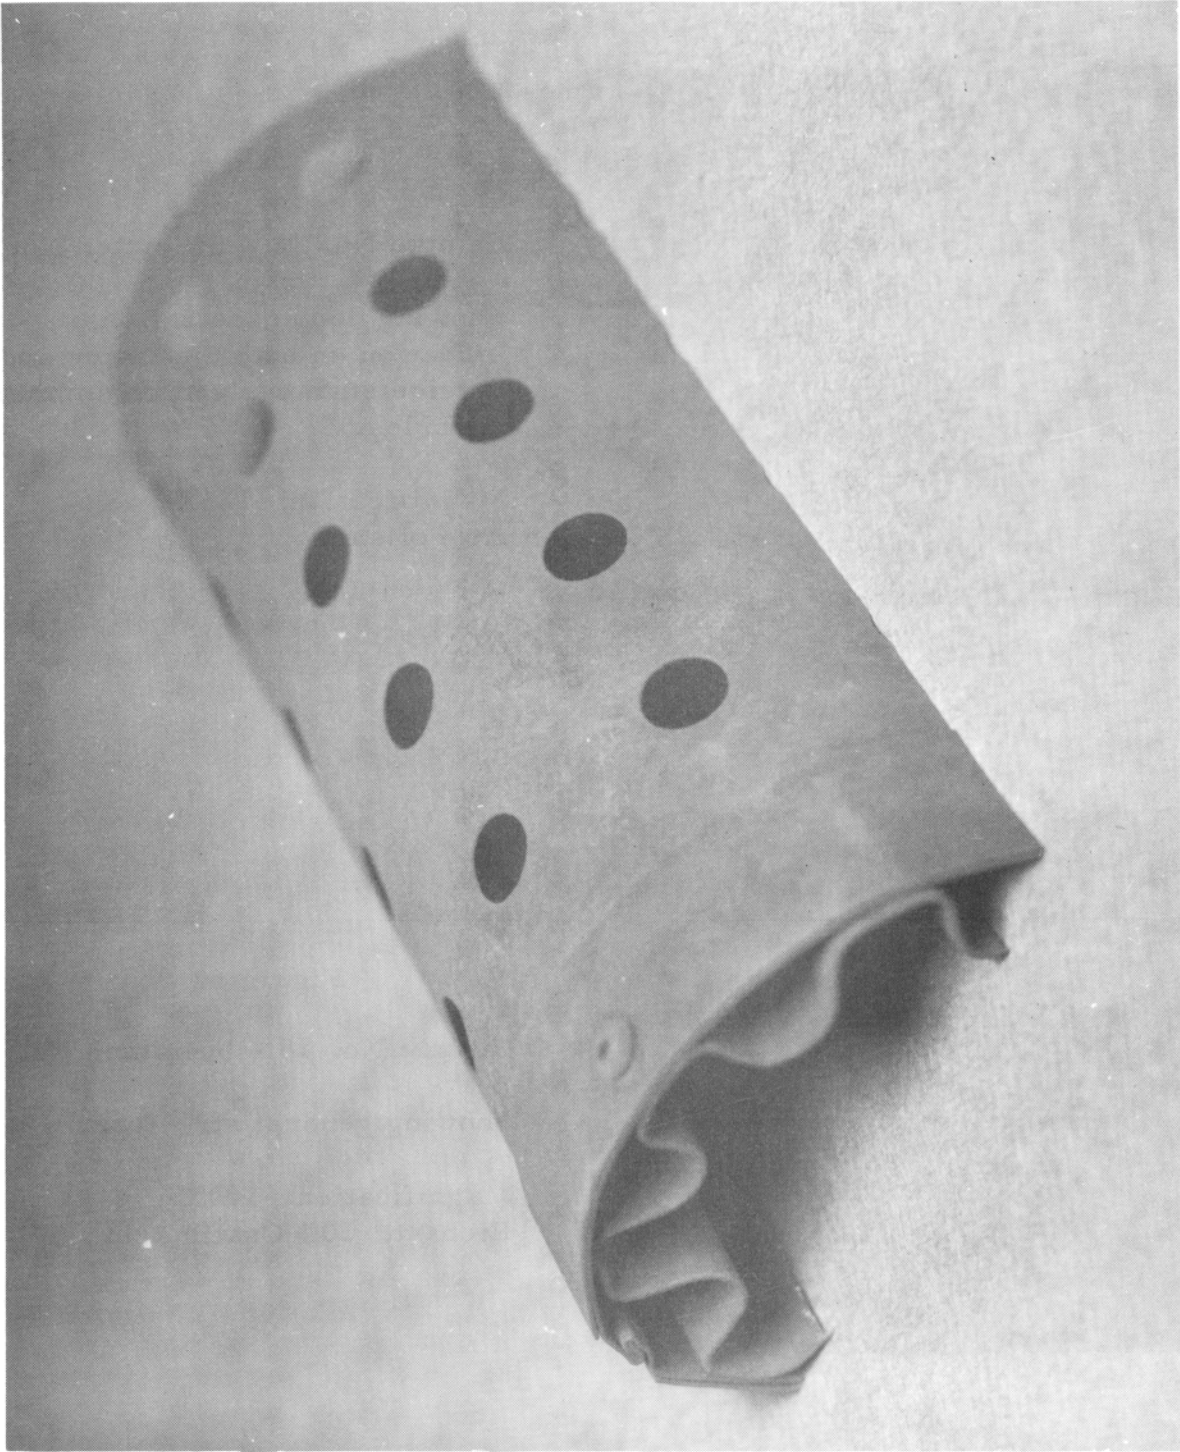
Figure 60. Sample No. 18 - Muffler Baffle, 490 Test Hours

Sample No. 18, Figure 60, was a Muffler Baffle similar in design to Samples No. 1, 4, and 5. The sample was test run for 490 hours and showed no sign of failure although the oxidation was thick. Chemical analyses showed the samples to be AISI 347.

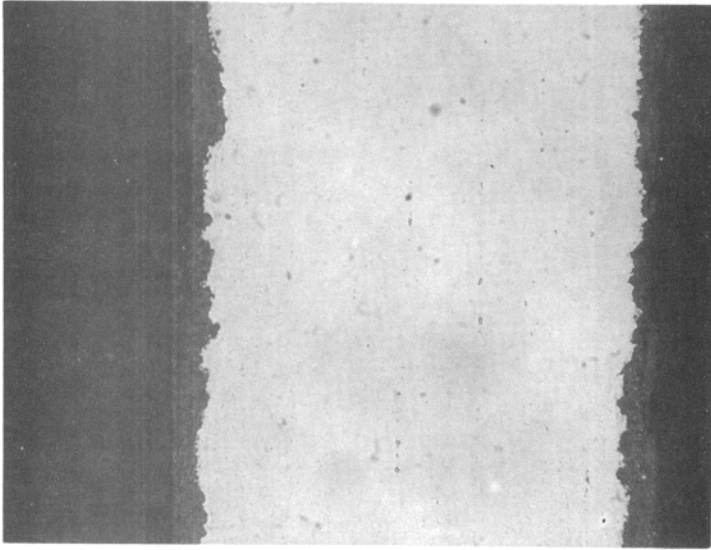
Figure 61

Metallographic examination in the unetched condition revealed a deep penetration of oxidation on both the inside and outside surfaces and columbium carbides. This condition is shown in Figure 61. Figure 62 shows the general structure of the sample. Intergranular corrosion is evident on the internal and external surfaces and there is a great amount of sigma phase present in the grain boundaries.

Showing deep penetration of oxidation on both the inside and outside surfaces and columbium carbides.

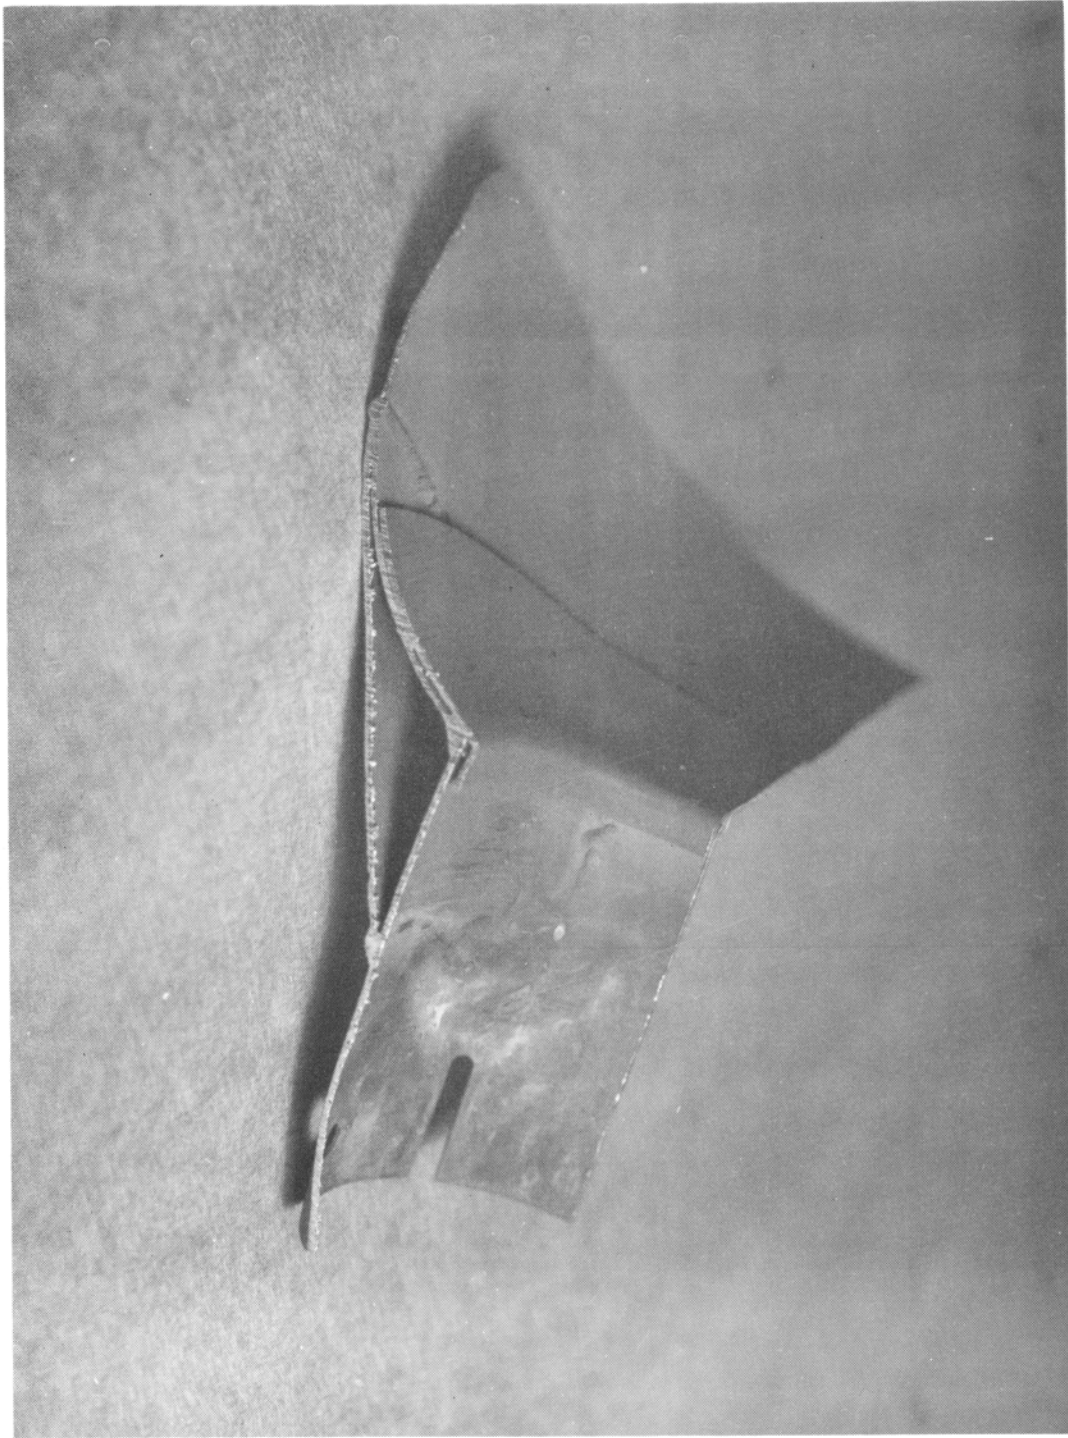
Figure 63. Sample No. 19 - Muffler Wall, 490 Test Hours

Sample No. 19, Figure 63, was a part of a Muffler Wall. The thickness was given as .02 inch and it was test run for 490 hours. This particular muffler was not of the same configuration as Sample No. 12-13, but a comparison of general condition was desired.

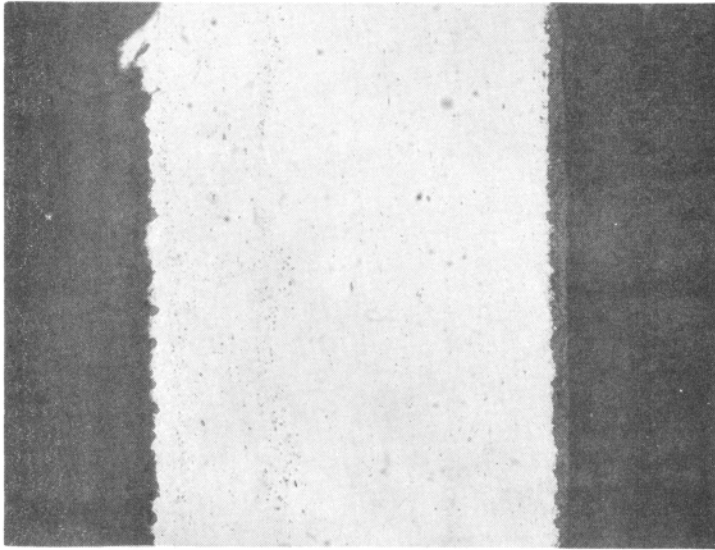
Figure 64

Showing penetration of oxidation.
