FINAL REPORT

Contract No. FA67NF-210  
Project No. 520-003-01X  
Report No. NA-68-22  
(DS-68-10)

METALLURGICAL EVALUATION OF AIRCRAFT  
EXHAUST SYSTEM COMPONENTS FAILED DURING  
GROUND TEST PROGRAM

April 1968

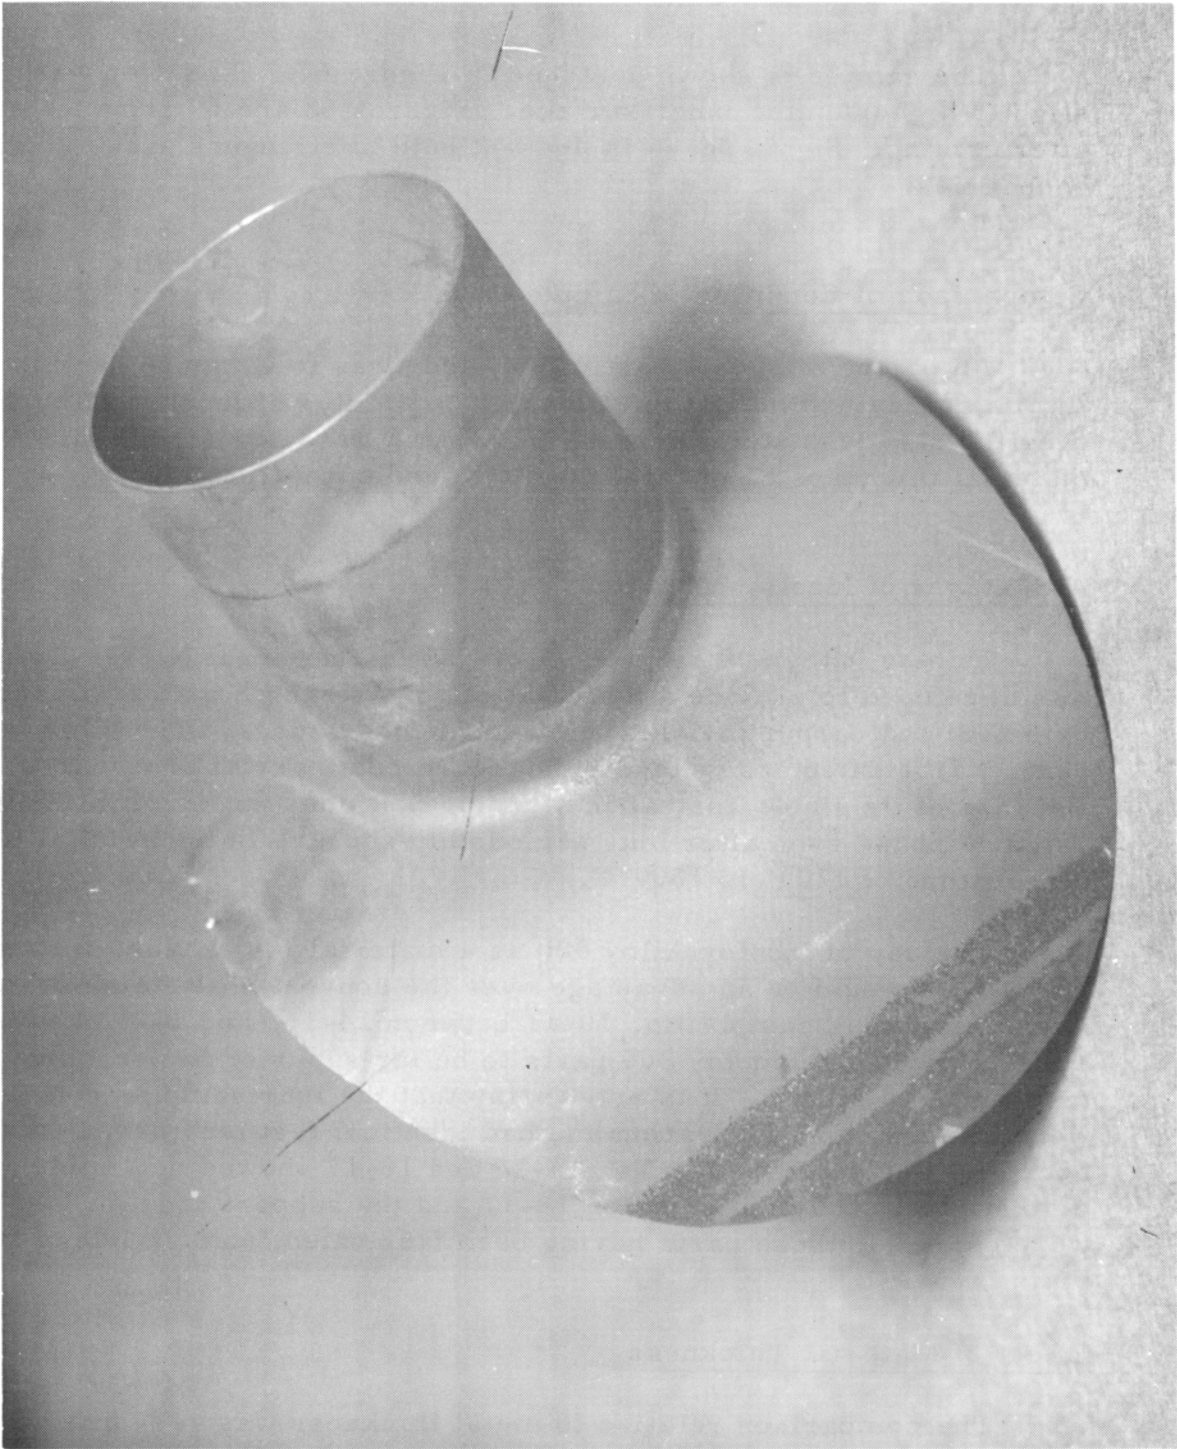
Figure 66. Sample No. 20 - Muffler Wall, 600 Test Hours

Sample No. 20 was a Muffler Wall .03 inch thick and test run for 600 test hours, as shown in Figure 66. This muffler wall was of a different configuration when compared to Samples No. 9, 12-13, 16-17, and 19. Chemical analyses showed the material to be Type 321.

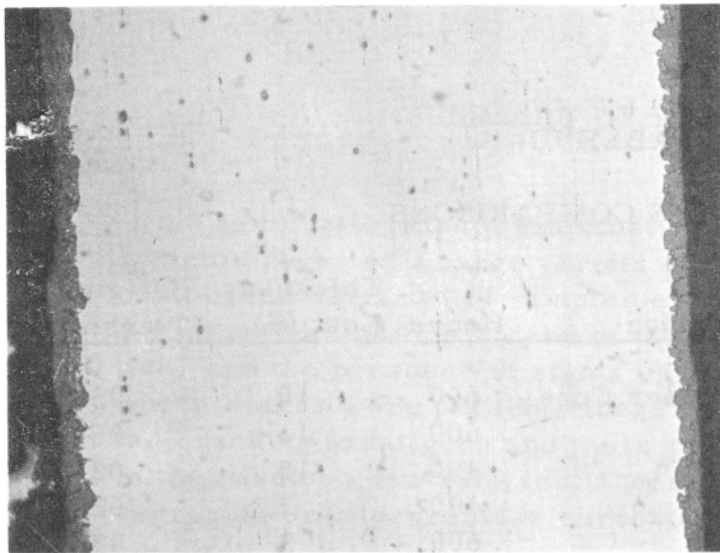
Figure 67

The sample is shown unetched in Figure 67. Oxidation was slightly higher on the inner surface. Figures 68 and 69 show the sample after etching. Sigma phase is present both in stringers and in the grain boundaries.

Showing penetration of oxidation  
and carbides.

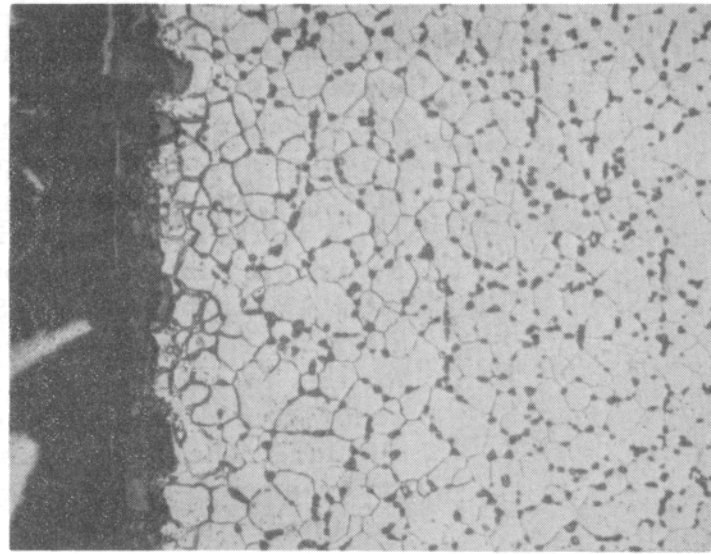
Figure 69

Showing intergranular corrosion,  
and sigma phase.
