Report No. NA-70-23
(DS-70-2)

**ACCELERATED TESTING OF
GENERAL AVIATION ENGINE EXHAUST SYSTEMS**

**DEPARTMENT OF TRANSPORTATION
FEDERAL AVIATION ADMINISTRATION
National Aviation Facilities Experimental Center
Atlantic City, New Jersey 08405**

February 1970

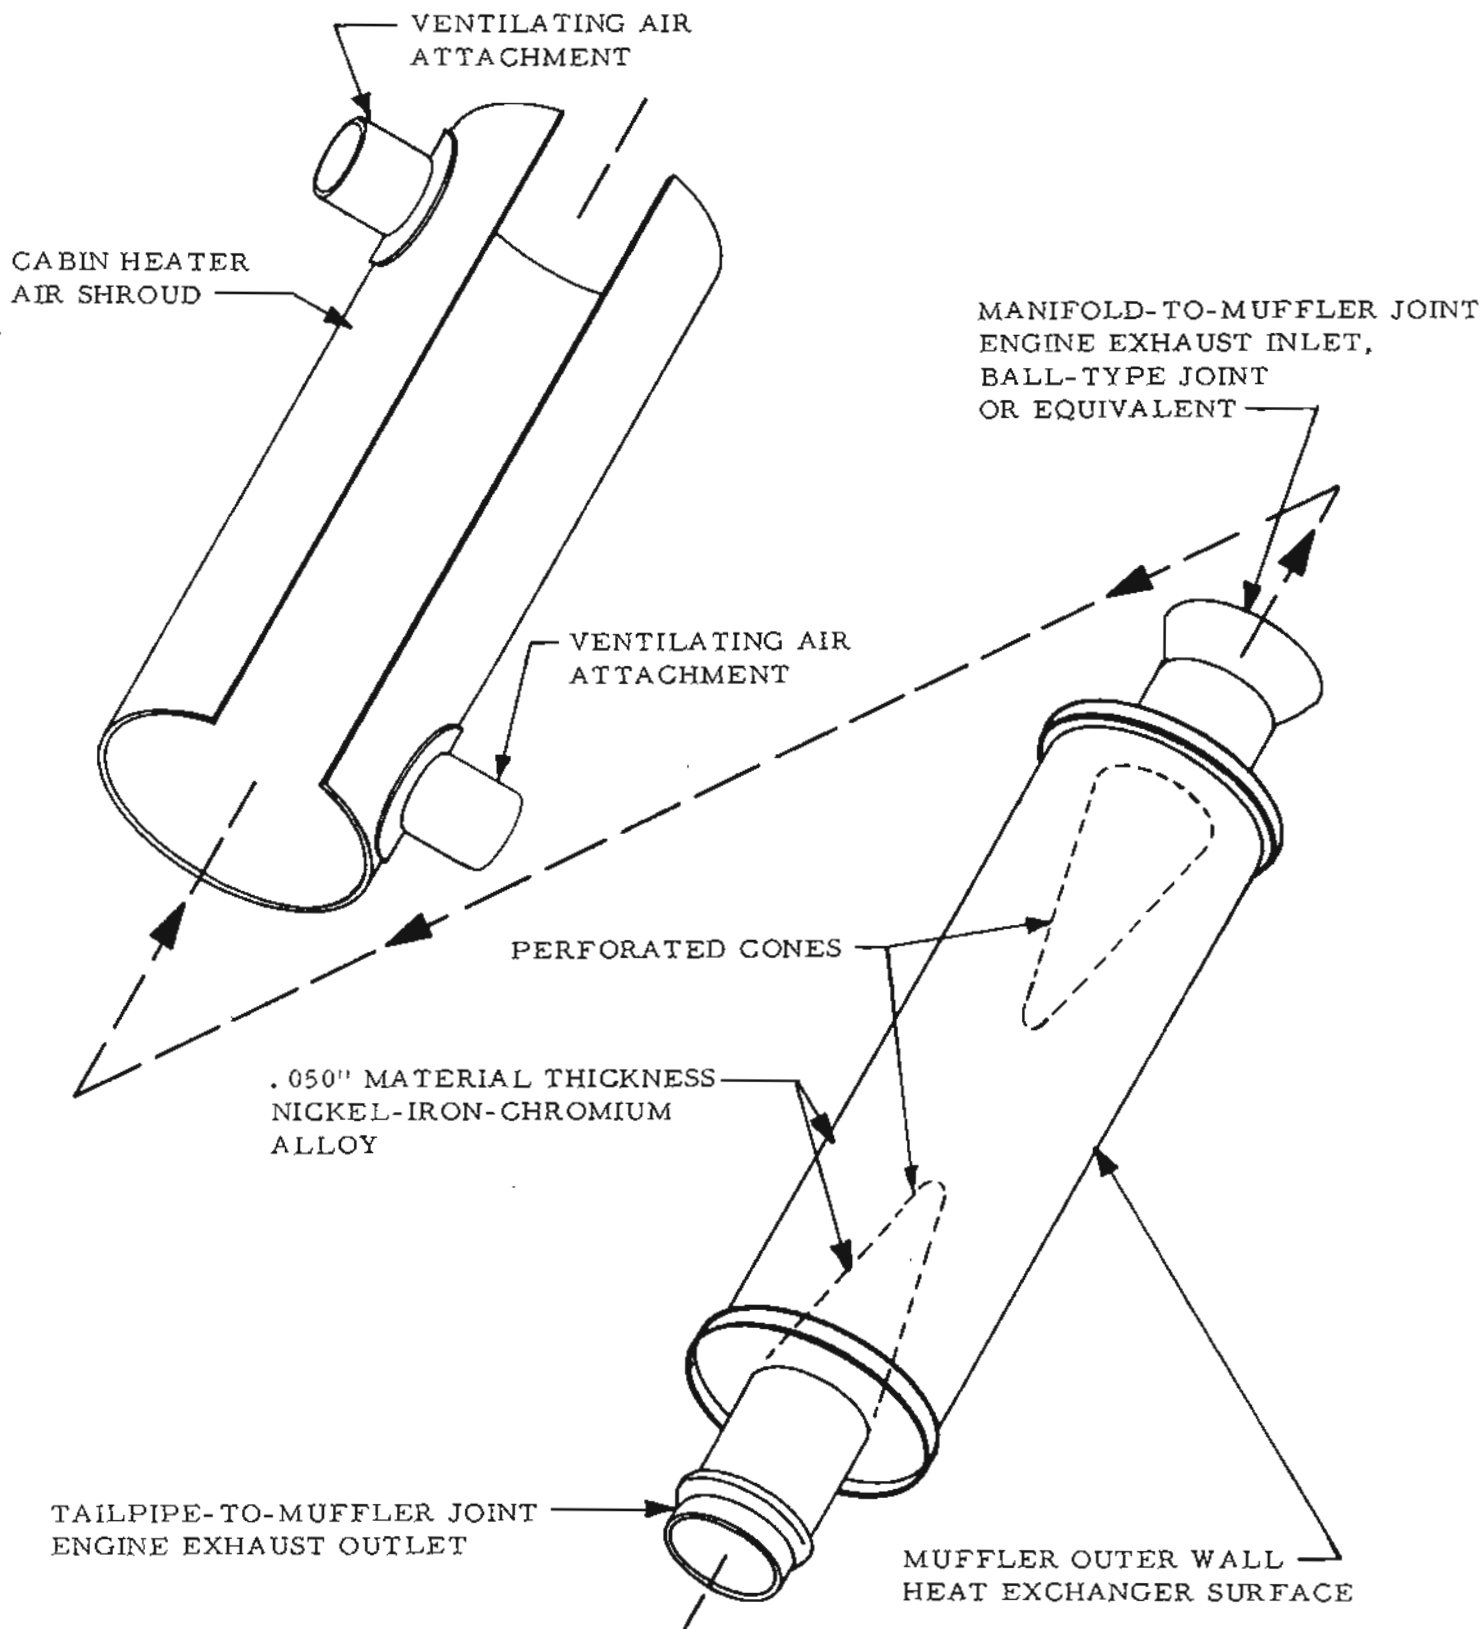
FIG. 4 RECOMMENDED MUFFLER AND HEAT EXCHANGER DESIGN

Cracks in the heat exchanger surface invariably occur in proximity to the stack inlet or tailpipe outlet attachments in areas of stress concentration. The carbon monoxide hazard could be reduced by excluding the areas of stress concentration from the heat exchanger surface. A recommended heat exchanger design, to minimize stress concentration in the heat exchanger, would incorporate an axial flow through muffler with the manifold inlet attached to one end plate and the tailpipe outlet attached to the opposite end plate as shown in Figure 4. The heater would be configured with an air shroud wrapped around the outer cylinder surface. A perforated cone welded to the end plate, at the tailpipe outlet location inside the muffler as shown in Figure 4, is suggested to prevent broken fragments from sealing off the exit area in the event of a failure. The muffler would be fabricated of a more corrosion-resistant alloy consisting of 32 percent nickel, 46 percent iron, and 21 percent chromium in material thickness of .050 inch.

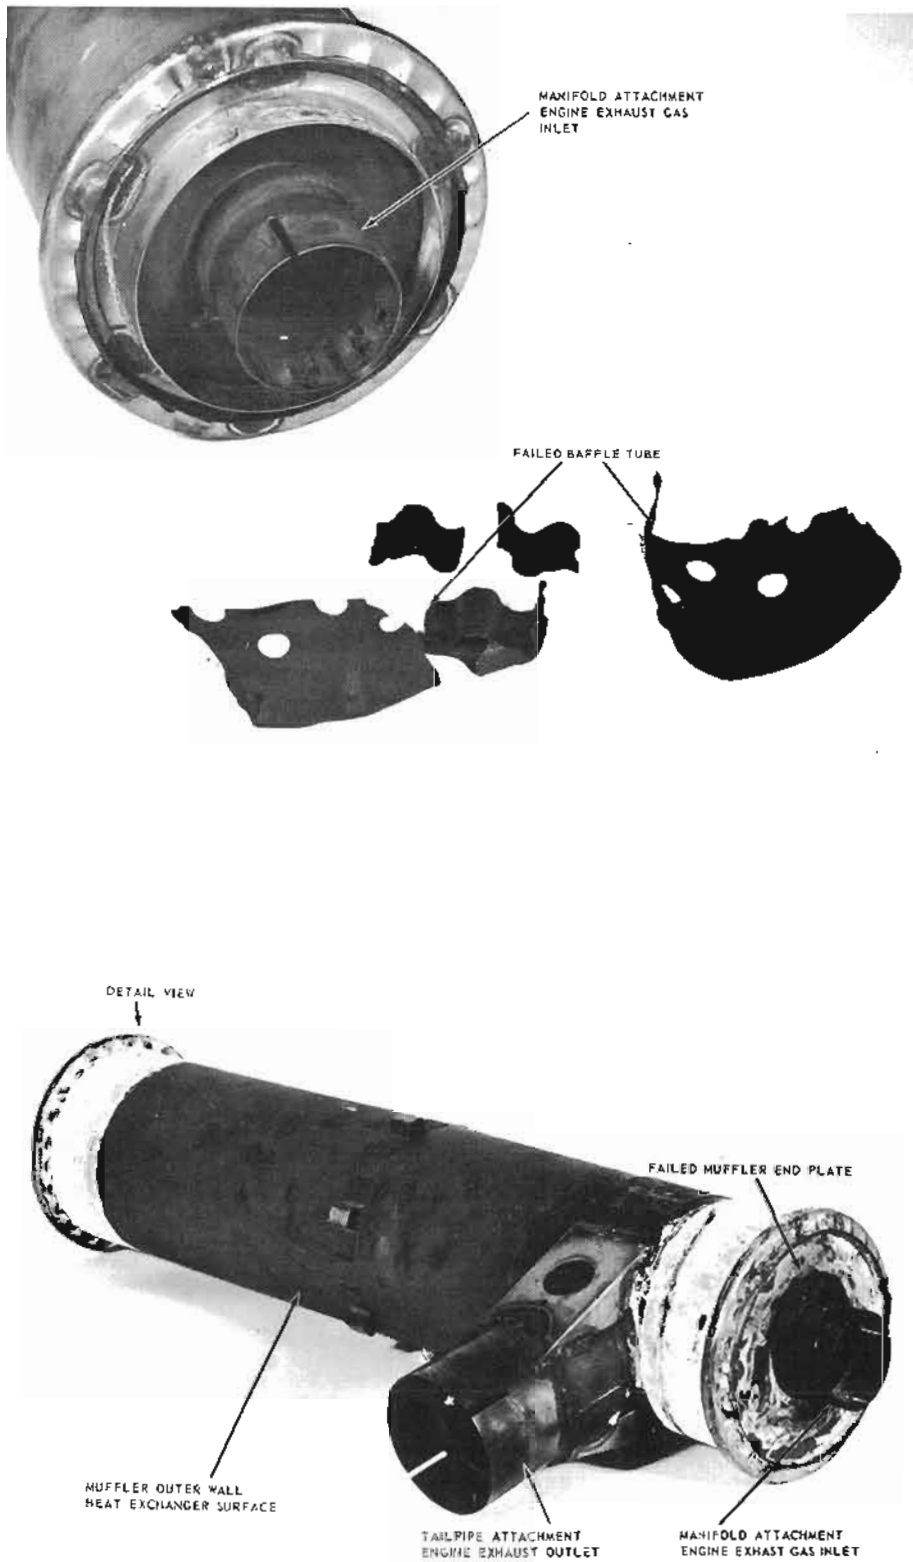
FIG. 1.1 FAILED MUFFLER BAFFLE TUBE AND END PLATES

Test Hours - 43: A muffler baffle tube and both muffler end plates failed at only 43 test hours as shown in Figures 1.1 and 1.2. A section from the floating end of the tube separated into pieces and passed through the tailpipe. In this instance, the fragments did not lodge in the muffler or tailpipe and restrict the exhaust gas flow and effect an engine power loss as often accompanies this malfunction in aircraft.

Metallurgical analysis of the baffle tube failure is discussed under the subheading of Sample No. 1, and the failure is shown in Figures 1, 2, 3, and 4 of Reference 5 in this report. As stated, "The entire sample was heavily oxidized and somewhat distorted. The end at which the failure occurred was severely oxidized and eroded." The part was fabricated from AISI 347 stainless steel .020 inch thick. High-temperature oxidation occurring on both sides weakened the baffle tube effecting a failure at low test time. Information in Reference 4 indicates that this part operates under temperature levels of 1500 F to 1600 F maximum. Numerous similar failures have occurred in operating aircraft.

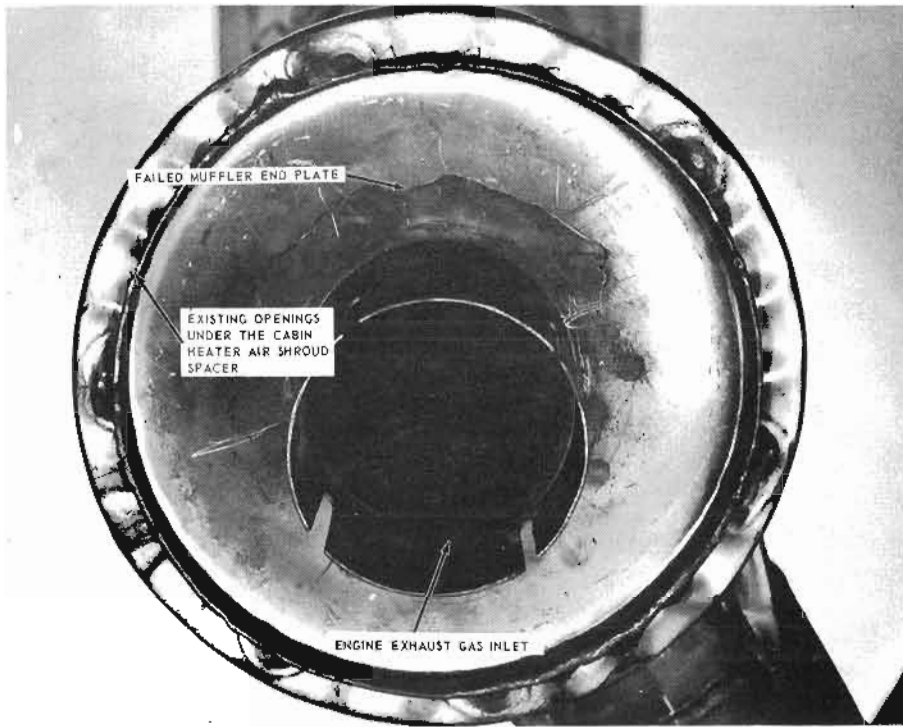
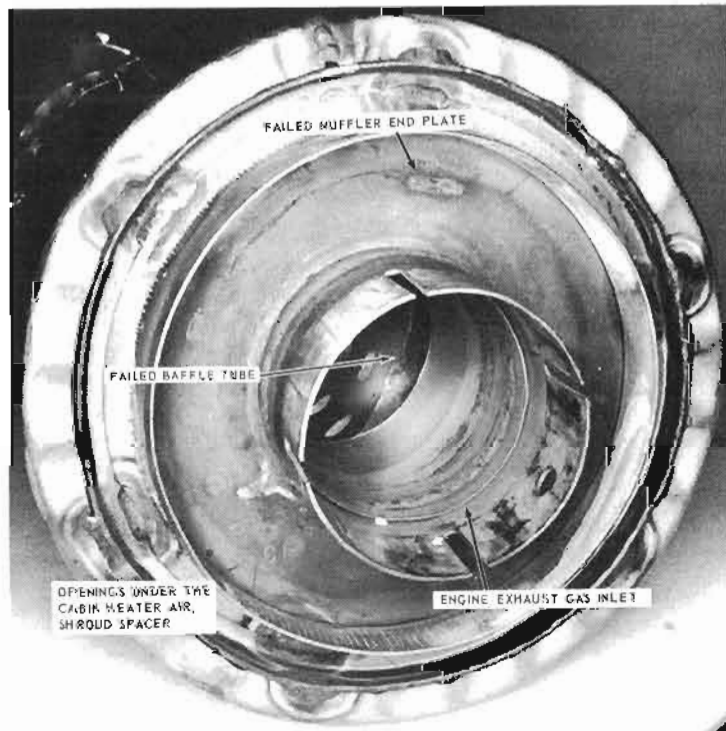
FIG. 1.2 FAILED MUFLER END PLATES AND BAFFLE TUBE

Failure of the end plates of the muffler is discussed under the subheadings of Samples Nos. 2 and 3, and depicted in Figures 5 through 13 of Reference 5. There was not an apparent metallurgical cause for failure noted. The most likely cause was believed to be high stresses induced by high-intensity vibration occurring after the baffle tube failure. Upon failure, the remaining portion of the tube was no longer supported from the floating end. A 19-inch section of the tube was then cantilevered from the end plate of the muffler effecting a severe vibration problem and high stresses.

A carbon monoxide hazard was effected by failure of the muffler end plates. Exhaust gases containing carbon monoxide exited through the fracture in the end plates and entered the cabin heater through the existing openings under the cabin heater air shroud and contaminated the cabin air with .010 percent carbon monoxide.

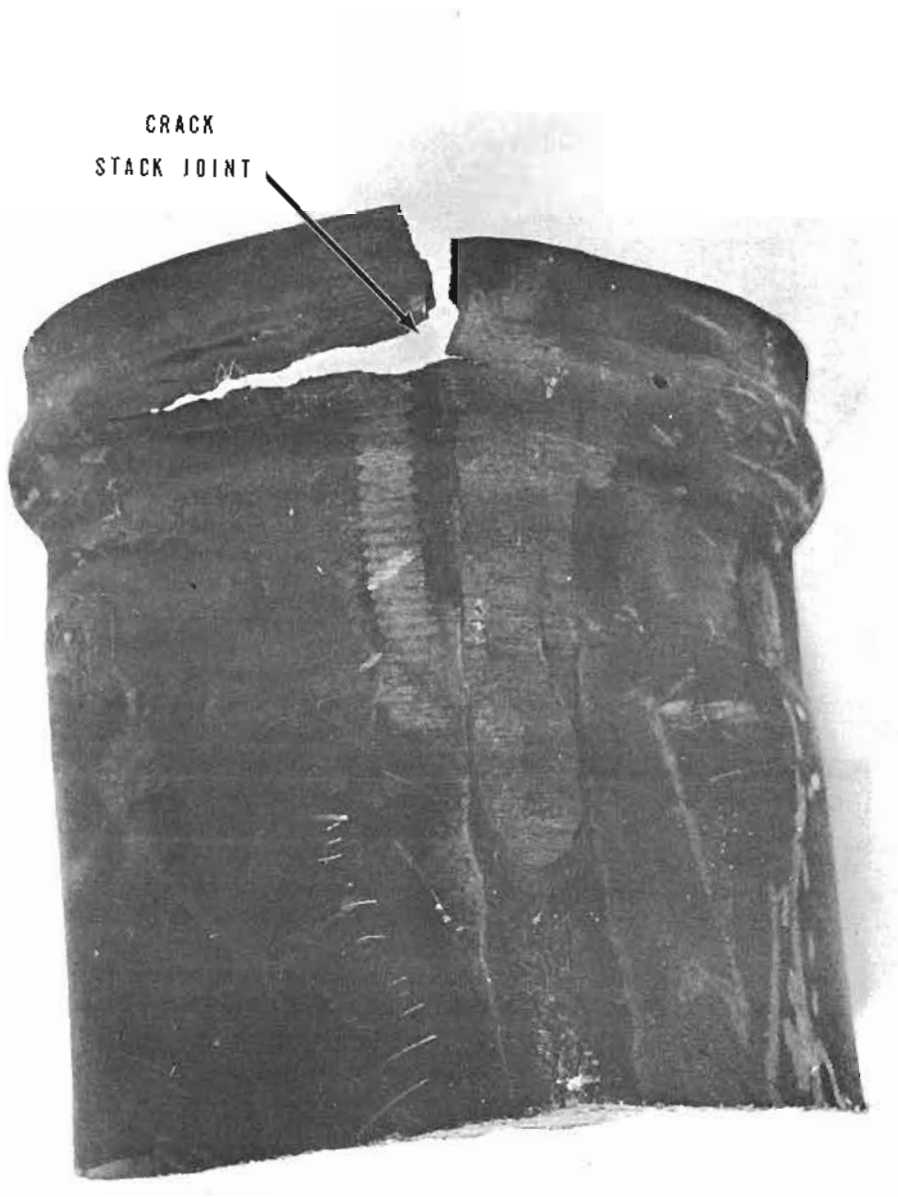
FIG. 1.3 FAILED STACK JOINT

Test Hours - 112 and 140: Two similar cracks occurred in the stack joints as shown in Figure 1.3. The failed stack was replaced with an identical unit which also failed. The crack occurred in the swaged ferrule utilized for clamping and locking the joint and extended out

through the welded seam of the pipe. Metallurgical evaluation of the defect is discussed under the subheading of Sample No. 8, and the failure is presented in Figures 29 through 33 of Reference 5. As stated, "The Metallographic examination of the cross section of the crack revealed heavy oxidation on the surfaces on either side of the crack. This is a strong indication of the progressive nature of the crack since oxidation occurred on the fracture surface as the crack progressed. The fact that there is no thinning of the metal at the fracture also suggests that it is a type of fatigue crack. Slip bands are typical of a condition created at the tip of a fatigue crack."

After the second failure occurred, the manufacturer submitted a stack incorporating a modified joint which accumulated 350 test hours without failure. This part was fabricated from AISI 321 stainless steel .050 inch thick and operates at metal temperature levels up to 1200°F. (See Reference 4.)

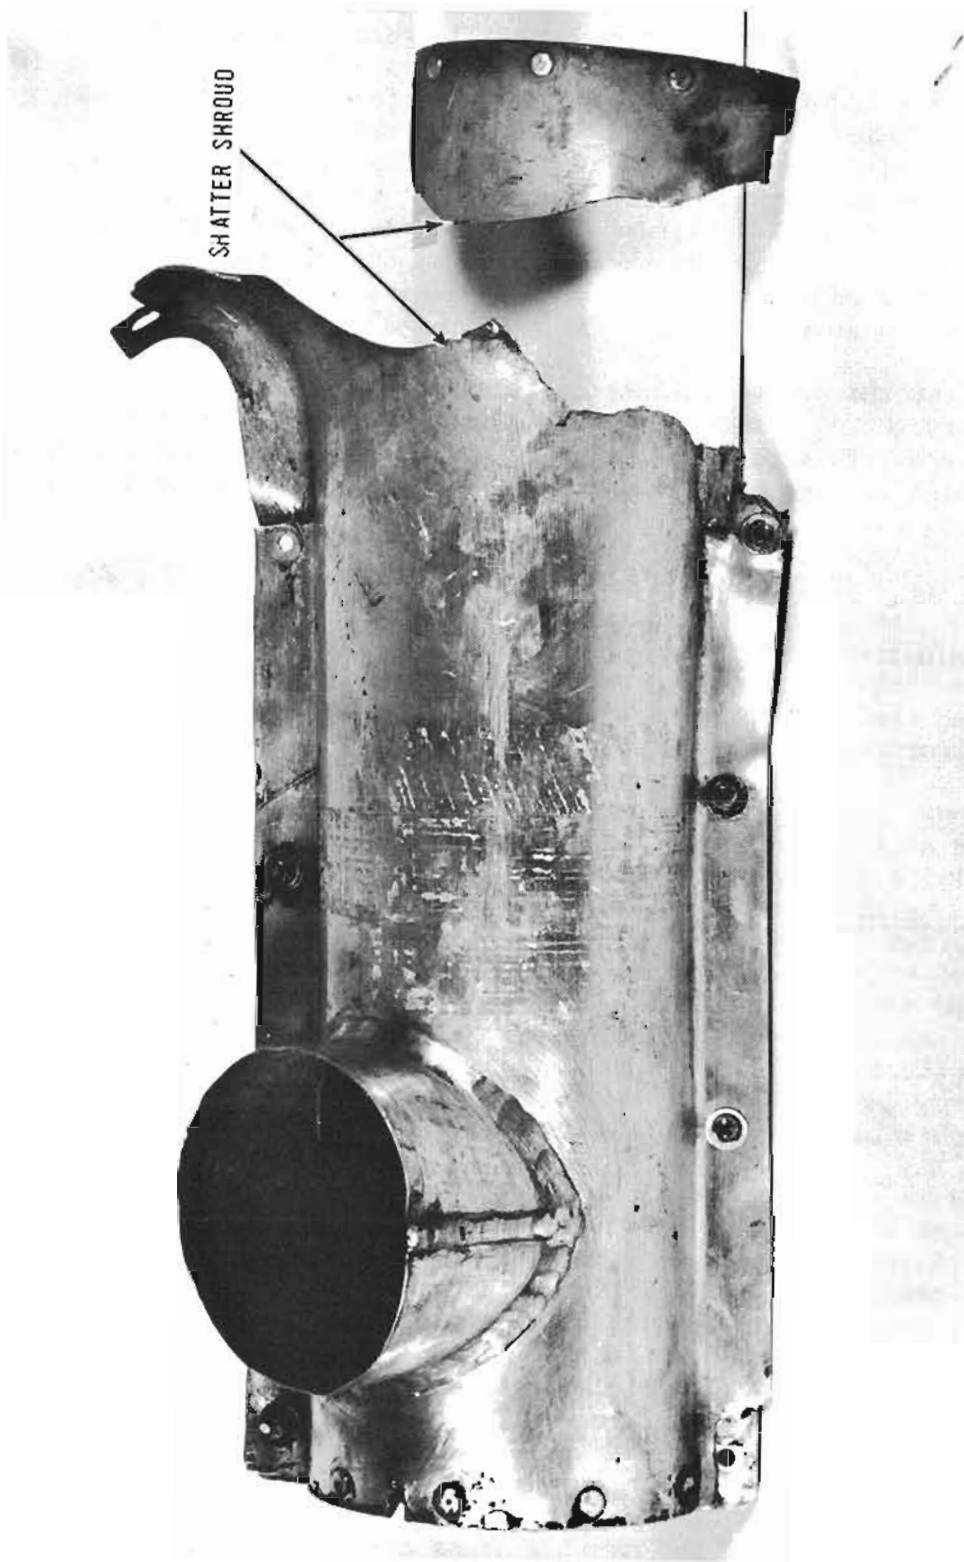
FIG. 1.4 FAILED CARBURETOR HEAT SHROUD

Test Hours - 150: One end of a carburetor heat air shroud shattered at 150 test hours as shown in Figure 1.4. This part was fabricated from aluminum except the support end plates which were steel. The aluminum failed from fatigue which was believed to be aggravated by high temperatures. A number of similar failures have occurred in operating aircraft.

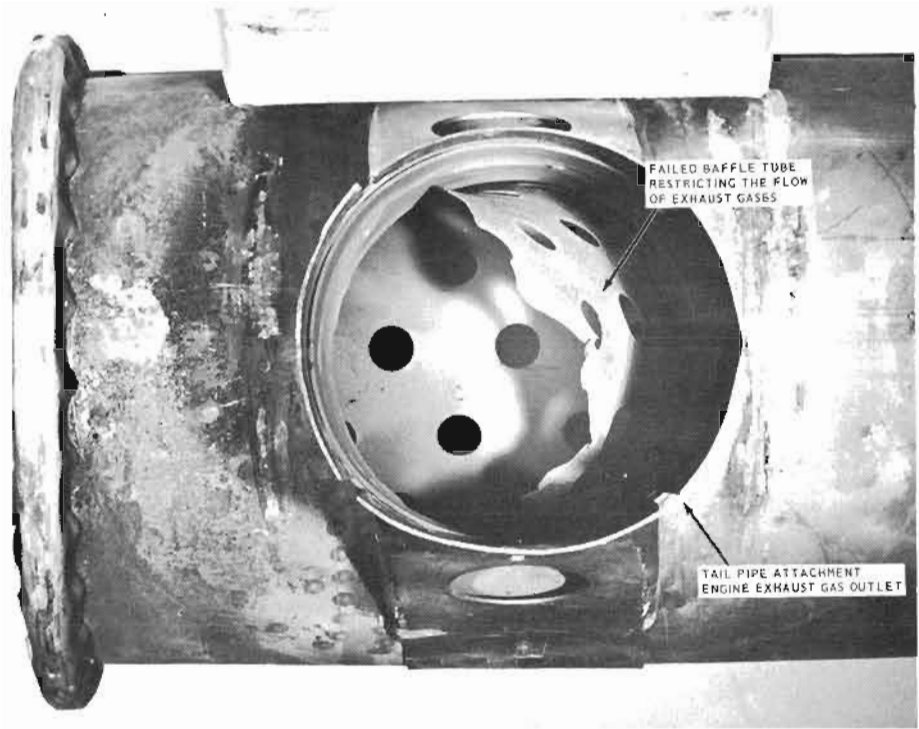
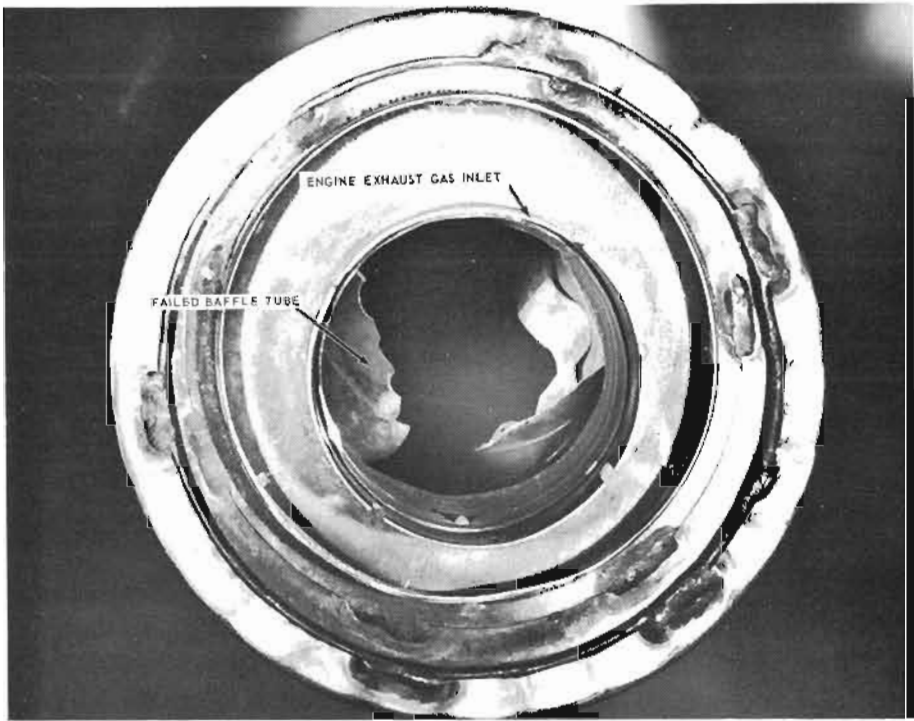
FIG. 1.5 FAILED MUFFLER BAFFLE TUBE

Test Hours - 160: A muffler baffle tube failed at 160 test hours effecting an engine power loss. A section of the baffle lodged in the muffler tailpipe outlet restricting the flow of exhaust gases as shown in Figure 1.5. Metallographic examination of this failure is analyzed under subheadings, Samples Nos. 4 and 5, and the failure is shown in Figures 14 through 19 of Reference 5. As stated, "The baffle exhibited severe oxidation and distorted edges at the failed area." This part was also fabricated from AISI 347 stainless steel material stock .020 inch thick. The basic failure was identical to the one occurring at 43 test hours discussed previously in this report. The baffle tube operates under maximum temperature levels of 1500°F to 1600°F. (See Reference 4.)

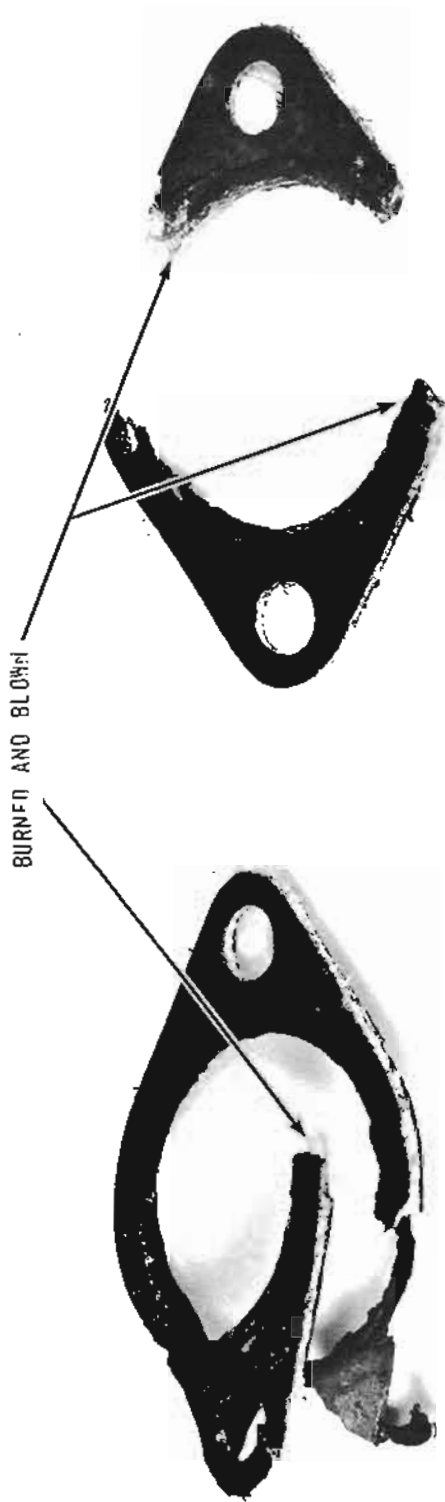
FIG. 1.6 FAILED ENGINE EXHAUST FLANGE GASKETS

Test Hours - 305, 346, 400, and 525: The exhaust gaskets burned through at the above listed test hours as shown in Figure 1.6. Gasket failures permitted exhaust gases to contaminate the engine nacelle and resulted in seepage into the cabin through openings in the heater ventilating air system. In two incidents, the aluminum retaining parts melted and failed to retain the seal composed of fiberglass. Exhaust gases exiting through the blown gaskets entered the heater seal openings and contaminated the cabin air with .0025 percent carbon monoxide. Also, two cases of blown exhaust gaskets resulted in traces of carbon monoxide in the cabin air when exhaust gases entered existing openings under the cabin heater air shroud. Exhaust gas from blown gaskets is diluted with cooling air in the nacelle and usually seeps into the cabin at concentrations less than the limit of .005 percent considered hazardous by the Federal Aviation Administration.

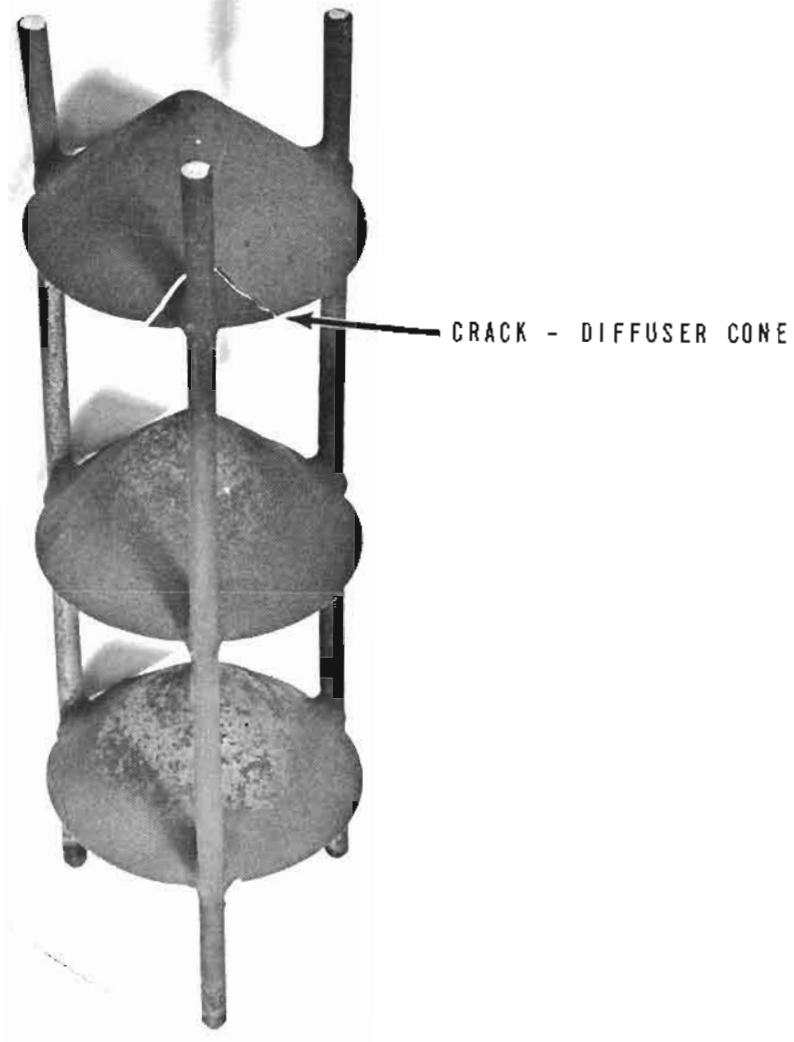
FIG. 1.7 FAILED MUFFLER DIFFUSER CONE

Test Hours - 440: A fracture occurred in a muffler diffuser cone as depicted in Figure 1.7. The part was fabricated from AISI 321 stainless steel .050 inch thick. Metallurgical evaluation of this part is located under the subheadings of Samples Nos. 10 and 11, and the part is shown in Figures 41 through 45 of Reference 5. As stated, "All of the cones were heavily oxidized on the lower surface. The failed cone showed little, if any, evidence of oxidation on the upper surface. Examination of the microstructure revealed a substantial amount of sigma phase in the grain boundaries and some within the grains." It was determined from Reference 4 that this part operates under maximum temperature levels of 1500°F to 1600°F.

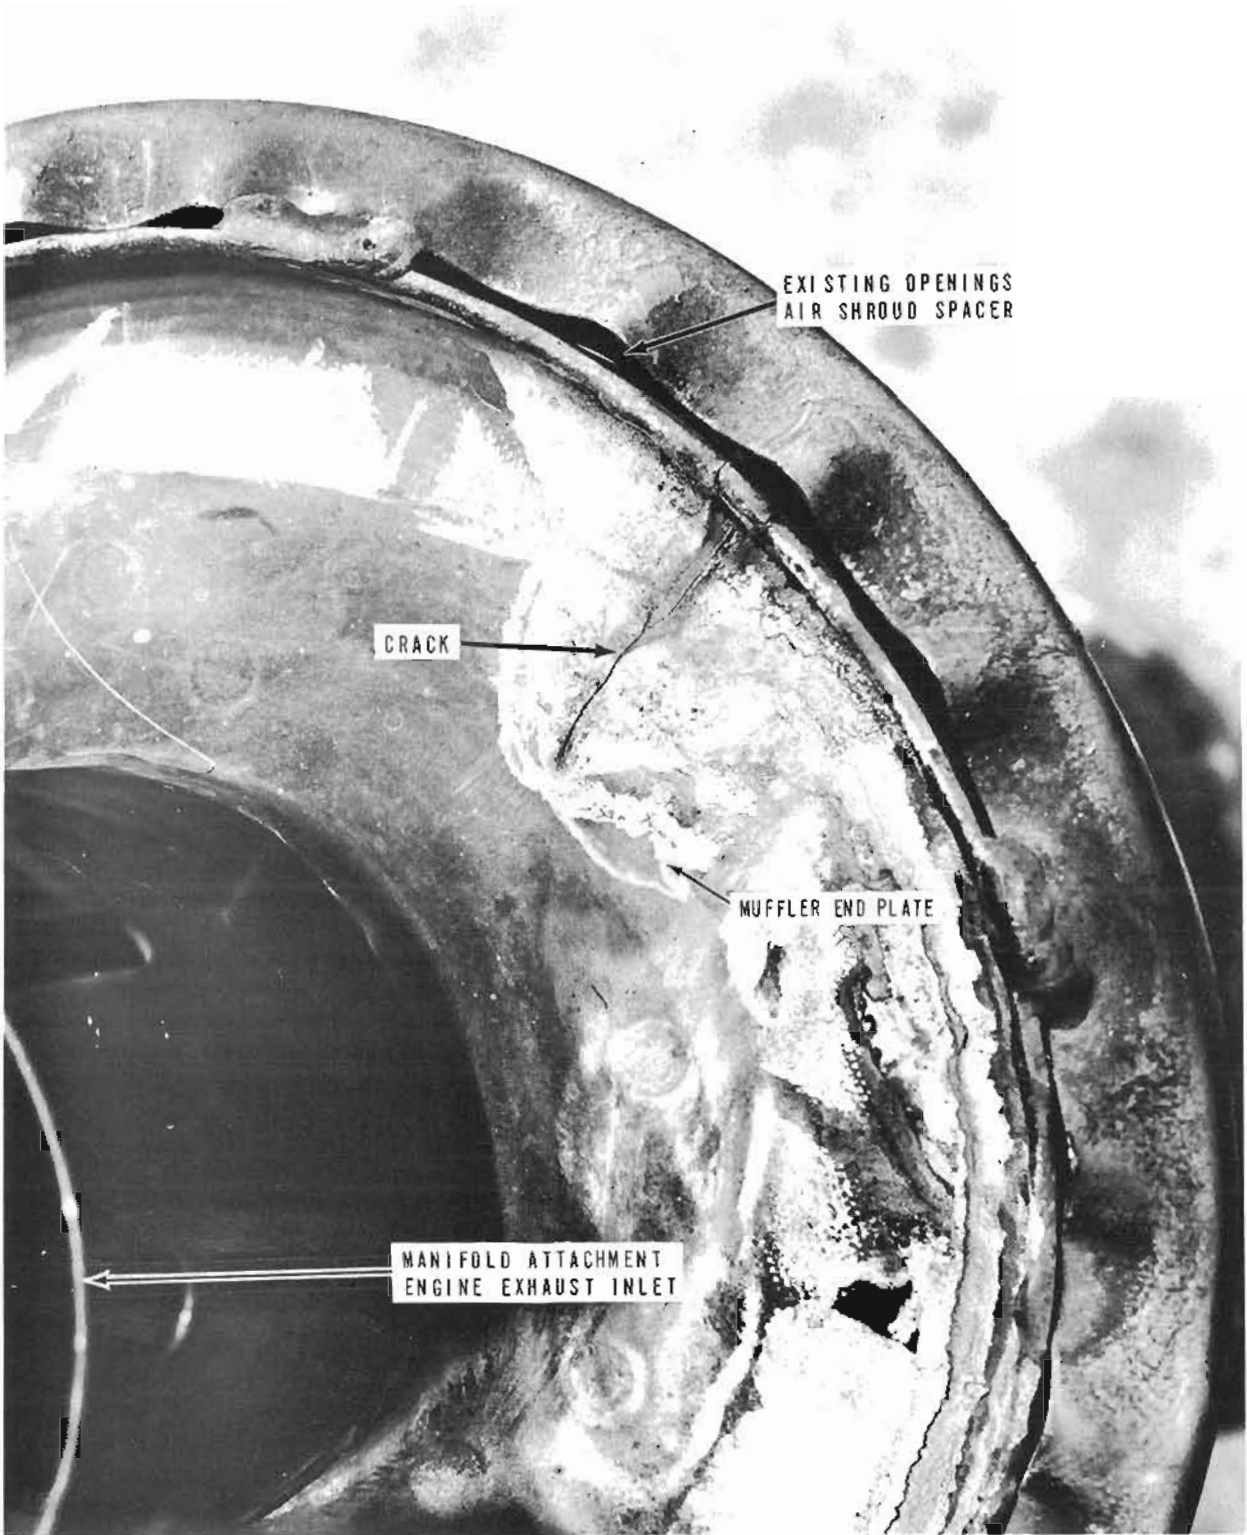
FIG. 1.8 FAILED MUFFLER END PLATE

Test Hours - 448: A crack occurred along the radius of a muffler end plate at 448 test hours as shown in Figure 1.8. Three of four rivets joining the baffle tube to the end plate intake tube were completely sheared and the fourth, while still intact, was cracked and weakened by loss of material. This is shown in Figure 1.9. Metallographic examination is discussed under the subheading of Sample No. 7, and the defects are shown including the rivet failure in Figures 26 through 28 of Reference 5. Material was AISI 347 stainless steel. The baffle tube operated at temperature levels of 1500°F to 1600°F maximum, and the end plate operated at 1000°F to 1200°F maximum temperature, as determined in Reference 4.

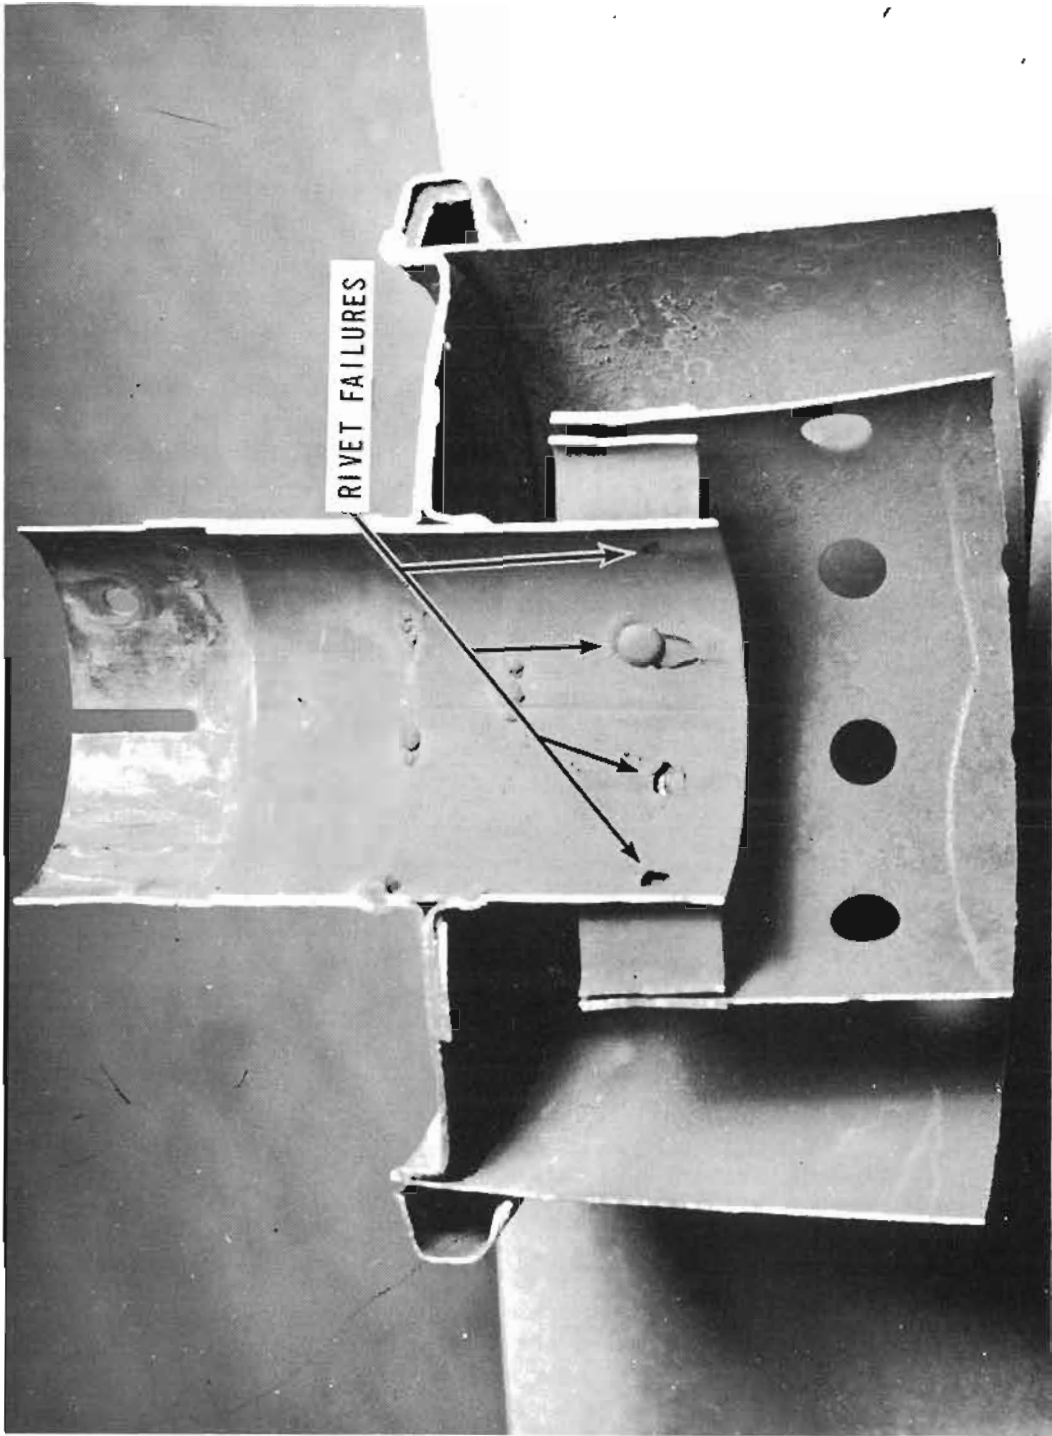
FIG. 1.9 FAILED BAFFLE TUBE RIVETS, MUFFLER

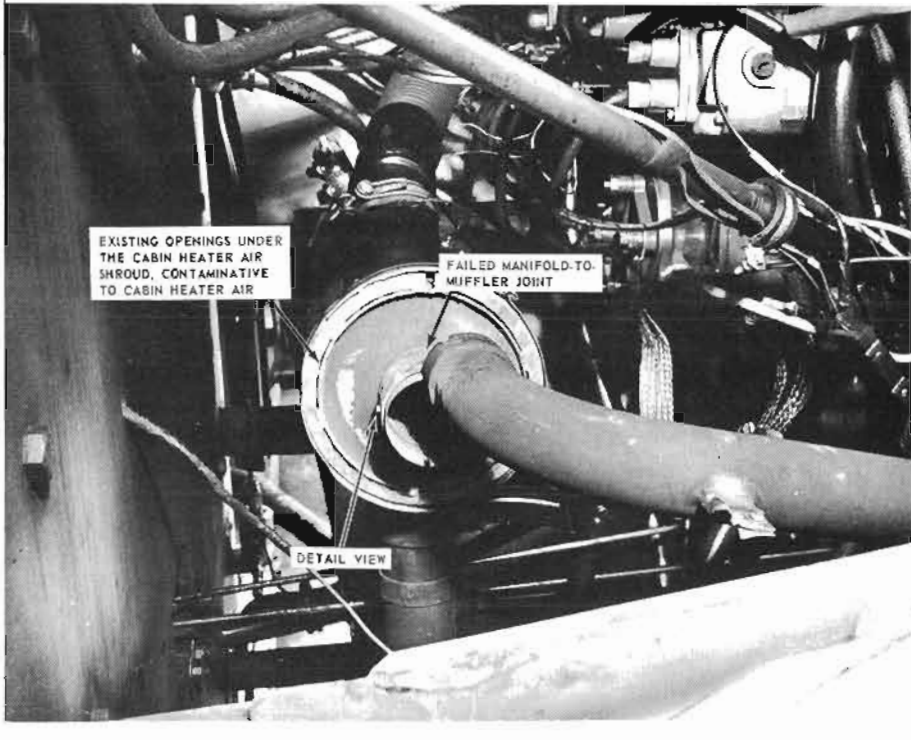
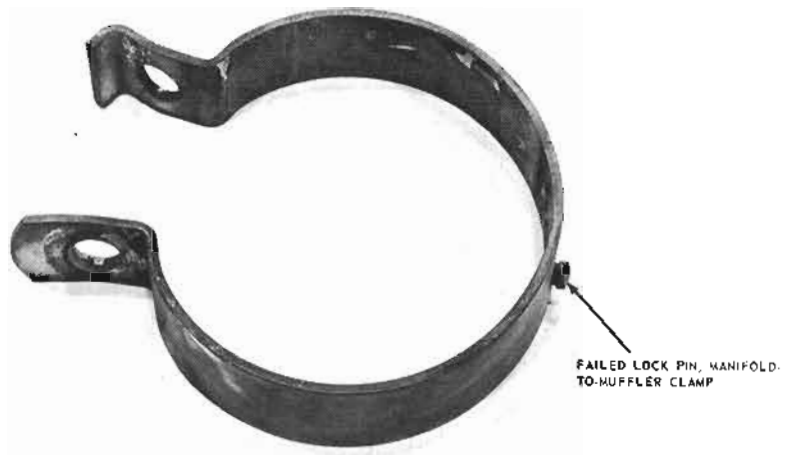
FIG. 1.10 FAILED MANIFOLD-TO-MUFFLER JOINT

Test Hours - 490: The clamp lock pin failed permitting the right manifold to separate from the muffler joint at 490 test hours. Exhaust gases were blasted through the existing openings under the cabin heater air shroud resulting in .065 percent carbon monoxide contamination of the cabin air. This malfunction is presented in Figures 1.10 and 1.11. Metal expansion with high-temperature exhaust gases may have influenced this failure. A number of similar failures has occurred in operating aircraft. The failure demonstrates and emphasizes that the cabin heaters must be designed and fabricated airtight or sealed to prevent outside contamination from entering the heaters upon occurrence of an unforeseen failure. A section of the muffler including the joint was analyzed metallurgically under the subheading of Sample No. 6, and depicted in Figures 24, 25, and 26 of Reference 5. The material is AISI 347 stainless steel .030 inch thick in the joint area and the baffle tube is .020 inch thick. Maximum operational temperature of the joint was 1000°F to 1200°F and the baffle tube operated at 1500°F to 1600°F maximum. (See Reference 4.)

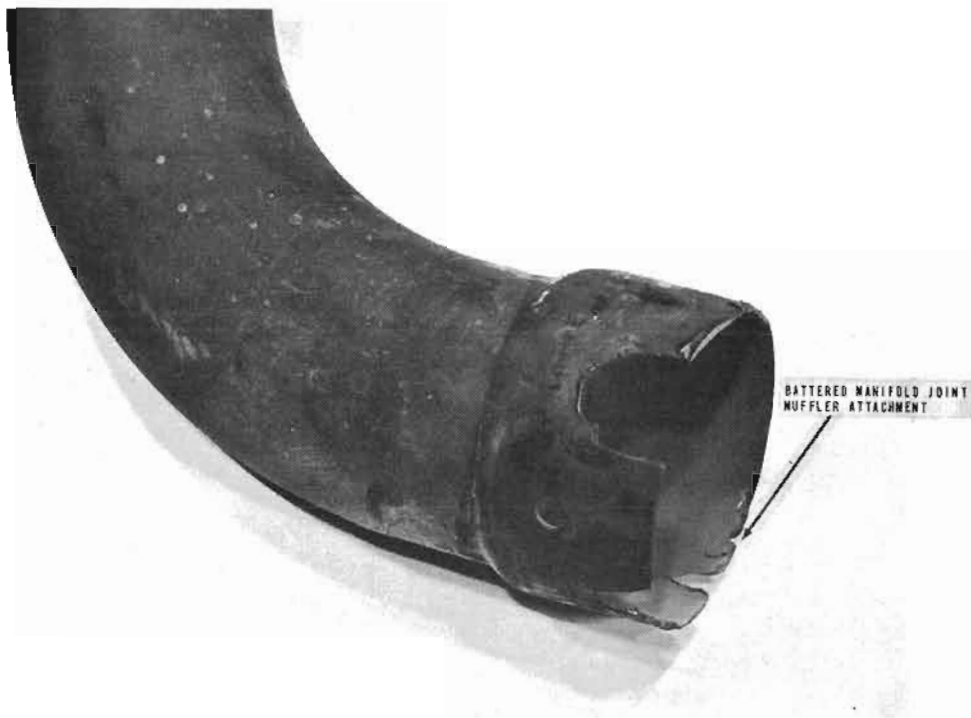
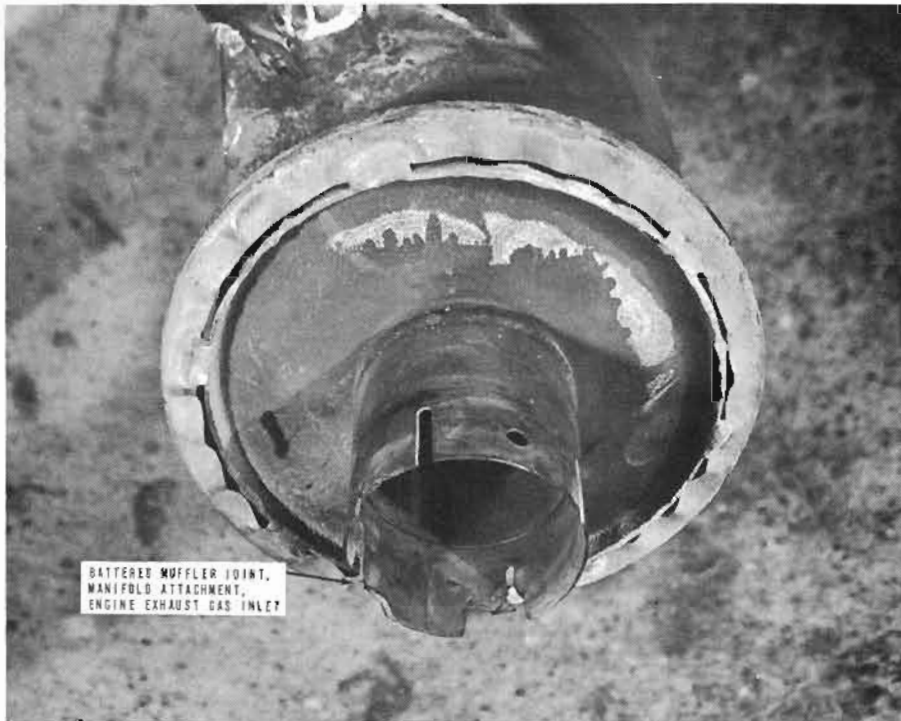
FIG. 1.11 BATTERED MUFFLER AND MANIFOLD JOINT

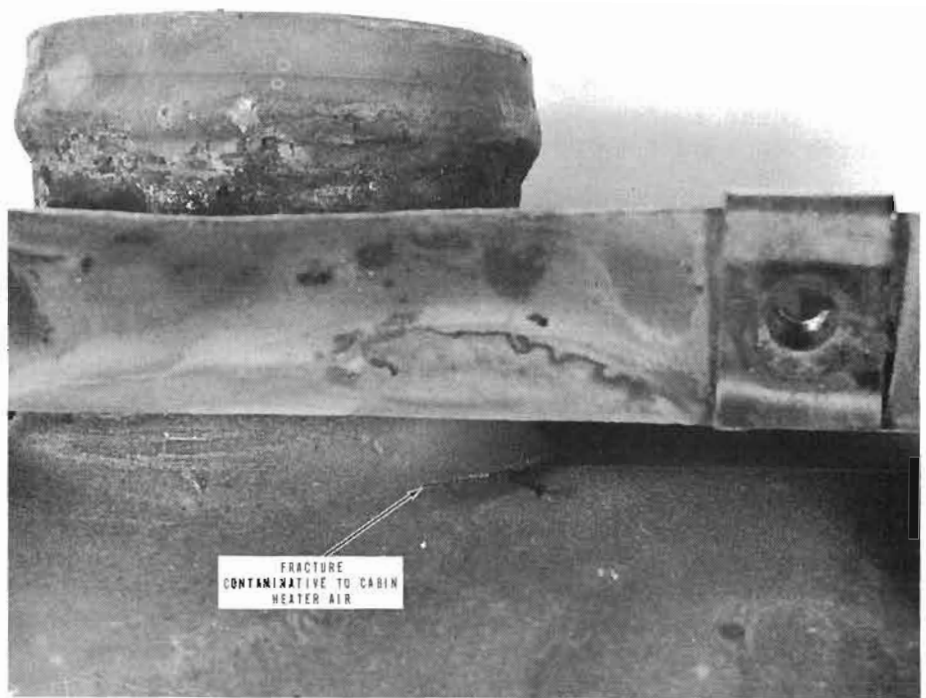
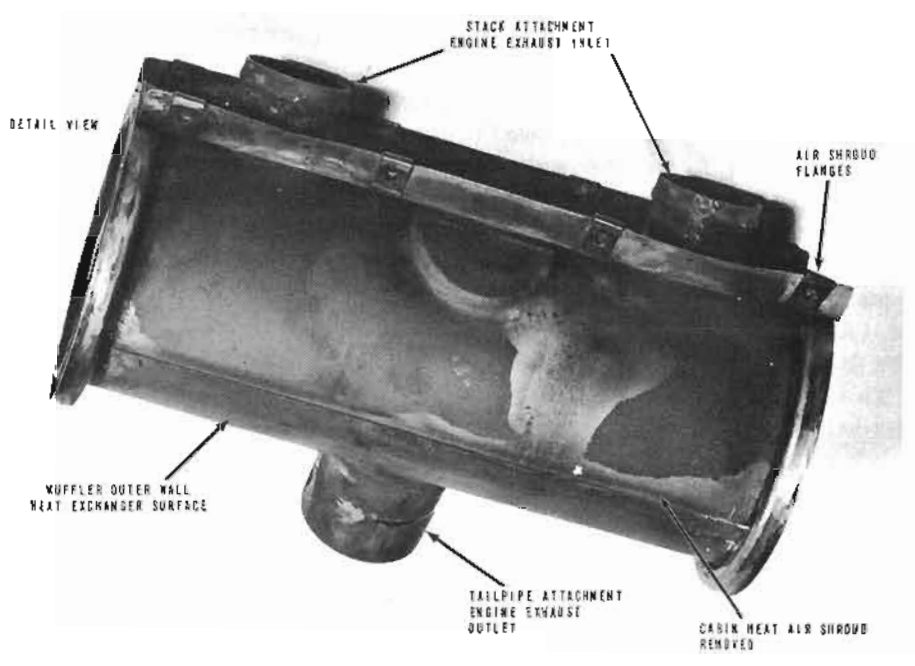
FIG. 1.12 FAILED CABIN HEAT EXCHANGER

Test Hours - 550: A crack developed in the muffler outer wall heat exchanger surface at 550 test hours and contaminated the cabin air with .012 percent carbon monoxide. The defect is shown in Figure 1.12. A long history of both identical failures and general failures of this type have occurred in operating aircraft. The crack occurred in the radius of the stack inlet attachment, an area of stress concentration.

The material was AISI 321 stainless steel .030 inch thick operating under metal temperatures of 1000°F and 1200°F maximum on the outer surface. The inner surface was in contact with exhaust gases at maximum temperatures of 1380°F to 1480°F. (See Reference 4.)

Metallurgical evaluation is discussed under the subheading of Sample No. 9, and photomicrographs are shown in Figures 37 through 40 of Reference 5. As stated, "The sample was heavily oxidized on both the inside and outside surfaces. The outside surface showed deeper penetration at various locations along the surface. It is considered significant that the oxidation corrosion penetrates in some areas in a sharp pointed manner, thus creating points of stress concentration from which fatigue cracks can originate. The structure around the crack contained sigma phase distributed discontinuously in the grain boundaries, and severe oxidation."
