Report No. FAA-RD-70-56

INVESTIGATION OF TWO METHODS FOR IMPROVING THE CRASHWORTHINESS OF INTEGRAL FUEL TANKS

FINAL REPORT

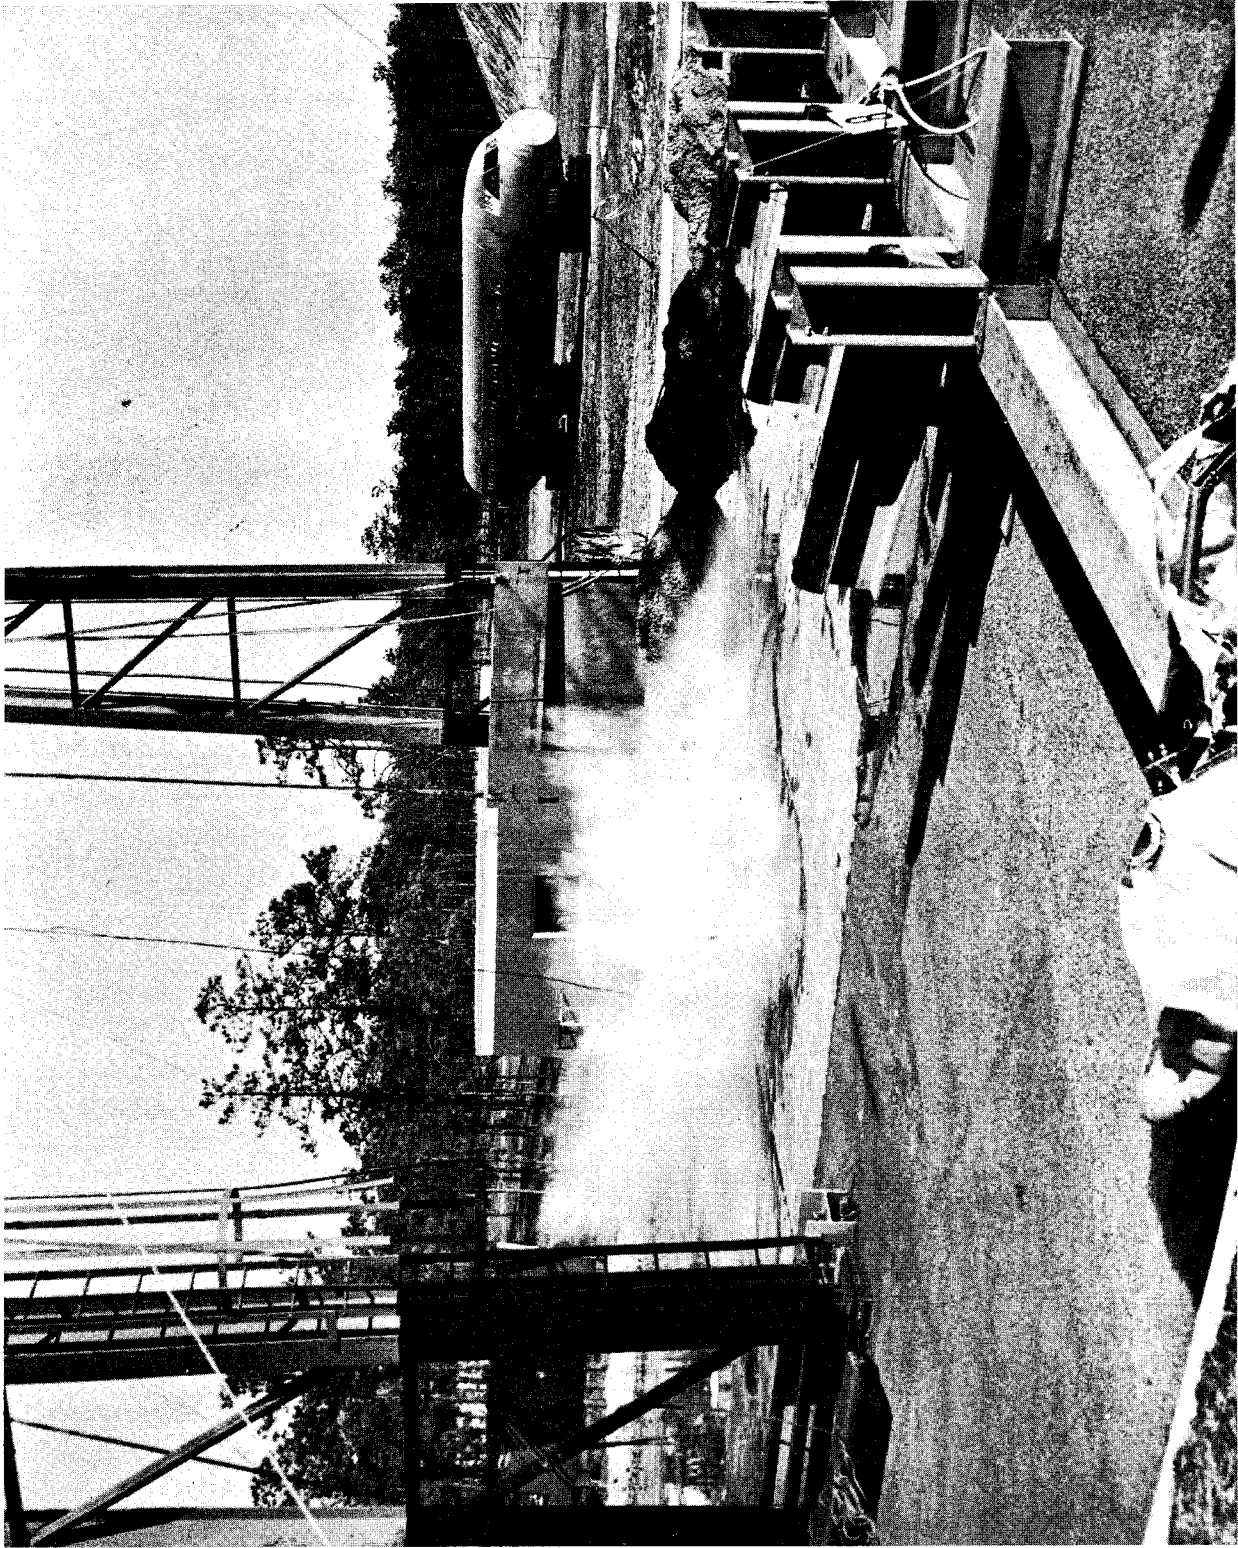
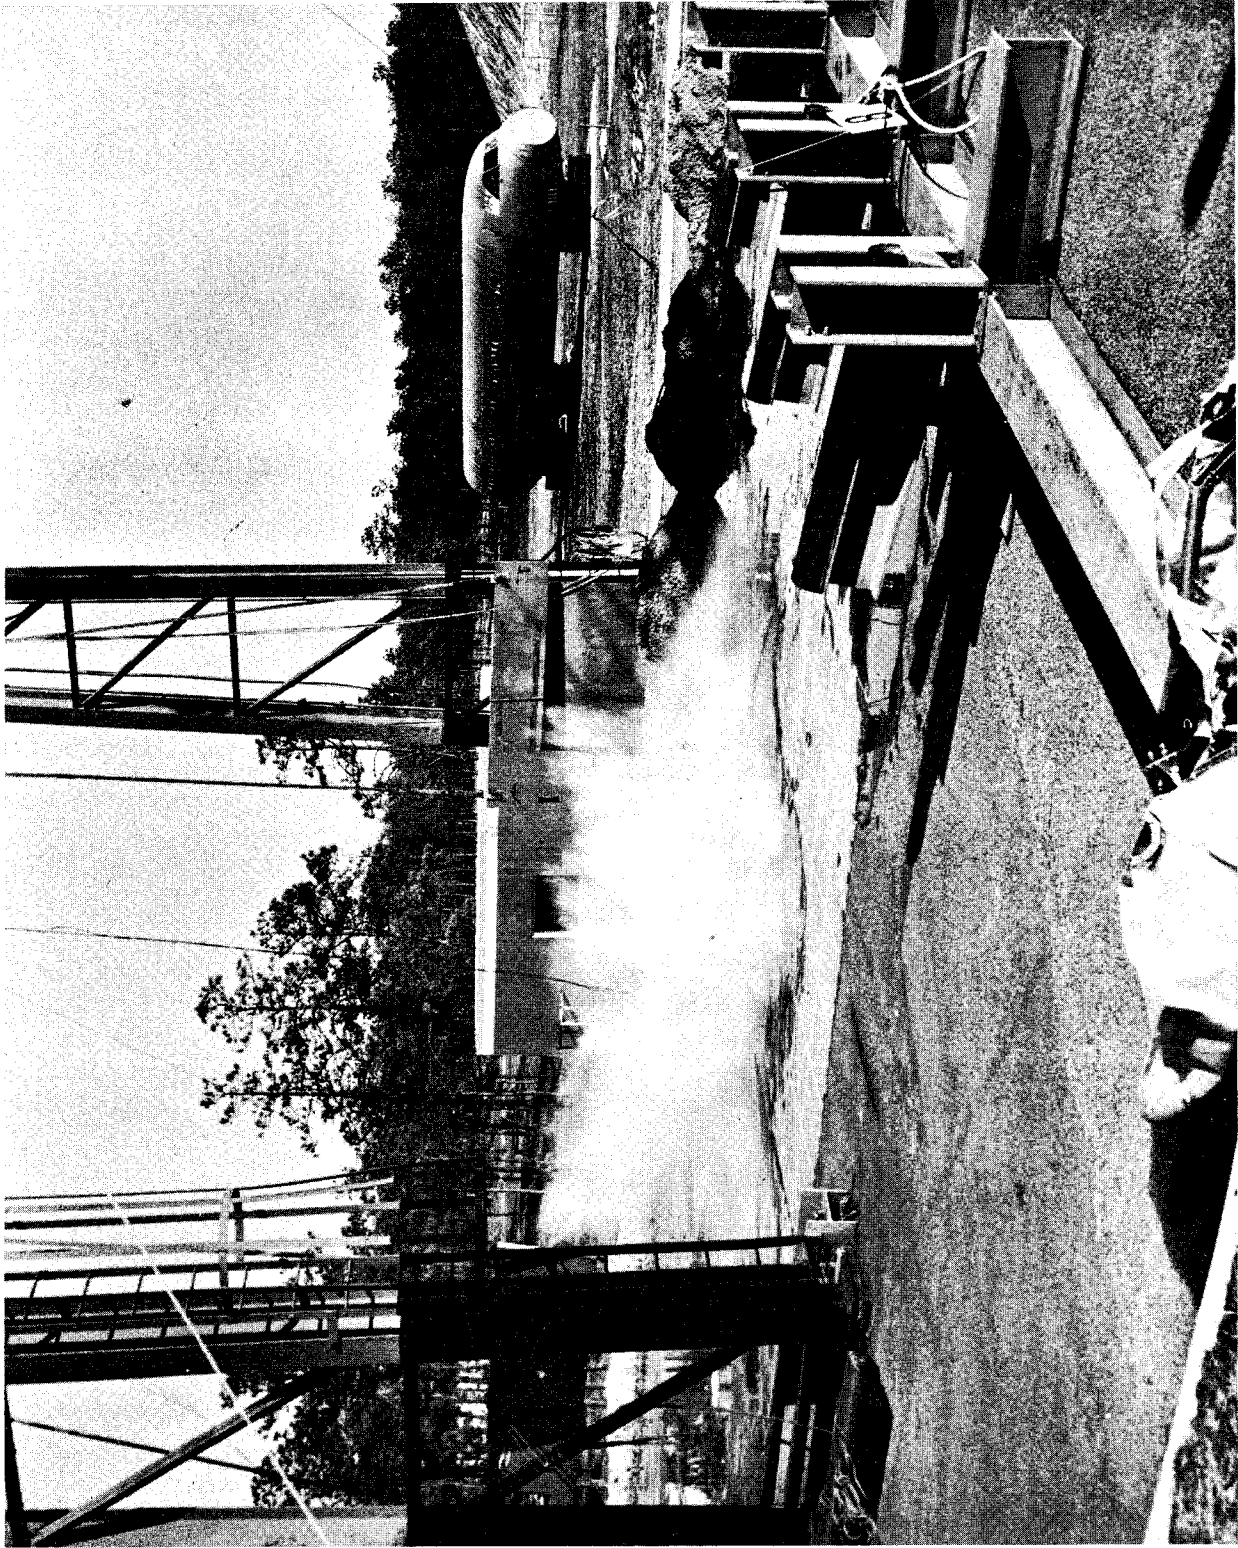
Evaluation of these data indicated that less fuel was sprayed into the air where the foam was a continuous piece or where the smaller pore size foam was used. However, since the spray patterns were similar in depth, the possibility of the spray contacting an ignition source was the same for all configurations drop tested.

FIGURE 4 F-86 FUEL TANK DROPPED FROM A HEIGHT OF 35 FEET

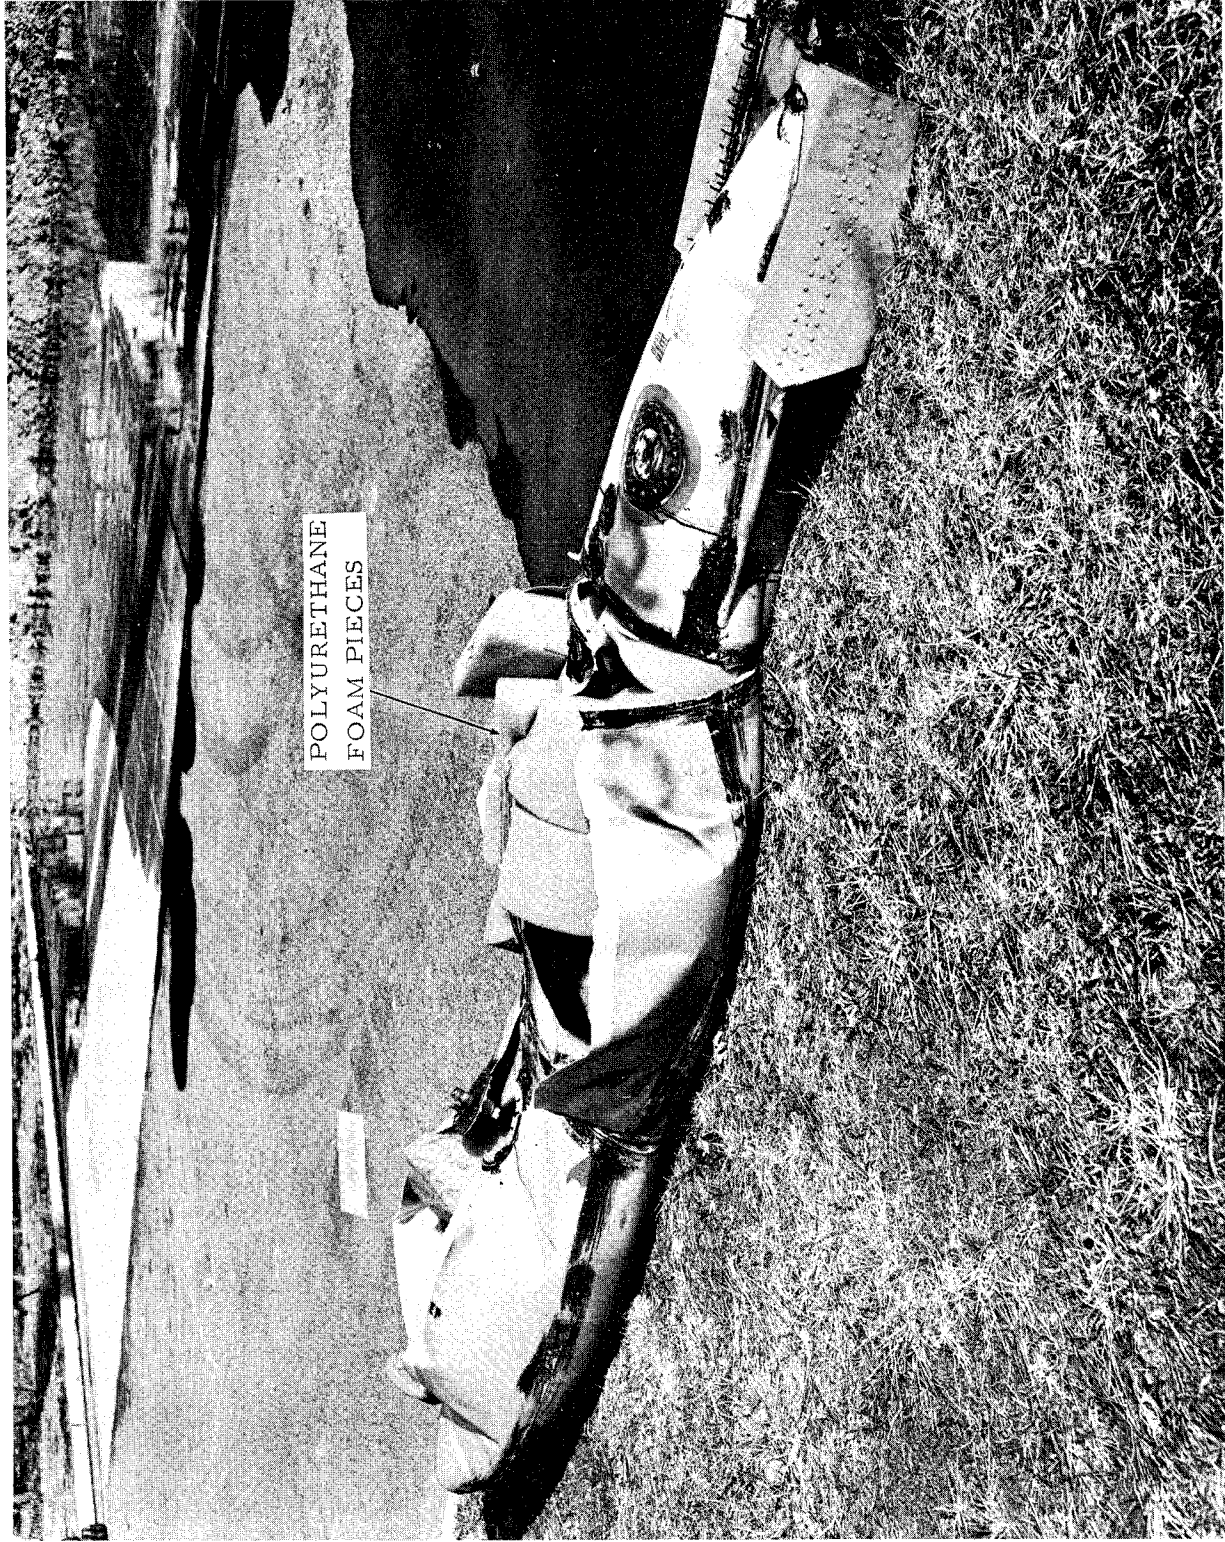
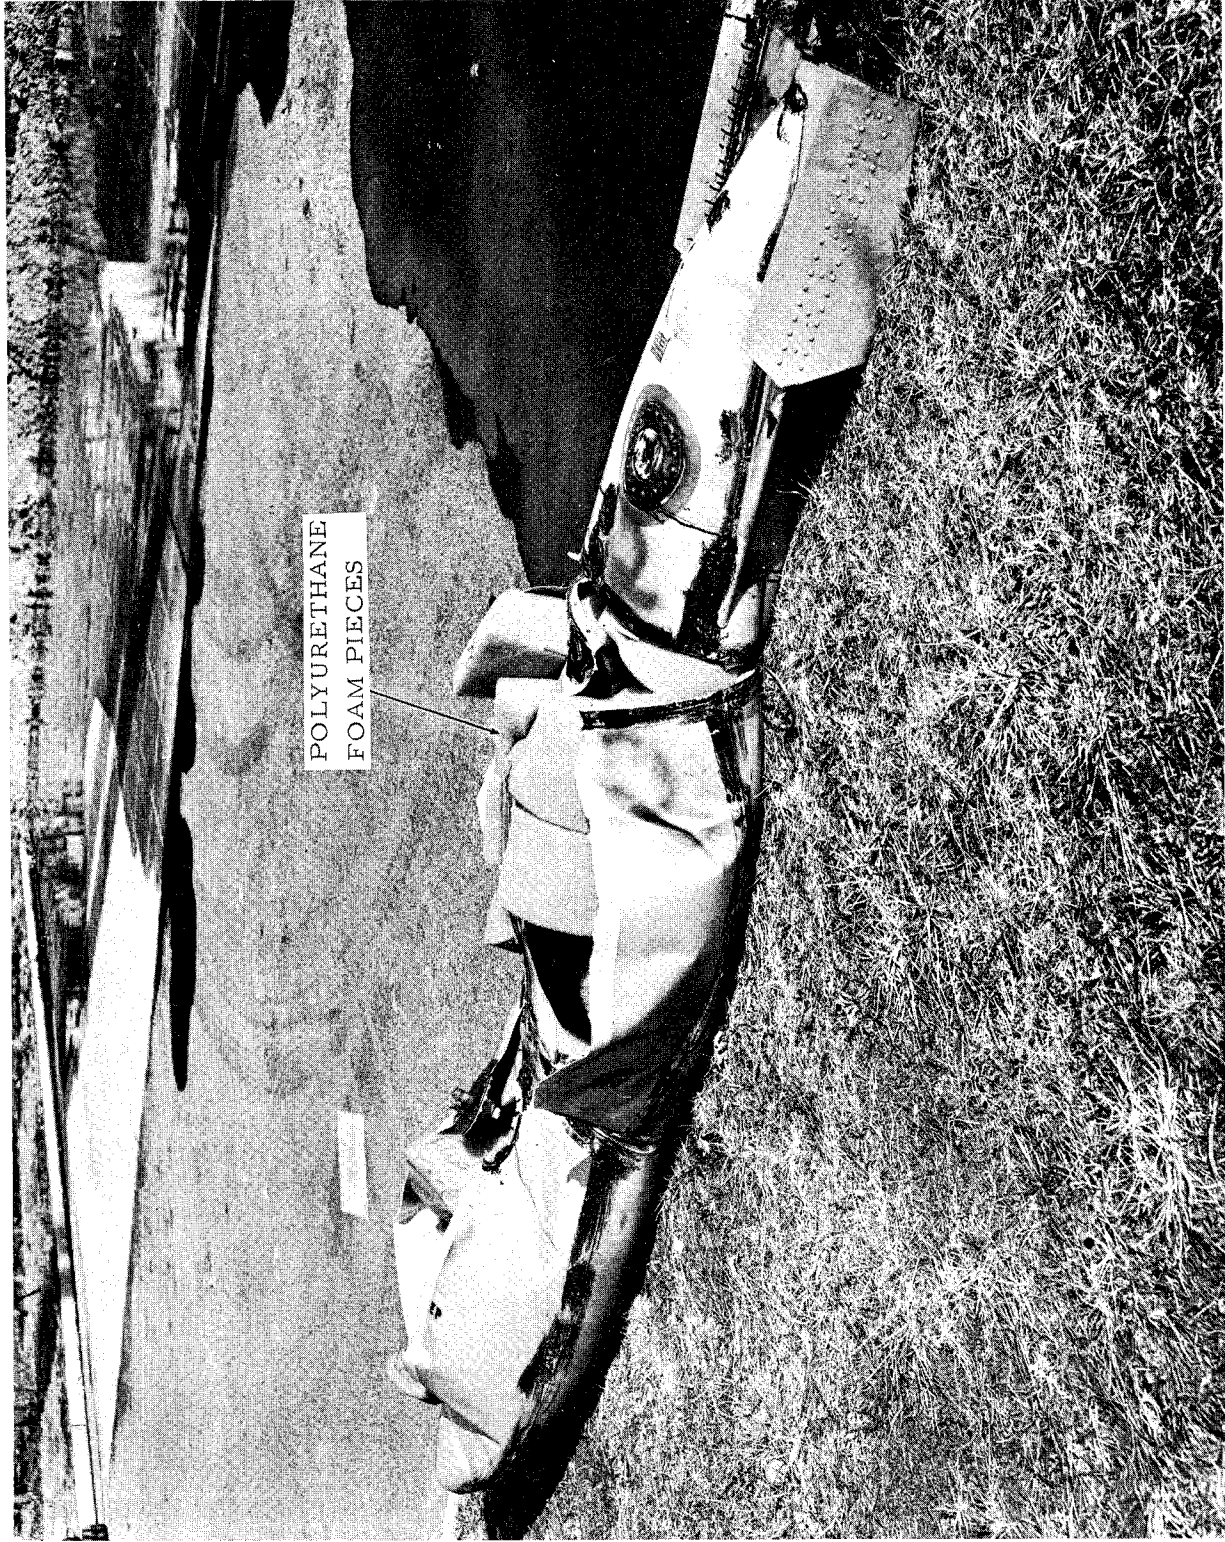
FIGURE 5 F-86 FUEL TANK WITH 10 PPI FOAM AFTER IMPACT

1. The 10 pores per inch (ppi) or the 60 ppi reticulated polyurethane foam when installed in fuel tanks does not effectively attenuate the fuel spray during impact, in terms of improved crashworthiness.

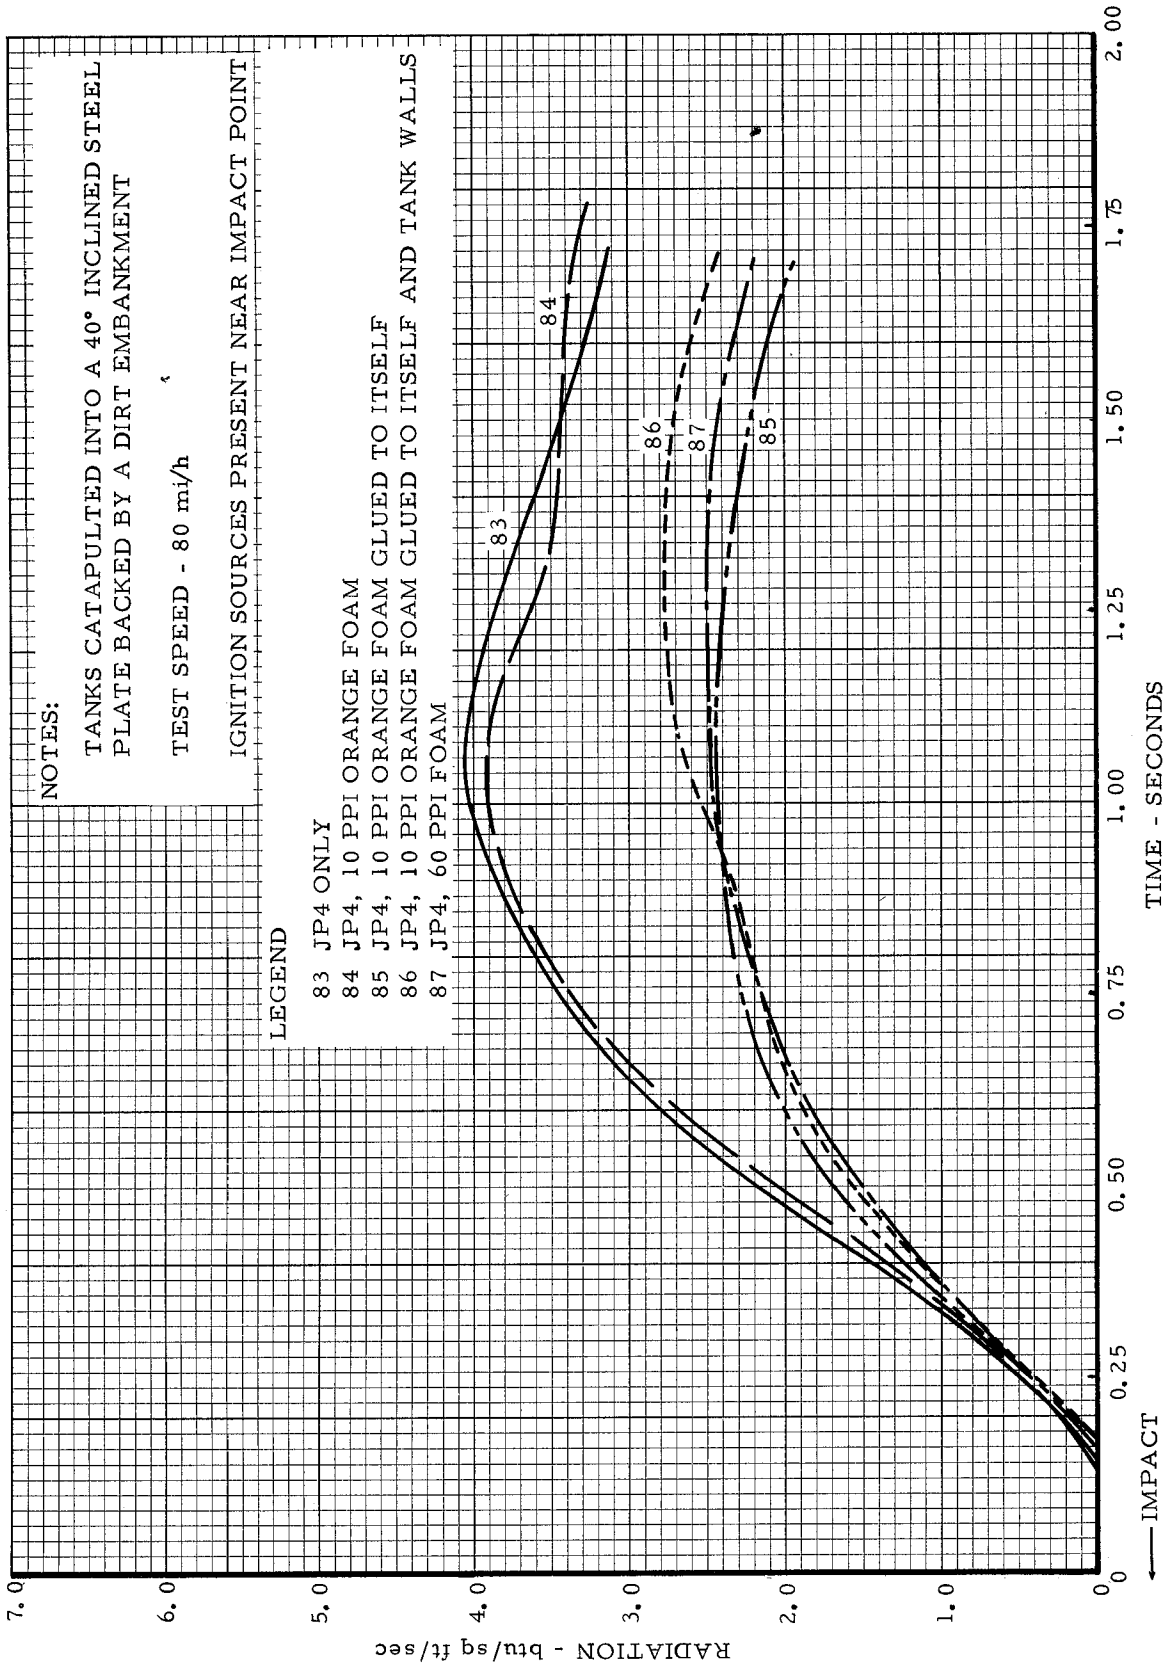
At impact the tanks broke open and the escaping fuel was ignited by burning smudge pots placed around the impact area. All of the fuel burned in the immediate vicinity of the impact area when the control tank containing JP-4 only was tested. On the other tests the fuel-soaked foam carried some of the burning fuel away from the impact area which accounts for the lower radiation readings for these tests as shown in Figure 6. Assessment of the high-speed photographs of these tests was made to determine if there was any substantial decrease in time for ignition of the fuel following impact. In all configurations tested, the fuel spray ignited within a time interval ranging from 40 milliseconds to 60 milliseconds after impact. This difference was considered to be quite insignificant.

FIGURE 6
 RADIOMETER RESULTS OF F-86 FUEL TANK
 CATAPULT TESTS

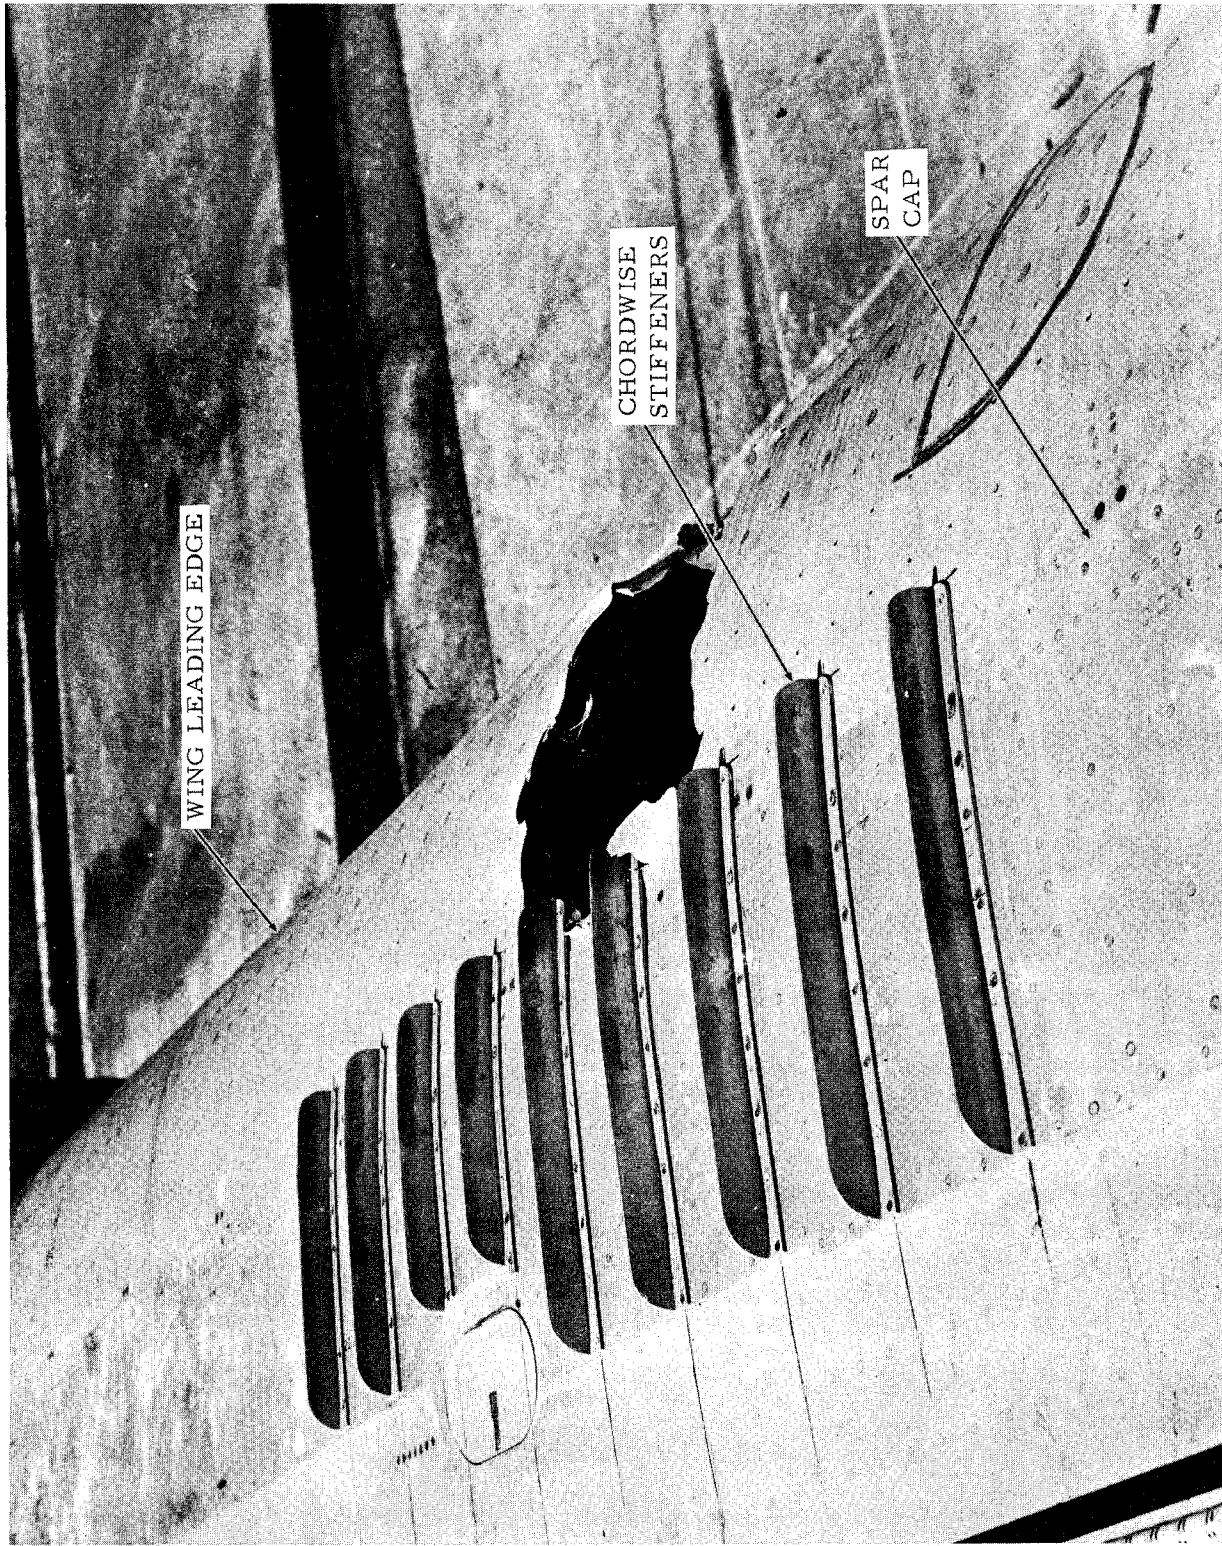
As shown in Figure 7, the tee sections were attached to the test specimen only in the immediate vicinity of the impact area. The actual weight of the tee was 8.24 pounds for this test, but extrapolation of this modification to the entire span of the outer wing panel would result in a total weight of tee sections of 45.5 pounds. The 0.020-inch-thick aluminum doubler weighed 15.5 pounds making the combined weight of structural reinforcement 61.0 pounds for the entire outer wing panel. Since the DC-7 outer panels weighed approximately 1000 pounds empty, this modification resulted in a 6 percent increase in weight. However, the 0.020-inch-thick doubler added no significant chordwise strength, and if retrofitted internal to the panel, the tees would be reduced in overall length by approximately the width of each stringer less its flange; thus decreasing the overall weight an additional increment so that at most the overall weight might be 40 pounds or only a 4 percent increase in dry wing weight.

The wing modified with the 0.040-inch-thick aluminum doubler ruptured almost as much as the unmodified control wing panel after impact, but the wing with the 0.020-inch-thick aluminum doubler and the 1 1/2-inch tee sections did not rupture upon impact.

FIGURE 7 CHORDWISE STIFFENERS ON DC-7 INTEGRAL WING TANK

2. The addition of 0.040-inch-thick aluminum alloy doubler strips aft of the upper and lower front spar caps did not appreciably increase the resistance of the integral tank structure to damage by impact. However, reinforcement of the front spar caps and internal chordwise structure between ribs such as simulated in these tests, can reduce damage to the point of preventing fuel leakage after impact.

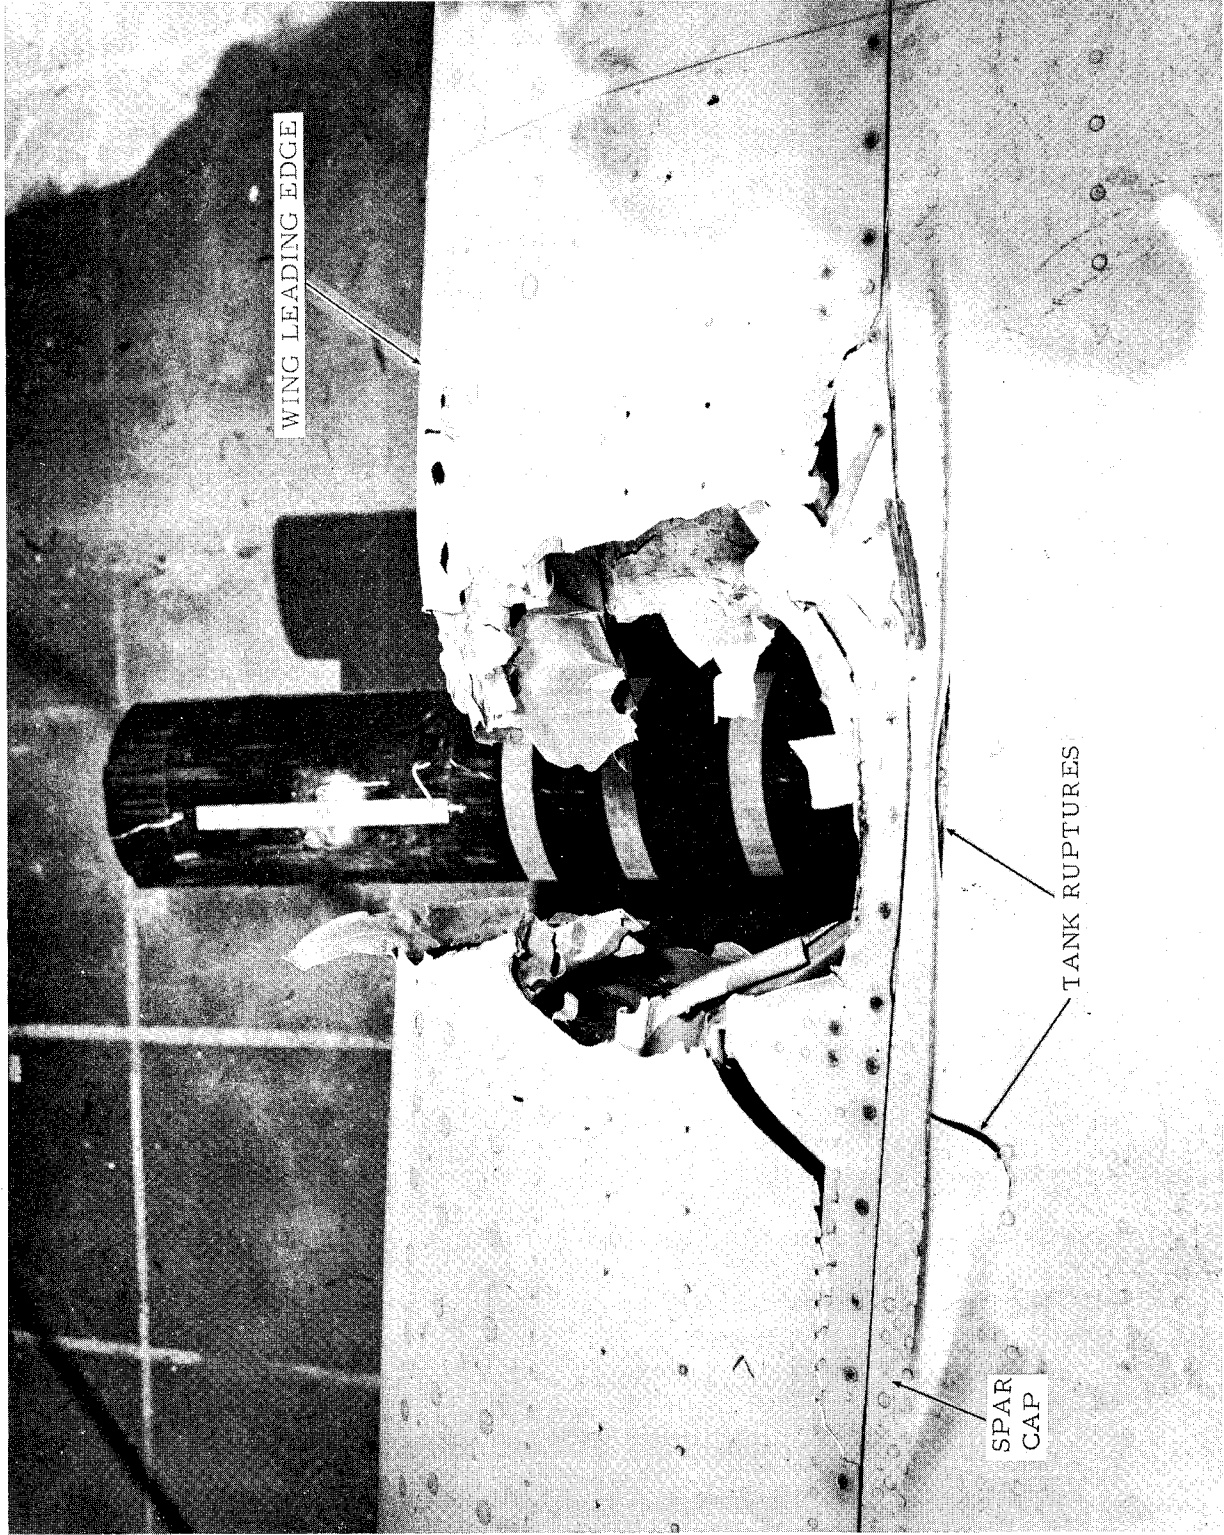
FIGURE 8 UNMODIFIED DC-7 INTEGRAL WING TANK AFTER IMPACT
