Report No. FAA-RD-71-3

TITANIUM FUSELAGE ENVIRONMENTAL CONDITIONS IN POST-CRASH FIRES

Constantine P. Sarkos
National Aviation Facilities Experimental Center
Atlantic City, New Jersey 08405

FINAL REPORT

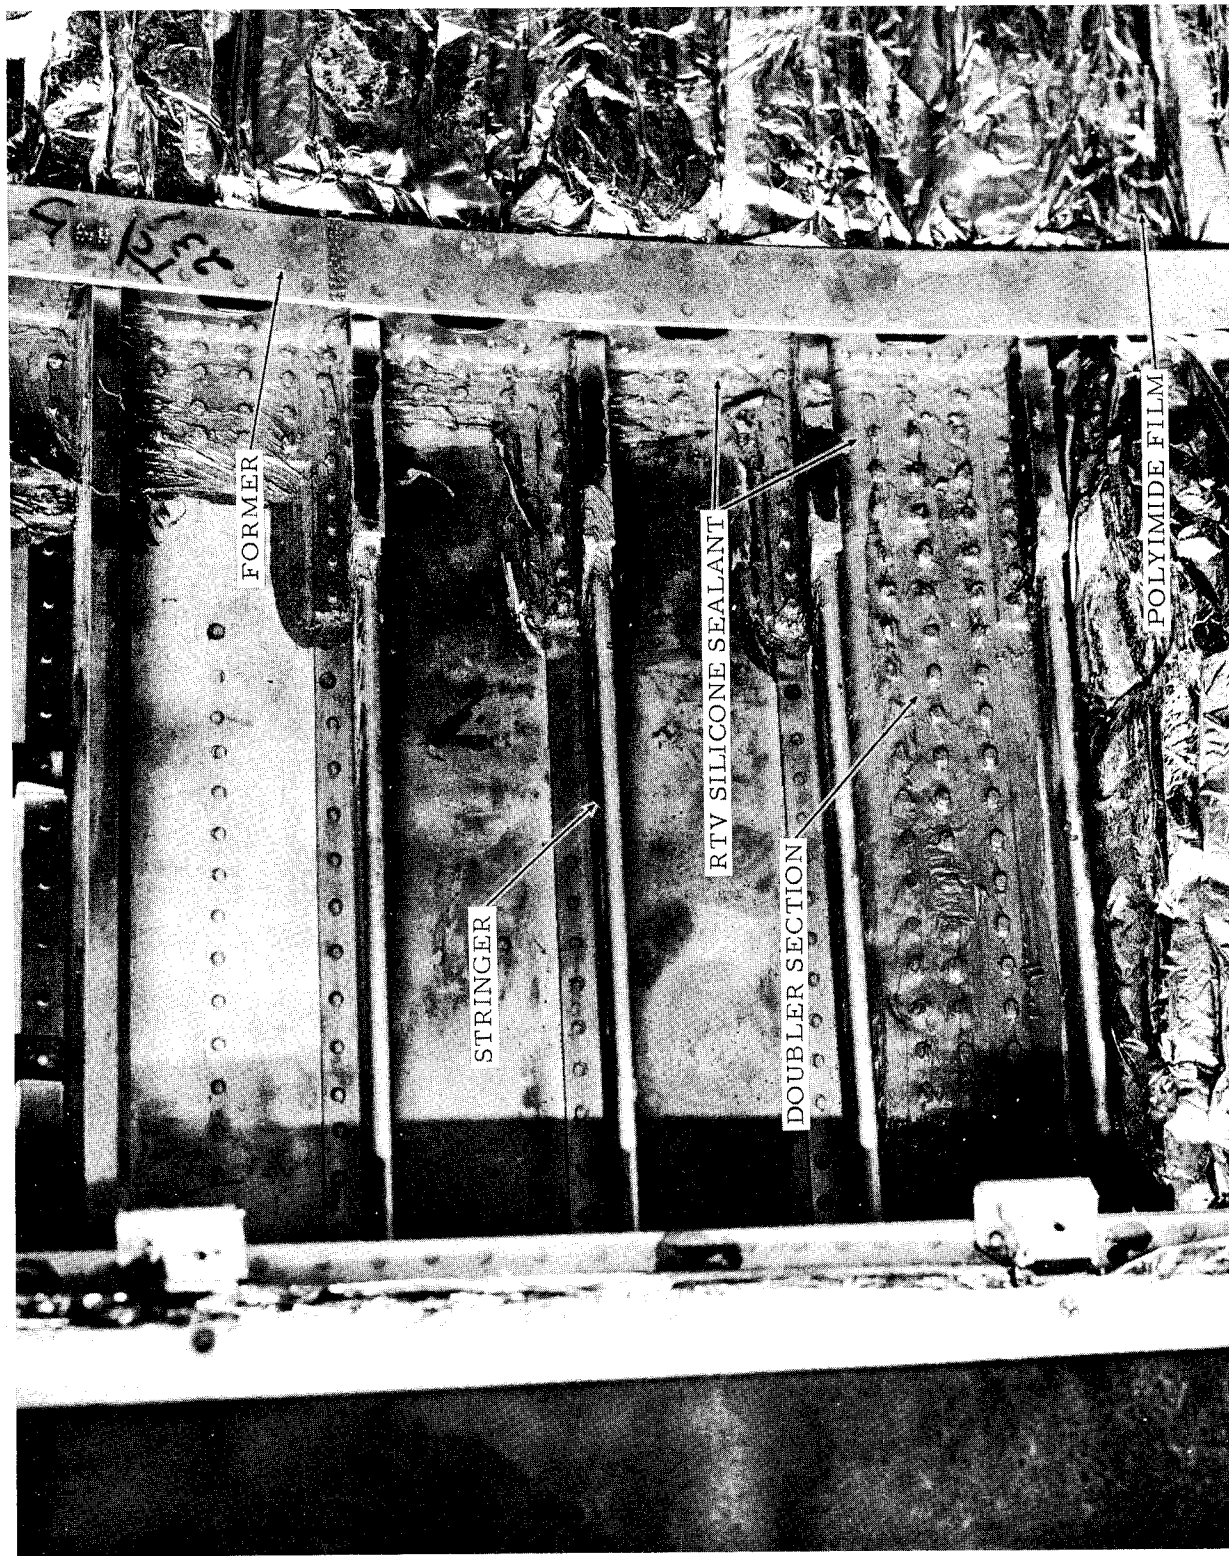
FIGURE 2 - EXTENSIVE USE OF RTV SILICONE AS CABIN
PRESSURE SEALANT

Room temperature vulcanizing (RTV) silicone sealant was originally used extensively along the interior surface of the titanium skin. It was especially thick at doubler sections and along the interface between the former and skin. Figure 2 shows a typical view between two formers. Moreover, it was applied to faying surfaces. Realizing that the pyrolysis products from the RTV would consist of smoke and both flammable and toxic gases, an attempt was made to remove the RTV from the fuselage skin. However, this was discovered to be a difficult task, and the effort was abandoned with the hope that the pyrolysis gases would have a negligible effect on the experimental results.

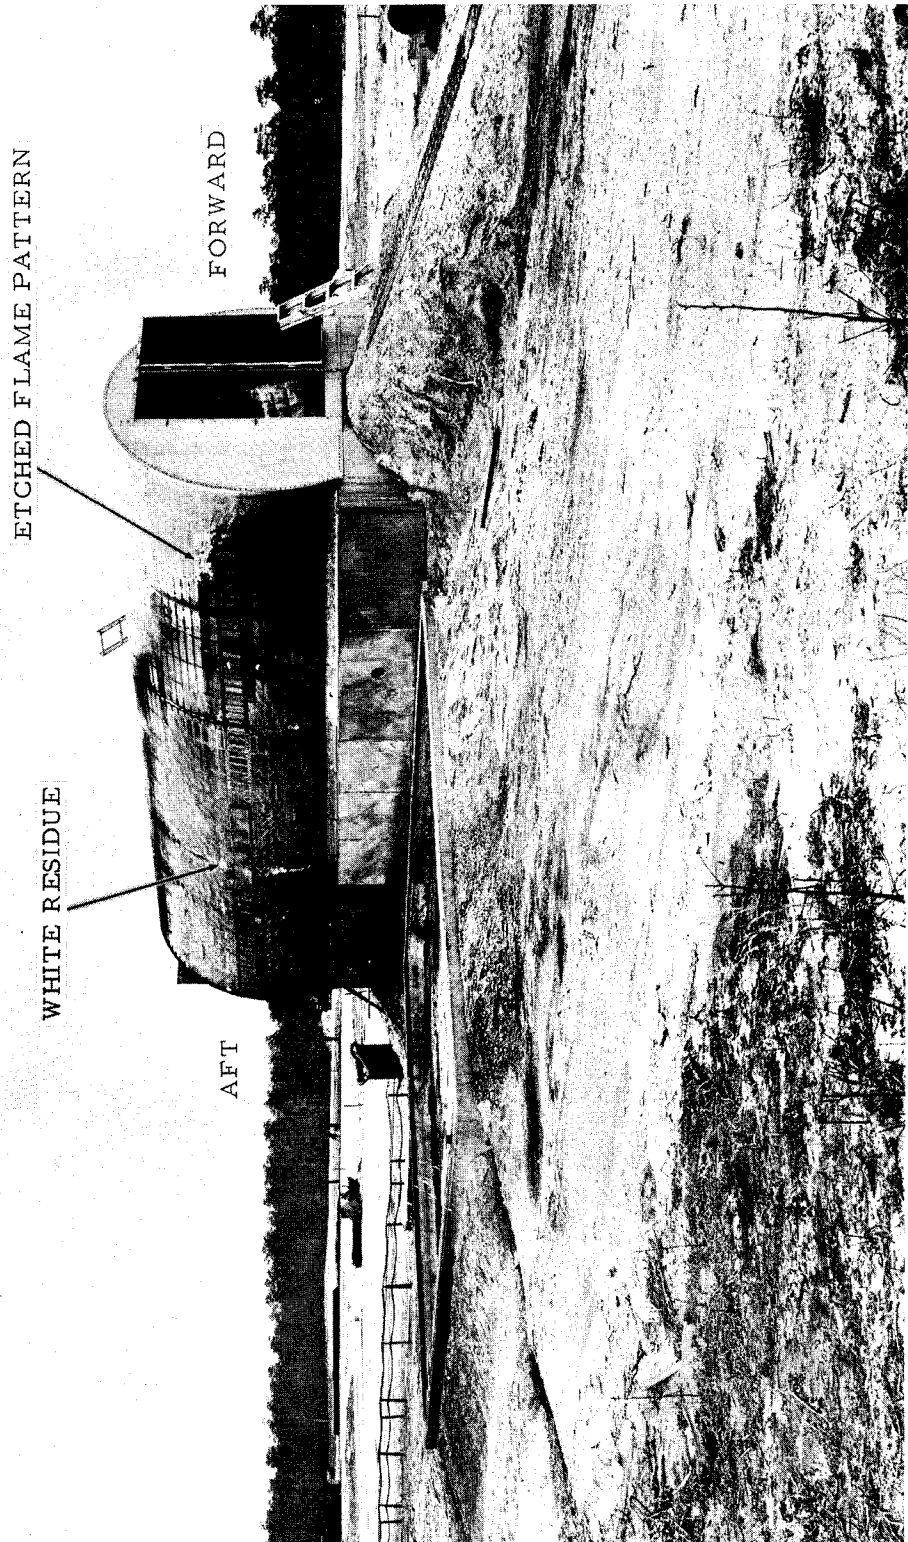
FIGURE 9 - TITANIUM FUSELAGE AFTER FIRE TEST

The side of the fuselage exposed to the fire presented considerable evidence of flame exposure, as is shown in Figure 9. This is quite a contrast to Figure 1, which shows the same view of the fuselage before the test. The flame pattern was etched on the titanium skin, demonstrating that the fuel flames had been drawn towards the firewhirl at the aft end of the fuselage. Because of the thermal stresses generated during the test, the titanium skin was permanently deformed and had a wrinkled appearance, especially at the areas which experienced the most severe heating. However, this deformation was insignificant in that it did not produce any gaps which could have allowed the fuel flames to come directly in contact with the interior materials within the fuselage. The fuselage skin near the lower aft end developed 12 fractures during the cooling-down period following the extinguishment of the pit fire (Figure 10). The length of tear ranged from 1 to 6 inches. An increase in the cooling of the skin because of the inadvertent application of extinguishing agent appears to have aided, if not caused, the formation of these fractures.

The first clue as to the probable cause of the flash fire was provided by the appearance of a white ash-like residue along the seams of the titanium skin (Figure 9). This residue is a characteristic product of RTV silicone combustion and had previously been observed when burning this material in a test tube. During the fuselage test, the RTV silicone applied to faying surfaces was pyrolyzed, producing combustible gases which egressed from the seams and were ignited by the fuel flames, thus producing the white residue along the seams. The pyrolysis and eventual combustion of the RTV silicone applied to the interior titanium surfaces then loomed as the possible cause of the cabin flash fire.

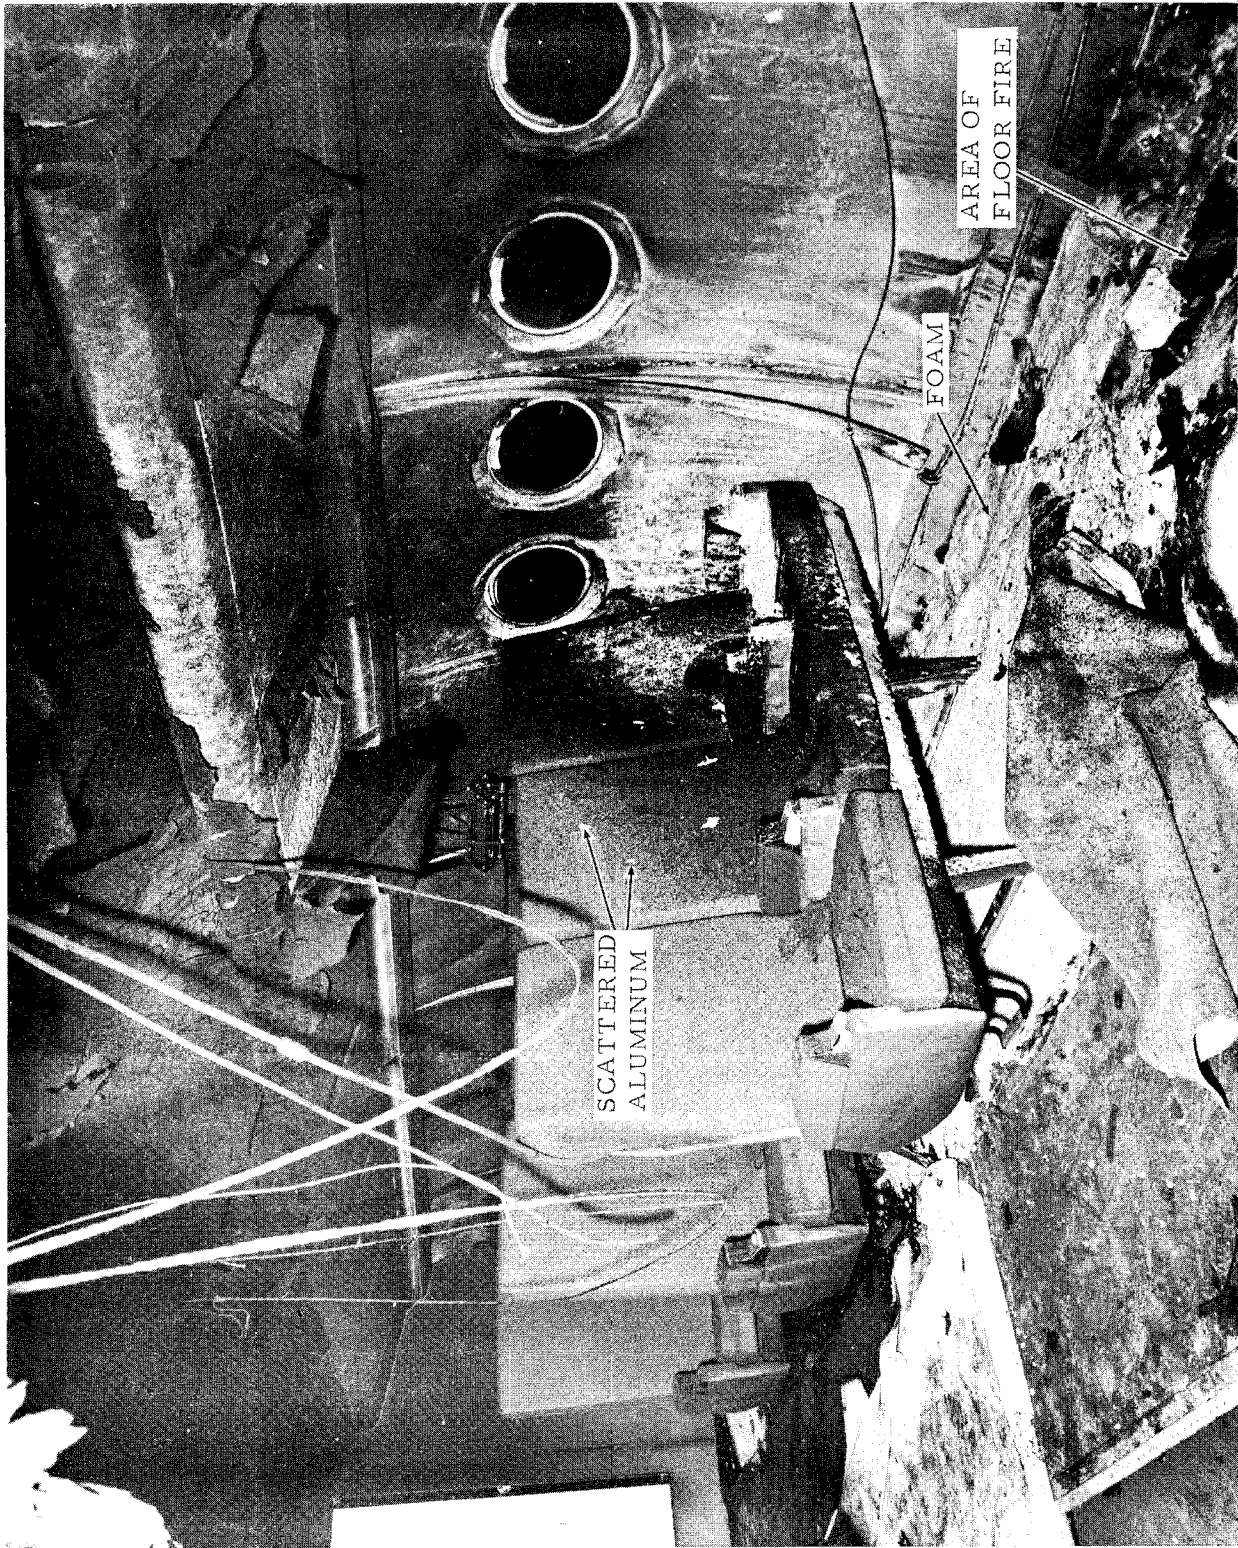
FIGURE 11 - CABIN DAMAGE AFTER FIRE TEST

A view of the cabin after the test is shown in Figure 11, and, when compared with Figure 4, exhibits considerable damage. Note the large amount of foam extinguishing agent accidentally discharged during the initial extinguishment of the floor fire. The hatrack and ceiling damage indicated that the flash fire originated at the aft end of the fuselage (the seats are facing aft) and, as expected, was more severe near the top of the cabin. Molten aluminum, splattered against the seats during the extinguishment of the floor fire, did not ignite the seat upholstery. A closeup of the locality of the floor fire is shown in Figure 12. Sections of the aluminum honeycomb floorboard and the flammable insulation were removed during the fire extinguishment. Special notice should be given to the presence of burn marks in the vicinity of the interior panel interfaces (this will be discussed subsequently in greater detail).

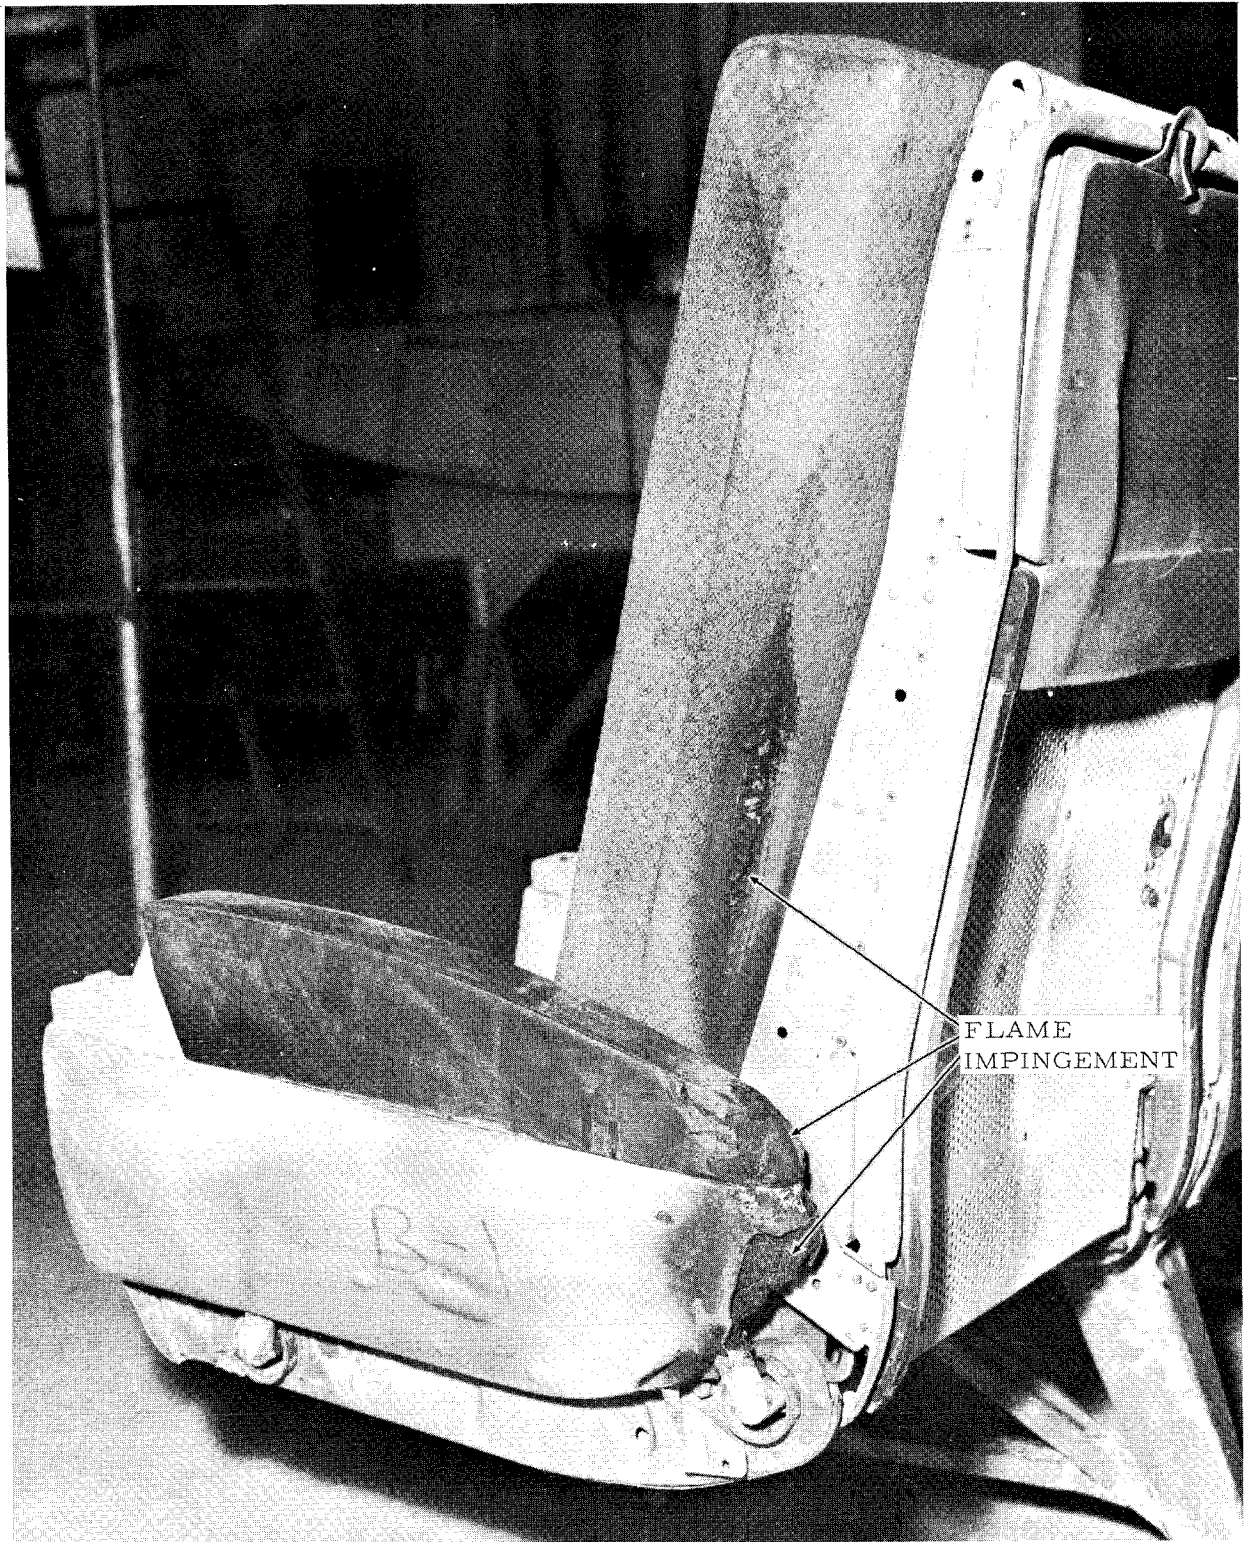
FIGURE 13 - DAMAGE TO AFT-MOST SEAT ADJACENT TO INTERIOR WALL

The first items removed from the fuselage were the seats and rug. Examination of the aft-most seat adjacent to the interior wall revealed evidence of flame impingement upon its side (Figure 13). The flame came from an interior panel interface which was adjacent to the burned seat area and burned away a small area of the seat cover; however, the fire did not spread from the area of flame impingement. Both the elastomeric armrest and the rigid foam siding also showed evidence of burning without any apparent flame spreading. The rug was burned away at the area immediate to the floor fire, but also without any noticeable flame spreading. This was also true of the rug areas struck by molten aluminum. The condition of the rug displayed the same trend as the hatrack and ceiling in that the damage to it decreased toward the forward end of the fuselage.

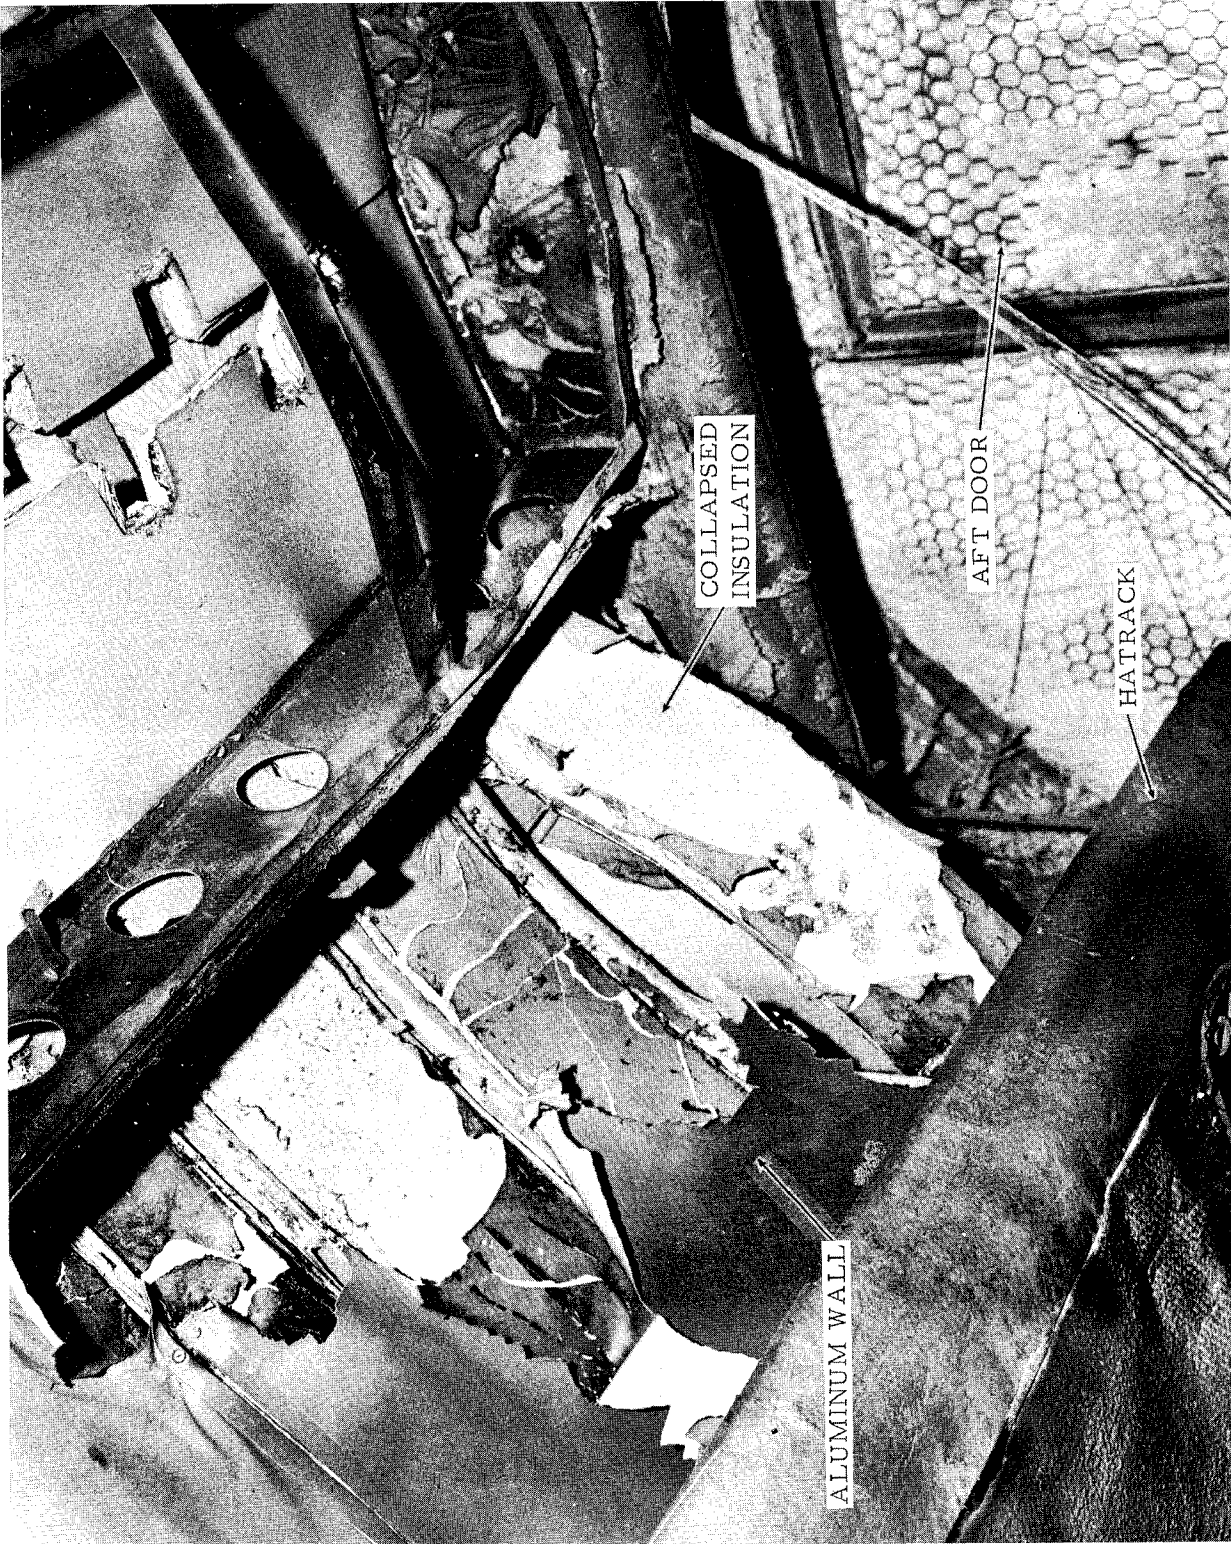
FIGURE 14 - RUPTURED ALUMINUM WALL

The false ceiling was next removed from the fuselage, revealing evidence of a pressure rupture above the hatrack near the aft end (Figure 14). Note the jagged appearance of the aluminum "isothermal" wall. Apparently, the space bounded by the inner aluminum and outer titanium walls was fairly airtight so as to allow a pressure buildup which eventually ruptured the aluminum. This failure probably initiated the flash fire--witnessed as a distinct pop and sudden outflow of smoke from the aft door's edges--which occurred at 1 minute 55 seconds after ignition.

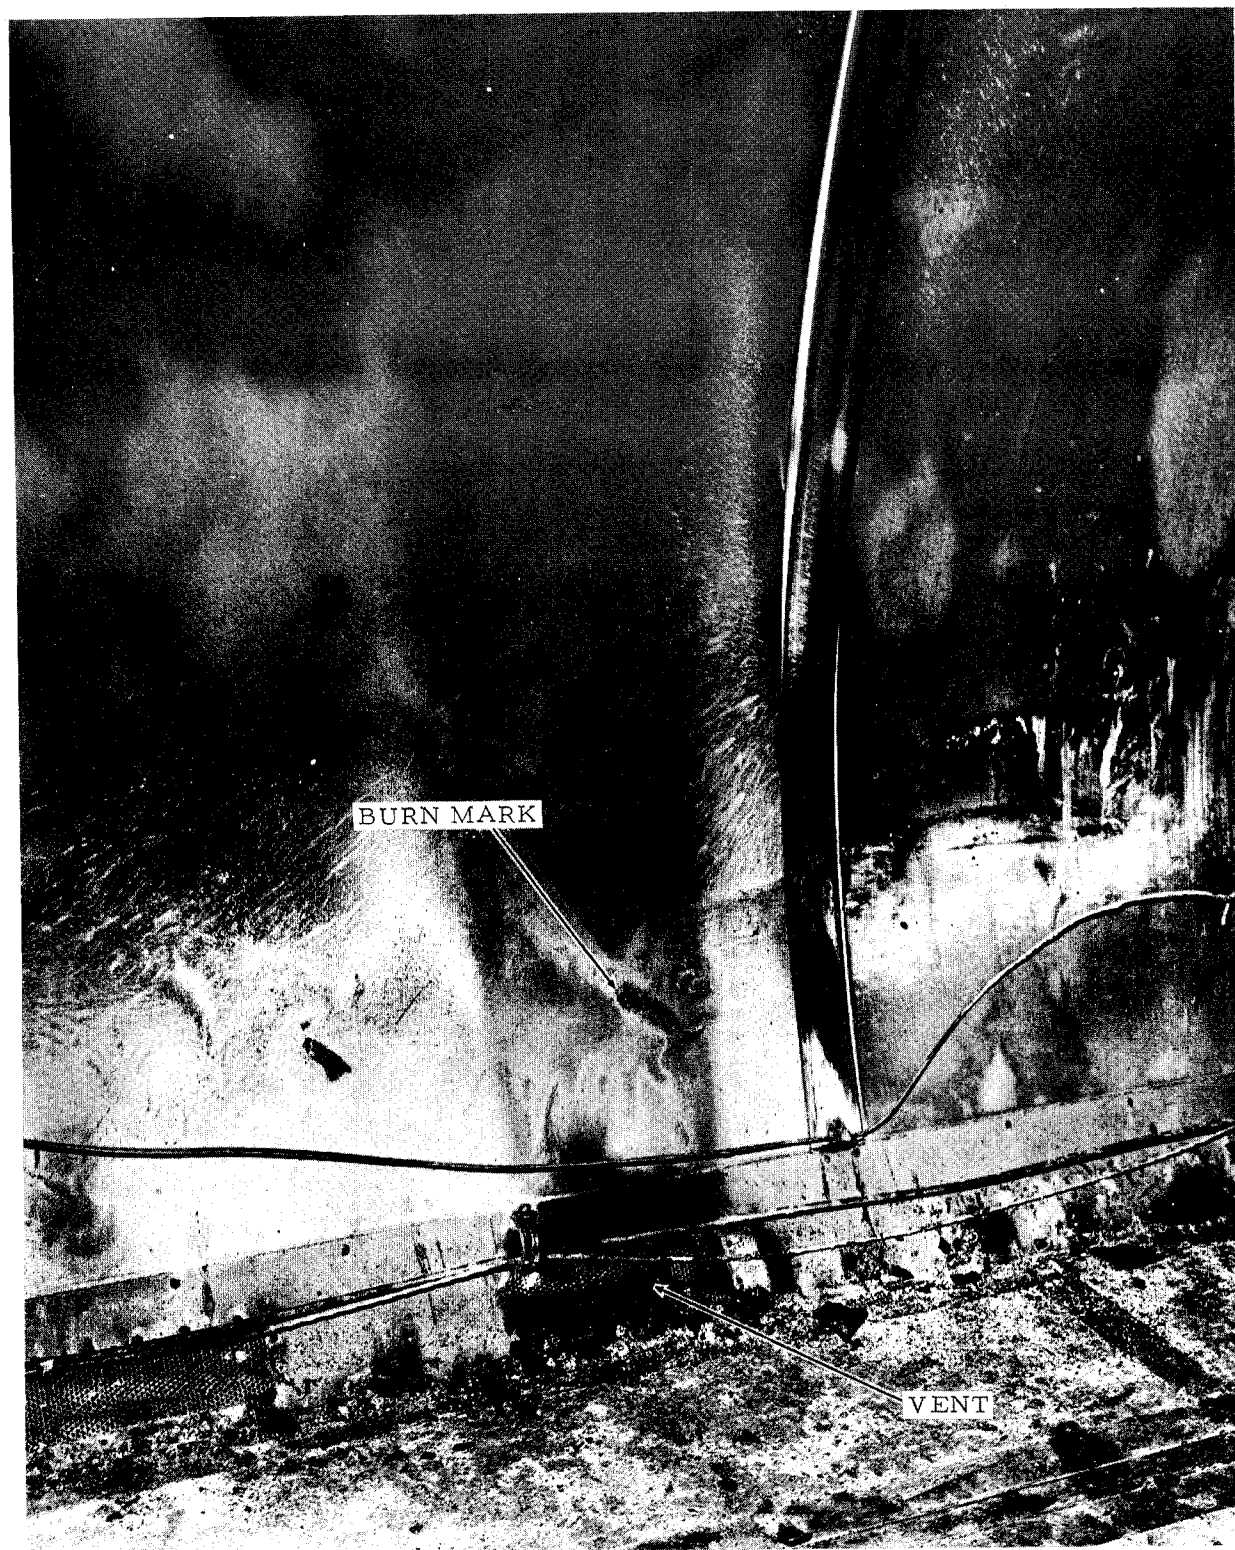
FIGURE 15 - BURNED AREA ABOVE VENT STUFFED WITH INSULATION

Figure 15 shows a closeup of the interior panel located slightly forward of the fuselage center. The area above the floorboard vent, which was the outlet for a duct stuffed tightly with fiberglass insulation, exhibited severe burn marks. It appeared as if the volatiles from the insulation's silicone binder were released during pyrolysis and ignited upon entering the cabin environment.

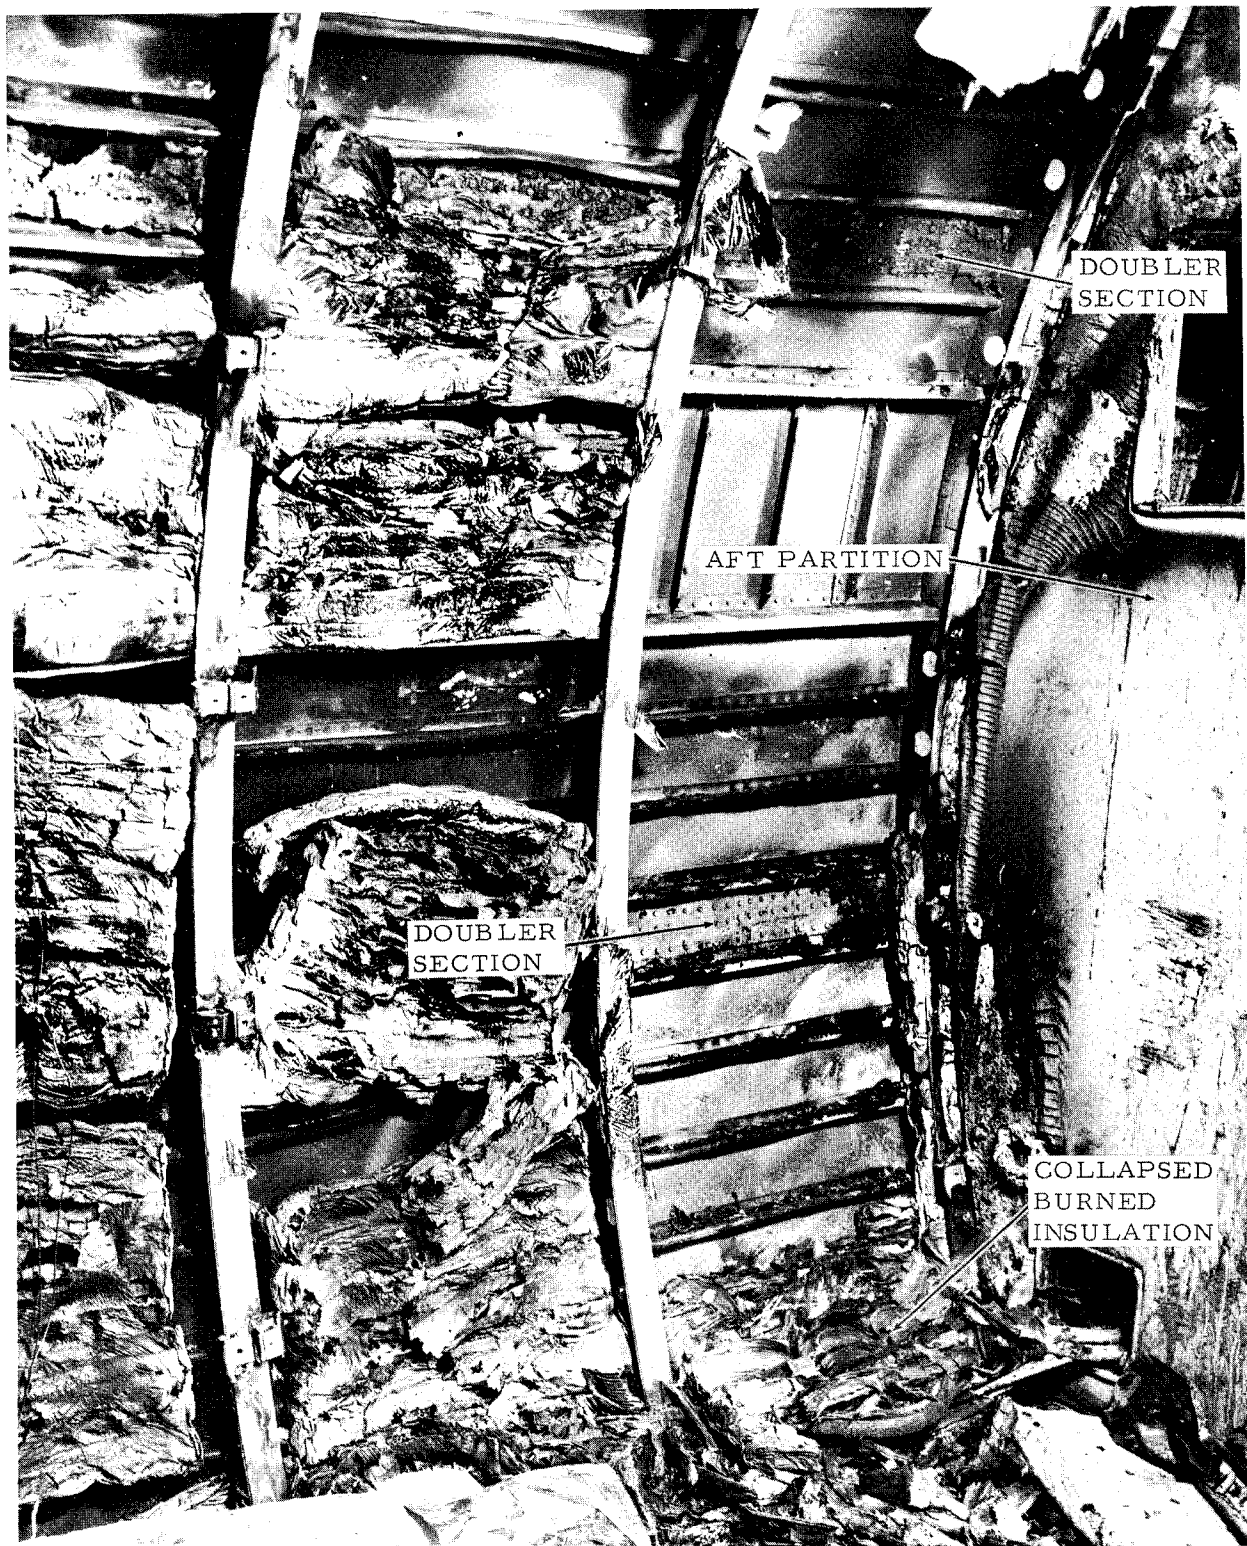
FIGURE 17 - BURNED SEALANT AND INSULATION NEAR AFT END

The next step in the examination of the test article was to remove the interior panels. Figure 17 shows the same section near the aft end as Figure 16, but with the interior panels removed. It was evident that severe burning of the RTV sealant and fiberglass (binder) insulation had occurred during the test. The degree of fire damage followed four trends: it was most severe (1) toward the aft end, (2) toward the cabin floor, (3) in the vicinity (especially above) of the RTV-covered doubler sections, and (4) toward the interior panel interfaces. The first two trends are clearly discernible in Figure 17, while the third trend is better illustrated by the closeup shown in Figure 18. Immediately above the RTV-covered doubler section the insulation was burned away, especially near the panel interface where the oxygen necessary for combustion could be obtained from the cabin air. It appears as if the RTV ignited first and acted as an ignition source for the burning of the insulation. Another closeup better displays the fourth trend (Figure 19). Although it is not clearly distinguishable in this black and white photograph, the insulation adjacent to the center former was unburned, while the insulation near the outer formers (panel interfaces) was severely damaged. Also, the RTV used on the formers as an adhesive was burned off the outer former, but that attached to the center former was unscathed. Clearly, the combustion occurred at the panel interfaces where oxygen was readily accessible from the cabin air.

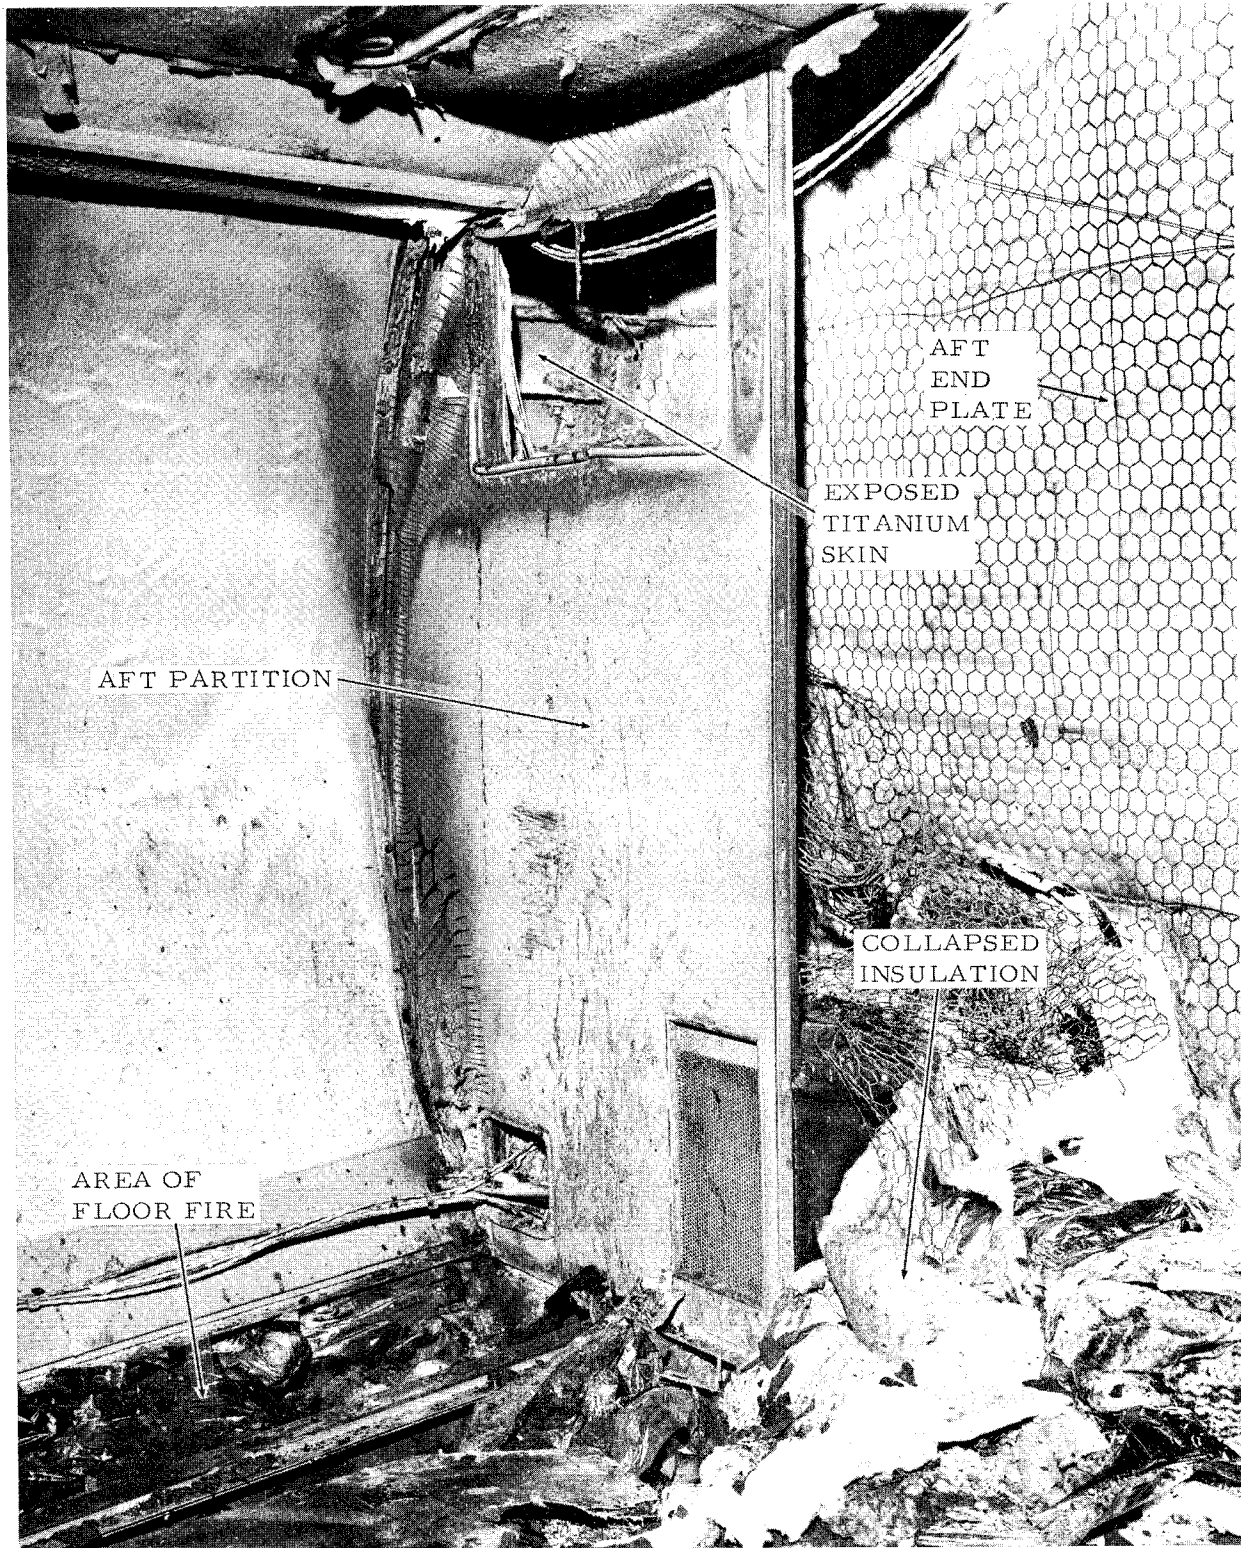
FIGURE 16 - DAMAGED CABIN NEAR AFT END

The short length of fuselage sidewall extending from the end plate to each partition was not insulated in the original titanium test article. It was necessary to insulate this area with fiberglass supported by chicken wire. As is noticeably evident in Figure 16, the insulation mounted at the aft end of the fuselage collapsed at some time during the test. This then allowed for a significant increase in heat transfer from the adjacent firewhirl which may have contributed (in addition to the panel interface and vent flaming) to the early heating of the cabin environment. The partition experienced fire damage alongside the interior panel from flames which, as will be subsequently demonstrated, originated from burning RTV sealant and fiberglass insulation.

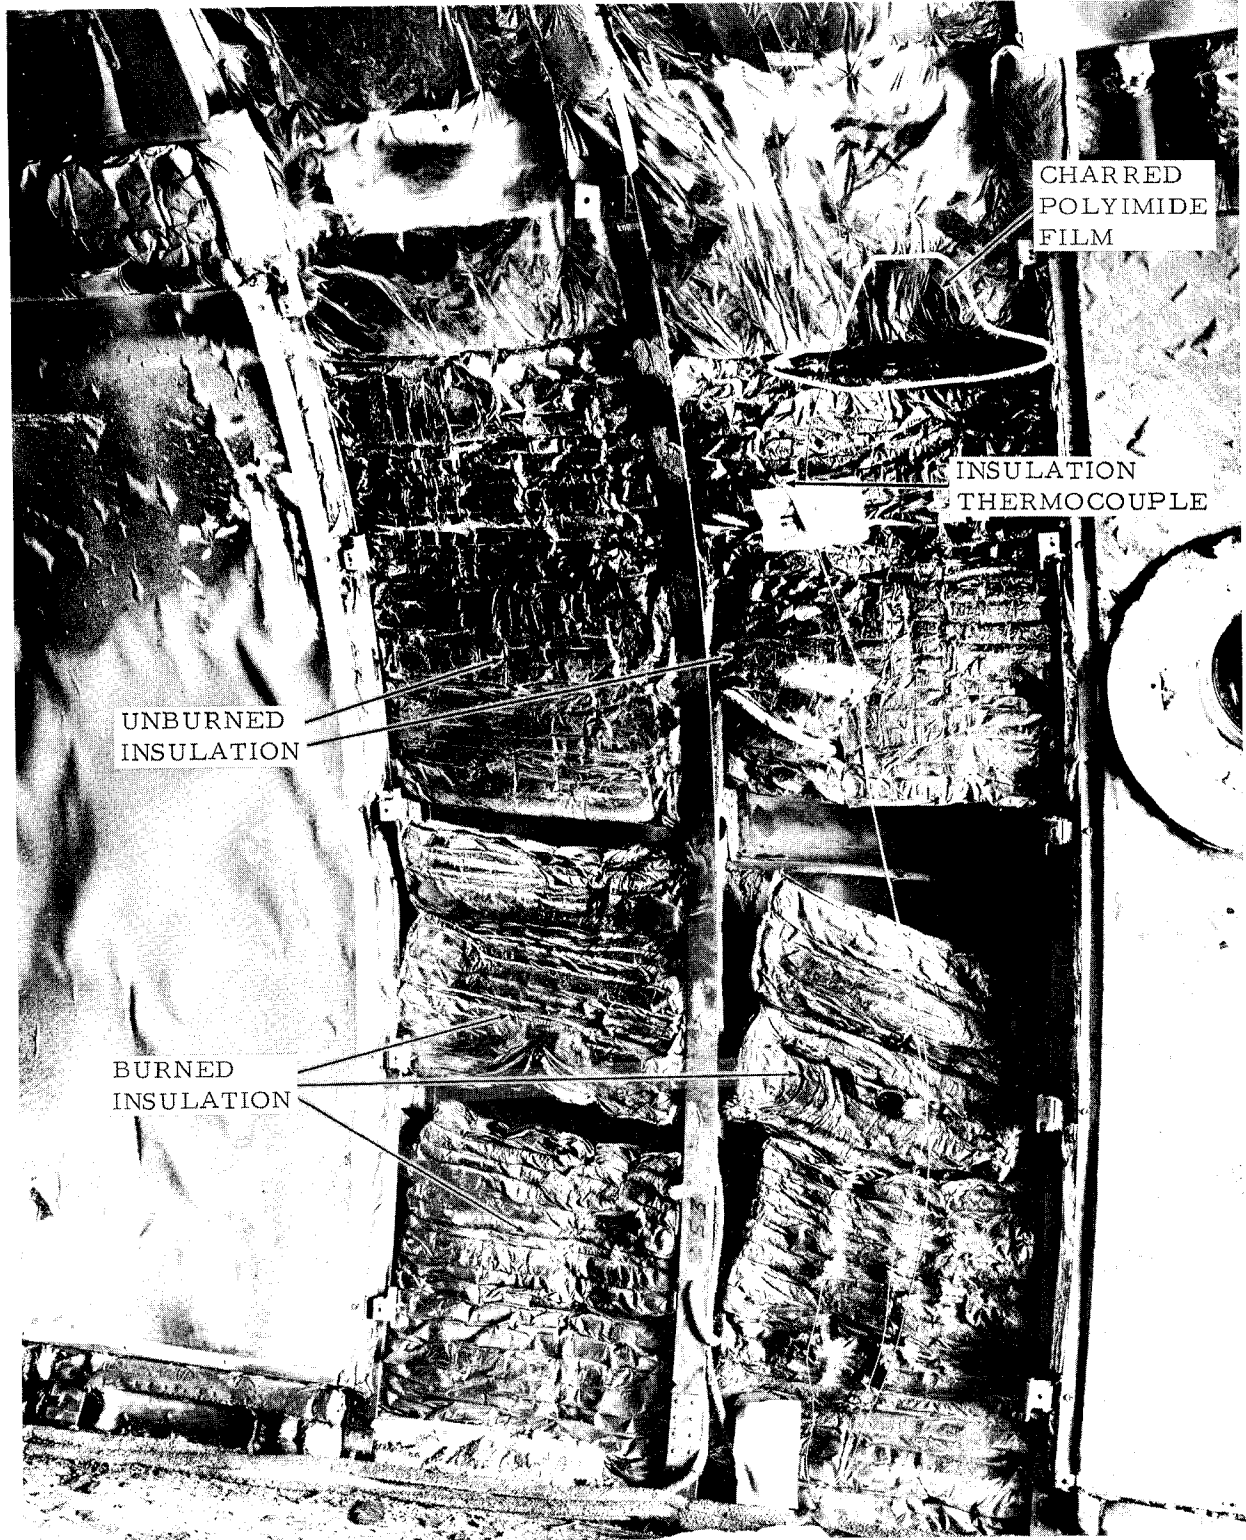
FIGURE 20 - CENTER INSTRUMENTATION SECTION WITH INTERIOR
PANEL REMOVED

Figure 20 shows the interior panel removed from the center instrumentation section. The amount of burned insulation was considerably less than that at the aft end. The insulation immediately above the floor was almost completely burned, while that above the window level, except for a small area adjacent to an RTV-covered doubler section, was unburned. This behavior follows the previously outlined second and third trends. Examination of the insulation batt adjacent to the doubler section

revealed that the polyimide film facing the titanium skin was severely charred, while the adjacent fiberglass was not damaged. The RTV coating on the doubler section was completely decomposed, with only an insignificant amount of flake remaining. The RTV sealant decomposed and burned more readily than the fiberglass insulation, and was probably the major contributor to the cabin flash fire. Removal of the interior panel from the forward instrumentation section revealed that all of the insulation and RTV sealant were unburned. Thus, examination of the three instrumentation sections indicated that the fire damage to the RTV sealant and fiberglass insulation occurred in proportion to the severity of the external fire.

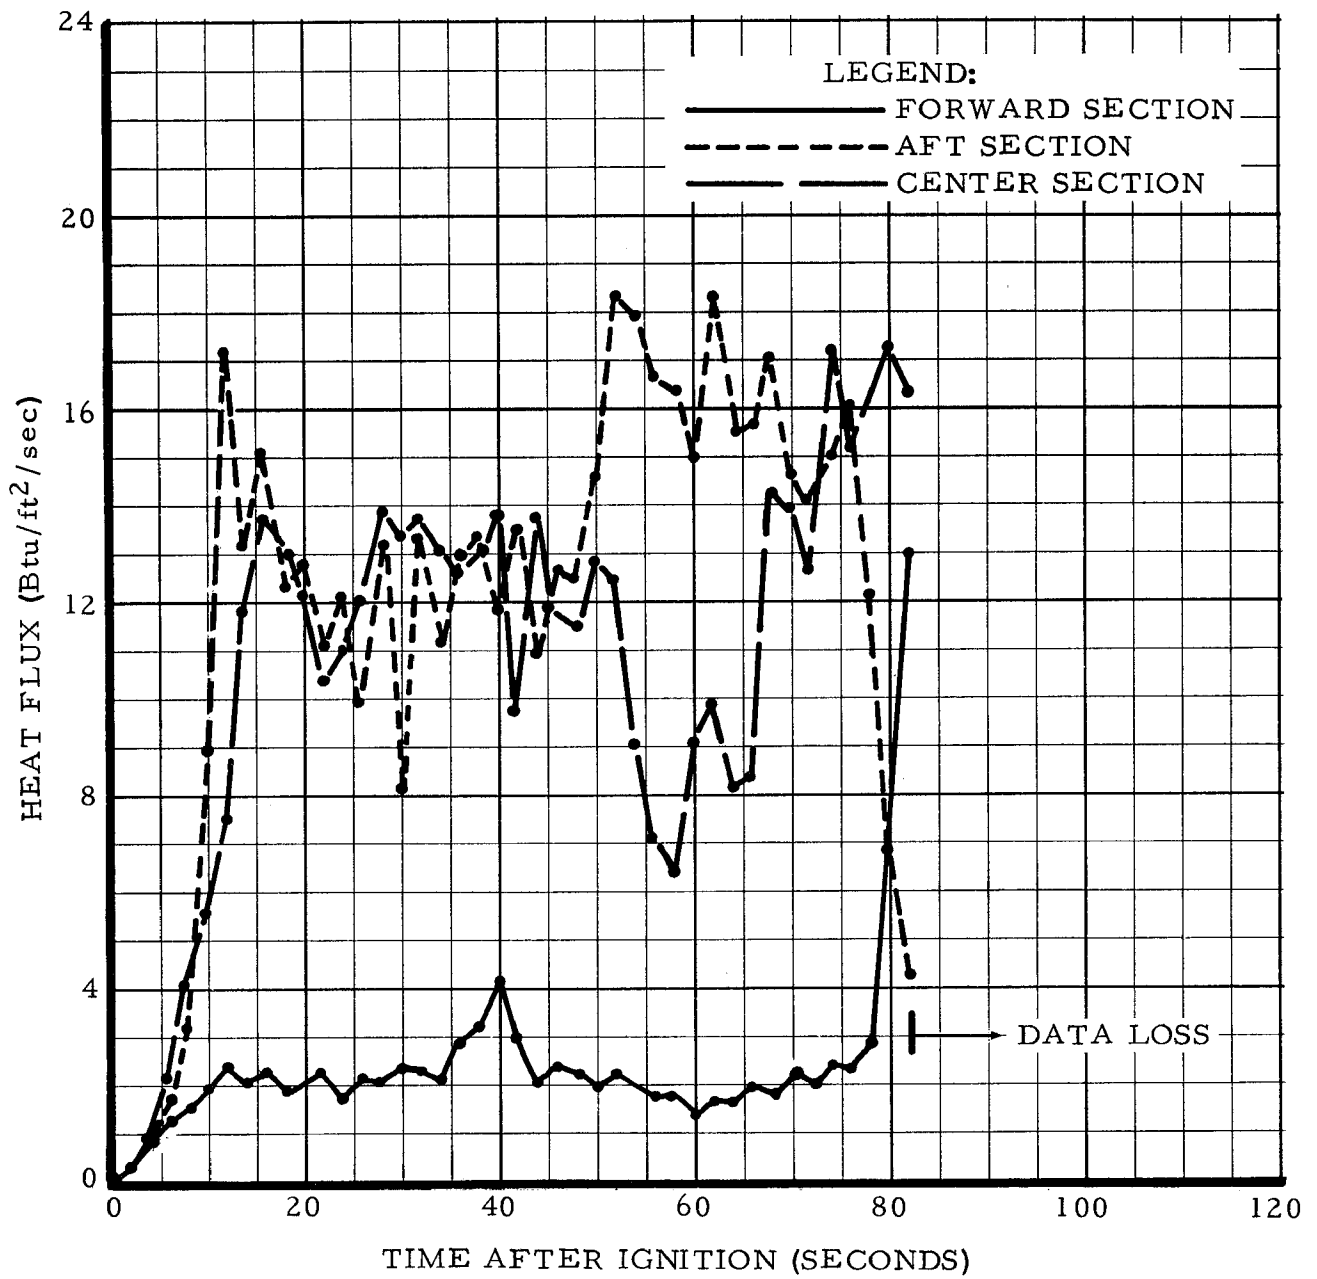
FIGURE 21 - HEAT FLUX UPON TITANIUM FUSELAGE DURING AN EXTERNAL FUEL FIRE

The intensity of the fuel fire was measured by three heat flux transducers and three thermocouples. Figure 21 compares the total heat flux impinging upon the fuselage at each instrumentation section. Each data point represents the average of five readings taken every one-half second. It was necessary to reduce the data by this procedure in order to eliminate the large, rapid fluctuations in heat flux characteristic of a turbulent fire of this size, thus making it possible to simultaneously compare the heat flux at each section. As was observed during the test, Figure 21 demonstrates that the fire did not reach full intensity until about 10-15 seconds after ignition. Also, it is apparent that the heat flux distribution was governed largely by the location of the firewhirl which, except for its movement at 80 seconds after ignition toward the forward end of the fuselage, was always adjacent to the fuselage near the aft end. Even though the center heat flux transducer was positioned at the center of the fire pit, the heat generated by the firewhirl was great enough to cause the aft total heat flux to exceed that at the center for most of the test. Convective flame bending toward the firewhirl caused the aft and forward heat flux, which were measured equidistant from the center of the fire pit, to differ by as much as a factor of ten. Data were abruptly terminated when the shielded cables connected to the heat flux transducers developed short circuits. Fortunately, temperature data were recorded throughout the test since all thermocouple wires were protected by asbestos insulation. Figure 22 shows the flame temperature at each instrumentation section. A comparison with the heat flux data revealed that the flame temperature closely followed the trends exhibited by
