Report No. FAA-RD-71-3

TITANIUM FUSELAGE ENVIRONMENTAL CONDITIONS IN POST-CRASH FIRES

Constantine P. Sarkos
National Aviation Facilities Experimental Center
Atlantic City, New Jersey 08405

FINAL REPORT

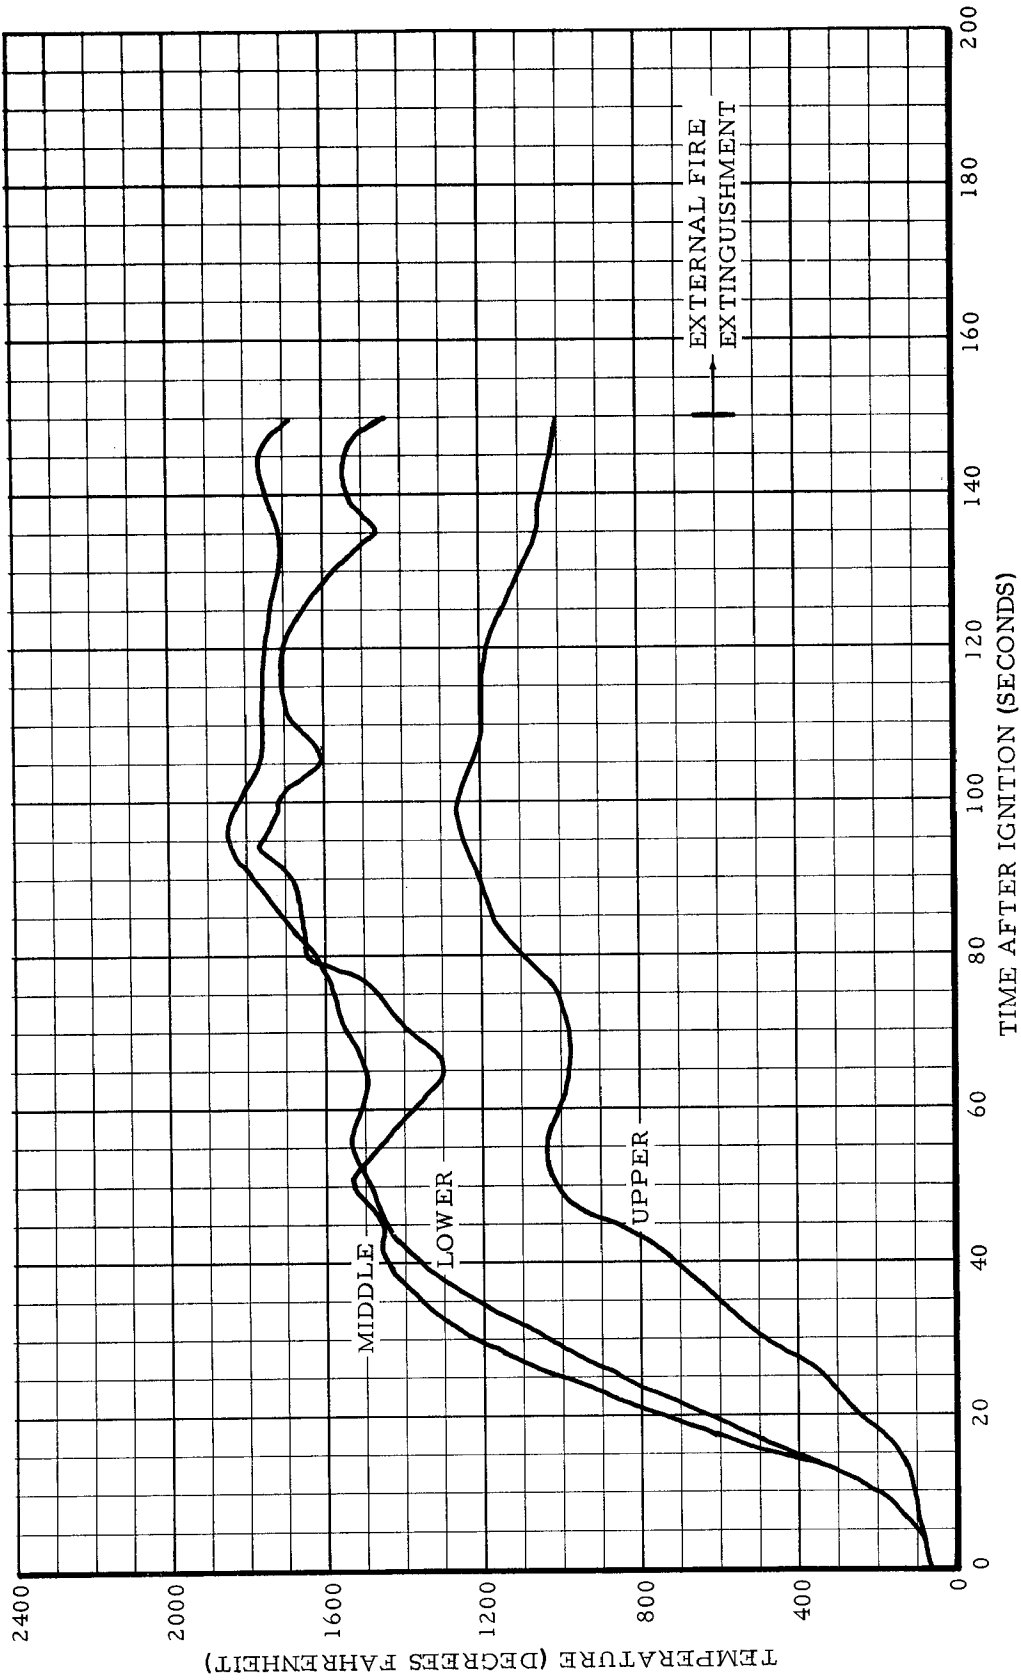
FIGURE 23 - TITANIUM FUSELAGE SKIN TEMPERATURE (CENTER SECTION) DURING AN EXTERNAL FUEL FIRE

The titanium skin temperatures at the center section are shown in Figure 23 for the three measurement levels. The middle and lower temperatures were fairly similar, while the upper temperature was substantially lower, indicating that flame bending around the fuselage was not significant enough to raise the upper fuselage skin temperatures to the values experienced by the areas adjacent to the fire. This trend was also exhibited by the aft and forward sections, although the forward temperatures were significantly lower than either the center or aft temperatures. Since an aluminum alloy melts over a temperature range extending from about 900° to 1200°F (Reference 2), the skin of a conventional subsonic aircraft experiencing the same temperature history shown in Figure 23 would melt in less than 30 seconds at some areas and allow fire entry into the cabin interior.

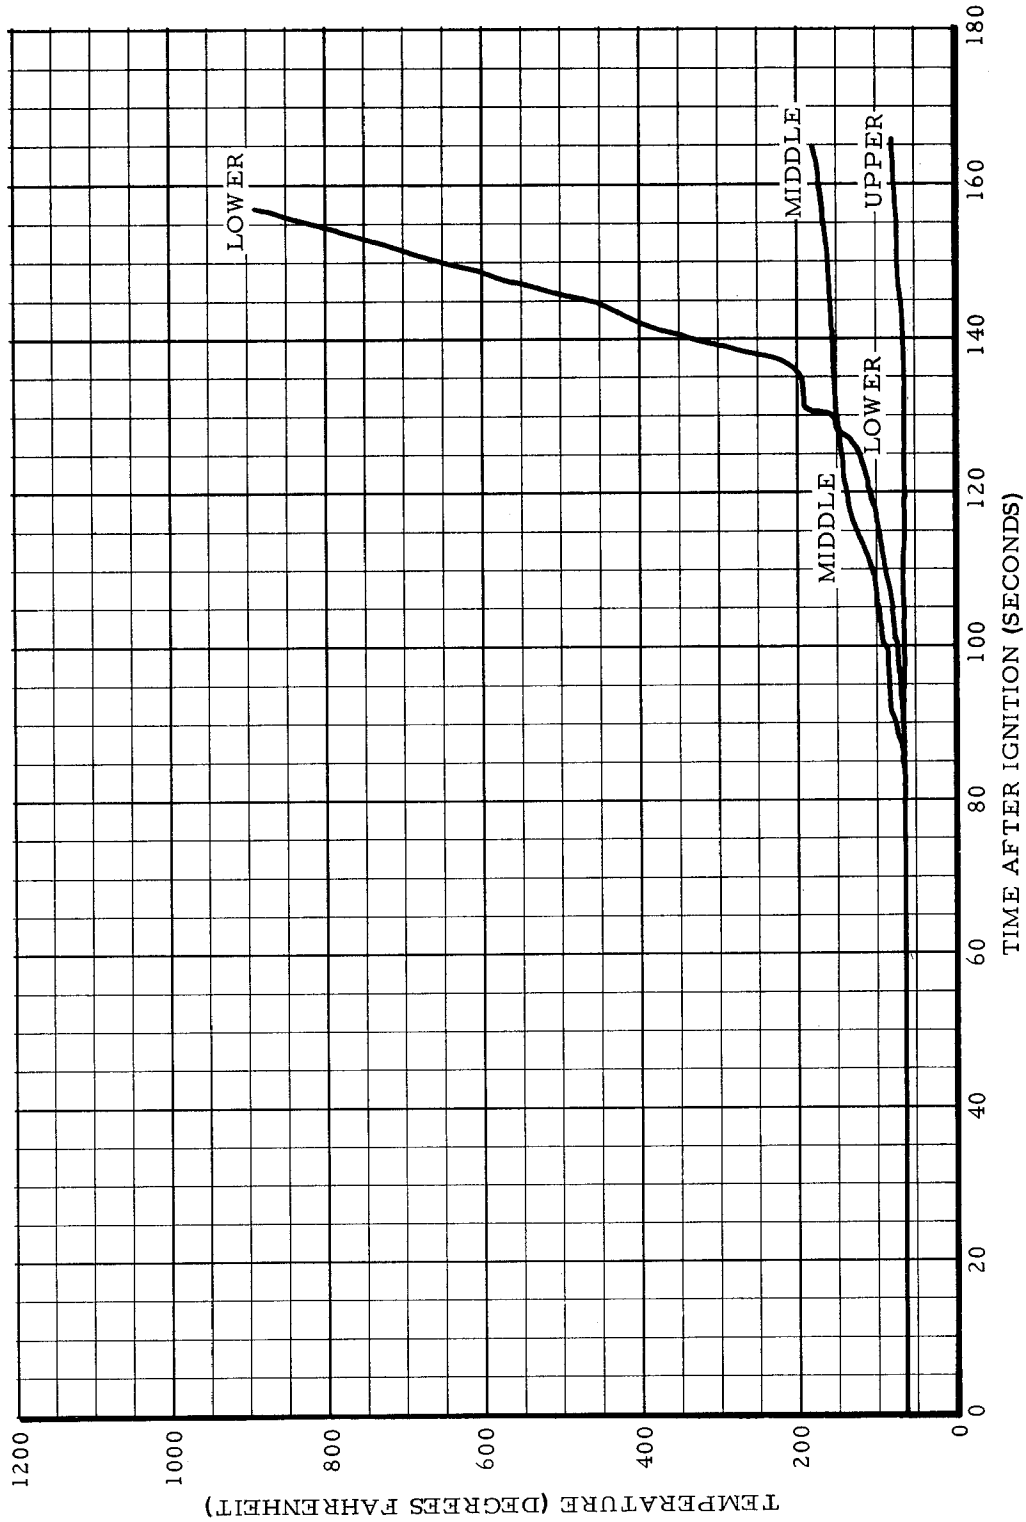
FIGURE 25 - TITANIUM FUSELAGE INSULATION TEMPERATURE (CENTER SECTION) DURING AN EXTERNAL FUEL FIRE

The heat transmitted through the titanium skin was impeded by the insulation batts, and from the preceding discussion, one would expect the insulation temperature at different levels to follow the same trends as the stringer temperature. Figure 25 shows that this was not the case. The middle temperature unexpectedly exceeded the lower temperature until about 130 seconds after ignition, probably because the middle thermocouple was feeling the heat from the combustion of the RTV silicone sealant. (The middle insulation thermocouple was located adjacent to an RTV-covered doubler section, while both the lower and upper thermocouples were not.) Because of the greater heat transfer at the lower level, the insulation there eventually ignited and burned, as indicated by the sharp and initially erratic increase in temperature starting at 125 seconds after ignition. Since both the middle and upper thermocouples did not experience any sharp increases in temperature which are characteristic of flaming, the thermocouple data were thus consistent with the appearance of the center section (Figure 20). All three aft insulation thermocouples showed sharp increases in temperature indicative of burning insulation, the remnants from which were observed in Figure 17. The insulation temperature of the forward section did not change throughout the test.
