Full-Scale Air Transport Category Fuselage Burnthrough Tests

Harry Webster et al.

February 1990

DOT/FAA/CT-TN89/65

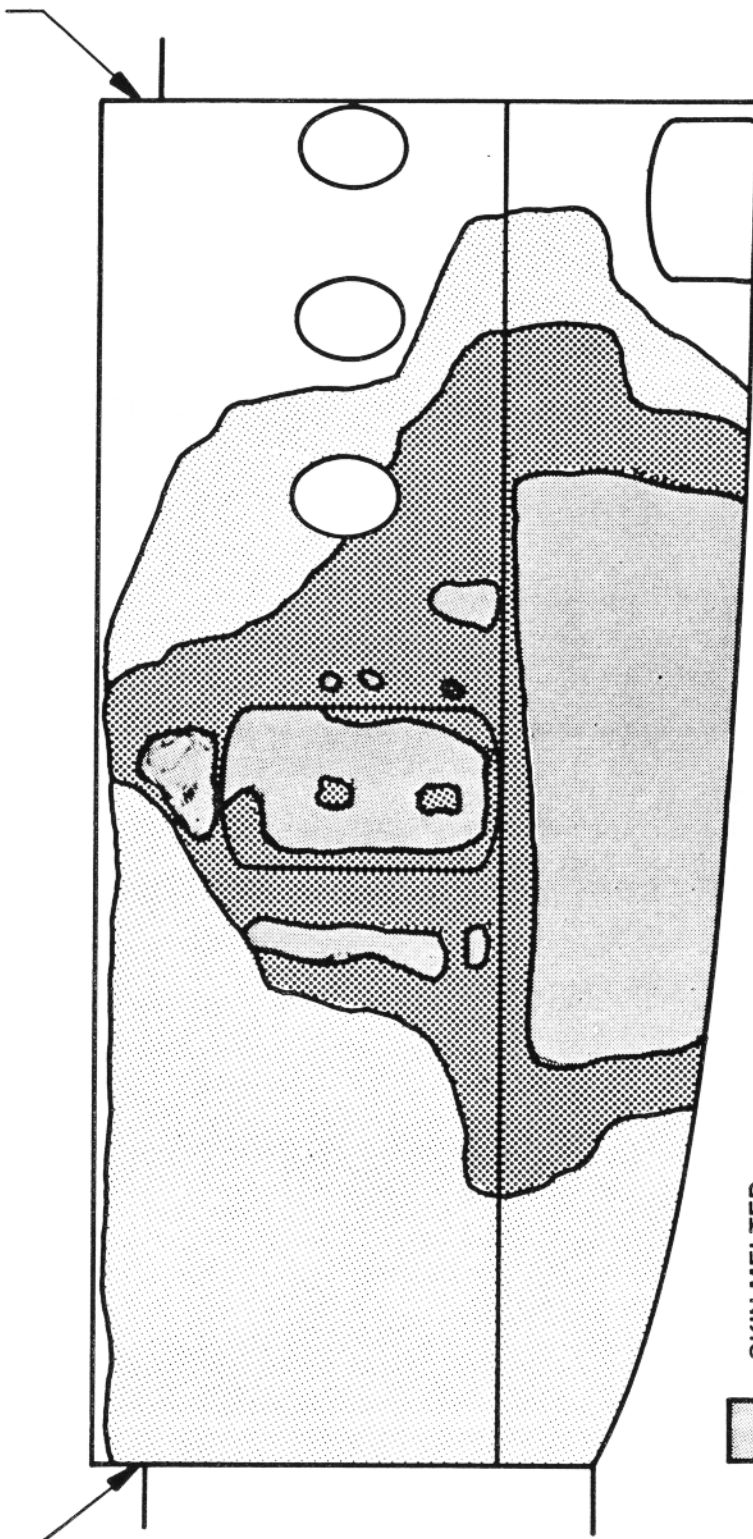
FIGURE B-1. EXTERIOR FIRE DAMAGE: AFT SECTION FUSELAGE STARBOARD SIDE

Skin Penetration. The aluminum skin melted away in an area below the floor centered about the aft service door (figure B-1). The damage extended approximately 6 feet forward and 5 feet aft of the door. The skin was buckled near the melted area, extending approximately 30 inches on all sides. The titanium doubler strips were undamaged. The skin above the door was melted in a triangular shape extending 12 inches on either side of the doorway and 30 inches above the door.

Fiberglass Insulation. The insulation exposed by the melted skin was charred but mostly intact. The insulation extended downward 30 inches from the floor level. The insulation had fallen away in the cheek area, approximately 3 feet forward of the aft service door, exposing the cargo compartment to the fire. The cargo liner was cracked and scorched in the area. Where the insulation remained in place, there was no fire damage to the interior of the aircraft.

Aft Service Door. The exterior skin of the door was completely burned away exposing the mechanism and interior panel to the fire. The door window exterior pressure pane was opaque and bulged toward the fire but remained intact. The interior fail-safe pane was clear and undamaged.

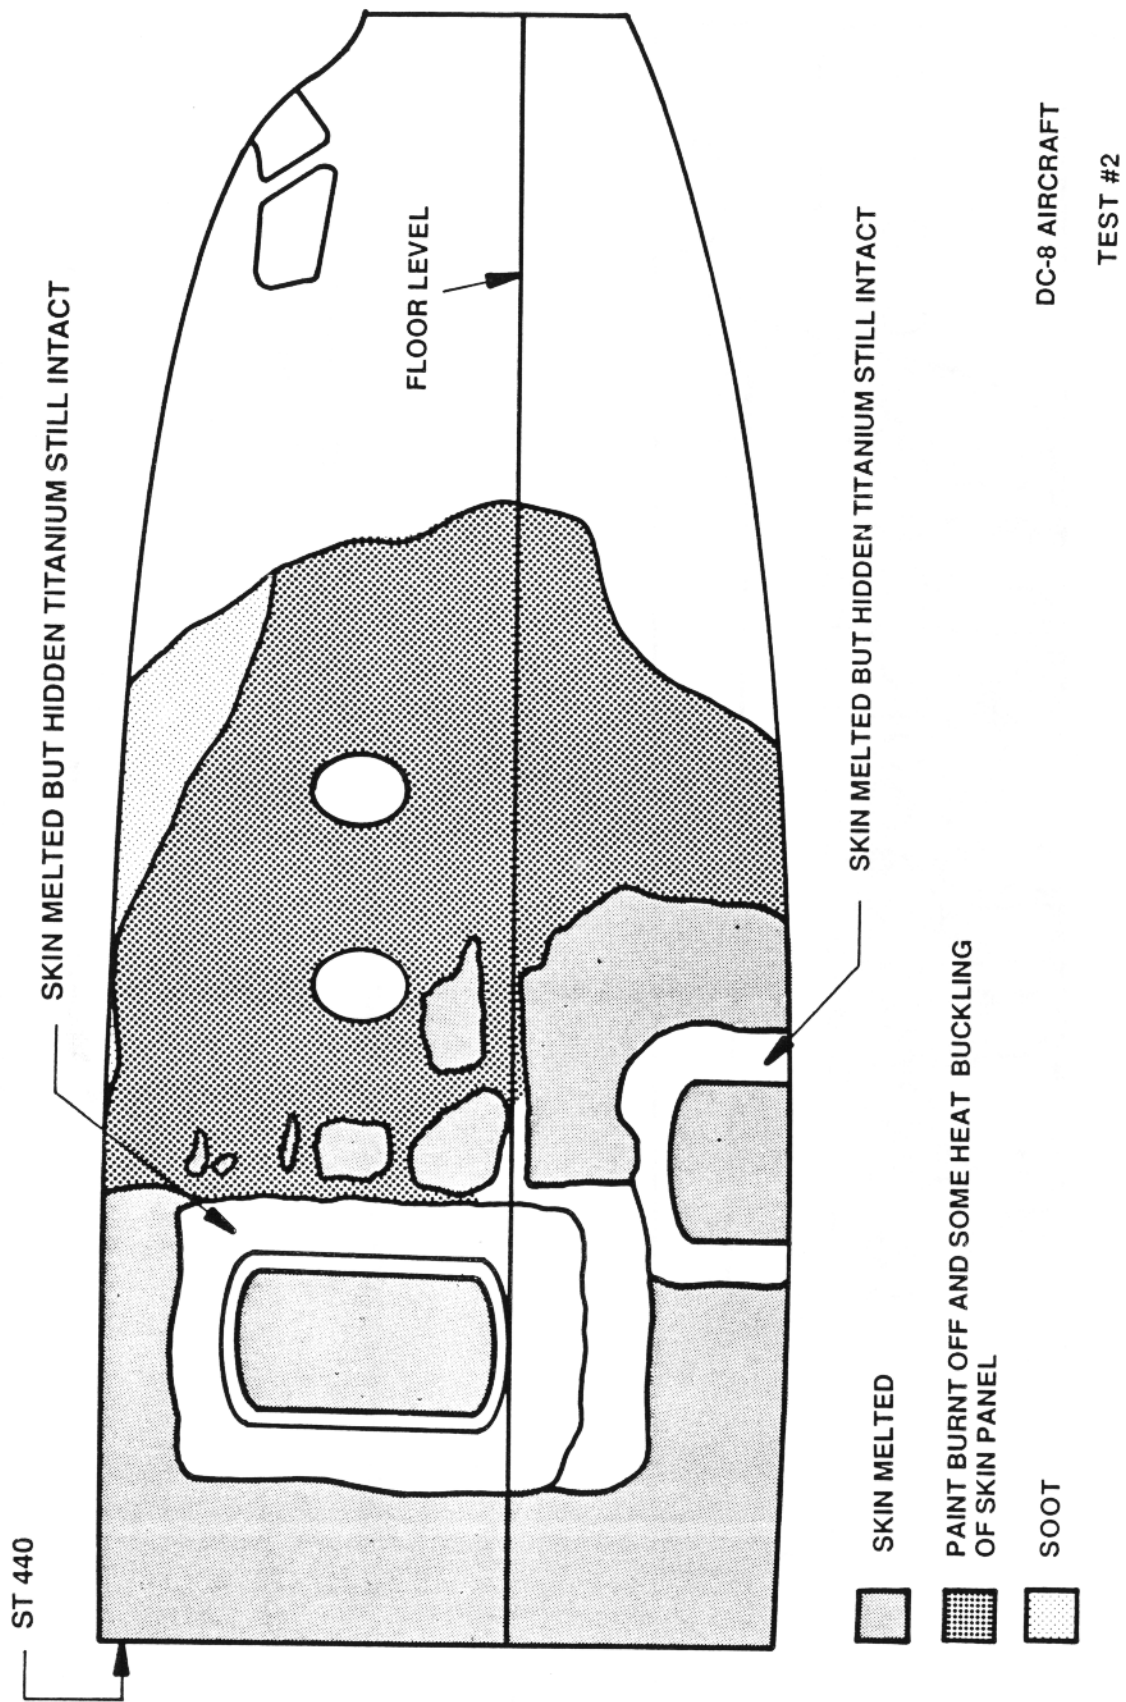
FIGURE B-2. EXTERIOR FIRE DAMAGE: FORWARD FUSELAGE STARBOARD SIDE

Skin Penetration. The aluminum skin was extensively destroyed from the fire barrier located at the compartment partition forward approximately 16 feet (figure B-2). The damage extended from ground level up to the center or the top of the aircraft. The skin on the service door was completely melted away. The

cargo door skin was also melted away. Nearly all of the skin below the floor level was melted. The two windows on the starboard side were checkered but were still in the frames.

Forward Service Door. The skin on the door was completely melted away. Both the door window pressure and fail-safe panes were gone from the frame and much of the frame was melted. The interior door panel was 80 percent destroyed leaving a hole approximately 2 by 4 feet to the outside.

Forward Cargo Door. The skin on the cargo door was completely melted away. The inner door panel was also completely destroyed allowing direct fire access to the cargo compartment.

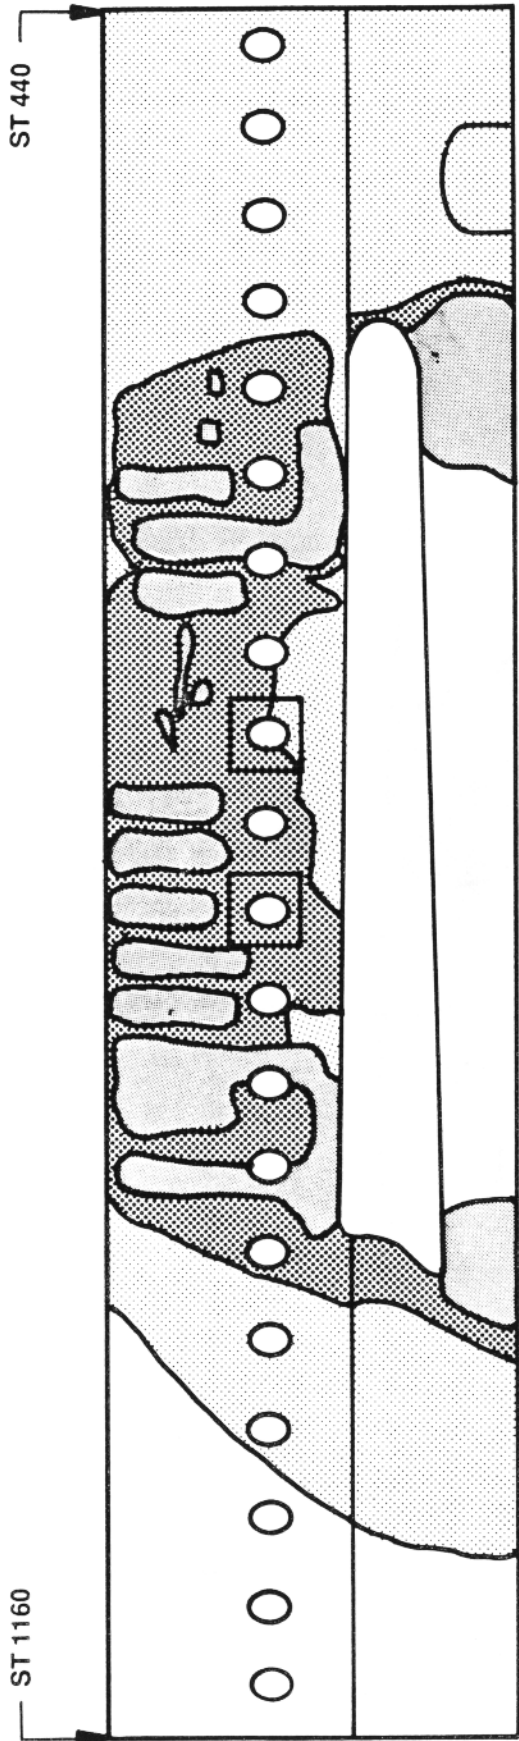
FIGURE B-3. EXTERIOR FIRE DAMAGE: CENTER SECTION FUSELAGE STARBOARD SIDE

Skin Penetration. The skin aft of the wing (enclosing the wheel well) was completely melted away up to the top of the well (figure B-3). There was a small hole above the wheel well, through the skin between the top of the wheel well and the cabin floor. Forward of the wing root, the skin in the cheek area was melted through exposing the cargo liner. The liner was heavily charred but not penetrated. The window located directly above the trailing edge of the wing was completely consumed, allowing flame penetration into the cabin. The other windows exhibited varying degrees of damage but did not allow penetration. The skin both forward and aft of the wing above the melted sections was wrinkled and perforated. Both overwing exits were operable after the test. There was a 2- by 2-foot section above the trailing edge of the wing into the overhead section of the aircraft where the skin completely melted away.

Wing. The trailing edge of the starboard wing was completely melted away up to the rear spar. The leading edge of the wing was burned through above the water level in the tank. The underside of the wing was blackened but undamaged. The top surface was relatively clean and undamaged. The water level in the tank was reduced to a few inches. The leading edge of the wing dropped down approximately 18 inches from its original position.

Overwing Escape Hatches. The outer window (pressure) panes on each hatch were destroyed. The inner (fail-safe) panes were heavily charred but still intact. The aluminum skin on the forward hatch was sooted and heat damaged but not melted. The skin on the aft hatch was 50 percent melted away.

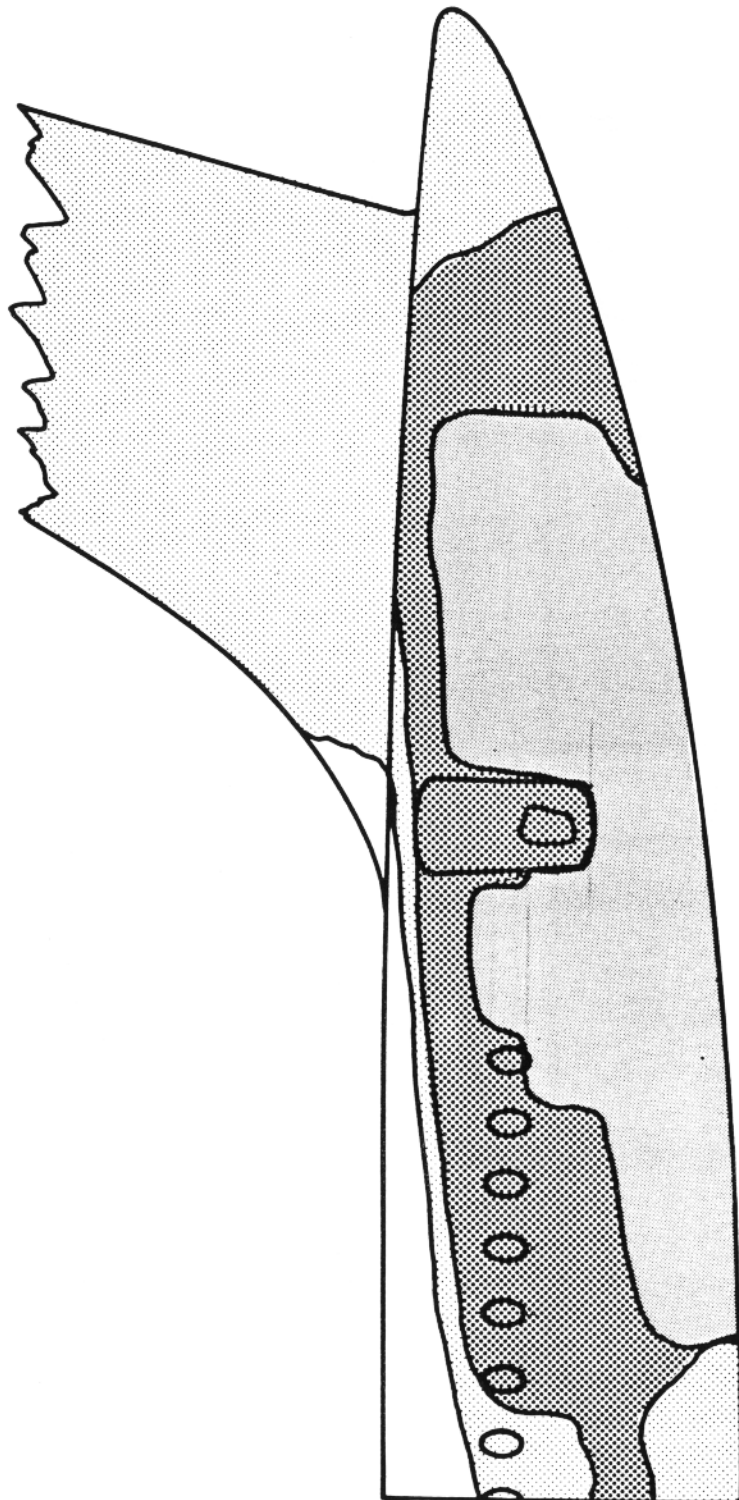
FIGURE B-4. EXTERIOR FIRE DAMAGE: AFT SECTION FUSELAGE PORT SIDE

Skin Penetration. The pool fire, though centered under the fuselage, damaged the port side significantly more than the starboard due to crosswind. The wind blew at 3 to 7 knots across the fuselage from the starboard side to the port side. The underside of the aircraft was completely destroyed from station 1040 aft to station 1350 (figures B-4 and B-5). The skin and frame members were completely gone. The skin on the port side was melted up to the window level from station 1163 to station 1350. The remainder of the skin was buckled and perforated. The starboard side sustained minor damage with some slight sooting of the paint.

Horizontal Stabilizer. The leading edge of the port stabilizer was burned off to the leading edge spar. The resistance heating elements for the deicer system hung from the stabilizer. The underside was sooted and scorched. The top side was heavily sooted but undamaged. The starboard stabilizer was clean and undamaged.

Windows. All but two of the windows on the port side were penetrated. The two remaining (station 1106-1125) had their pressure panes destroyed and the fail-safe panes charred. The windows on the starboard side were undamaged in the fire.

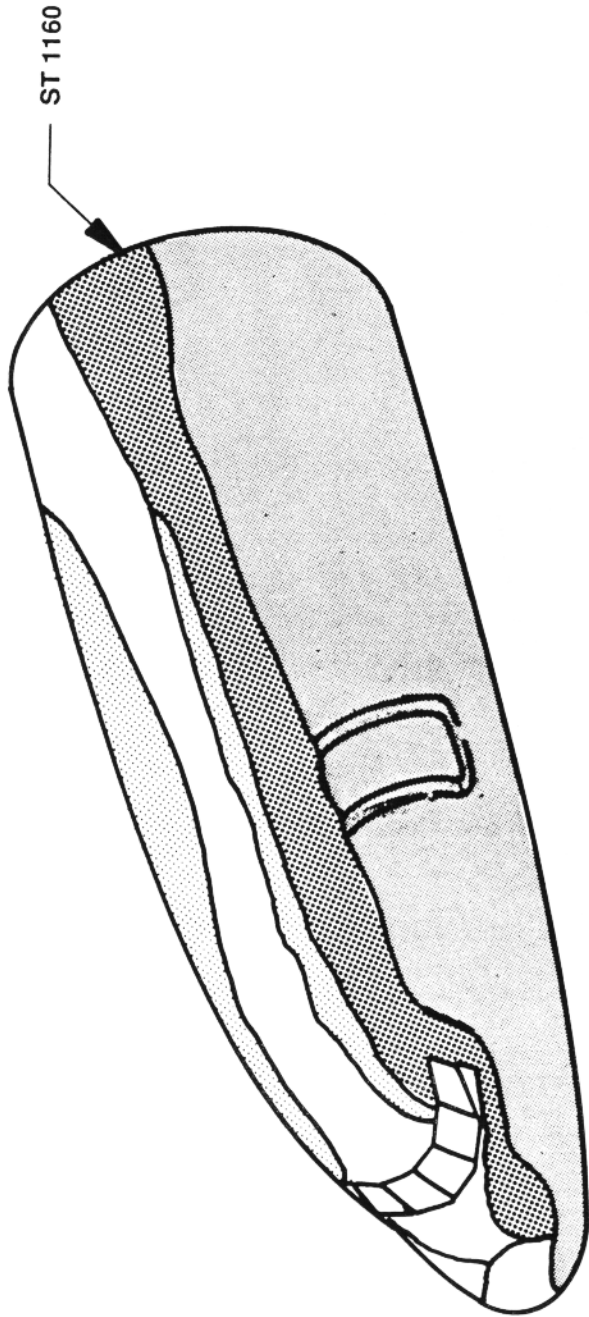
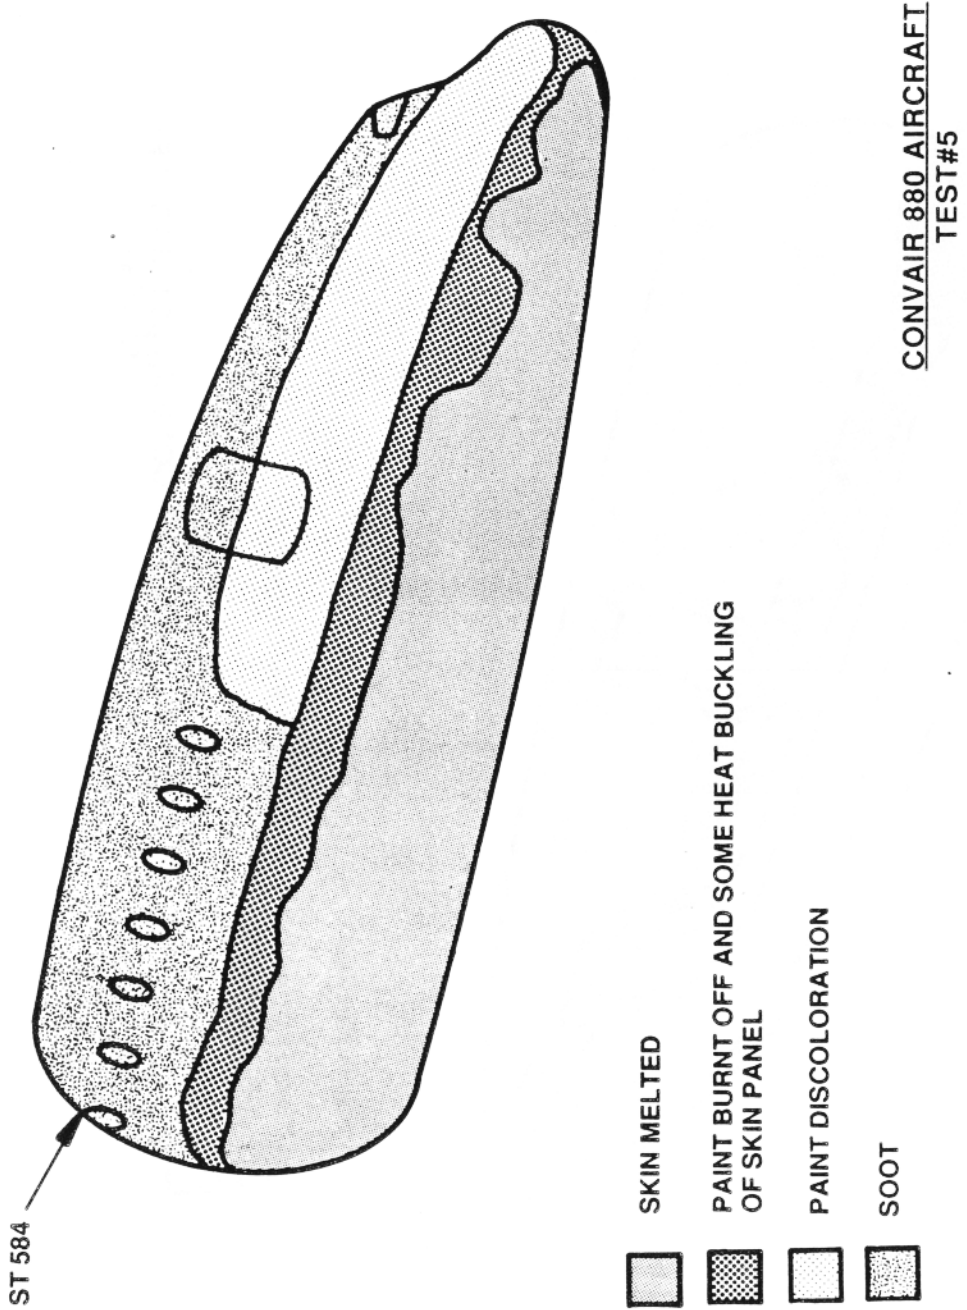
Skin Penetration. The nose section was severely damaged by the fire (figures B-6 and B-7). The port side was completely destroyed up to the centerline of the top of the fuselage. The cockpit windows were still intact; all other windows on the port side were gone. The entire underside of the aircraft was burned away. Nothing remained of the cargo compartment, the electronic bay, or the nose wheel well. The starboard side fared a little better. The belly of the aircraft was burned away up to the floor level. The remainder of the fuselage on the starboard side was sooted and heat damaged. The windows and the starboard service door were intact. The service door would not open after the test but the mechanism did operate. The structure was so badly damaged that the nose of the aircraft collapsed to the ground near the end of the test.

Windows. All the windows on the port side were consumed in the fire. The windows on the starboard side were sooted and heat damaged but were still intact.

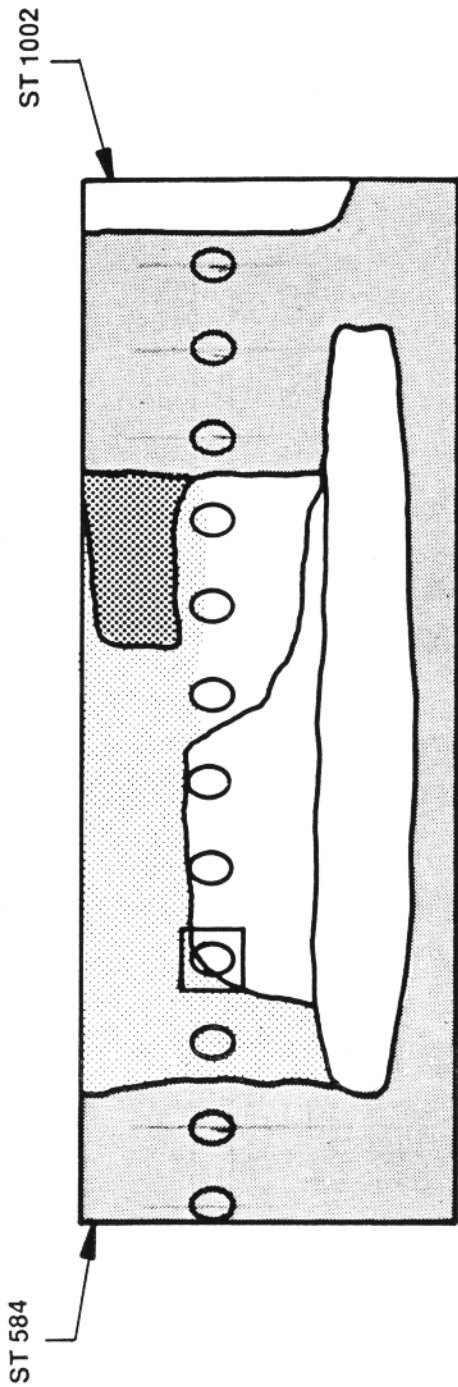
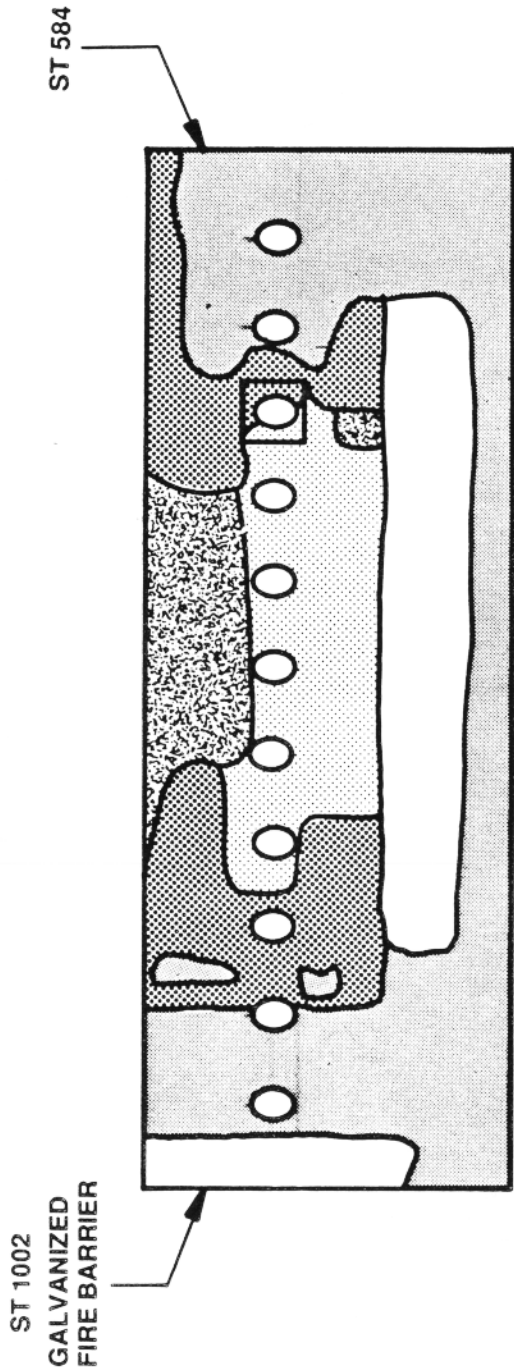
Skin Penetration. The port-side skin that was forward of the leading edge of the wing was completely burned away up to the top of the fuselage (figures B-8 and B-9). The windows in this area (station 584) were completely burned through. The windows over the wing were charred but not penetrated. The skin aft of the wing was also burned away with damage extending forward to station 584. The exposed ribs at the aft end were buckled. The windows aft of the wing had the outer pressure pane completely burned away, but the inner fail safe pane was not penetrated. The insulation exposed by the melted skin on the fire side was charred but intact. The skin on the belly of the aircraft was heavily charred and buckled but not penetrated except forward and aft of the wing. The starboard side sustained damage similar to the port side. The skin aft of the wing was completely melted away exposing the insulation. The windows aft of the wing were burned through to the interior. The section forward of the wing also had the skin completely melted. The windows in this section had the pressure panes burned away with the fail-safe panes charred but not penetrated. The insulation in all cases was heavily charred but intact.

Wings. The leading and trailing edges of the wings were heavily damaged by the fire. In each case the skin was melted away up to the wing spars. The upper surface of the wings were clean and undamaged. The lower surface was heavily charred and sooted but not penetrated except in the wheel well area. Here, the fire penetrated up into the landing gear mounting points where the structure was completely burned away. When the fuselage collapsed to the ground, the gear assembly punched through the top of the wing. It should be noted that the wing fuel tanks were filled with water to lessen the possibility of explosion. This provided a heat sink effect that protected the wings in the tank areas.

Overwing Escape Hatches. The overwing escape hatch on the starboard side was relatively undamaged. The paint was burned off and the window pane was charred. The hatch would not operate after the test. The hatch on the port side of the aircraft was also undamaged. The surface was soot covered and the window was charred. This hatch also would not open after the test. It should be noted that the hatches on the Convair 880 are located near the leading edge of the wing so they were very close to the severe fire damage that occurred in the leading edge area.
