**EFFECTIVENESS OF FLIGHT ATTENDANTS ATTEMPTING
TO EXTINGUISH FIRES IN AN ACCESSIBLE CARGO COMPARTMENT.**

David Blake
Fire Safety Section
Federal Aviation Administration
William J. Hughes Technical Center
Atlantic City Airport, NJ 08405

International Aircraft Fire and Cabin Safety Research Conference
November 16-20, 1998
Atlantic City, NJ

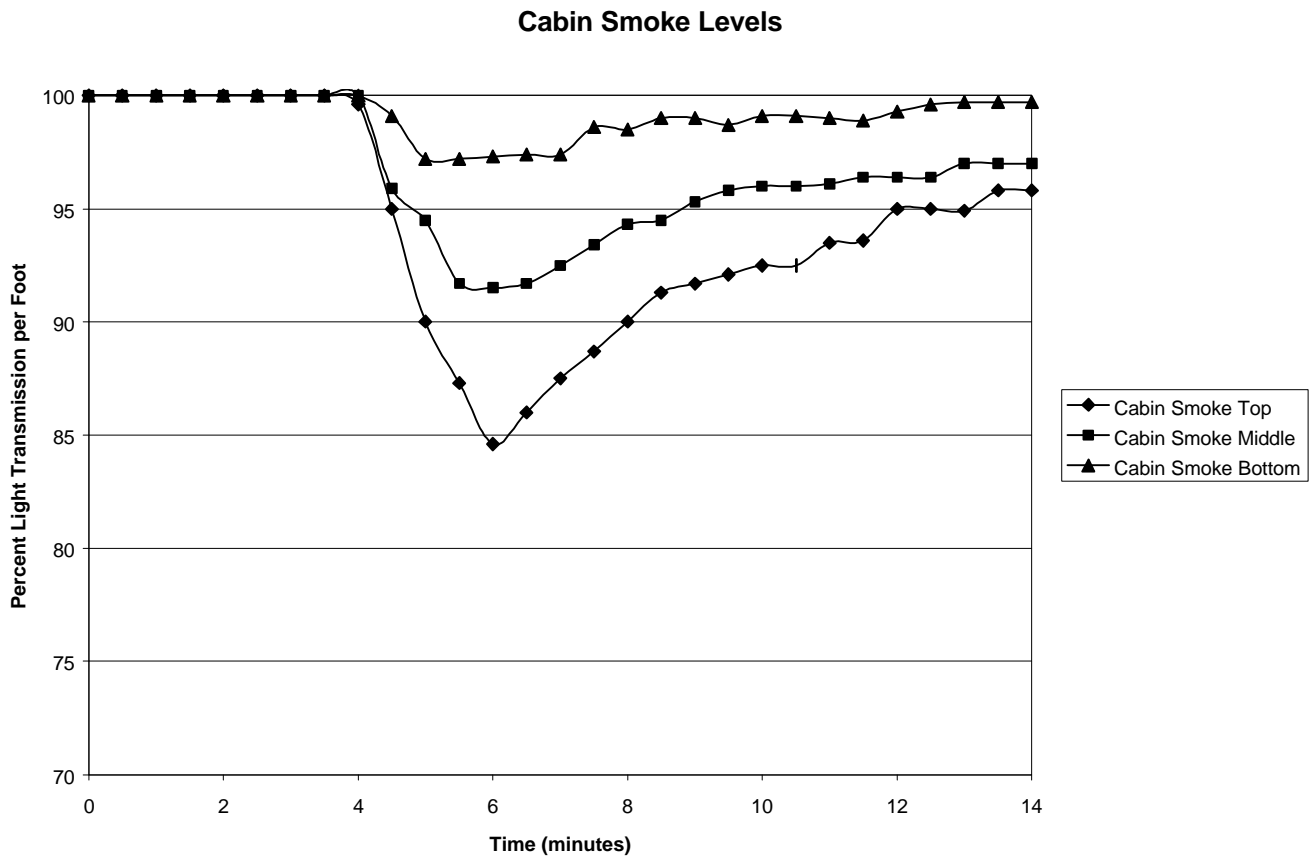
Figure 2.

In all of the tests, including those that were extinguished, smoke, carbon dioxide and carbon monoxide accumulated in the normally occupied cabin area of the test article. The smoke and gases produced by the cargo fire were buoyant and hot enough to overcome the slight positive pressure in the cabin caused by the ventilation system. Figure 2 shows the smoke obscuration levels in the cabin at three heights during a typical test.
