Hidden Fires – Contaminated Thermal Acoustic Insulation

Some Relevant In-service Occurrences

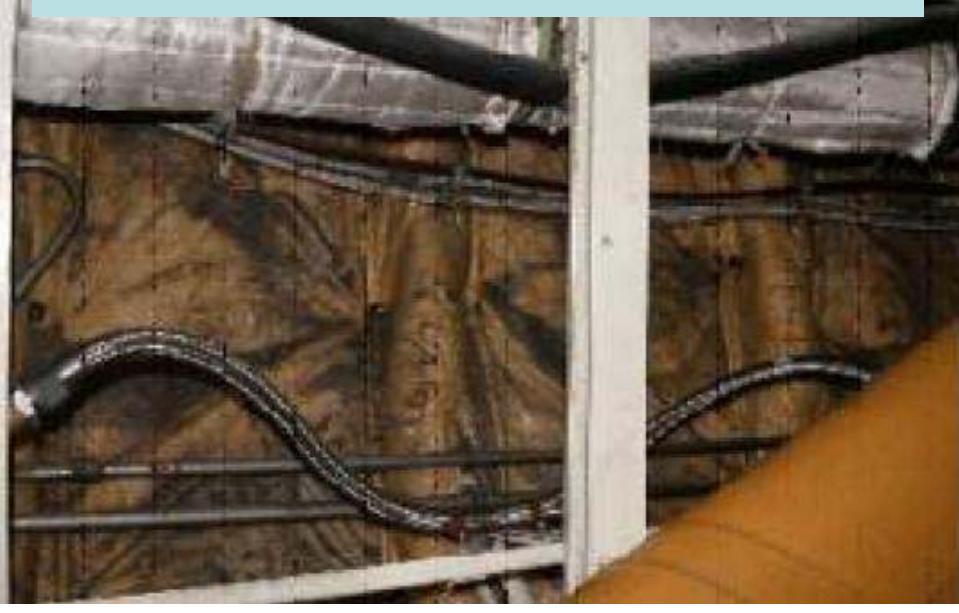
Boeing 767-300 May 2002

DUST AND LINT ACCUMULATION - INSULATION

The Master Warning Fire/Overheat light illuminated, the fire warning bell sounded, and the Aft Cargo Fire light illuminated.

The flight crew followed the procedures for a cargo fire and activated the cargo fire extinguishing system. An emergency was declared.

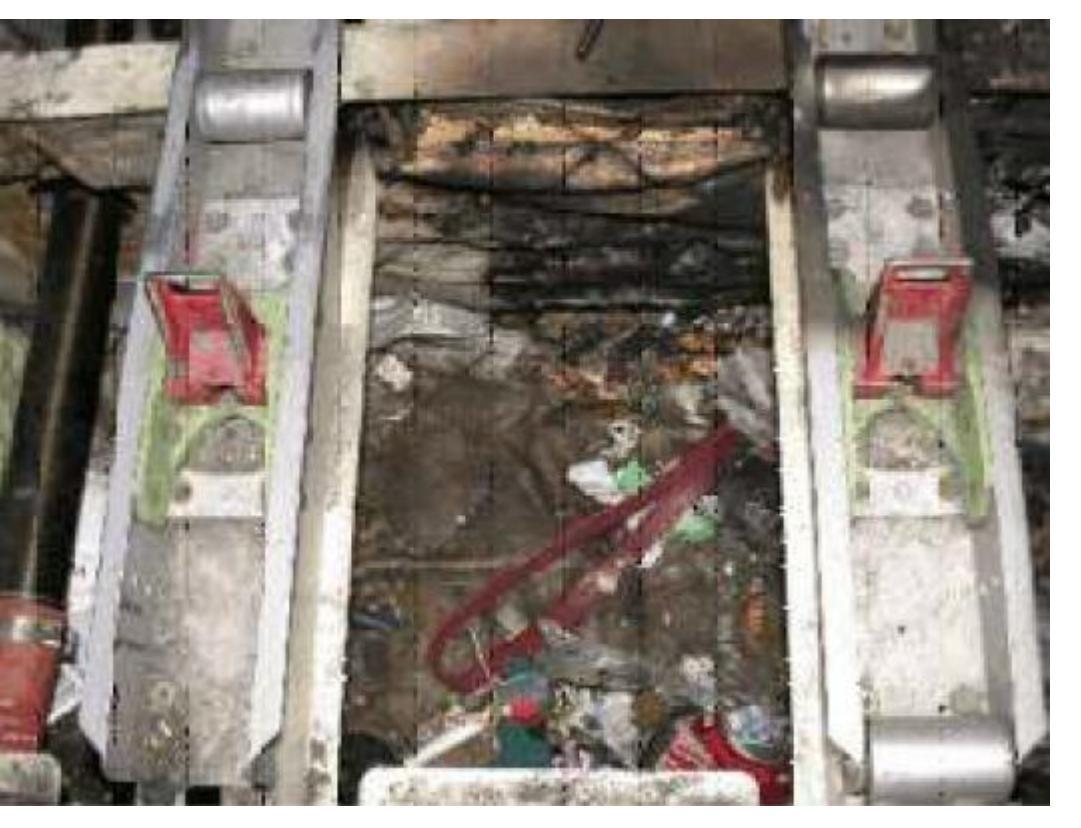
Boeing 767-300 May 2002

The polyethylene terephthalate (PET) covering material of the thermal acoustic insulation was contaminated. The contaminated material provided an ignitable source of fuel for a self-sustaining fire.

The contamination consisted of soiled insulation blankets and of flammable debris in the form of paper, candy wrappers, Styrofoam packing peanuts, small polyethylene beads, and rubber powder from a **Power Drive Unit.**

CONTAMINATED INSULATION BLANKETS

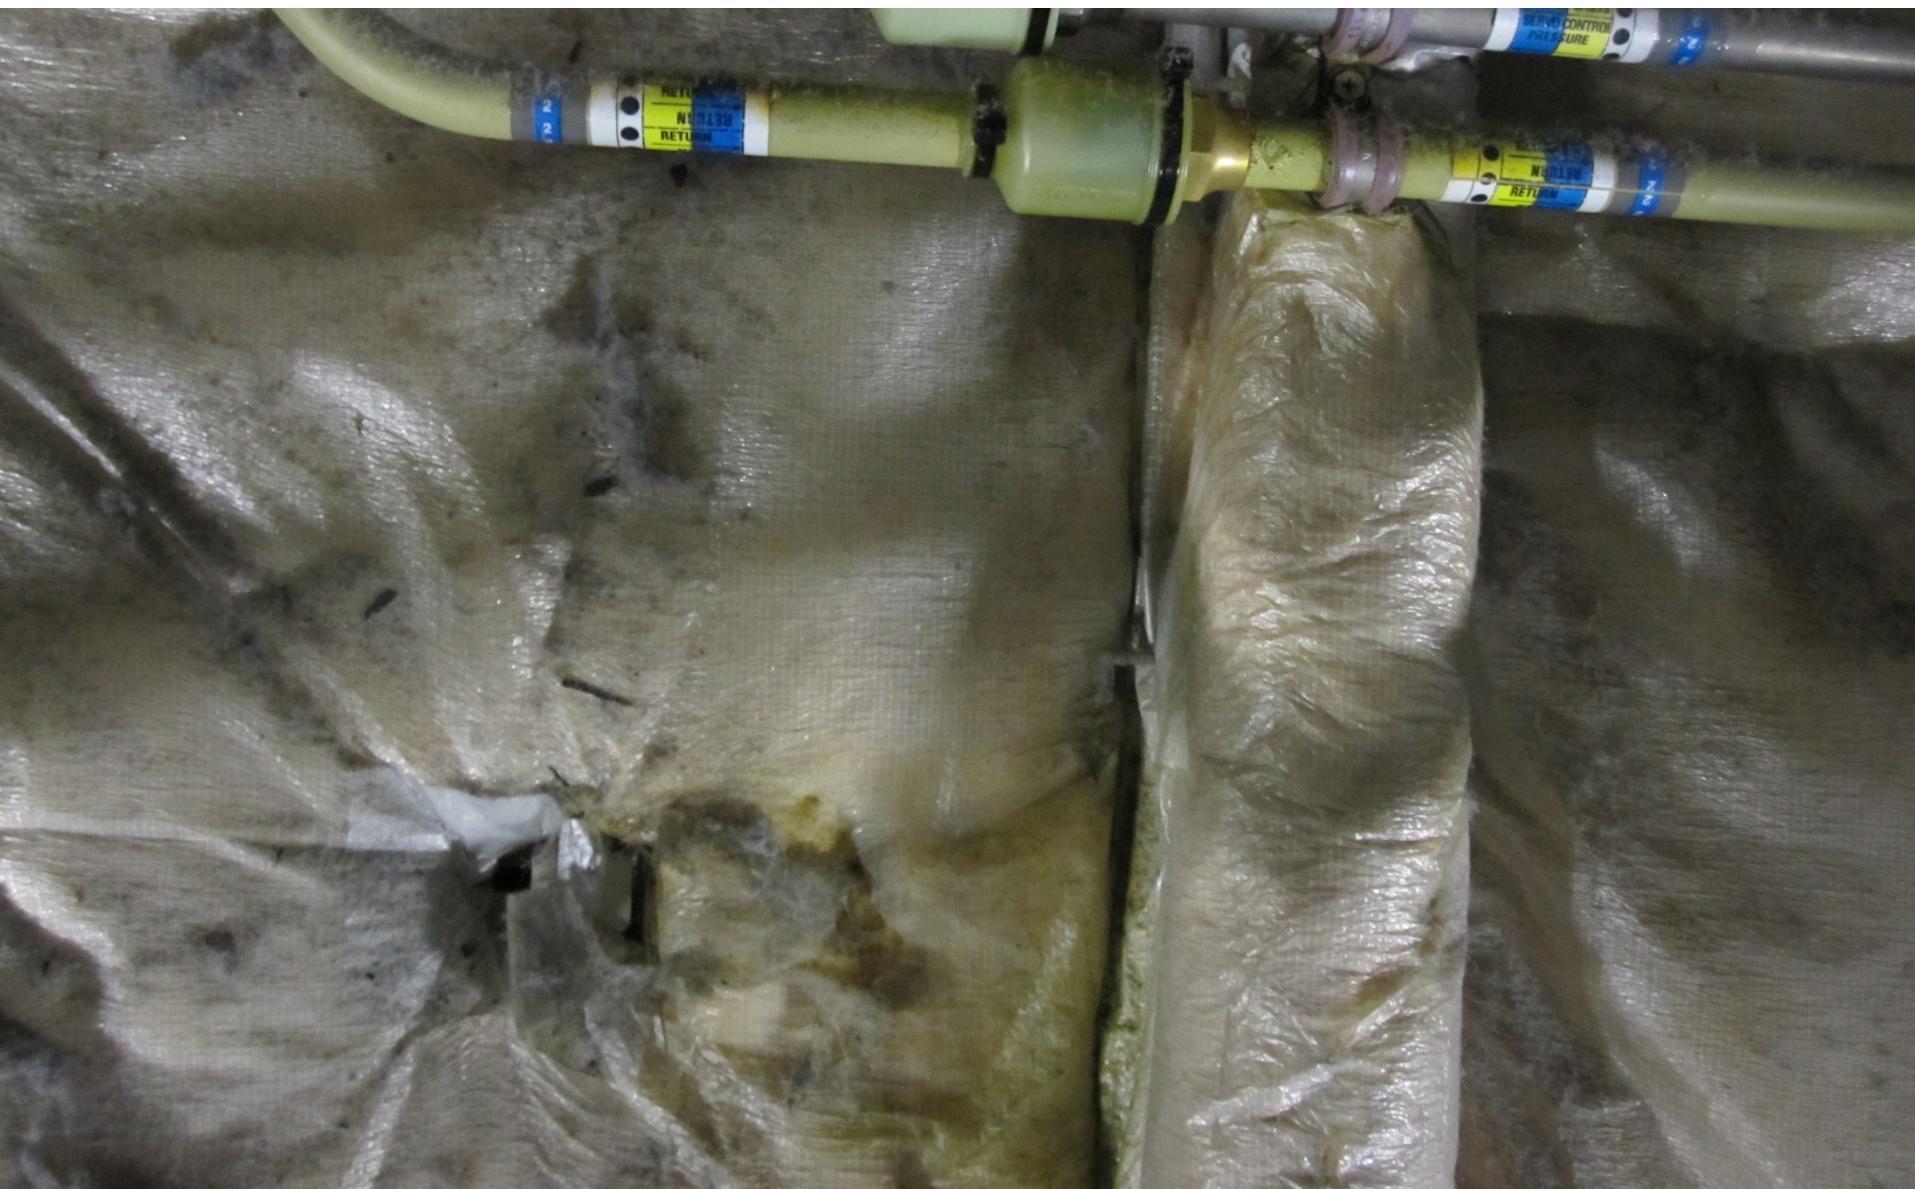
In Service Aircraft Contaminated with Hydraulic Oil

• Further consideration is given to Aircraft Maintenance Manual recommendations regarding the in-service repair and replacement of TAI materials.

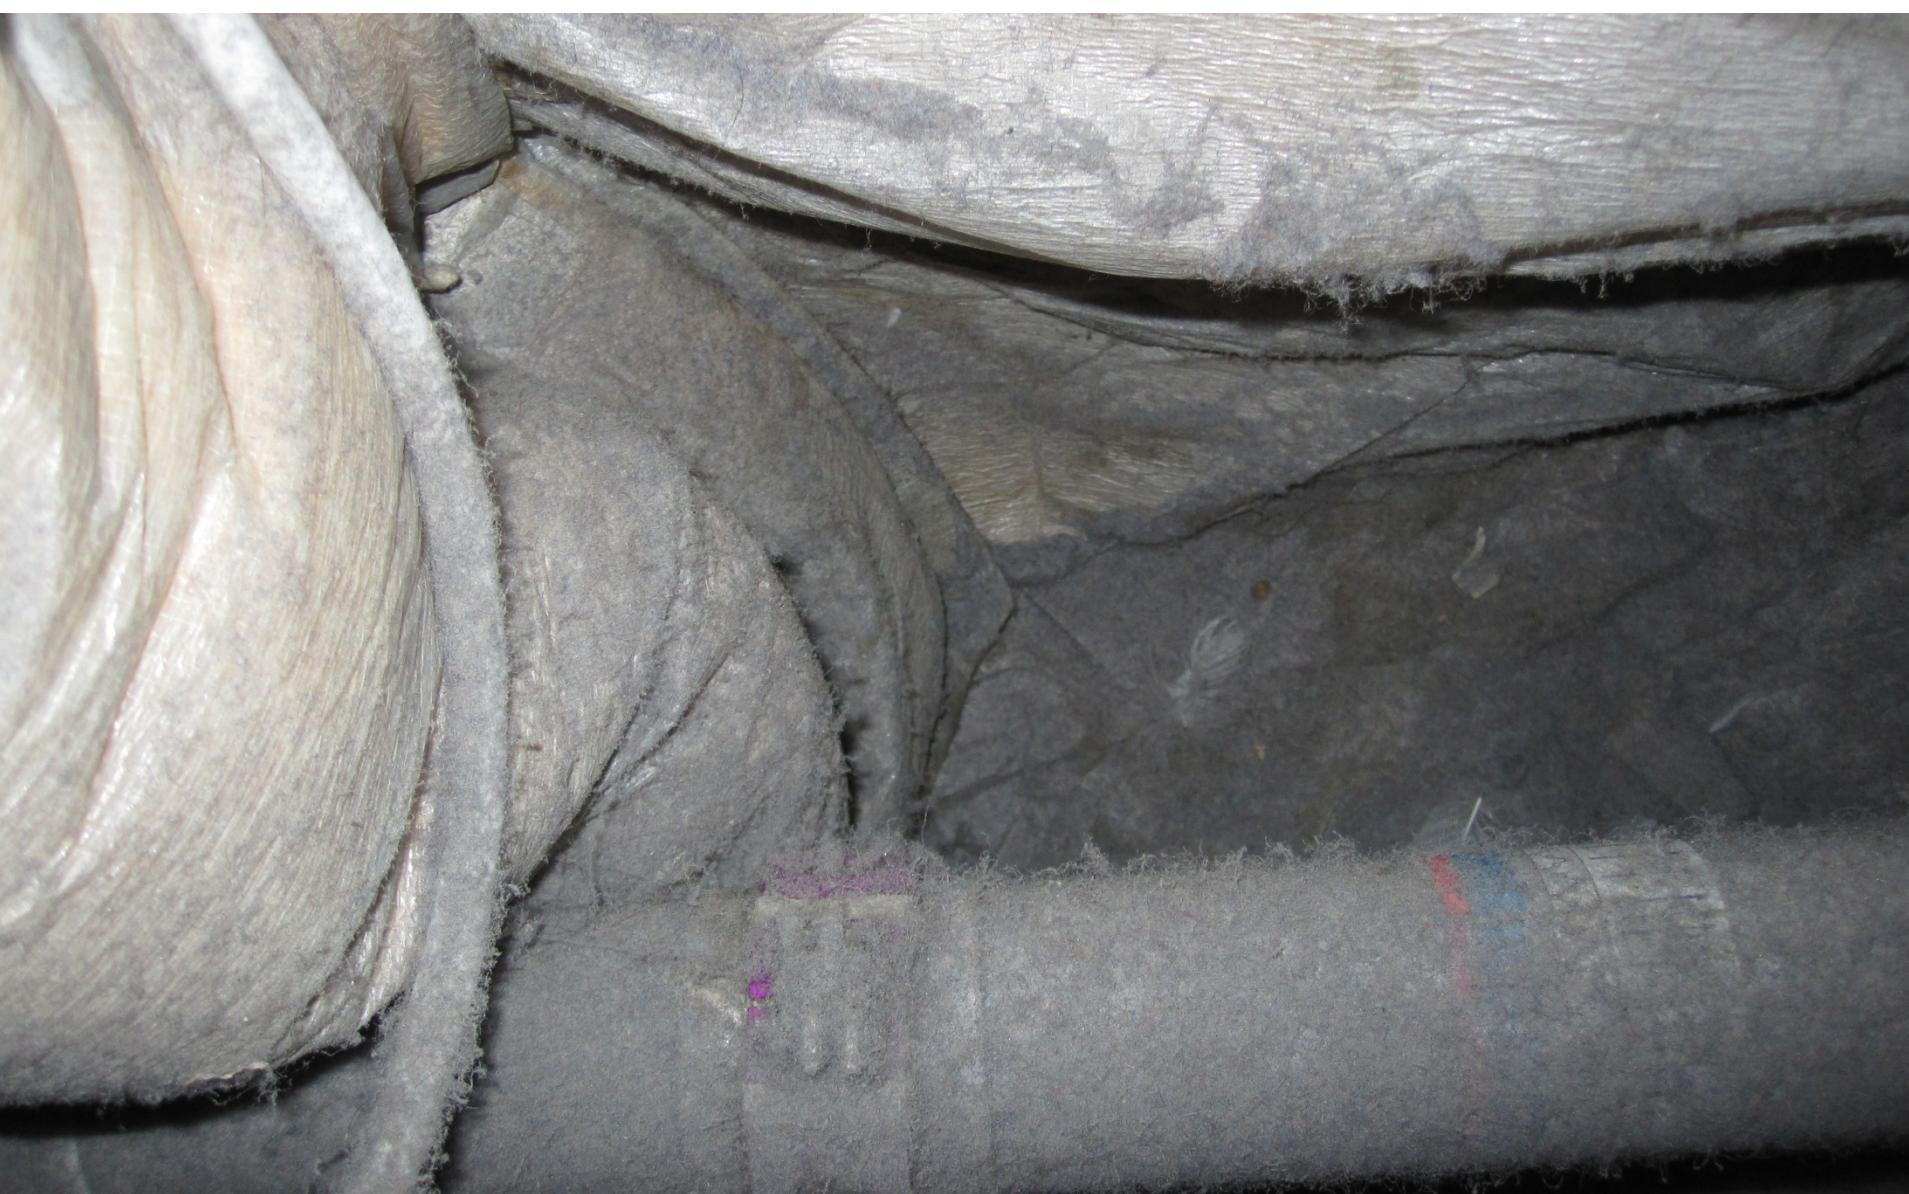
In Service Aircraft Contaminated with Dust & Lint

- It is recommended that:
- Further consideration is given to the rate of accumulation of Dust/Lint on in-service aircraft in order to ascertain whether the frequency of cleaning currently proposed will adequately mitigate the in-flight fire threat.

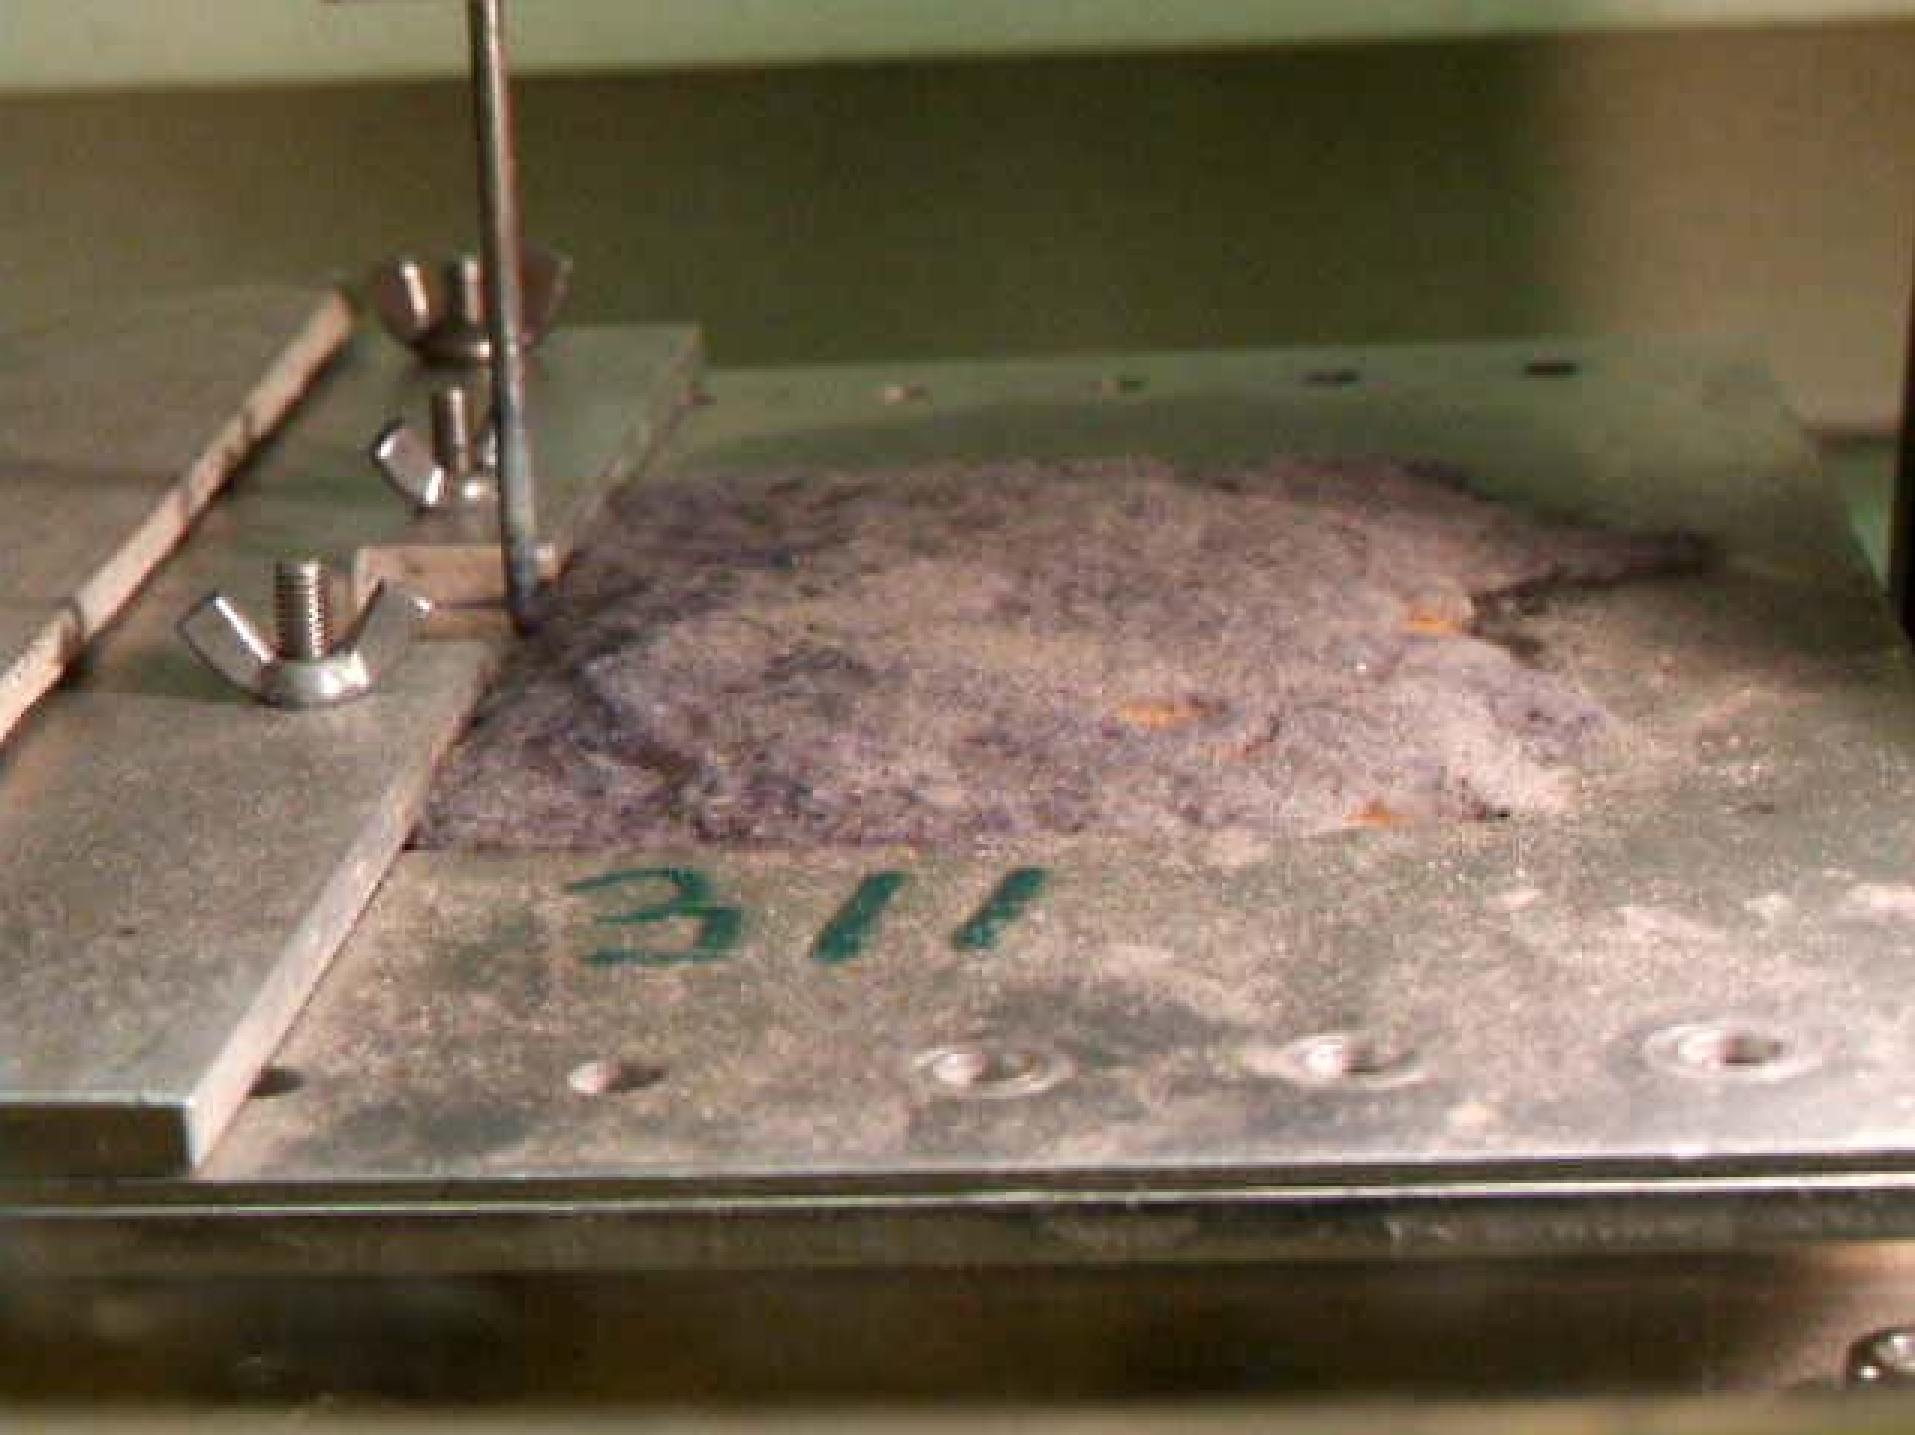
Dust & Lint –

from an in-service Aeroplane undergoing Maintenance
