# Fire-Extinguishing Studies of the Northrop F-89 Powerplant

By  
Allen V. Young  
Aircraft Division

**TECHNICAL DEVELOPMENT REPORT NO. 365**

**CIVIL AERONAUTICS ADMINISTRATION  
TECHNICAL DEVELOPMENT CENTER  
INDIANAPOLIS, INDIANA**

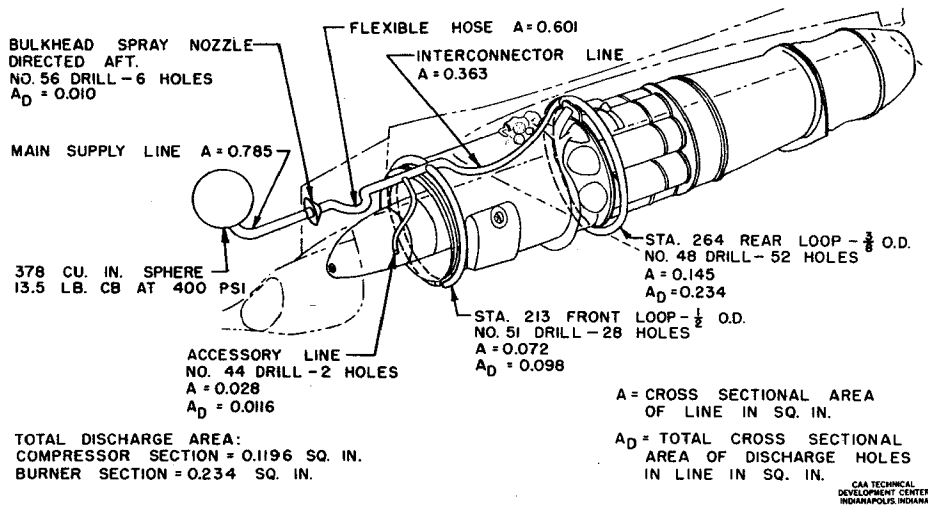
Fig. 2 F-89 Powerplant Fire Extinguishing System

After the completion of these eight tests, several facts were apparent. First, the fire was extinguished rapidly in the burner section but flashed back in the compressor section during four of the tests, due presumably to a lingering pocket of fire in that section which reignited the fuel still being injected into the bay. Second, a considerable quantity of CB poured from the bottom of the compressor section onto the test cell floor following each discharge, indicating improper utilization of agent.

The percentage of fires extinguished was reduced, none being extinguished in the compressor section and only 55 per cent in the burner section. This indicated that the system was relatively ineffective.

Upon examination of the production perforated tubing discharge system after a number of fire tests, several deficiencies were noted. Several of the discharge holes were covered in the installation by mounting clamps used to hold the tubing in position on the engine. Metal shavings and burrs inside the discharge holes as a result of the drilling operation were forced back into the holes after discharge of the agent, resulting in restrictions of many of the holes. Repeated discharge of the bromochloromethane resulted in corrosion of some of the holes, thereby sealing them so that the agent could not pass through.

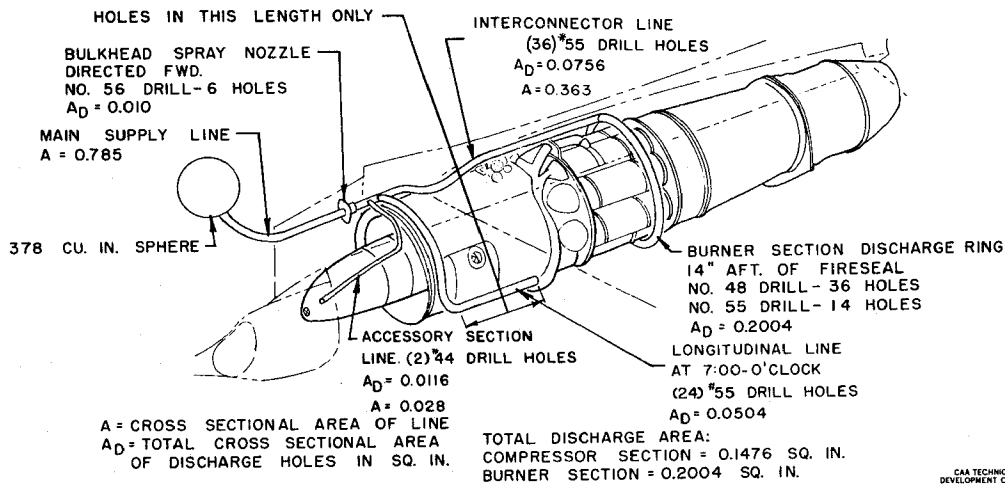
Fig. 4 Modified Perforated Tubing Distribution System

In the series of tests involving the third modification, neither the standard charge of CB nor a 19.0-pound charge of CB in a 536-cubic-inch sphere gave complete extinguishment of all test fires. A standard charge pressurized to 600 psi did not extinguish the fire in the compressor section even though this higher pressure produced a tremendous mixing effect and the discharge could be heard above the engine roar. Flashback occurred in five instances, four during normal cruise conditions and one during taxi power.

1. In the burner section all of the holes discharging agent outward toward the engine bay doors and keel were sealed. Smaller holes were drilled at these locations directing the agent aft, thus reducing the total discharge area in the burner section by 0.043 square inch.
2. The discharge ring in the burner section was relocated 14 inches aft of the firewall separating the compressor and burner sections.
3. Additional holes were drilled in the interconnector line in the compressor section.
4. An additional longitudinal distribution line was added at the 7 o'clock position in the compressor section.
5. The forward bulkhead spray nozzle was moved from the forward bulkhead and relocated at the tee-fitting of the interconnector line and directed forward.

These latest changes are illustrated in Fig. 4. The fuel to the test fire was released at a rate of 0.475 gpm. In this series of tests, quantity, type, and pressurization of agent were varied to obtain a direct comparison of these factors, but the fill ratio was maintained at 50 per cent. The test procedure included engine shutdown prior to discharge of the agent. The results of the series of test fires conducted with this configuration are given in Table X. Pressurization was 400 psi in all tests except those noted in the table.

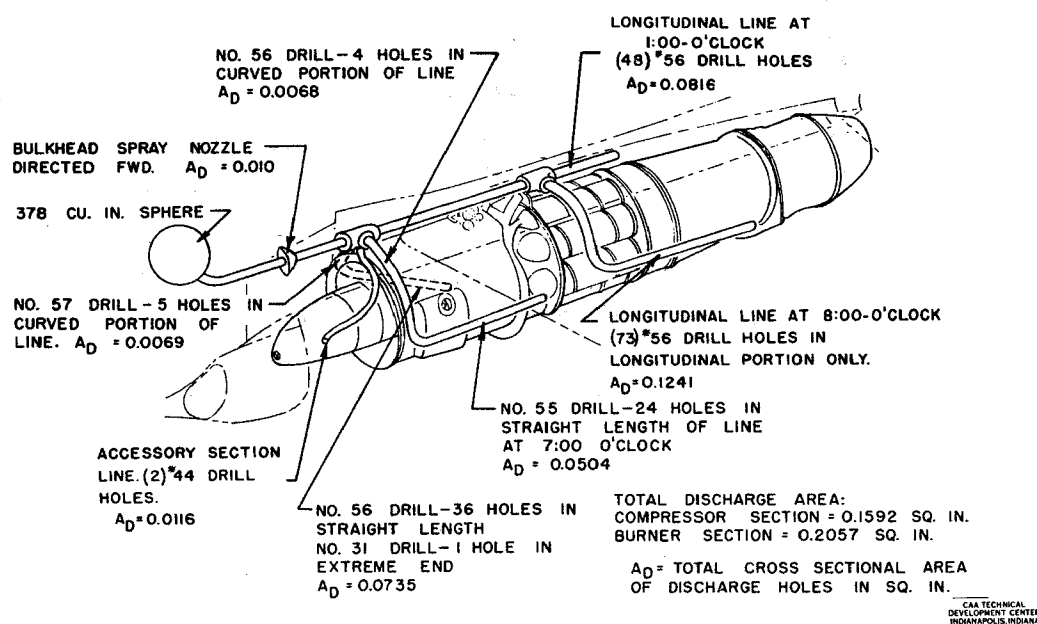
Fig. 5 Final Configuration of Perforated Tubing Distribution System

In the last series of fire tests, as indicated in Table XIV, the fuel to the fire was increased to 3.73 gpm in six of the tests. With this quantity of fuel, an extremely severe fire existed in the engine bay and, upon the discharge of 13.5 pounds of CB, continued to burn with practically no abatement. For fires of this magnitude, on which 16.2 pounds of DB was used, however, extinguishment was instantaneous and there was no reignition even though raw fuel continued to be released into the engine bay. Three flashbacks occurred in the compressor section and one in the burner section during the fire tests in which CB was used.

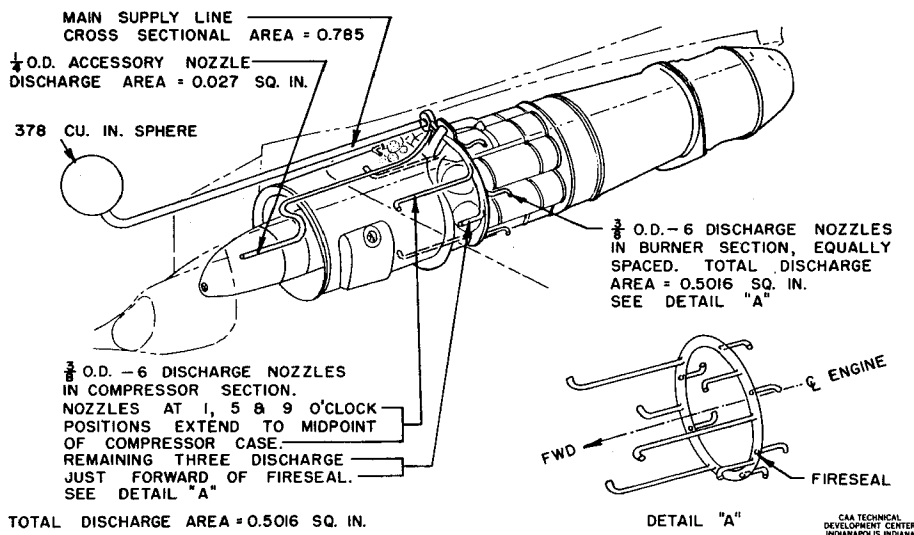
Fig. 7 Final HRD System

This was the final HRD system evaluated and its design is illustrated in Fig. 7. After it was determined that 16.2 pounds of DB would extinguish a maximum fire in the engine bay, the amount of agent was decreased to determine the minimum quantity required for extinguishment. Extinguishment was accomplished with quantities of DB as low as 13.0 pounds, or a 40-per-cent fill ratio. However, there was no excess agent to cool the hot surfaces and the danger of reignition was great. The one test using 11.1 pounds of BT was not conclusive because it

extinguished the fire in the burner section but not in the compressor section, It was intended to investigate the capabilities of this agent further but at this point the doors on the engine bay of the test article had been burned away to the point where a tight seal could be maintained no longer. Therefore, the fire tests on the F-89 test article were concluded.

The 1/4-inch o. d. lines in the compressor section were replaced by 3/8-inch o. d. lines in the same position as the second HRD configuration. This more than doubled the discharge area in the compressor section. In the tests evaluating the HRD system, modification no. 2, the engine power remained at cruise setting for all runs. Both DB and BT were used in various fill ratios in a 378-cubic-inch sphere. Container pressurization was 400 psi. JP-4 fuel was introduced into each engine bay from multiple sources to obtain maximum dispersion, but for the purposes of these tests, it still was considered as being one fire in each section. Table XVII gives the test conditions and results for this configuration.
