Evaluation of Means Adopted To Provide Fire Protection in B-36 Aircraft Powerplants

By
Lyle E. Tarbell
Aircraft Division

TECHNICAL DEVELOPMENT REPORT NO. 366

December 1958

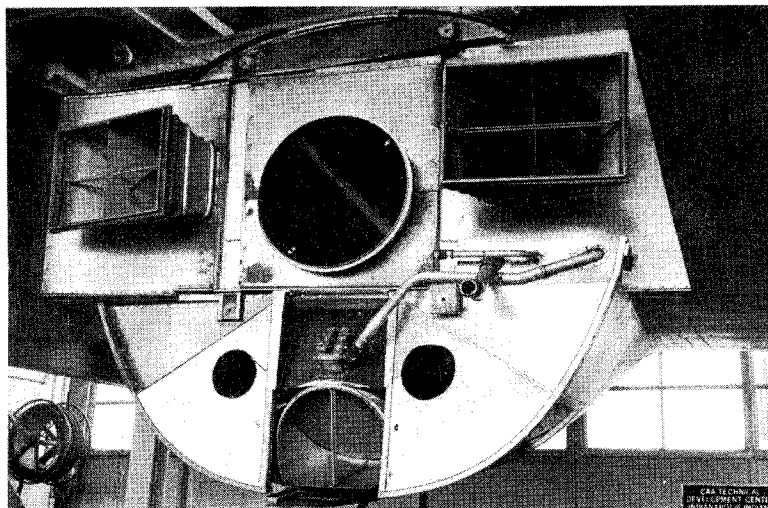
Fig. 3 View of Sheet Metal Fire Curtain Installed at Cleavage Plane

Before any tests were conducted, it was decided in conference with the Department of the Air Force, that all B-36 nacelles would have a new fire barrier installed. This barrier was called a "fire curtain," rather than a firewall, because it was to be fabricated of a flexible material rather than of sheet metal. However, at the time that the work was done, a suitable flexible material had not been found.² Therefore, the fire curtain in the test nacelle was constructed of sheet steel. Figures 2 and 3 show how this was done. The openings into the

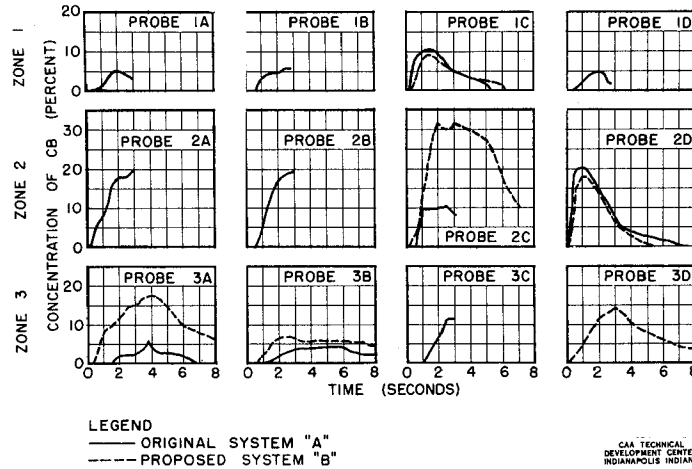
Fig. 8 COB Concentrations Produced by the Original System A and by the Proposed Fire-Extinguishing System B

In Zone 1, the concentrations were relatively low at all points and insufficient to produce extinguishment of fire. In Zone 2, concentrations were appreciably higher than in Zone 1 although at probe location 2C insufficient agent vapor was indicated. However, this probe was located inside the shroud on the downstream side of the heat exchanger and the reading did not portray conditions within the zone proper. In Zone 3, some concentration of agent was recorded. This resulted from leakage of agent from Zone 2 as no agent was released directly into Zone 3.

The single measurement made in Zone 1 indicated that concentrations produced in this zone were approximately the same as those produced by the original system and were not sufficient to extinguish fires. The single measurement made in Zone 2 at probe location 2D indicated that concentration of agent in Zone 2 provided by System B was sufficient to extinguish fires in this zone. The agent provided inside the shroud downstream of the heat exchanger, as indicated by probe 2C, was ample for extinguishment and considerably higher than was produced by the original System A. Measurements made in Zone 3 indicated that System B provided concentrations at locations 3A and 3D sufficient to extinguish fires. However, the concentration at location 3B was inadequate. No agent was provided in the oil cooler by System B and therefore, no concentration was recorded by probe 3C. In summation, the results of the concentration measurements indicated that System B provided inadequate protection.

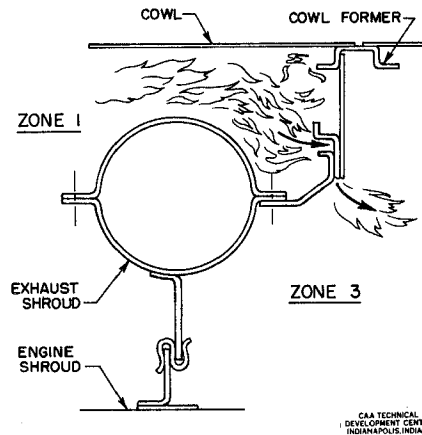
Fig. 25 Cross Section Taken at the Firewall to Show Where Zone 1 Fires Penetrate into Zone 3

According to a study made in 1949, a large percentage of fire incidents occurring in operating B-36 aircraft was the result of exhaust-system failures in Zone 1. The extinguishing system was not designed to combat such fires. In lieu of this type of protection, the firewall between Zone 1 and the adjoining zones was improved and strengthened. During the fire-testing program, the effect of the revamping was observed. For the most part, the improved firewall was an effective barrier. However, one area was discovered where unburned fuel and flame could penetrate the lap joint between Zone 1 and Zone 3. This occurred in the manner illustrated in Fig. 25. The joint was fairly tight and normally would not permit the passage of flames. During a fire, however, sufficient warpage occurred to permit appreciable leakage. Fire did not enter Zone 2 in a similar manner through the fire seal in the lower portion of Zone 1. The quantity of agent discharged inside the main duct for use against Zone 1 fires was equal approximately to that discharged into Zone 2 but the concentrations measured in Zone 1 were comparatively low because of the high airflow through the main duct. Fires were more difficult to ignite in this airstream but they could be ignited, as was demonstrated by two tests using a 2-gpm flow of gasoline. These fires were extinguished by the system using CB as the agent. Oil fires originating at the engine might be more difficult to extinguish because oil clings to the engine surfaces; and oil fires outside the confines of the engine in Zone 1 probably would escape extinguishment because of the low agent concentration in the space surrounding the engine. Protection for the airplane then would depend on the integrity of the firewalls and fire curtains, plus curtailment of flammable fluid flow and elimination of the ignition sources by engine shutdown.

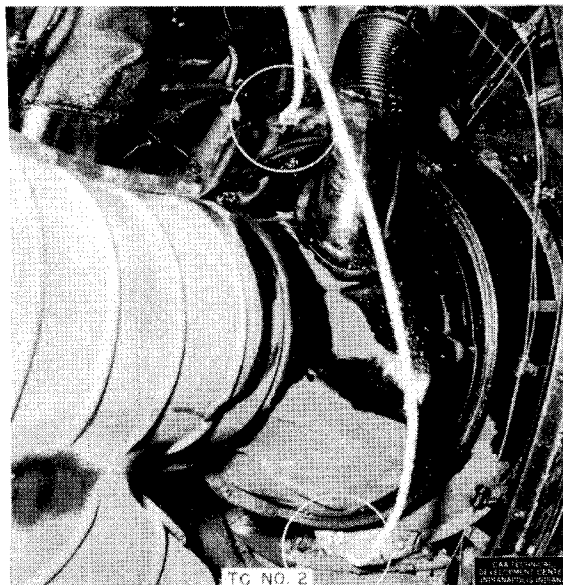
Fig. 26 Unshrouded Portions of the Exhaust Stacks

Four unshrouded areas on the exhaust stacks near the turbosuperchargers were found to be at temperatures in excess of 800° F. during normal operation. Two of these spots near the right-hand turbosupercharger are circled in Fig. 26; the others were in comparable positions near the left-hand turbosupercharger. The lower circled area was the hottest of the four, and was given further study. A thermocouple was placed on the forward side of this stack and designated as thermocouple No. 1. The thermocouple shown in the lower circled area was designated thermocouple No. 2. Time-temperature relationships following engine shutdown for two operating conditions were determined by use of the two thermocouples and a Brown temperature recorder. The records are plotted in Fig. 27 for normal cooling and forced air cooling with air from the main air duct. The air was directed on the side where the No. 2 thermocouple was attached. With normal cooling, approximately 50 seconds were required for at least one part of the stack to cool from 1,000° F. to 800° F. With forced air cooling, the maximum temperature recorded was only 880° F., and 12 seconds were required to cool to 800° F.

A stream of oil preheated to 160° F. was sprayed on the exposed surfaces. When the surfaces were cooled with the cooling air, the oil failed to ignite but when the oil was sprayed on the surfaces without benefit of the cooling air, ignition took place within approximately 5 seconds. Although the cooling air appeared to be instrumental in preventing ignition, it was not considered advisable to introduce free air into the zone because once a fire started, the free air would assist combustion. As an alternative means of preventing ignition, the exposed surfaces were covered with asbestos and waterglass. Following this, fires continued to ignite. Still another attempt to cool the hot surfaces by spraying a limited amount of water on them over a period of several seconds met with little success.

exhausts and particularly in the spaces between the stacks and the shrouds. Apparently, it was possible for oil to leak into these spaces and ignite. The agent, however, did not enter these spaces in sufficient concentrations to extinguish these isolated fires simultaneously with the main body of fire.

2. The provisions for extinguishing fires are inadequate in all zones. Although Zone 2 receives adequate concentration and distribution of agent in the zone proper, insufficient agent is provided the shrouded spaces, and inadequate shrouding of hot exhaust surfaces permits fuel or oil to enter shrouded areas. This results in fires occurring within shrouded areas which cannot be extinguished by System D and which cause reignition of fuel or oil in Zone 2.
