DEPARTMENT OF TRANSPORTATION
FEDERAL AVIATION ADMINISTRATION
NATIONAL AVIATION FACILITIES EXPERIMENTAL CENTER
ATLANTIC CITY, NEW JERSEY 08405
PROPULSION SECTION, NA-542

DATA REPORT NO. 68

March 1970

EVALUATION OF THE EDISON ULTRAVIOLET
SURVEILLANCE FIRE WARNING SYSTEM AS
A BURNER-CAN BURN-THROUGH DETECTOR
PROJECT 520-001-14X
Prepared by: Richard G. Hill

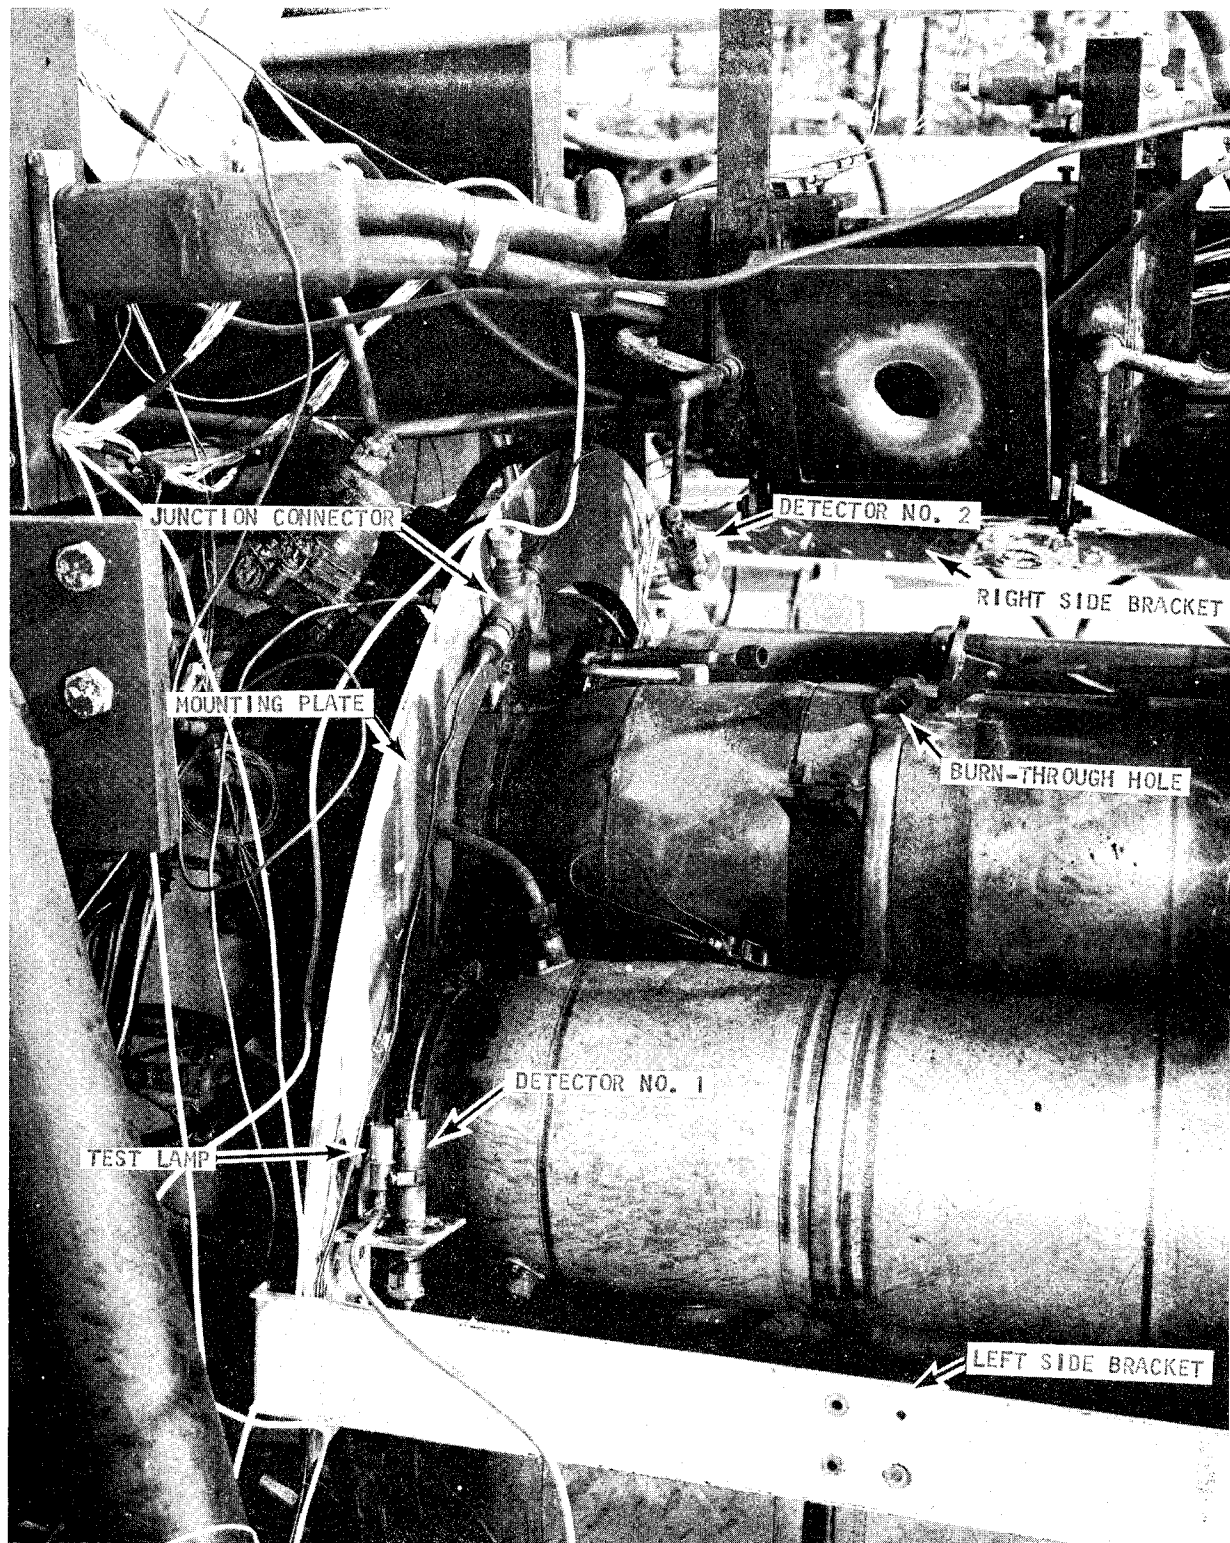
24	80° X 9½ in.	-	Perpendicular to Engine Axis	--	80-100	500	640-700	640-660	Yes	No	
25	330° X 9½ in.	-	Perpendicular to Engine Axis	--	820	840	840	840	Yes	No	
26	90° X 9½ in.	-	Perpendicular to Engine Axis	--	0	0	0	0	No	No	Faulty Sensor - Sensor Replaced
27	90° X 9½ in.	-	Perpendicular to Engine Axis	--	40-60	40-60	40-60	130	Yes	Yes	Fire Warning From Sun. 40-60 Pulses Per Second

FIG. 4 SENSORS LOCATED PERPENDICULAR TO ENGINE AXIS, 9 1/2 INCHES FORWARD OF BURN-THROUGH HOLE, 4 INCHES ABOVE THE BURNER-CANS, WITH LENSES LOOKING AFT

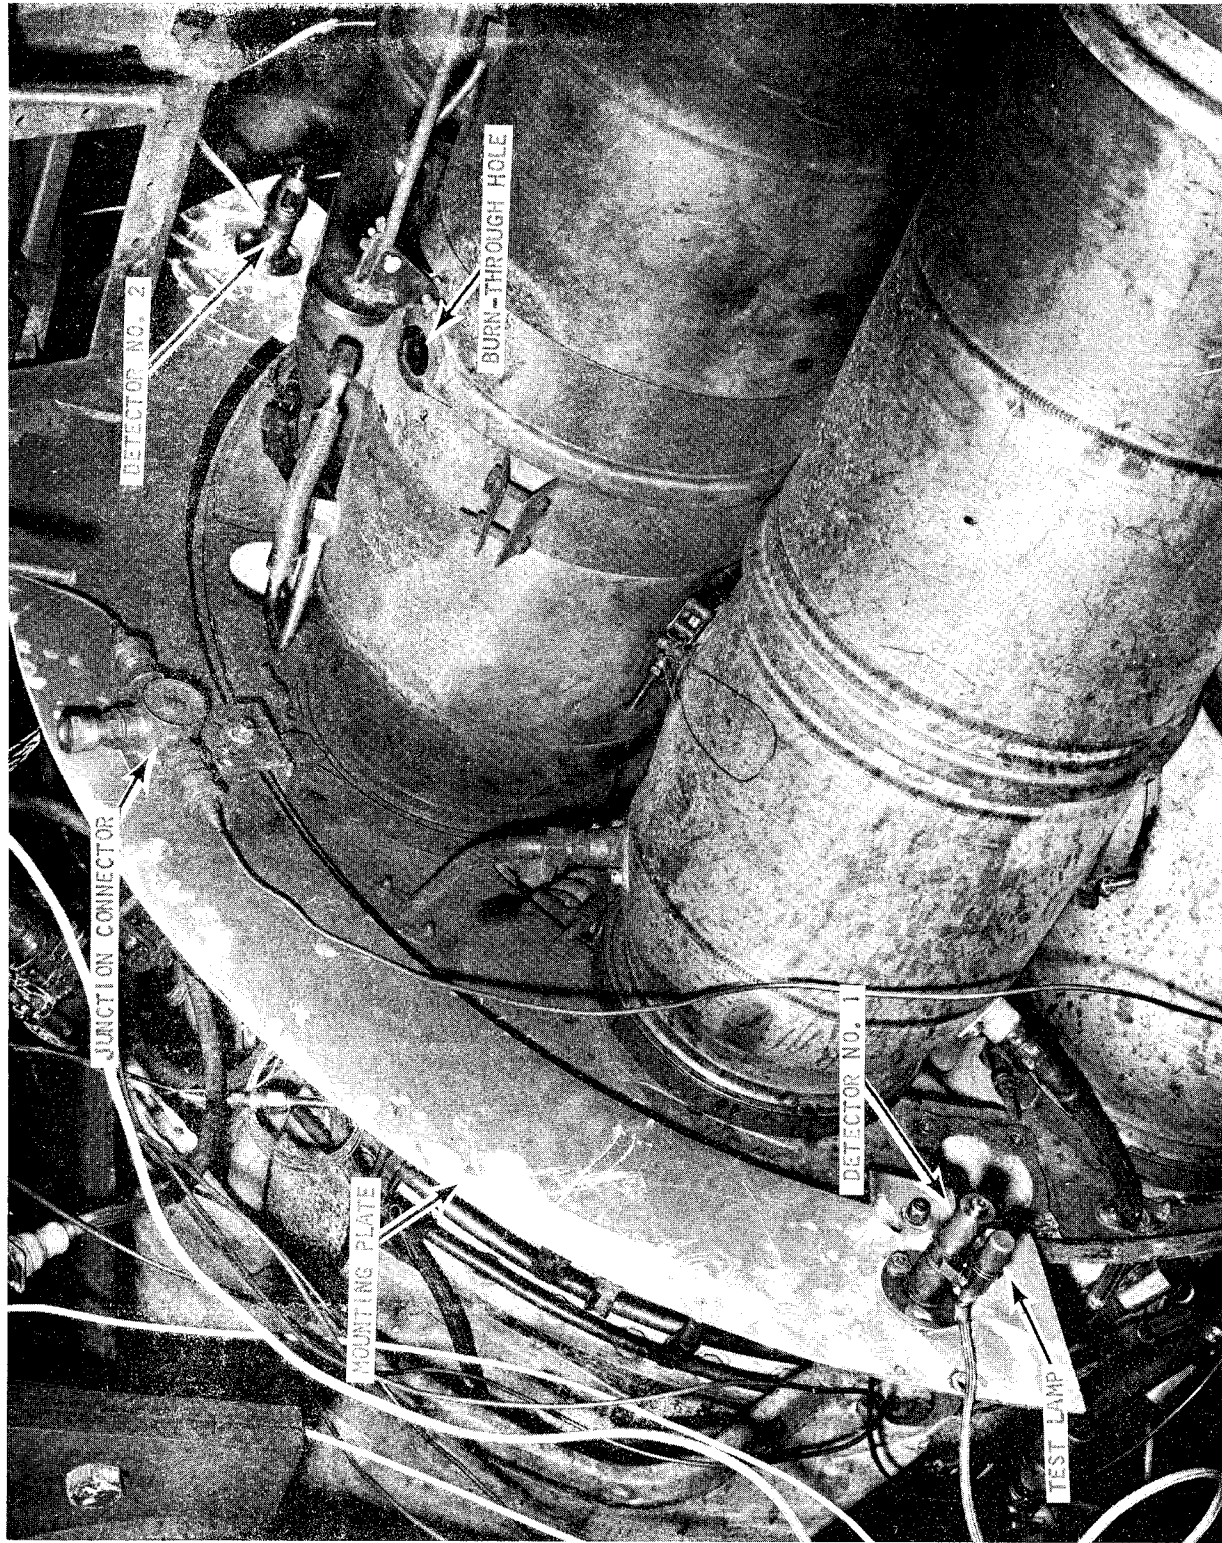
The initial series of tests was performed with two sensors mounted on a bracket at the forward end of the burner-can section as shown in Figure 5. Referring to Figure 6 they were located 9.5 inches forward of the burn-through hole, 120° apart, at 60° and 300° from the burn-through hole on the engine circumference, and 4 inches above the burner-cans with the lenses looking tangent to the burner-cans. These tests involved first using both sensors together and subsequently each one separately. The latter was accomplished by hooding the unused sensor, as shown in Figure 3. The sensors were then relocated around the engine circumference in several different locations, as noted in Table 1. The test procedure was repeated after each relocation.

FIG. 5 SENSORS LOCATED PARALLEL TO ENGINE AXIS, 9 1/2 INCHES FORWARD OF BURN-THROUGH HOLE, 4 INCHES ABOVE THE BURNER-CANS, WITH LENSES LOOKING TANGENT TO BURNER-CANS

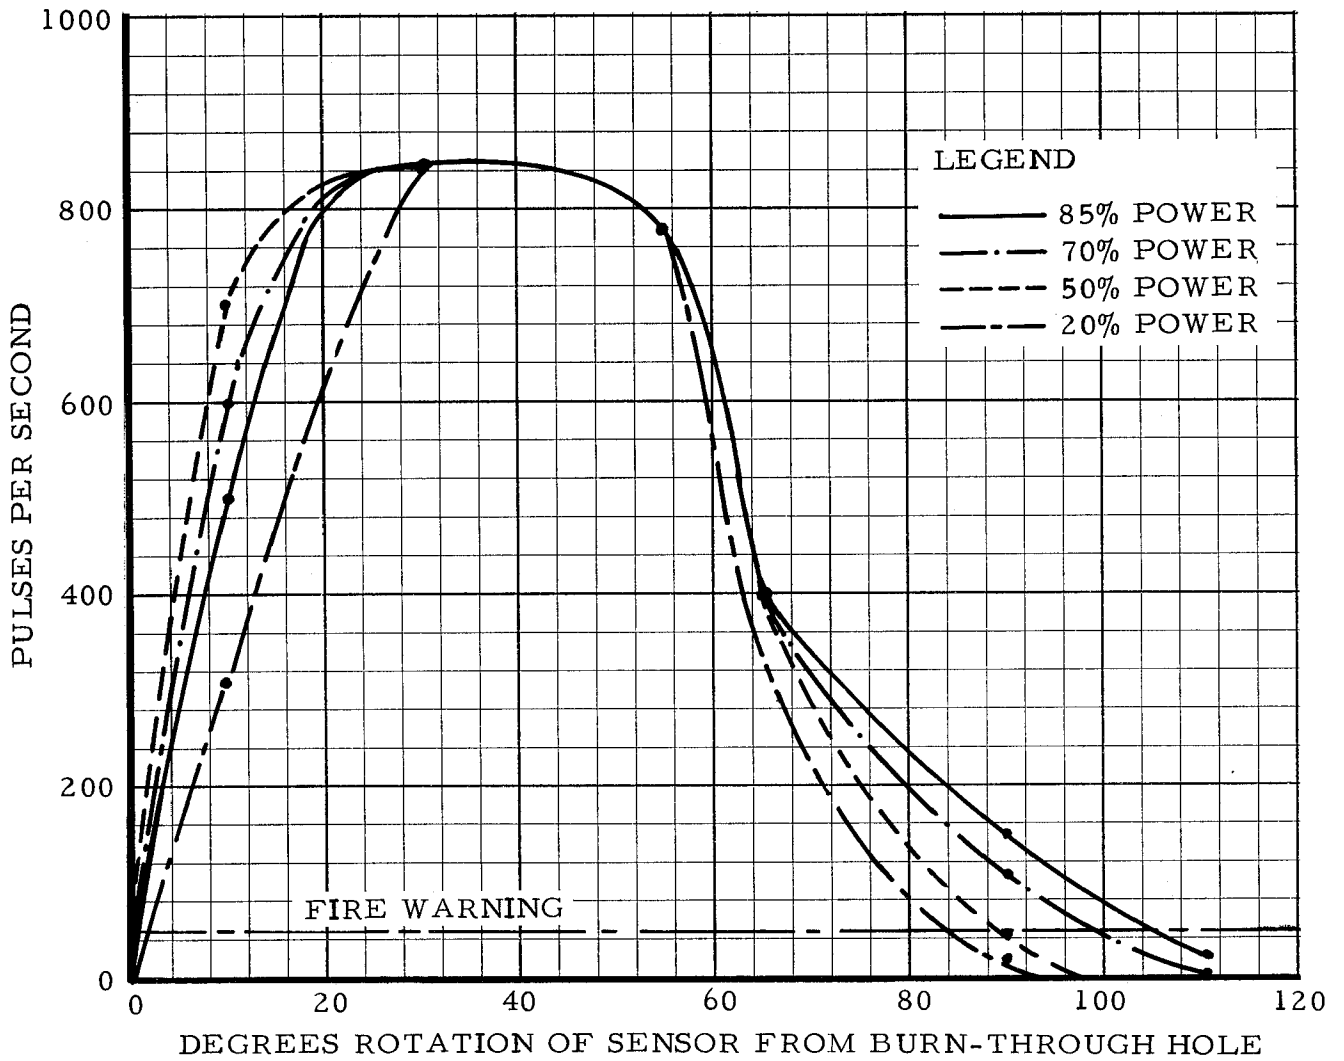
The range of the detector system varied approximately 10 to 15 degrees around the engine circumference as the engine power setting varied between 50 and 85 percent (see Figures 7 and 8). When the power setting was brought down to 20 percent there was a very noticeable decrease in pulses per second. The angular range of the system detecting a propane torch flame differed greatly from the range in detecting a burn-through flame. Figure 9 shows the angular view needed to:

FIG. 7 PULSES PER SECOND RECEIVED FROM SENSOR, LOCATED IN POSITION AS DEFINED IN FIG. 5, AS IT IS ROTATED AROUND ENGINE CIRCUMFERENCE, AT FOUR DIFFERENT ENGINE POWER SETTINGS.

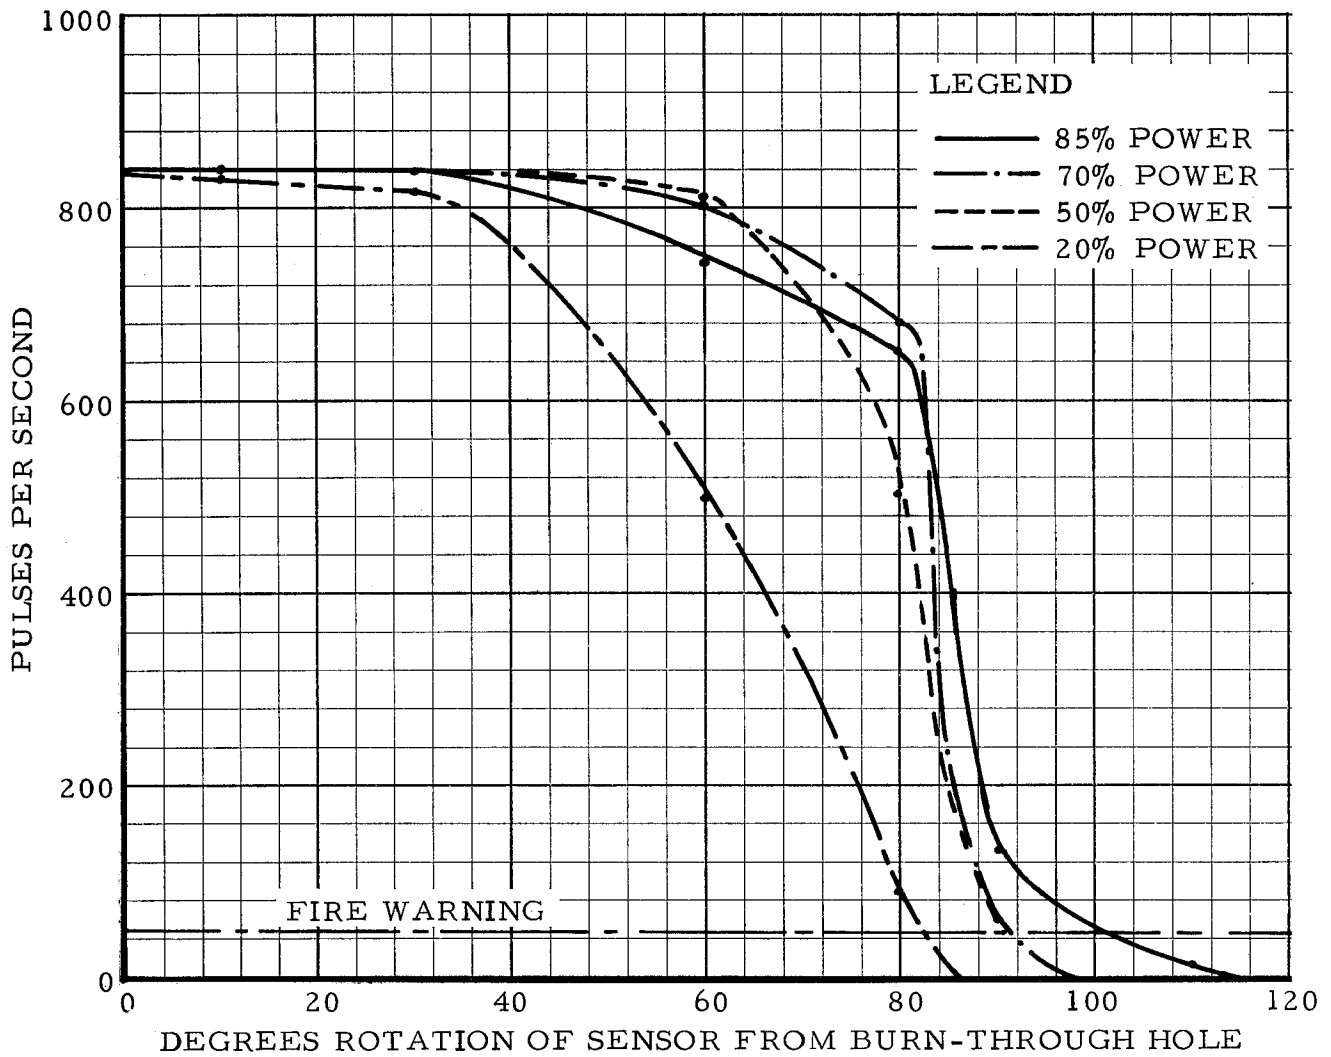
FIG. 8 PULSES PER SECOND RECEIVED FROM SENSOR, LOCATED IN POSITION AS DEFINED IN FIG. 4, AS IT IS ROTATED AROUND ENGINE CIRCUMFERENCE, AT FOUR DIFFERENT ENGINE POWER SETTINGS.

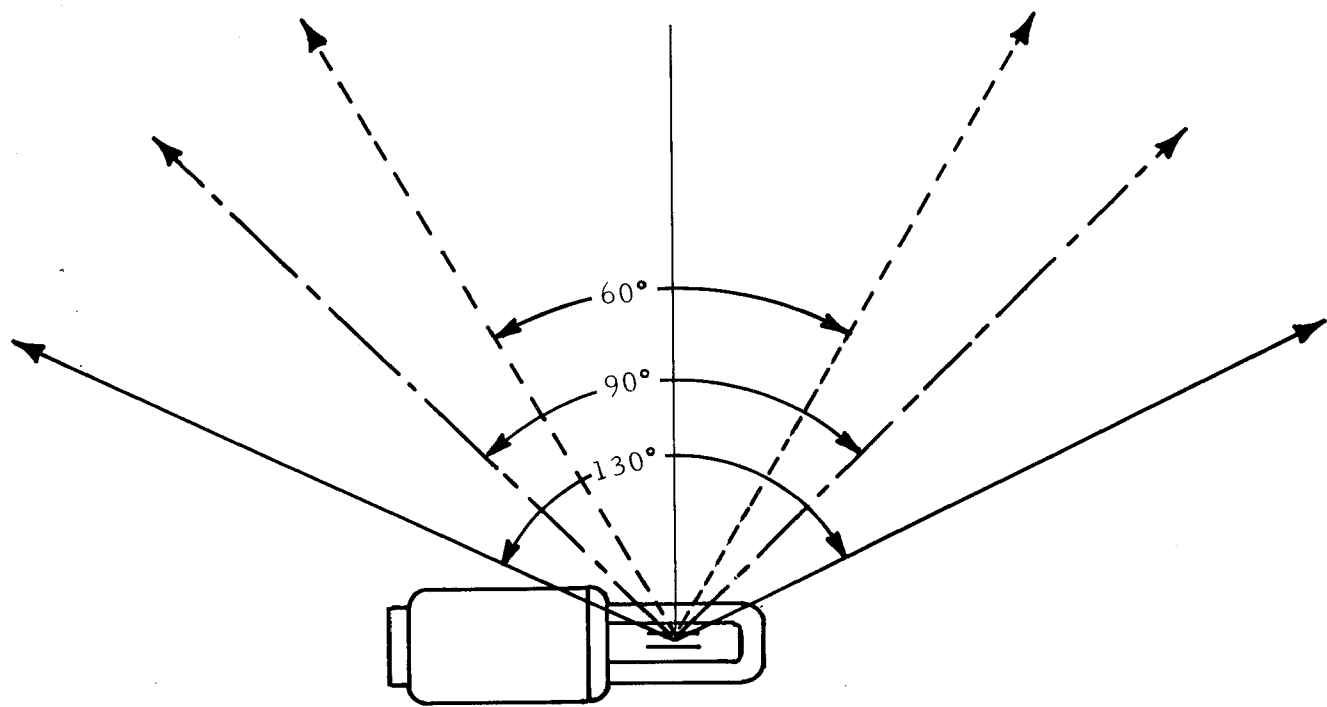
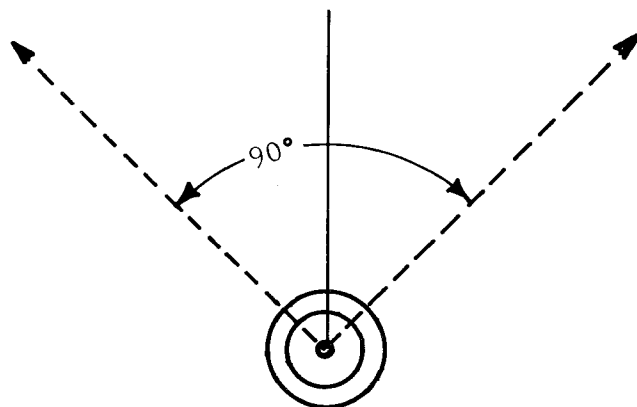
1. Produce a fire warning from a flame of a small propane torch.
2. Produce 840 pulses per second from a burner-can burn-through flame.
3. Produce a fire warning from a burner-can burn-through flame.

1. In all tests the detector responded immediately to any flame within its range, as defined in Figure 9, except when the lens was covered with an oil film.
2. Direct sunlight impinging on the sensor lens caused false fire warnings.
3. Problems encountered with the detection system involved continuous false alarms until the push-to-test circuit became inoperative, after which no further unexplainable false alarms were noted and toward the end of the testing one sensor failed to detect ultraviolet light.

FIG. 9 ANGULAR RANGE OF EDISON ULTRAVIOLET SENSOR.
