# OSU & NBS March Materials Meeting

Materials Working Group

March 4<sup>th</sup> & 5<sup>th</sup>, 2008

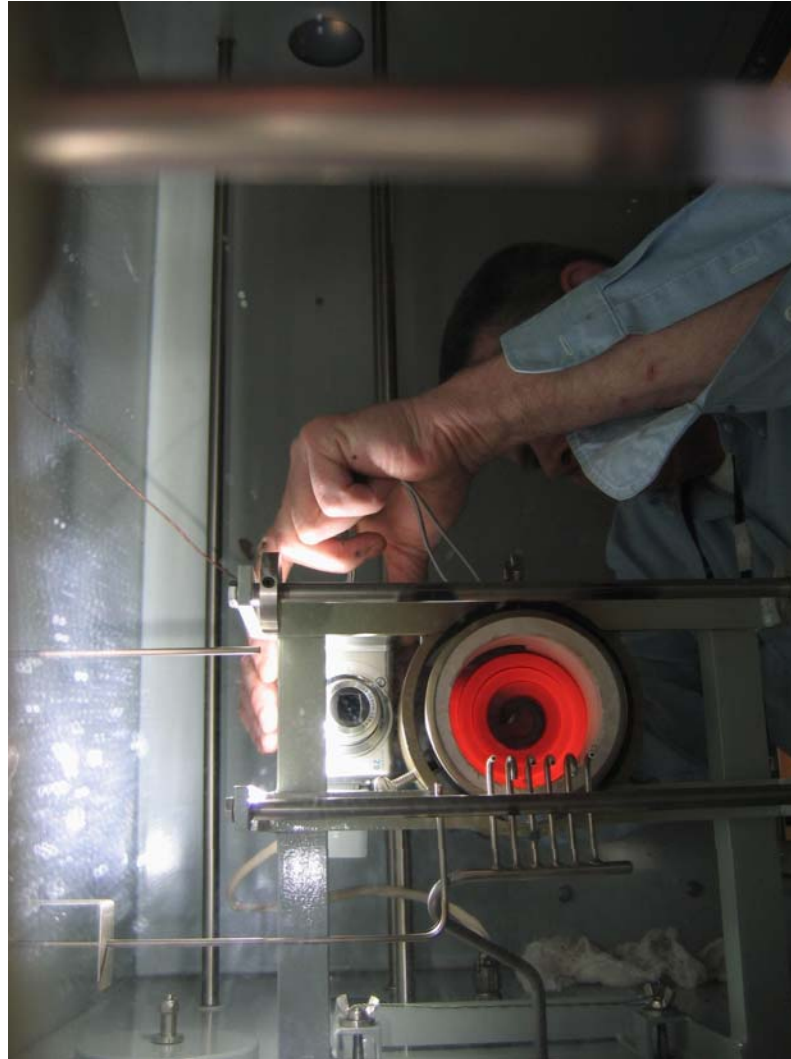
# Furnace Defect

- **A problem with replacement furnaces of the NBS Smoke chamber has recently been observed**
  - A dark “eye” in the center of the furnace has been observed on some coils even after being calibrated to the 2.5 W/cm<sup>2</sup> value

- **Drawing 40A132880 (NIST report NISTIR 4917, New Heater and Flux Guage for the NBS Smoke Box)**
  - Thought to be the most recent authoritative document, however, original designer did not specify tolerances
  - Original designer/manufacturer of furnace no longer in business
  - The current manufacturer is actively working with the FAA to resolve this issue
