SAE/ISO Standard for Fire Containment Covers

Presented to: International Aircraft Systems Fire Protection Working Group. Long Beach, CA

By: Dave Blake, FAA Technical Center Fire Safety

Date: Nov 14-15, 2012

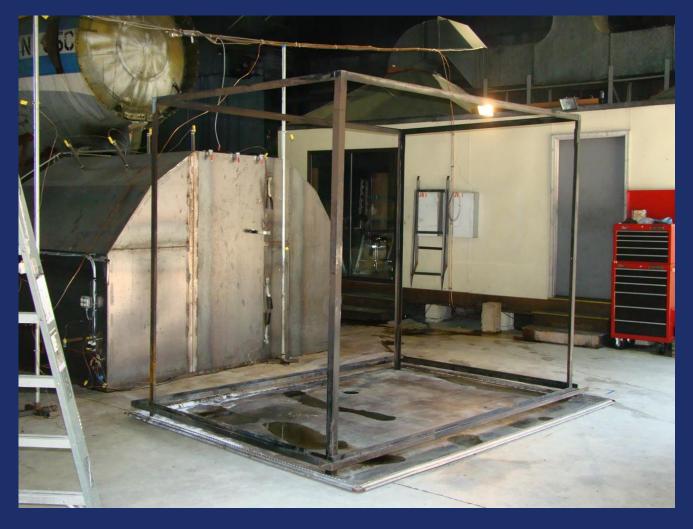
•4" steel channel all around lower edge of frame to catch lower edge of FCC and keep a constant air gap present for the duration of the 2 hour test.

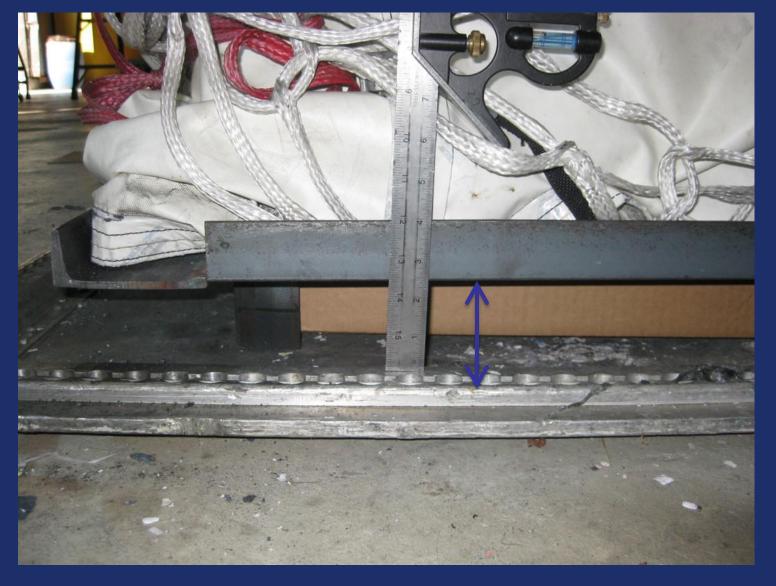
2.5" gap between pallet rail and lowest edge of channel

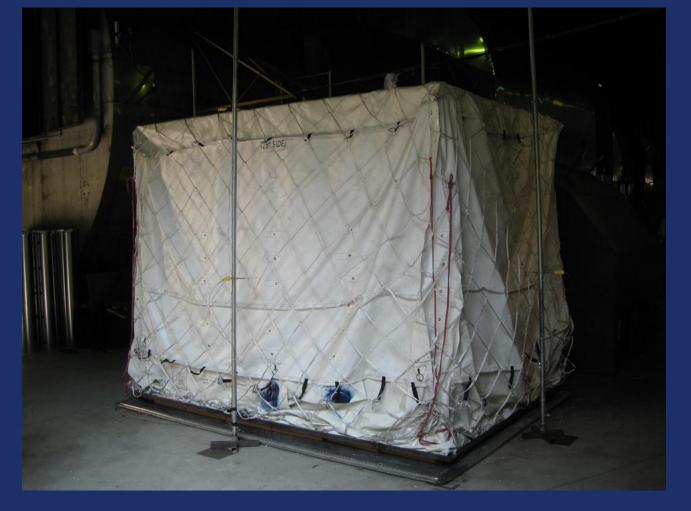
•Fire load was cardboard boxes filled with shredded newspaper. Metal poles visible outside FCC are for mounting thermocouples at 48" and 90" above floor, 4" from sides of FCC on all four sides (only 2 are visible in picture)

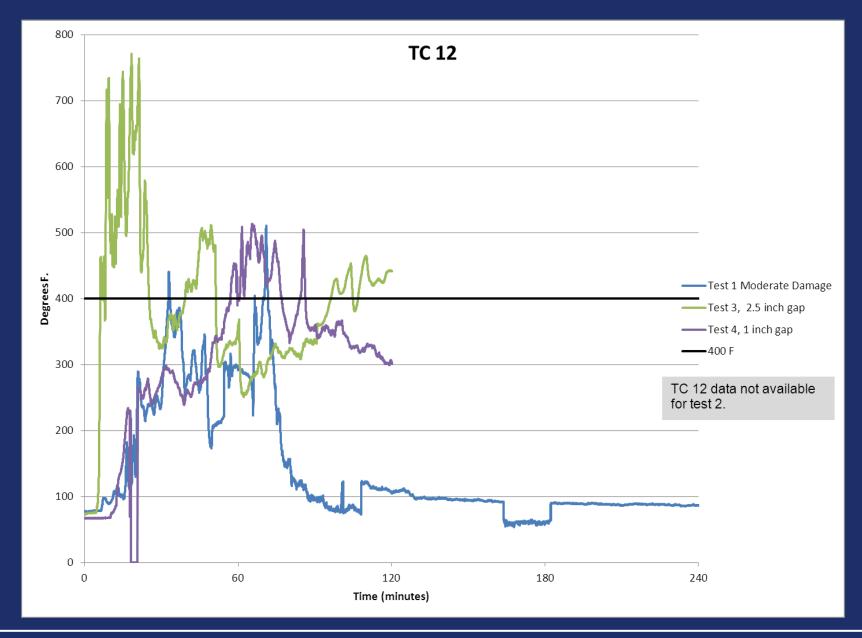
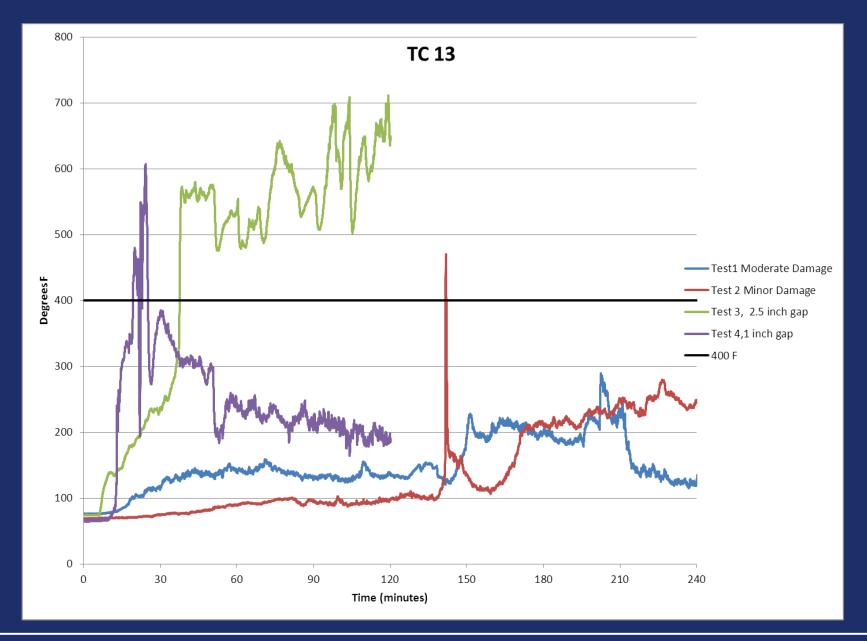
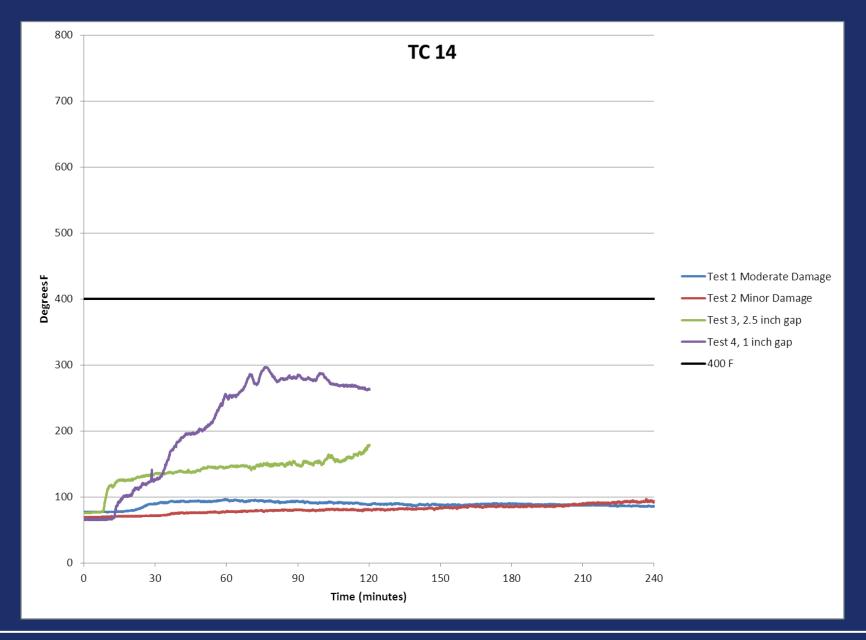
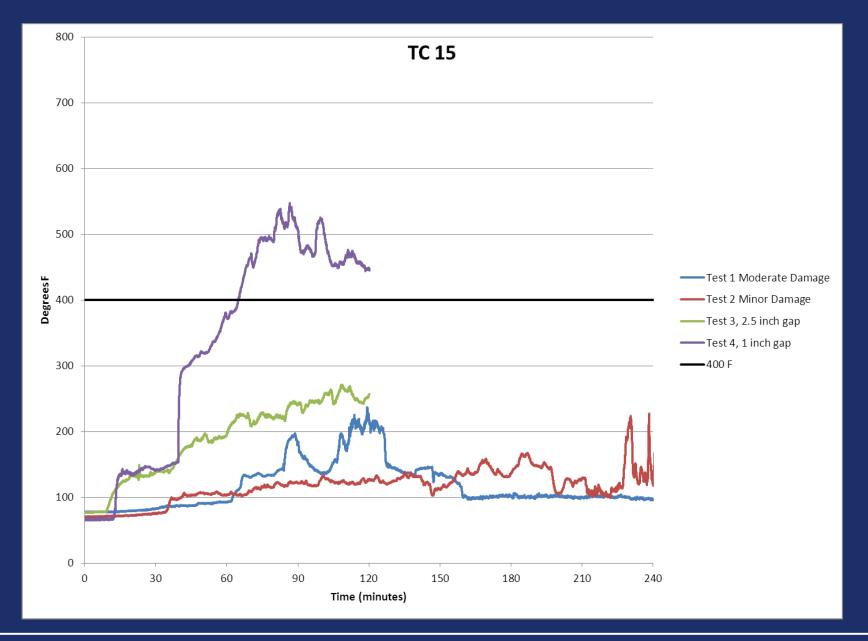
- All 4 tests failed due to exceeding 400° F on thermocouples 4" away from outside surface of FCC's per draft SAE/ISO Standards.
- All 4 test fires were contained by the FCC's but not extinguished.
- Small sections of the exteriors of the FCC's briefly ignited in most test due to ignition of off-gassing resins.
- Cargo net on exterior of FCC's ignited in all tests. (Net sample was tested to the 12 second vertical bunsen burner test and failed. Current regulations do not require this test but the draft SAE/ISO Standards do)
