DOT/FAA/TCTN-22/27

Federal Aviation Administration
William J. Hughes Technical Center
Aviation Research Division
Atlantic City International Airport
New Jersey 08405

An Analysis of State of Charge in Lithium-ion Batteries

Technical Note

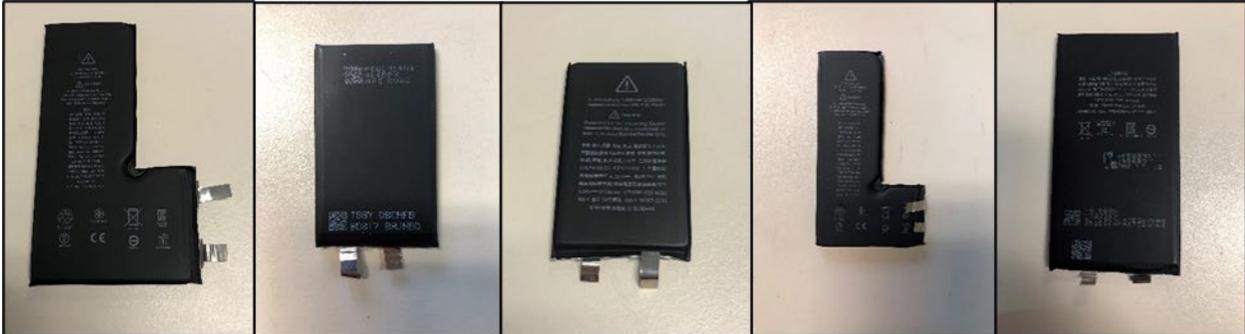
Figure 1. Battery Cells from left to right; 3.79V, 3.80V Cell #1, 3.80V Cell #2, 3.83 L-Shaped, 3.83 Square

A total of 140 pouch cells of five different types; 3.79V, 3.80V Cell #1, 3.80V Cell #2, 3.83V L-Shape, and 3.83V Square were shipped to the Federal Aviation Administration’s (FAA) William J. Hughes Technical Center. Figure 1 shows pictures of each cell. The cells were used for replacements of various iPhone models including the iPhone 11 Max, iPhone XS Max, iPhone 11 Pro and iPhone 12 Pro ®. Due to the lack of information found during internet research, it was determined that the cells were not from the original equipment manufacturer (OEM).

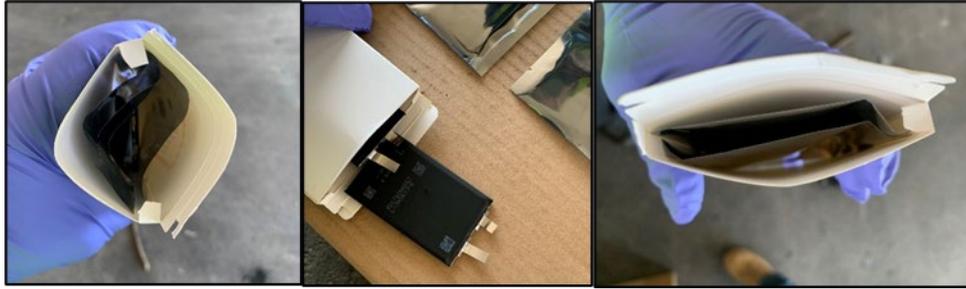
Figure 2. 3.80V Interior Packaging

Cells were packed within unsealed hydrostatic sleeves, each contained within its own cardboard box. An exception to this was the 3.80V cells, in which two cells were packed within each cardboard container, as shown in Figure 2. It is hypothesized that the original package fire started when two 3.80V cells within the same cardboard container slipped out of the plastic sleeves and the terminals to the two batteries made contact, short circuiting the cells and causing thermal runaway. Subsequently, the fire was able to propagate to other nearby cells and the entire package caught fire.

Prior to testing, it was hypothesized that the ignition of the fire was caused when two of the 3.80V cells, which were packaged together, had slipped out of their plastic sleeves and touched

terminals of the opposite polarity, causing the batteries to short circuit, overheat and catch fire. Experimentation was conducted to test this hypothesis and to analyze the correlation between cells charged at varying SOC and flammability risks.

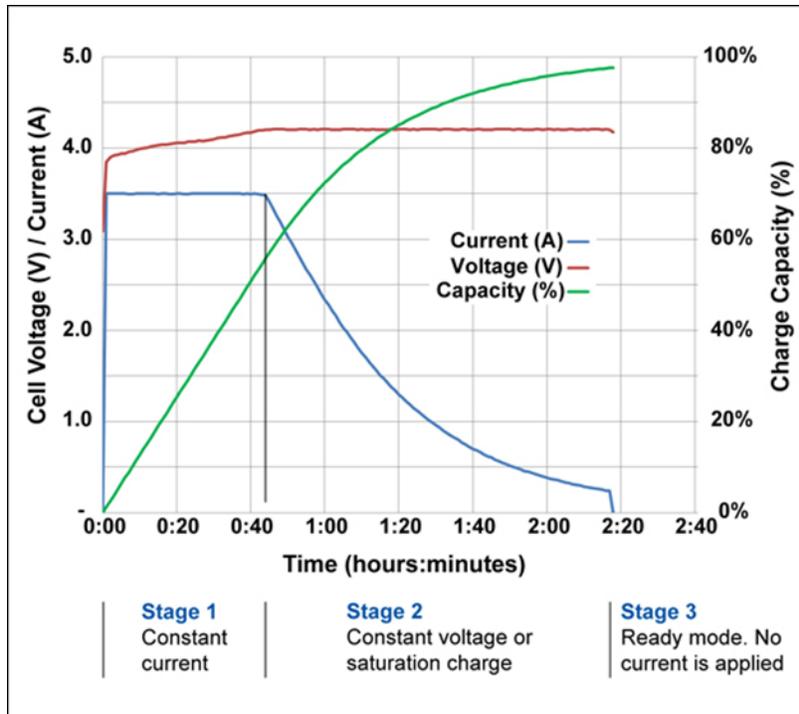
Figure 3. CC-CV Charging Method

A sample size of twenty cells were evaluated, in which four batteries of each type (3.79V, 3.80V Cell #1, 3.80V Cell #2, 3.83 Square, and 3.83 L-Shape) were charged using a Constant Current – Constant Voltage (CC-CV) charging method. In this method, constant current (CC) was used to charge the cell until the voltage reached the maximum charging voltage value, then the charging process shifted to constant voltage (CV) charging. In CV, the cell was charged at the maximum charging voltage value and the current decreased until it reached the minimum current termination value. A CC-CV charging method is standard for lithium-ion cells/batteries. An example of this charging method is shown in Figure 3 (Buchmann, 2017).

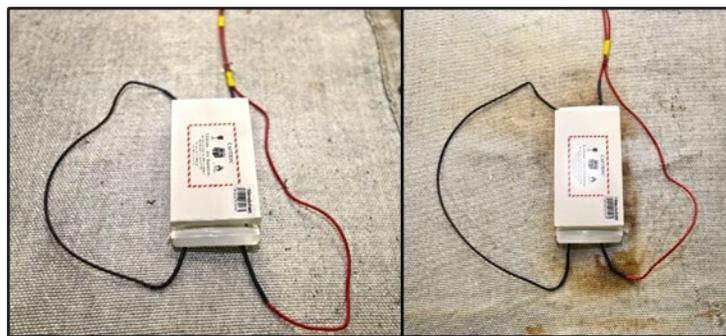
Figure 4. Test Setup and Battery Wiring

Each stack consisted of two 3.80V cells within the bottom container and a 3.79V cell within the top container. Batteries were placed within their original packaging which included an unsealed plastic sleeve for each cell and the outer cardboard container. A picture of the setup is shown in Figure 4. The 3.80V cells within each stack were put into thermal runaway by cross-wiring the terminals, causing the cells to short circuit. All three stacks were cross-wired at the same time using a switch and the time needed for the batteries to experience thermal runaway was observed.

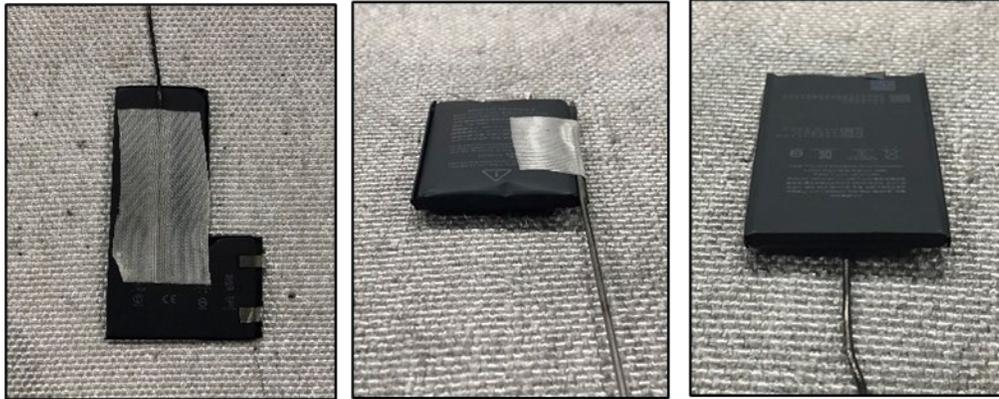
Figure 5. Thermocouple positioning of the 3.79V, 3.80V and 3.83V cells

Type K stainless steel sheathed thermocouples were attached to each cell as shown in Figure 5. Thermocouples were attached to the side of the 3.80V cell to ensure that the thermocouple would not interfere with temperature propagation.

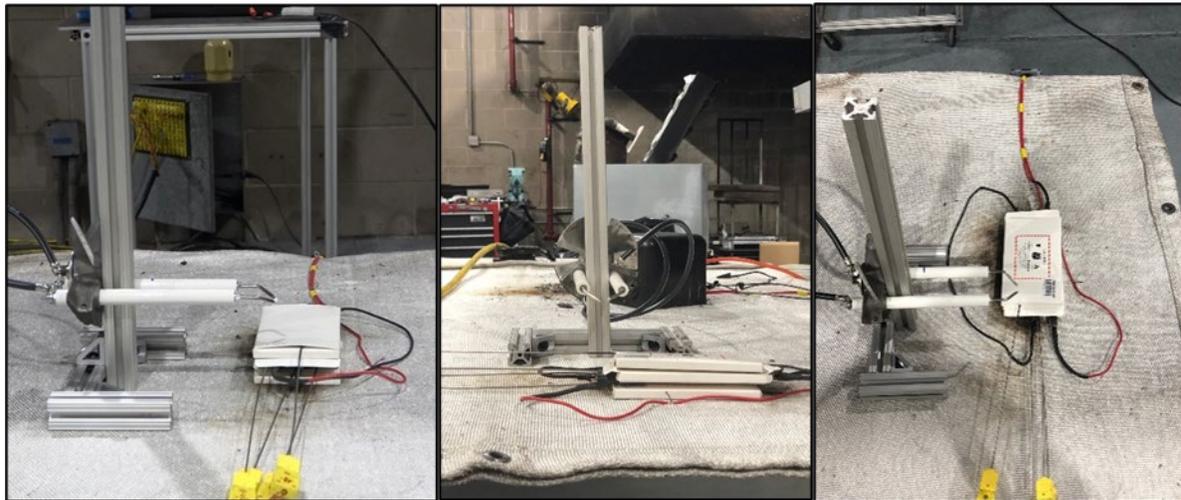
Figure 6. Spark Igniter Setup

For the last stack tested, a high-voltage spark igniter was added to determine if a spark could ignite the gases released during thermal runaway. The igniter was oriented three inches above the top front edge of the stack. A picture of the spark igniter's orientation is shown in Figure 6.

In Test #4, the spark igniter ignited the gases released by the batteries during the thermal runaway event and a significant amount of flame was present. During thermal runaway events, lithium-ion and lithium metals batteries can sporadically create sparks that can ignite surrounding gases. This indicates that the gases released during thermal runaway may have ignited from a spark produced from the cell.

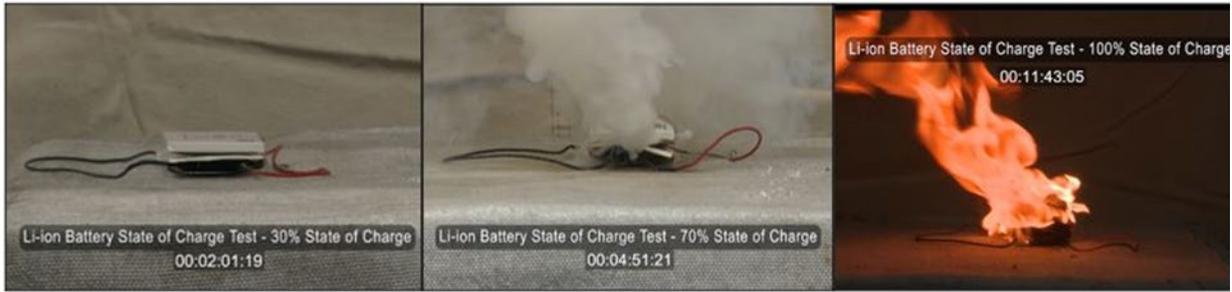
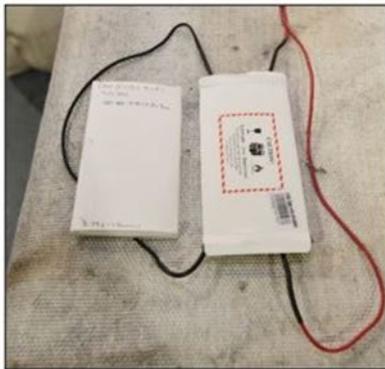
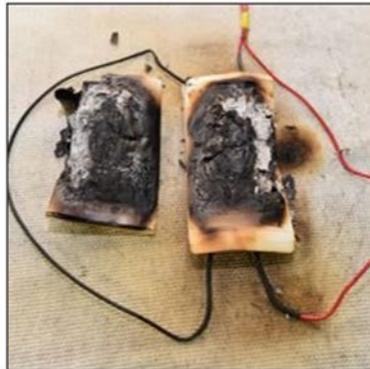
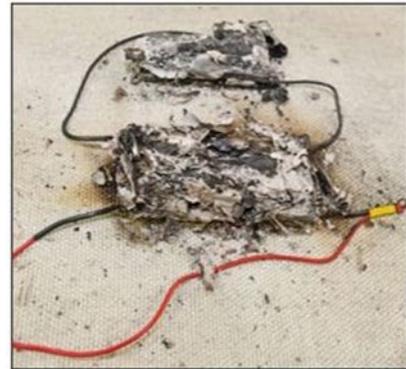
Figure 7. Peak reaction and post-test damages of each cell stack

The 30% cell stack released very little smoke and minimal damage was present in the post test analysis. Only the 3.80V cells showed signs of some damage presenting as slight swelling in the cells. It is common for damaged lithium-ion pouch cells to swell if damaged or overheated.

There were no visible signs of damage to the 3.79V cell. No signs of flame or burn damage were present in this 30% SOC stack. Since only the 3.80V cells showed signs of damage and the 3.79V cells did not, this suggests that the heat was not able to propagate to the top cardboard container.

The 70% SOC stack went into thermal runaway and released a significant amount of smoke and gas. Additionally, there was a small amount of flame present within the interior of the packaging. There were signs of thermal propagation, as all cells within the stack experienced thermal runaway at different times during testing. Charring and burn damage were observed in both the cells and surrounding packaging during the post-test analysis.

The 100% SOC stack experienced thermal runaway and a significant amount of smoke, gas and flames were released. As the 3.79V cell underwent thermal runaway, the surrounding gas ignited and large flames were released. There was clear evidence of thermal propagation and the packaging and cells for all containers were completely destroyed.

Images of the peak reaction for each stack and the damages for each SOC stack is shown in Figure 7.

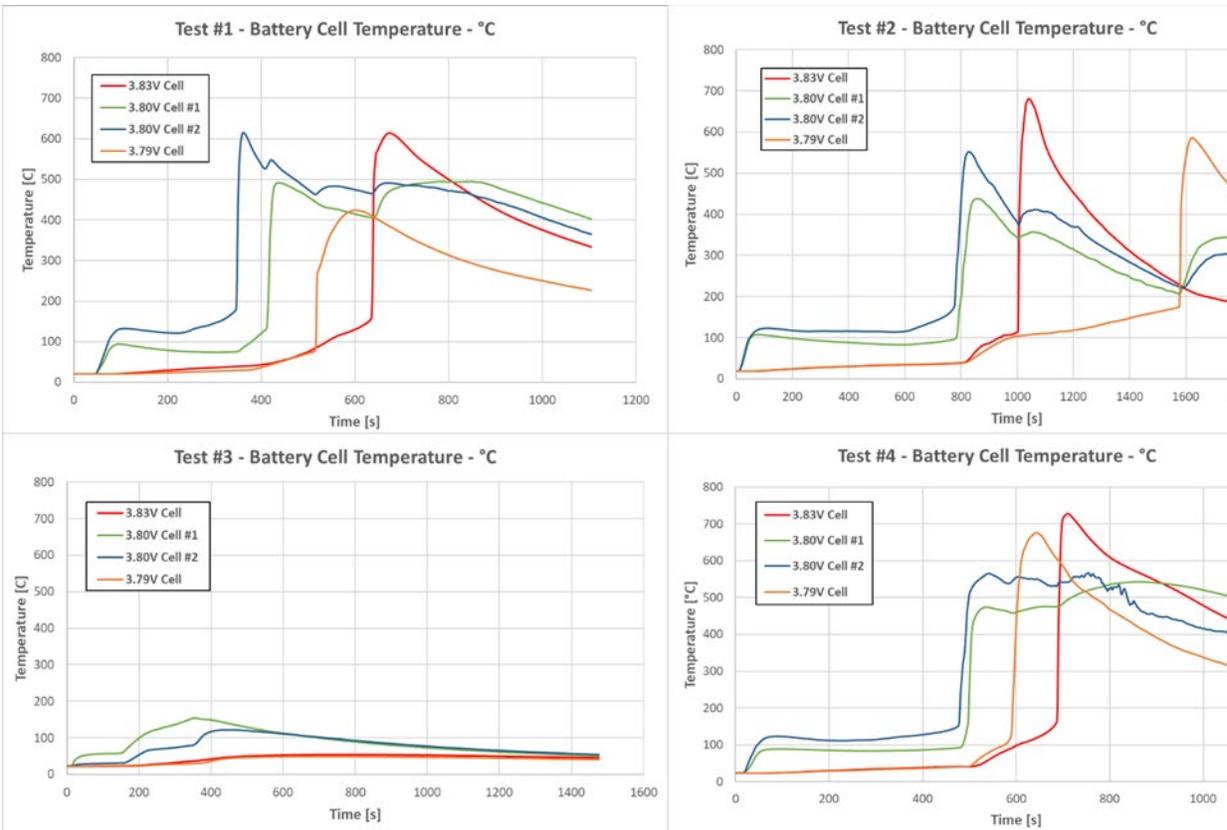
Figure 8. Cell Temperatures

The ability of the cells to reach thermal runaway was inconsistent between tests. In three of the four tests, all cells underwent thermal runaway and reached temperatures ranging from 400 to 700°C. The 3.79V and 3.83V cells, which had the highest capacities, had the highest overall temperature peaks. Figure 8 shows the temperatures of all cells throughout testing. The sudden increase in temperature indicates that a cell has reached thermal runaway.

It was observed that the as-delivered 70% SOC cells experienced some temperature propagation between cardboard containers. Furthermore, it was evident during testing that the cell within the top container had reached thermal runaway shortly after the bottom cells went into thermal runaway. This suggests that the batteries were at a high enough SOC in the initial package fire incident that the temperature from one thermal runaway cell had enough energy to propagate to other cells within the container.

The time needed for cells to reach thermal runaway was inconsistent throughout repeated testing. Throughout all four tests, the time from test to the initial thermal runaway event varied between six minutes to thirteen minutes. Once the initial cell achieved thermal runaway, however, the temperature was able to propagate to surrounding cells and cause them to enter thermal runaway within a few minutes.

In Test #1, the first cell was able to reach thermal runaway within the six minutes of testing and the temperature was able to propagate to all other cells in the stack within a five-minute period.

In Test #2, the first cell did not achieve thermal runaway until almost thirteen minutes into testing during which both 3.80V cells experienced thermal runaway. The temperature was able to propagate to both the top and bottom container, but it took an additional thirteen minutes for the 3.79V Cell to reach thermal runaway. This was a much longer time period compared to other tests, as it typically took less than five minutes for the temperature to propagate.

In Test #3, none of the cells experienced any thermal runaway events. Approximately five minutes into the test, 3.80V Cell 1 reached a max temperature of 150°C, but no other cells exceeded this temperature. No flame and very little smoke were visible for this particular test. A post-test analysis showed no signs of burn damage to the cells or surrounding container, however
