# Summary of Results from Three Full Scale High Wing General Aviation Crash Tests

FAA Fire and Cabin Safety Conference  
October 24-27, 2016  
Atlantic City, New Jersey

Justin Littell Ph.D.  
Structural Dynamics Branch  
NASA Langley Research Center

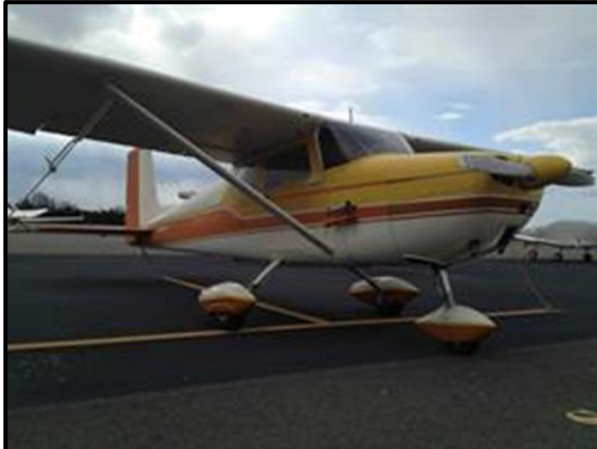
- N8834B
- 1958 C172
- TTAF 4,400 hrs
- Airworthy and current on annual inspection

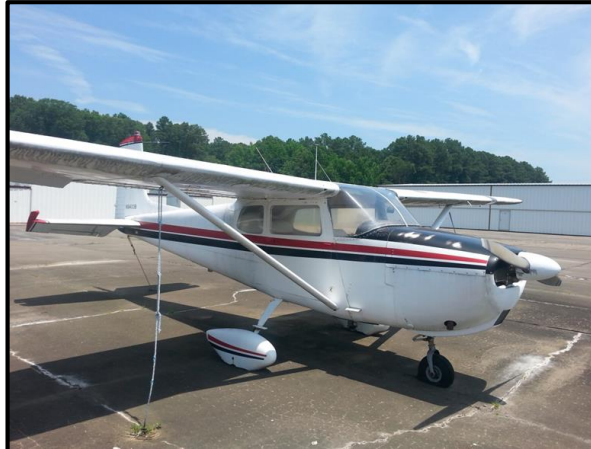
- N9400B
- 1958 C175
- Purchased out of probate
- On ramp ~ 10 years

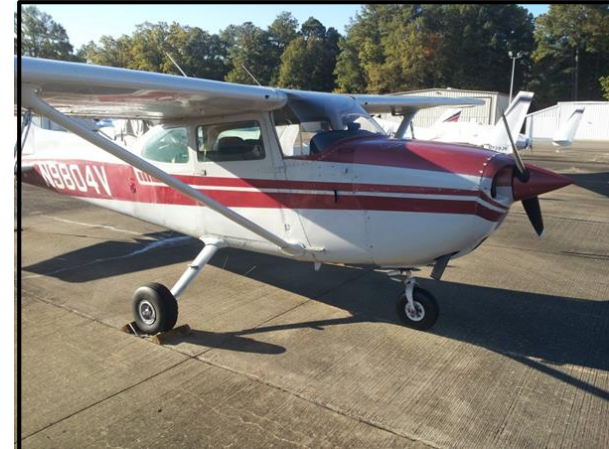
- N9804V
- 1974 C172
- TTAF >28,000(!) hrs
- Airworthy and current on annual inspection

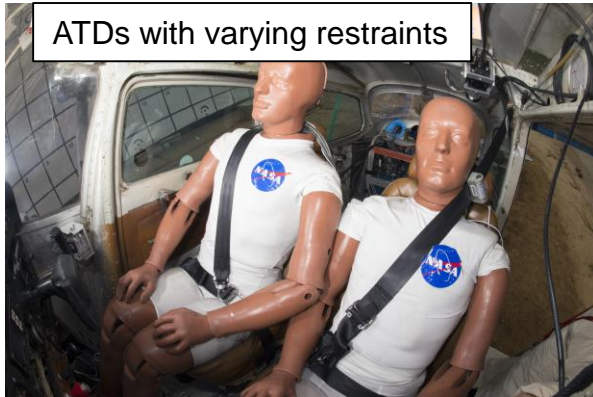
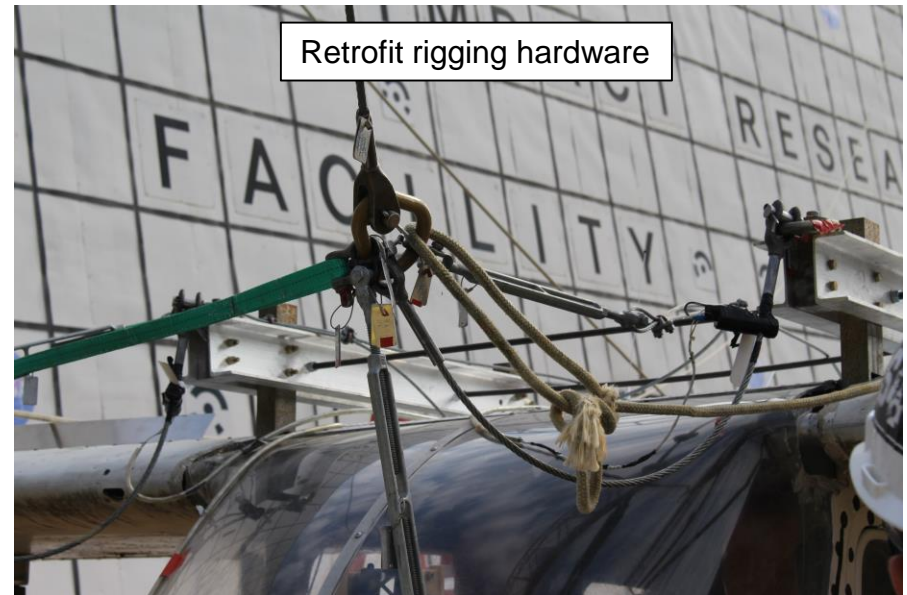
# Turning Airplanes into Test Articles

- Rigging hardware mounted above wings and on main landing gear
- 64 channel data acquisition system which includes airframe accelerations and occupant loading
- 2 Hybrid III - 50<sup>th</sup> Percentile ATD's with varying types of restraints used per test
- High speed cameras both onboard and off board
- Speckle coating used for digital image correlation
- 4-5 ELTs per airplane

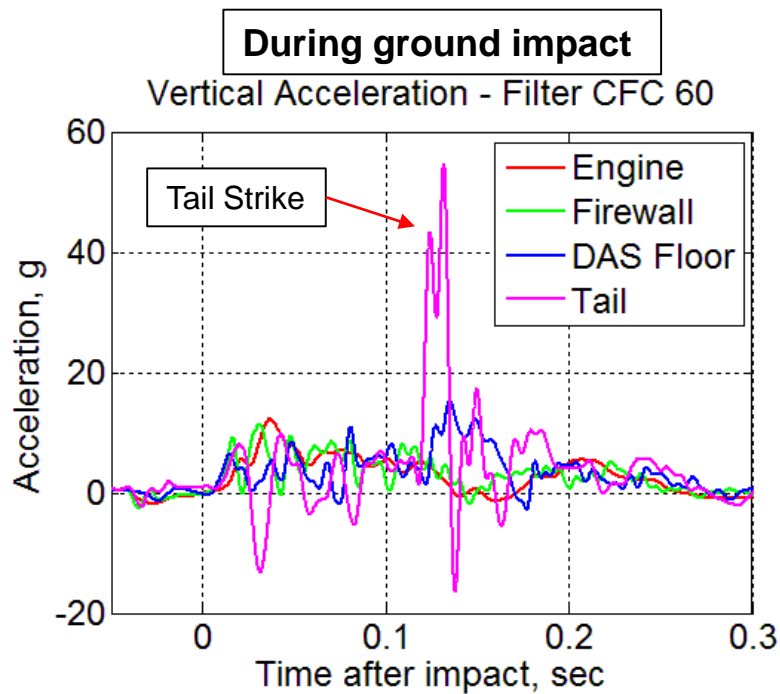
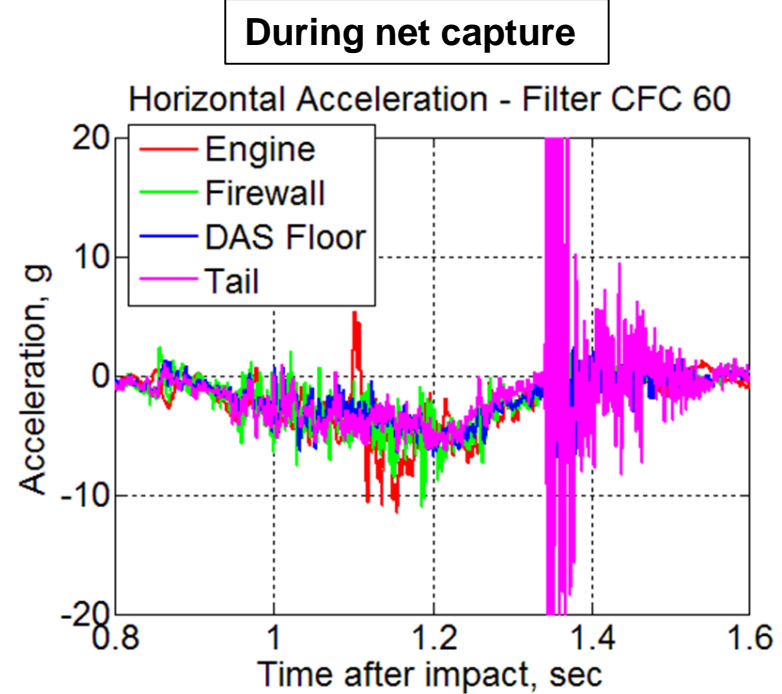
# Test 1 – Airframe Response

- During ground impact
  - Vertical accelerations resembled a plateau which ranged between 4.1 g (engine) to 5.9 g (tail)
  - Horizontal accelerations negligible
- During net capture
  - Vertical accelerations negligible
  - Horizontal accelerations were triangular in shape and peaked between 4.0 g (tail) to 5.3 g (engine)

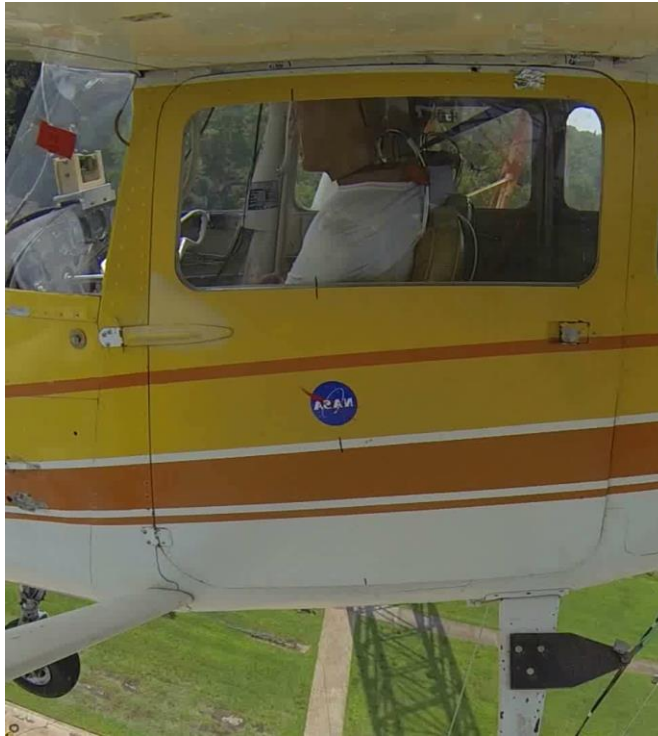
**Co-Pilot -**  
Fixed lap belt  
ONLY

- Major lumbar load occurred during ground impact
- Major head flail occurred during net capture
- Head flail was reduced by approximately 13 inches when a shoulder belt was used

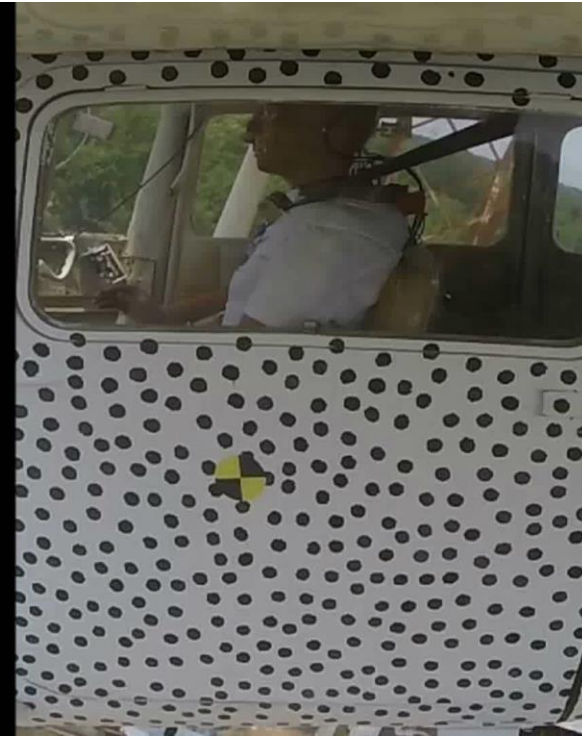
**Pilot -**  
Fixed shoulder  
and lap belt

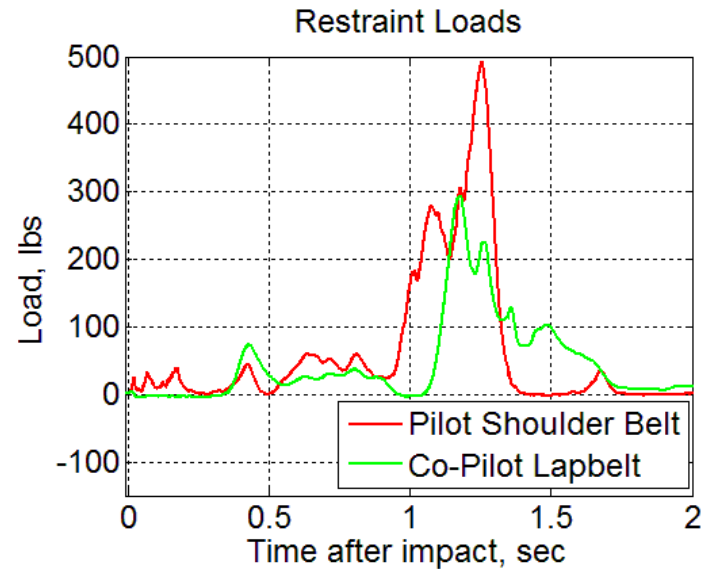
# Test 1 – Occupant Response (cont.)

Occupant	HIC
Pilot	11
Co-Pilot	25

- HIC, lumbar load, and belt are below injury limits according to FAR 25.562

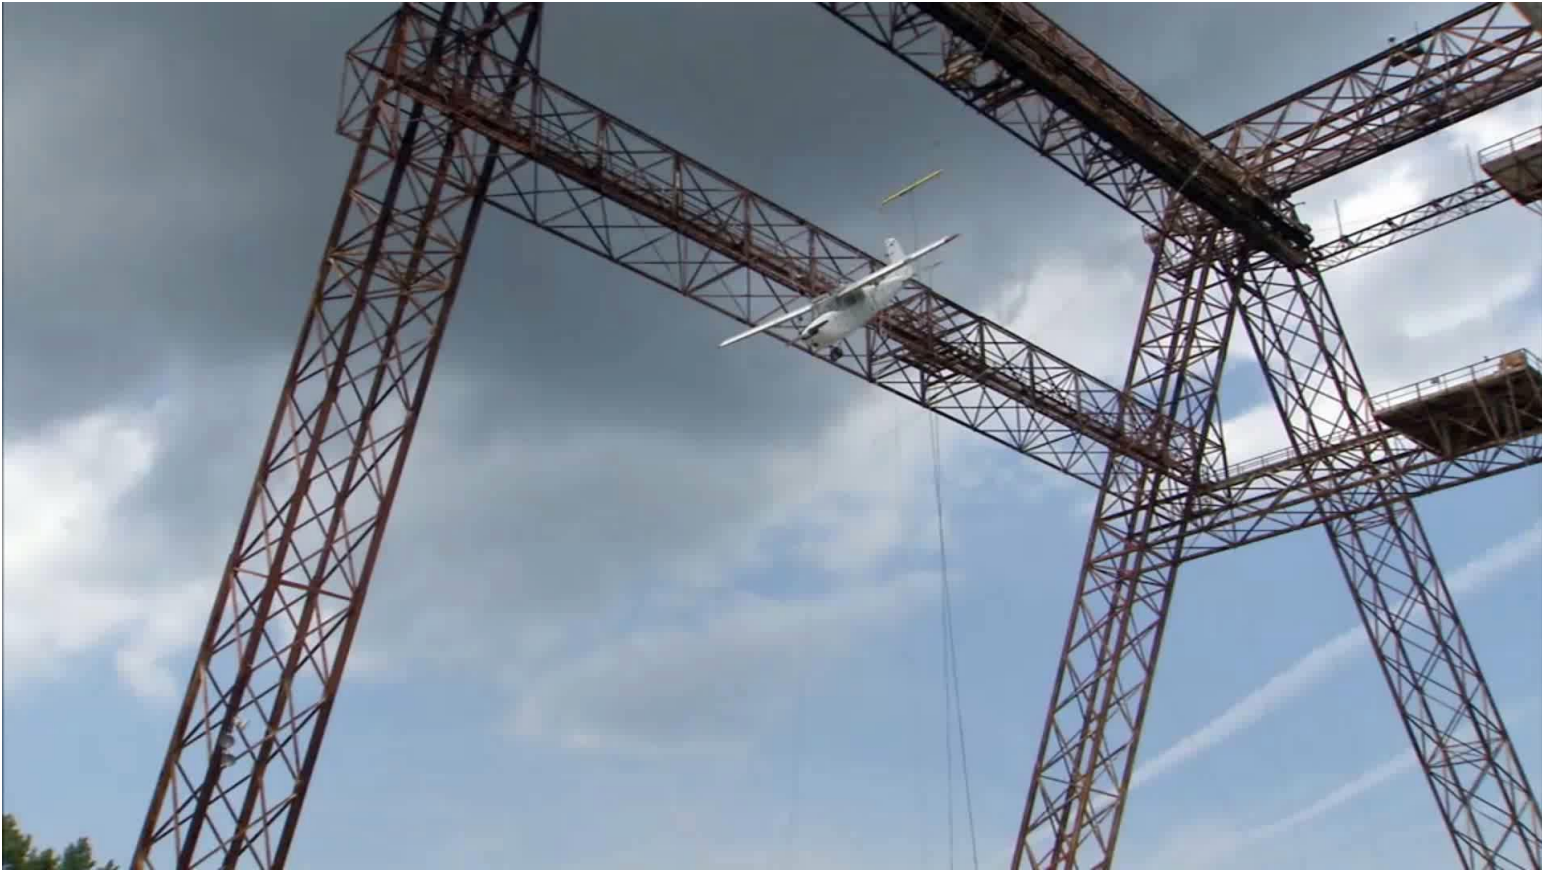
# Test 2 – Controlled Flight into Terrain (CFIT) Nose Down

- Horizontal Velocity = 68.6 ft/sec
- Vertical Velocity = 28.7 ft/sec
- Pitch Angle = 12.2 deg nose down

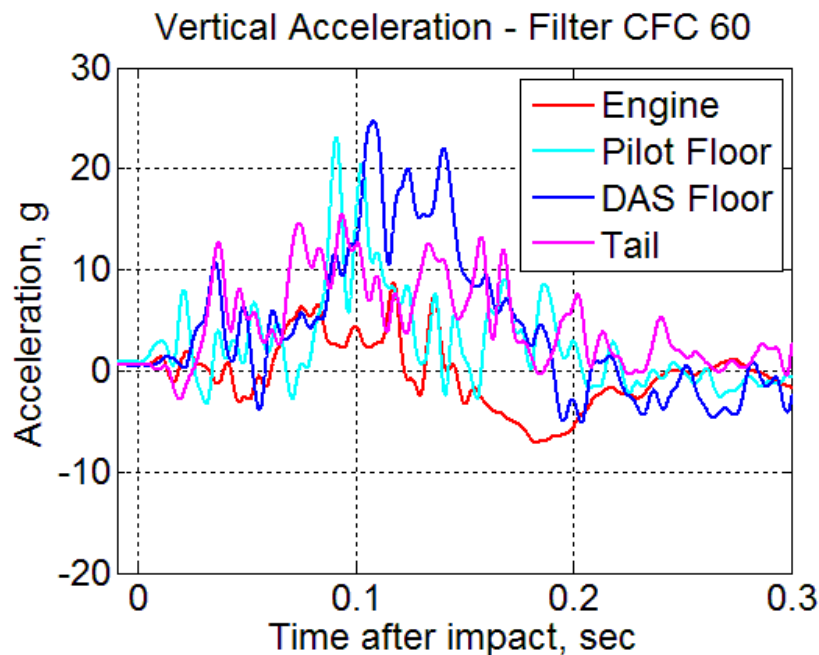
# Test 2 – Airframe Response

- Vertical Acceleration
  - Triangular to trapezoidal in nature
  - Peaks of 23.2 g and 24.7 g for Pilot floor and DAS floor, respectively
- Horizontal Acceleration
  - Triangular in nature with peaks of 27.1, 39.5 and 19.9 g in Pilot Floor, DAS Floor and Tail
  - Uniform in shape
  - Large spike in DAS floor could be from any number of dynamic events onboard
- Rotation of the airplane occurs well after the peak values in acceleration shown (i.e. at 1 second the aircraft is vertical)

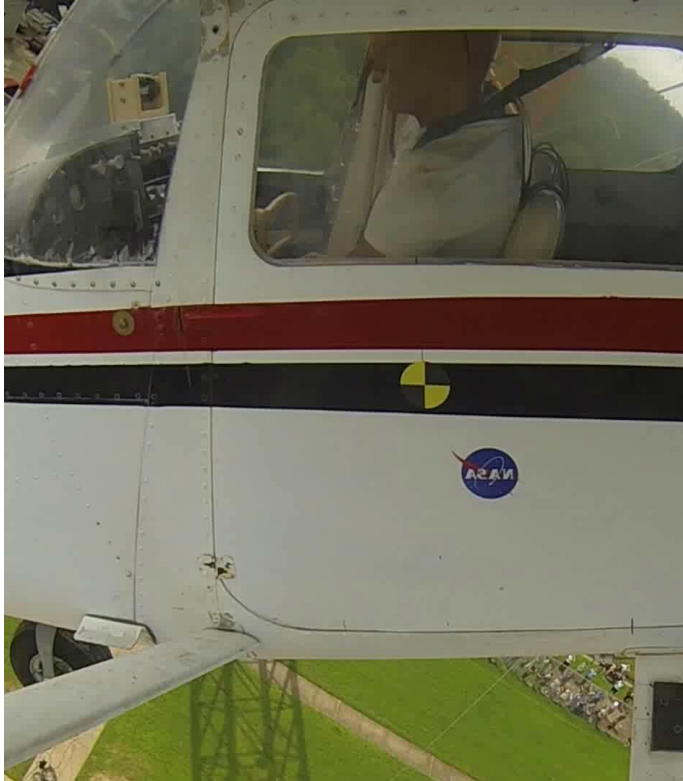
**Co-Pilot -  
Y-harness**

- Failure in y-harness restraint in Co-Pilot gave similar flail motion to lapbelt only restraint in Pilot

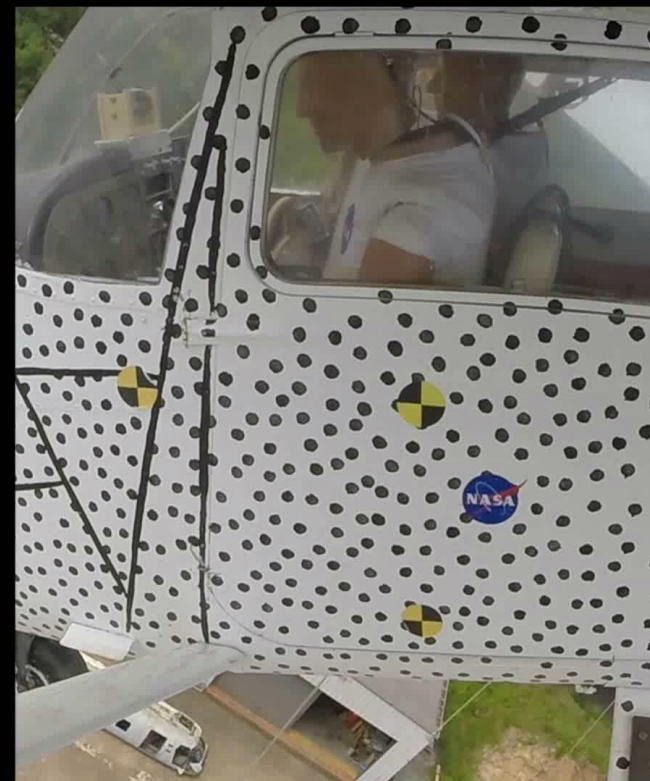
**Pilot -  
Lapbelt**

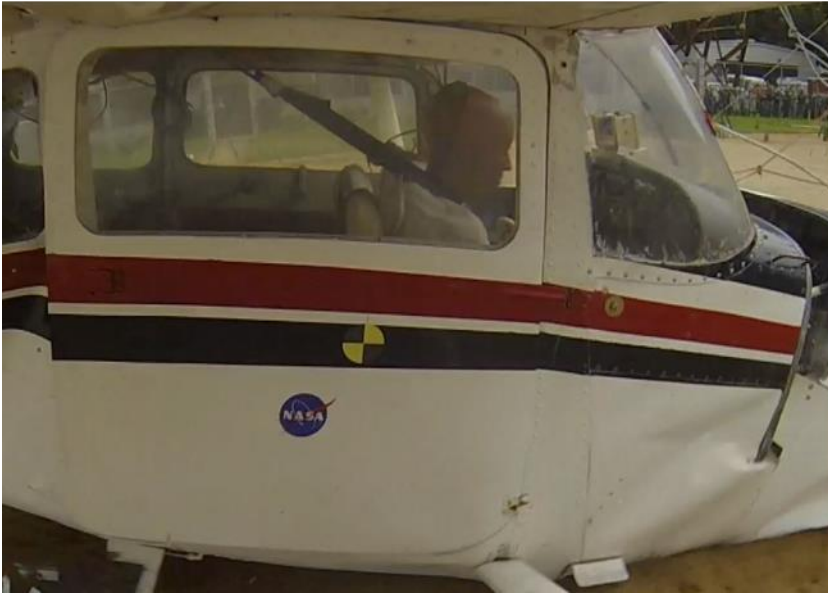
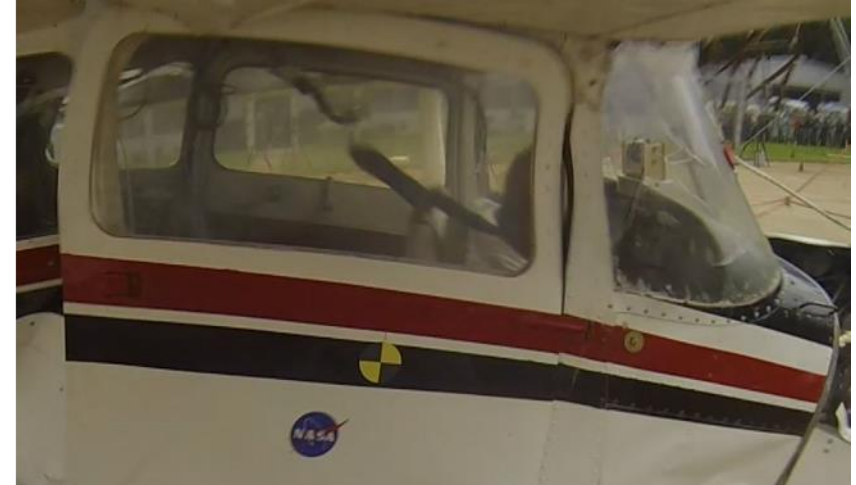
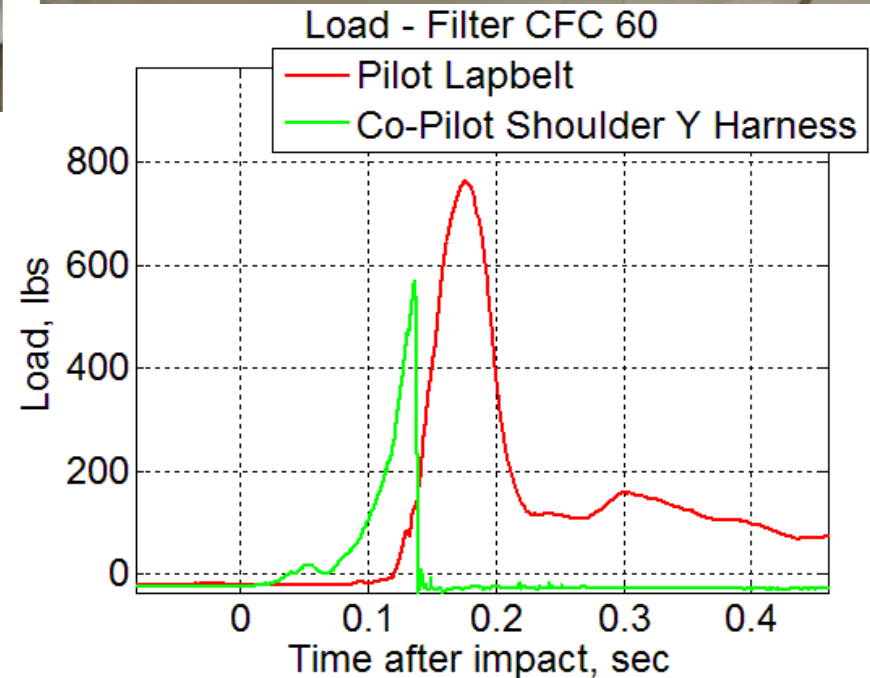
# Test 2 – Restraint Fail

- Y-harness failed at the stitching, not webbing

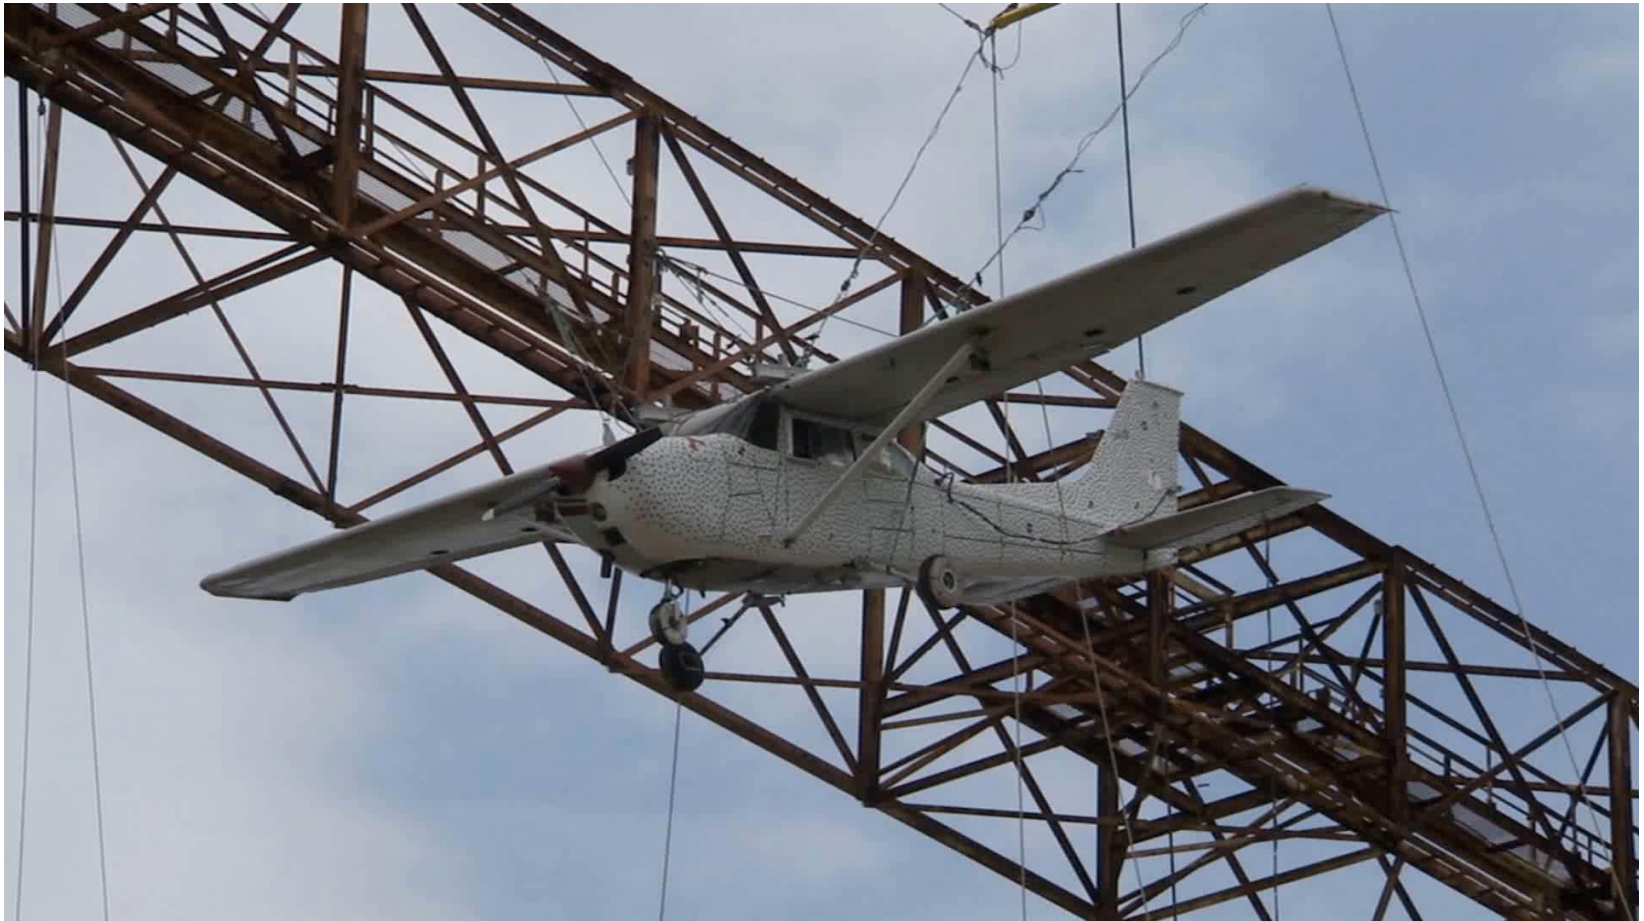
# Test 3 – CFIT Tail Strike

- Horizontal Velocity = 56.9 ft/sec
- Vertical Velocity = 23.6 ft/sec
- Pitch Angle = 8.0 deg nose up

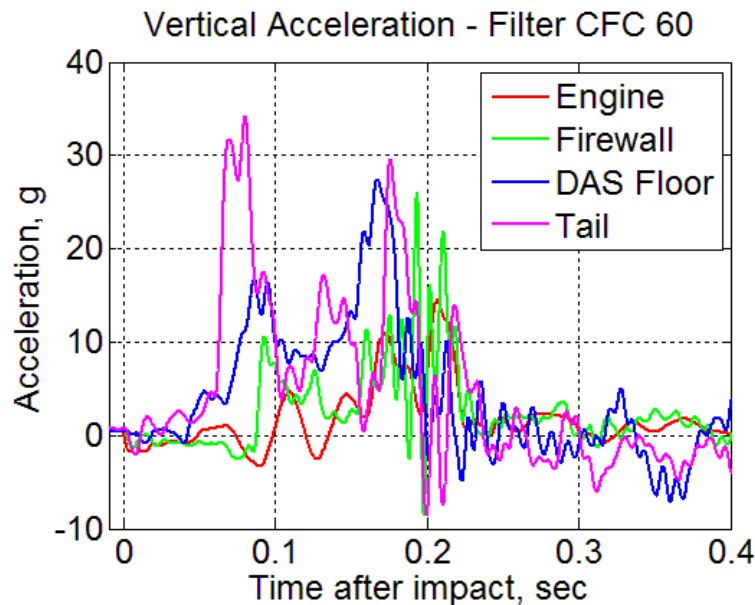
# Test 3 – Airframe Response

- Vertical Acceleration
  - Trapezoidal in nature with peaks at end, due to “slap down” effect
  - Tail strike is captured in vertical acceleration peaks at 32 g
  - Peaks of 27.5 g, 26.0 g, and 15.5 g for DAS floor, firewall and engine, respectively
- Horizontal Acceleration
  - Triangular to trapezoidal in nature
  - Firewall peaks at 38.9 g, however, signal likely noisy -> engine peaks at 22.1 g
  - DAS floor can be interpreted as being a trapezoidal pulse shape having a sustained acceleration of 50 msec and a sustained peak of 8.7 g
- Rotation of the airplane occurs well after the peak values in acceleration shown

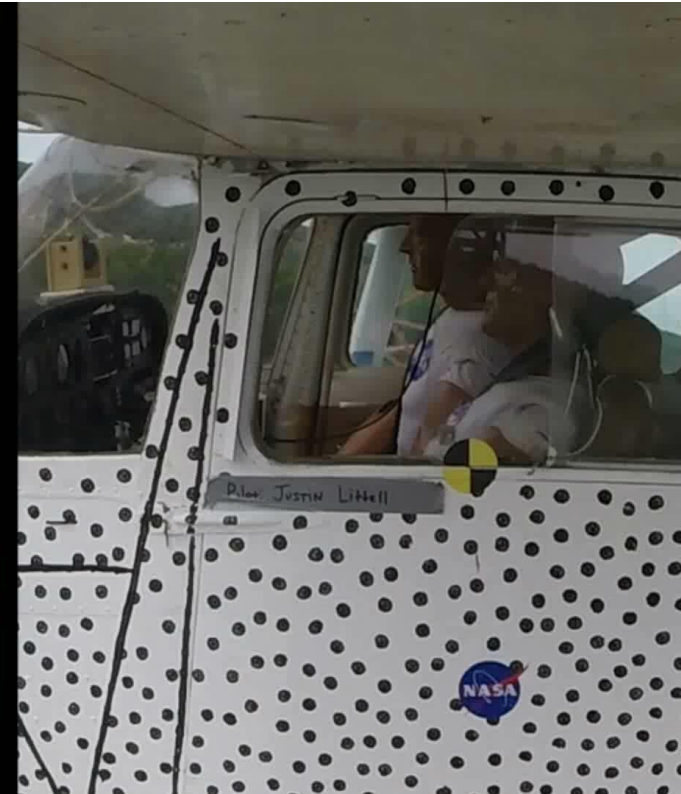
**Pilot -**  
Shoulder+  
Lap

- Due to the addition of an armrest on the door, the Co-Pilot positioning was offset forward of the Pilot
- Both types of restraints limited ATD head motion

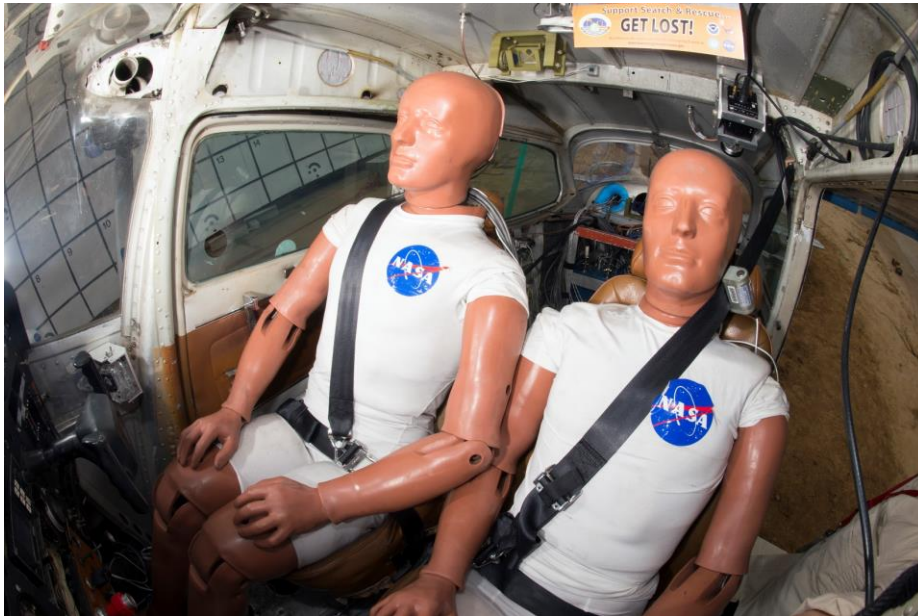
# Test 3 – Restraint Loads

- Both measured on the shoulder harness
- Similar response exhibited by inertia reel and fixed shoulder harness
