Detecting Hidden Fires On Aircraft Using Thermal Imaging Cameras

Report No.: LTR-SMM-2017-0120

NATIONAL RESEARCH COUNCIL CANADA

AEROSPACE

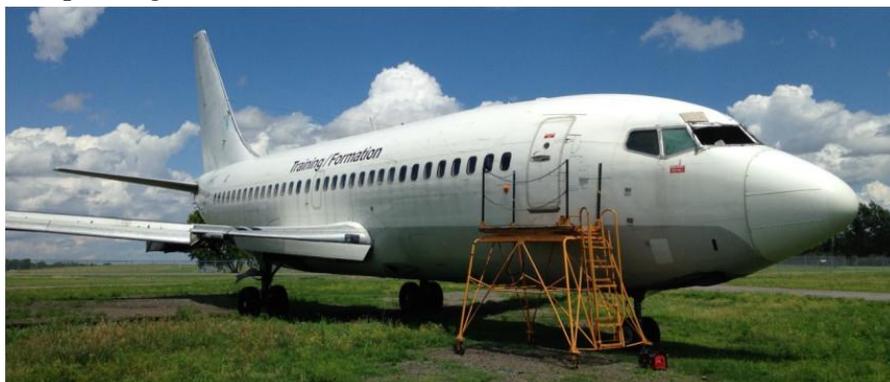
Fig. 1. OIAA ERS Trainer: Passenger B737-200.

The project was executed in collaboration with the OIAA ERS. The majority of tests were performed on the OIAA ERS's Boeing 737-200 training aircraft, shown in Fig. 1. The aircraft is configured with a passenger interior.

The B737 training aircraft was donated to the ERS in an incomplete passenger configuration. Some ceiling and over-head baggage bins were missing, as were many seat sets. The final operating configuration had been as a Combi, where the forward section was fitted for bulk main-deck cargo. The interior has since been populated with additional seat sets, but they do not fully fill the cabin at the normal density (99 seats). The aircraft electrical systems can not be powered.

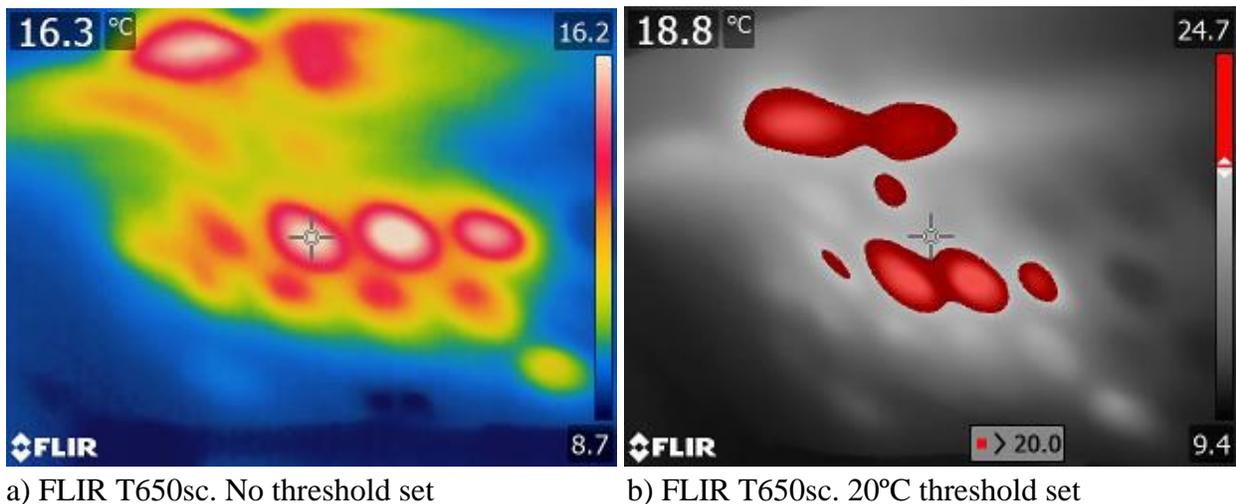
Fig. 3. Colour and greyscale thermal images.

Fig. 3a is false-colour with no threshold set, while Fig. 3b shows the areas that exceed a 20°C threshold setting in shades of red. These two views compare the same area taken with the FLIR T650sc.

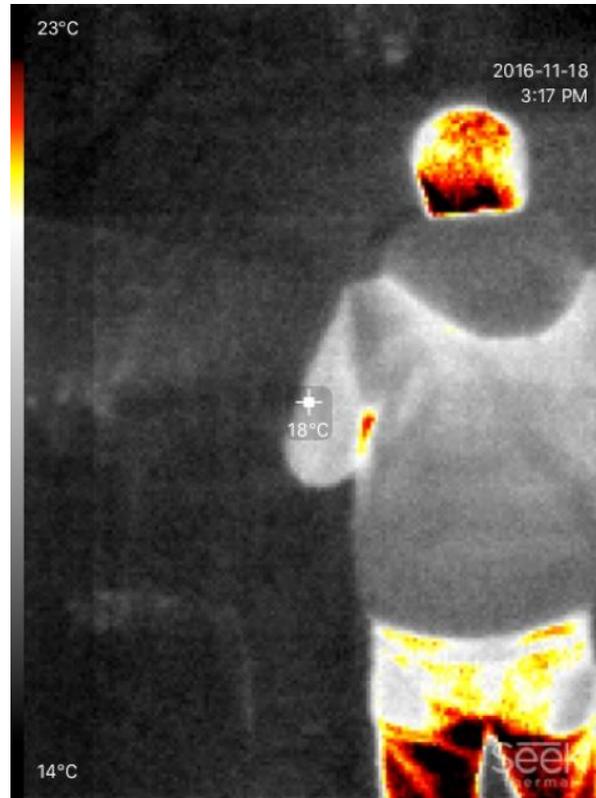
Fig. 4. SEEK Thermal image of TIC operator, 20°C threshold.

A SEEK Compact thermal image of a person in the test aircraft cabin is shown in Fig. 4. The camera is set to “White is Hot”, centre spot, with a threshold of 20°C. Note that the increasing temperatures are represented in a gradient starting from black up to white at the threshold. Above the threshold the areas are false-coloured starting with yellow, then red and the highest temperatures are again black.

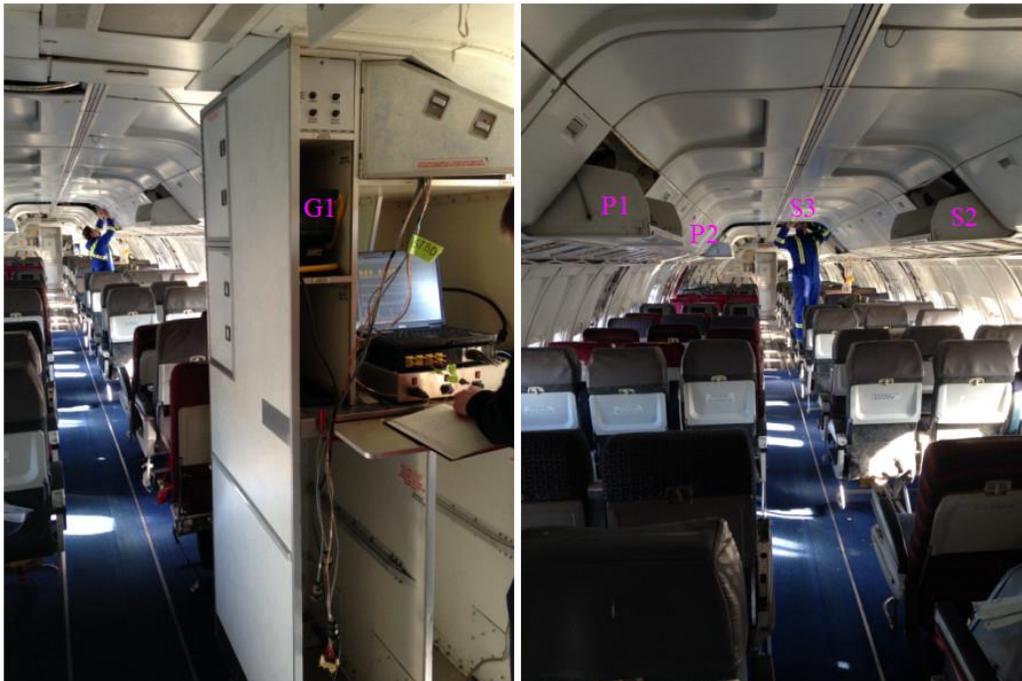
a) Computer and heater control in aft galley b) Heater installation in bins, seats, attic

A computer in the aft galley, shown in Fig. 5a, controlled the heater strip power supplies individually via a thermocouple (TC) attached to each heater. A heating ramp rate was set along with a maximum temperature to be maintained (104°F or 194°F, 40°C or 90°C). The flexible wire-grid heater strips were 6 x 1 inch (15.2 x 2.5 cm) and affixed to a small aluminium plate. At each heater installation, a second thermocouple was mounted on the structure to monitor and record the local heating, as shown in Fig. 6. The ambient temperature in the un-powered, un-heated aircraft at the times of the tests varied between -4°F to 57°F (-21°C to 14°C). Very low maximum heater temperatures were set to avoid heat damage and unintentional fires. The highest temperature measured in a 40°C test was 38°C, and in a 90°C test was 88°C.

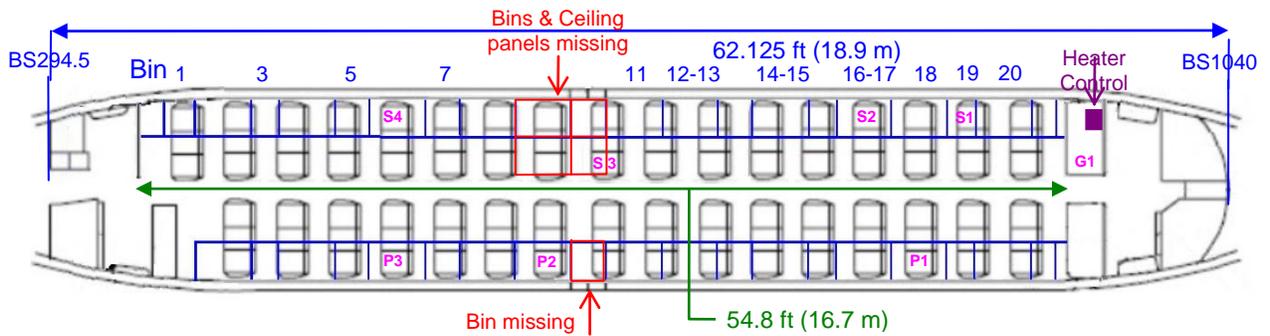
Fig. 7. B737-200 single class cabin layout.

head bin numbering system, as marked in the cabin, is also illustrated.

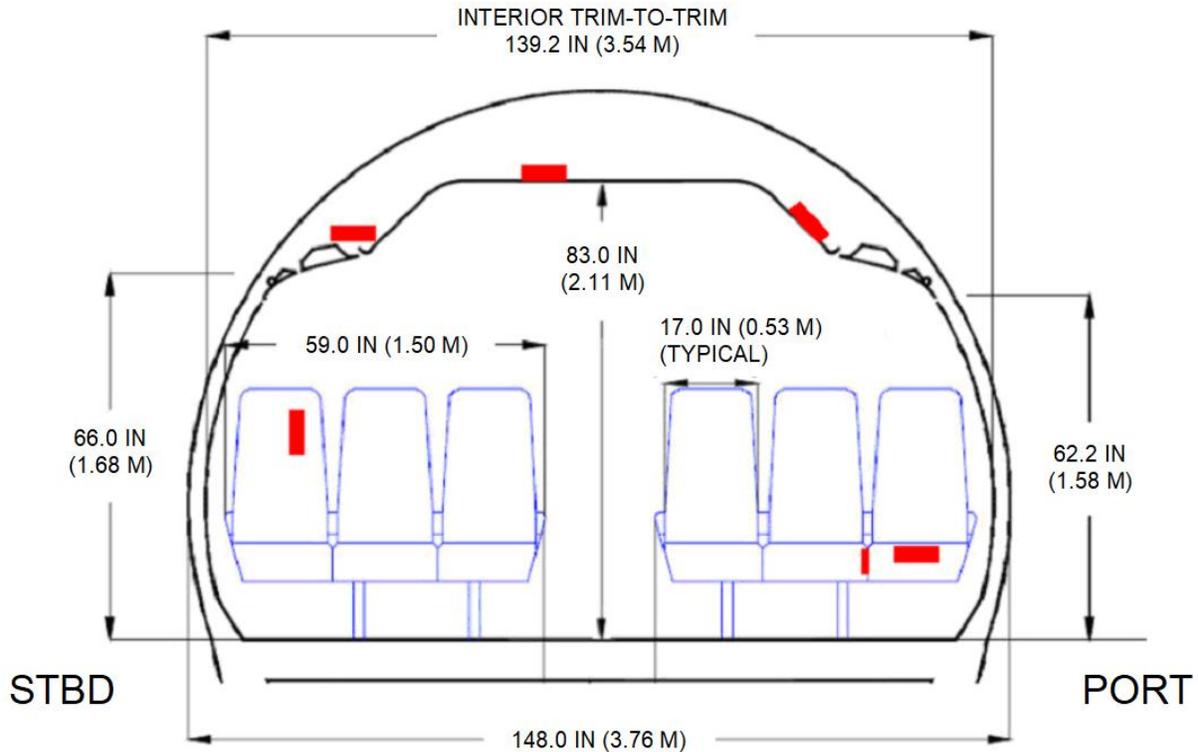
Fig. 8. Cabin cross-section, looking aft with dimensions and test sites.

Fig. 8 shows the cabin in cross-section. Table 1 provides a description of the eight test sites.

Sites S1, S2, P2 and P3 are significant because these luggage bins may contain a heat source (damaged or shorted PED battery that produces heat and open flames) combined with an adjacent fuel supply (baggage container and contents potentially including other battery cells). Initially they may be the source of an early warning odour and/or smoke. The heat source cannot be remotely turned off.

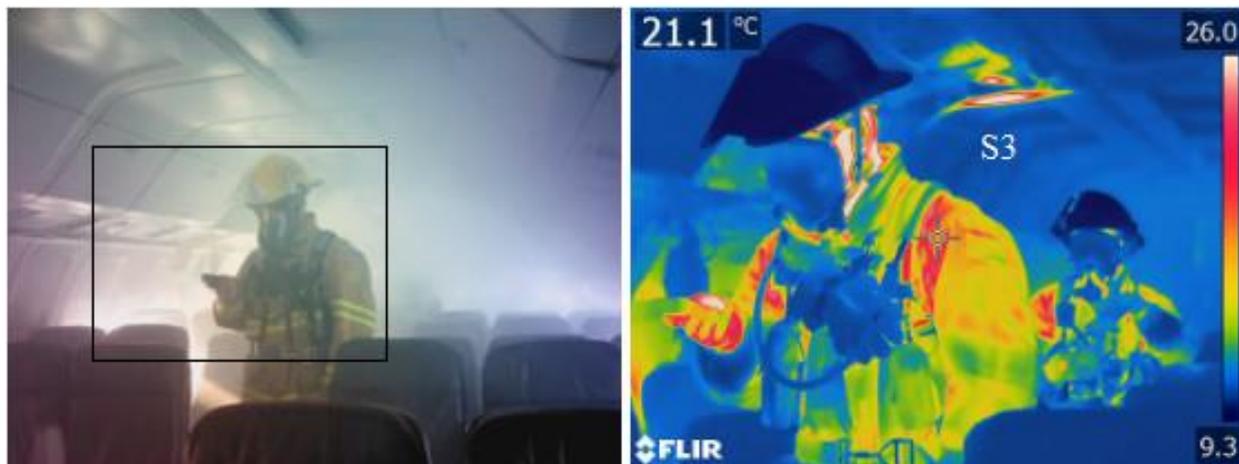
Fig. 10. FLIR T650sc visual and thermal image pair of heat source in ceiling panel. Note second firefighter obscured by fog.

The fog became thick enough that eventually personnel could not navigate the interior of the aircraft without the aid of a thermal camera. The participants, even those firefighters wearing SCBA with full-face mask could still manage to see the thermal camera displays through a face shield or respirator mask, as shown in Fig. 10. Note the heat source in the ceiling panel and the second firefighter, who cannot be seen in the optical image.

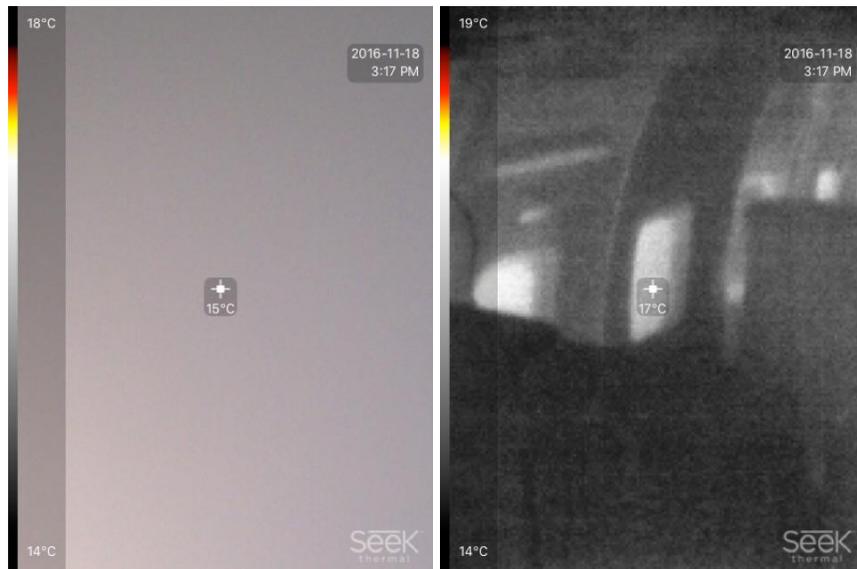
Fig. 11. SEEK Thermal and Visual image pair of port OWE area, in fog.

Fig. 11 shows SEEK Compact visual and thermal camera views captured of the port OWE area after the cabin was filled with fog.

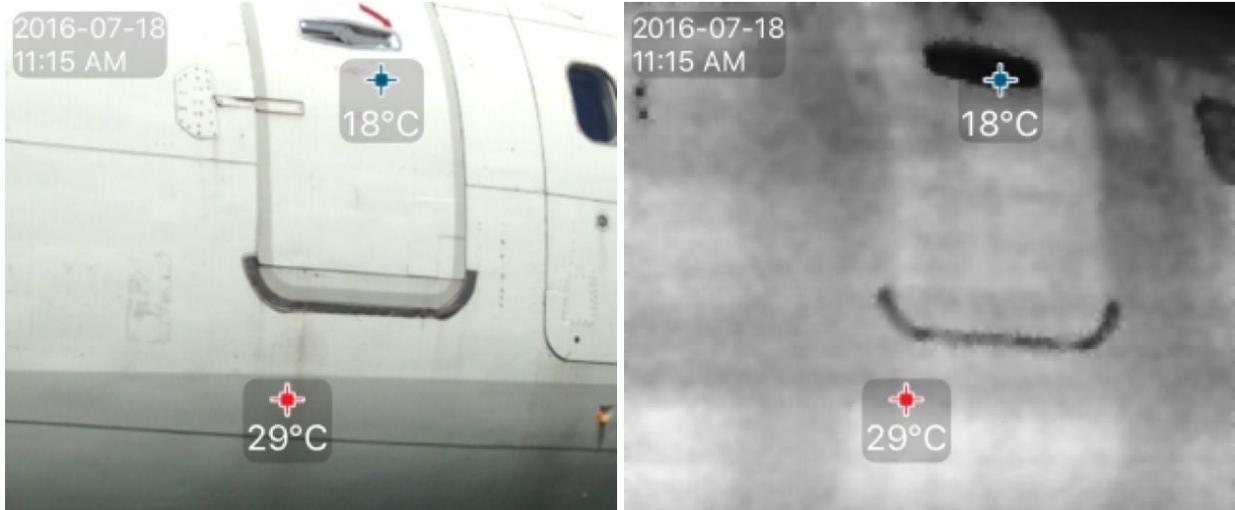
Fig. 13. SEEK visual and thermal pair of the ERS aircraft exterior at the L1 door.

Prior to this project, the work with thermal imaging and analysis has been directed to the exterior of the aircraft. Examples of surfaces and materials that have differing emissivity ratios and how they affect the image and the temperature reported are shown in Fig. 13 where the pallet is “White is Hot”. The different emissivity of the unpainted metal door handle, sill plate and cabin window perimeter compared to the painted exterior of the aircraft makes these areas look cooler because of the inaccurate emissivity setting which has caused the thermal camera software to report the door handle temperature as 18°C whereas the exterior of the aircraft is at 29°C. There are few metallic surfaces in the ERS training aircraft cabin. By themselves they would not obscure a heat source, as other materials surround them.

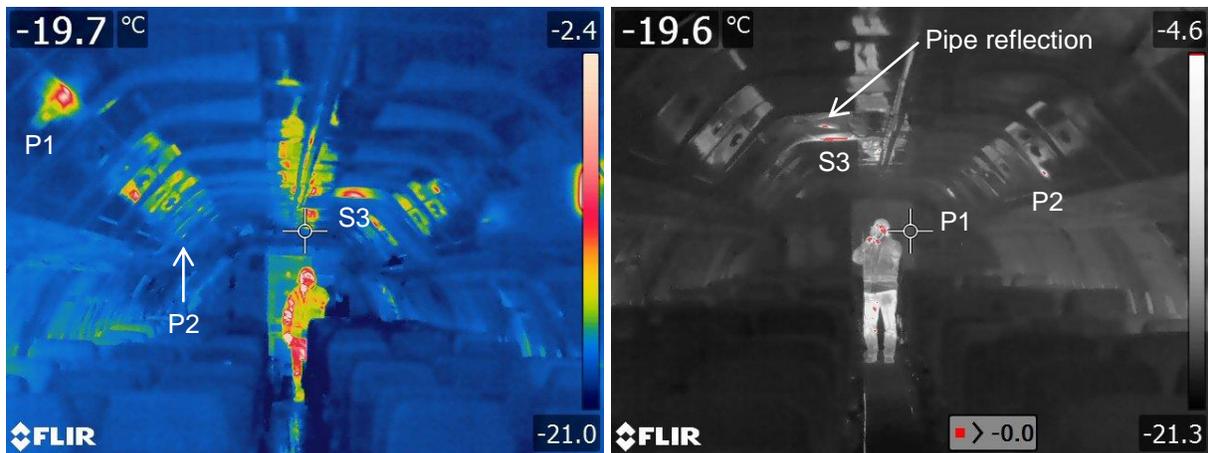
a) False-colour thermal image

The operator’s body heat was observed as reflections in one instance where the cabin ambient was -4°F (-20°C). The operator’s breath condensed on the interior panel surfaces making them reflective. In Fig. 14a the body heat of a person standing at the forward end of the cabin is seen in a false-colour image. The TIC settings were changed from false-colour to greyscale and a temperature threshold of 32°F (0°C) was set. These settings removed the distraction of the body heat reflections as shown in Fig. 14b, which was taken looking aft. In both figures, the heater strips at Site P1, P2 and S3 are energized. This issue, of thermal energy reflecting off an adjacent surface, was previously observed on an attic pipe above Site S3 in the un-powered ERS aircraft – Section 7.6.

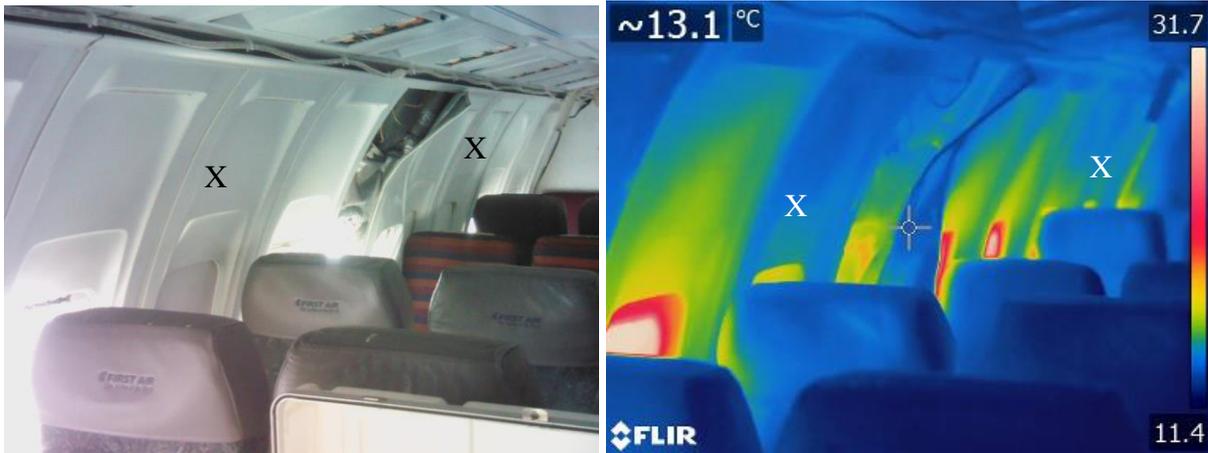
Fig. 15. FLIR T650sc solar heating visual and thermal image pair. Mechanical shades open and closed (X).

Solar heating of cabin windows, their mechanical shades and adjacent side-wall panels has been observed in the un-powered ERS training aircraft. The mechanical window shades are both open and closed as marked (X) in Fig. 15. It is yet to be determined if solar heating of these same components will be observed in thermal views of a cabin during a daytime commercial flight. Air movement resulting from an operating Environment Control System (ECS) may mitigate some of the solar heating. Closing the mechanical blinds or dimming electric windows may still be preferred when scanning the cabin during a search for a hidden fire.

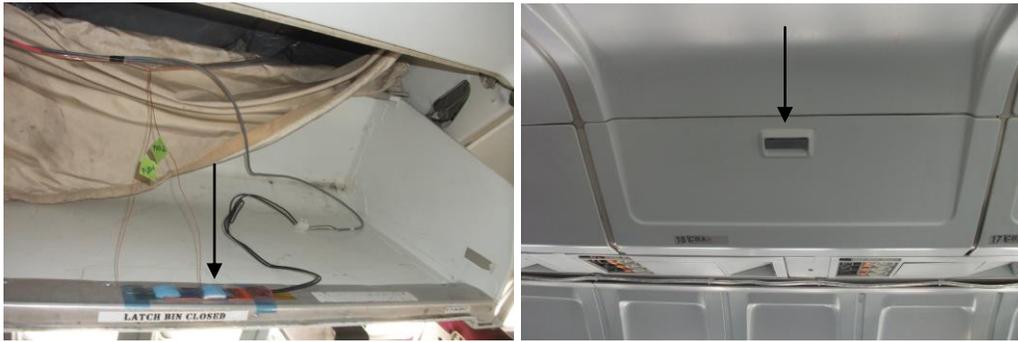
Fig. 16. P1 heater and TC installation in port Bin 18.

An electrical heater strip with both control and sensing thermocouples was adhered to the inner metal edge of the port overhead luggage Bin 18. The heater was set to ramp up to 40°C (104°F) and is shown in Fig. 16. The actual heater setpoint compared to the temperature measured by the IR cameras is of no consequence since the objective is to simply create a hot spot for detection. A heater in an overhead bin could simulate a fire source which is pressed up against the outside edge of the bin or one deep inside a bag, which would be less apparent.

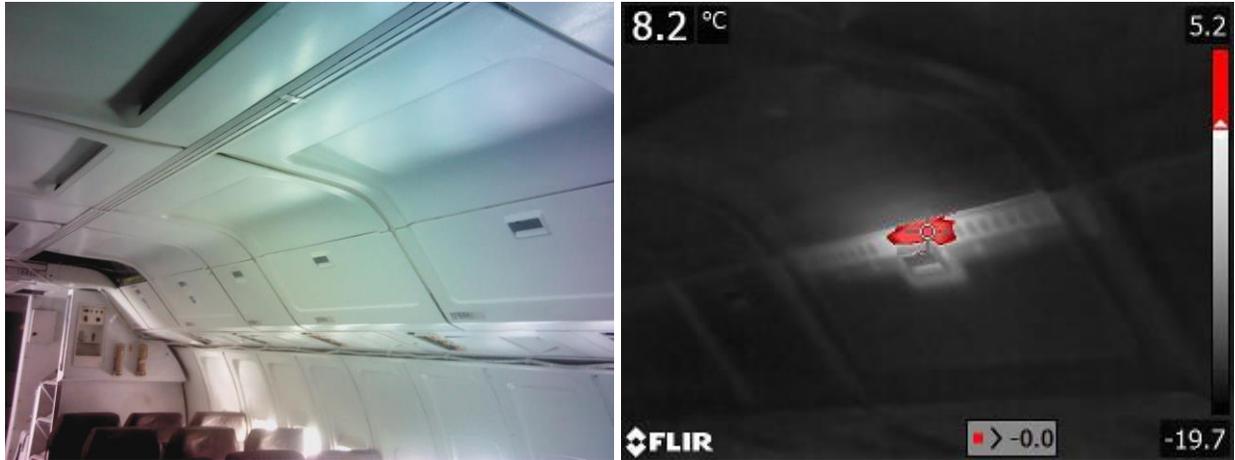
Fig. 18. FLIR T650sc visible and thermal image pair of Bin 18. Greyscale with threshold false-coloured.

this close-up view. The miss-match displaces the superimposed Hi/Lo targets on the visible image. The operator does not see this on the display, it only appears on the stored visual image. Fig. 18 – 20 are pairs of optical and TIC images for both the FLIR T650sc and the SEEK Compact cameras, with and without smoke obscuration.

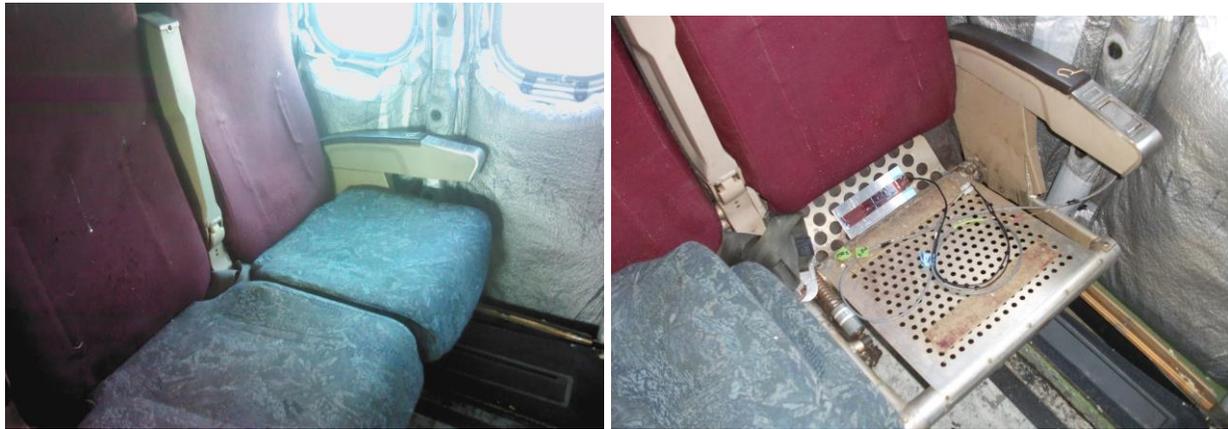
a) Cloth covered seat

There are five different seat constructions populating the cabin. Four types have cloth coverings and one is leather. Three have fabric seat pans while both the newest (2013) and oldest designs (1980) have a metal pan. The 1980s type used for the P3 site had a perforated metal seat pan as shown in Fig. 24b. An electric strip heater attached to a metal plate represented an overheating PED fallen behind or between seat cushions. The seat cushions may envelope and hide the PED from view while acting as an insulation layer above the heat source. The heater was set to 90°C maximum.

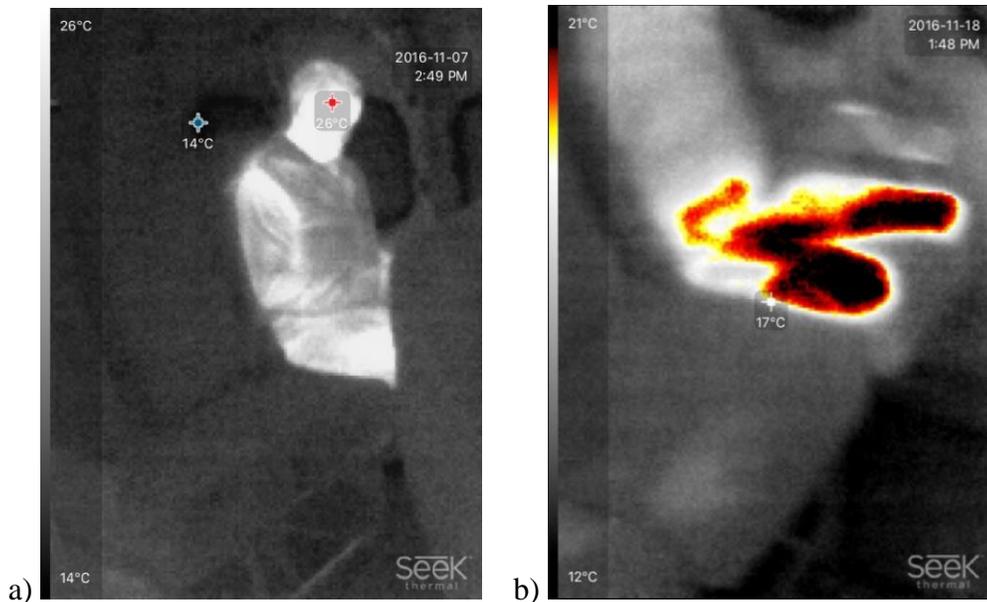
a)

Early detection from the front side may be problematic due to there being an occupant or residual heat in the cushions after being vacated by the occupant, as illustrated in Fig. 25.

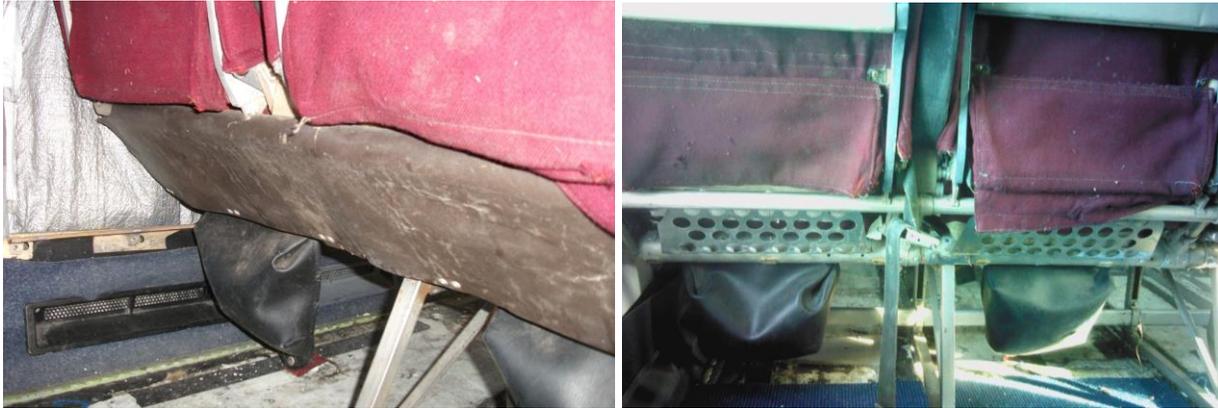
a) Seat back with plastic valence panel

This concern lead to thermal views being captured from the seat row behind to explore this as a better viewing position. The seat has a plastic rear valence, which is shown in-situ and removed in Fig. 26. Detection from behind would not be affected by a passenger occupying the seat.

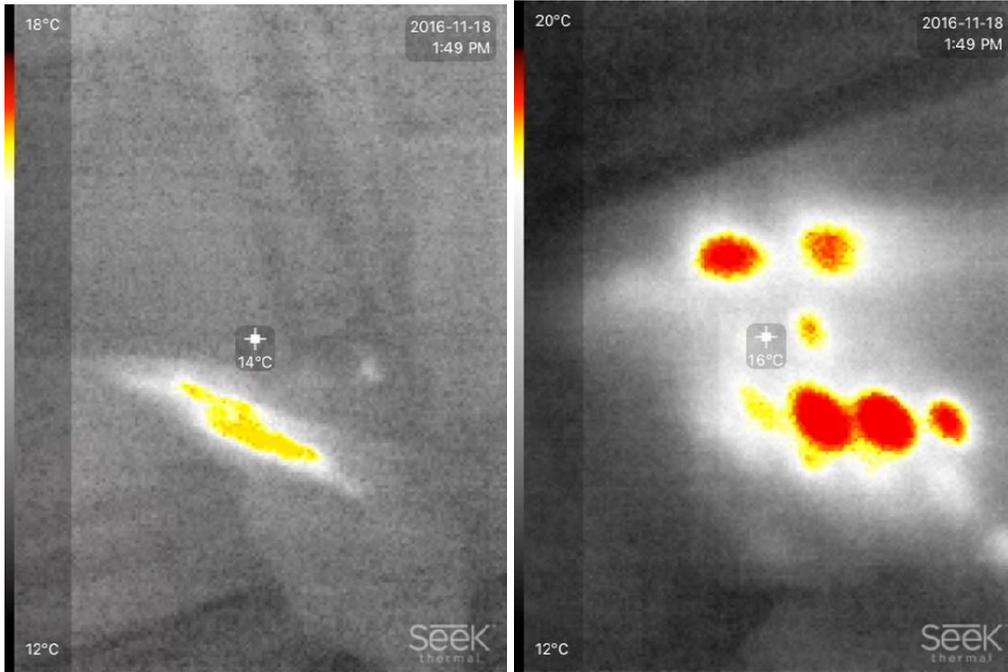
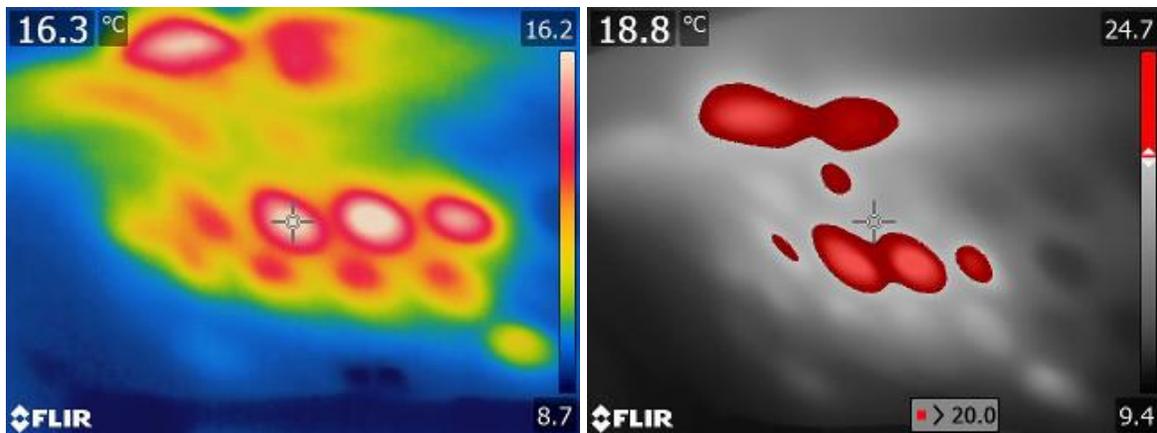
a) SEEK thermal viewed from centre aisle b) Seat back viewed from behind

Fig. 27 shows four thermal views of heat affecting the rear valence as seen first from the aisle and then from more directly behind. Heat is radiating more directly onto the valence through the perforations in the seat structure.

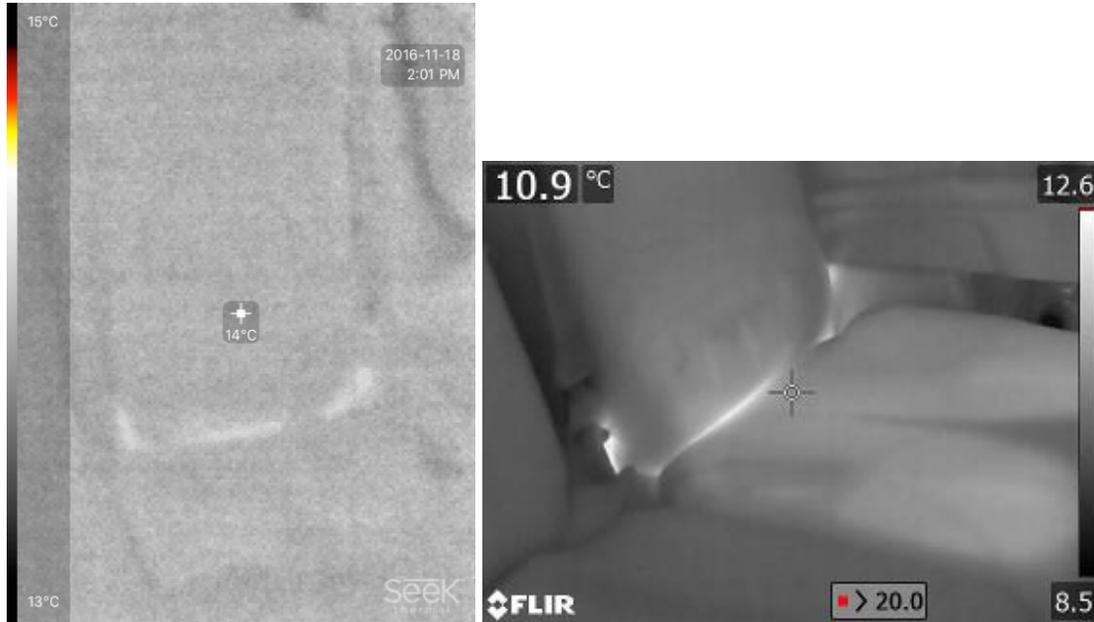
Fig. 28. SEEK and FLIR T650sc views of heater at rear of bottom cushion, site P3.

Fig. 28 shows two TIC views with the heater between the back and seat cushions. The image was taken 13 minutes after the thermal image Fig. 25b was captured. Note that some residual heat from the occupant is still visible on the seat cushion in that view.

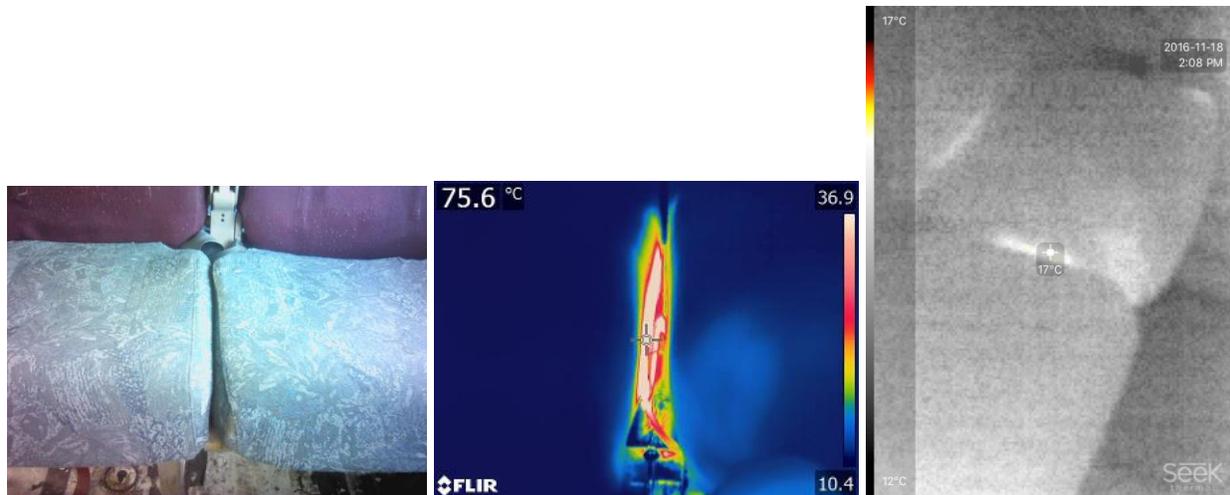
a) Heater between cushions b) FLIR T650sc thermal c) SEEK thermal from aisle

It was found that a heater located between adjacent seat cushions could be enveloped and insulated by the low thermal conductivity of the cushions, making detection in this location difficult. Thermal views from directly in front and also from the aisle are shown in Fig. 29.

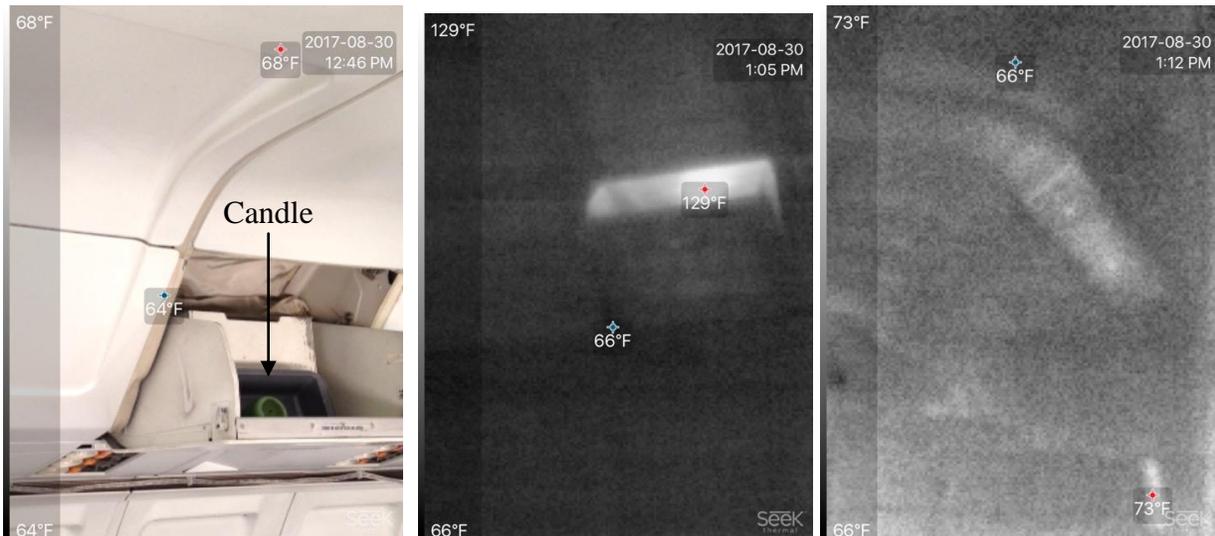
a) Bin 19, candle in metal pan b) At 5:16 Bin opened briefly c) At 11:29

The candle was burned for a total of 12 minutes, although the last overall thermal view of the bin exterior was captured at 11:29. In this view, shown in Fig. 30c, the temperature differential between the coldest (an adjacent ceiling panel) and the hottest (a solar heated cabin window) areas is only 7°F (3.9°C). The representation of the heated bin and ceiling panel is obvious in the thermal view, yet it is composed of temperatures within this small differential.

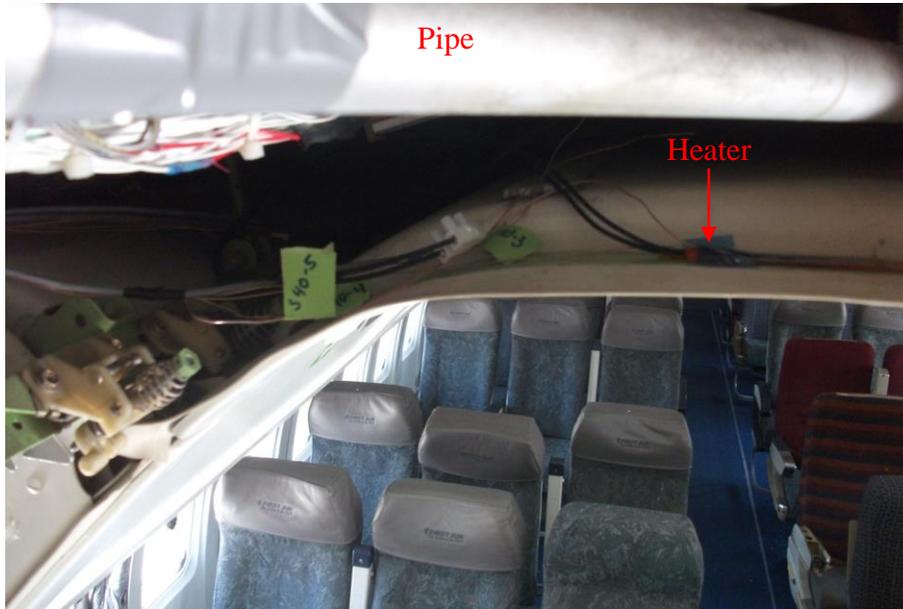
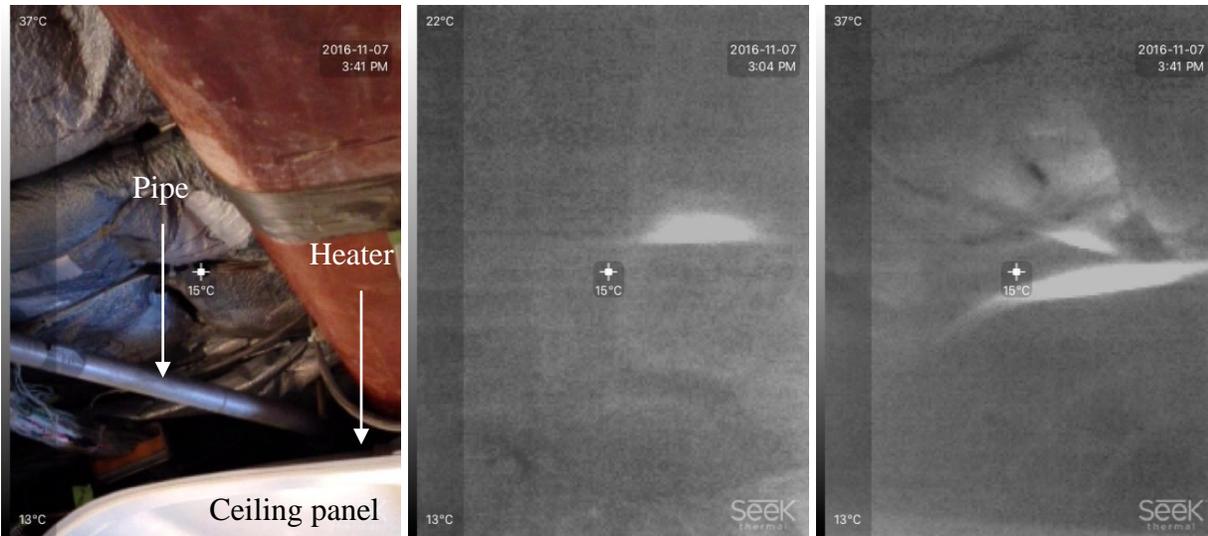
Fig. 32. Site S3 Heater installation and SEEK Thermal views.

An electric strip heater was installed on the upper surface, forward edge, of the ceiling panel adjacent to starboard Bin 11, as shown in Fig. 32a. The adjacent ceiling panel was missing. With the heater energized and viewed from forward and into the exposed attic space, a metal pipe was found to reflect the radiant energy, as shown in Fig. 32b. This was one of the few instances where heat was reflected off of another surface that could potentially confuse the location of the actual heat source.

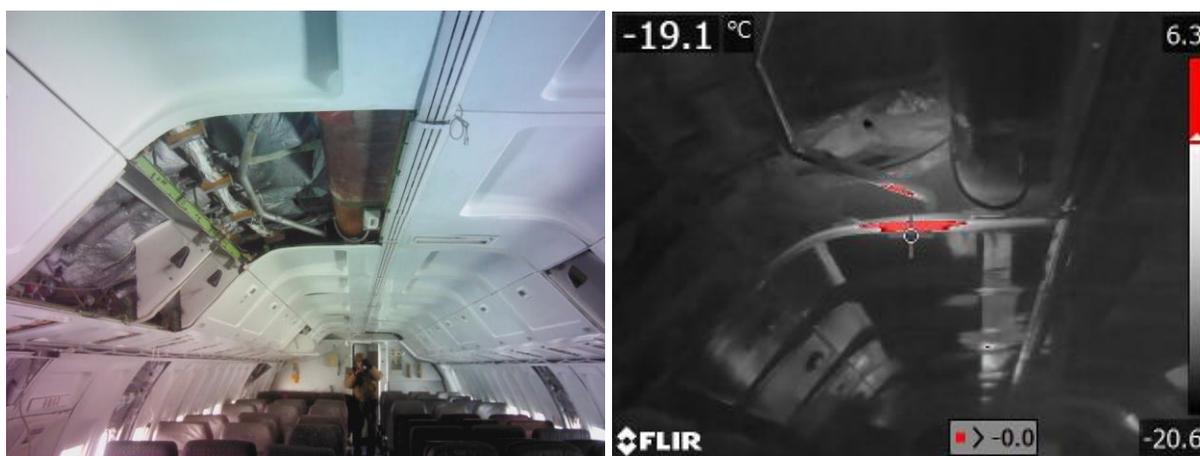
Fig. 33. Visual and Thermal image pairs of ceiling panel, site S3.

b) FLIR T650sc. From FWD

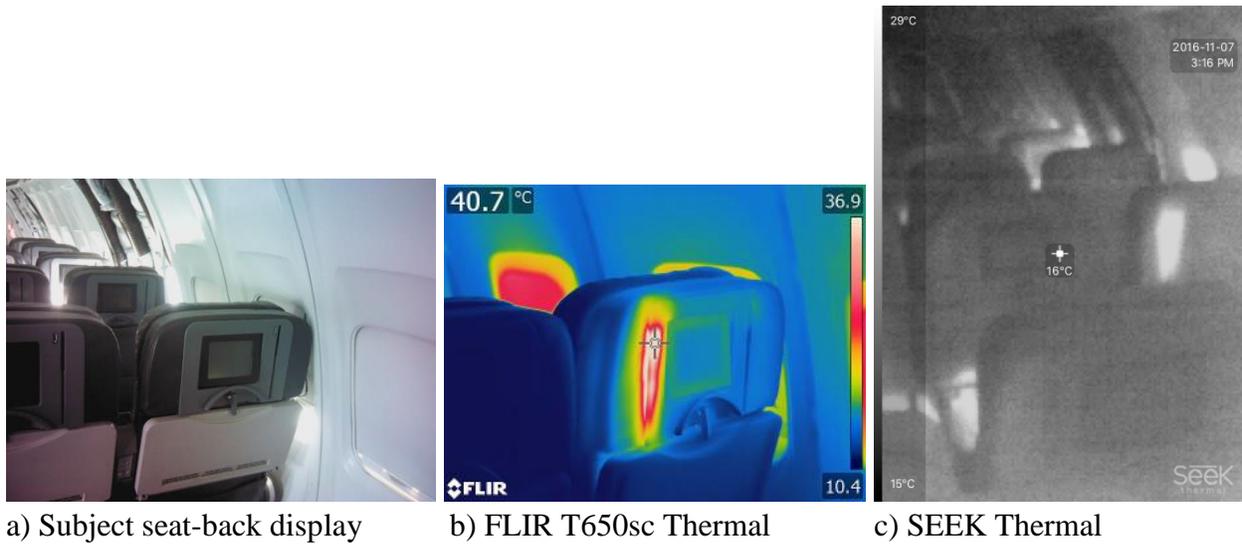
Fig. 34. Seat-back display with electric heater strip energized, site 4.

The simulated overheating of the electronics of a seat-back display was not tested in fog conditions. The surrounding material of one seat-back display on the un-powered ERS training aircraft was removed to install an electric heating strip under the plastic trim piece, which was then re-installed. With the heater strip energized, the FLIR T650sc measured a maximum temperature on the surface of the surround at 105.3°F (40.7°C). The SEEK thermal camera was also set to centre spot, which was located on the adjacent seat-back (ambient at 60.8°F, 16°C), as shown in Fig. 34. The highest temperature in the view was 84.2°F (29°C). The operator may not know if the highest temperature is the solar heating of the cabin window, but the seat-back heating would be unusual compared to the other seats in the view and thus draw attention.

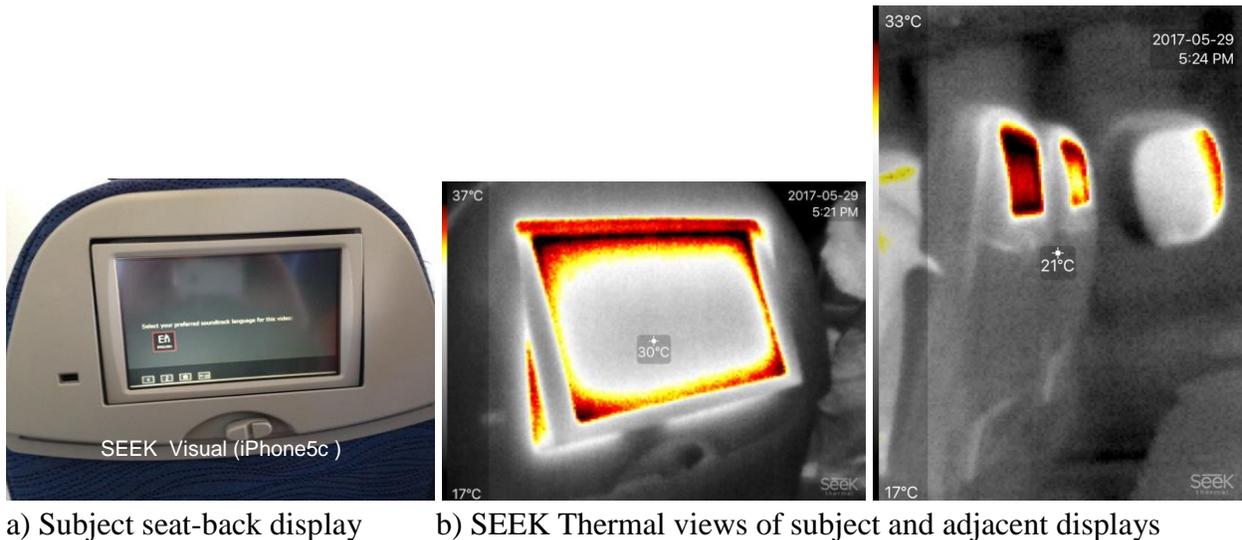
Fig. 35. Visual and Thermal views of operational seat-back displays.

Visual and thermal images were captured of the normal operational condition of a seat-back display in-flight, as shown in Fig. 35. A threshold of 86°F (30°C) was set and those areas exceeding this temperature were false-coloured. The adjacent seat close-up image shows a maximum temperature of 98.6°F (37°C) while the view across the aisle of two identical displays shows a maximum of 91.4°F (33°C). The colourized area in the cabin window area may be a thermal reflection.

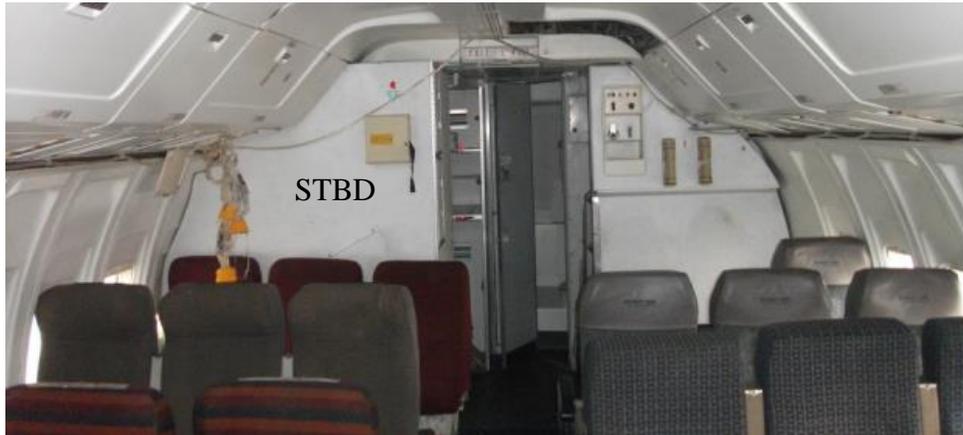
Fig. 36. Aft cabin galley area viewed from cabin, site G1.

On aircraft, the ovens and coffee machines are used to re-heat prepared foods. The coffee carafe is heated by an electrical element in the base of the unit. The electrical supply to the oven(s), coffee maker(s) and other appliances in the galley is through an adjacent circuit-breaker panel in the galley cabinet.

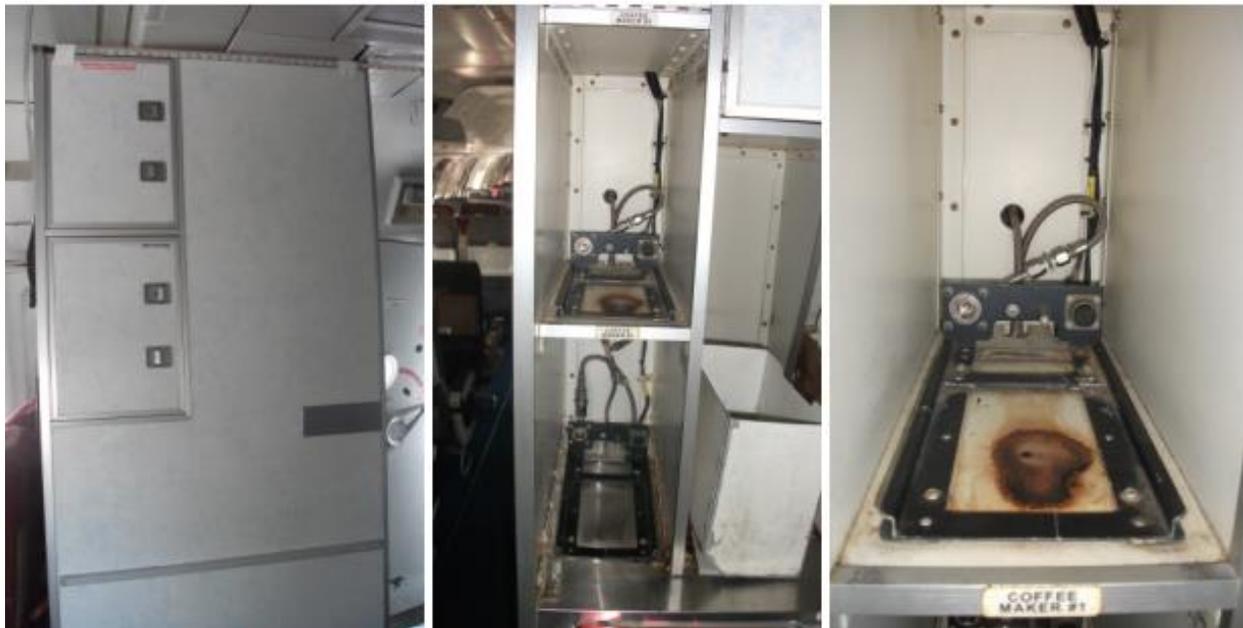
Fig. 37. Aisle side view and coffee maker bays of aft starboard galley, site G1.

A quartz halogen heat lamp was placed in the upper coffee maker bay of the aft starboard galley. The bottom partition of the upper bay showed evidence of minor heat damage as shown in Fig. 37. The lower bay has a metal sheet covering the surface and thus did not show any heat damage.

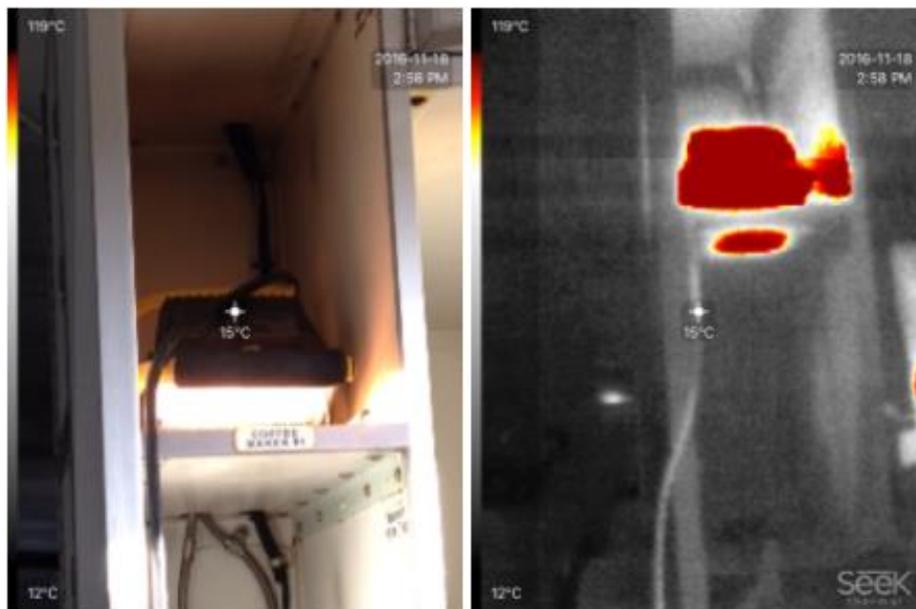
Fig. 38. Heat lamp effect on bottom partition of upper coffee maker bay, site G1.

Fig. 38 shows the heat lamp energized and the corresponding SEEK thermal image. With both coffee makers in place, it would be difficult to detect an overheat of the upper unit while viewing from in front or below.

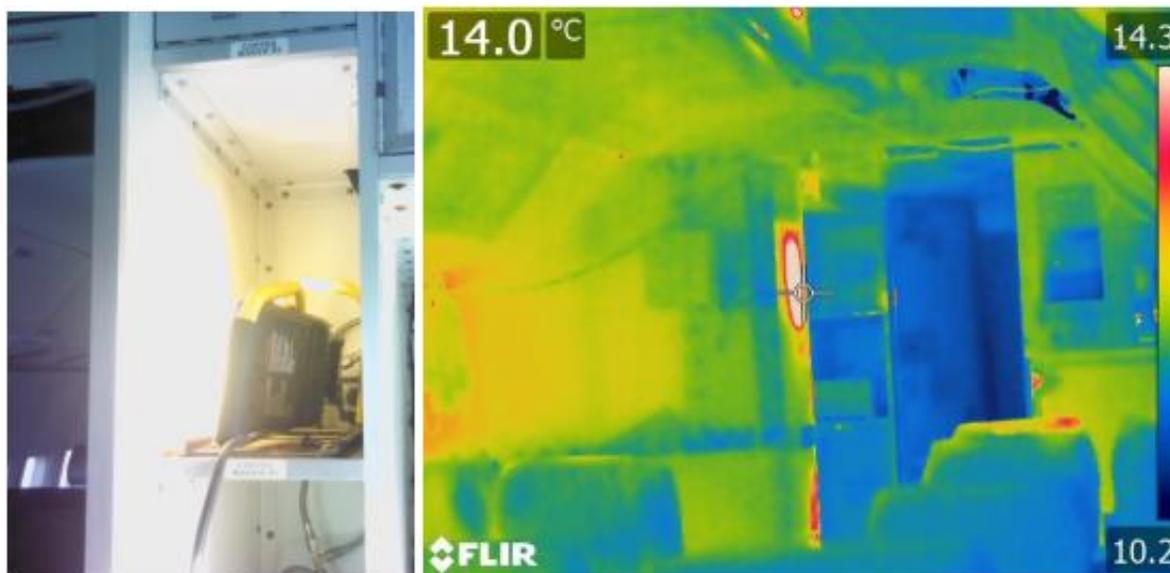
a) Heat lamp in coffee maker bay b) FLIR T650sc Thermal view from cabin

The lamp was next oriented towards the aisle side-wall of the galley cabinet to determine if an overheating event could be more easily detected from the outside of the cabinet. It did not take long for the heat to be detected from a position forward in the cabin, as shown in Fig. 39.

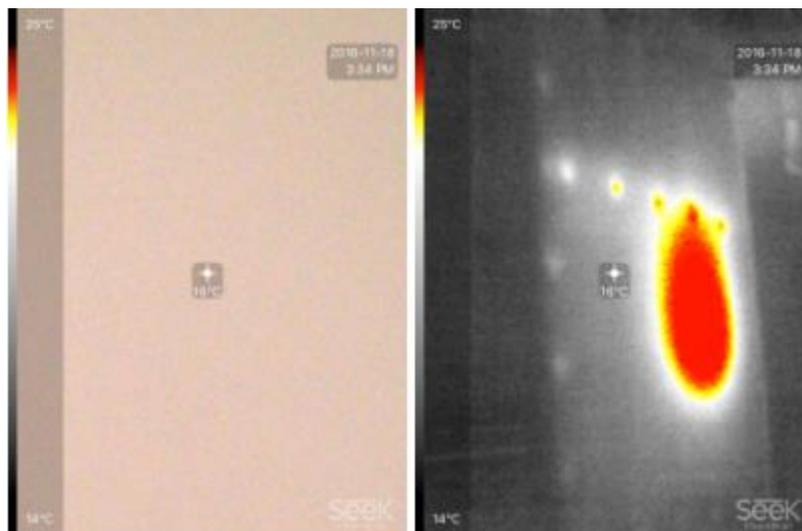
Fig. 40. SEEK Visual and Thermal image pair of coffee maker bay, in fog, site G1.

This same test condition was also repeated after the introduction of fog, as shown in Fig. 40.

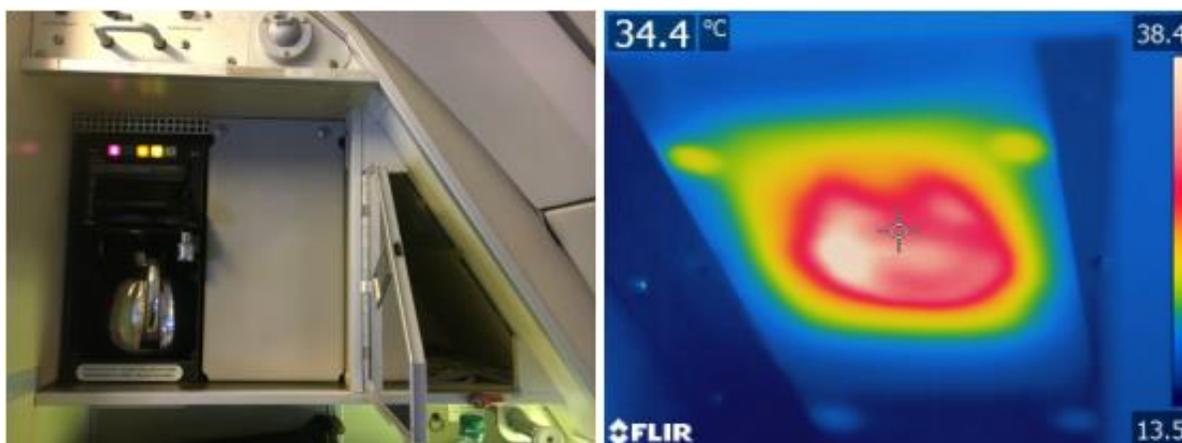
Fig. 41. Single coffee heater carafe in upper galley bay, site G1.

In some galley configurations there is a single coffee heater on an upper shelf with clear access to view the bottom surface. Fig. 41 illustrates such a configuration. The thermal image of the bottom surface of the upper bay in the ERS galley, heated with the heat lamp, illustrates the possibility to view the underside for overheat conditions.
