Detecting Hidden Fires On Aircraft Using Thermal Imaging Cameras

Report No.: LTR-SMM-2017-0120

NATIONAL RESEARCH COUNCIL CANADA

AEROSPACE

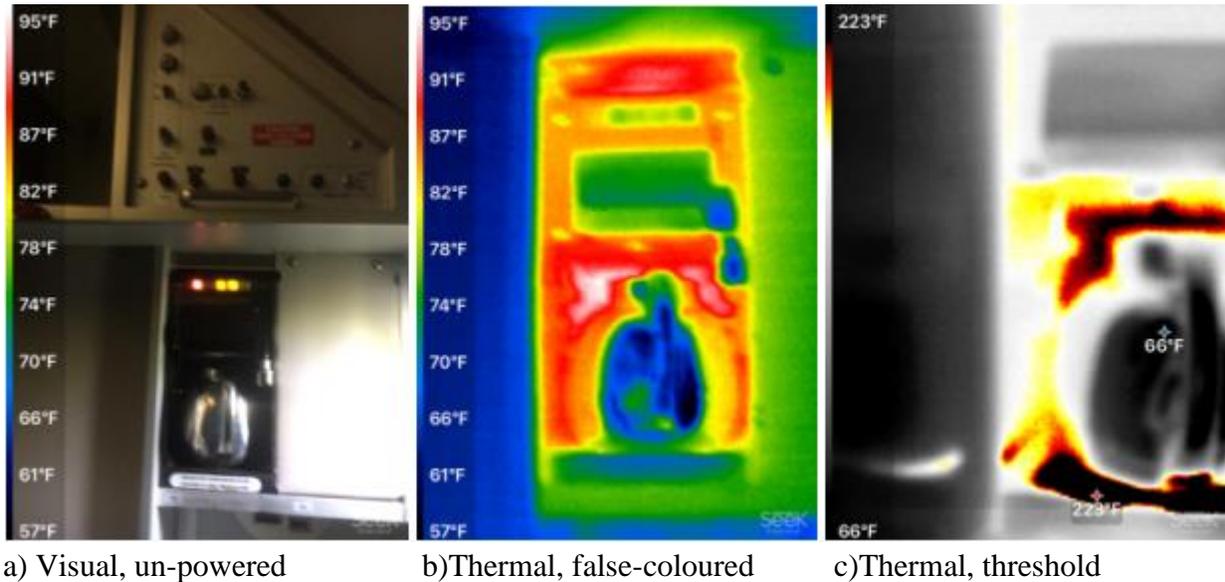
Fig. 42. SEEK Visual and Thermal views of powered coffee heater, site G1.

Normal operating temperatures of a galley coffee warmer were collected in-flight. The coffee warmer, shown in Fig. 42a and b, is cooling down after the heater element has been turned OFF. The heating element is ON in Fig. 42c, which is a greyscale image with a false-colour threshold set at 180°F (82°C) and the hottest area on the element is reported as 223°F (106°C). The carafe looks cold 66°F (19°C) due to the emissivity difference of stainless steel.

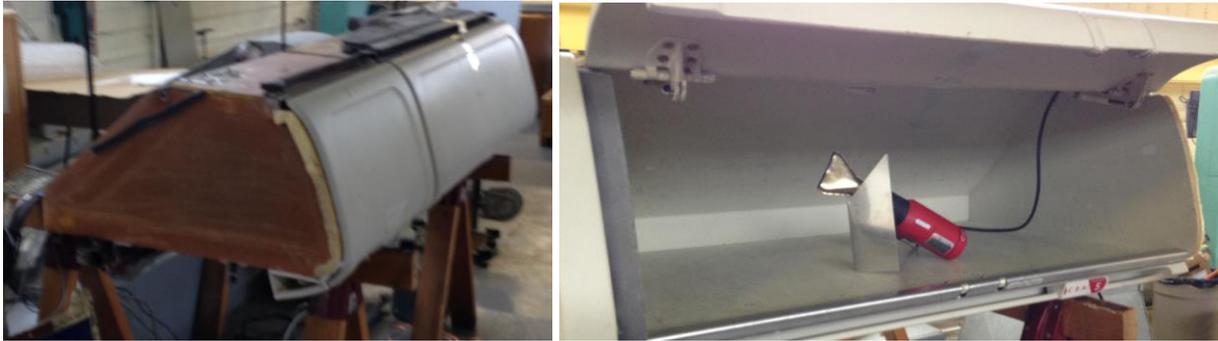
Fig. 43. Two-bin over-head luggage bin.

a) Overall view

b) Longer bin, open, showing hot-air gun

The first overhead bin was two separate units on a common chassis, as shown in Fig. 43a. One bin was longer than the other. The heat gun was placed in the middle of the long bin, as shown in Fig. 43b. There is a gap between the end walls of the two bins. This thermal disconnect is evident in Fig. 43c, where the smaller bin is almost invisible, and in Fig. 43d, where the visible image edge-detection feature outlines the small bin.

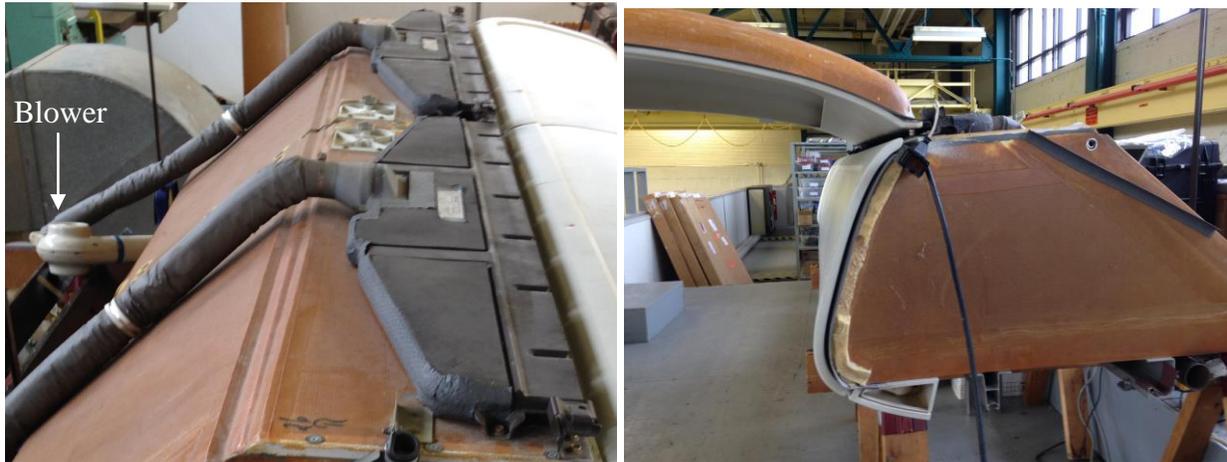
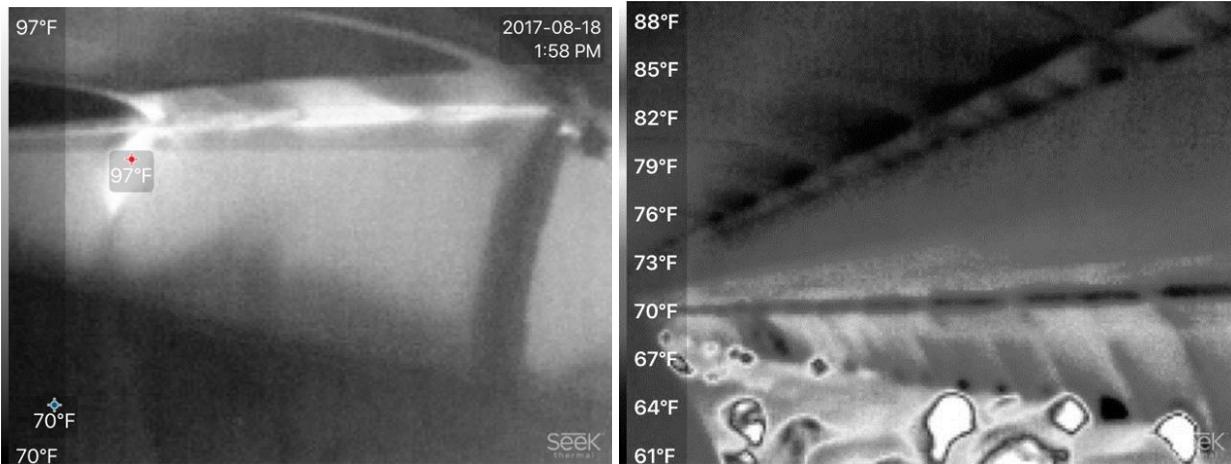
a) ECS diffuser ducts, blower. Bin doors open b) Ceiling panel added. Bin doors closed

In an aircraft, the conditioned air enters the cabin through diffuser ducts located on the top of the bins, as shown in Fig. 45a. Note the blower and that the bin doors are open and a ceiling panel is not in place in this image. Fig. 45b shows the set-up with the addition of a ceiling panel. To replicate the influence of the Environmental Control System (ECS), ambient room air (70°F, 21.1°C) was flowed through the diffuser with the blower. This diffuser airflow was operating at the time when Fig. 45c was taken, and illustrates how bins, where the top edge of the door are at the top of the bin cavity, will leak heated air that may first affect the cabin-side surface of ceiling panels immediately above. This is opposite to the candle heating in the older style bin, Site S1, where the ceiling panel was heated from the back side. Fig. 45c shows a similar configuration to Fig. 45d and is of an aircraft in-flight with cabin populated and conditioned air cooling the ceiling panels. In an operating aircraft, the heat rising from a bin fire will be mixed with the cooler air from the ECS airflow, which may delay or reduce the heating rate of the adjacent ceiling panels.

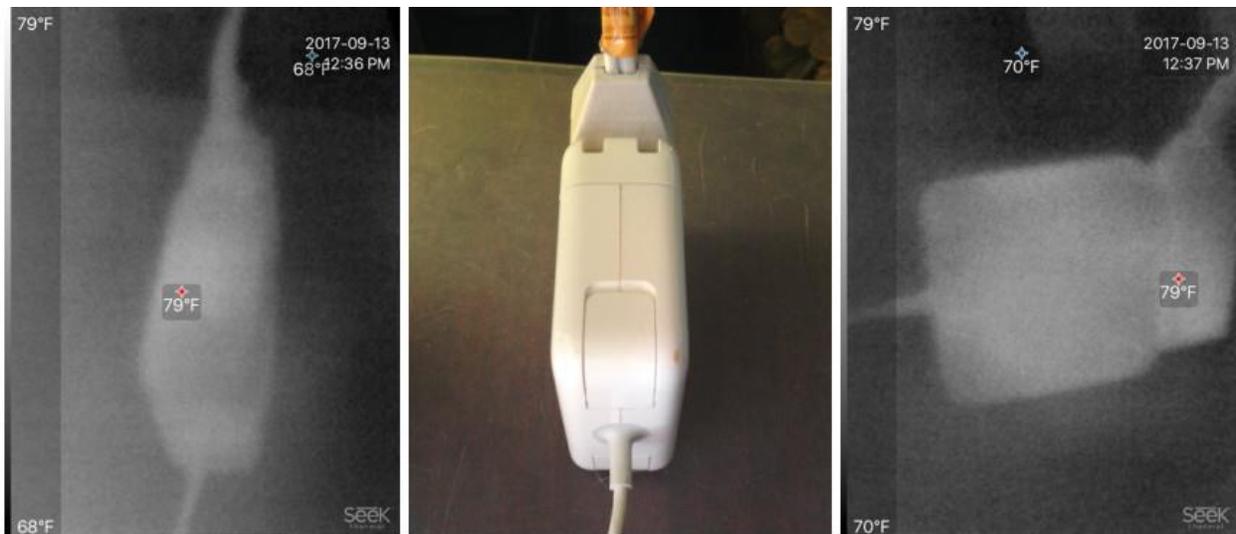
Fig. 46. PED power transformer.

a) Laptop PED power supply plugged into aircraft seat-back 115 \tilde{v}

b) Laptop PED power supply plugged into domestic 115 \tilde{v}

On both a B777 and B787 aircraft (115 \tilde{v} , 400 Hz) and at a hotel in Denmark (240 \tilde{v} , 50 Hz) this Apple lap-top charger/power supply transformer ran uncomfortably hot to the touch (104°F, 40°C), as shown in Fig. 46a. On domestic 115 \tilde{v} , 60 Hz the unit stabilizes at 79°F (26.1°C), as shown in Fig. 46b.

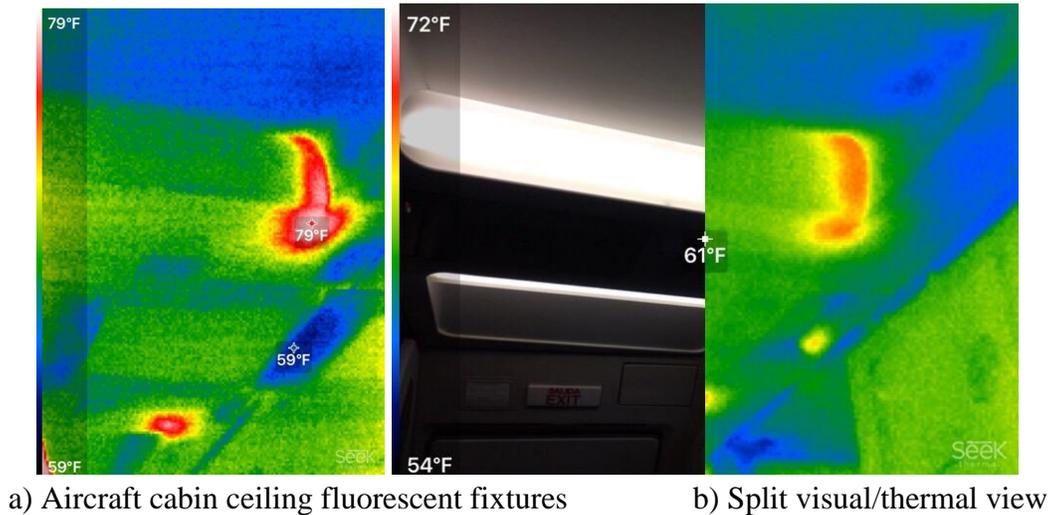
Fig. 47. Aircraft cabin ceiling fluorescent fixtures.

The vast majority of cabin lighting fixtures are fluorescent tubes powered by high-voltage ballasts, which may be co-located or remote from the fixture and behind the cabin panelling. The failure of ballast units [9] has caused smoke events and flight diversions. Comparison of energized lighting fixtures could aid in detecting ballast malfunctions. Fig. 47 shows two thermal views of a fixture under normal conditions.

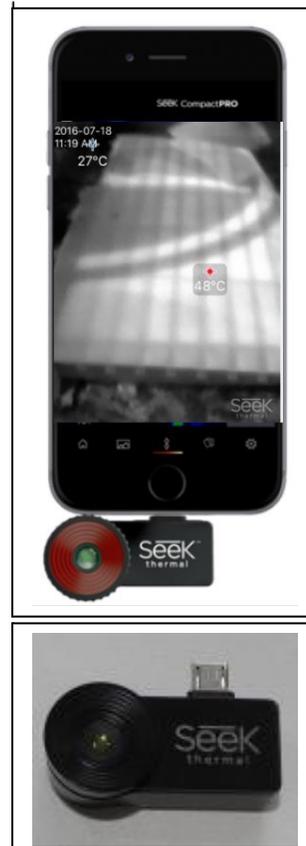
Appendix A 1. SEEK Compact specifications.

SPECIFICATIONS	DESCRIPTION
DETECTOR & OPTICS	
Thermal Sensor	206 x 156
Detection Distance	1,000 feet (330 yards, 300 meters)
Field of View	36 Degree FOV
Temperature Range	-40F to 626F (-40C to 330C)
Frame Rate	< 9 Hz
Focus	Adjustable Focus
Lens Material	Chalcogenide
Microbolometer	Vanadium Oxide
Pixel Pitch	12 Microns
Spectral Range	7.5 - 14 Microns
SYSTEM SPECS	
User Interface	Connects to a smartphone. Controlled by free Seek mobile app.
Temp. Display Scale	Fahrenheit or Celsius
Color Palettes	9 Options
Thermal Tools	Spot Thermography, Hi-Low, and Threshold modes
Capture Settings	Records photos and video
Storage Media	Stores photos and video directly to smartphone
Sharing	Share directly from mobile app to email, text, and social media
Battery	No batteries required. Powered by smartphone
Phone Compatibility	iPhone® and Android™ For compatible phone list, visit thermal.com/supported
DEVICE & PACKAGE INFO	
Country of Origin	Designed and manufactured in Santa Barbara, California, USA with global components

Color	Black
Device Dimensions (H x W x D)	1 x 1.75 x .8 inches
Device Weight	.5 ounces
Box Dimensions (H x W x D)	7 x 3.75 x 1.25 inches
Package Weight	8.3 ounces
Included in the box	Seek Compact and Waterproof Carrying Case

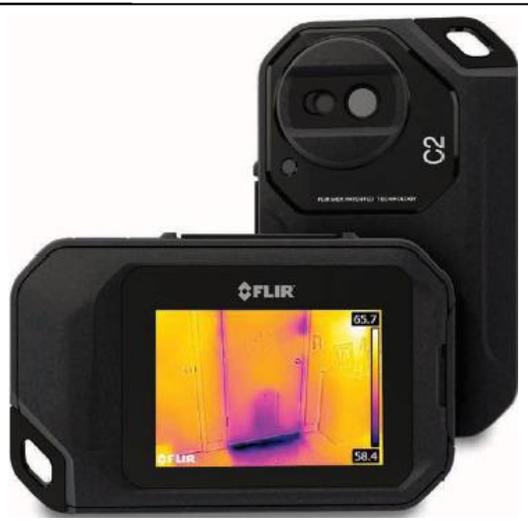
Source: http://www.flir.com/uploadedFiles/Instruments/Products/C2/C2_Datasheet.pdf**Appendix A 2. FLIR C2 specifications.**

Imaging and optical data	
NETD	100 mK
Field of view	41° x 31°
Minimum focus distance	<ul style="list-style-type: none"> Thermal: 0.15 m (0.49 ft.) MSX: 1.0 m (3.3 ft.)
Focal length	1.54 mm (0.061 in.)
Spatial resolution (IFOV)	11 mrad
F-number	1.1
Image frequency	9 Hz
Focus	Focus free
Detector data	
Focal Plane Array	Uncooled microbolometer
Spectral range	7.5–14 μm
Detector pitch	17 μm
IR sensor size	80 x 60
Image presentation	
Display (color)	<ul style="list-style-type: none"> 3.0 in. 320 x 240 pixels
Display, aspect ratio	4:3
Auto orientation	Yes
Touch screen	Yes, capacitive
Image adjustment (alignment calibration)	Yes
Image presentation modes	
Infrared image	Yes
Visual image	Yes
MSX	Yes
Gallery	Yes
Measurement	
Object temperature range	-10°C to +150°C (14 to 302°F)
Accuracy	$\pm 2^\circ\text{C}$ ($\pm 3.6^\circ\text{F}$) or 2%, whichever is greater, at 25°C (77°F) nominal.
Measurement analysis	
Spotmeter	On/off
Emissivity correction	Yes; matt/semi-matt/semi-glossy + custom value

Measurements correction	<ul style="list-style-type: none"> Emissivity Reflected apparent temperature
