DOT/FAA/AR-00/18

Development of Supplemental Inspection Report for the Fairchild Metro SA226 and SA227 Airplane

April 2000

Final Report

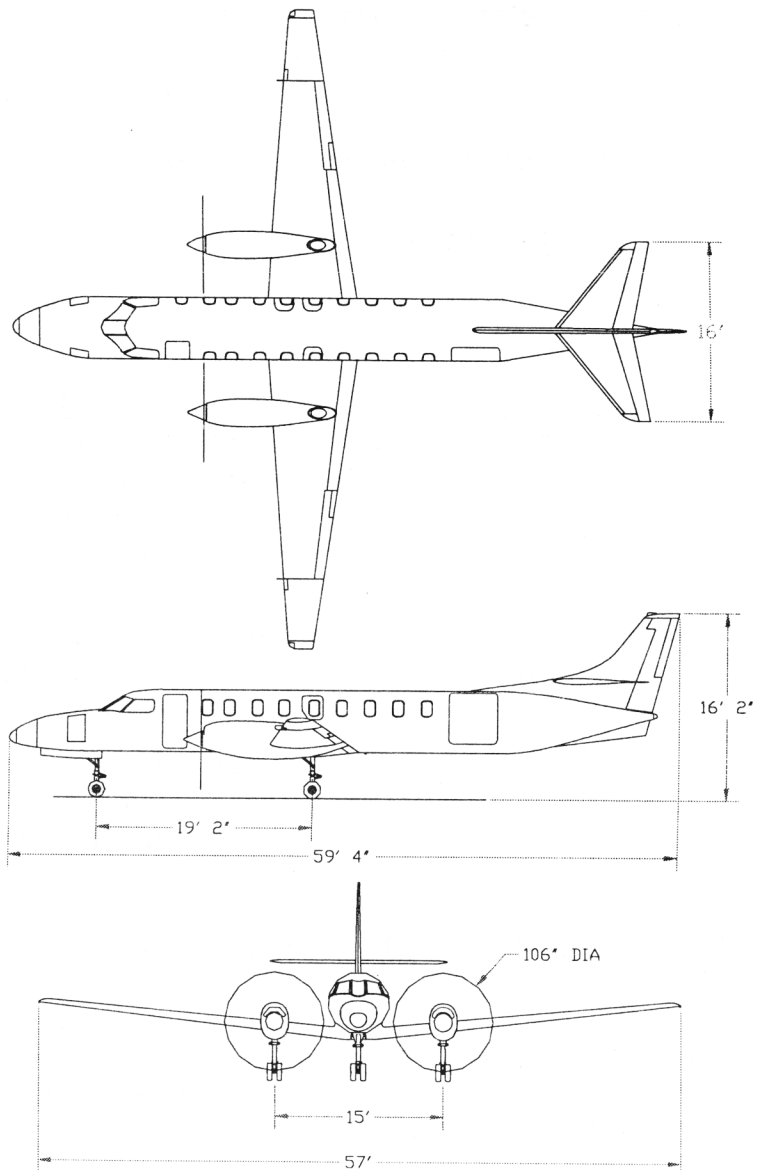
FIGURE 1. SA227 BASIC GEOMETRY

DATA	
<u>BASIC DIMENSIONS</u>	
LENGTH	59' 0"
HEIGHT	16' 8"
SPAN	57' 2"
<u>WING DATA</u>	
AREA:	
WING (TOTAL)	308.1 SQ FT
AILERON (TOTAL)	14.12 SQ FT
FLAP SLOTTED (TOTAL)	40.66 SQ FT
AIRFOIL:	
ROOT	NACA65 A215
TIP	MODIFIED NACA64 A415
ASPECT RATIO, AR	10.59
MAC	72.3 IN
SWEEP AT QUARTER CHORD	0.9 DEG
TAPER RATIO	.257
DIHEDRAL (WRP AT 32% CHORD)	5 DEG
ANGLE OF INCIDENCE:	
ROOT	+1 DEG
TIP	-2.69 DEG
GEOMETRIC TWIST	-3.69 DEG
<u>POWERPLANT DATA</u>	
ENGINES:	
TWO AIRESEARCH TPE331-12UA-701G (MAX CONT.)	1100 SHP
PROPELLERS:	
TWO 4 BLADED FULL FEATHERING	106 IN DIA
<u>LANDING GEAR DATA</u>	
MAIN GEAR (DUAL WHEELS)	
TOTAL STRUT STROKE	10 IN
TIRE (TUBELESS) 19.5 X 6.75-8, PLY RATING=10	
WHEEL	18 X 5.5
NOSE GEAR (DUAL WHEELS)	
TOTAL STRUT STROKE	8 IN
TIRE (TUBELESS) 18 X 4.4, PLY RATING=10	
WHEEL	18 X 4.4
<u>SPECIFICATIONS</u>	
WEIGHTS:	
TAKEOFF WEIGHT	16,500 LBS
EMPTY WEIGHT	8,680 LBS
LANDING WEIGHT	15,675 LBS
ZERO FUEL WEIGHT	14,500 LBS
<u>PERFORMANCE</u>

SPEEDS:	
$V_{LO} = V_{LE} = 248$ KNOTS, CAS	
$V_{LO} = 311$ KNOTS, CAS	
MAX. OPERATING ALTITUDE	25,000 FT
<u>EMPELLAGE DATA</u>	
HORIZONTAL TAIL:	
AREA, TOTAL (INCLUDING FUSELAGE)	75.970 SQ FT
AREA, STABILIZERS (TOTAL)	54.7 SQ FT
AREA, ELEVATORS (TOTAL)	21.27 SQ FT
AIRFOIL SECTION:	
ROOT	MODIFIED NACA66A009
TIP	MODIFIED NACA63A009
INCIDENCE	VARIABLE
DIHEDRAL	0 DEG
VERTICAL TAIL:	
AREA, TOTAL (INCLUDING DORSAL)	56.0 SQ FT
AREA, (VERTICAL STABILIZER)	24.036 SQ FT
AREA, RUDDER	19.38 SQ FT
AREA, DORSAL FIN	10.583 SQ FT
AIRFOIL SECTION	
ROOT	MODIFIED NACA66A009
TIP	MODIFIED NACA63A009
AREA, VENTRAL	5.48 SQ FT

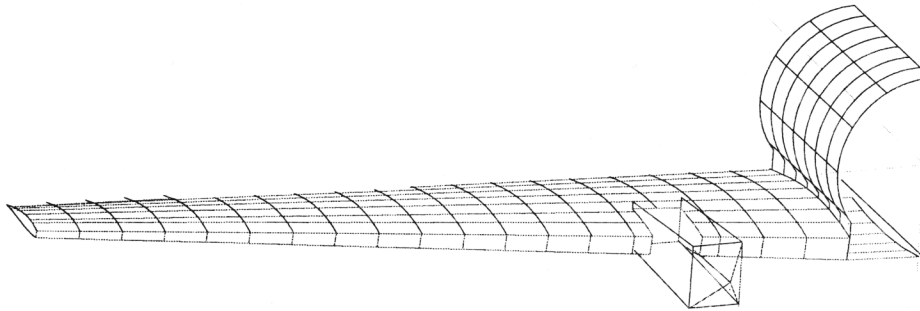
FIGURE 2. SA227 WING FINITE ELEMENT MODEL

The wing finite element model shown in figure 2 was used to analyze the SA227 wing [1]. The results were checked during the SA227 wing static test [2] and shown to be within about 1% of the measured stress for the more heavily loaded portions of the wing. The finite element model was therefore used as an aid for selecting critical PSE areas and determining stress at locations on the wing other than strain gage locations.

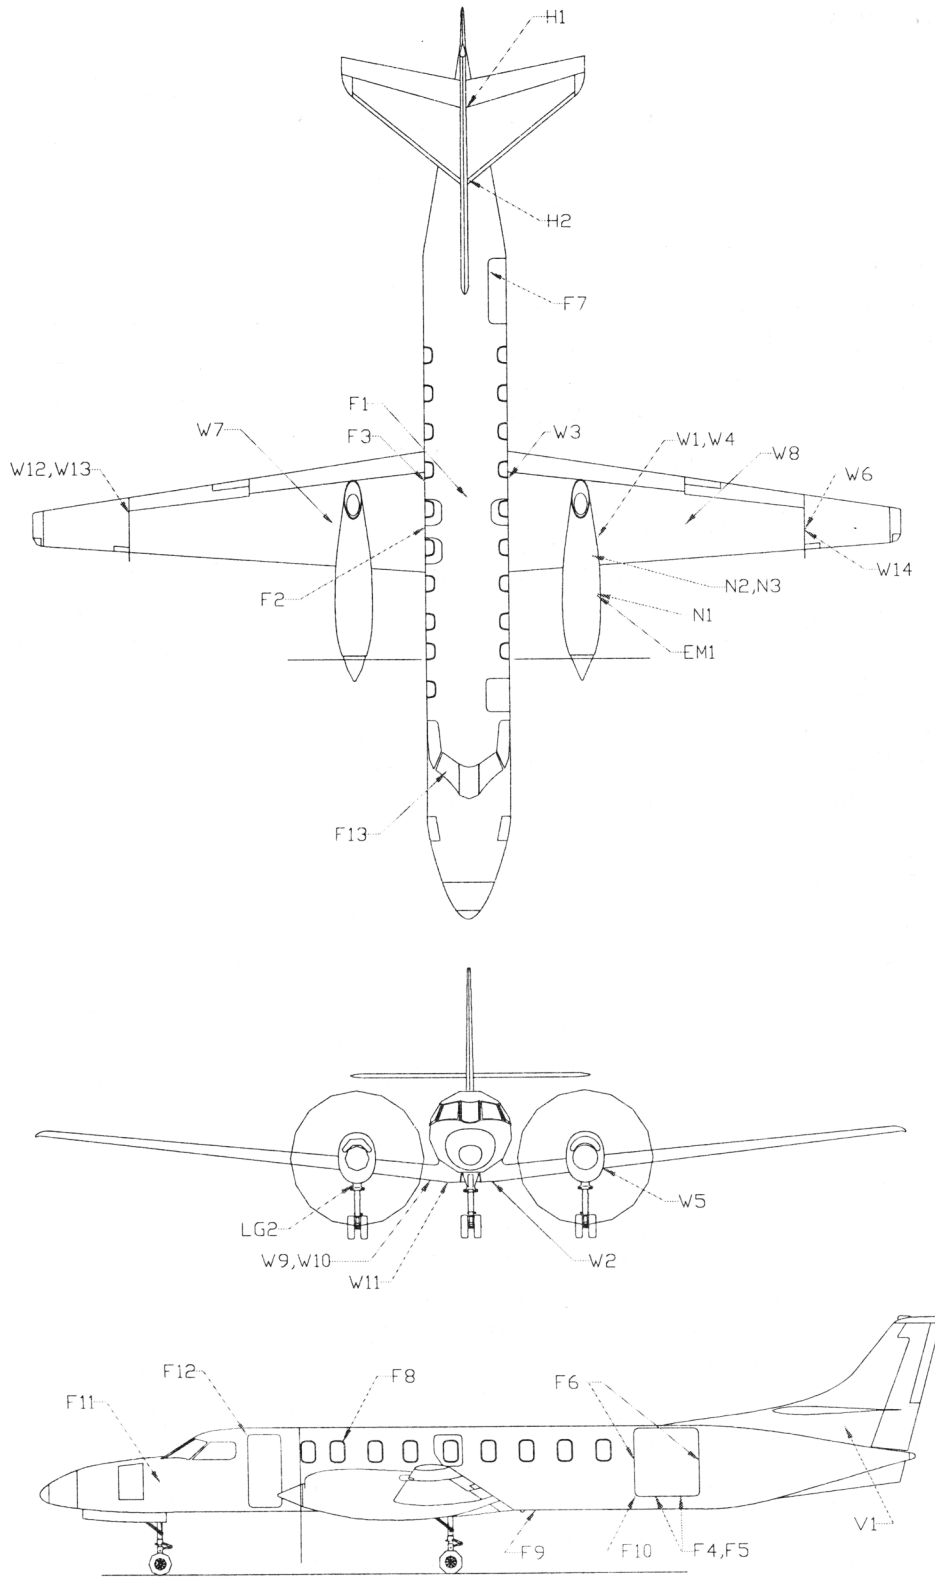
FIGURE 4. LOCATIONS OF CRITICAL AREAS

Table 4 presents the PSE critical areas selected for damage tolerance analysis. Figure 4 shows the locations of the critical areas. They are also depicted in reference 3.

F3	SA226 and SA227 Wing-fuselage aft attachment fittings
F4	SA226 and SA227 Fuselage frame at fore/aft cargo door latches @ FS 454.5/455.7 and 473.4/474.6
F5	SA226 and SA227 Fuselage frame at fore/aft cargo door latches @ FS 455.7/473.4
F6	SA226 and SA227 Fuselage frame at cargo door sides
F7	SA226 and SA227 Cargo door hinge
F8	SA226 and SA227 Corners of passenger window cutouts
F9	SA226 T-stringer at bottom centerline aft of FS 362
F10	SA226 and SA227 Cargo door opening corners
F11	SA226 and SA227 Forward pressure bulkhead
F12	SA226 and SA227 Passenger door opening corners
F13	SA226 and SA227 Control column roller bearing
H1	SA226 and SA227 Rib strap at horizontal stabilizer rear spar @ BL 3.135
H2	SA226 and SA227 Horizontal stabilizer pitch trim actuator fittings
N1	SA226 and SA227 Nacelle upper longeron at firewall
N2	SA226 and SA227 Nacelle upper longeron at attachment to wing rib attach angles at main spar

N3	SA226 and SA227 Nacelle upper longeron to wing rib attach angles at wing rib
V1	SA226 and SA227 Vertical fin main spar cap strips at bottom of pivot fitting
EM1	SA227 Engine mount at firewall
LG2	SA226 and SA227 Landing gear cylinder 5453001-1,-3

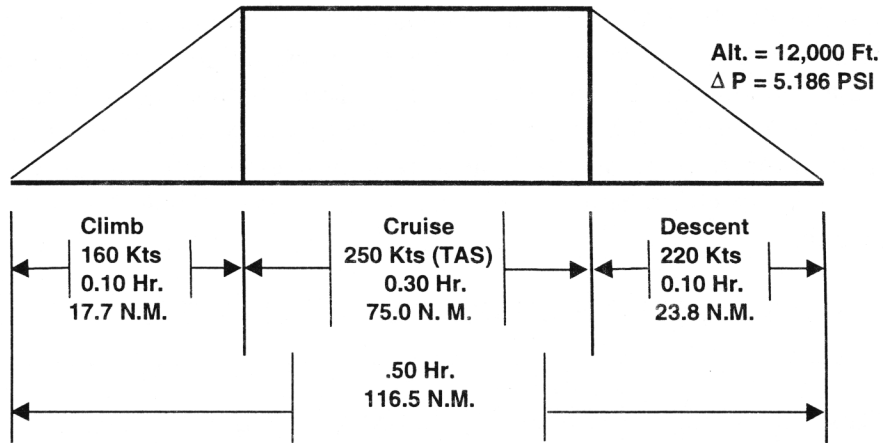
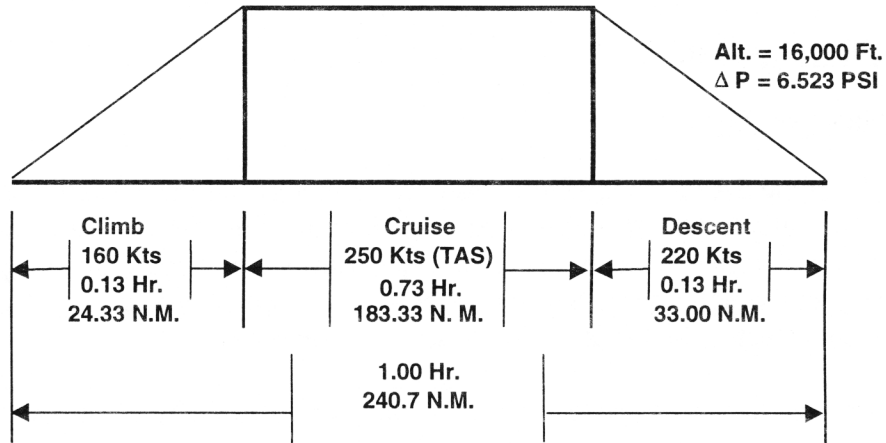
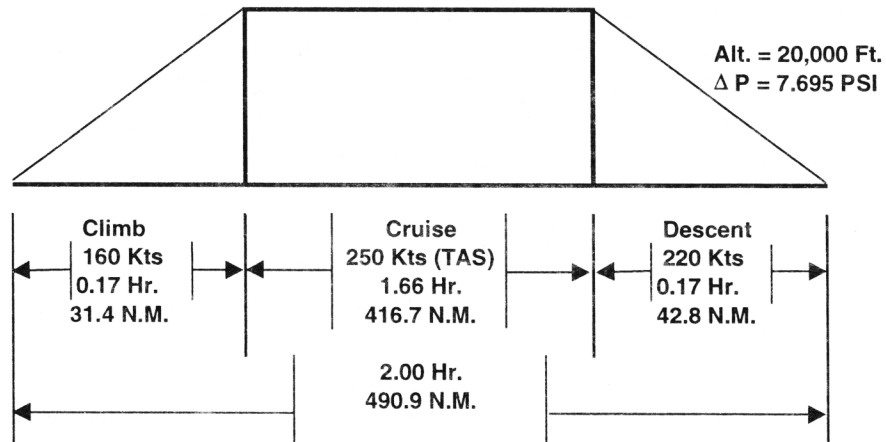
FIGURE 7. SA227 FLIGHT PROFILES

Flight Profile Group	Flight Length (minutes)	Cruise Altitude (ft)	Gross Takeoff Weight (lbs)	Landing Weight (lbs)	Climb Speed (kts)	Descent Speed (kts)	Cruise Speed (kts)
Commuter	30	12000	12800	12500	160	220	250
Cargo	60	16000	13300	13000	160	220	250
Executive	120	20000	13800	12700	160	220	250

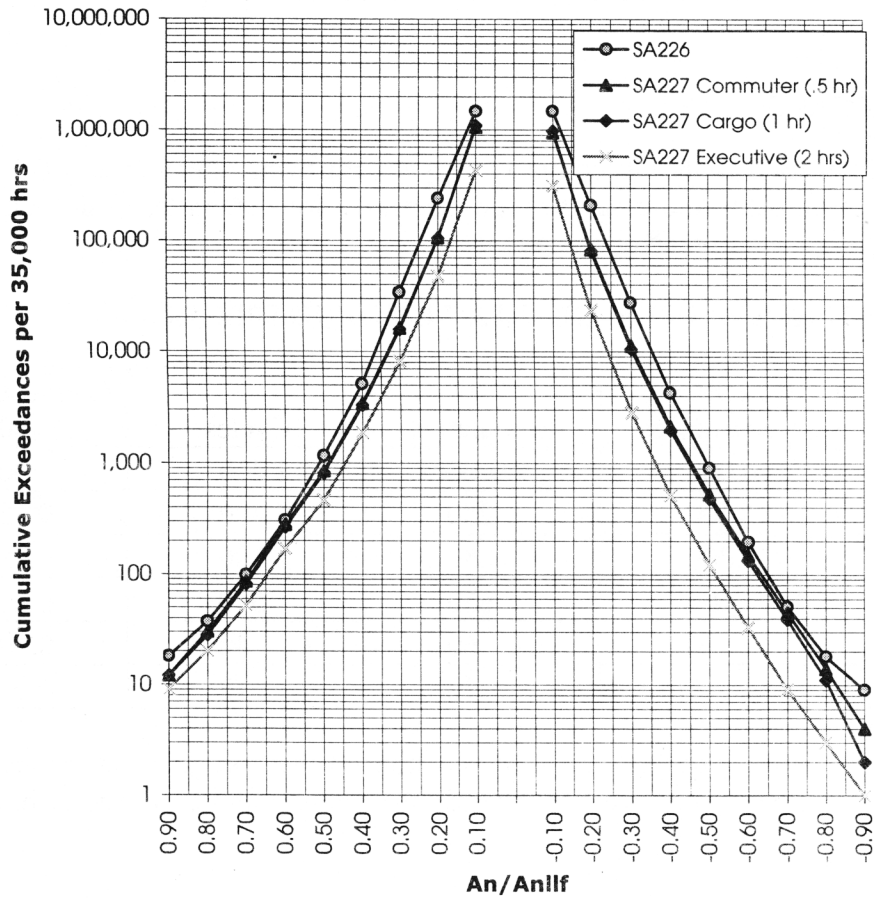
FIGURE 8. GUST AND MANEUVER LOAD SPECTRA

Figure 8 shows the gust and maneuver load spectra for the SA226 and each of the three SA227 mission profiles.

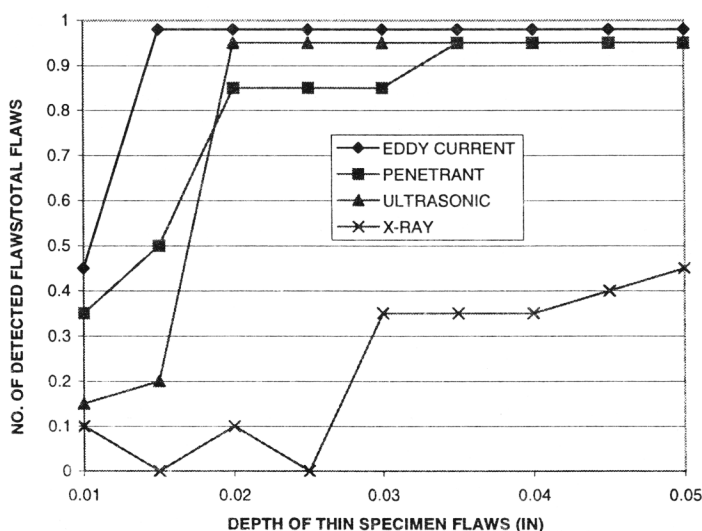
FIGURE 9. SAMPLE CRACK DETECTION PROBABILITY CURVES

Figure 9, reproduced from reference 12 page 4-85, shows probability of detection for uncovered flaws in thin aluminum. Table 11 lists quoted minimum detectable crack sizes from specific installations in the Cessna 402 [13]. Reference 14 gives the following formula for detectable crack size of surface eddy-current probes: Detectable Crack Length = (Fastener Head DIA – Fastener Shank DIA) / 2 + Coil DIA

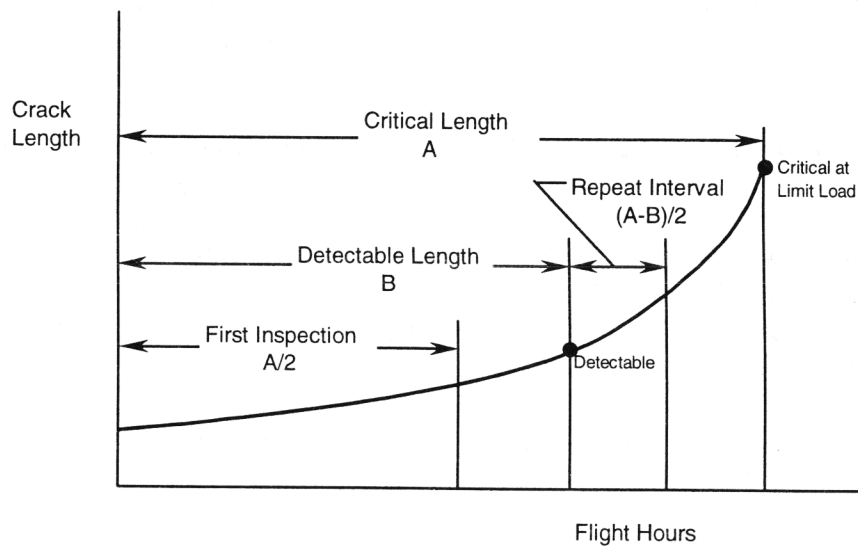
FIGURE 10. INSPECTION INTERVAL AND CRACK GROWTH CURVE RELATIONSHIP

The recommended repeat inspection intervals for each PSE are presented in the SA226 and SA227 SID [16]. Figure 10 summarizes how the inspection intervals were obtained based on crack growth analysis. Scatter factors of 2 are assumed.

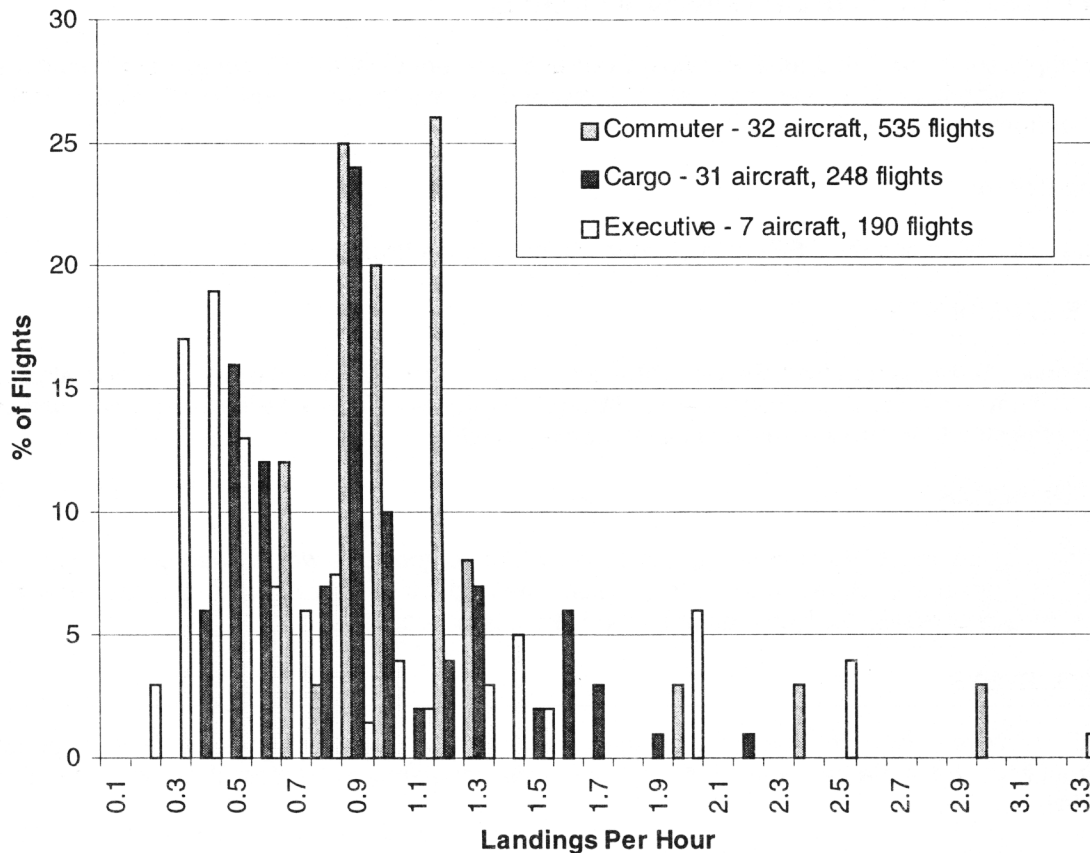
Figure 1. Flight Length Summary (Sheet 1)

Additional information was gathered from the Official Airline Guide and teleconferences with operators. A graphical summary of the usage data from the survey is shown in Figure 1.

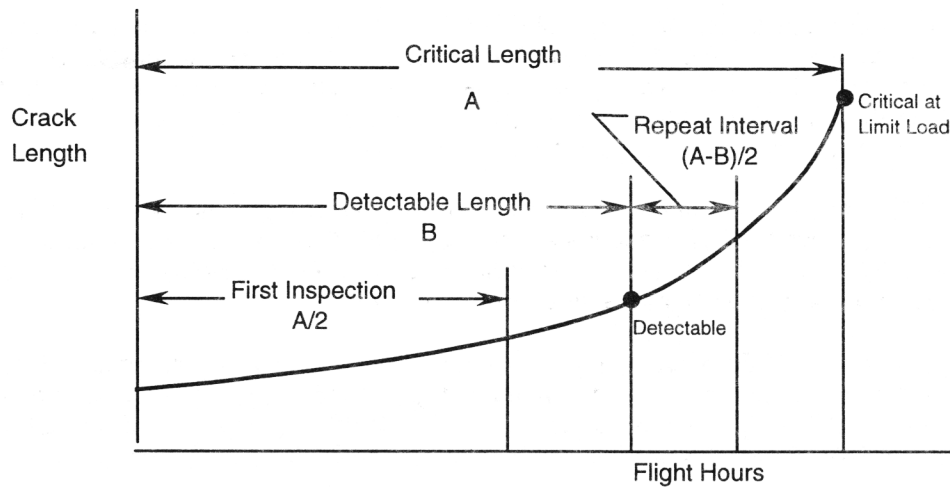
Figure 2. Typical Crack Growth Curve

Initial inspections were based on the shorter of analytical crack growth curves, fatigue test results, or service experience. Where analytical crack growth was used, the initial inspection was set at $c_{crit}/2$, where c_{crit} is the crack size at which the structure can no longer support limit load. The initial crack size was assumed to be 0.05 inch in most cases. Figure 2 shows a typical crack growth curve and the inspection intervals determined therefrom.

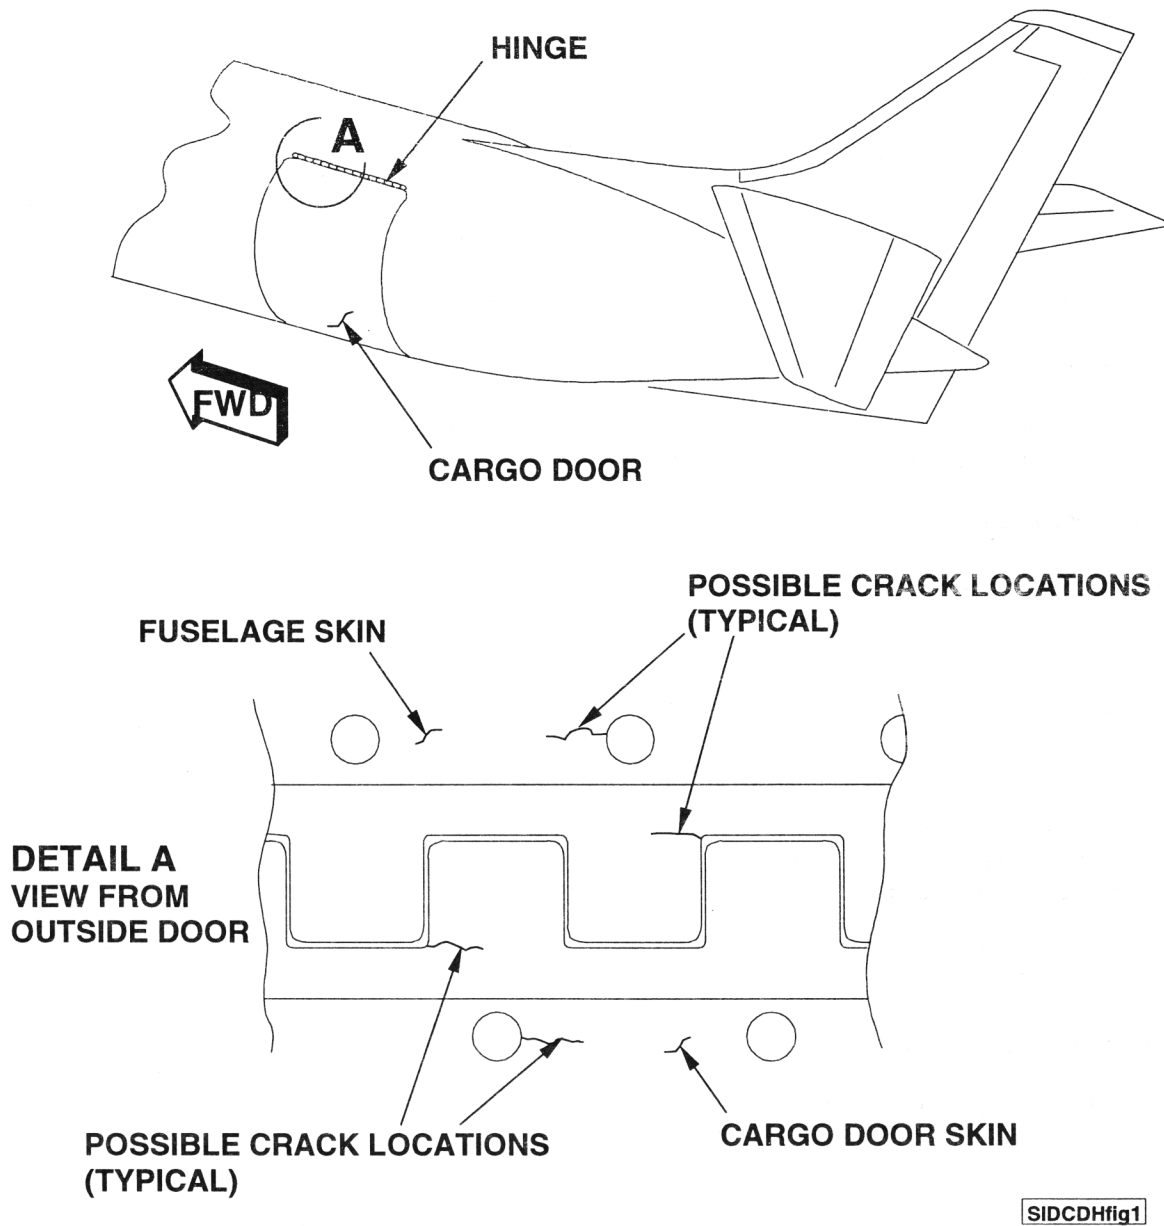
Figure 1. SA226/SA227 Cargo Door Hinge

1. Adhere to procedures for Eddy-Current Inspection given in the SA226/227/227CC Structural Repair Manual, Chapter 51-30-07.
2. Refer to Figure 1. Inspect the hinge tabs and around fastener holes along the length of the hinge. Inspect the top piece (on fuselage) and bottom piece (on cargo door). Observe the phase and amplitude changes on the instrument.
3. Cracks are most likely to occur near the ends of the hinge.
4. If an indication is noted, carefully repeat the inspection pass in the opposite direction to verify the indication.
5. All cracks detected shall be reported to Fairchild Service Engineering. Report the location, direction, and length of each crack.

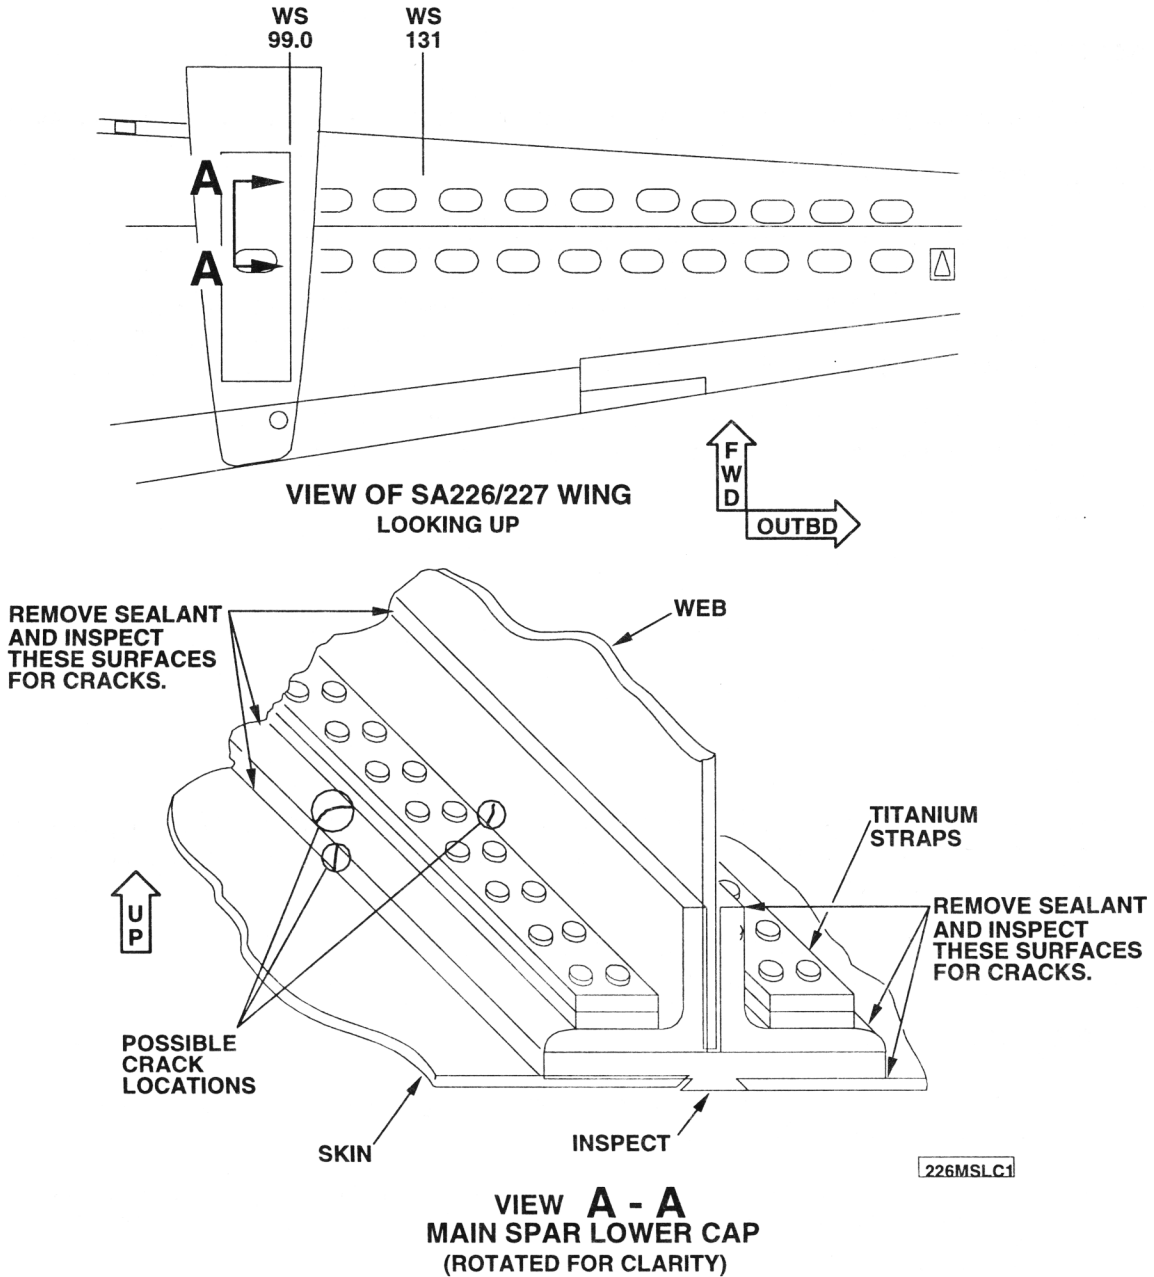
FIGURE 1. SA226/227 WING MAIN SPAR LOWER CAP WS 99

6. If an indication is noted, carefully repeat the inspection pass in the opposite direction to verify the indication.
7. All cracks detected shall be reported to Fairchild Service Engineering. Report the location, direction, and length of each crack.

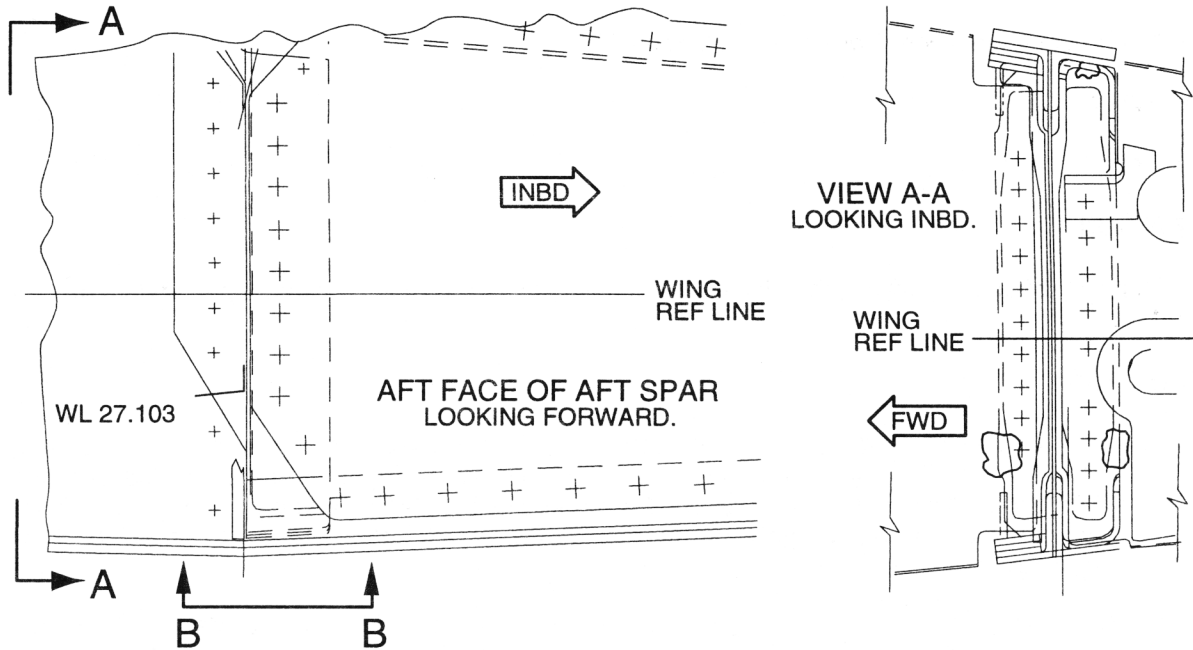
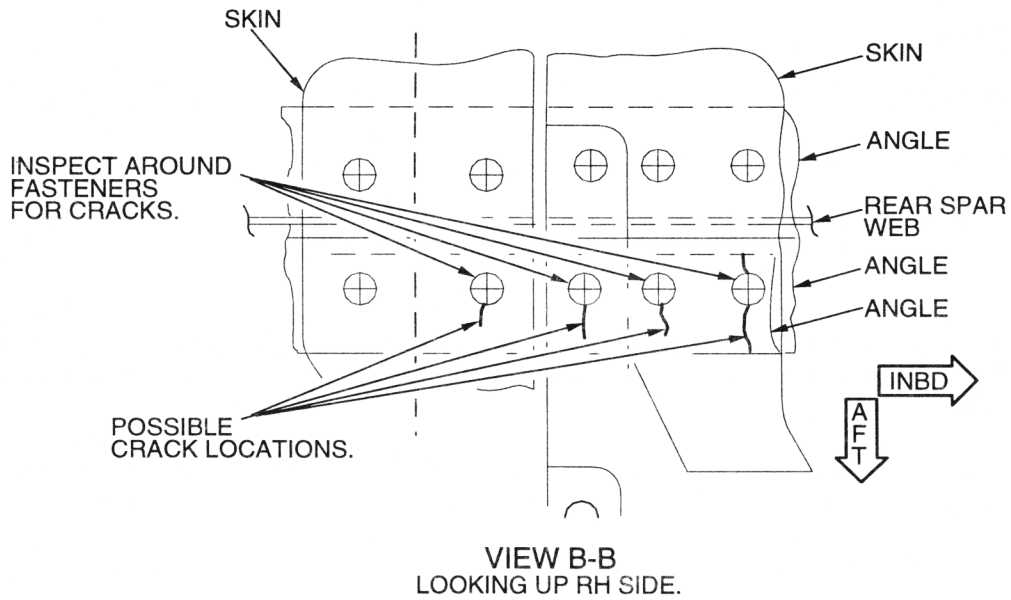
SA226 WING REAR SPAR LOWER CAP AT WS 27
 FIGURE 1

1. Adhere to procedures for Eddy-Current Inspection given in the SA226/227 Structural Repair Manual, Chapter 51-30-07.
2. Refer to Figure 1. Inspect aft aluminum spar cap angle around the fastener holes between stations 24 and 27, left and right wing. Observe the phase and amplitude changes on the instrument.
3. If an indication is noted, carefully repeat the inspection pass in the opposite direction to verify the indication.
4. All cracks detected shall be reported to Fairchild Service Engineering. Report the location, direction, and length of each crack.

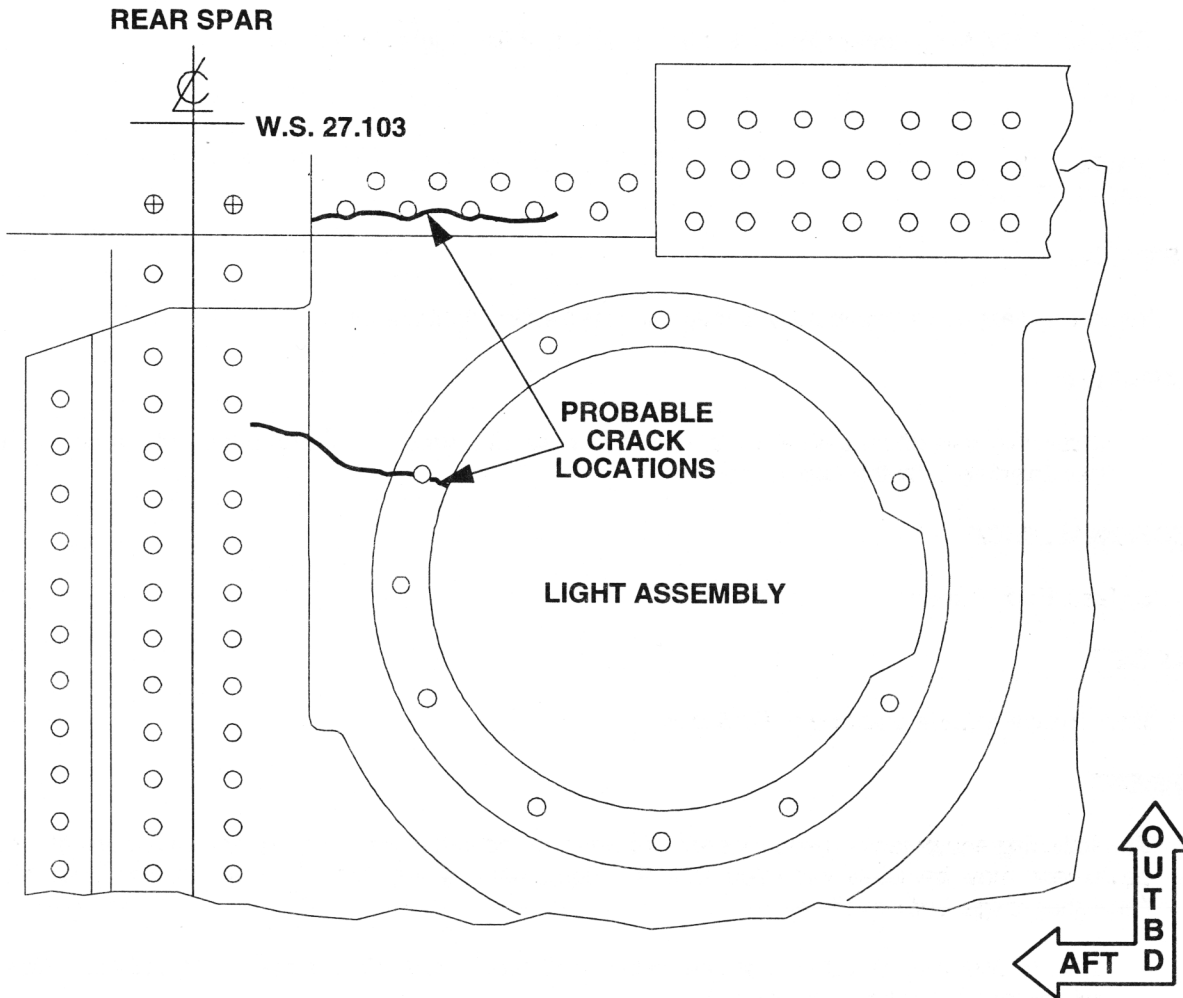
Figure 1. SA226/SA227 Wing Center Section Skin at Landing Light Cutout

1. Adhere to procedures for Eddy-Current Inspection given in the SA226/227 Structural Repair Manual, Chapter 51-30-07.
2. Refer to Figure 1. Inspect belly skin around landing light cutout and at splice of belly skin to center wing skin. Observe the phase and amplitude changes on the instrument.
3. If an indication is noted, carefully repeat the inspection pass in the opposite direction to verify the indication.
4. All cracks detected shall be reported to Fairchild Field Support Engineering. Report the location, direction, and length of each crack.
