DOT/FAA/AR-96/10

# The Role of Fretting Fatigue on Aircraft Rivet Hole Cracking

October 1996

Final Report

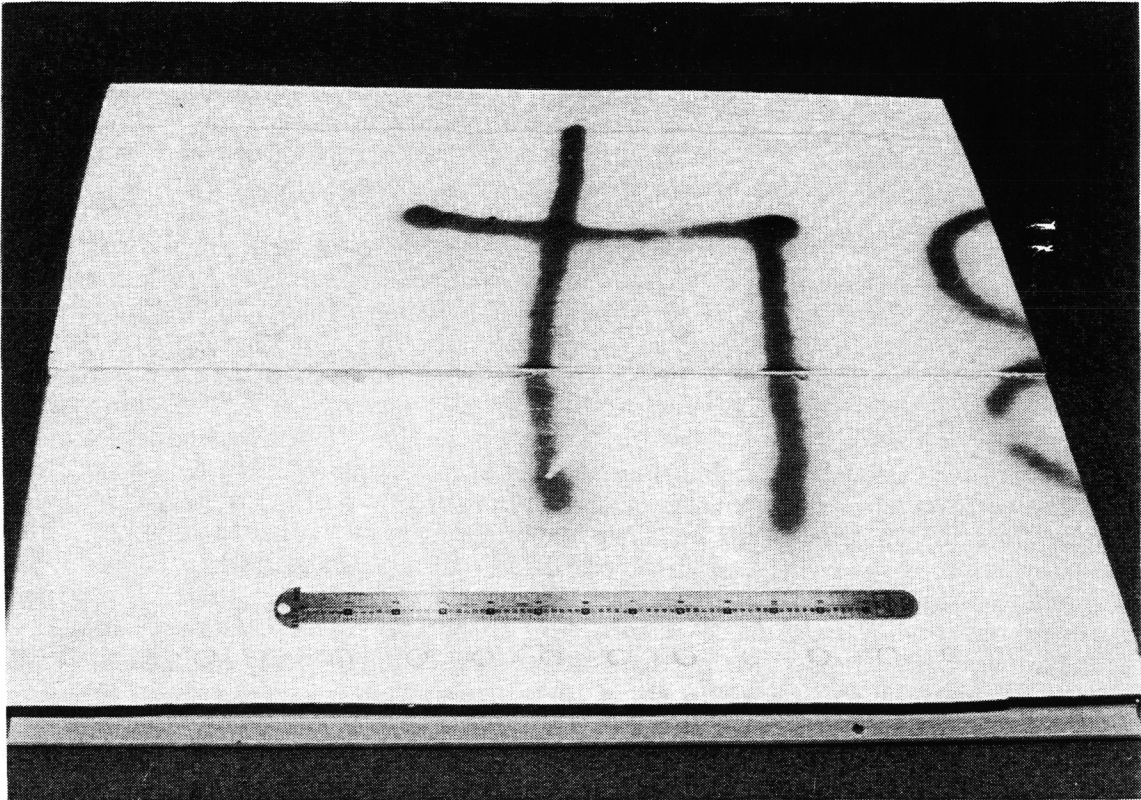
A lap joint panel from Saudi Air, Boeing 707-320C, serial number 19810 (39,834 hours and 26,017 flight cycles) was investigated for evidence of fretting induced cracking in and adjacent to the rivet holes. A picture of this panel, which was provided by Boeing Defense and Space Group, is shown in figure 1. Of interest is the lap joint region that runs horizontally across the panel, slightly above the center of the picture.

The panel was visually inspected and inspected with an optical microscope. Selected riveted joints then were sectioned in the vertical direction in figure 1 and the rivets removed. The rivet holes were inspected visually and with an optical microscope. Then the rivet holes and regions adjacent to the holes were inspected in a scanning electron microscope (SEM). To aid in crack detection, tensile loading was used to expand the rivet holes. Procedures were similar to those used by Piascik et al. [3]. Following these inspections, those rivet hole sections which had cracks of interest, based on subjective evaluation, were fractured so that the crack surfaces could be inspected to determine the crack nucleation sites.

Figure 1. Picture of the lap joint panel that was investigated.

Visually, without magnification, the panel appeared to be serviceable and corrosion free. There is no reason to believe that this panel would have been inspected further or replaced in a periodic inspection. However, close optical inspection showed the presence of a black substance indicative of fretting at all but two of the rivet holes in the panel.

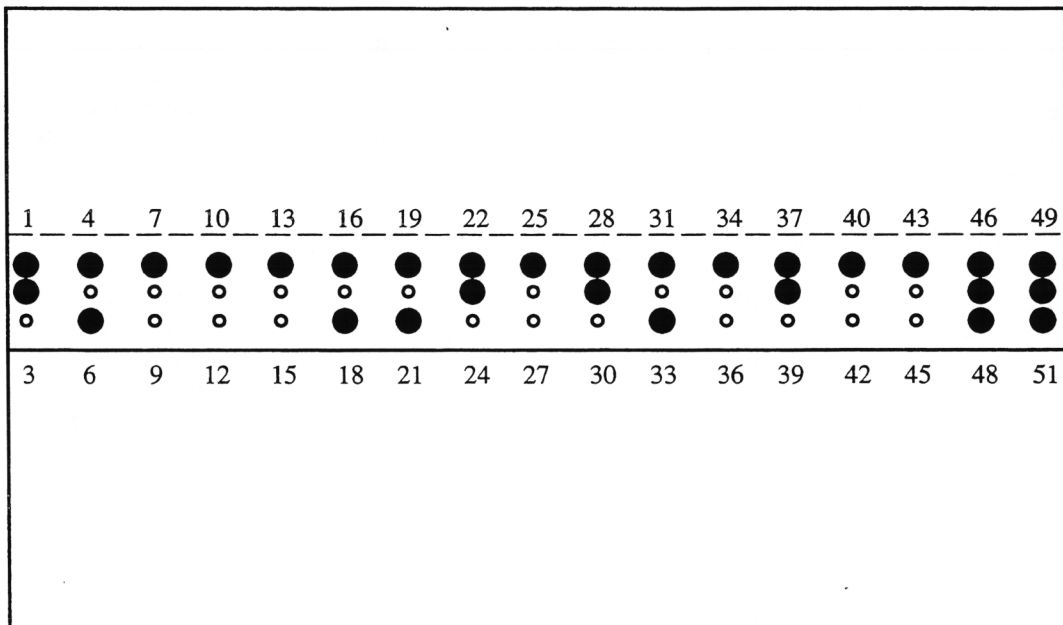
Figure 2 shows the rivet pattern and numbering scheme assigned to the rivets in the panel. The critical row of rivets is that containing rivets 1, 4, ..., 46, 49. Rivet 46 was randomly selected from this row and then its hole and those of proximate rivets 43, 47, 48, and 49 were inspected in a pilot investigation. Based on the results of this investigation, it was decided to inspect all rivet holes in the critical row and five additional randomly selected rivet holes in the other two rows. The rivet holes that were inspected are darkened in figure 2.

Figure 2. Rivet pattern and numbering scheme assigned to the rivets in the panel. The rivet holes that were inspected are darkened.

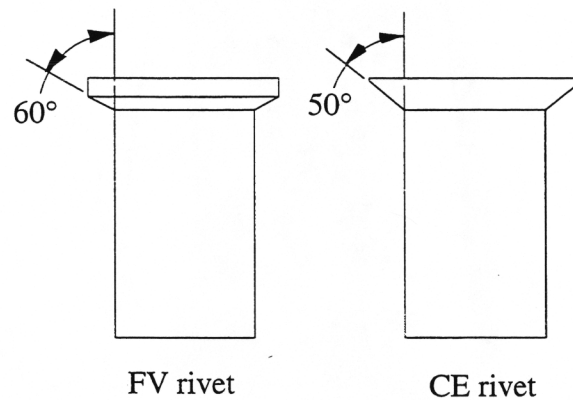
Figure 3. Profile views of an FV and a CE rivet.

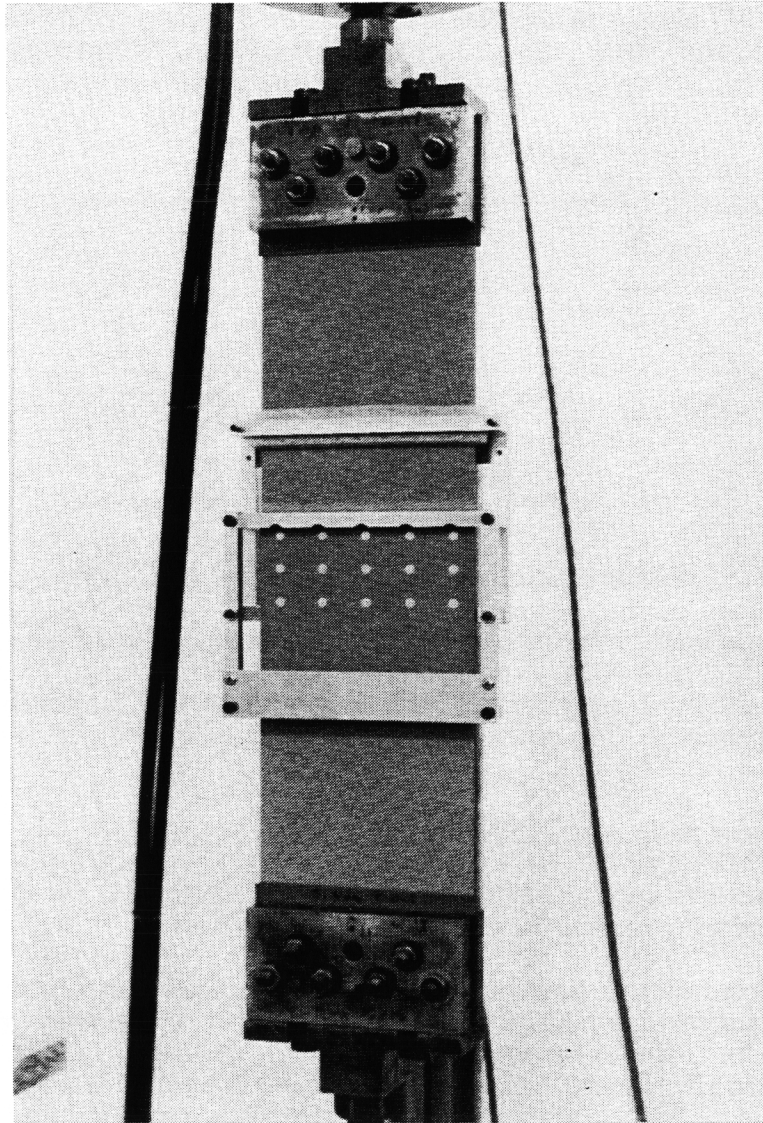
Figure 4. Specimen attached to the MTS load frame with the antibending system installed.

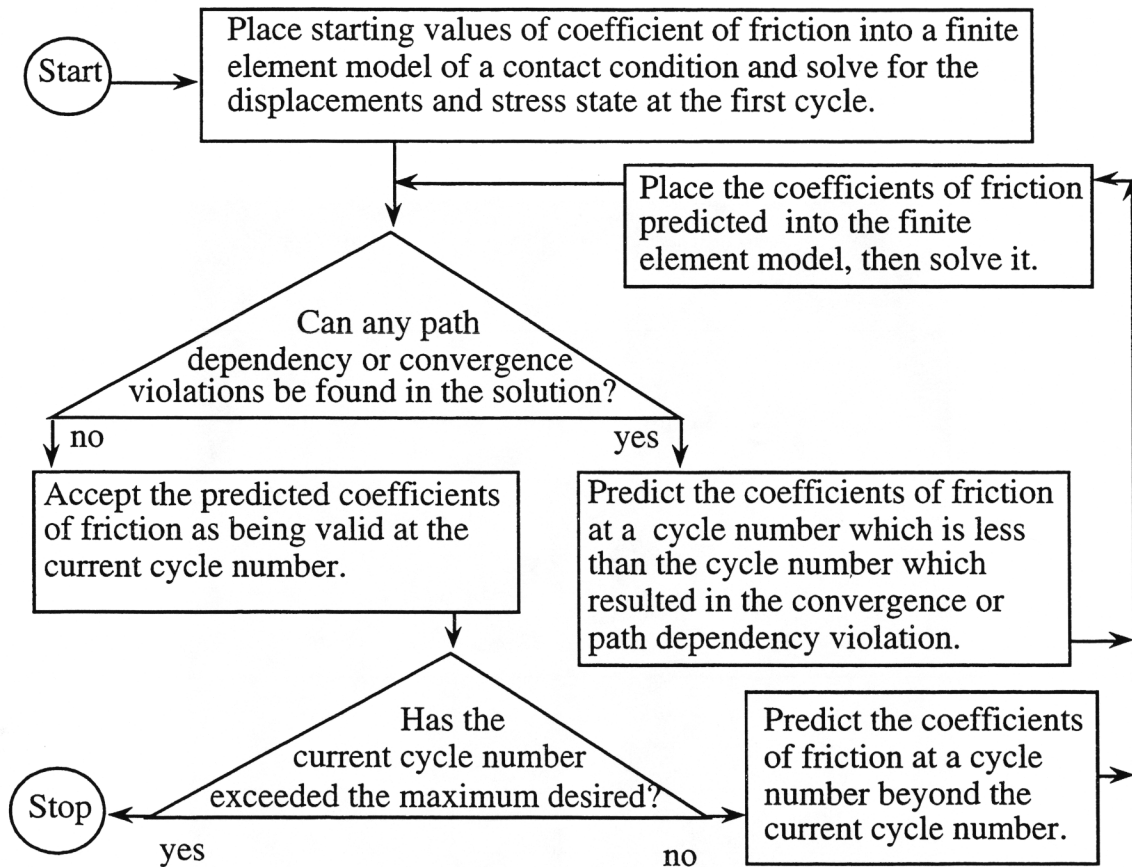
A method was developed to predict coefficient of friction characteristics within a fretted contact during the nucleation of a crack. The method consists of an iterative procedure that compares computed local frictional values from a three-dimensional (3D) linear ADINA® finite element model with predicted frictional values and updates the predictions as necessary until agreement is reached at each model node. Starting with the first cycle, the method steps forward in cycles at a rate that ensures convergence until the required number of cycles has been considered. A flow chart of the protocol that ensures convergence is shown in figure 5.

Figure 5. Flow chart of the method to predict how the coefficient of friction will change for a fretting contact.

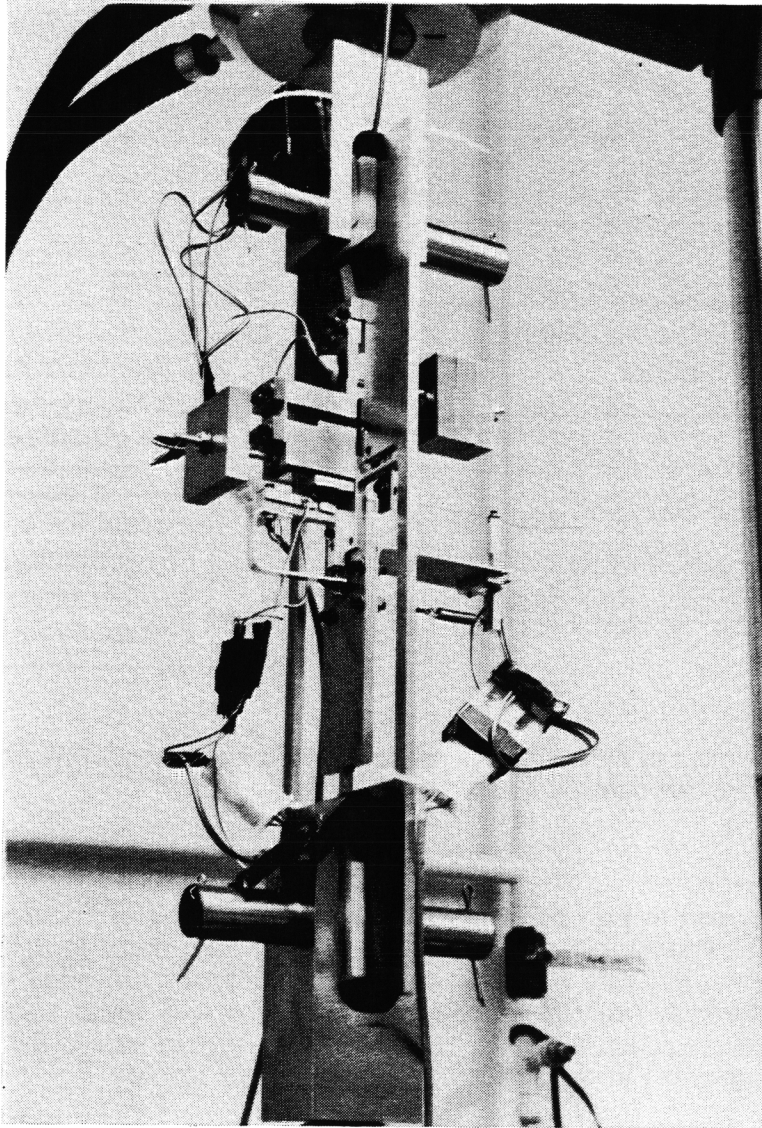
Figure 6. Close-up view of the fretting test apparatus.

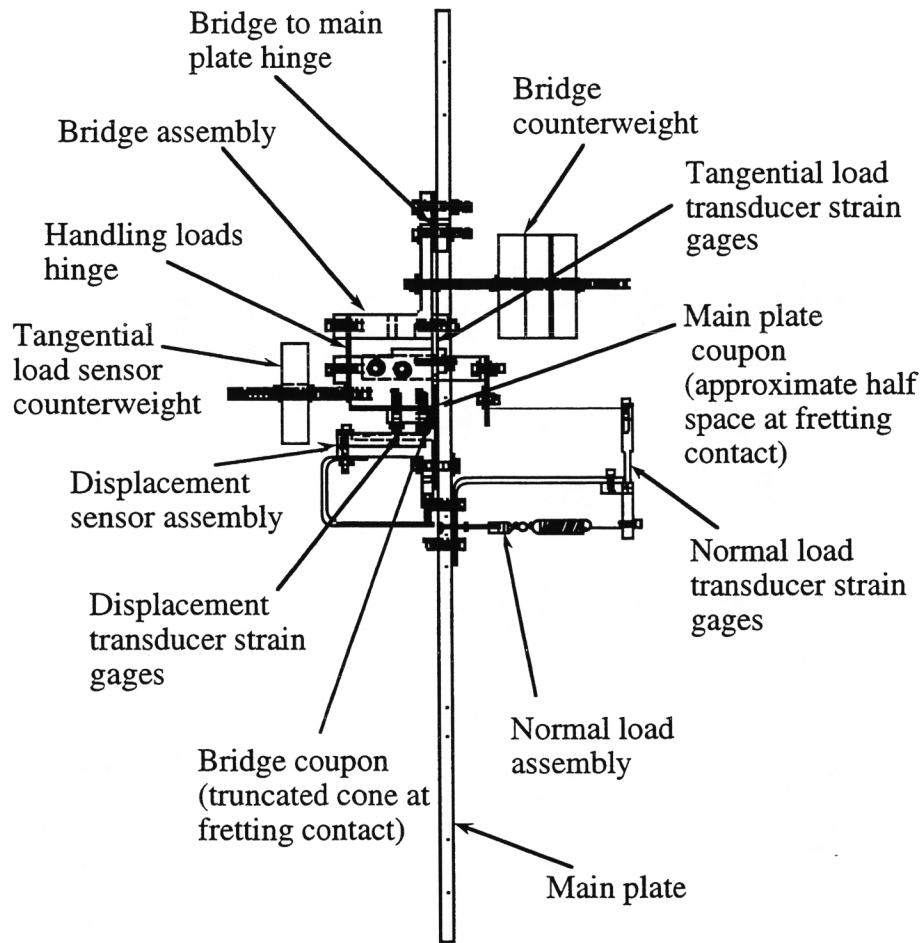
Figure 7. Major components of the coefficient of friction during fretting test apparatus.

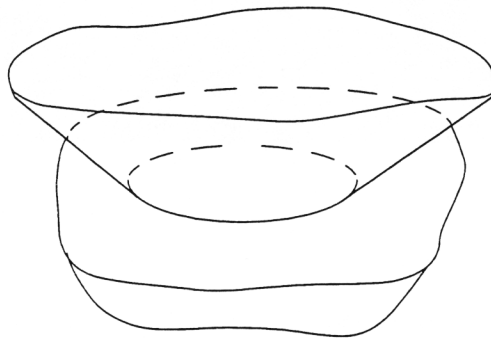
Figure 8. Truncated cone on half space fretting contact geometry.

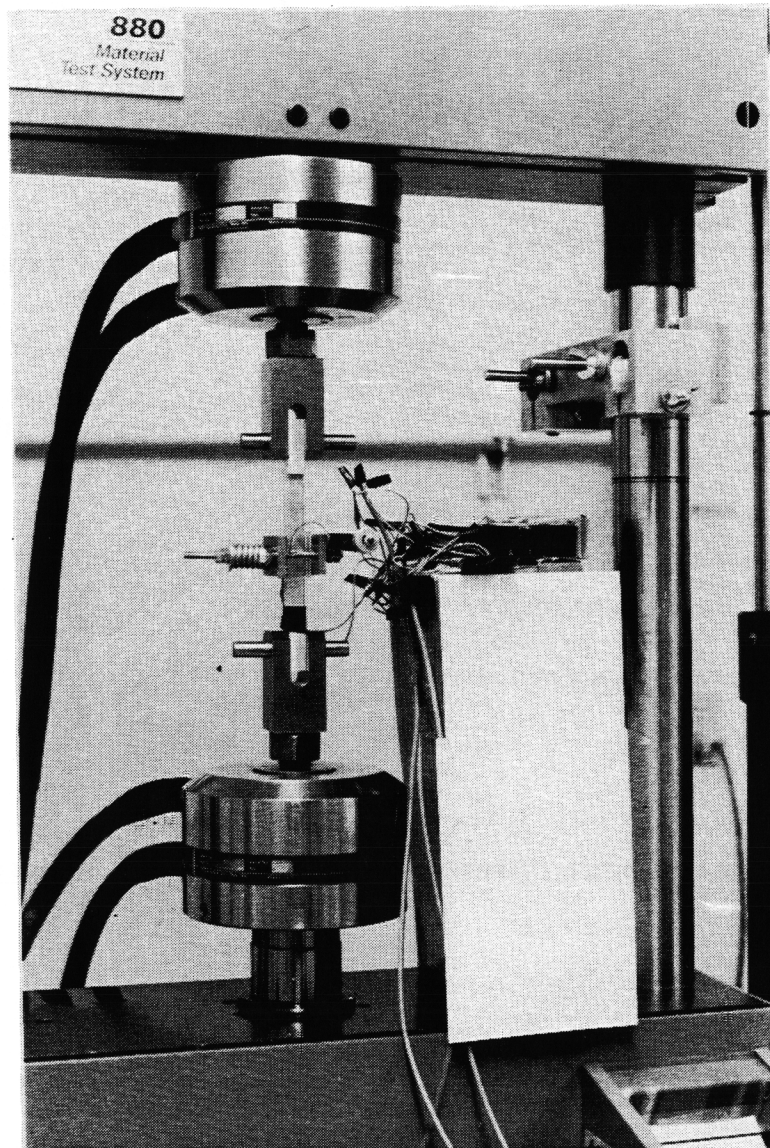
Figure 9. The verification test apparatus installed in a load frame. (The items to the right of the apparatus are bridge completion resistors, thermal compensation gages, and shunt calibration jumpers).

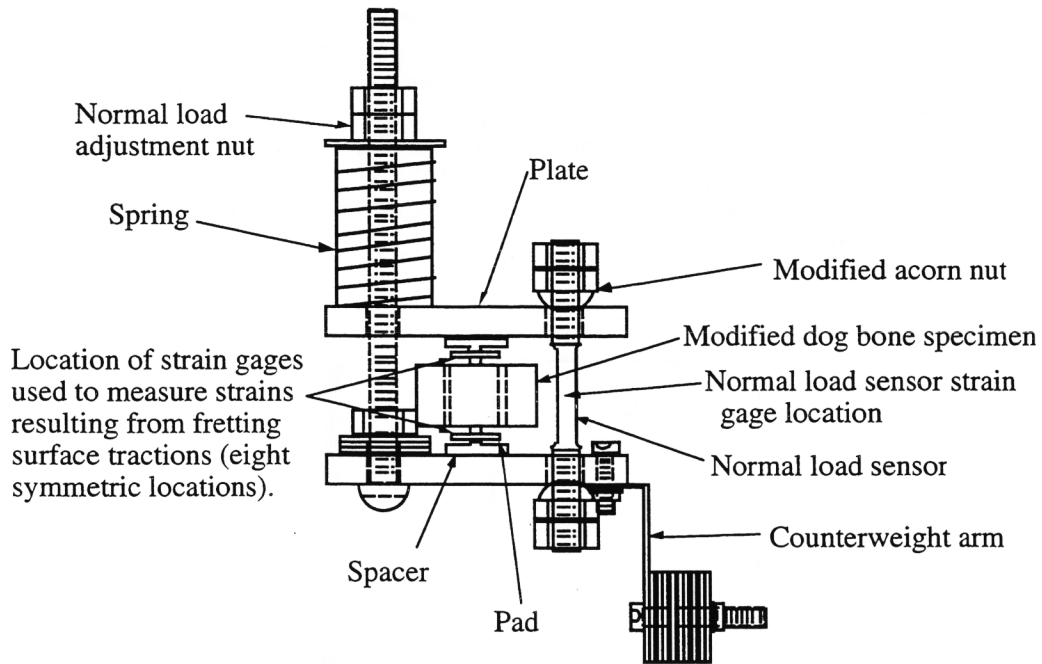
Figure 10. The verification test apparatus with the major components labeled.

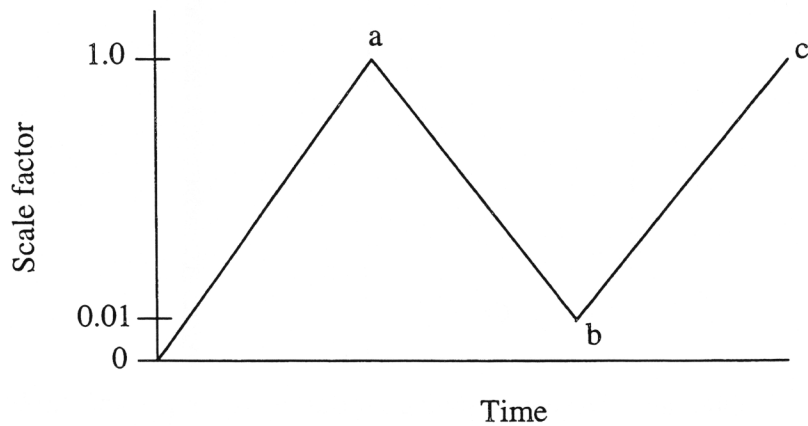
A finite element model of a one rivet section of the CE joint tested during the sensitivity study portion of this grant was constructed. This was considered to be a valid baseline condition to use for applying the method for prediction of coefficient of friction during fretting (section 2.3) to a riveted joint. This model was developed and executed for a simulated 1 1/2 cycles as shown in figure 11.

Figure 11. Cycles simulated during the analysis. The scale factor was based upon a far field maximum stress of 17,000 psi as used in the sensitivity study.

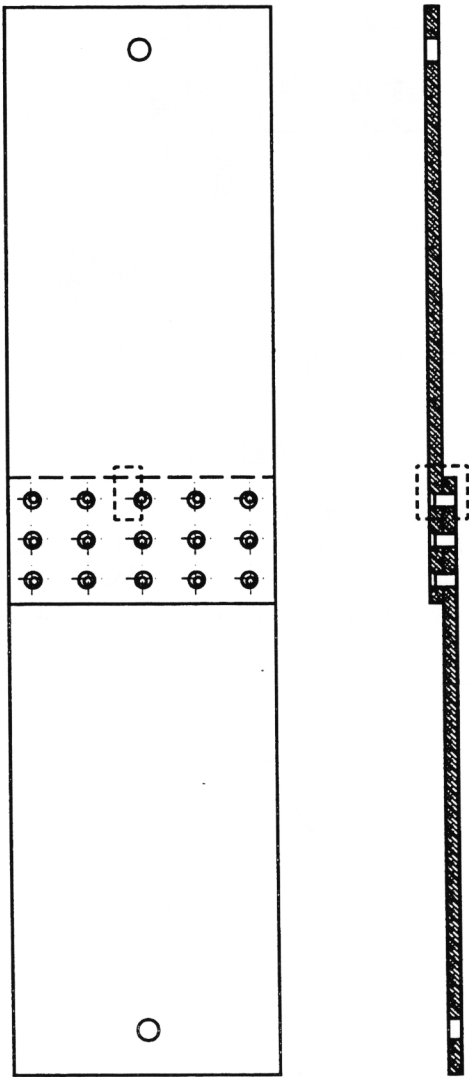
The model simulated one of the fasteners on the critical row as shown in figure 12. The boundary conditions of the model are shown in figure 13. The portion of far field stress which was considered to be transferred by the critical row of fasteners was based on other research in QIDEC [6]. The model included the influence of plasticity of the upper sheet, lower sheet, and rivet. Kinematic hardening was assumed. The interfay sealant and the friction between the rivet and the sheets also were included in the model. The direction of the axis of the rivet was not constrained. The ADINA-IN<sup>®</sup> and ADINA-PLOT<sup>®</sup> codes used to obtain the plots found in this report will be made available upon request to the authors.

Figure 12. Diagram of a riveted joint used during the sensitivity study with the boundaries of the computer model shown in dashed lines.

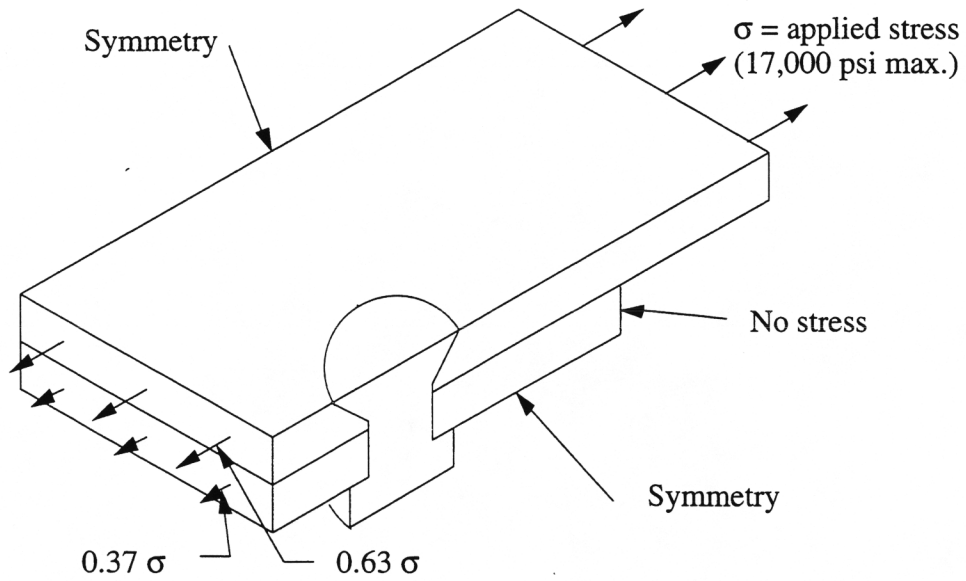
Figure 13. Boundary conditions of the model.

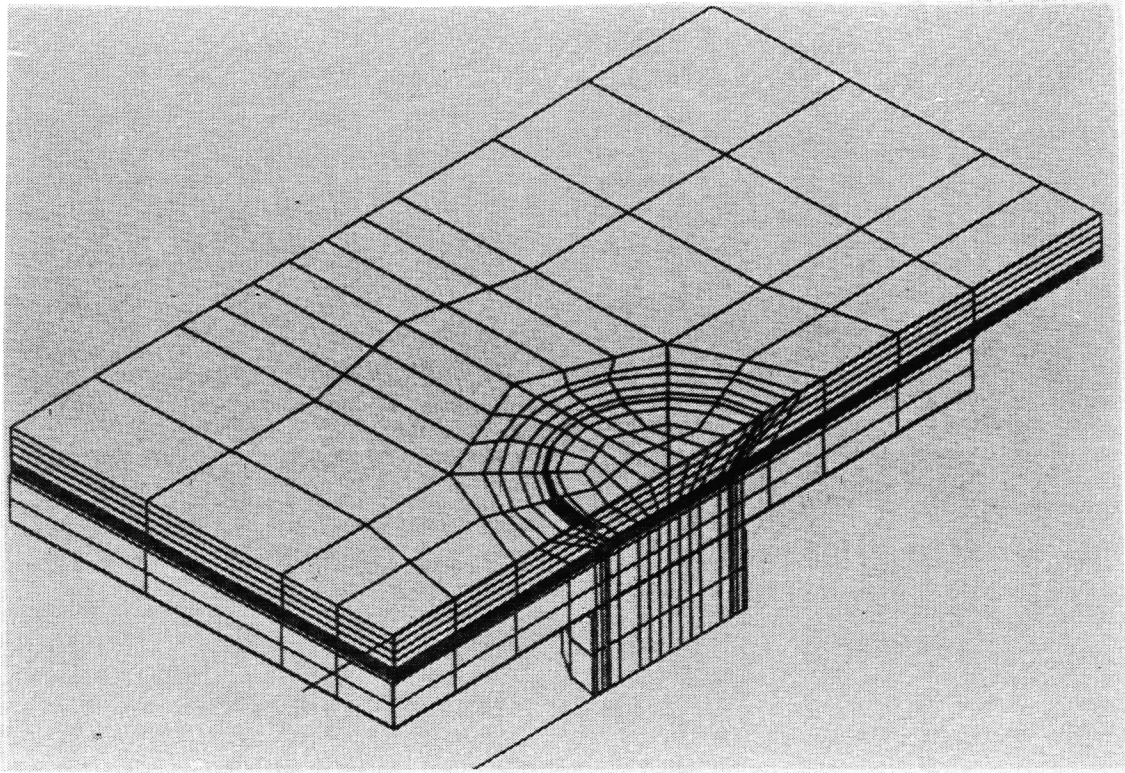
A plot of the model is shown in figure 14 and a plot of the riveted joint mesh is shown in figure 15. A plot of half of the upper plate mesh is shown in figure 16. This figure includes an arrow indicating the high stress region in which the stress plots described in section 3.4 are shown. Figure 17 shows a magnified view of this high stress region mesh.

Figure 14. Mesh of the entire model. The dark areas are due to the resolution of the plotter and have no practical significance.

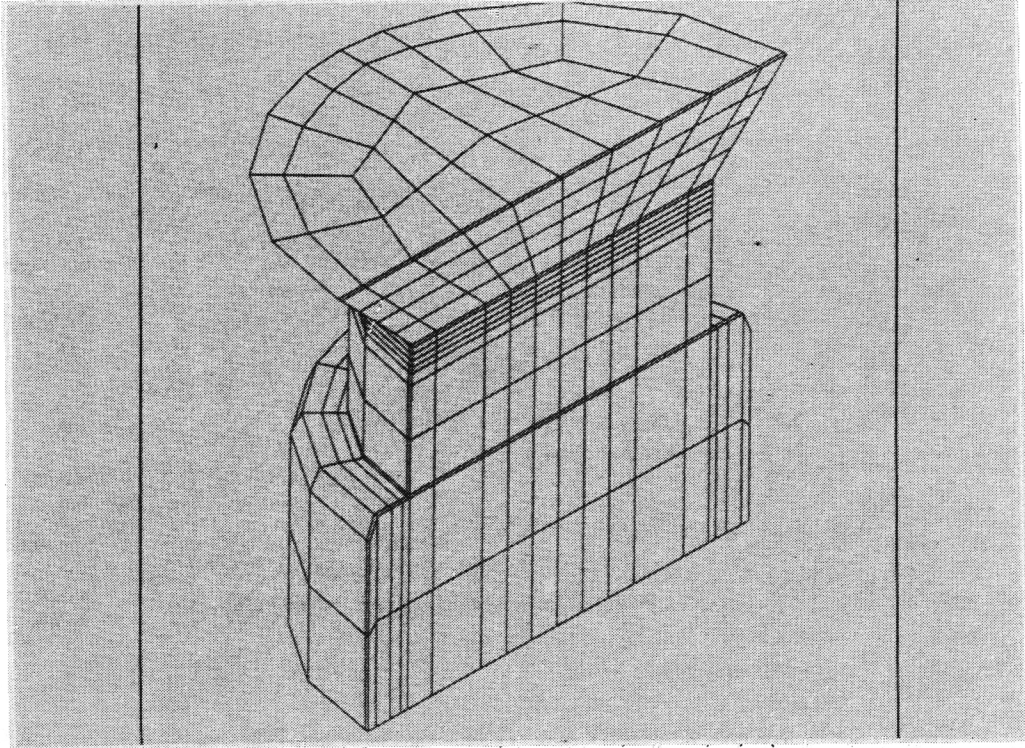
Figure 15. Mesh of the rivet.

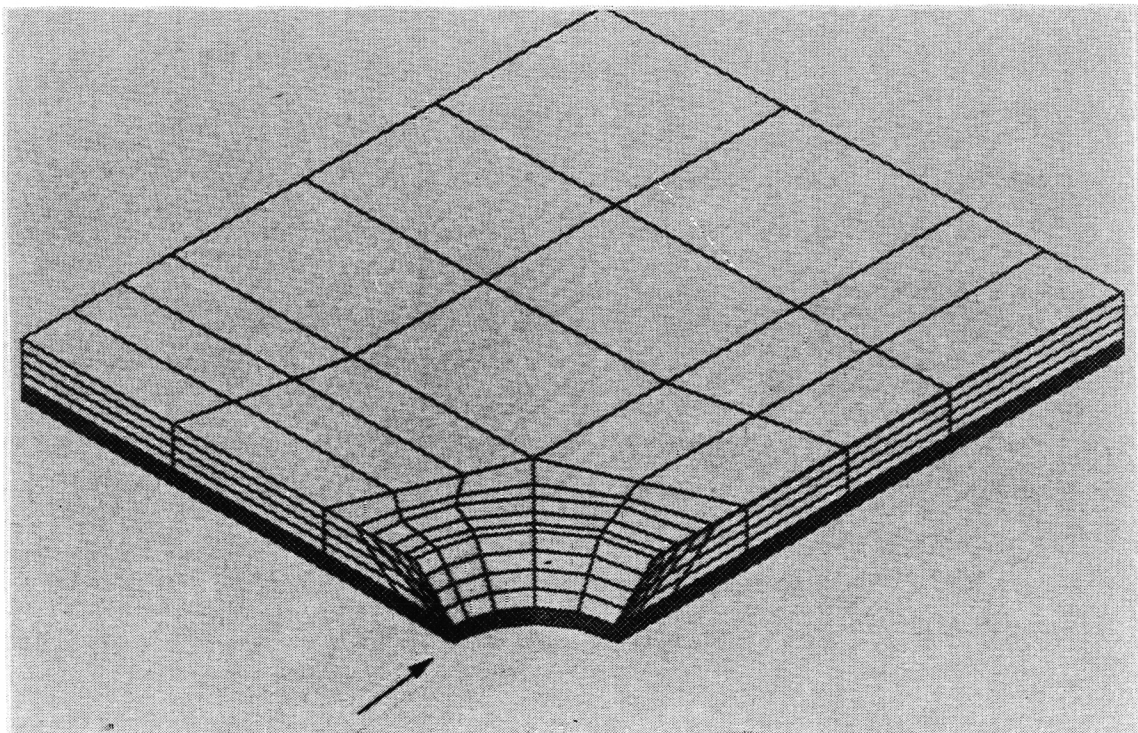
Figure 16. Mesh of one quarter of the upper plate. An arrow marks the high stress region for which the stress plots in section 3.4 are shown. The stress direction for the plots is the direction of fatigue loading which is from upper right to lower left in this figure.

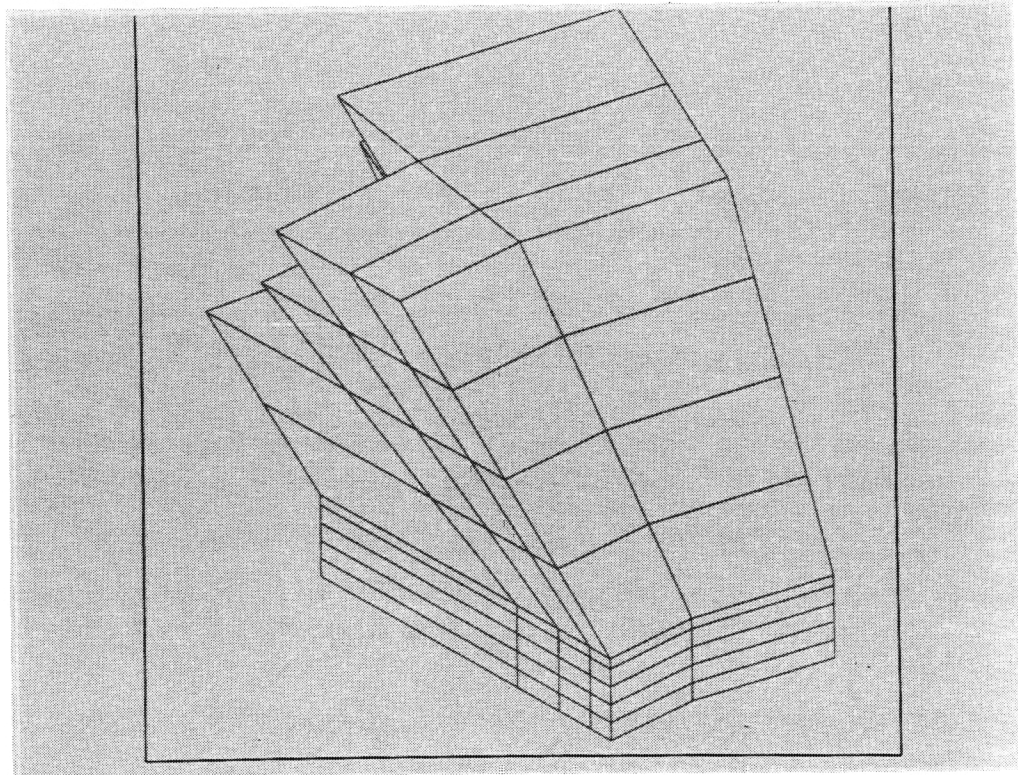
Figure 17. Mesh of the region just underneath the countersink in the upper plate in the region of highest stress concentration.

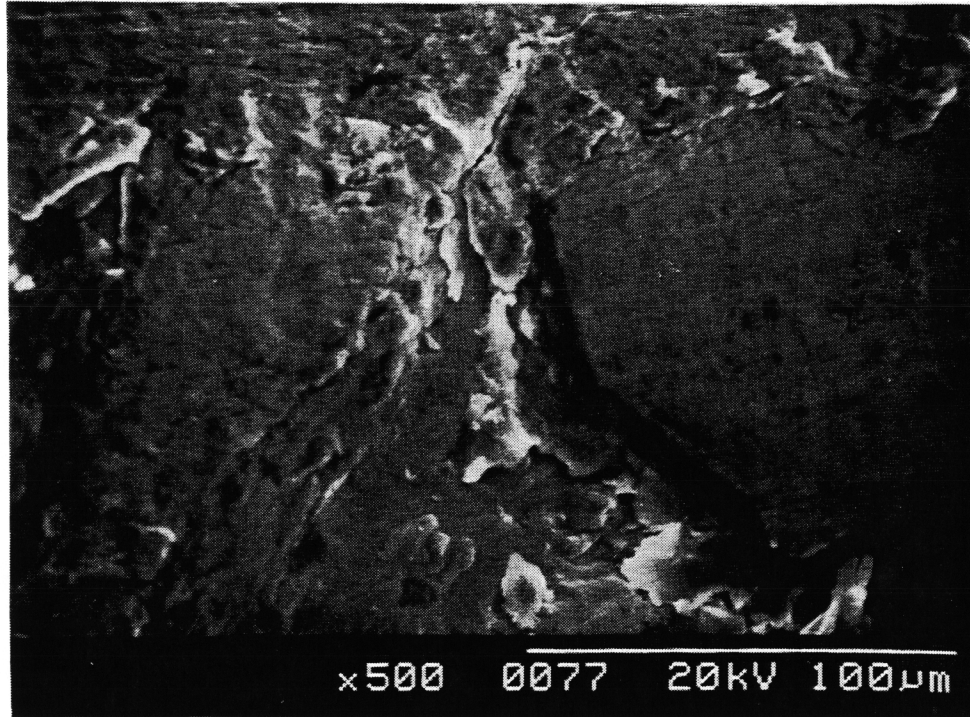
By optical microscope and/or SEM inspection fretting debris was found in all of the rivet holes that were inspected. Additionally, cracks were found in the fretting debris in each hole. Figures 18 and 19 show examples of cracks in fretting debris in rivet holes as previously defined in figure 2.

Figure 18. Example of cracks in fretting debris in rivet hole 1. The top of the picture is in the countersink region and the bottom is in the rivet body region.

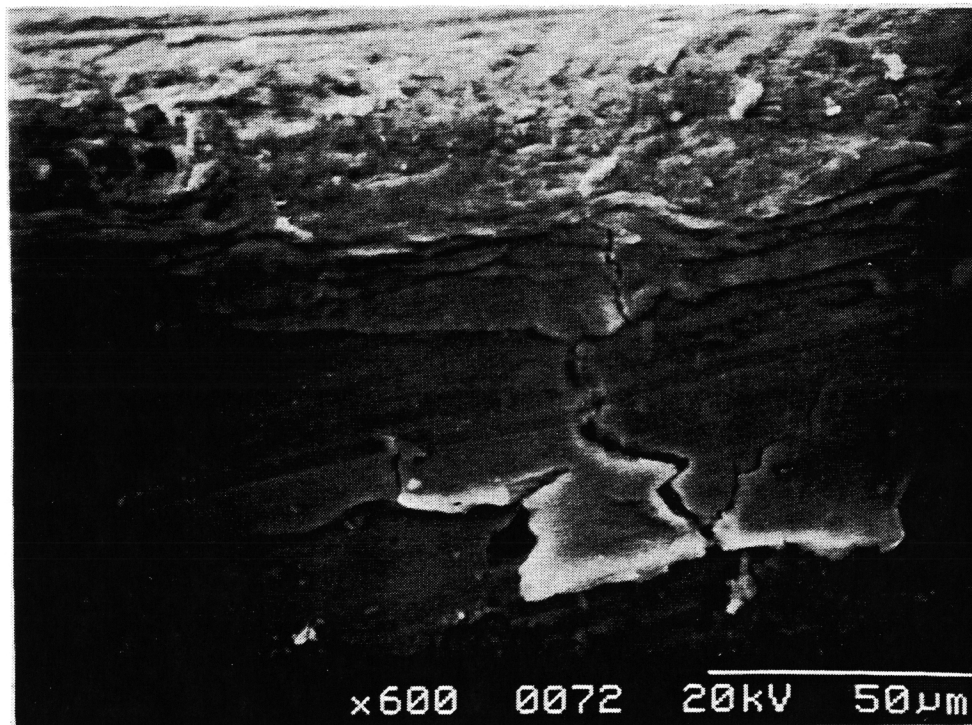
Figure 19. Example of cracks in fretting debris in rivet hole 46. The top of the picture is in the countersink region and the bottom is in the rivet body region.

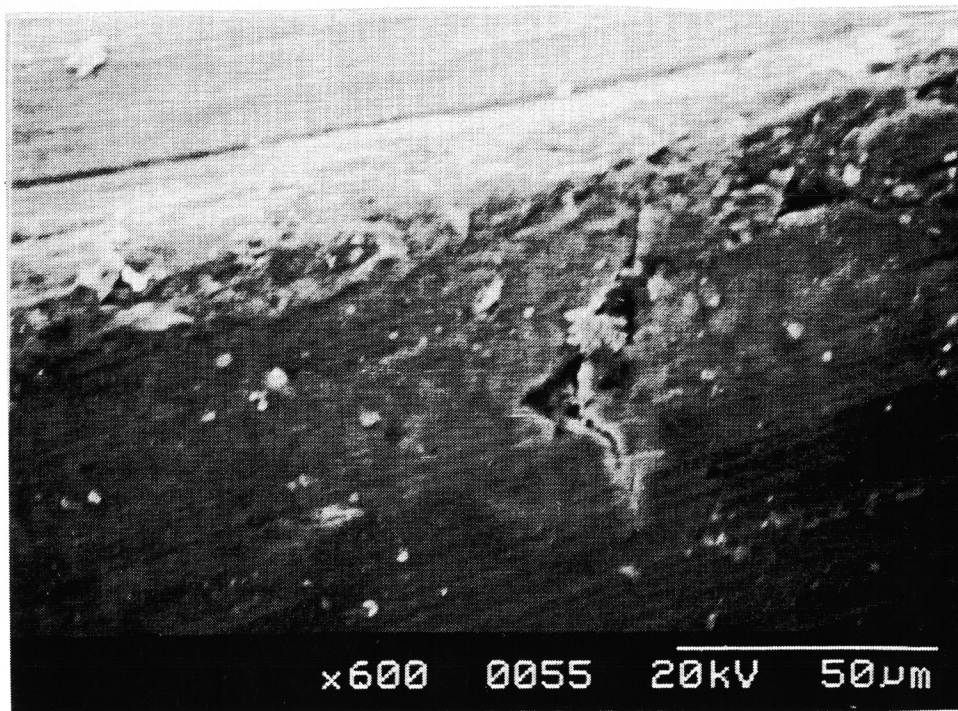
Several cracks were found in regions that appeared to have had relatively little fretting damage. However, these cracks were generally attributable to other identifiable causes such as the crack emanating from a void or inclusion as shown in figure 20.

Figure 20. Crack emanating from a void or inclusion in a relatively unfretted region in rivet hole 49.

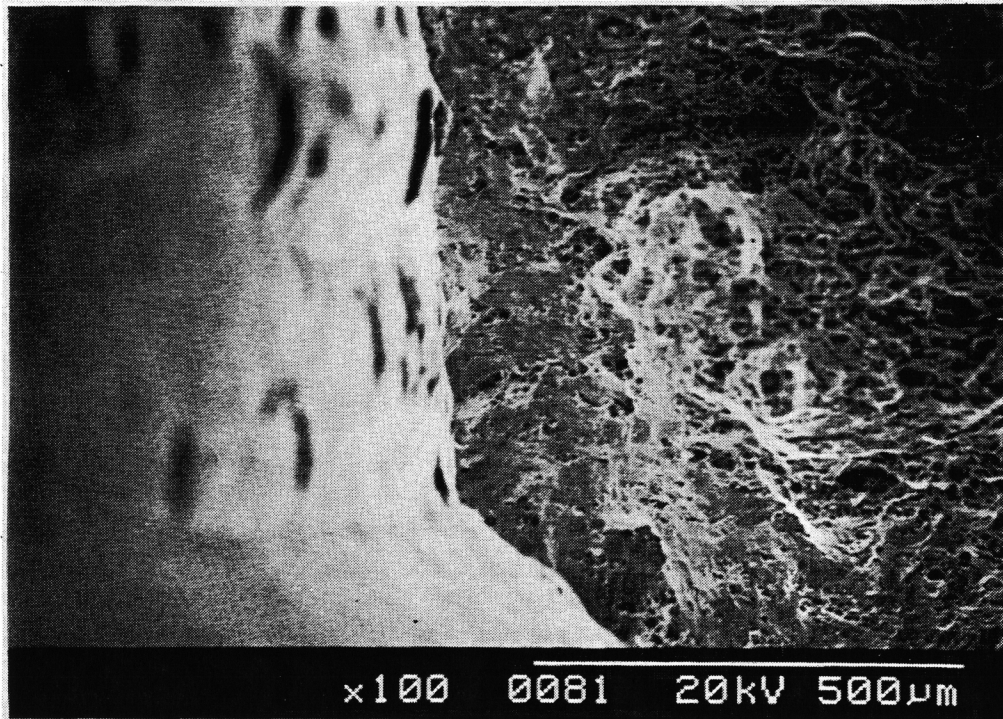
Based on examination of the surfaces of the rivet holes and examination of the crack surfaces for those cracks in fretting debris, it was determined that crack nucleation generally occurred in the rivet body region of the rivet holes near the countersink region of the holes. This can be seen in figures 18 and 19. Crack surface views of two other fatigue cracks within the rivet holes are shown in figures 21 and 22.

Figure 21. Crack surface at rivet hole 49. The top of the picture is in the rivet body region and the bottom is in the countersink region.

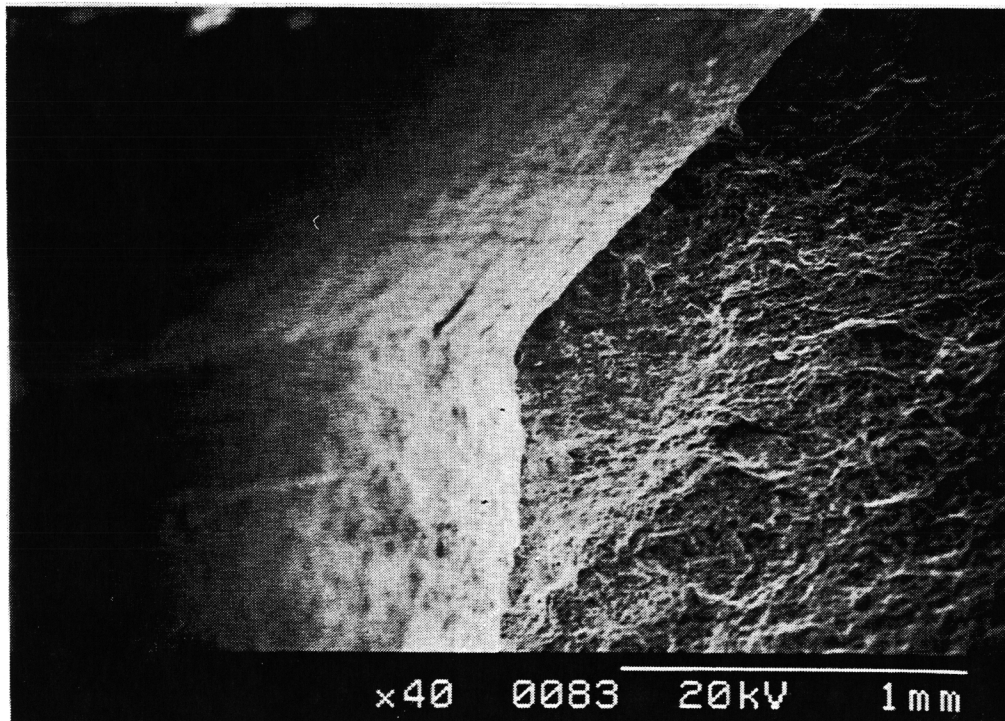
Figure 22. Crack surface at rivet hole 50. The top of the picture is in the countersink region and the bottom is in the rivet body region.

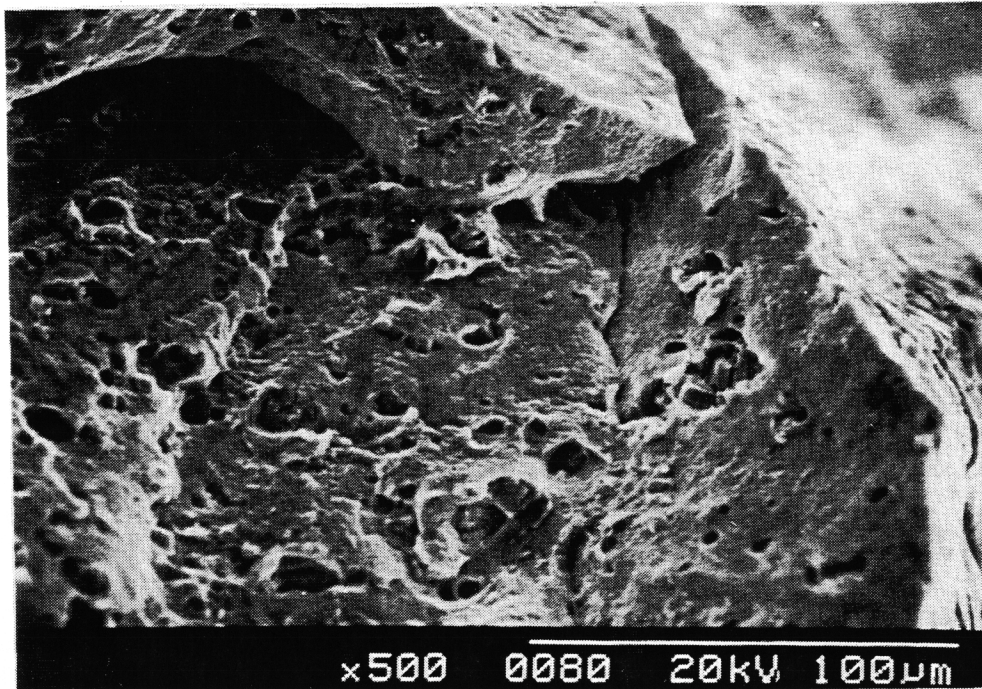
Observation of figures 21 and 22 can lead to a misconception that only single cracks occurred. This was not necessarily the case, but rather a function of how the region near the rivet hole was fractured for inspection. As can be seen in figure 23, numerous cracks were possible within the rivet holes.

Figure 23. Crack surface at rivet hole 1. The fracture surface shows several cracks, and additional cracking can be seen on the rivet hole surface to the right of the figure.

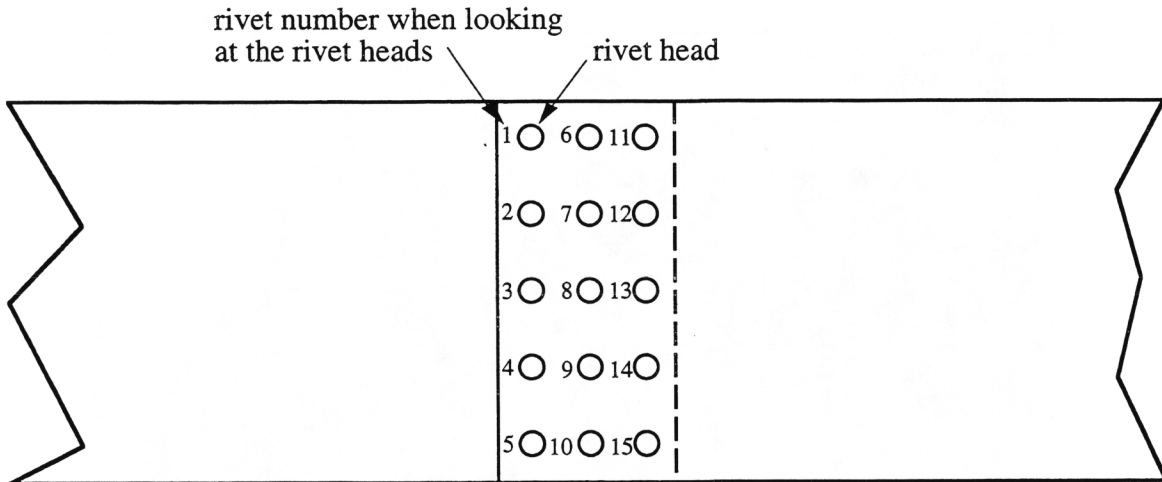
For all specimens, failure resulted from instability due to fatigue crack propagation in the line of rivets 11 through 15 as shown in figure 24. Cycles-to-failure data are shown in table 2. With the exception of some relatively short cracks, all fatigue cracks that were identified had nucleated in fretted regions within or adjacent to the rivet holes. These locations of fretting were identified by observed fretting debris. Tables 3 and 4 contain a listing of the locations of fretting debris in which cracks nucleated for the CE and the FV rivets respectively. Figures 25 and 26 contain the keys for the location codes in tables 3 and 4 respectively. Figures 27 and 28 show typical cracks which nucleated in fretted regions. Figure 29 shows the fracture surface of a plate for which crack nucleation was in the region between the 2024 alloy sheets.

Figure 24. Riveted region in a sensitivity study specimen showing the rivet numbering scheme.

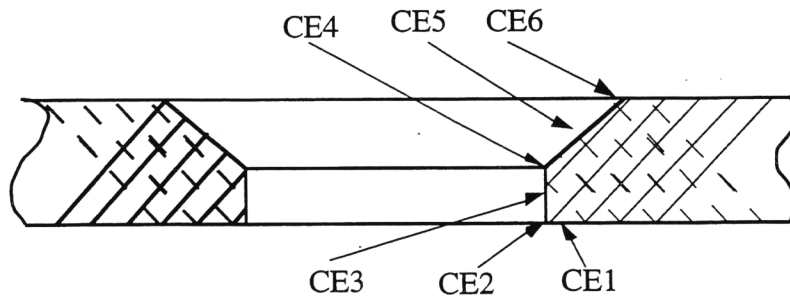
Table 3. Locations of fretting debris in which cracks nucleated and frequency of nucleation within the debris for CE riveted joints. See figure 25 for the meaning of the location codes.

Figure 25. Drawing of a hole in a plate for a CE rivet showing the coded locations of cracks which nucleated from fretted regions. The codes are used in table 3 above and in the text.

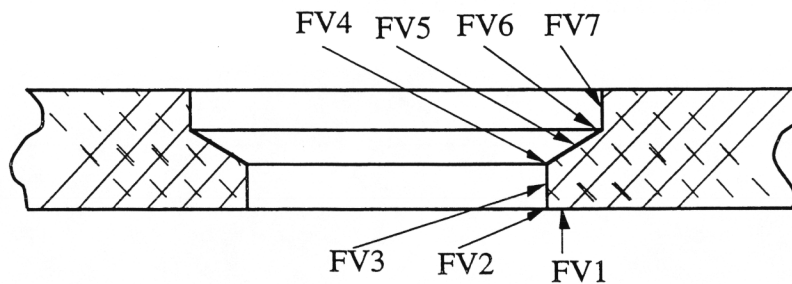
Table 4. Locations of fretting debris in which cracks nucleated and frequency of nucleation within the debris for FV riveted joints. See figure 26 for the meaning of the location codes.

Figure 26. Drawing of a hole in a plate for an FV rivet showing the coded locations of cracks which nucleated from fretted regions. The codes are used in table 4 above and in the text.

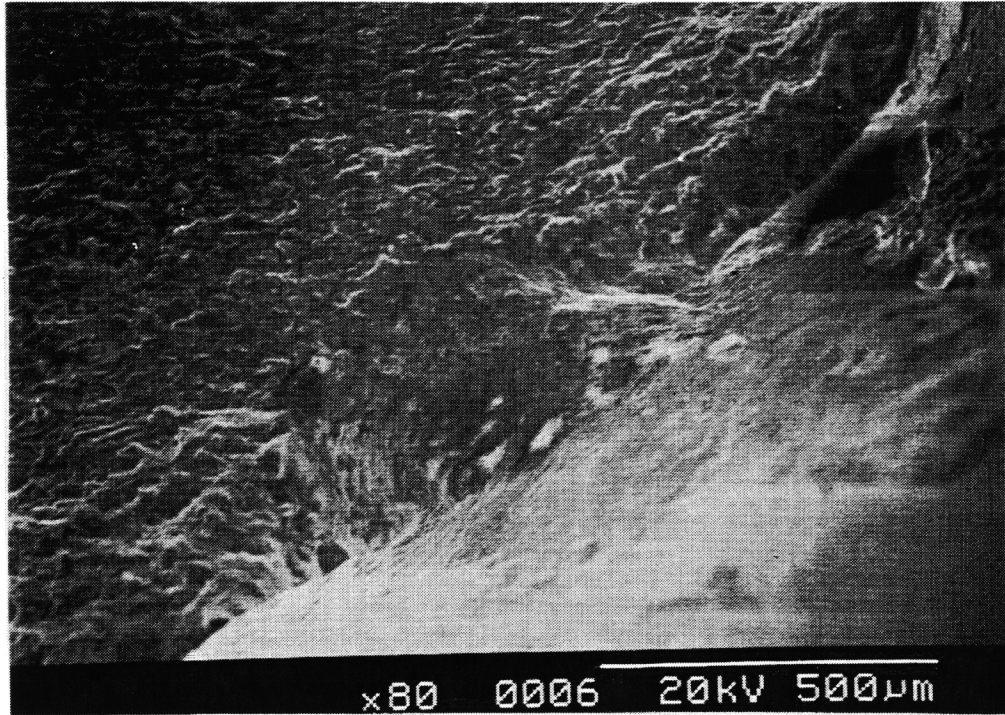
Figure 27. Fracture surface of a crack which nucleated within a region subject to fretting. The fretting is at location CE5 of figure 25.

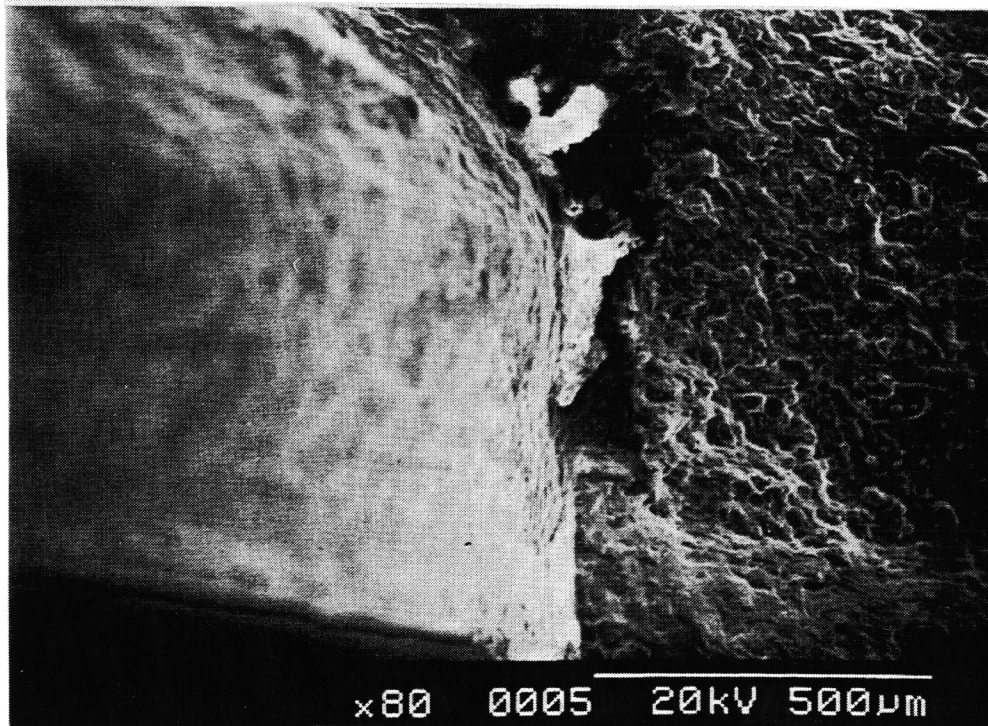
Figure 28. Fracture surface of a crack which nucleated within a region subject to fretting. The fretting is at location FV6 in figure 26.

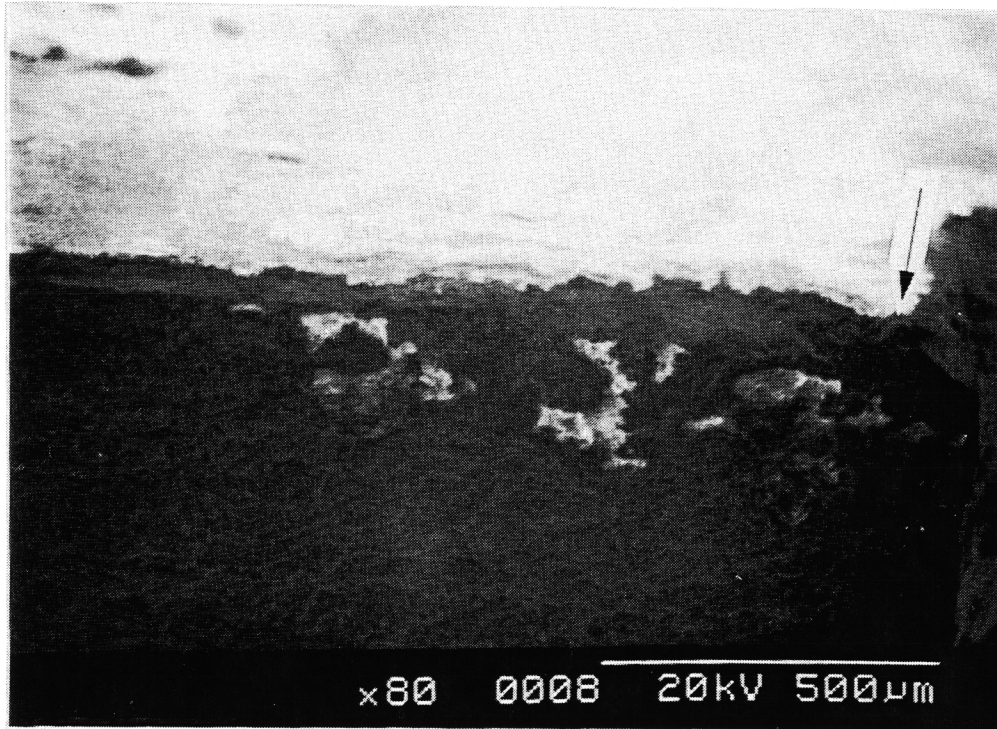
Figure 29. Fracture surface (bottom of picture) for crack from a fretted area (see arrow) between the plates. The substance at the top of the picture is interfacial sealant.

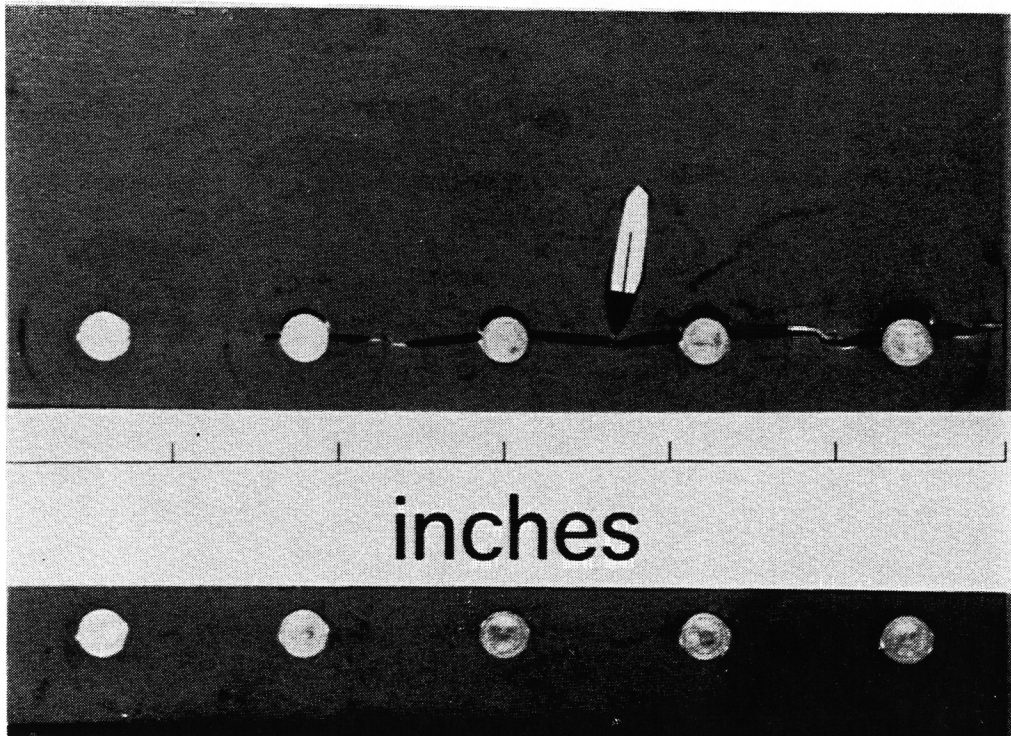
Specimens 3, 13, and 10R did not fracture (break into two pieces) because the error detectors sensed failure and activated the interlocks which stopped specimen loading before fracture could occur. Because of the extent of cracking in these specimens (for example see figure 30), it is felt that additional cycling would have been minimal if the test had not been stopped because the interlocks were activated. Therefore, the cycle count at the time of interlock for each specimen was used in the data analysis.

Figure 30. View of test specimen 3 showing extensive cracking but not fracture.
