DOT/FAA/AR-96/10

# The Role of Fretting Fatigue on Aircraft Rivet Hole Cracking

October 1996

Final Report

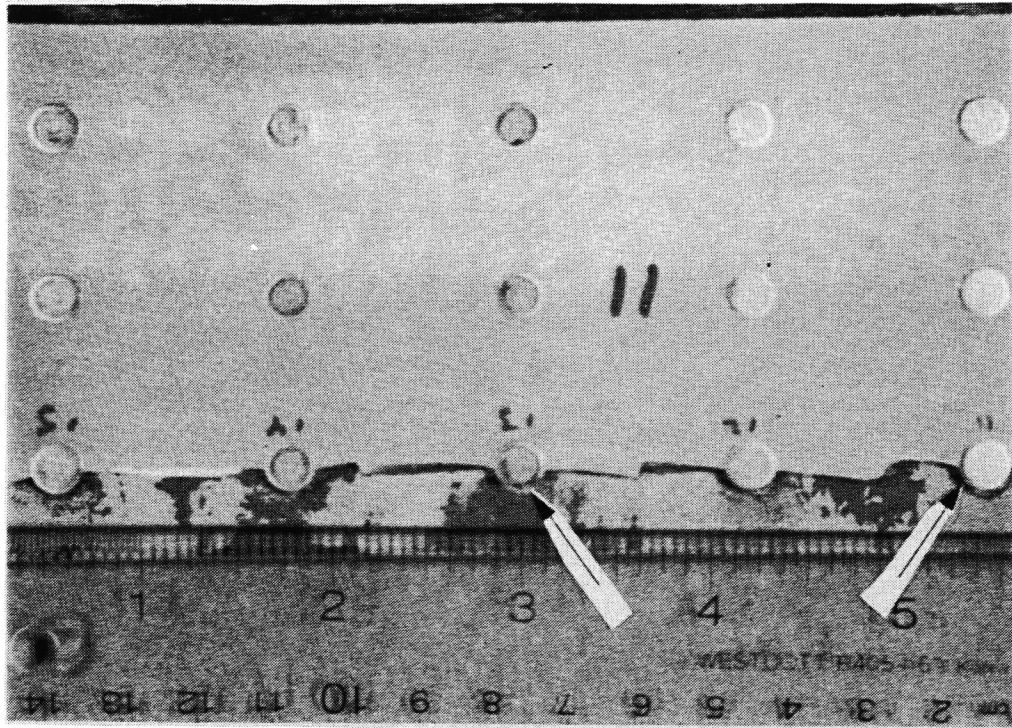
Seven of the eight specimens riveted with FV/C-Squeeze procedures were found through optical microscope inspection to have cracks along a chord of the circular top of the rivet head. Four of these rivet heads (one each in specimens 8, 11, 3R, and 10R) had fractured. Figure 31 shows fractured specimen 11 in which rivet 13 has fractured and a crack is observed in rivet 11. In all, 12 rivets were observed to be cracked or fractured. Of these, one was in rivet 11, three were in rivet 12, five were in rivet 13, and three were in rivet 14. No cracks were found in any CE or FV/rivet gun with bucking bar specimens. The fracture surface of rivet 13 specimen 11 is shown in figure 32. Ratchet marks near the arrow in this figure indicate that fatigue cracks nucleated at the countersink surface of the rivet. This is confirmed in figure 33 which shows fatigue striations located at the point of the arrow in figure 32.

Figure 31. Fractured specimen 11 in which rivet 13 has fractured and a crack is observed in rivet 11.

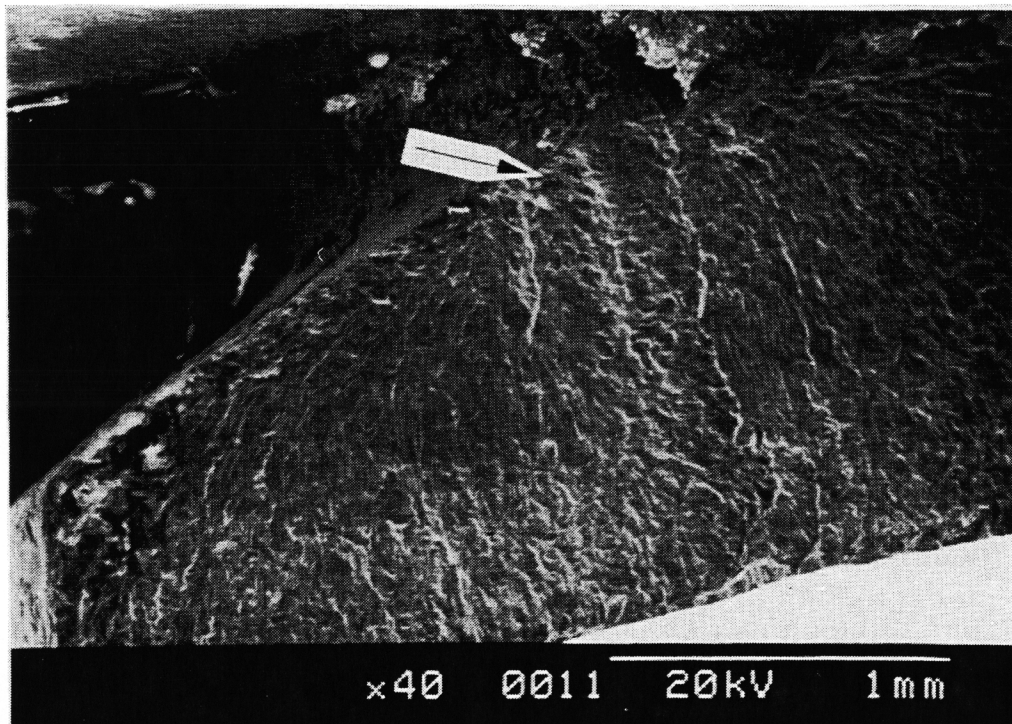
Figure 32. The fracture surface of rivet 13 specimen 11. Ratchet marks near the arrow indicate that fatigue cracks nucleated at the countersink surface. The striations in figure 33 are at the point of the arrow in this figure.

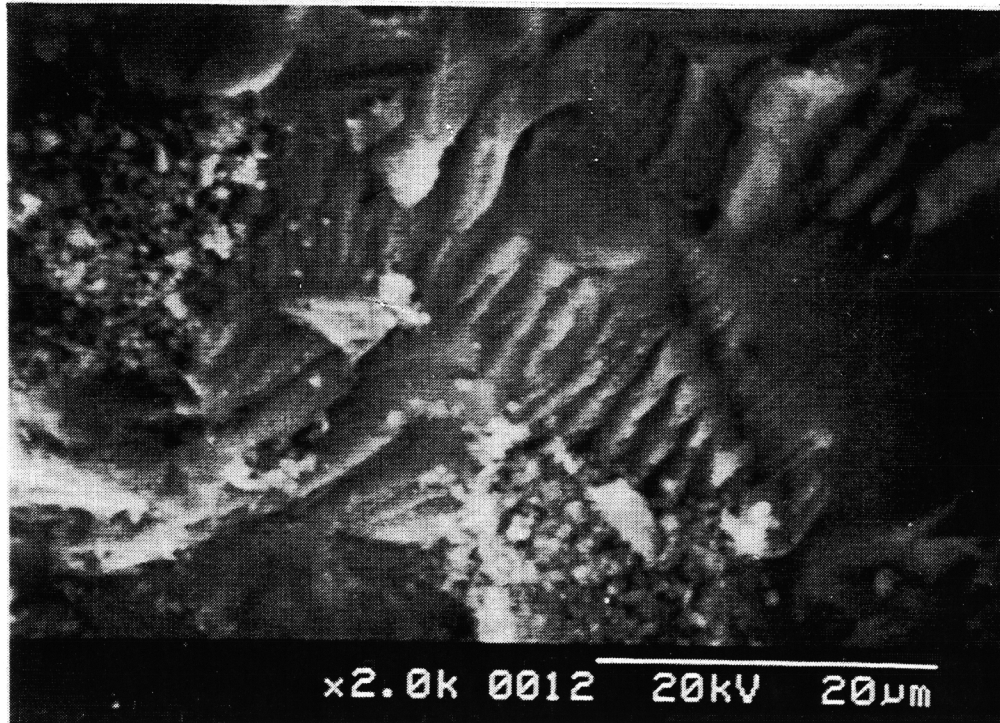
Figure 33. Striations indicative of fatigue crack propagation in rivet 13 specimen 11. This picture is at the point of the arrow in figure 32 and is oriented in the same direction as that figure.

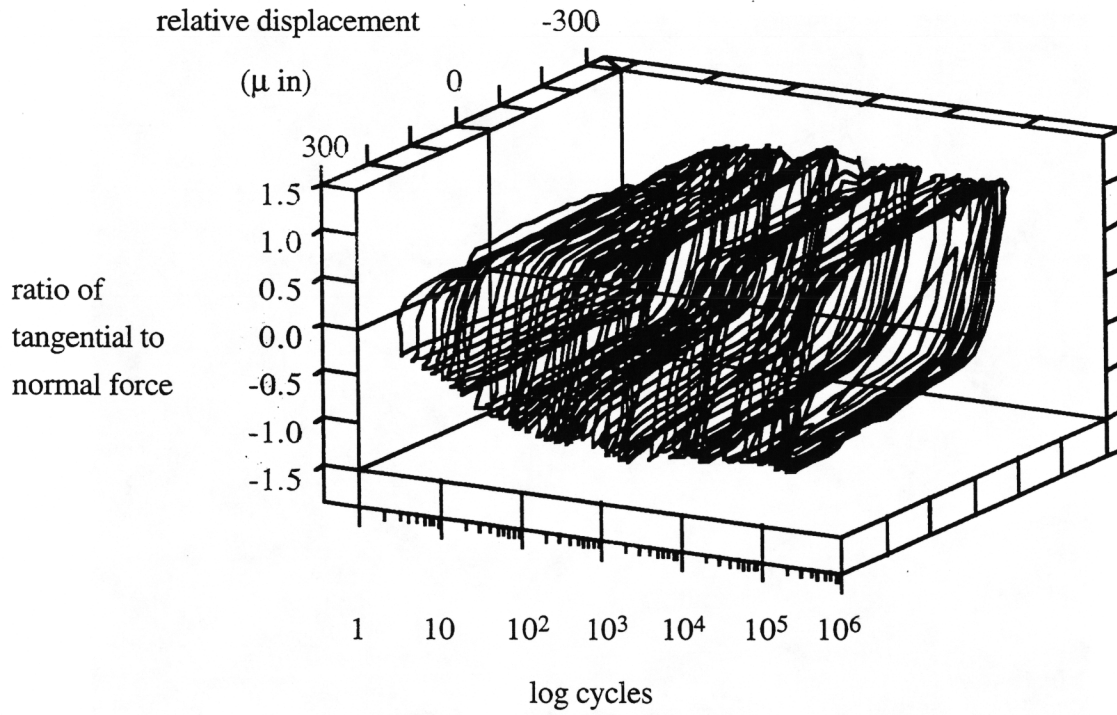
Figure 34. Typical friction log of coefficient of friction during fretting test.

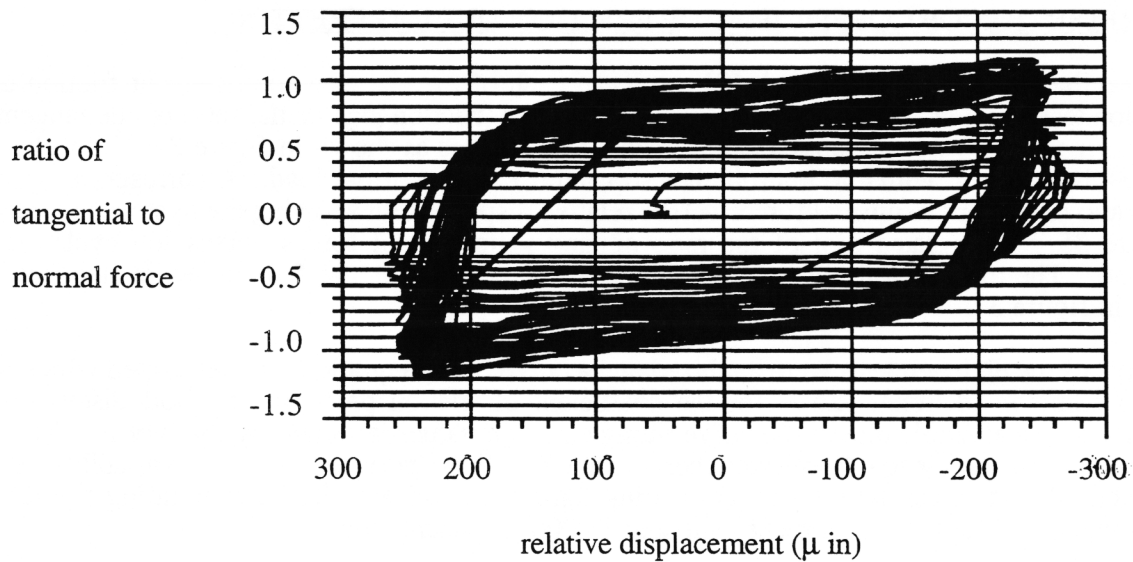
Figure 35. Example of hysteresis loops for coefficient of friction during fretting test (see figure 37 for an explanation of the view).

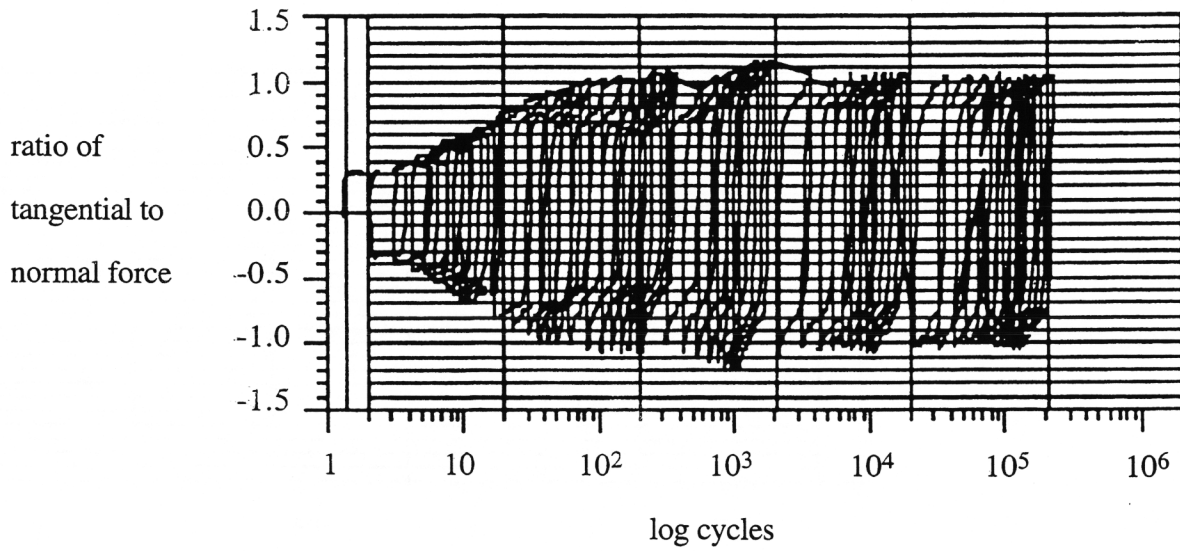
Figure 36. Example of the ratio of tangential to normal force versus cycles for a coefficient of friction during fretting test (440 microinches slip and 6,750 psi normal load). See figure 37 for an explanation of the view.

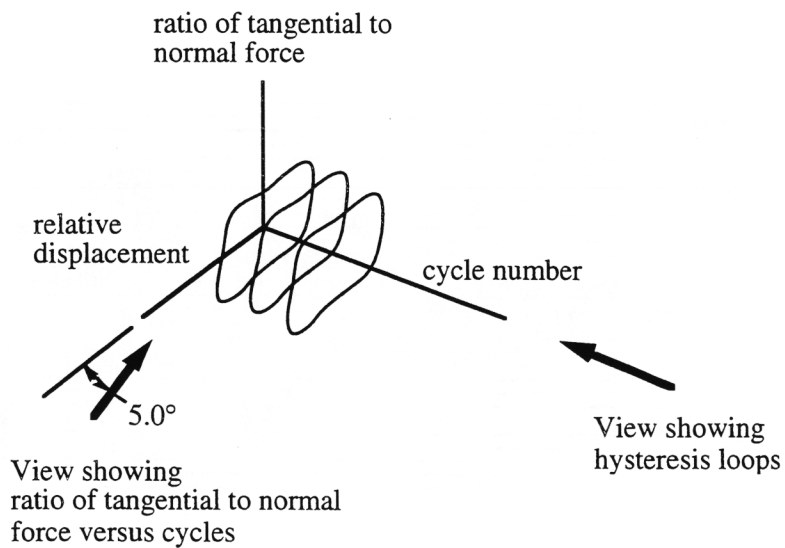
Figure 37. Friction log idealization with illustration of the different views of coefficient of friction during fretting test data plotted.

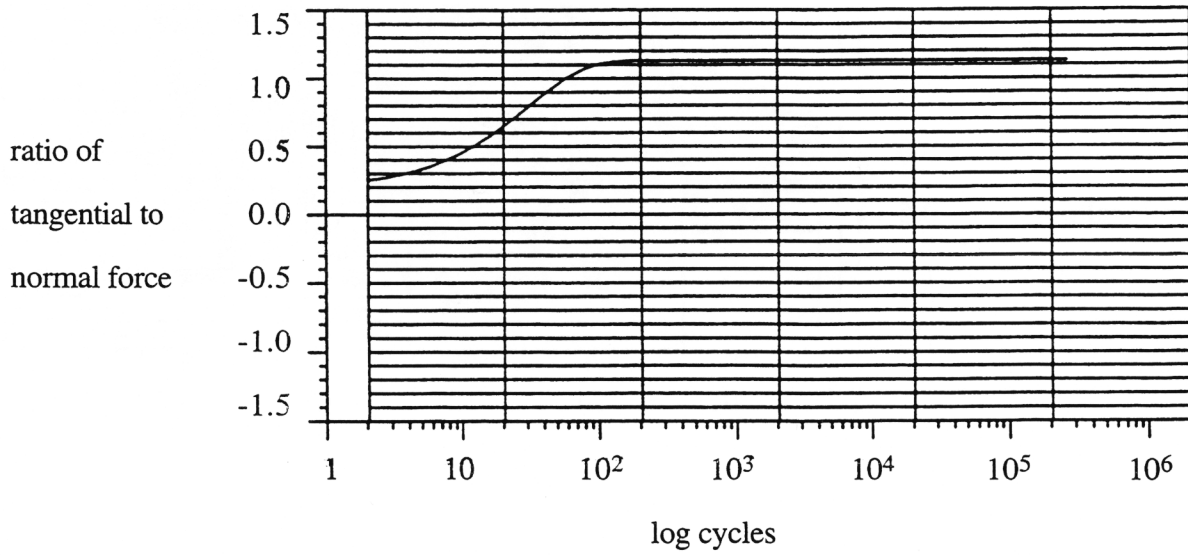
Figure 38. An example plot of the curve fitting equation values corresponding to 440 microinches slip and 6,750 psi normal load.

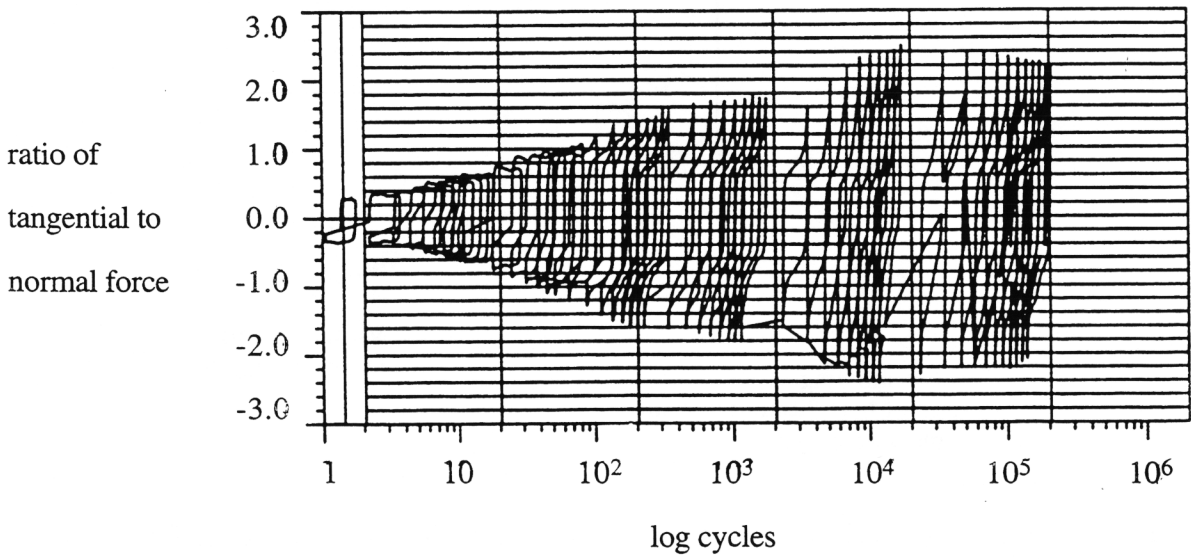
Figure 39. Example of the ratio of tangential to normal force versus cycles for a coefficient of friction during fretting test (800 microinches slip and 13,000 psi normal load).

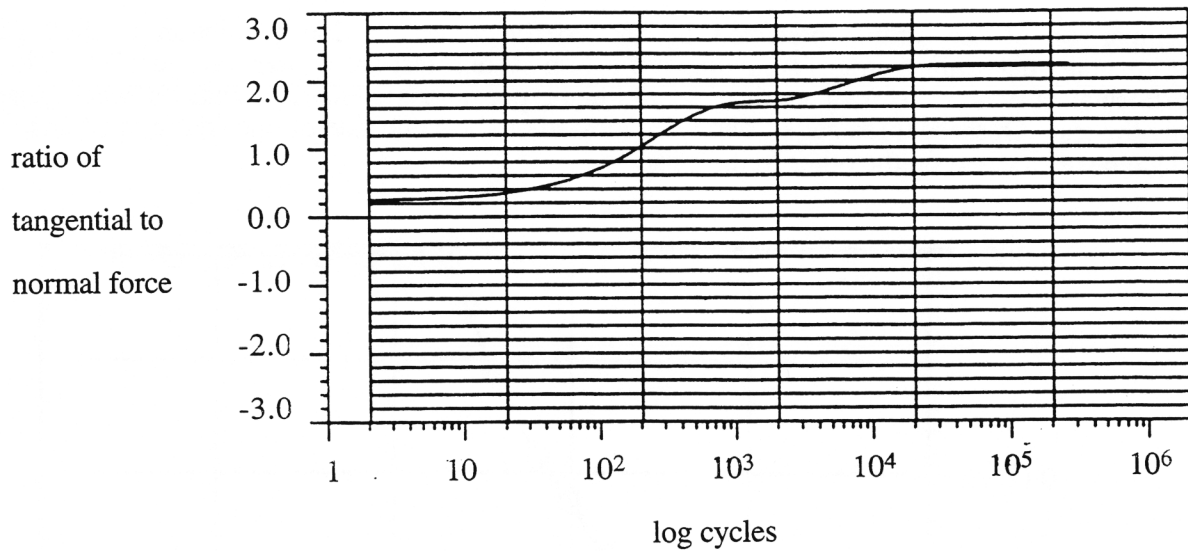
Figure 40. An example plot of the curve fitting equation values corresponding to 800 microinches slip and 13,000 psi normal load.

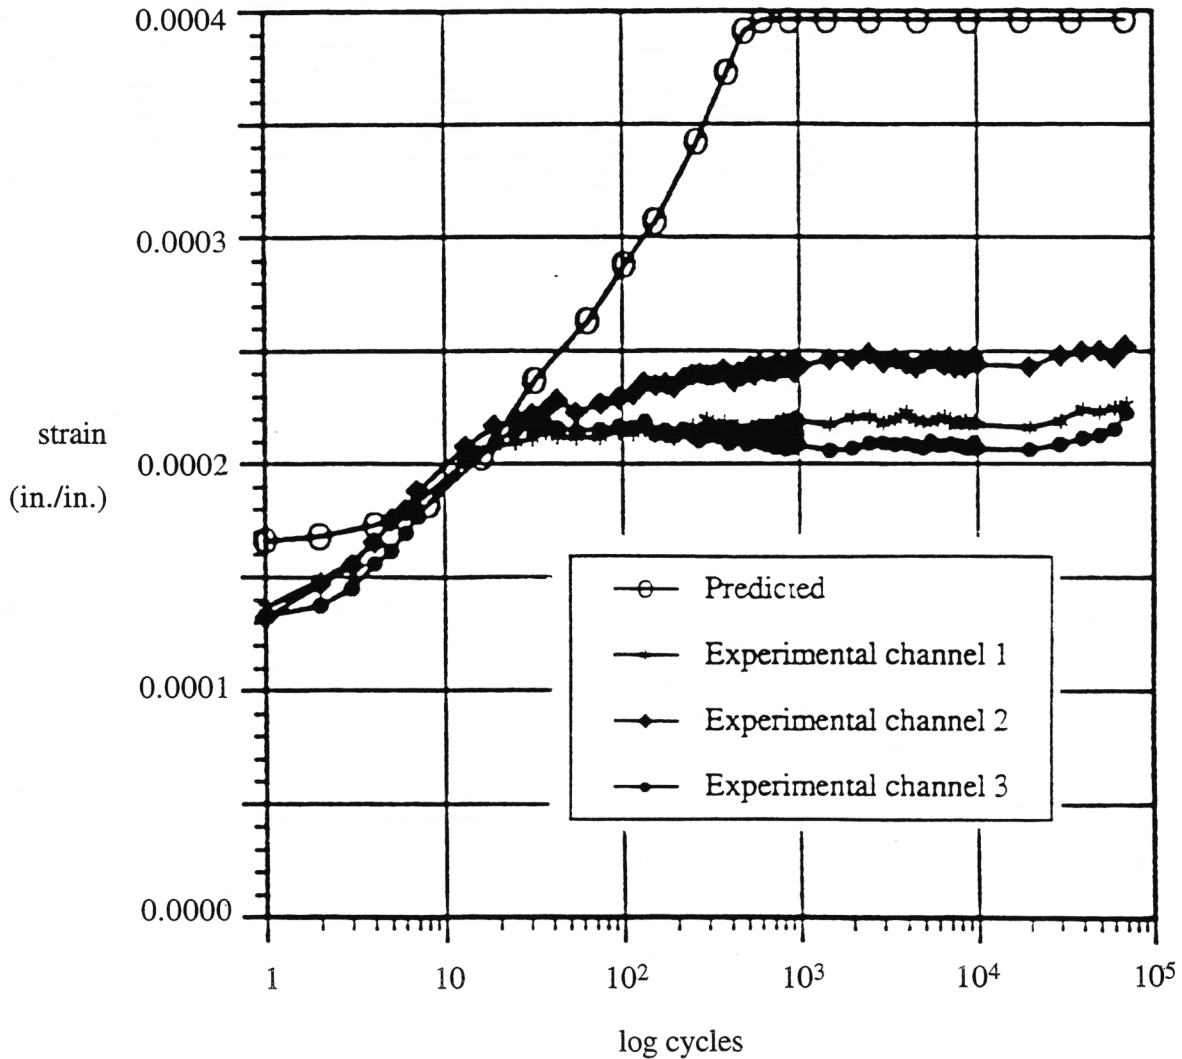
A comparison of the strains predicted by the coefficient of friction prediction method and experimentally determined strains from the verification system test are shown in figure 41. Three experimental curves are shown as three of the eight possible symmetric locations were gaged during the test. Of these three gages, two were located on the same side of one fretting pad and the third gage was located on the other fretting pad.

Figure 41. Predicted and experimentally determined strains of the verification apparatus.

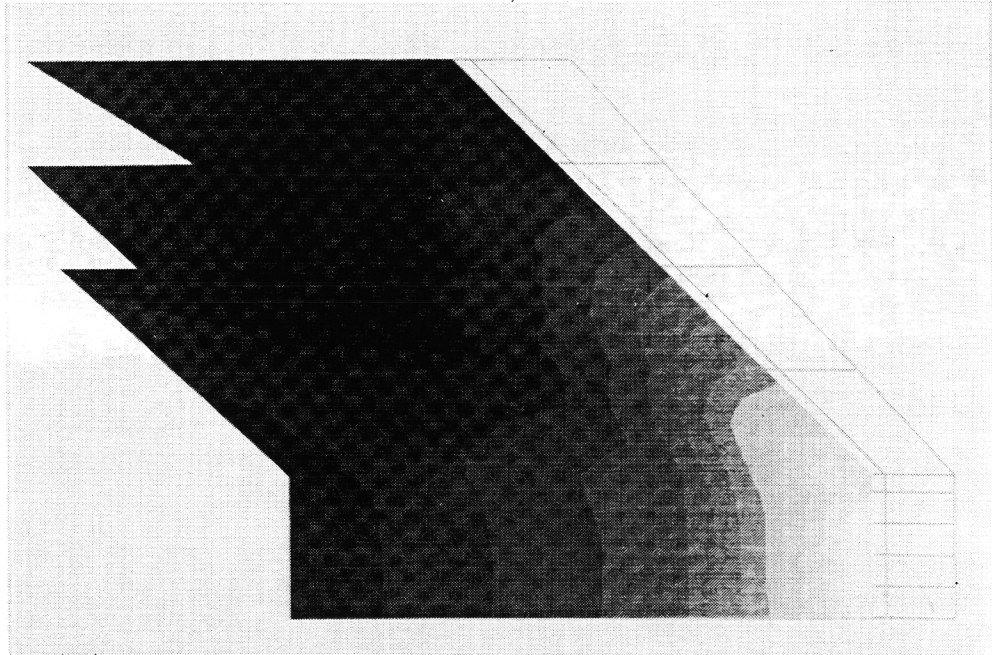
Figure 42. Fatigue loading direction stresses within the plate after the far field stress is increased to 17,000 psi, then decreased to 170 psi. Stresses are as discussed in figure 16. The stresses range from 15,000 psi (darkest) to -55,000 psi (lightest) in fifteen increments of 5,000 psi each.

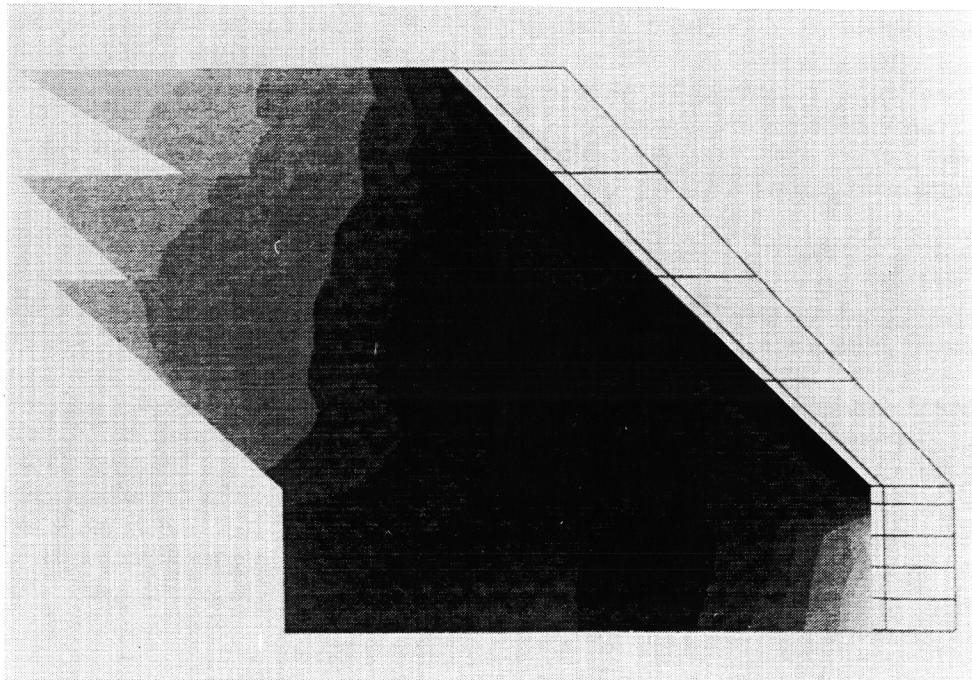
Figure 43. Fatigue loading direction stresses within the plate after the far field stress is increased to 17,000 psi, decreased to 170 psi, and returned to 17,000 psi. Stresses are as discussed in figure 16. The stresses range from 60,000 psi (darkest) to 18,000 psi (lightest) in fifteen increments of 3,000 psi each.
