DOT/FAA/AR-96/119

Vertical Drop Test of a Beechcraft 1900C Airliner

Final Report

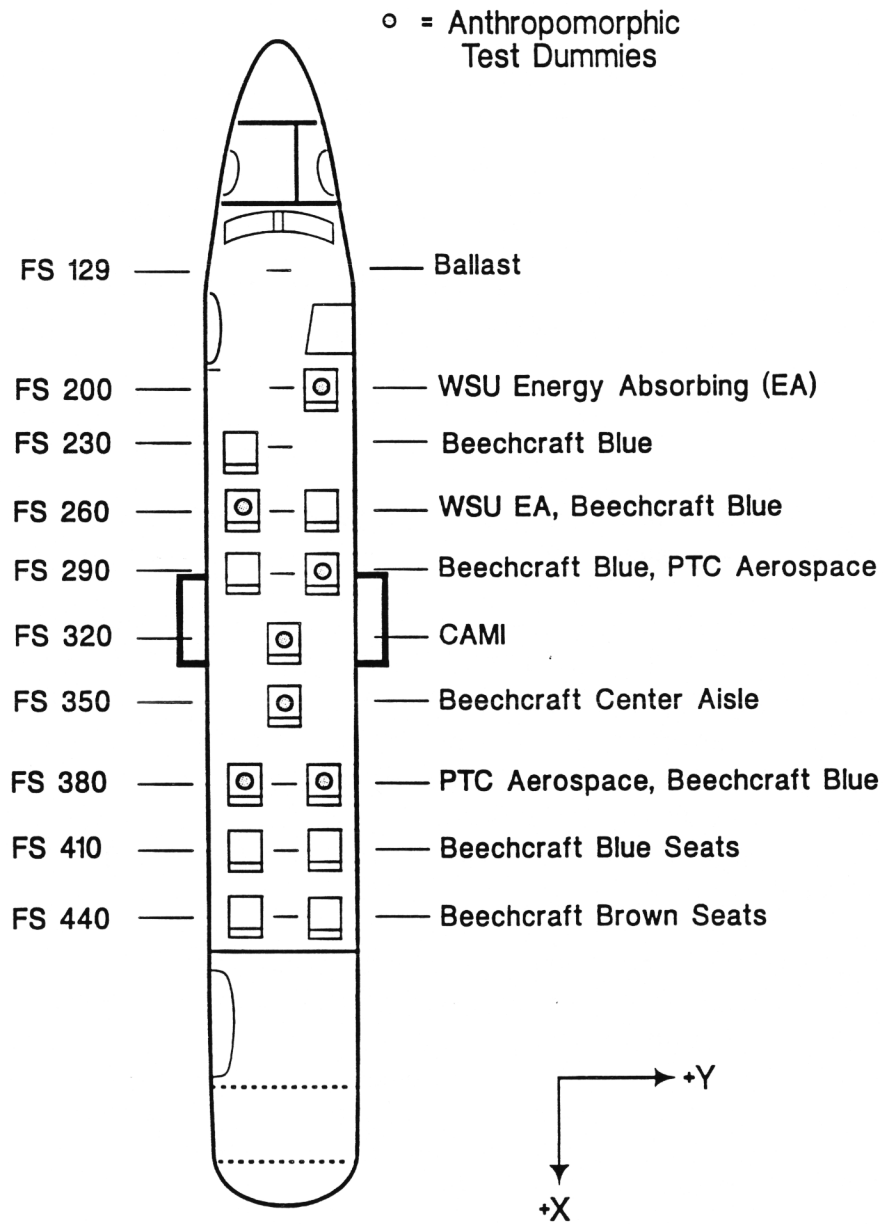
FIGURE 2. BEECHCRAFT 1900C AIRLINER

The internal seating arrangement was modified for the test to accommodate a variety of seats. Seats included in this test were PTC Aerospace seats, Wichita State University (WSU) experimental energy-absorbing seats, the FAA Civil Aeromedical Institute's (CAMI) experimental energy-absorbing seat, a center aisle Beechcraft seat, and standard Beechcraft seats both blue and brown in color. The blue and brown Beechcraft seats are structurally identical except the brown seats have a lower seat back. The following is a listing of the type of seats located at the fuselage stations (FS) along the length of the airplane. Seat configuration and locations are shown in figure 2:

- FS 129 - Flight deck seats were not installed, ballast was used
- FS 200 - Wichita State University experimental energy-absorbing seat
- FS 230 - Standard Beechcraft seat (blue)
- FS 260 - WSU experimental seat and standard Beechcraft seat (blue)
- FS 290 - Standard Beechcraft seat (blue) and PTC Aerospace seat
- FS 320 - FAA Civil Aeromedical Institute's energy-absorbing seat
- FS 350 - Center aisle Beechcraft seat
- FS 380 - PTC Aerospace seat and standard Beechcraft seat (blue)
- FS 410 - Two standard Beechcraft seats (blue)
- FS 440 - Two standard Beechcraft seats (brown)

Seven of the test dummies were 50th percentile Hybrid II anthropomorphic dummies. All of the anthropomorphic test dummies were instrumented with load cells and accelerometers. The instrumented test dummies were located at fuselage stations 200, 260, 290, 320, 350, and 380 (see figure 2).
