Heat Shields for Aircraft— A New Concept to Save Lives in Crash Fires

NASA Ames Research Center

AVCO Corporation

Test of the concept, which draws on research for Apollo, opens the way to considering retrofit systems and designing shields for new aircraft, where the protection system may involve little or no weight penalty

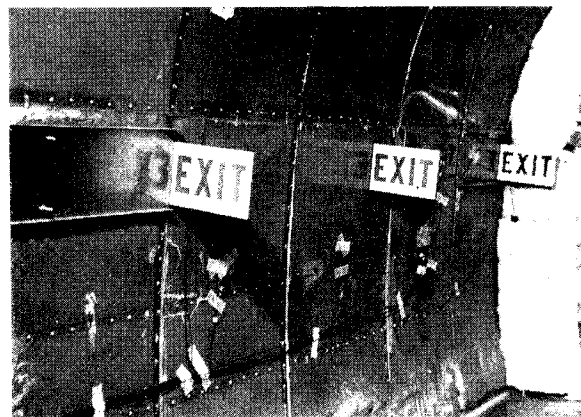
Interior of protected section before test.

Photos at right show the fuselage exterior and the interior of the protected section before the test. Simulated exit signs and an optical target permitted evaluation of any smoke effects. The interior of the unprotected section bore no exit signs or optical target.

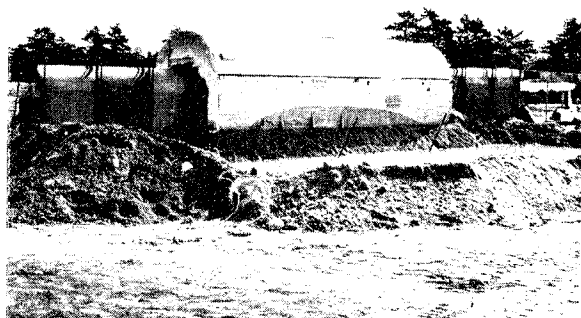
Fuselage section before test.

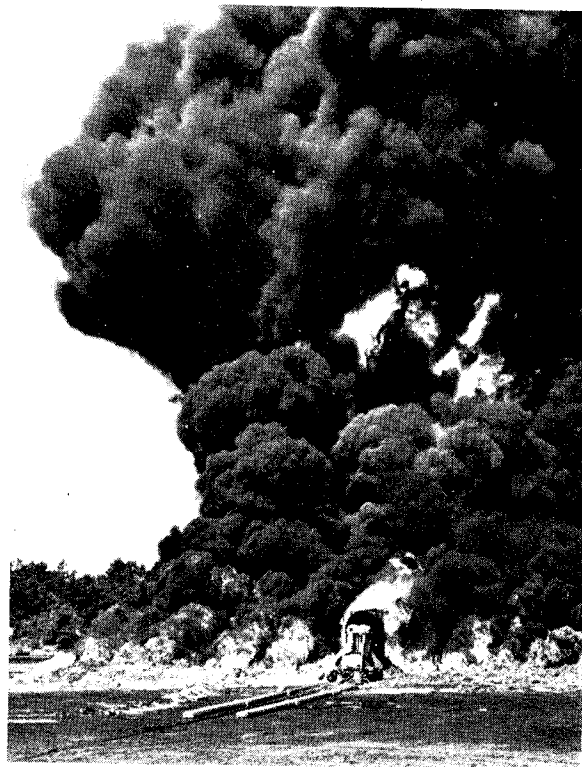
Fire during test. A North side of test fuselage. B East end of test fuselage.

Photos at right show two views of the fire during the test. Throughout most of the test, flames engulfed the entire test section. Because of the volume of flames and smoke, it was hard to see by eye what was happening. About 5 min after ignition, a light wind arose from the southeast and directed the flames so that occasionally you could see the end of the protected section. A tremendous vortex of flames around the entire fuselage accompanied this wind shift. Swirling extended about 100 ft upward. Peaks of the flames reached some 200 ft high.

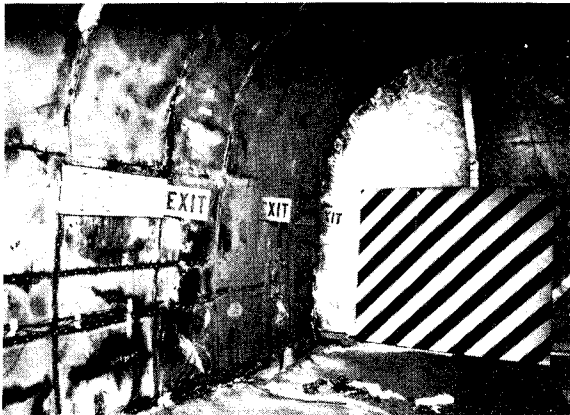
Interior of protected section after test. South side.

Following the test, you could see a dramatic difference between the protected and unprotected sections, as shown by the photo on page 22. The photos on page 22 show the interior of the protected section. Some time during tail-off of the fire, flames reached a relatively unprotected floor seam along the top of the dirt mound supporting the test section. Heat penetrated at this point, and eventually caused a slight burn-through and considerable blackening of the interior walls. This occurred *after the main fire burned out*. It should be attributed to the design of the test and *not* to a failure of the thermal-protection system.

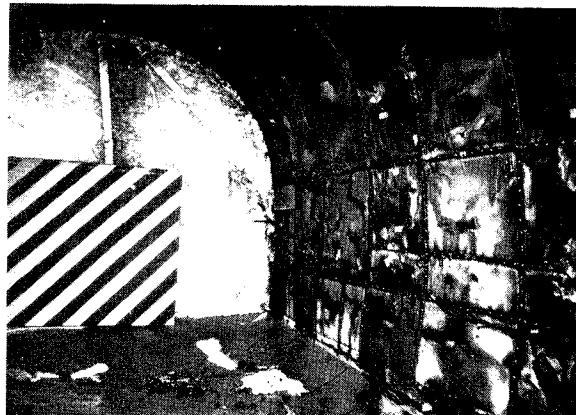
North side.
