Investigation of Fuselage Penetrations in Burnthrough Protected Area

Tim Marker

FAA Technical Center

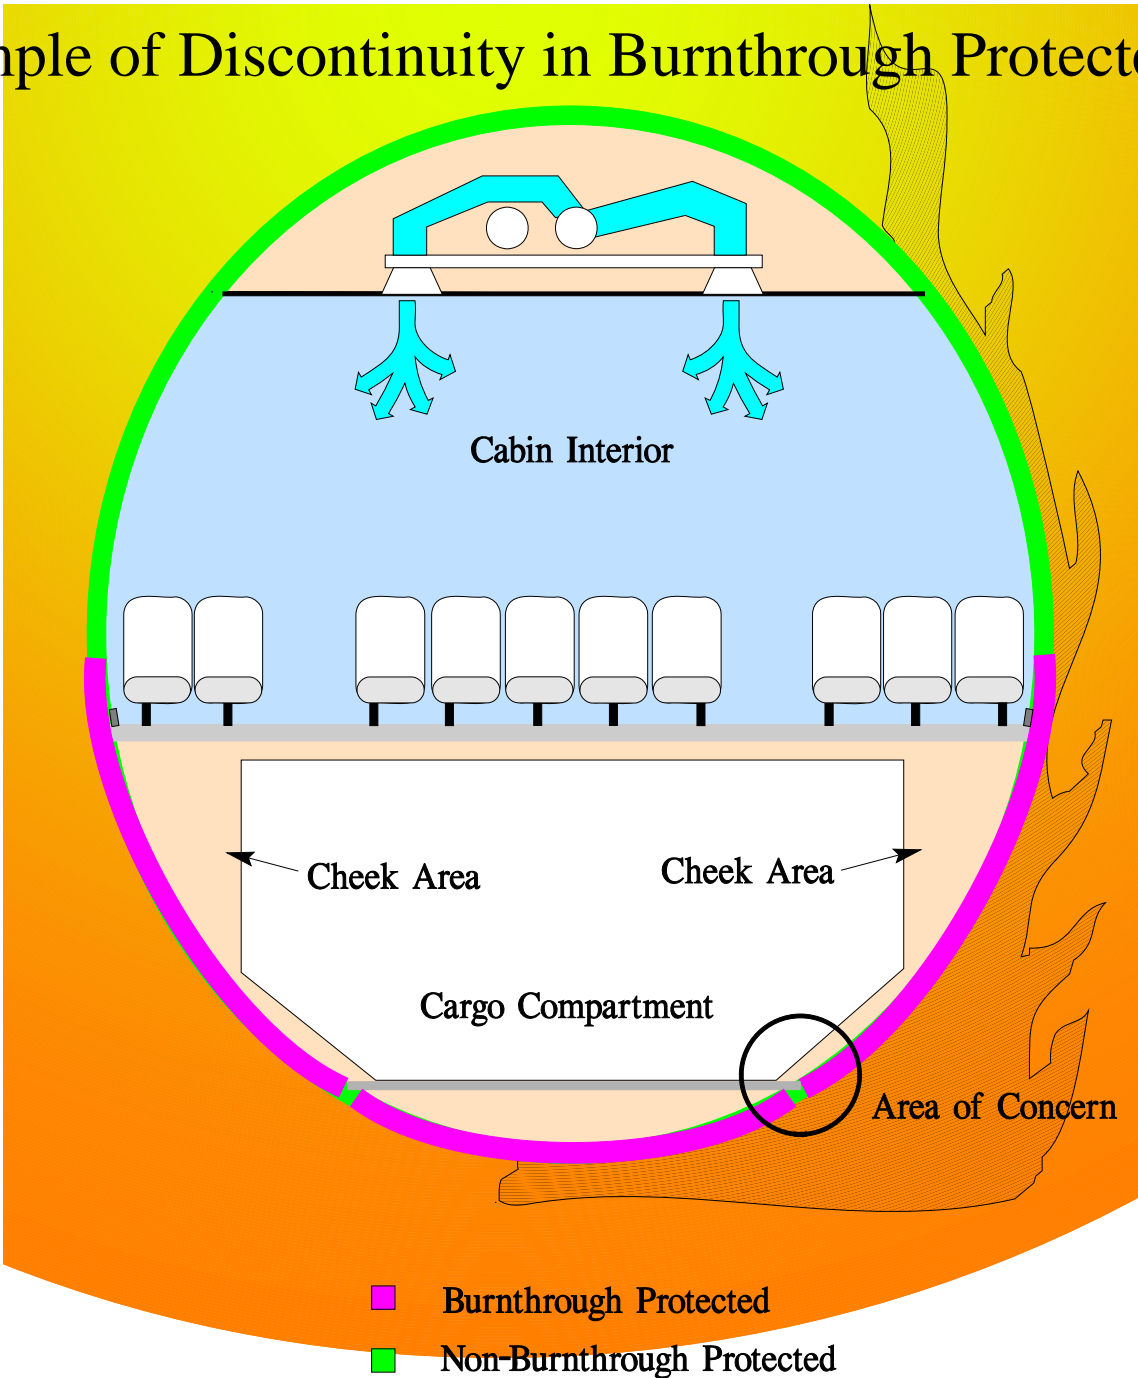
Example of Discontinuity in Burnthrough Protected Area

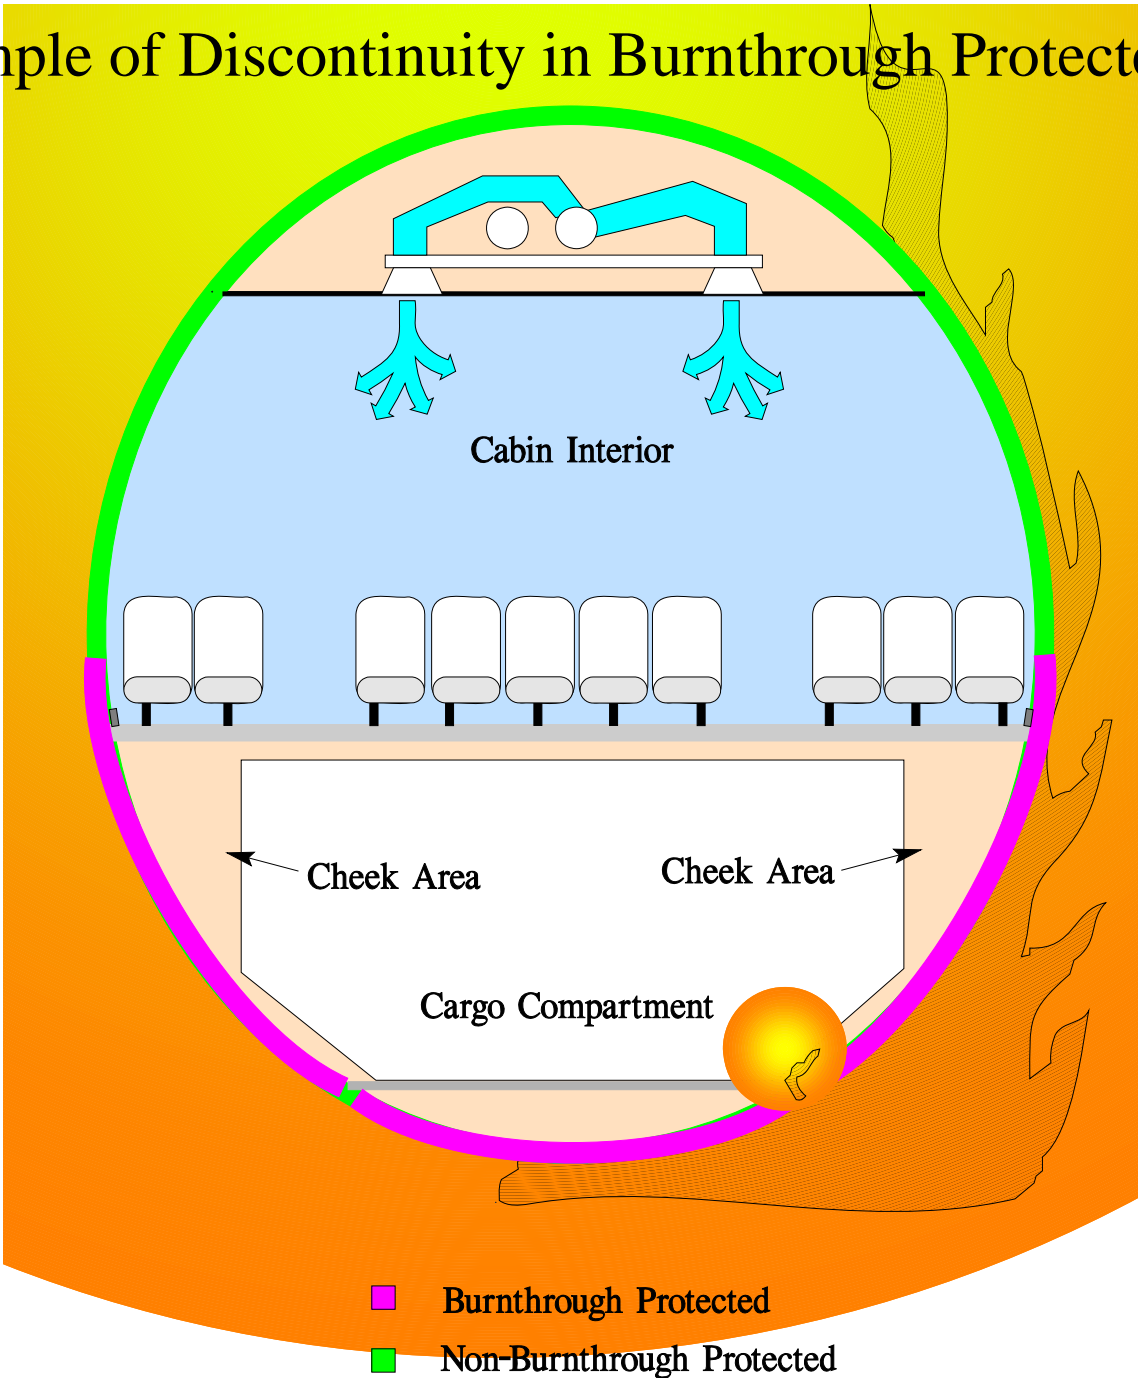
Example of Discontinuity in Burnthrough Protected Area

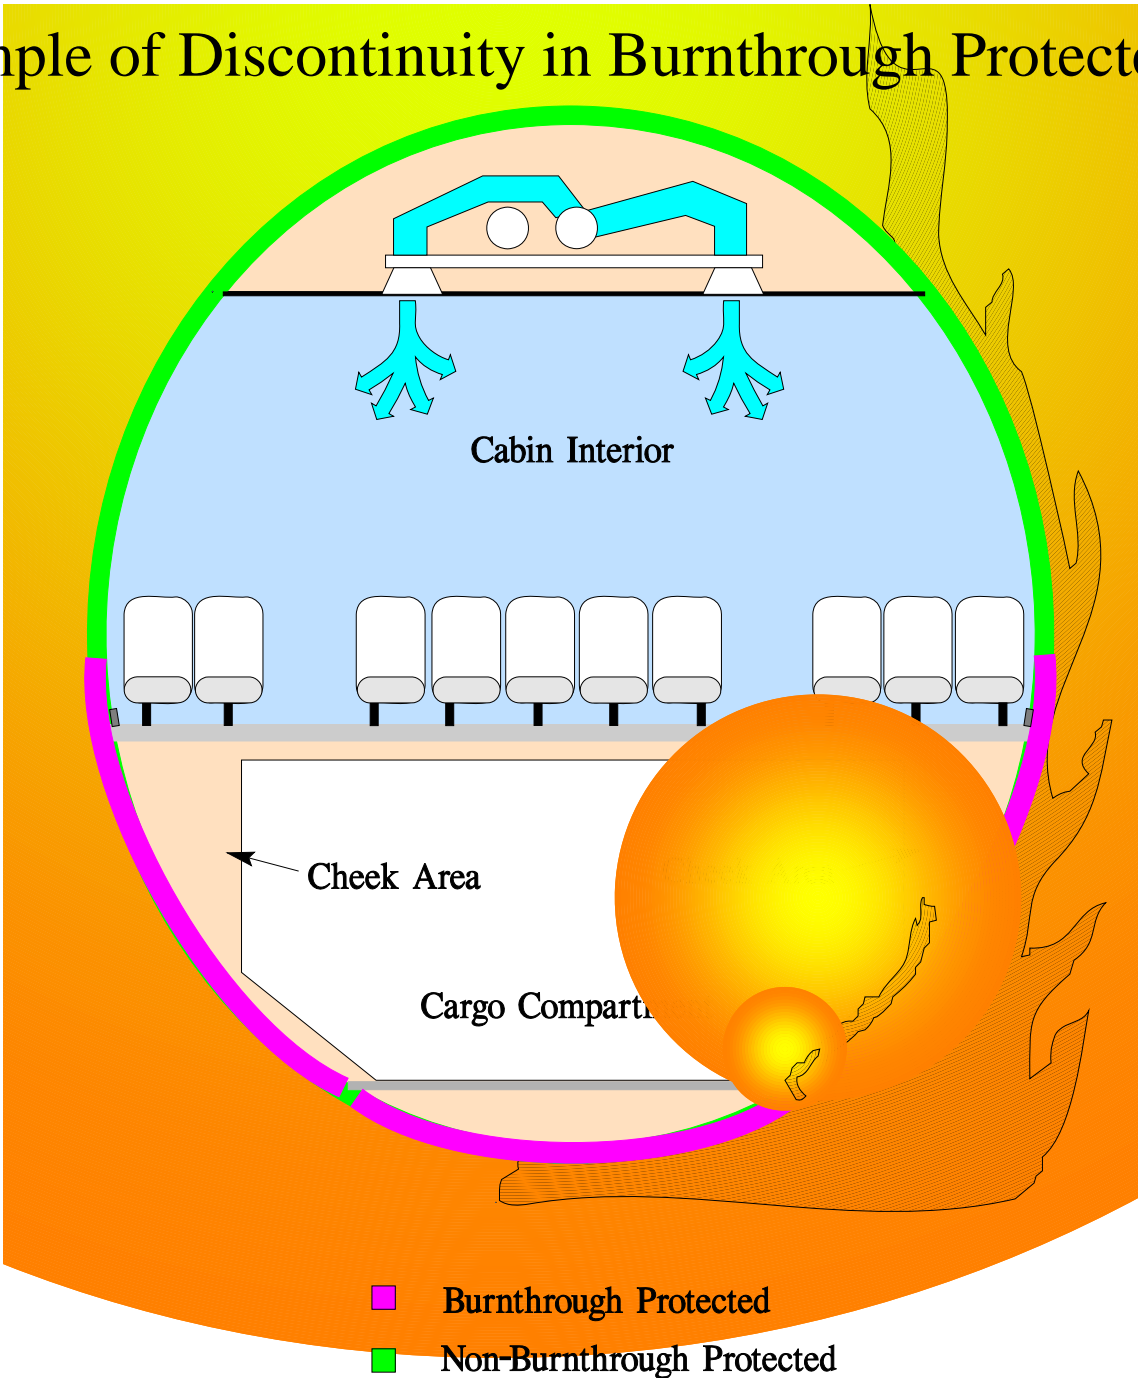
Example of Discontinuity in Burnthrough Protected Area

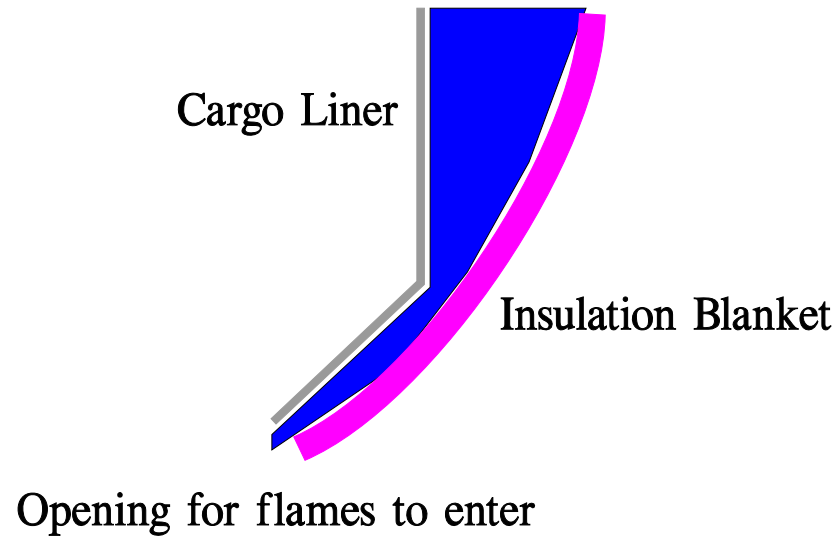
Initial Area to be Mocked-up

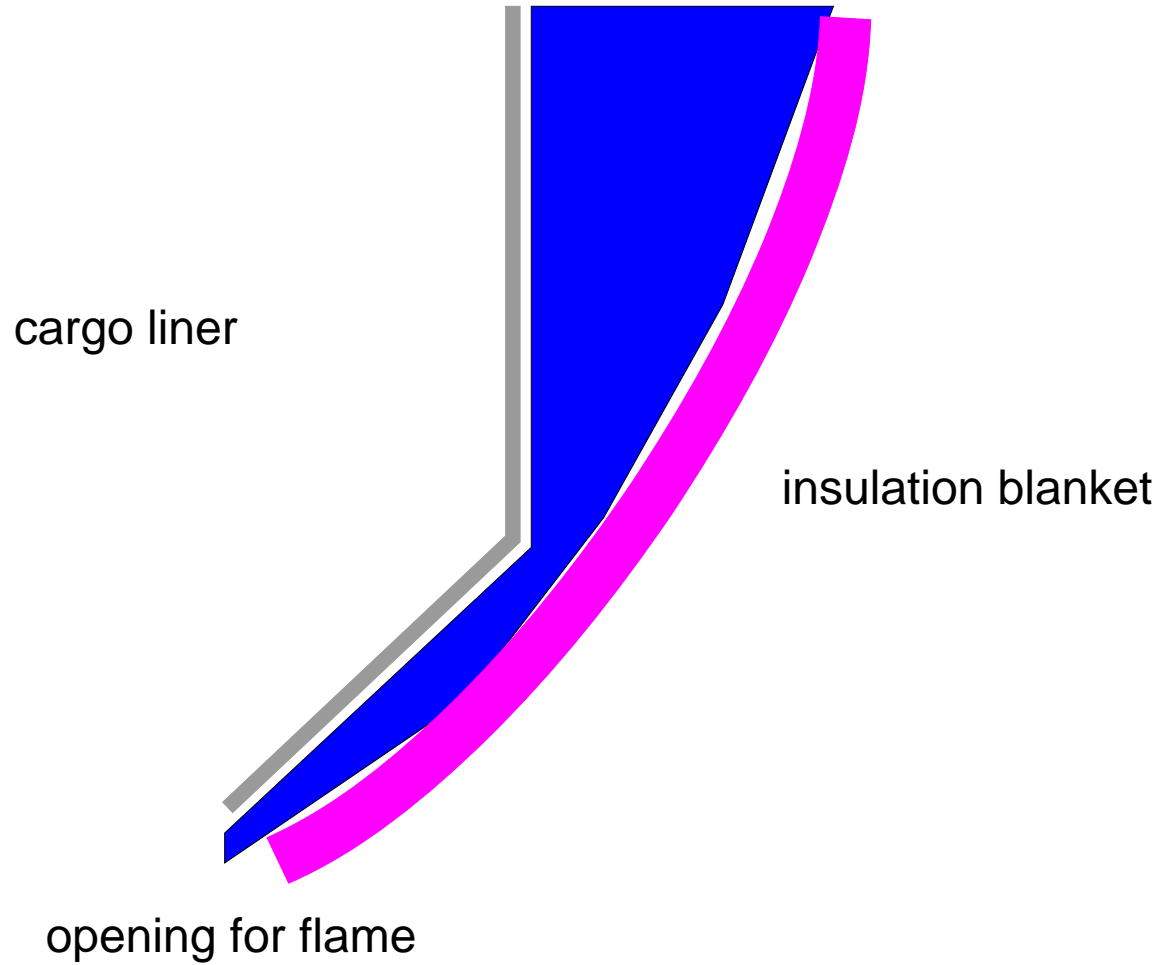
Initial Area to be Mocked-up

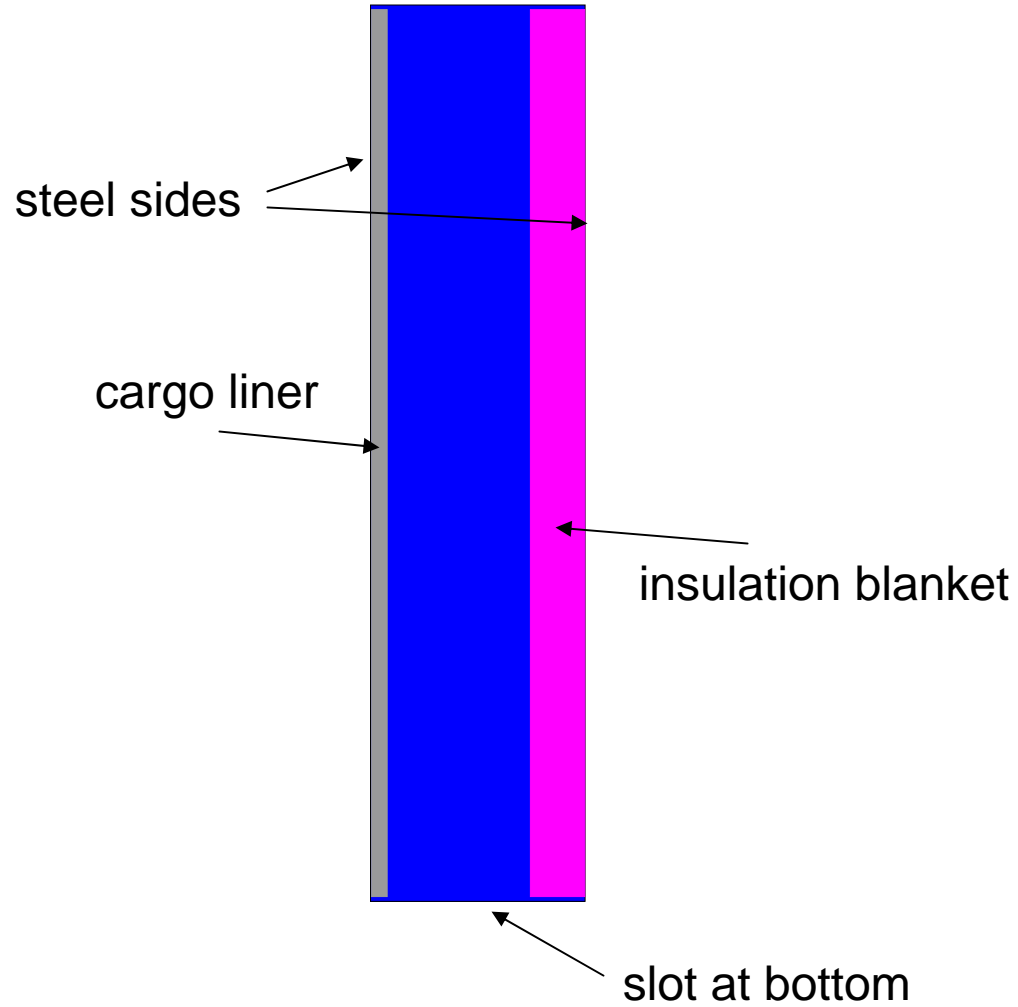
Mock-up Box Cross Section

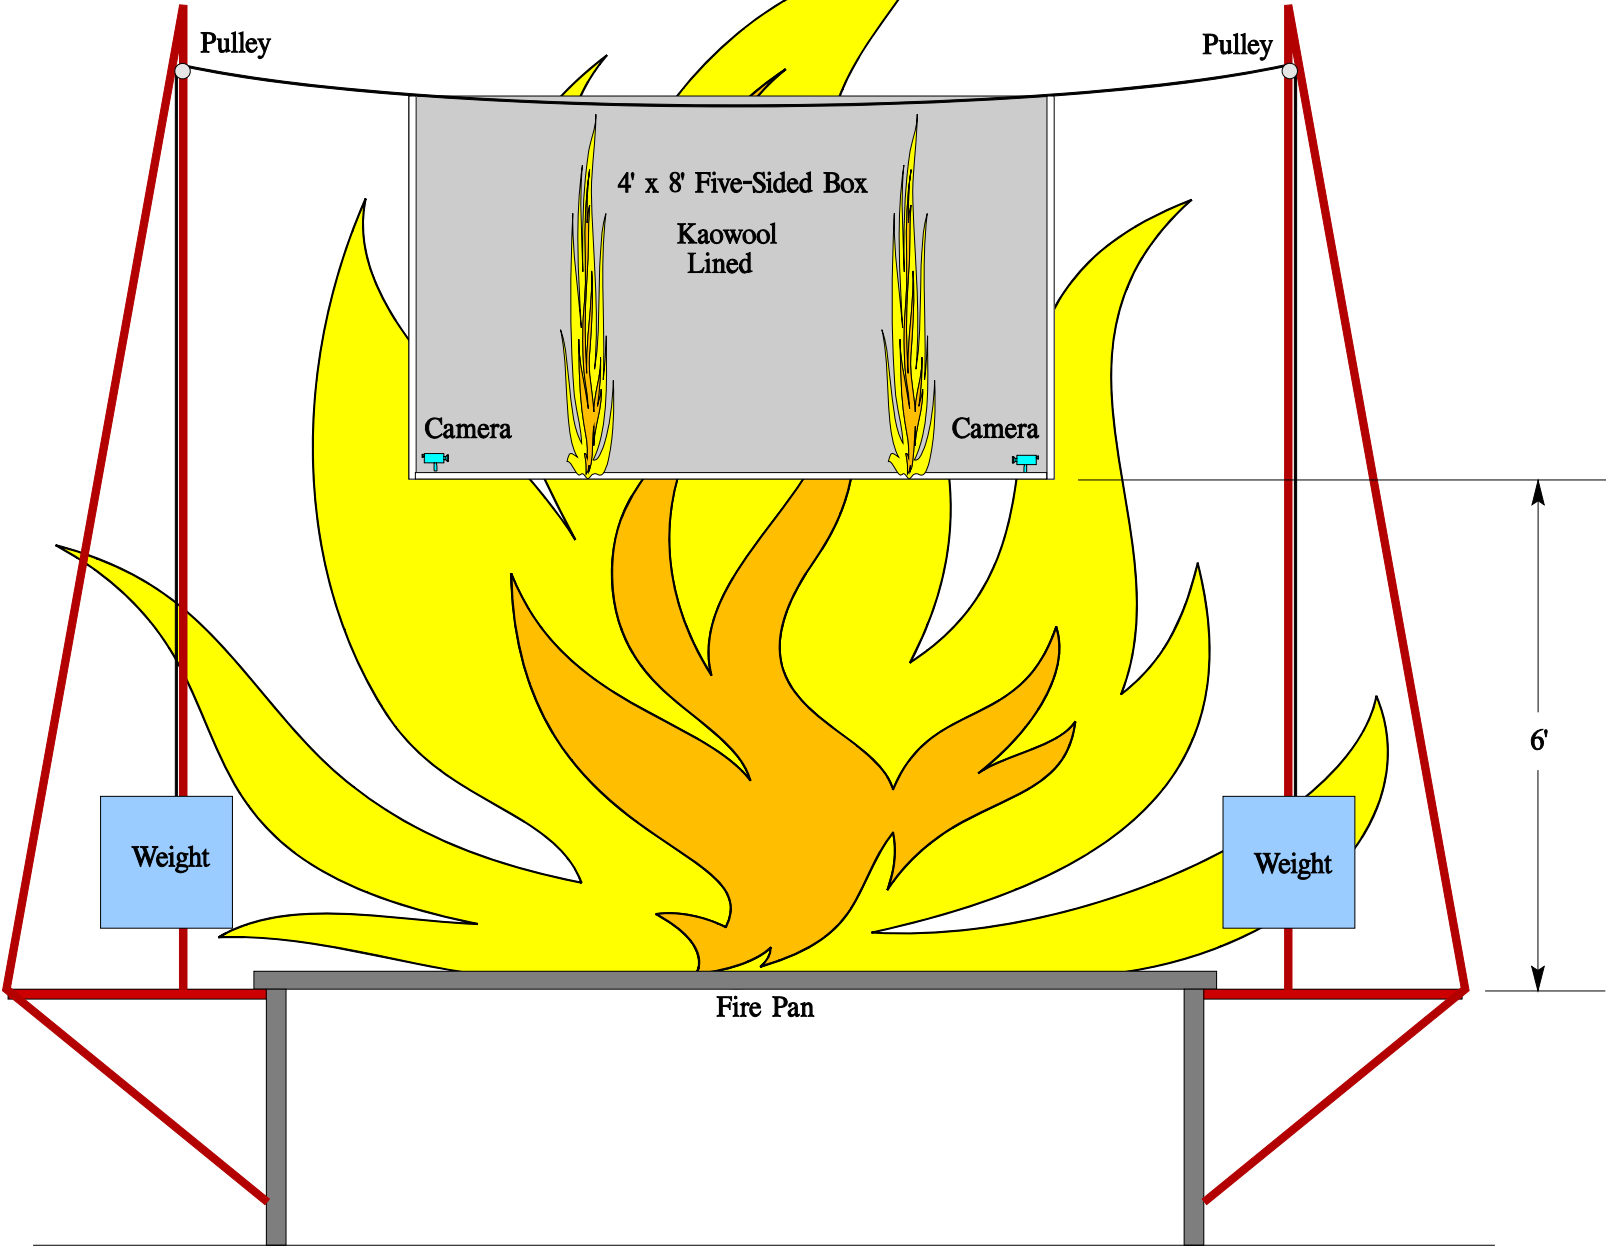
Adjustable Height Concept Mock-up Box

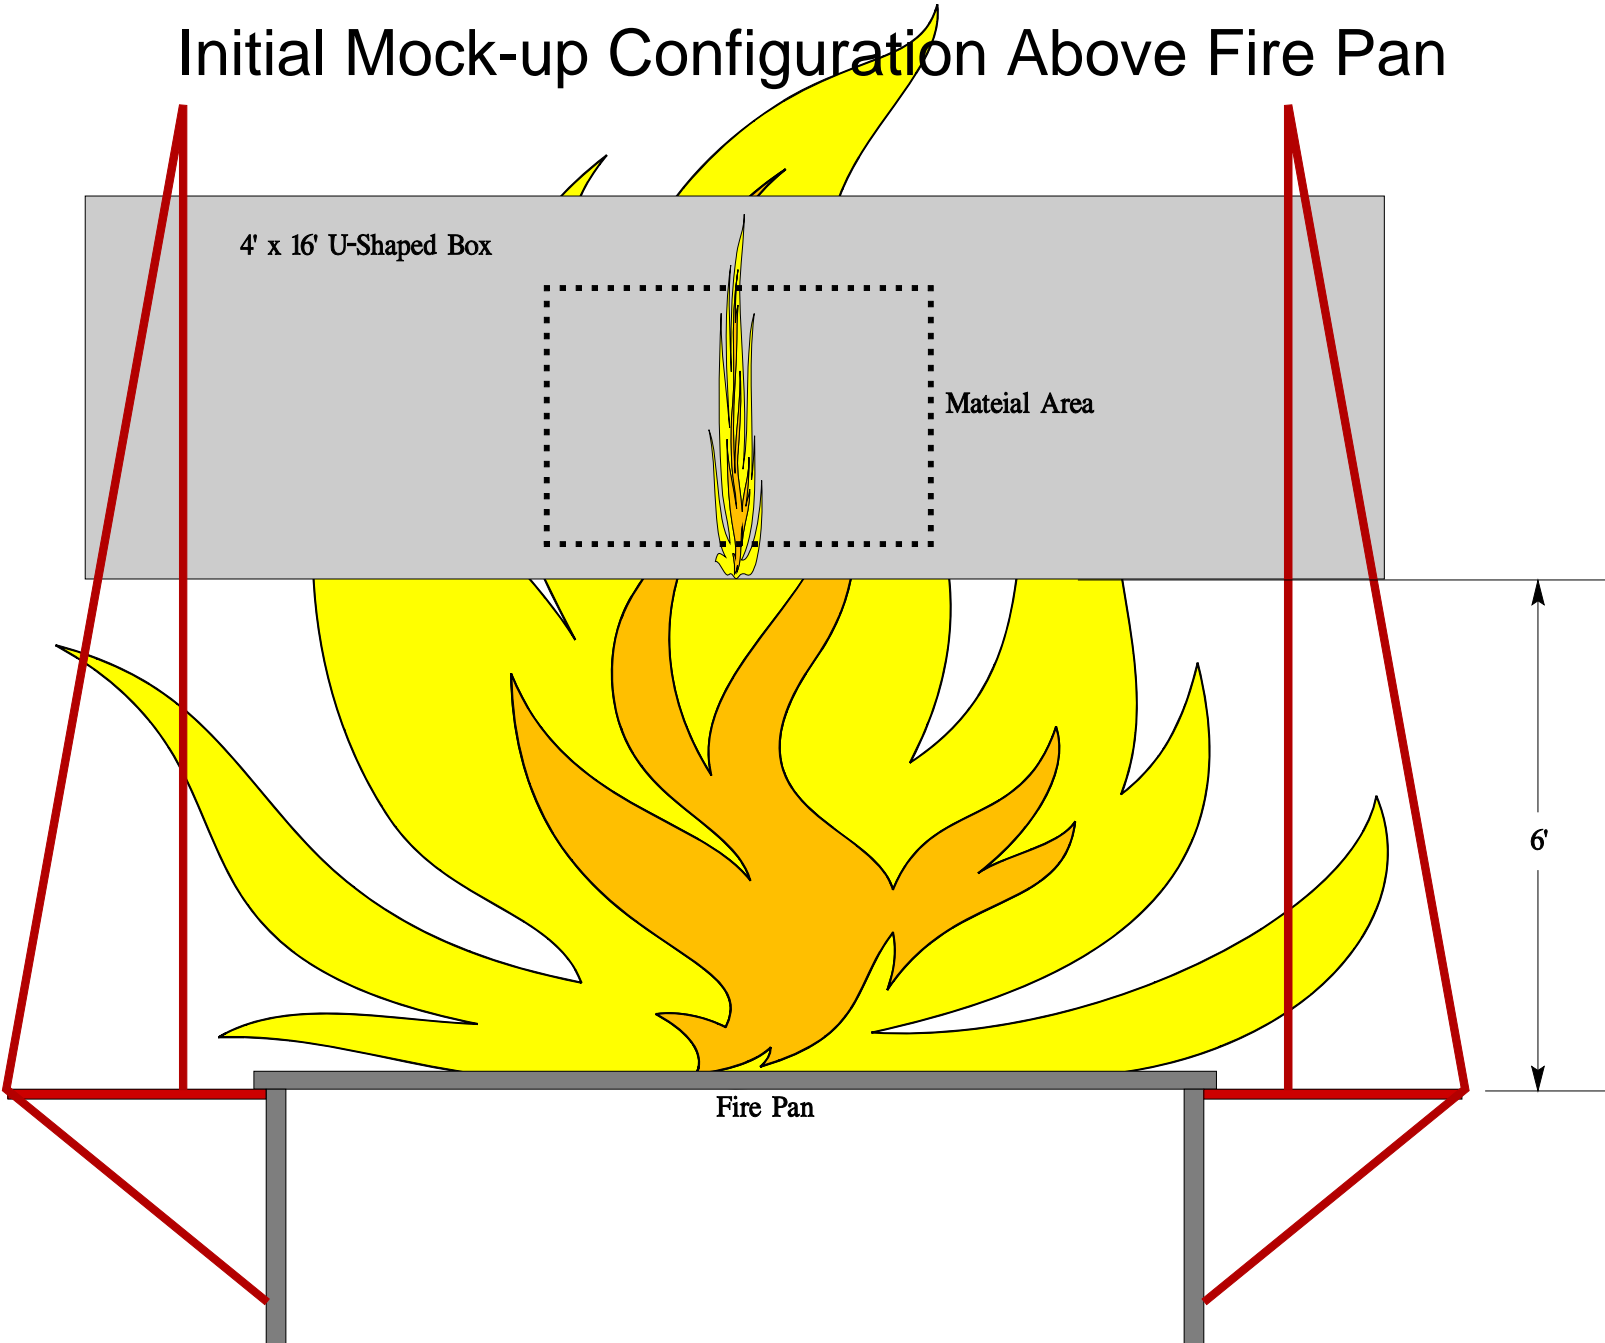
Initial Mock-up Configuration Above Fire Pan

4' x 16' U-Shaped Box

Material Area

Fire Pan

6'

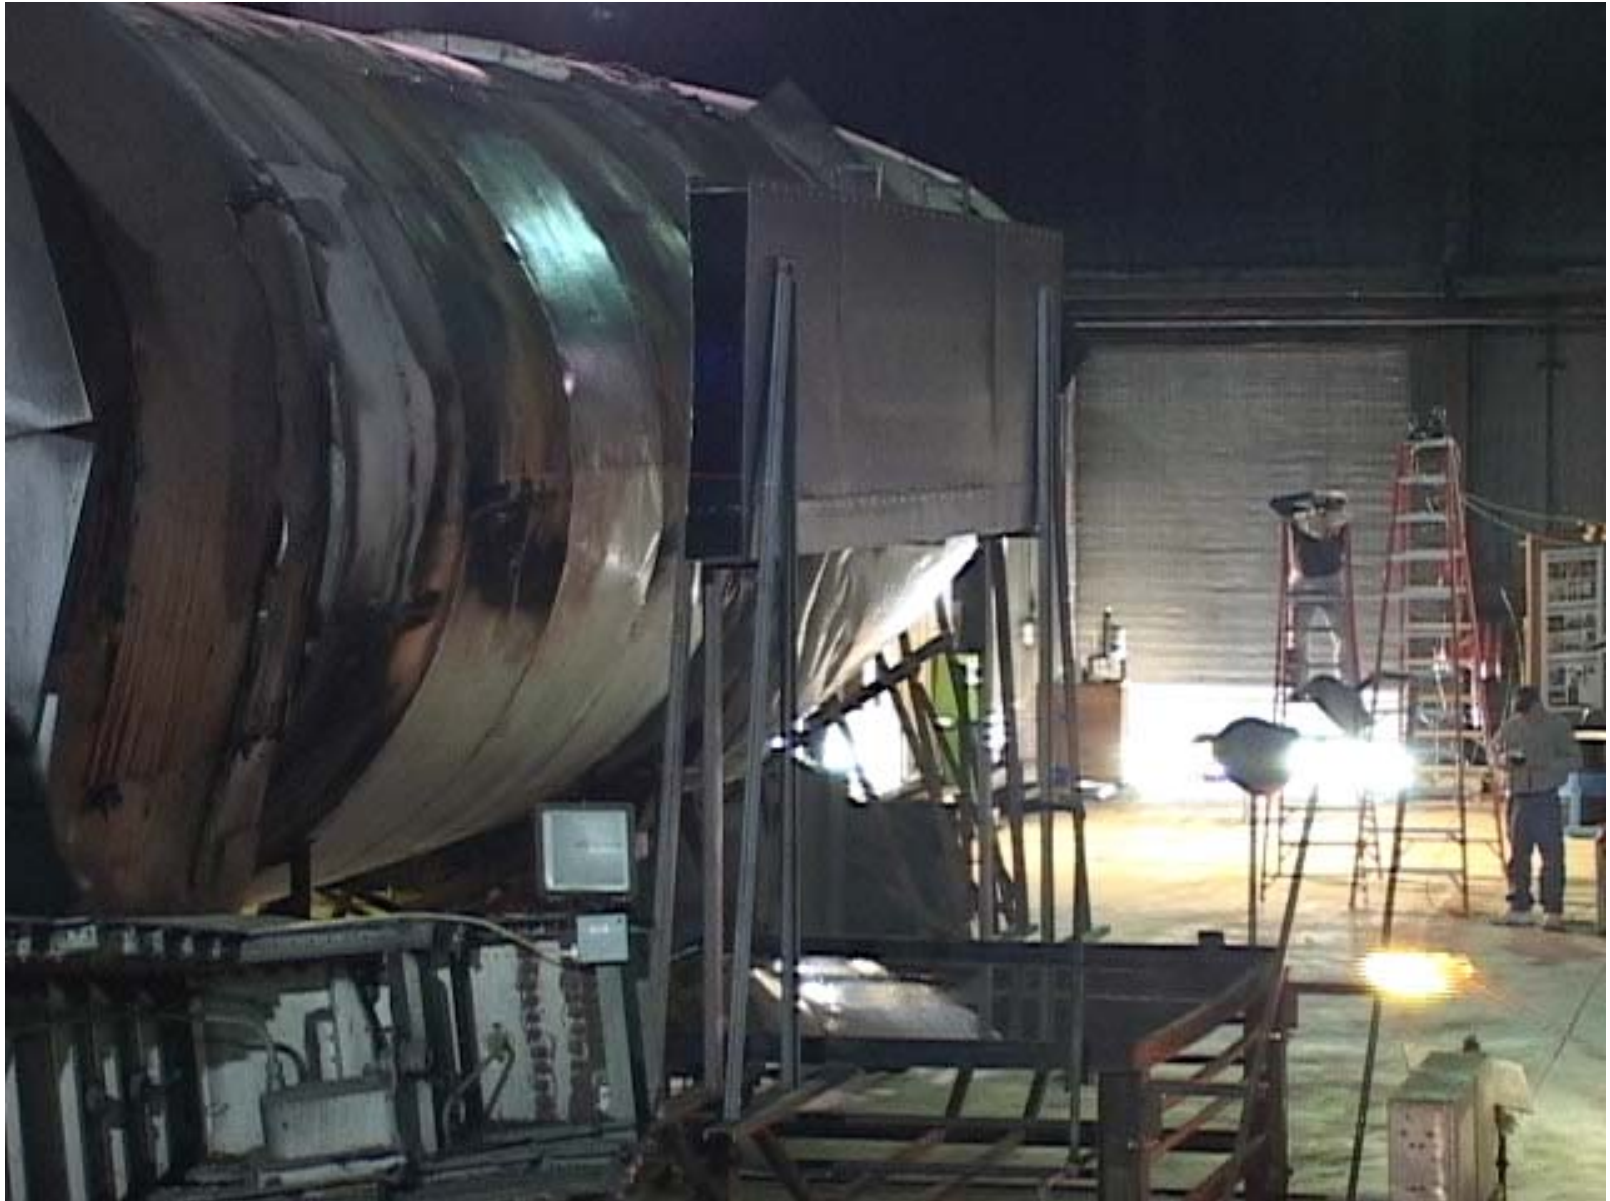
Mock-up Box at 6 Feet Above Fire Pan

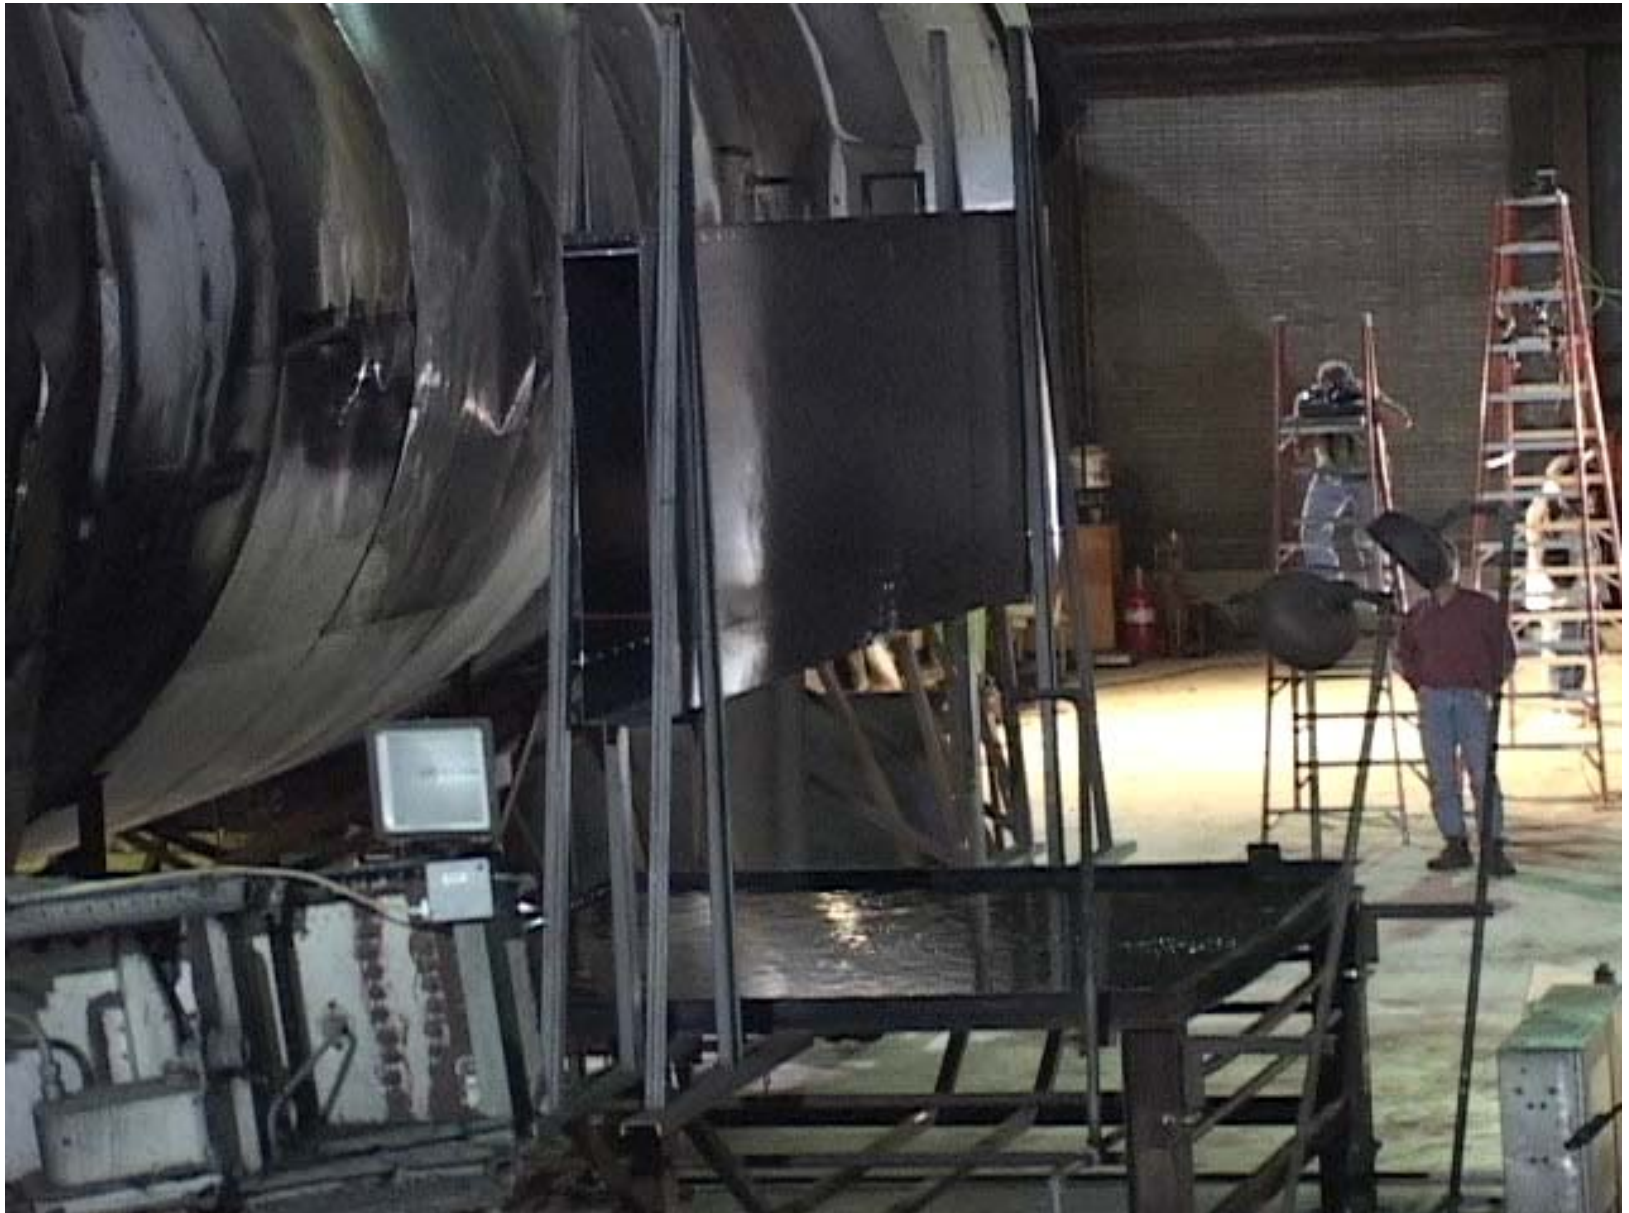
Mock-up Box at 3 Feet Above Fire Pan

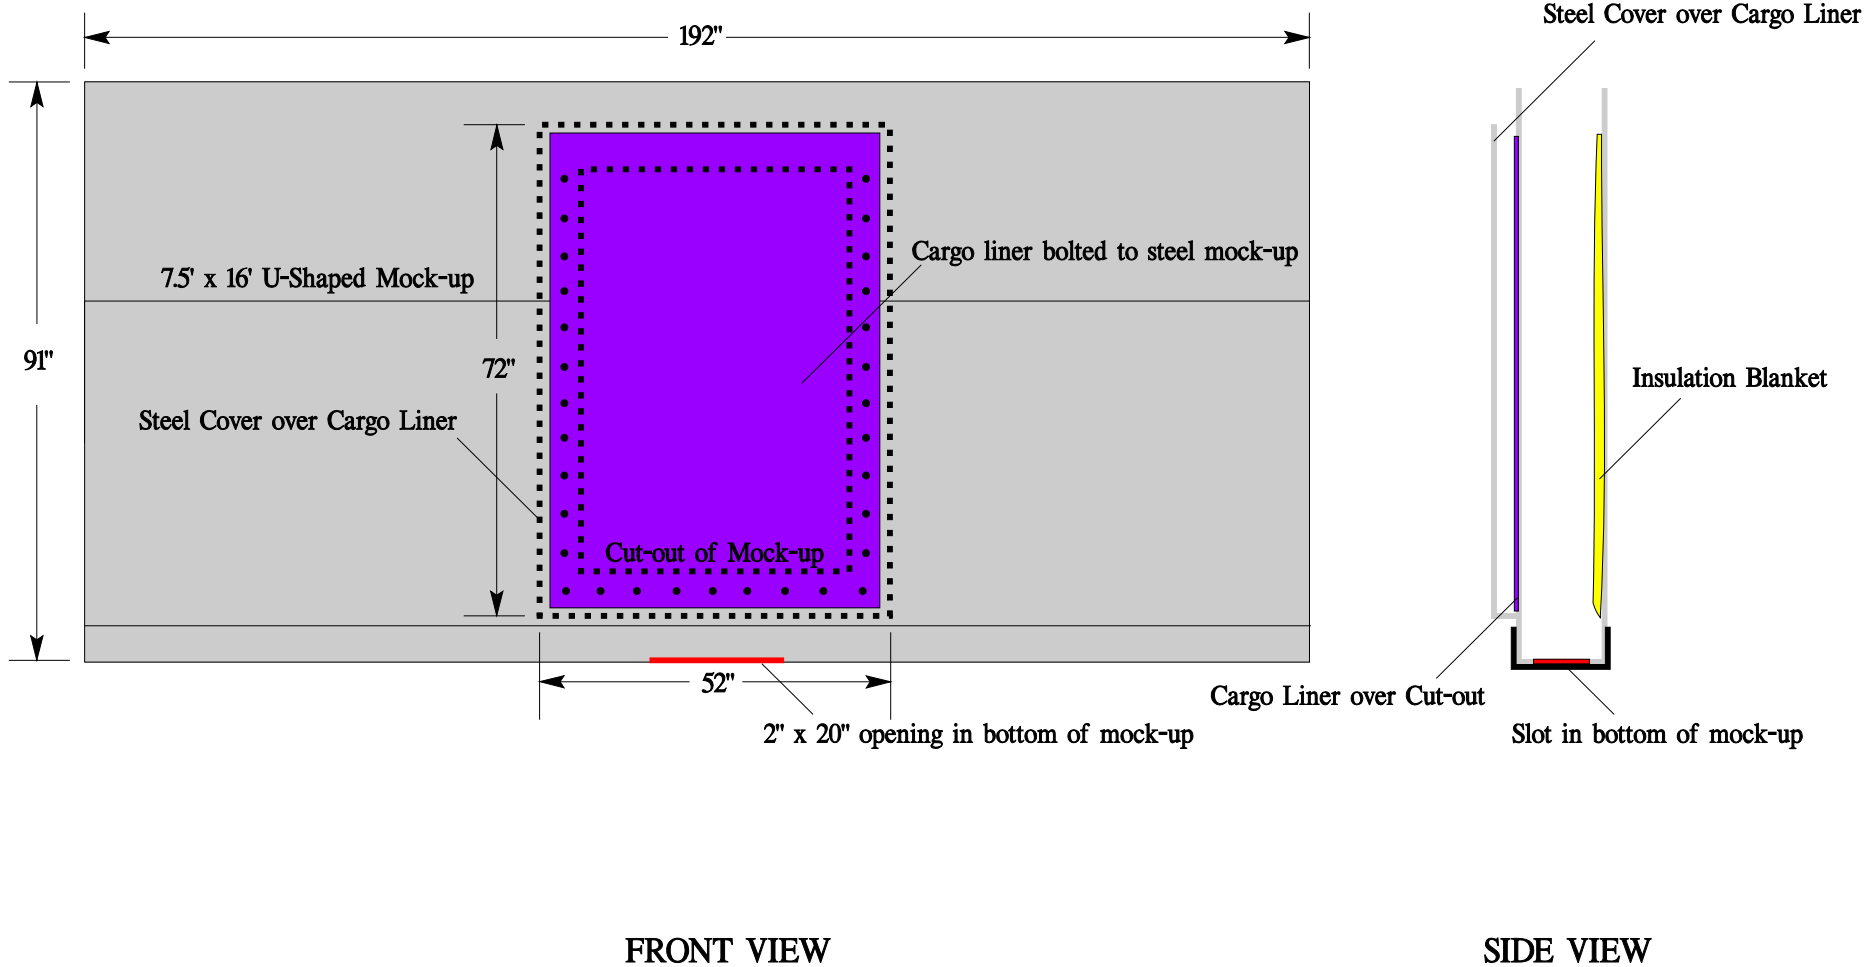
Modified Mock-up Box Configuration

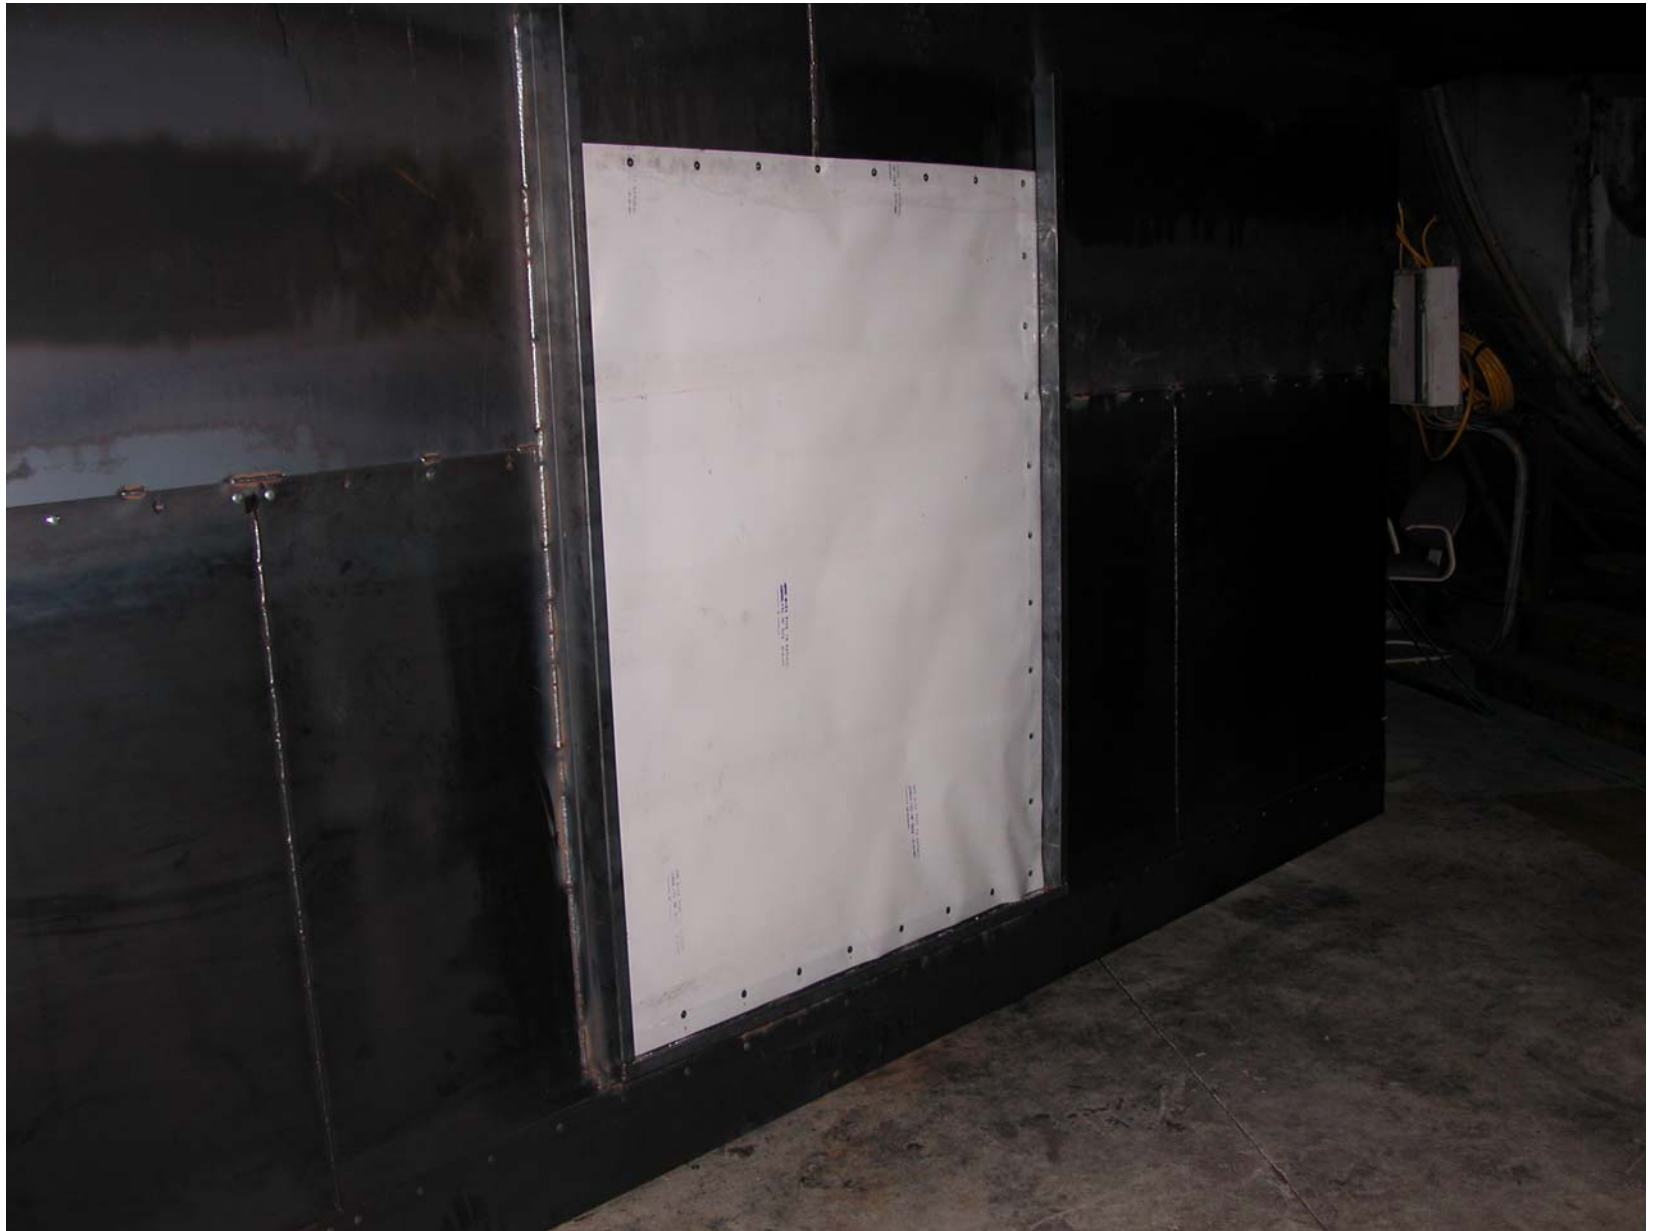
Cargo Liner Mounted Over Opening

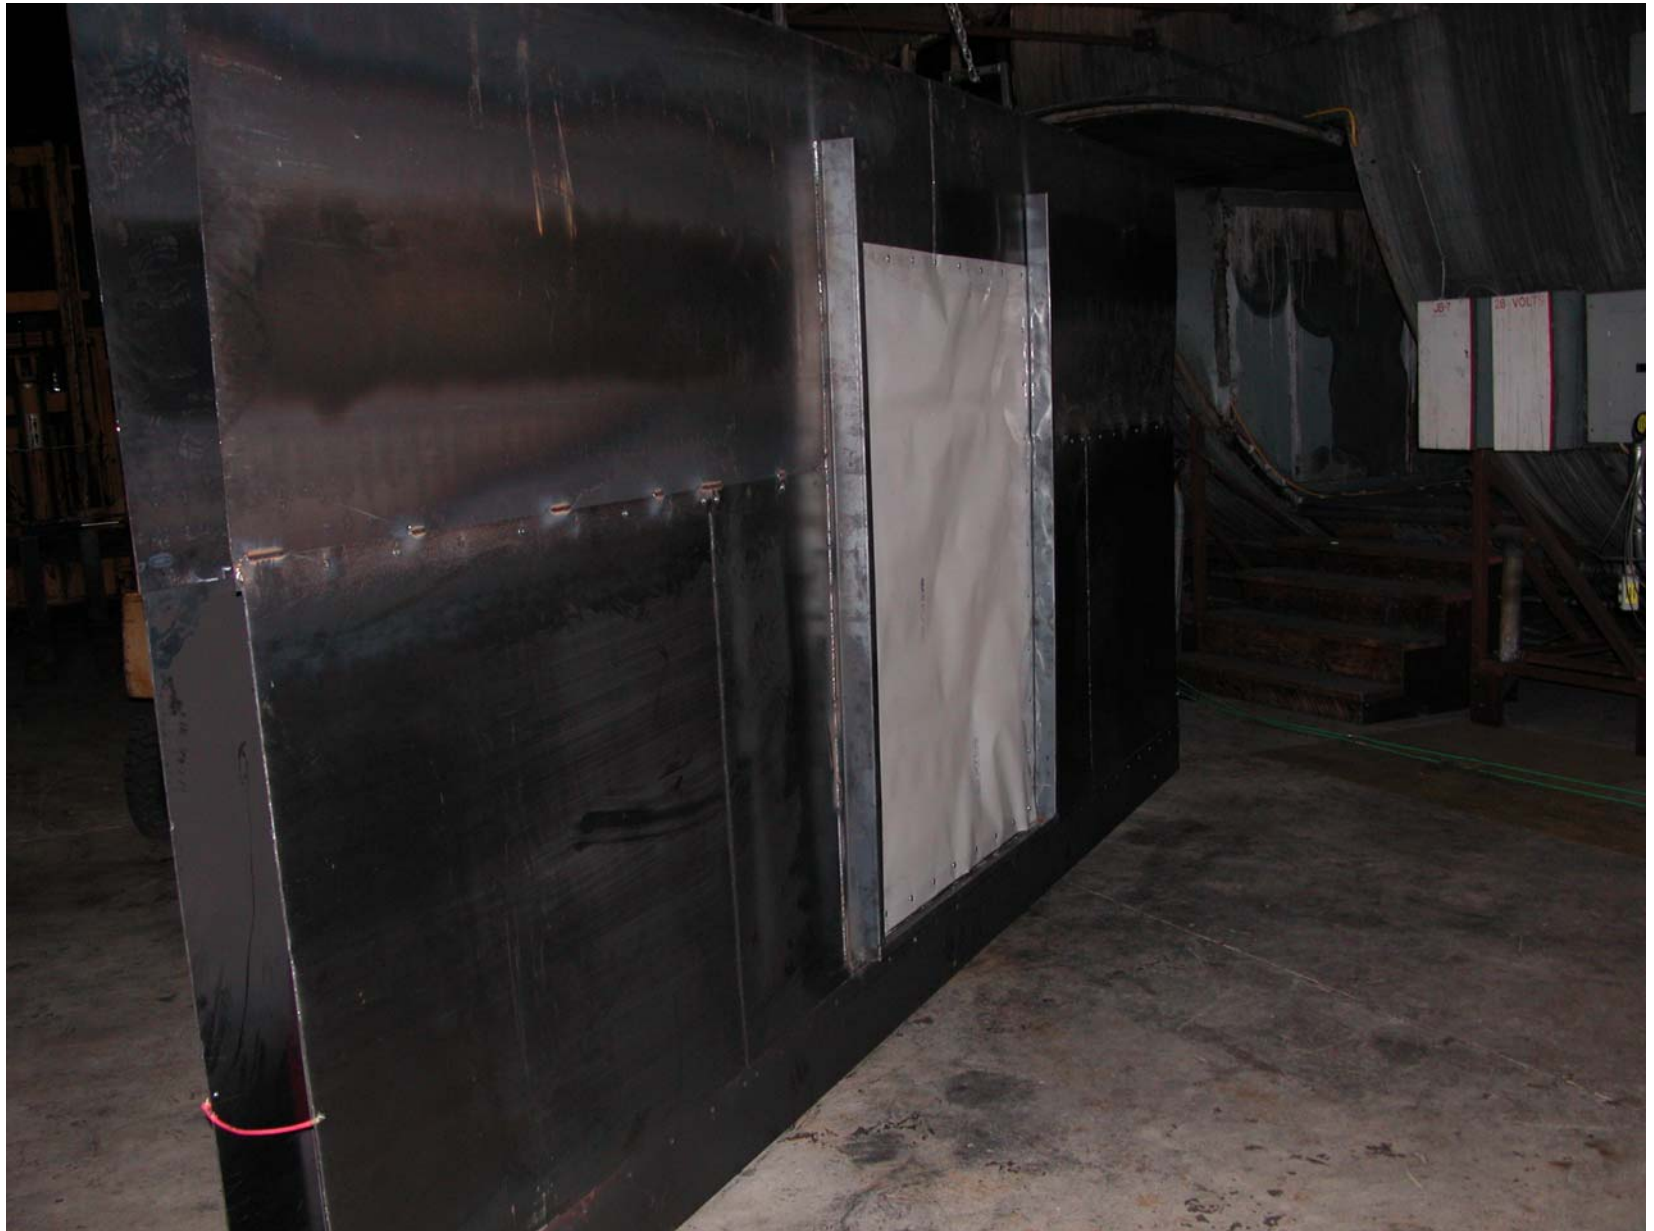
Cargo Liner Mounted Over Opening

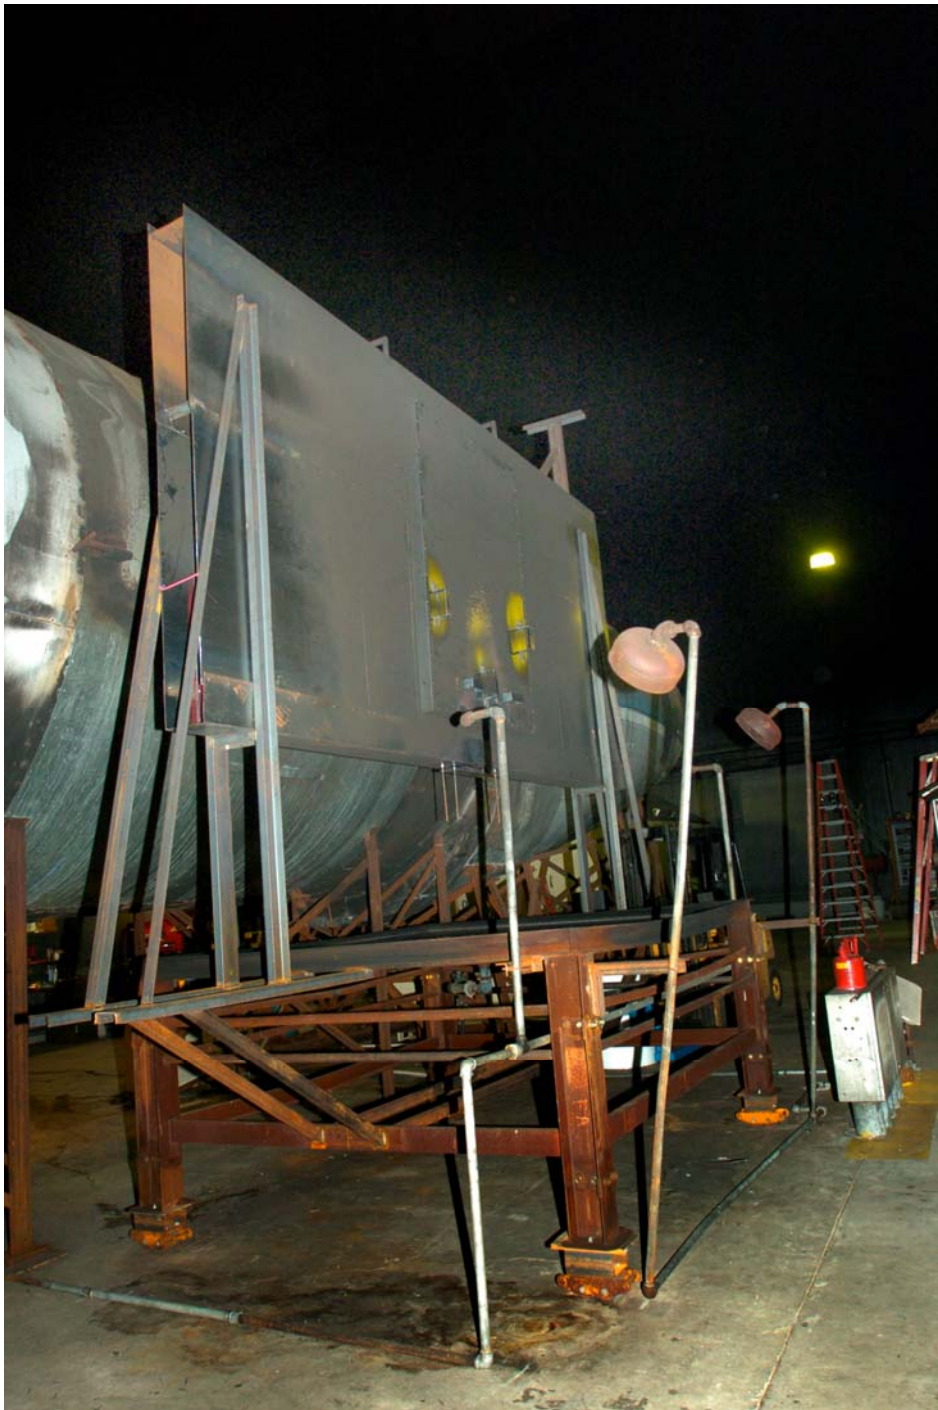
Modified
Mock-up Box
Configuration
Over Fuel Pan
