Investigation of Fuselage Penetrations in Burnthrough Protected Area

Tim Marker

FAA Technical Center

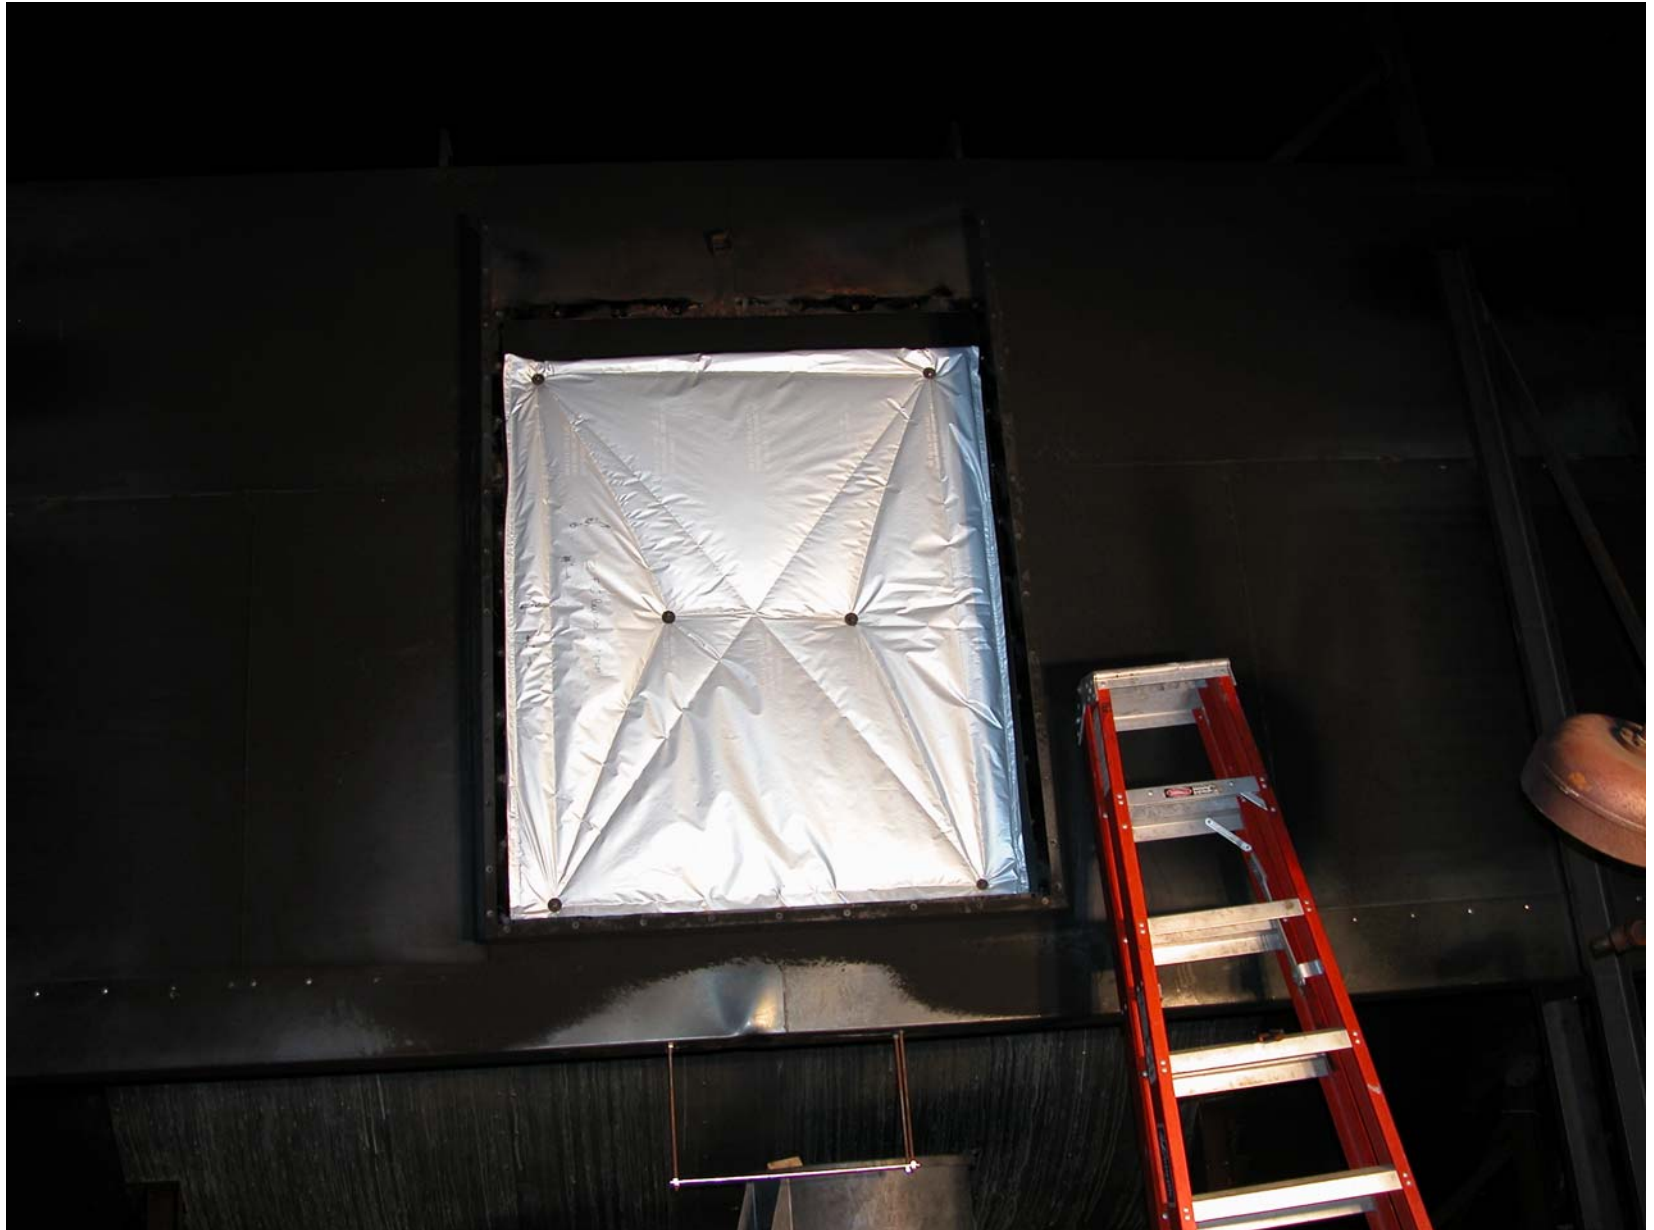
Insulation Blanket Mounted in Mock-up

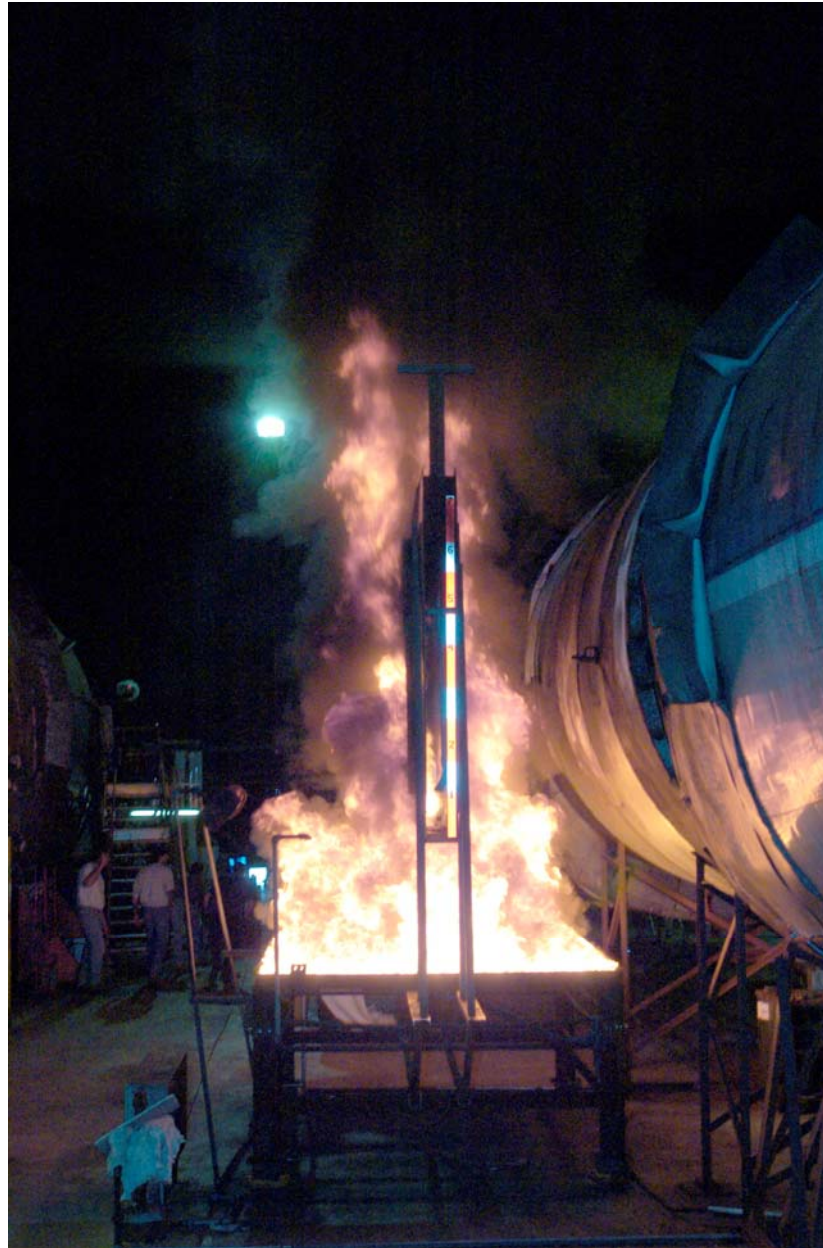
Typical Mock-up Box Test With Materials

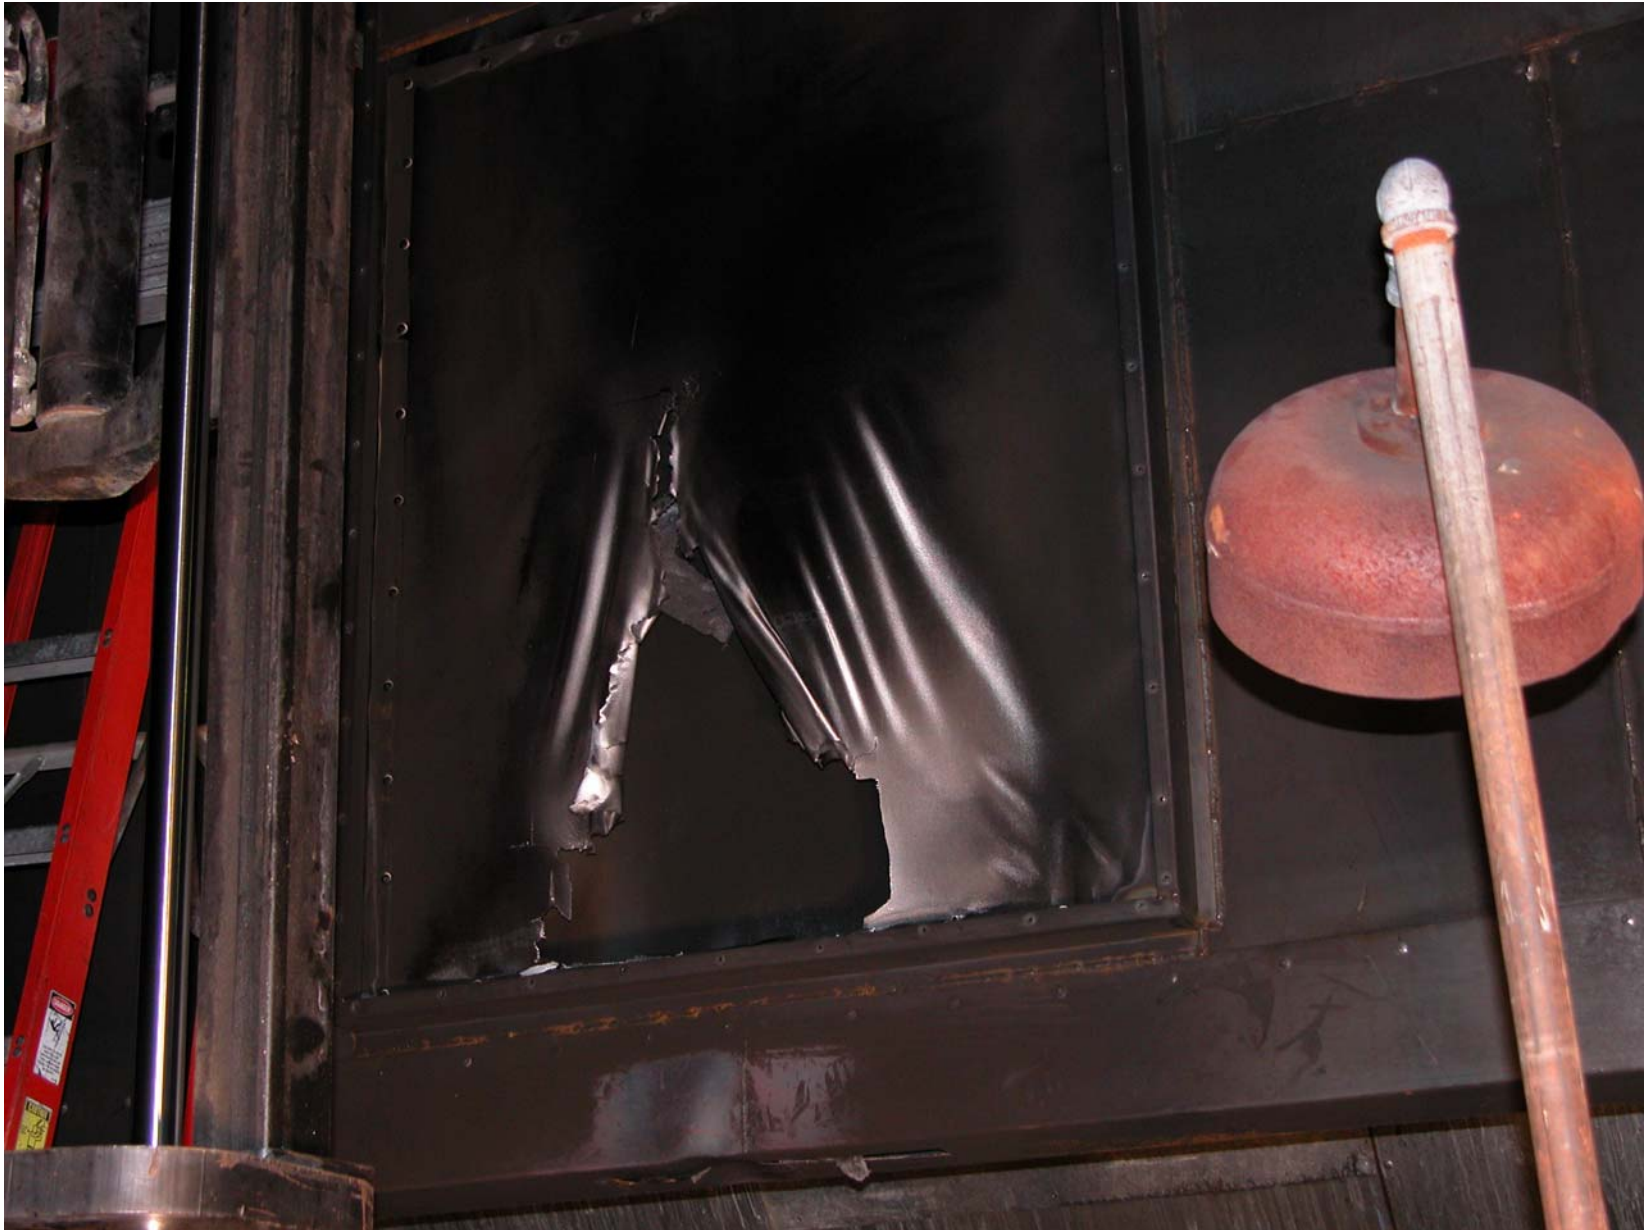
Post-Test Damage to Cargo Liner

Unblocked opening allows flames to enter and climb up materials during modified box tests

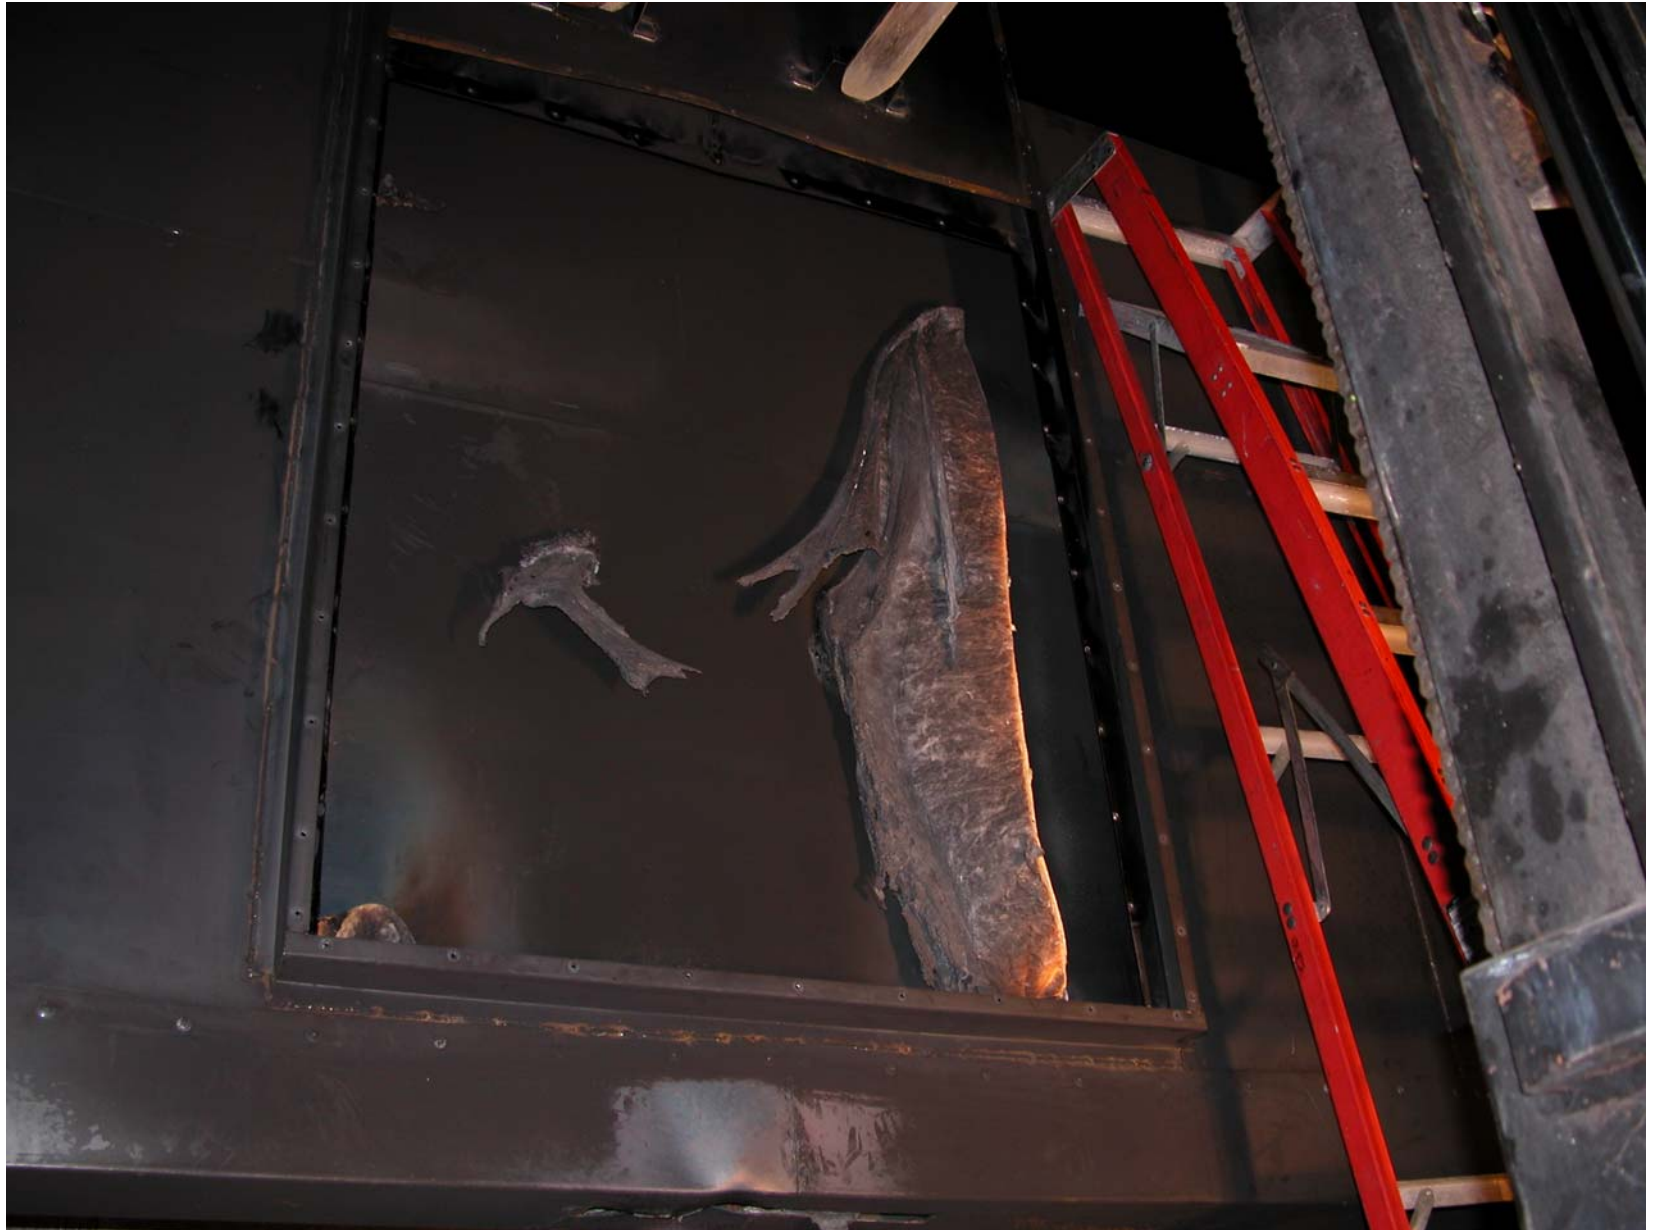
Post-Test Damage to Insulation Blanket

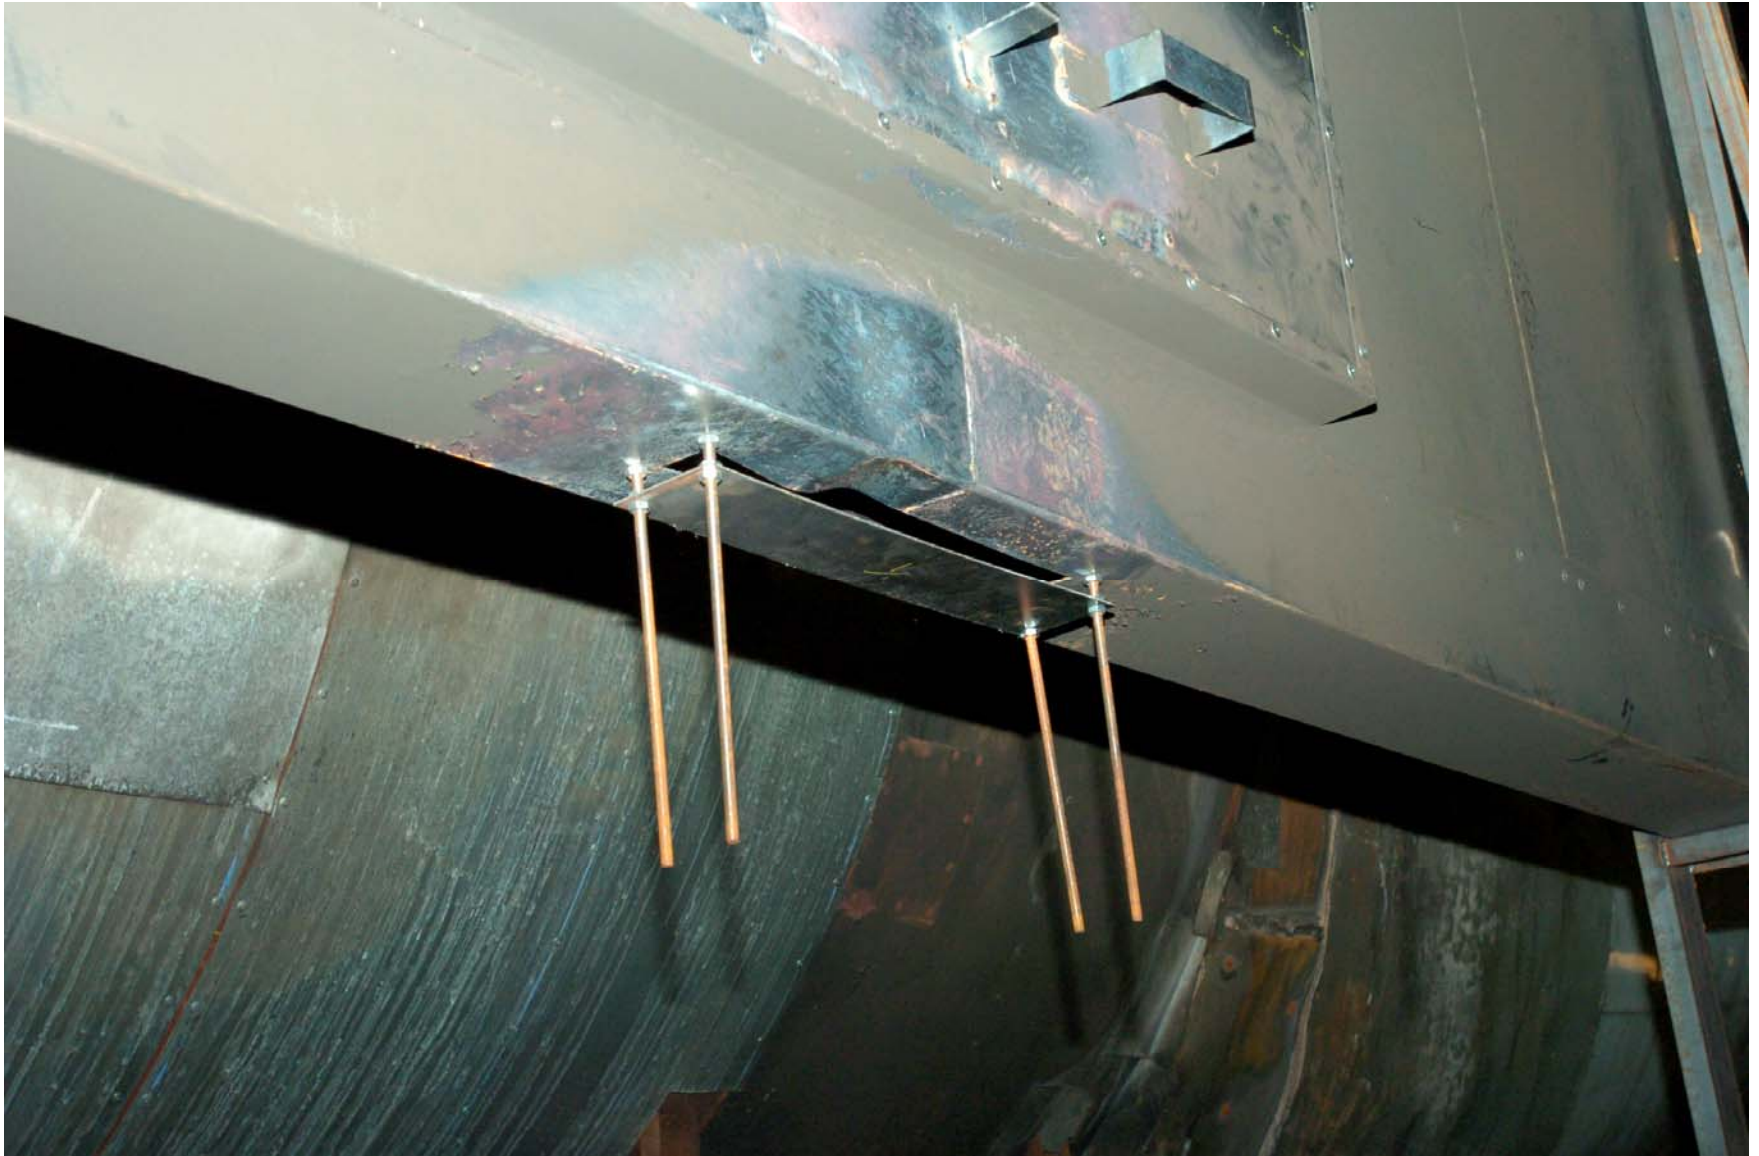
Steel Baffle Test (5/02/07)

4- by 22-Inch Steel Baffle Below Opening

Non-coated baffle provides marginal decrease in fire penetration

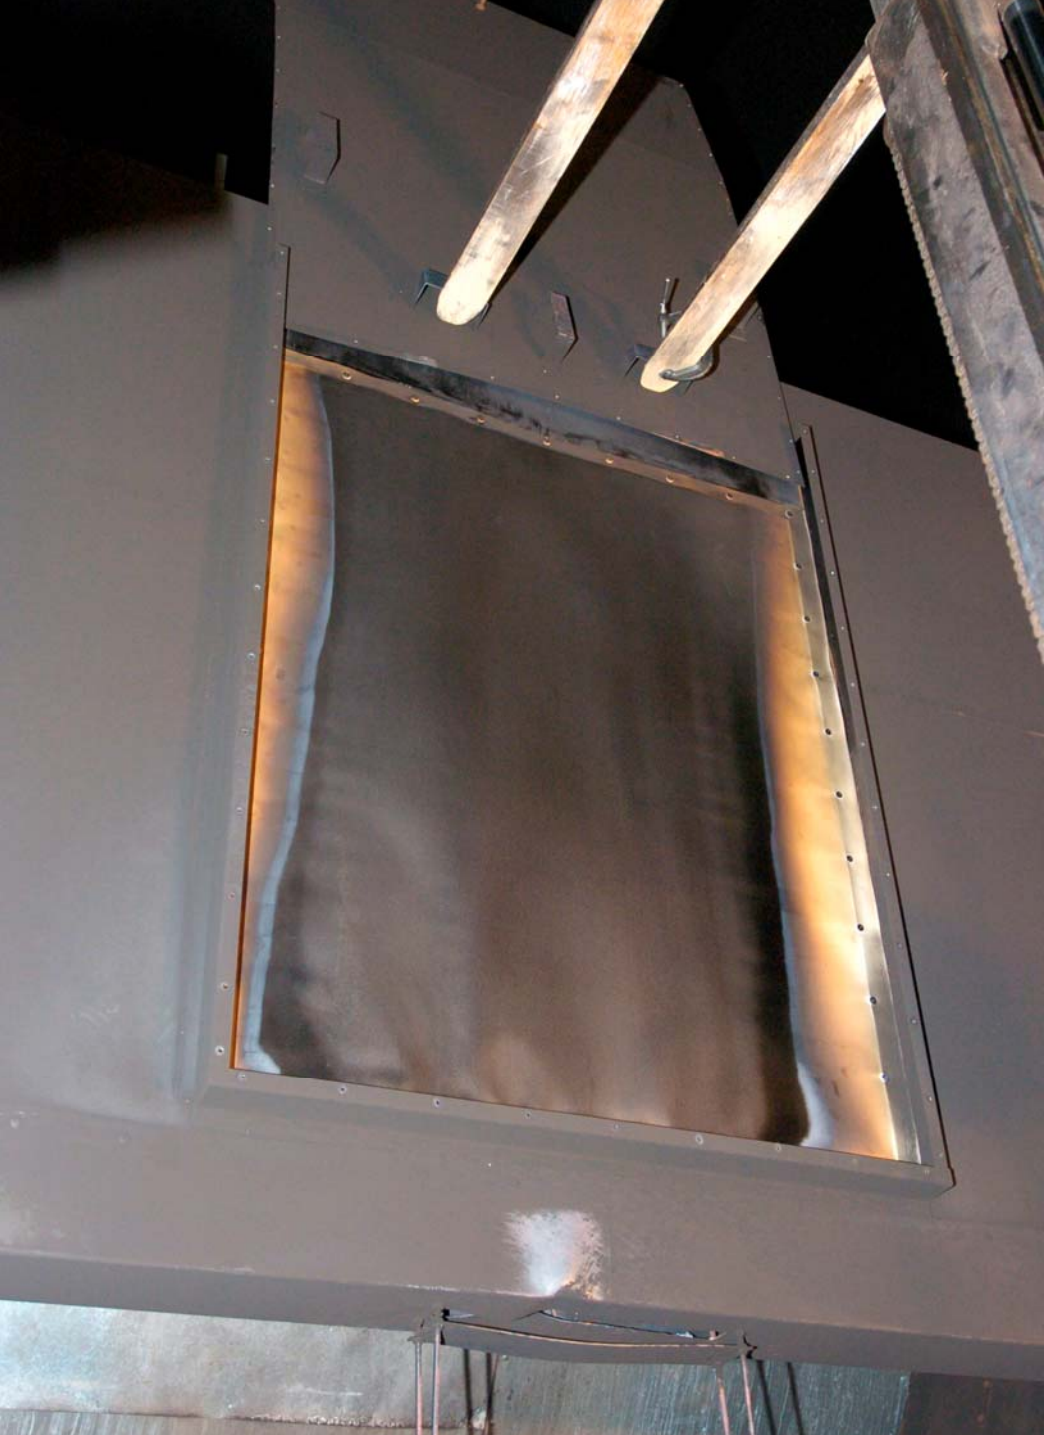
Cargo Liner
Post Test

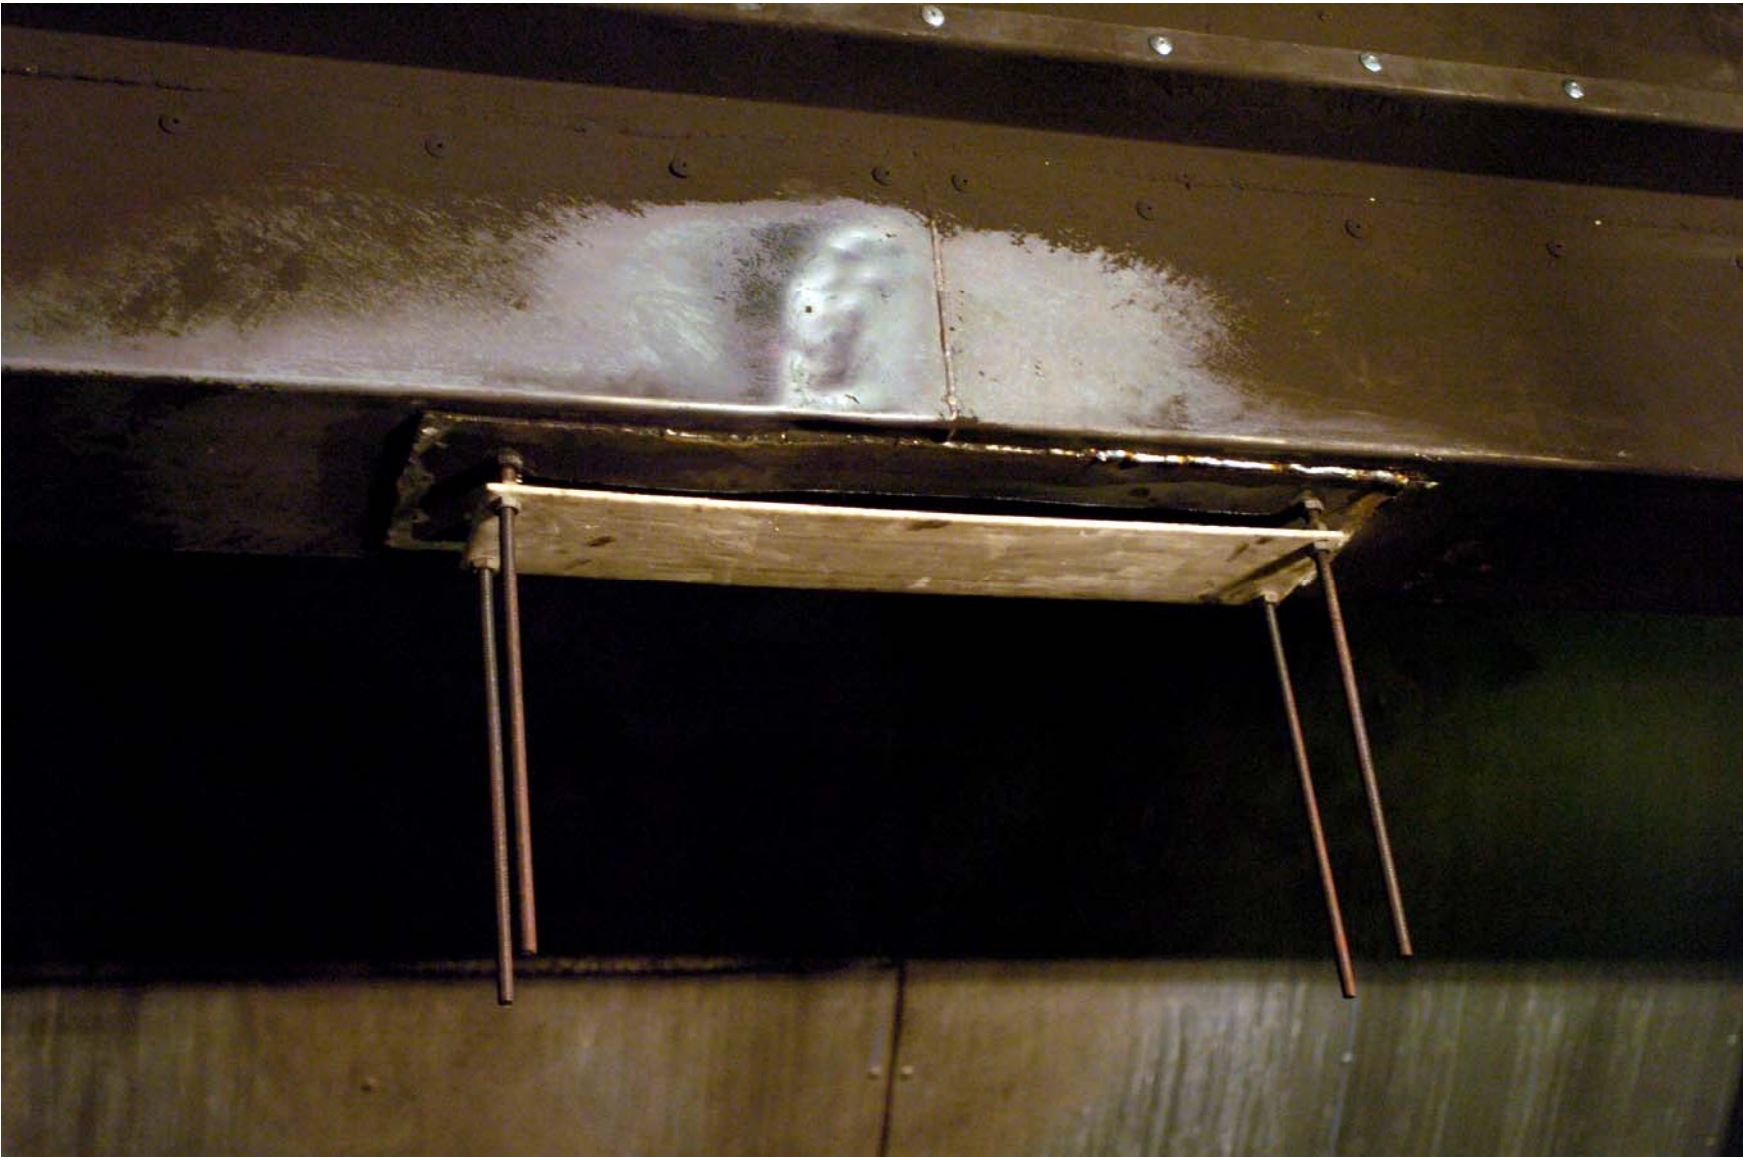
Intumescent Coated Steel Baffle (5/16/07)

Intumescent-coated baffles limit damage to insulation blanket/cargo liner

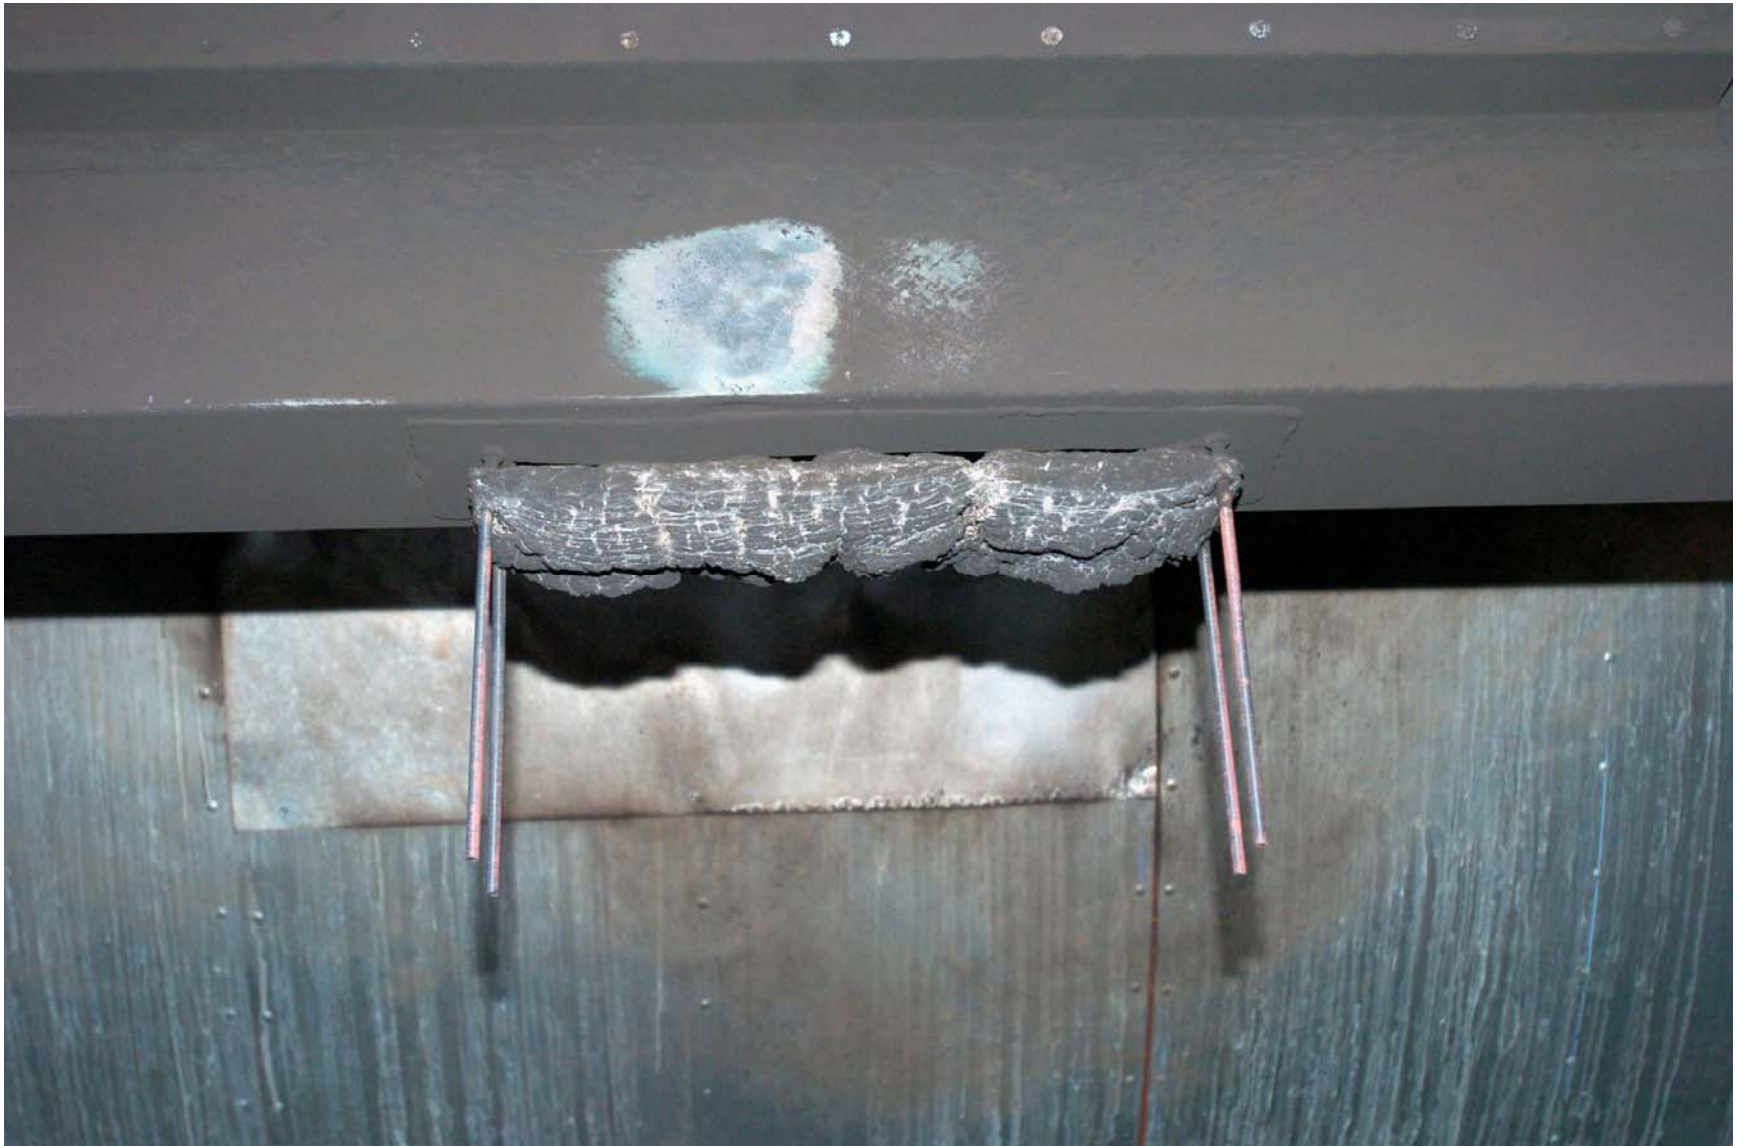
Intumescent Coated Steel Baffle Post Test

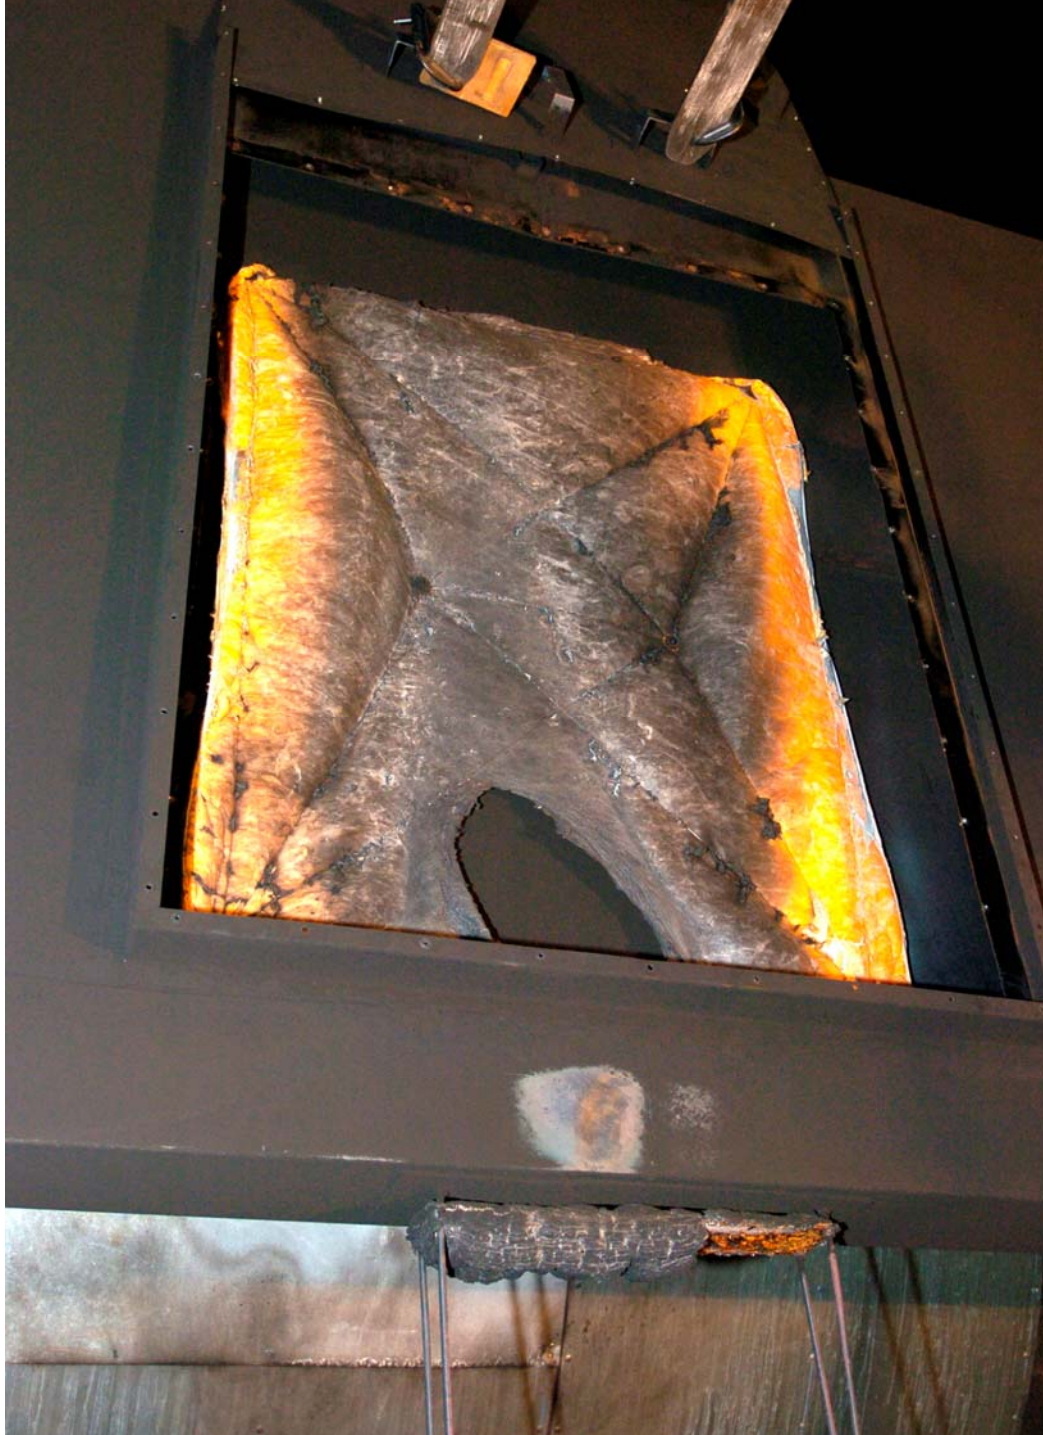
Insulation
Blanket
Post Test

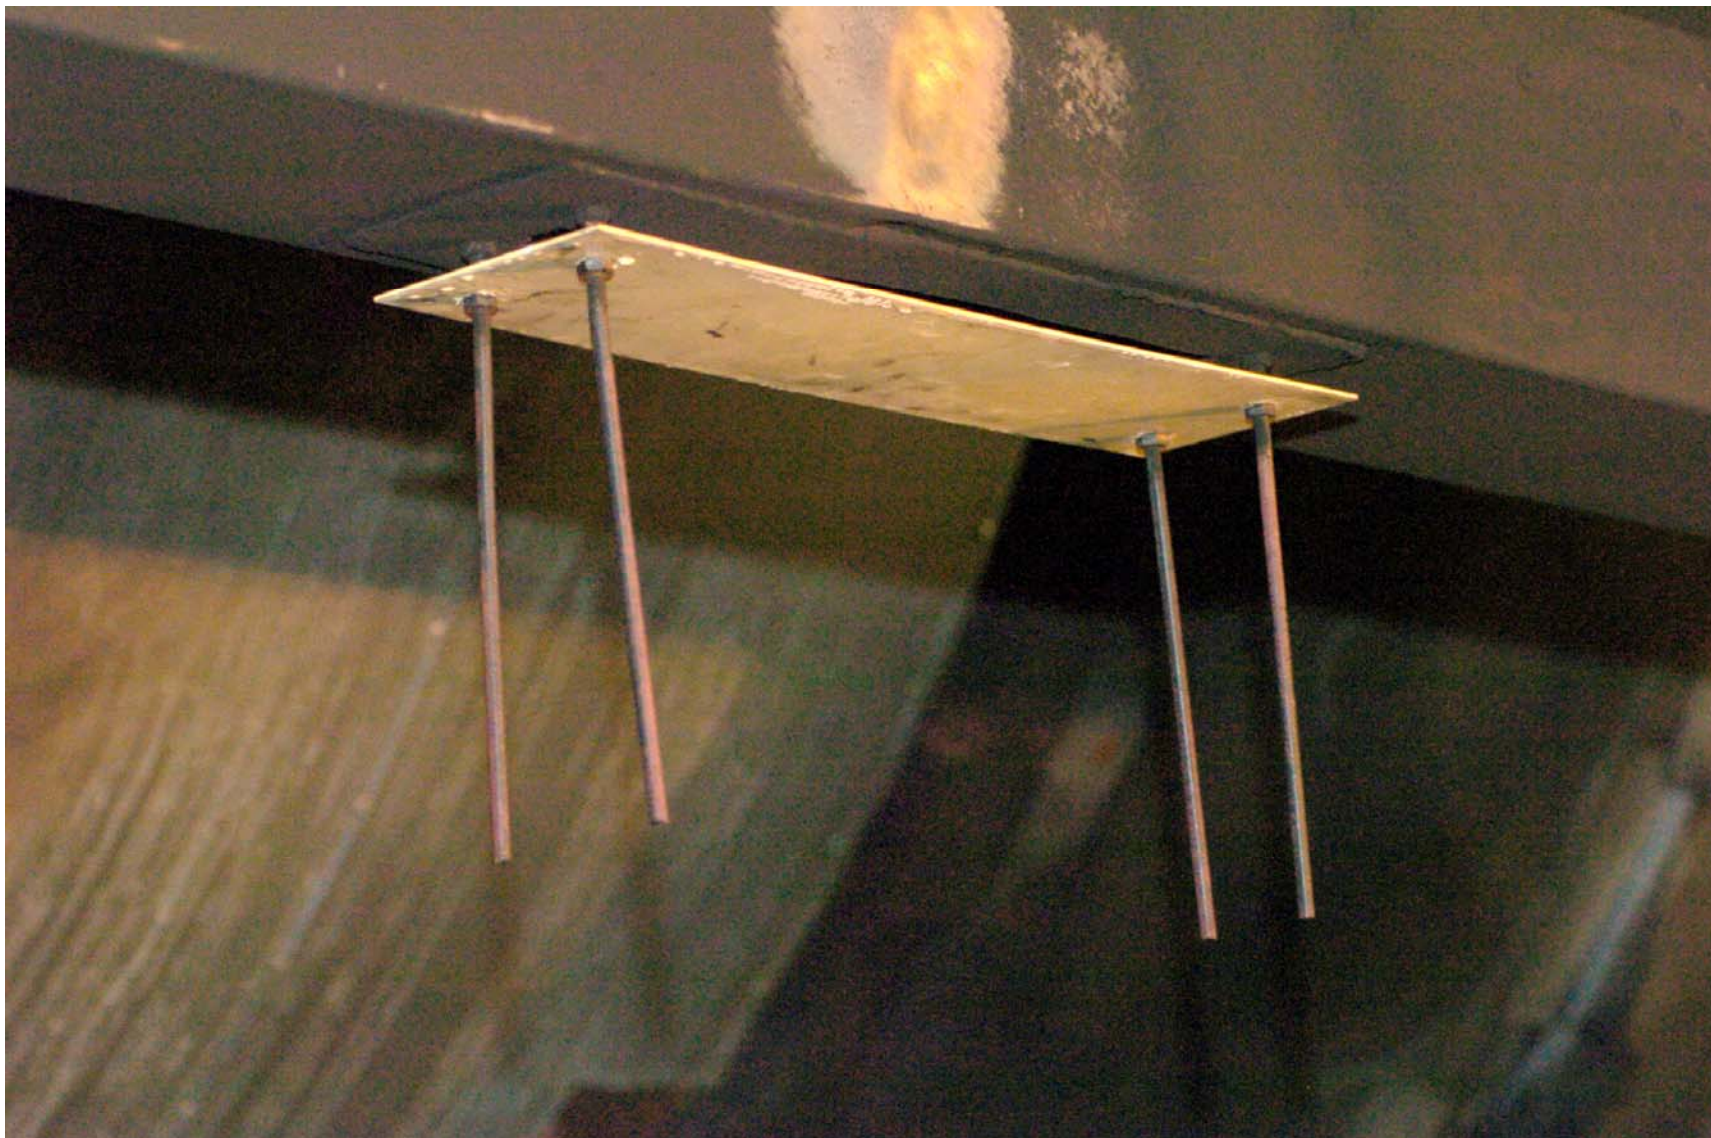
Oversized Intumescent Coated Aluminum Baffle (6/1/07)

6- by 24-Inch Intumescent Coated Aluminum Baffle

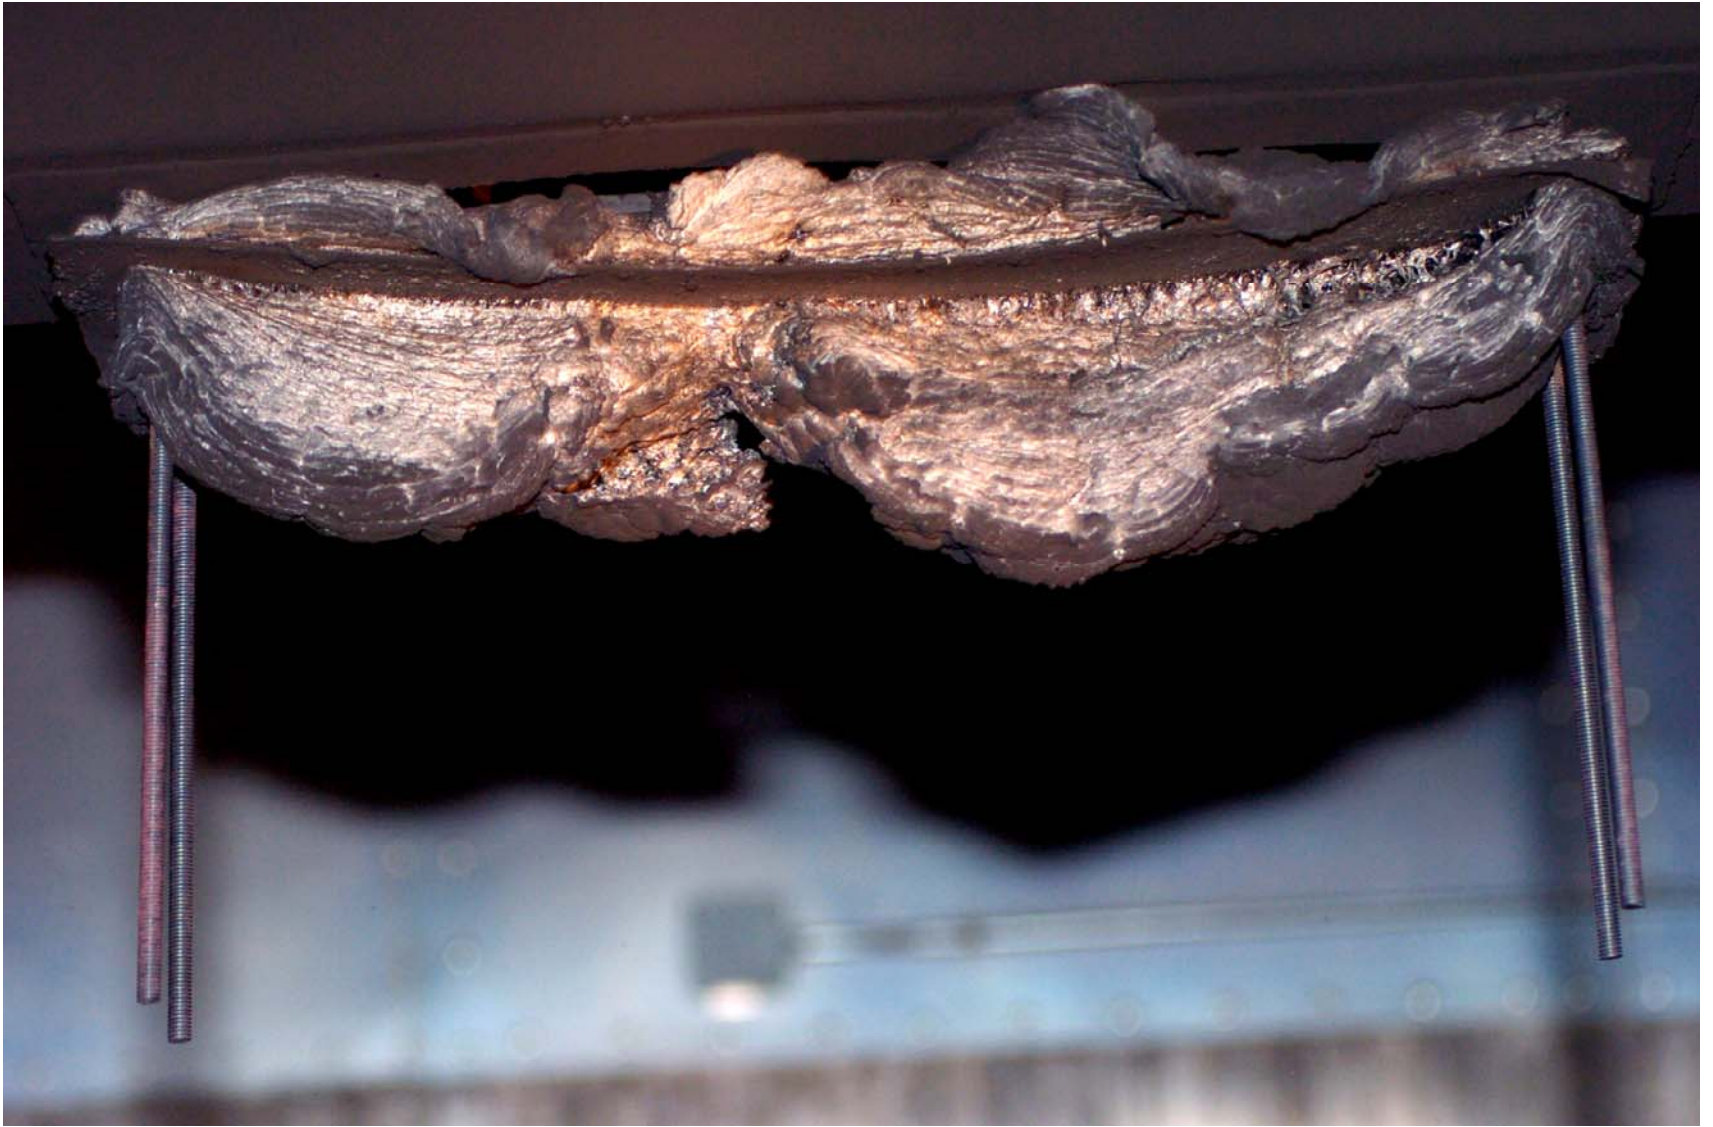
Intumescent-Coated Aluminum Baffle Post Test

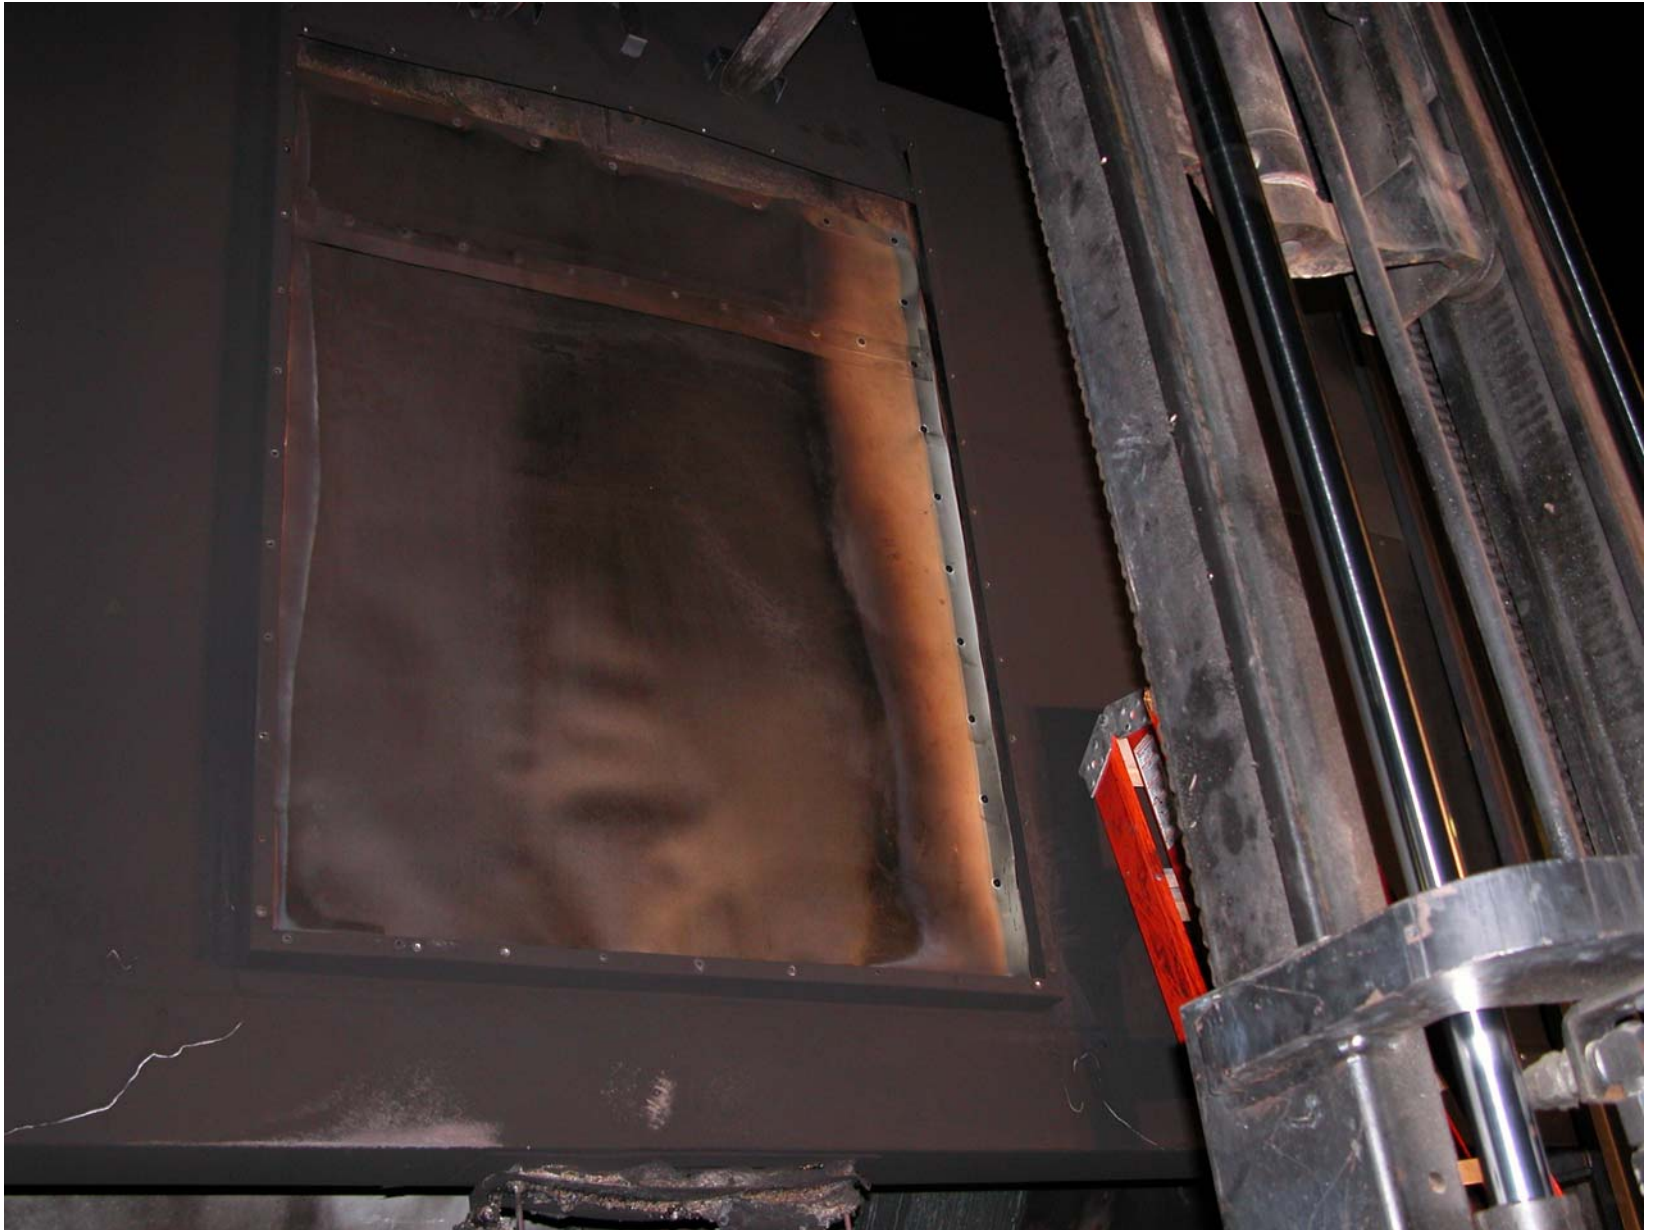
Cargo Liner Post Test
