Investigation of Fuselage Penetrations in Burnthrough Protected Area

Tim Marker

FAA Technical Center

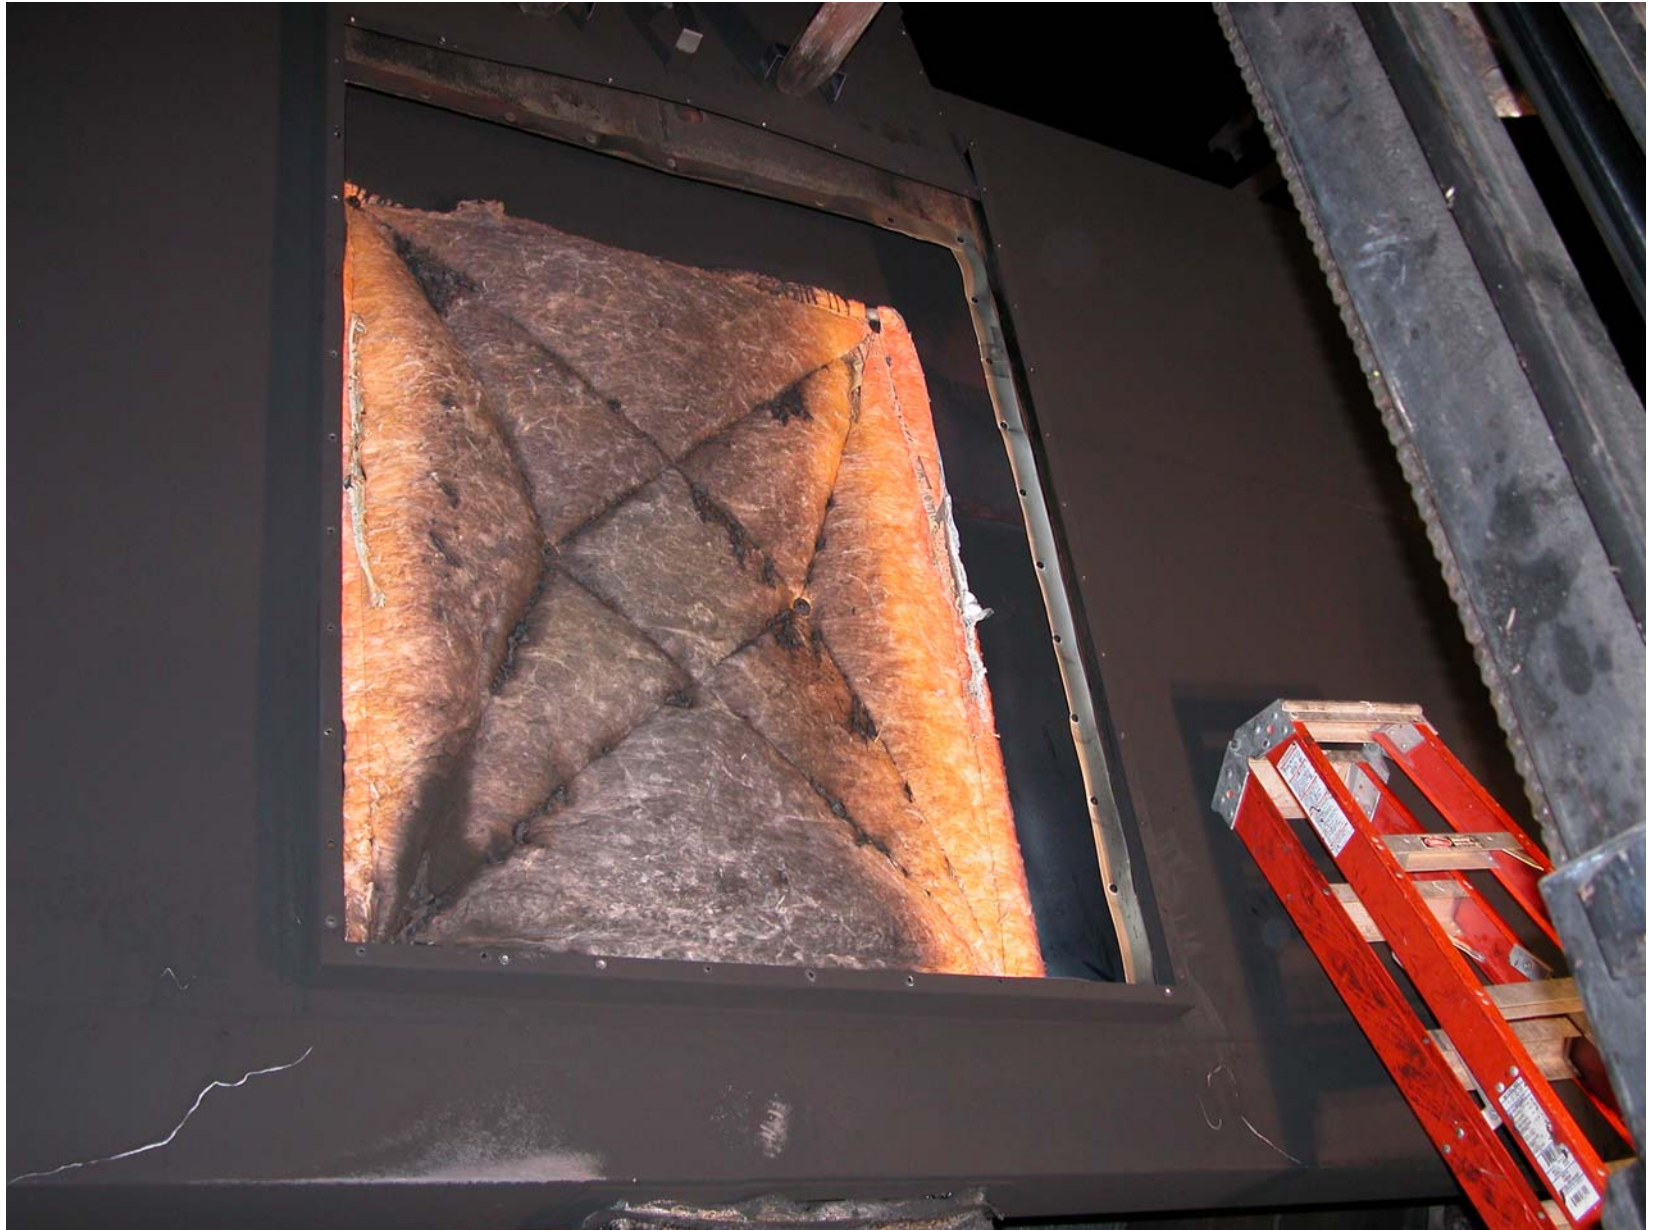
Insulation Blanket Post Test
