Full-Scale Testing of Intumescent-Coated Aluminum Skin

Fuselage Burnthrough Protection Using Intumescent Coating

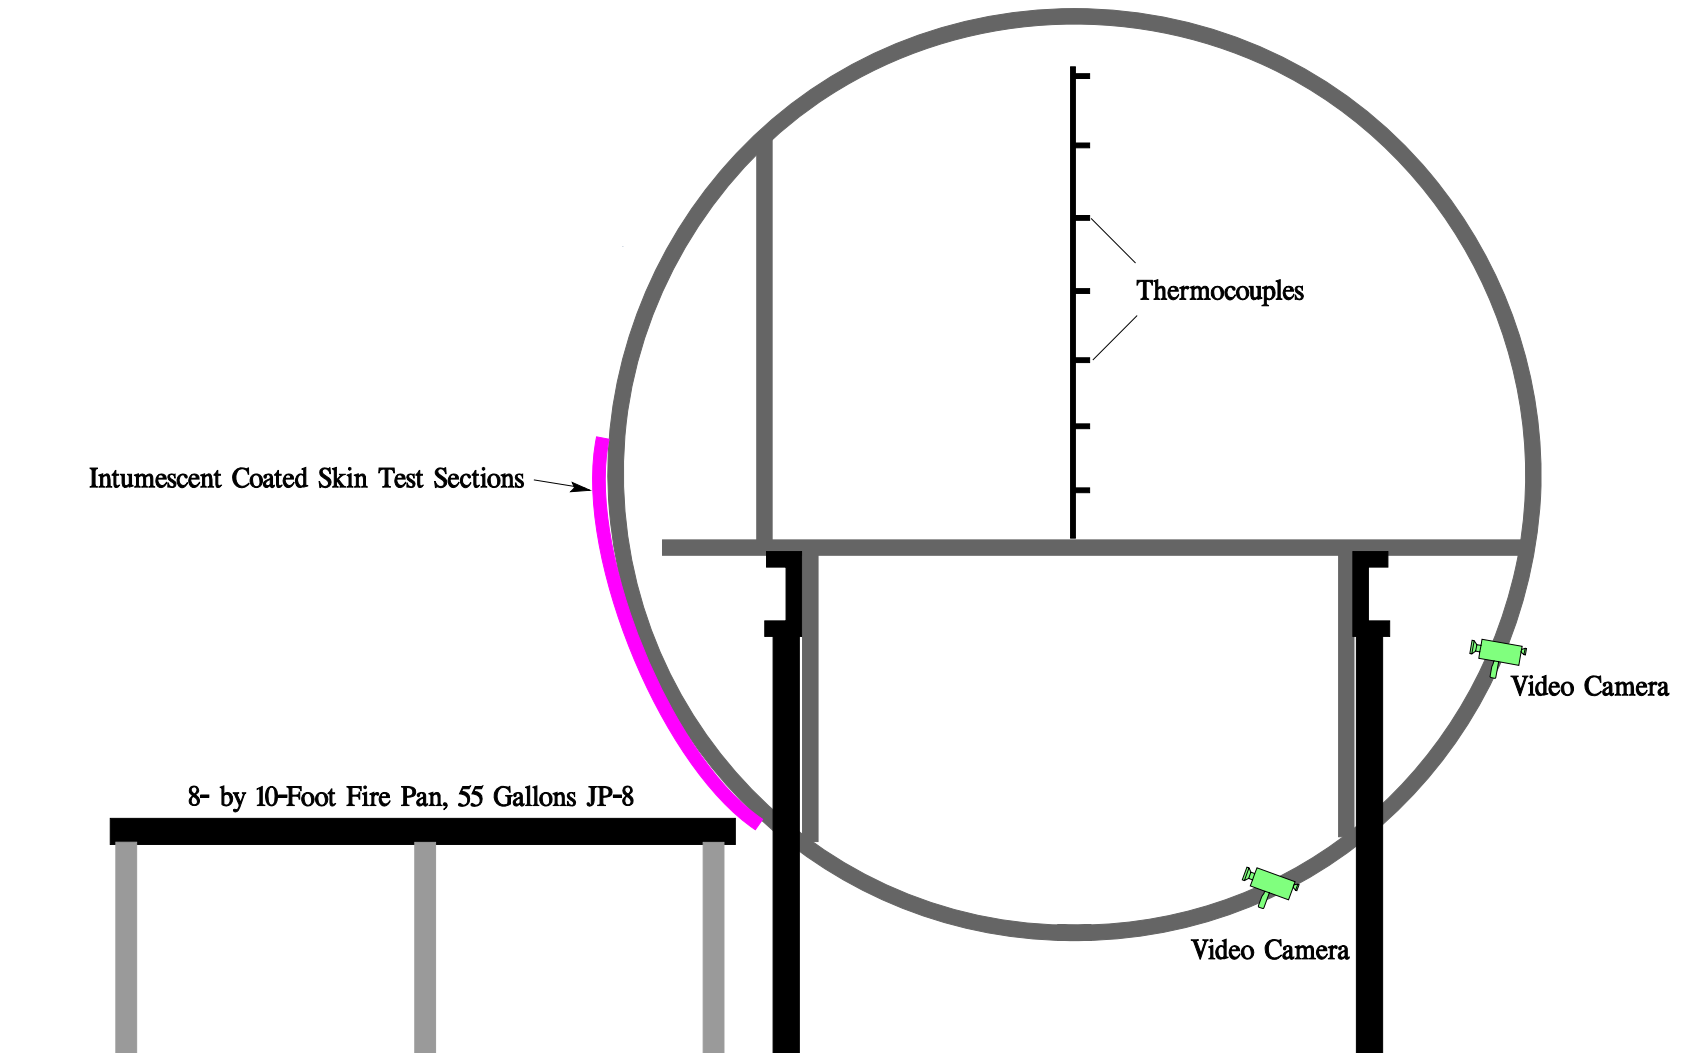
Full-Scale Test Rig To Evaluate Intumescent-Coated Panels

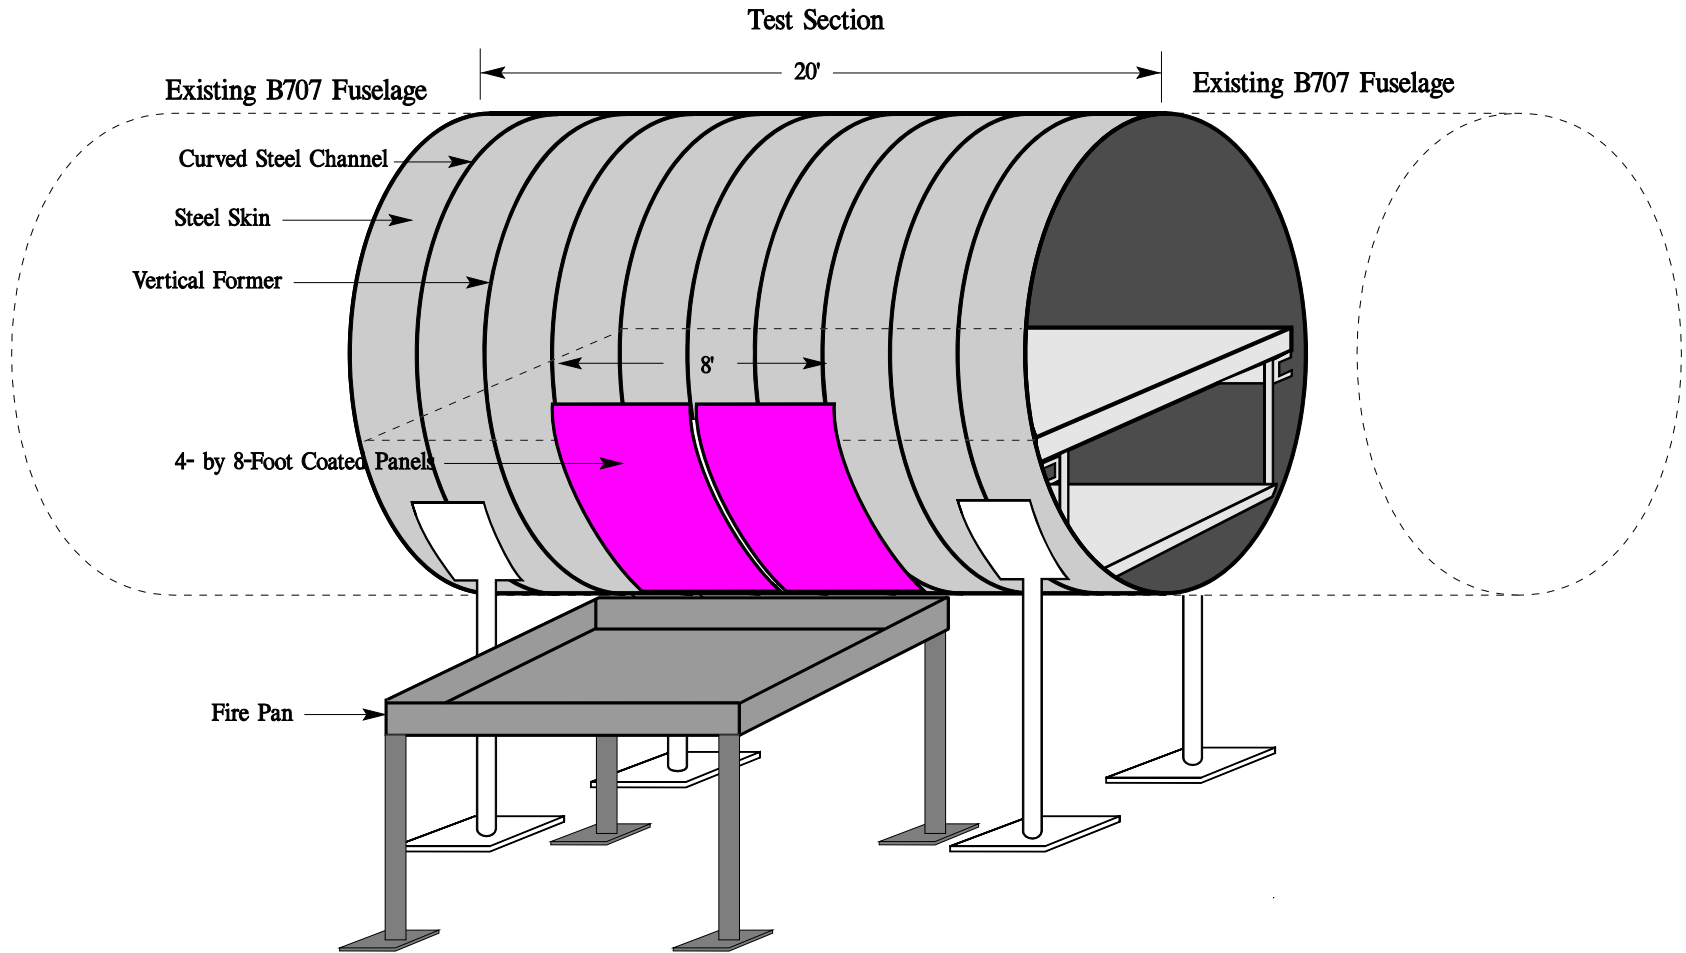
Full-Scale Test Rig To Evaluate Intumescent-Coated Panels

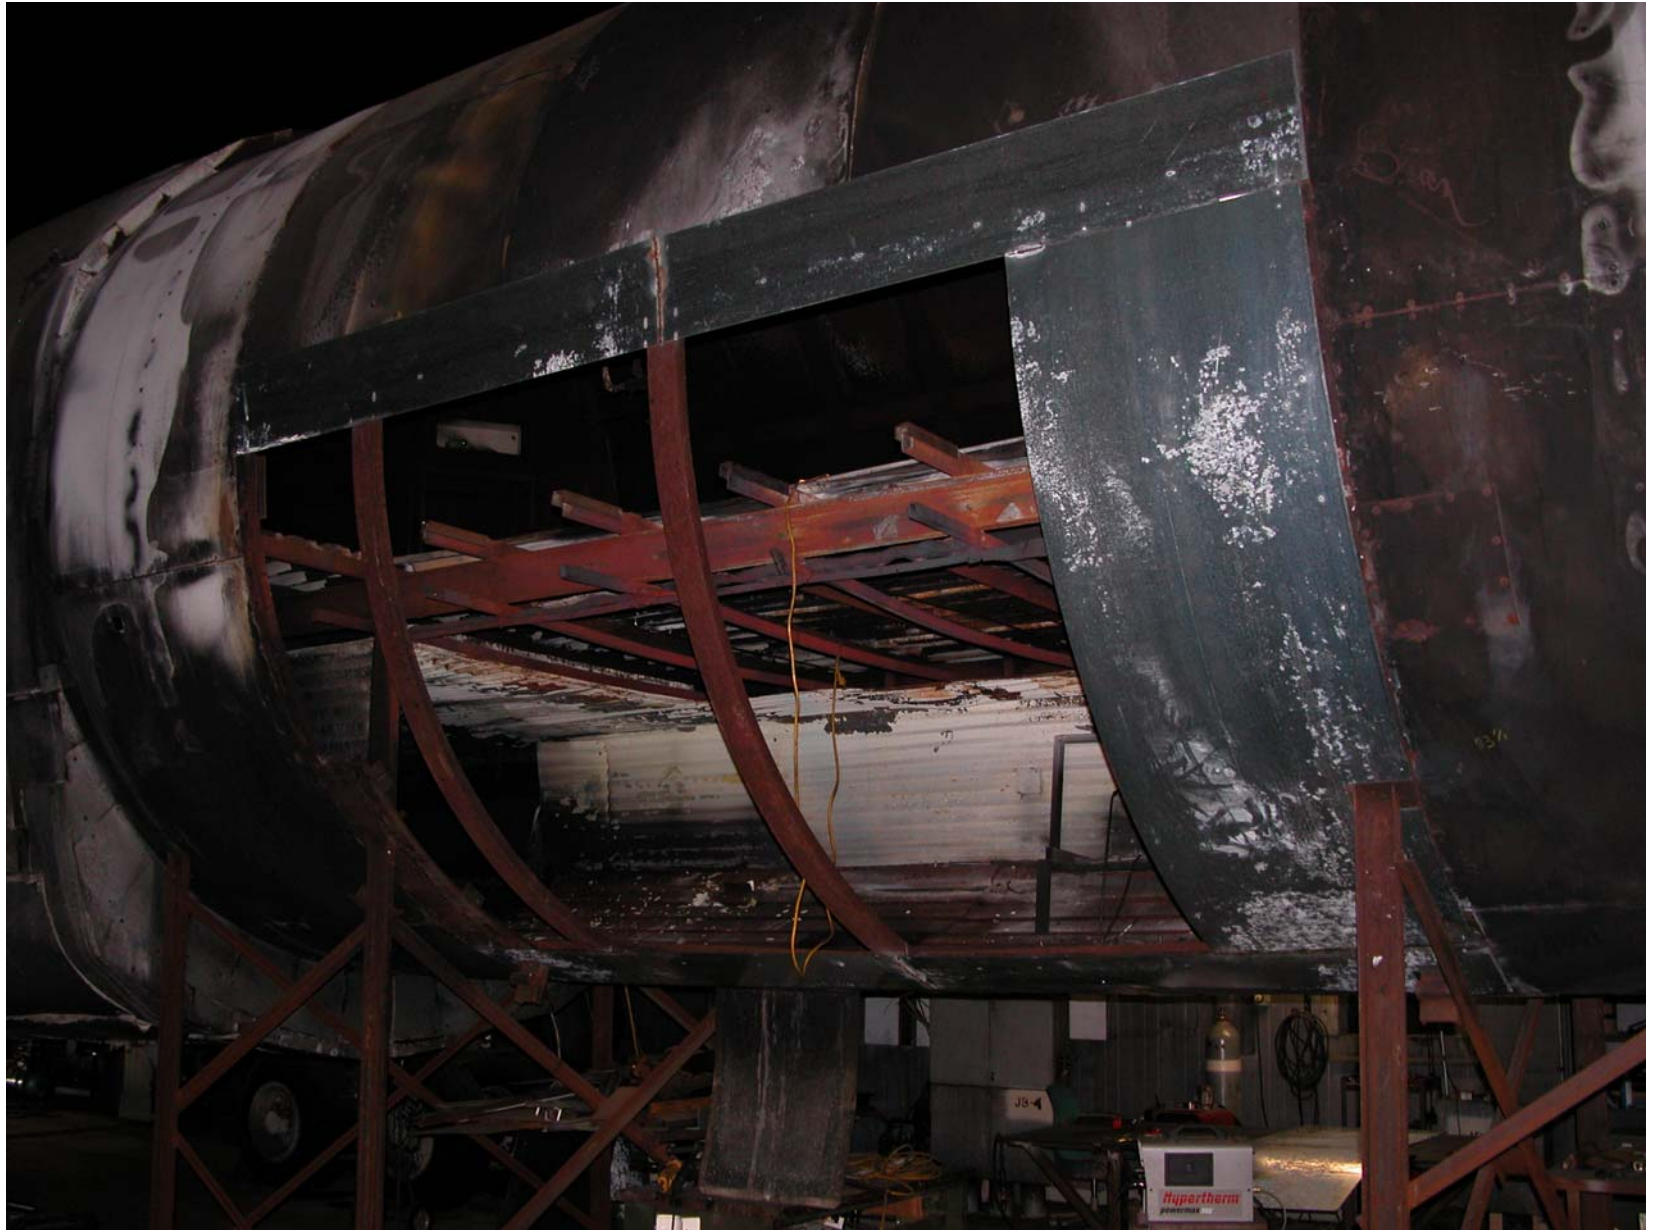
Full-Scale Test Rig To Evaluate Intumescent-Coated Panels

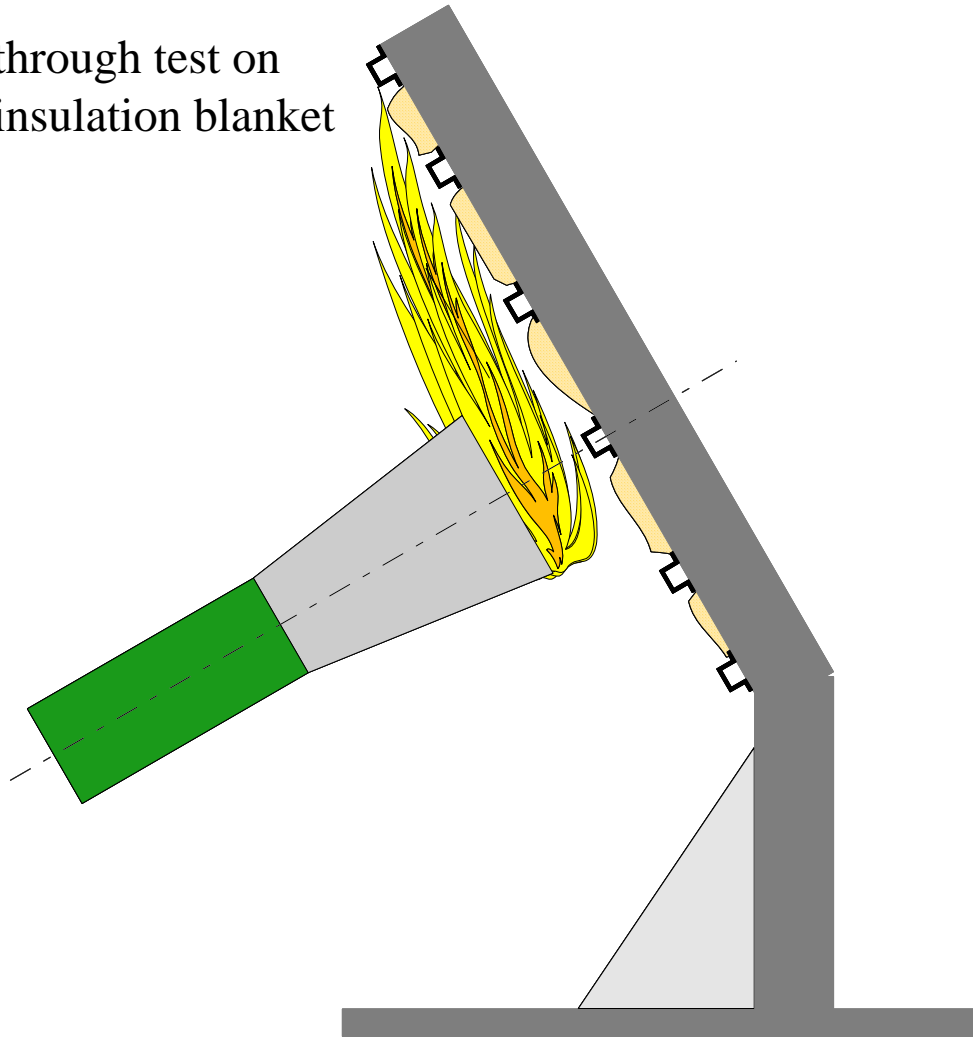
burnthrough test on
typical insulation blanket

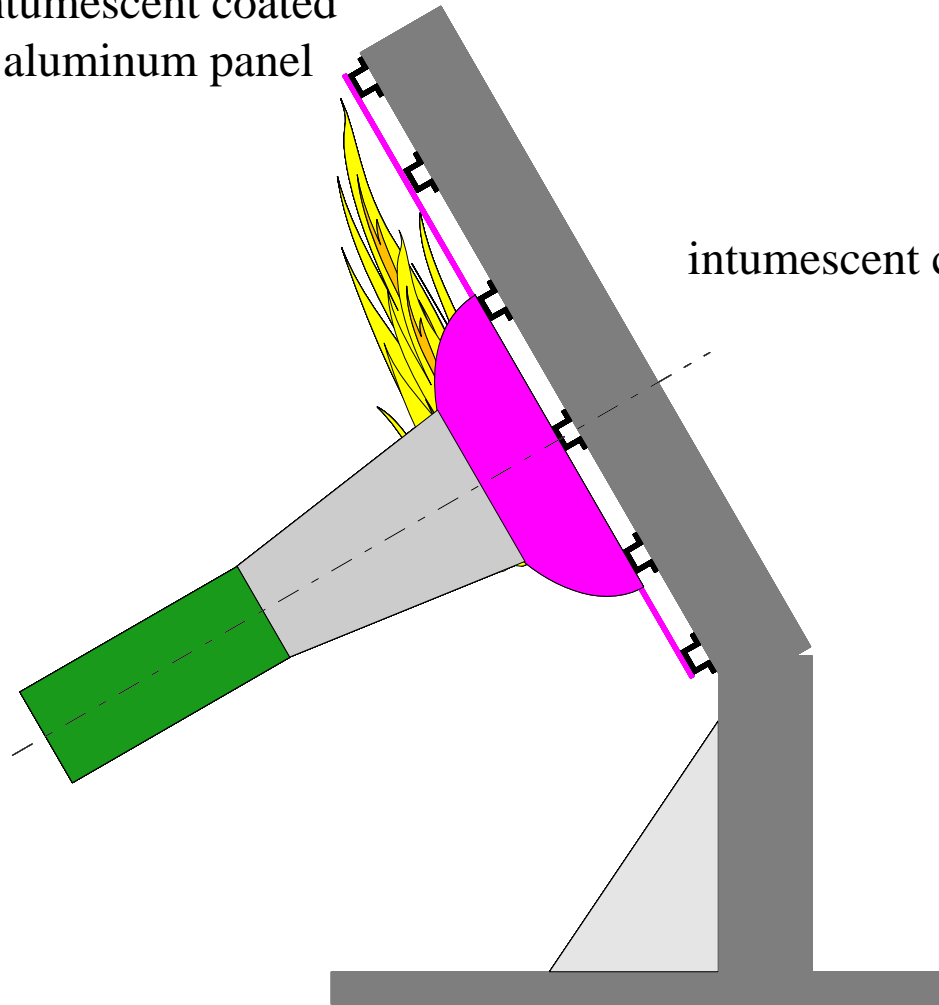
intumescent coated
aluminum panel

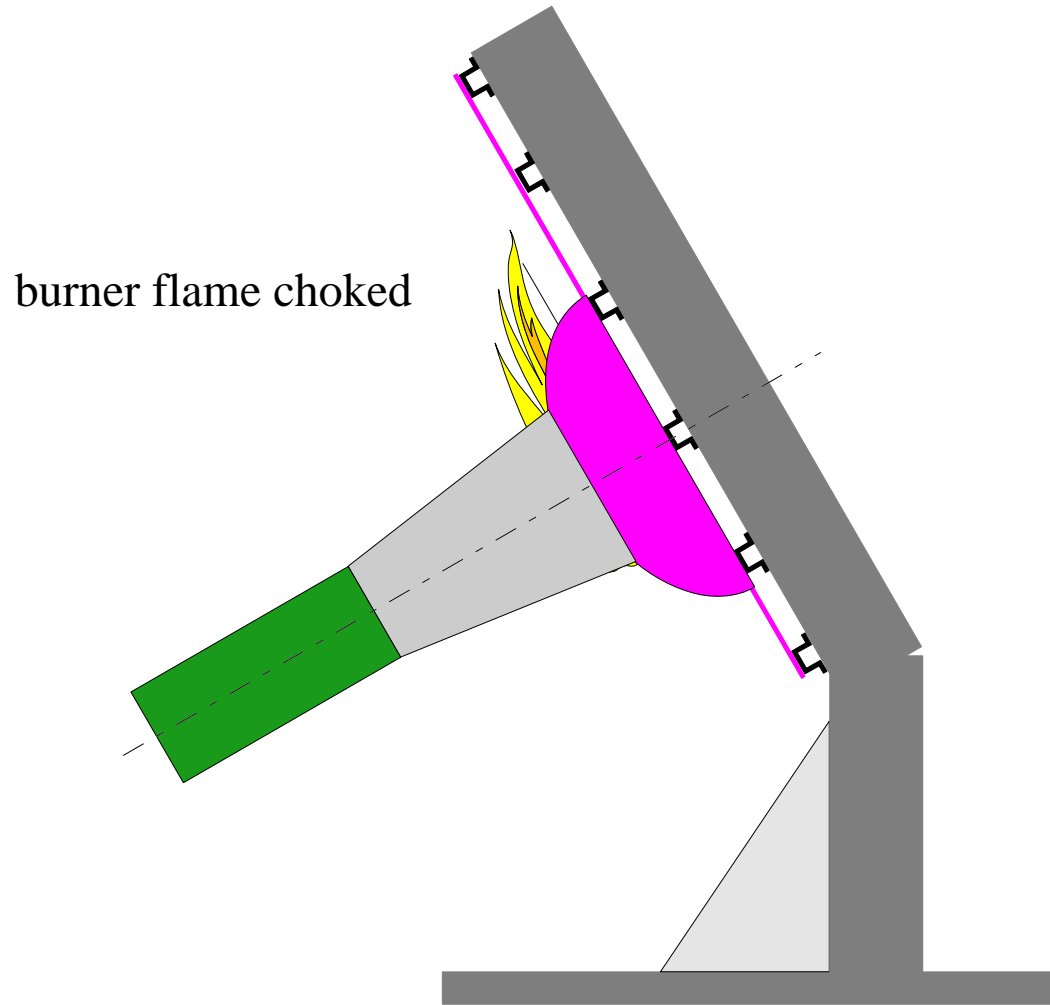
intumescent coating begins expanding

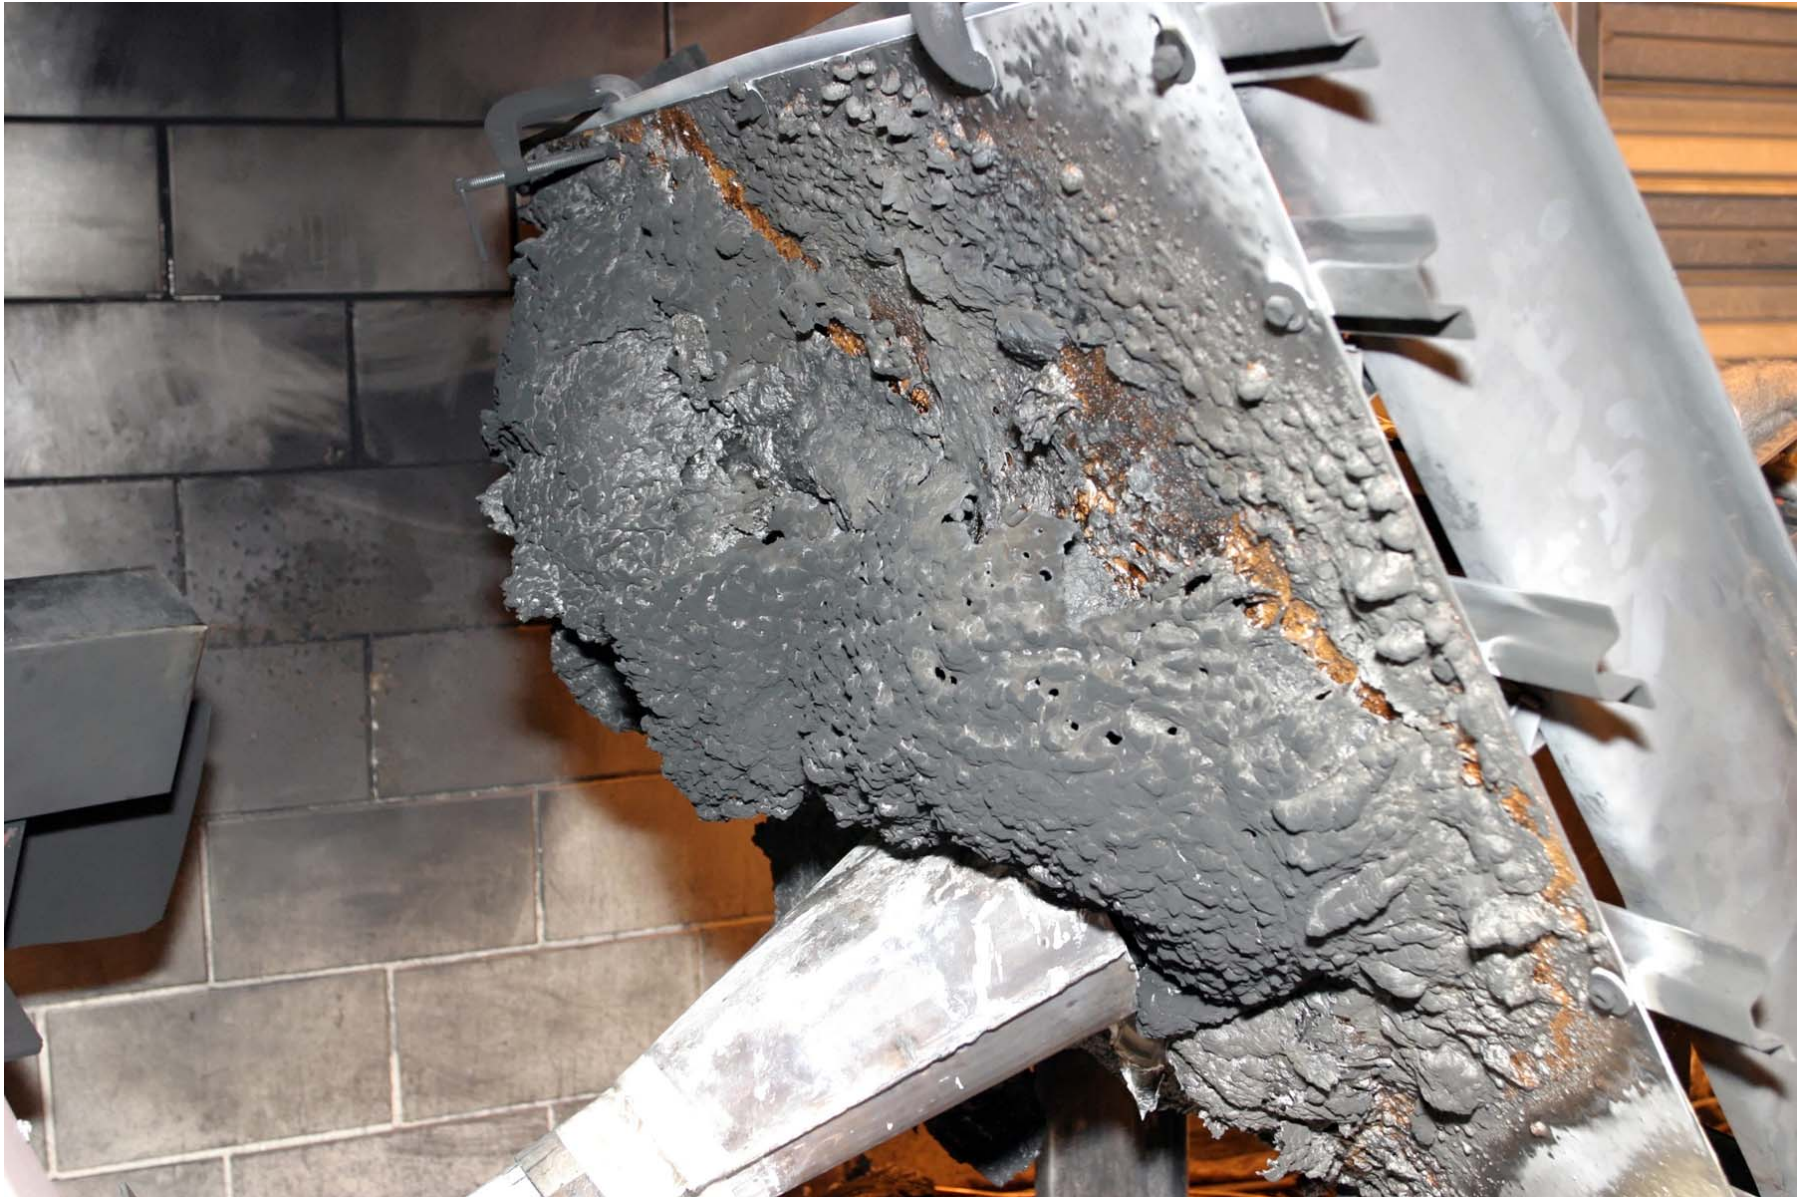
Difficulty Testing Intumescent Using Present Burnthrough Test Rig
