International Aircraft Materials Fire Test Working Group Meeting

Seat Cushion and Cargo Liner Oil Burner Update

By: Tim Salter, FAA Technical Center

Date: June 3-4, 2015, Bremen, Germany

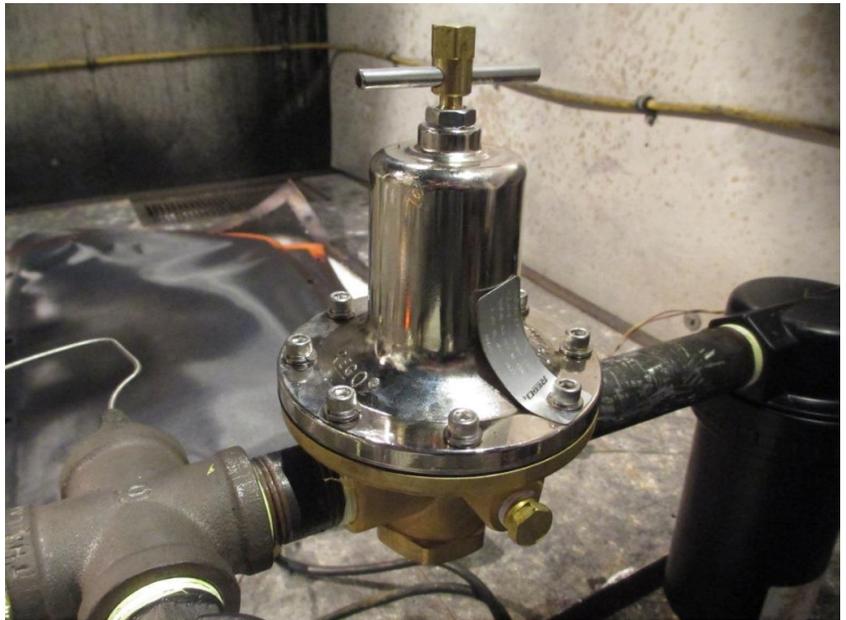
- **Previously recommend McMaster-Carr regulator part # 49305K23 with an operating range of 0-55 psi (shown right)**
- **Testing revealed this regulator is not suited well for use with the NexGen burner**
- **Air pressure readings measured at the 1/4" NPT port on the side of the regulator differed from readings measured downstream of the regulator but before the sonic orifice as much as 7 psi**

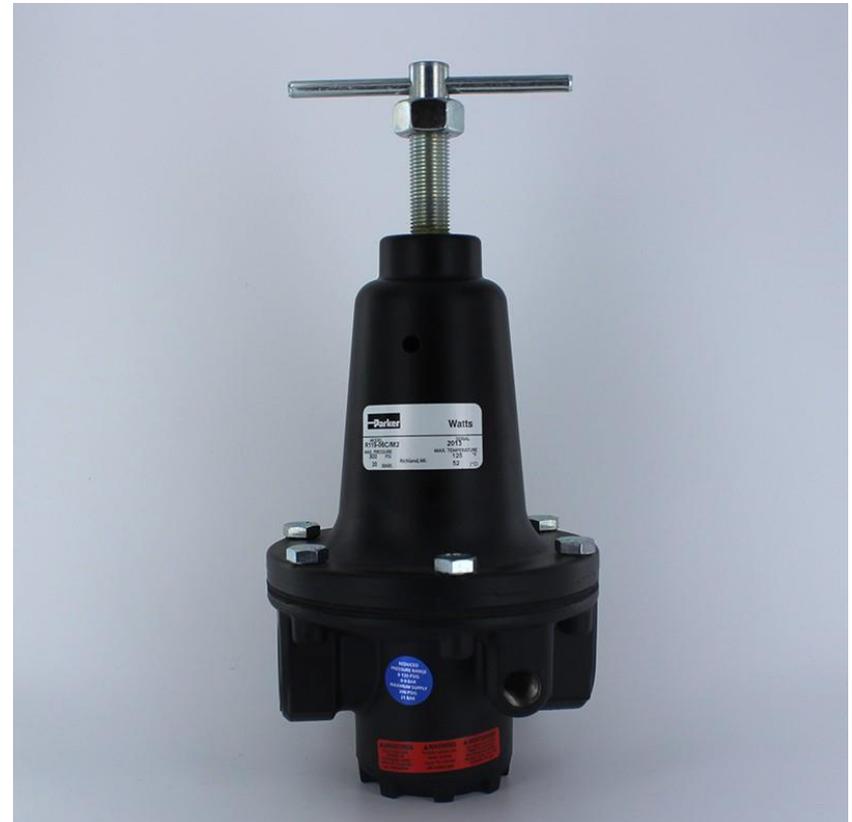
- **Air pressure at the sonic orifice will determine the mass flow rate of air**
- **Air pressure measurement taken at the sonic orifice and pressure regulator should be identical**
- **A more suitable regulator is available from MSC.com having part # 73535627, Parker 1" heavy duty regulator model R119-08CG/M2 (shown right)**

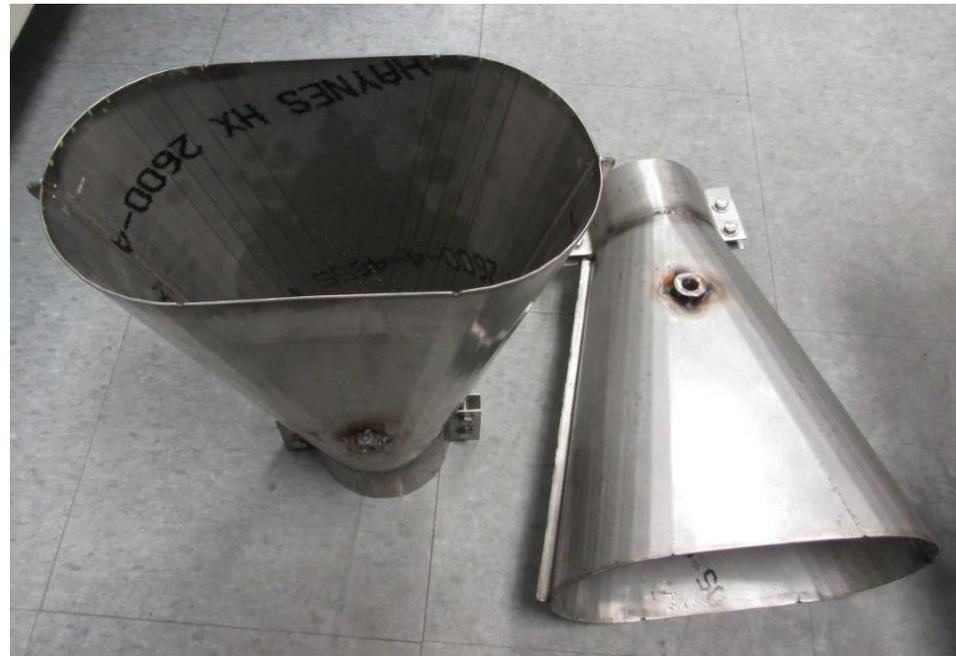
- **Current rule for burner cone alloy is 16Ga, 310 stainless steel**
- **SS cones have deformed up to 1/2 inch after only one heat cycle**
- **Recent study involved testing 625 Inconel and Hastelloy X alloy cones**
- **Testing involved running the burner for 5 minutes, cool-down for 5 minutes with burner air on, then measure the cone in four different locations (A, B, C, D), and repeat for 10 heat cycles**

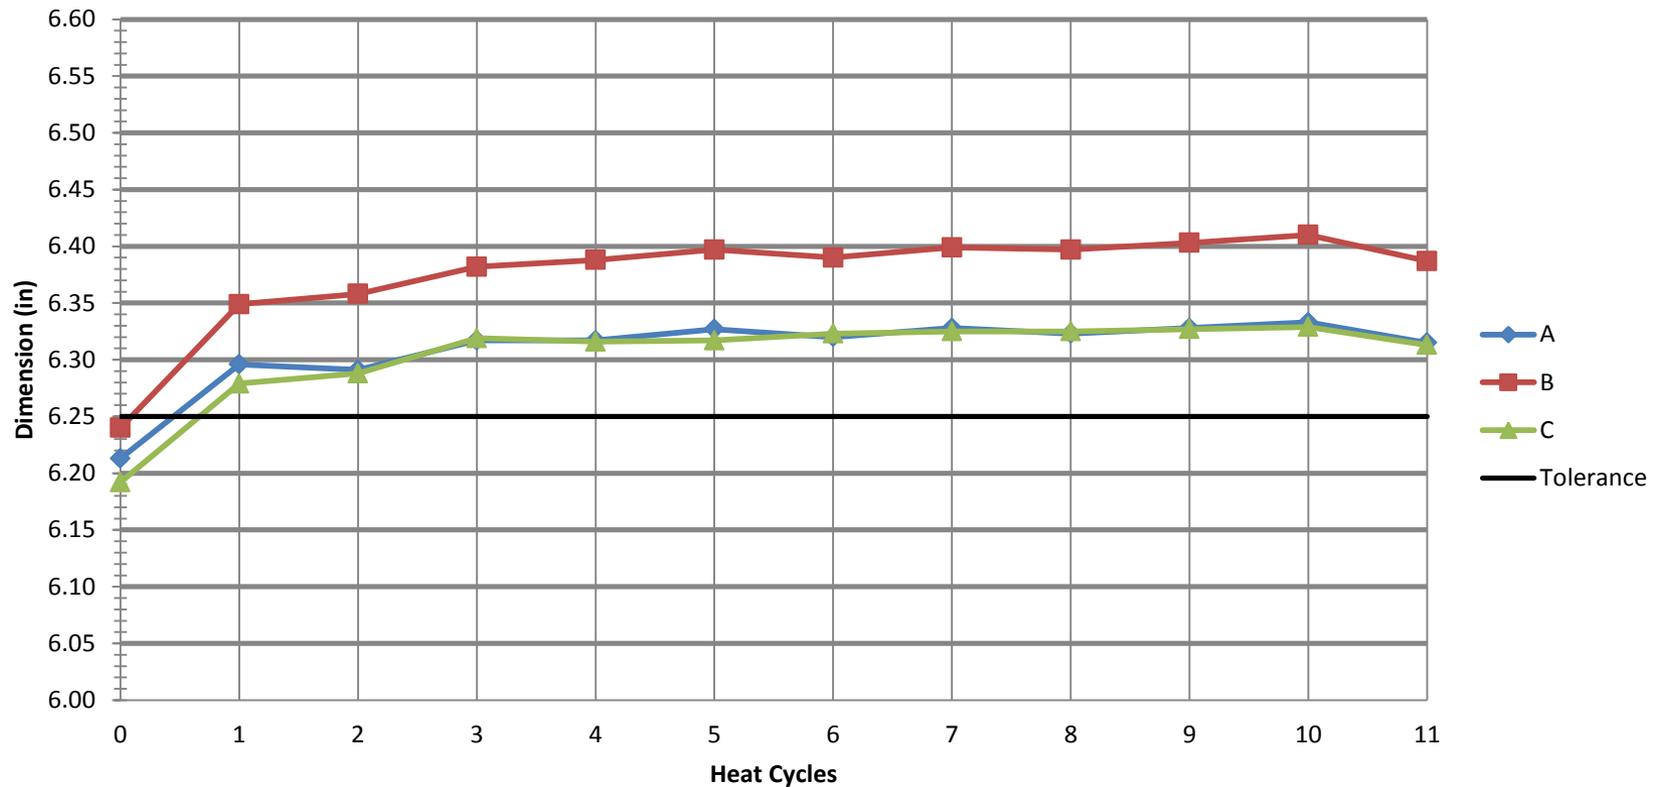
Hastelloy Cone Dimensions

Maximum Deformation

A (in)	B (in)	C (in)
0.12	0.17	0.14

Hastelloy Cone

- **A: 6.213" → 6.315"**
- **B: 6.240" → 6.387"**
- **C: 6.192" → 6.313"**
- **D: 11.000" → 10.813"**

Dimensions shown are initial measurements taken before exposure to flame and final measurements after 10 heat cycles after the cone was allowed to cool to ambient temperature

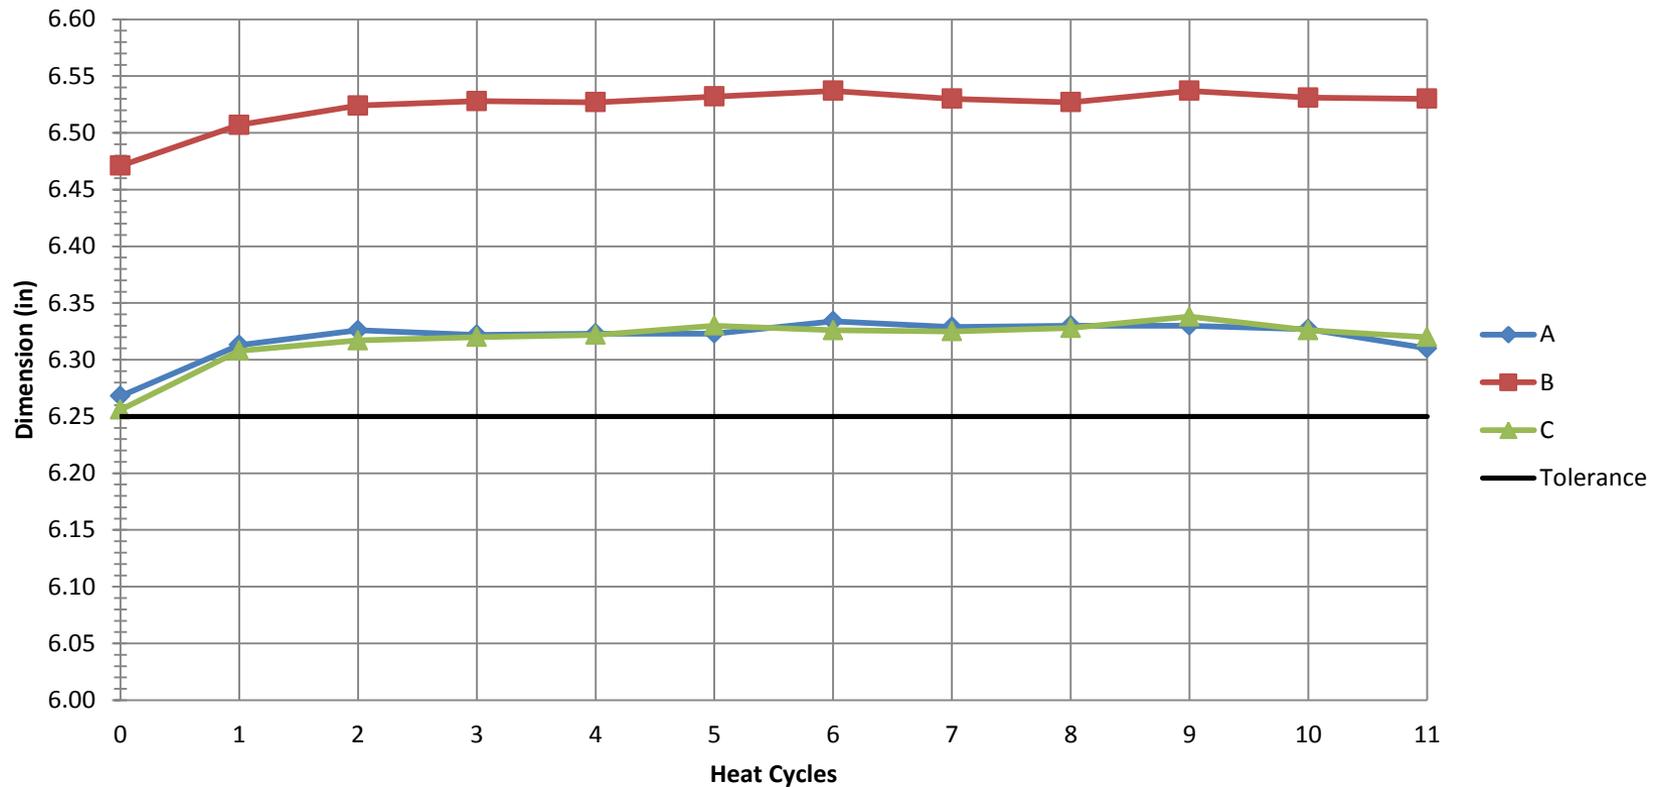
Inconel Cone Dimensions

Maximum Deformation

A (in)	B (in)	C (in)
0.07	0.07	0.08

Inconel Cone

- **A: 6.268" → 6.310"**
- **B: 6.471" → 6.530"**
- **C: 6.256" → 6.320"**
- **D: 10.938" → 10.875"**

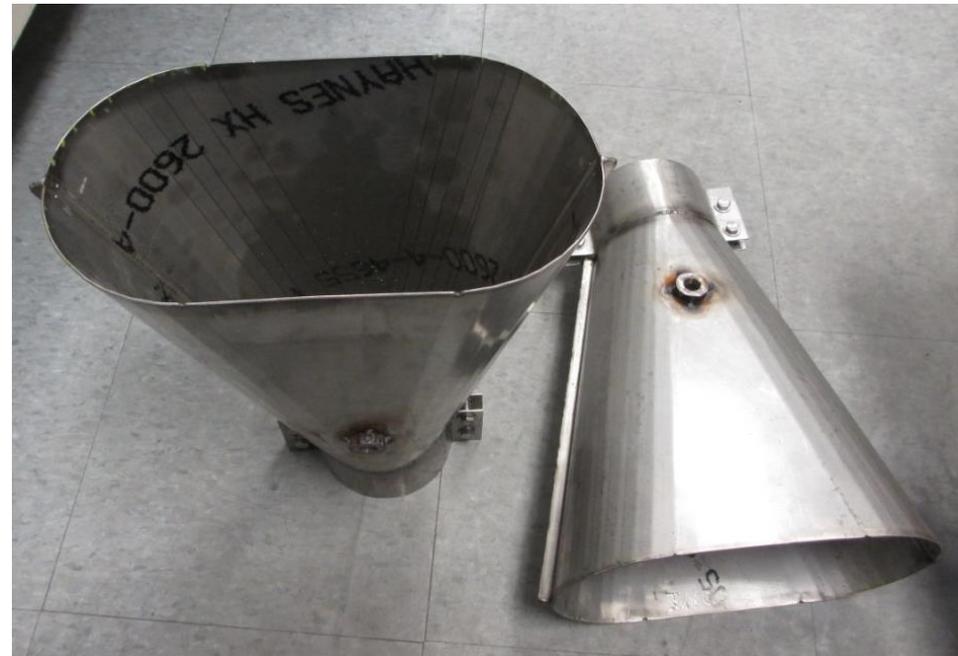
- **Most deformation occurs after only the first heat cycle**
- **It may be possible to alter the initial design of the cone in order to accommodate deformation**
- **Inconel tends to deform significantly less compared to 310 stainless steel**
- **The cost of an Inconel cone is approximately 25%-30% more compared to a 310 SS cone**
- **Initial cost may be offset by the working life span of the cone**

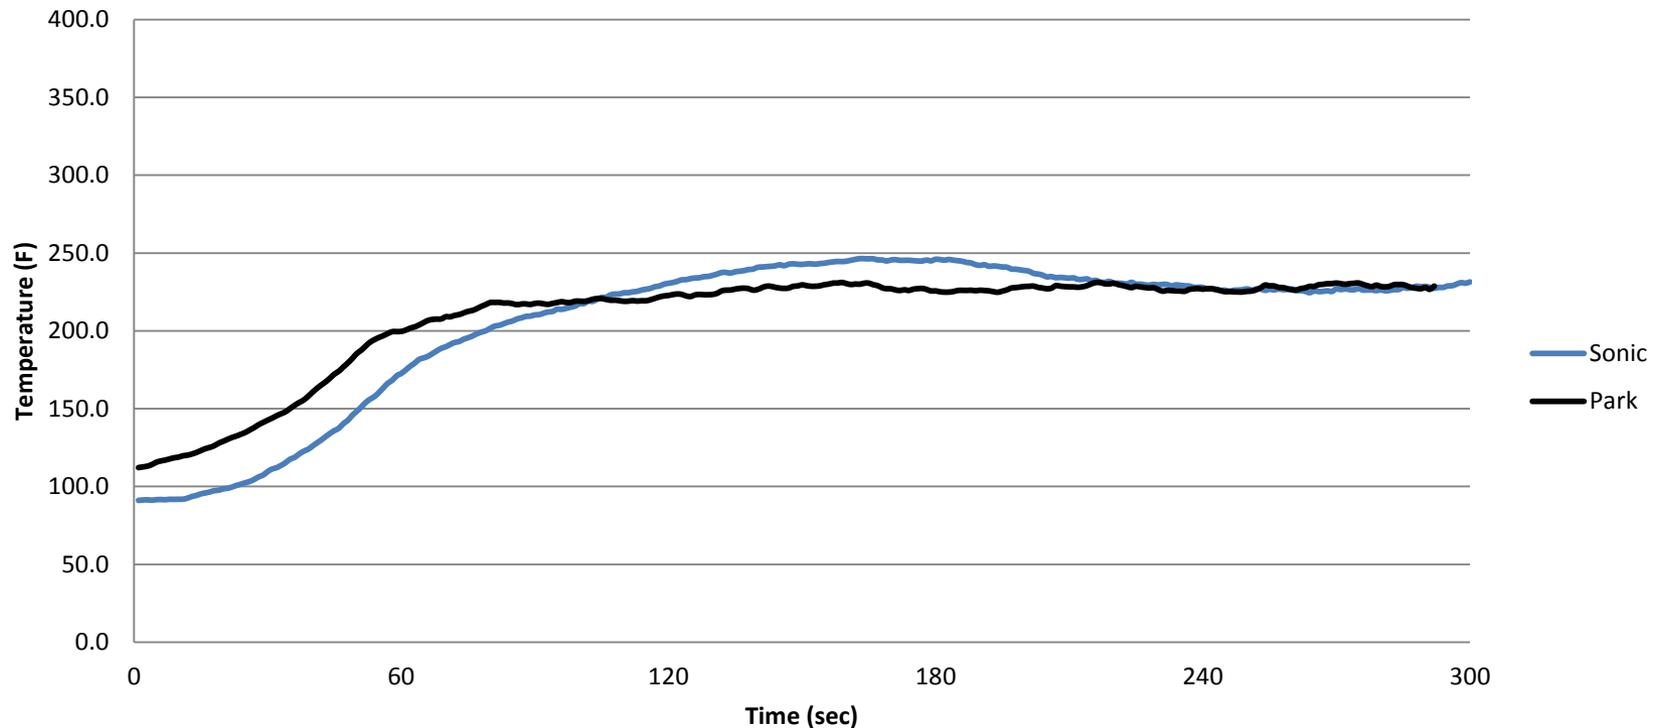
Sonic and Park Comparison

Average Temperature Measured 4-Inches above 0.035" Woven Fiberglass Polyester Reinforced Cargo Liner Samples

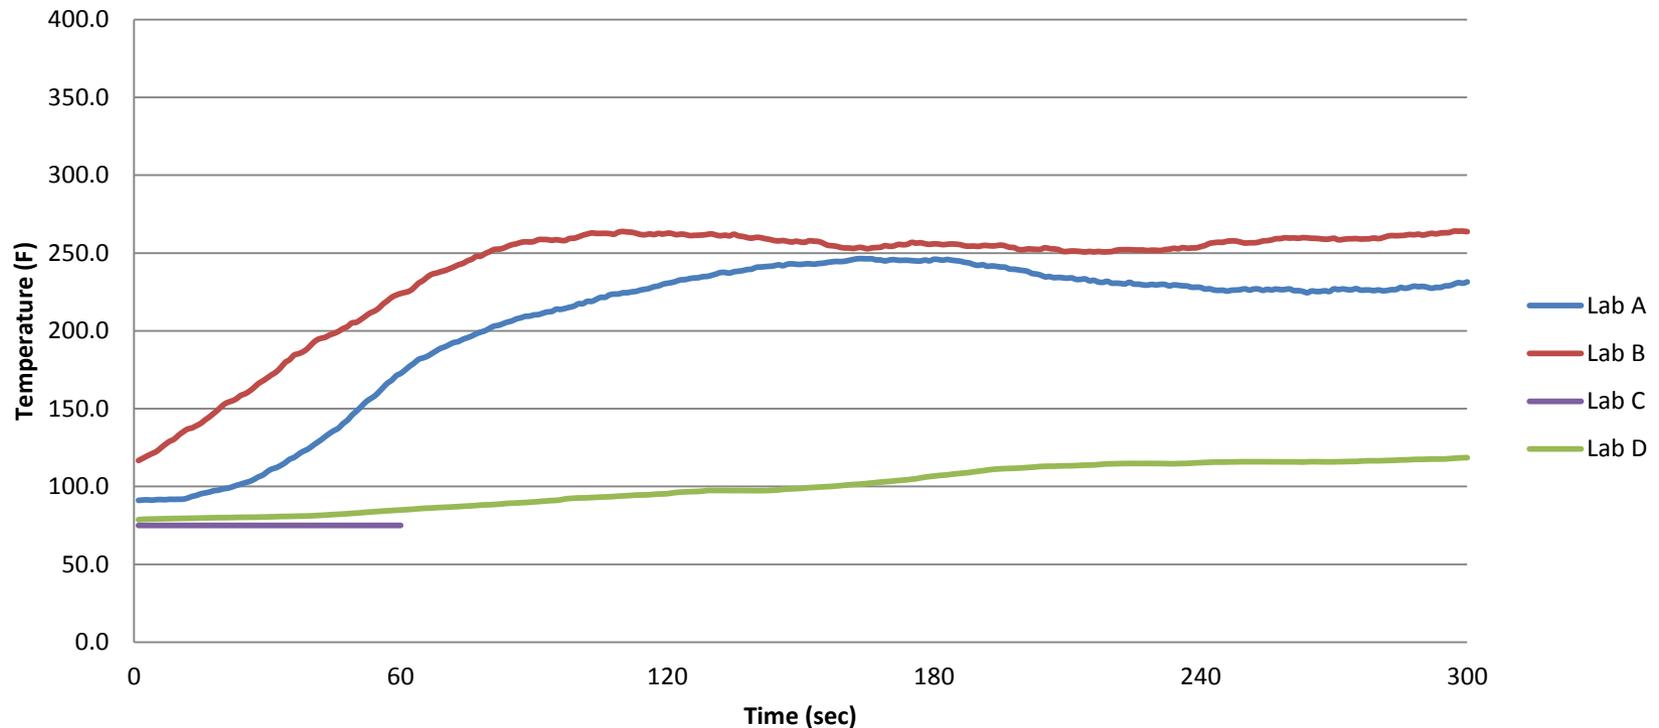
Cargo Liner Round Robin Results

Average Temperature Measured 4-Inches above 0.035" Woven Fiberglass Polyester Reinforced Cargo Liner Samples

- **The current cargo liner interlab study is on-going**
- **Additional materials will be supplied to participating labs for further testing and aid in burner and test cell research**
- **These additional supplied materials are intended to burn-through unlike the liner materials already tested**
- **The final results of this study will be presented at the materials working group meeting in Atlantic City, NJ on dates October, 19-20**

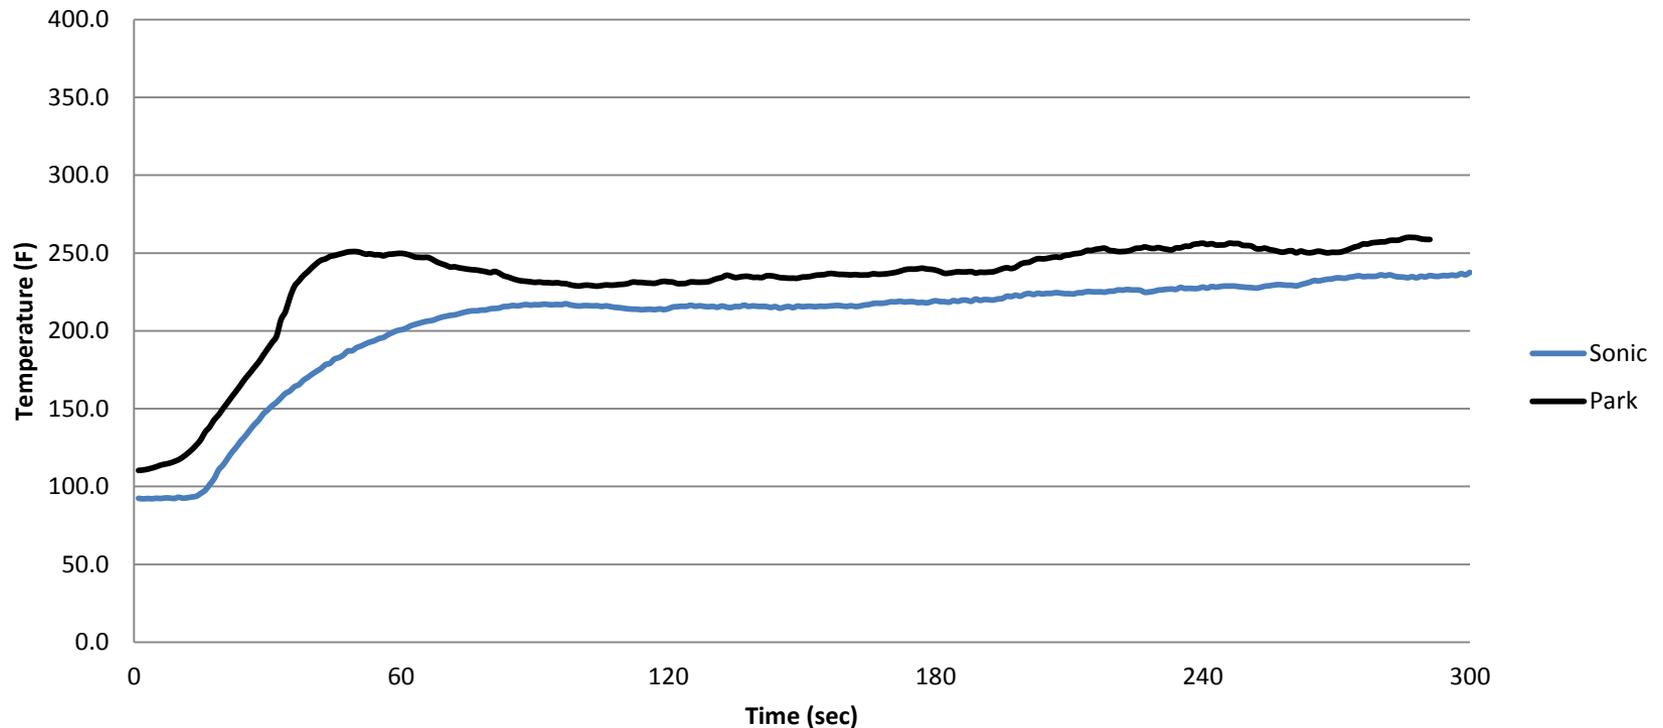
Sonic and Park Comparison

Average Temperature Measured 4-Inches above 0.013" Woven Fiberglass Reinforced Phenolic Cargo Liner Samples

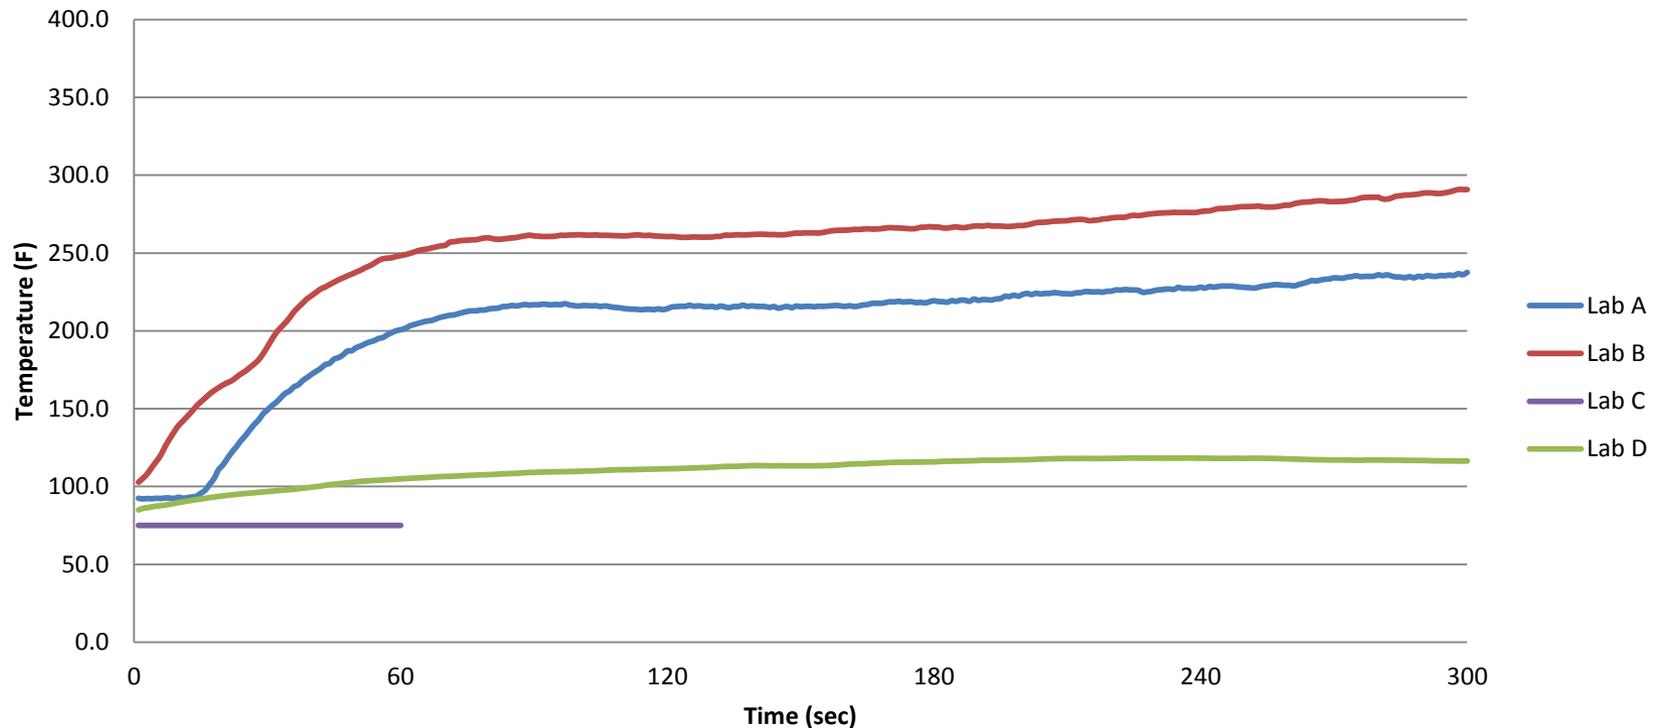
Cargo Liner Round Robin Results

Average Temperature Measured 4-Inches above 0.013" Woven Fiberglass Reinforced Phenolic Cargo Liner Samples

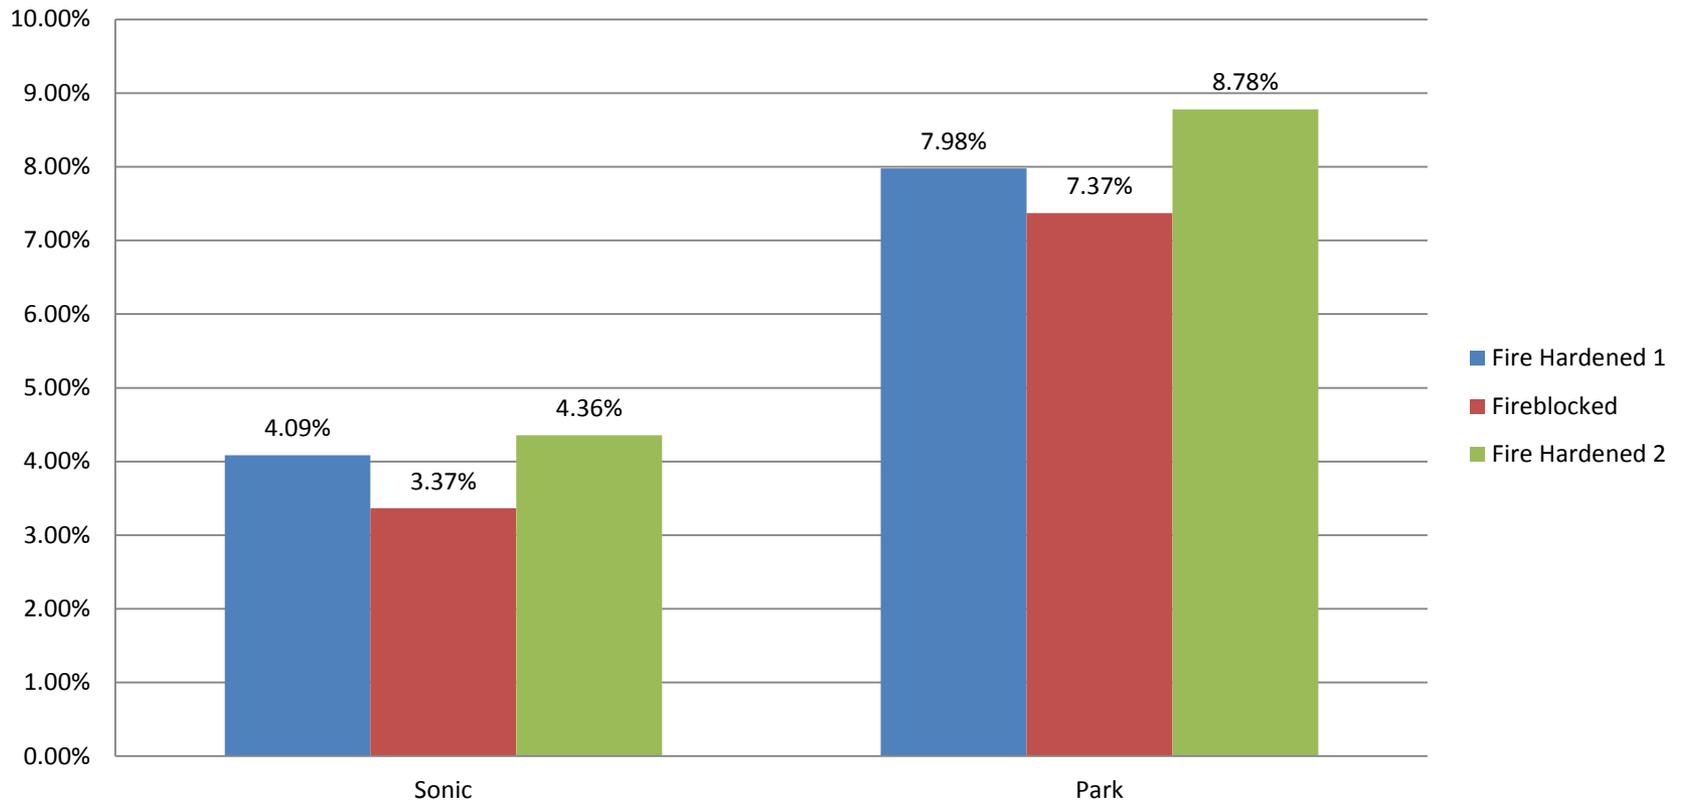
Sonic and Park Comparison

Average Cushion Set Weight Loss %

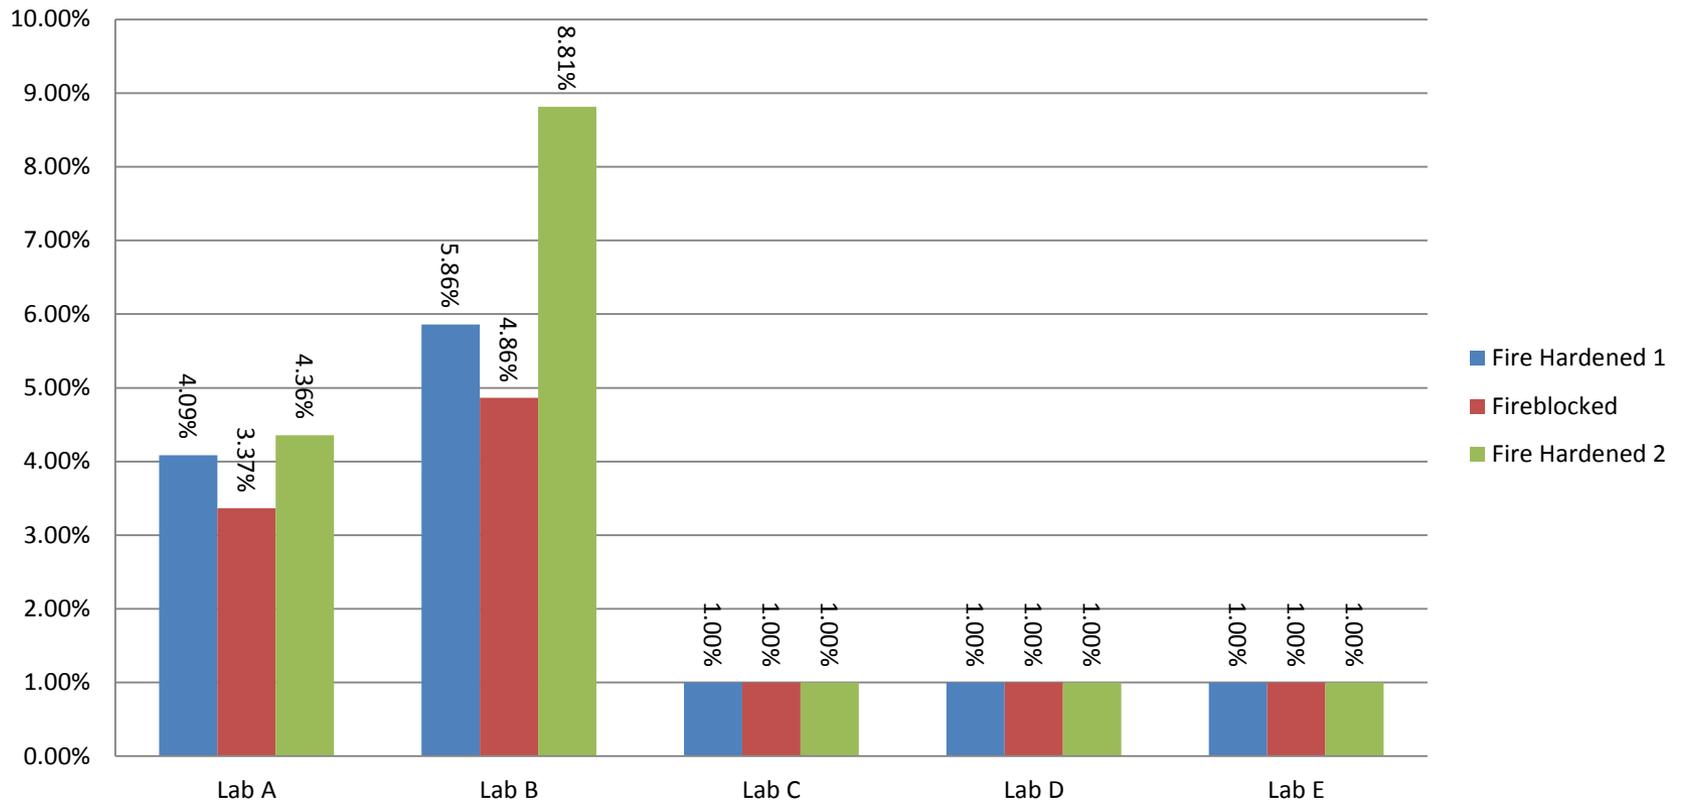
Seat Cushion Round Robin Results

Average Cushion Set Weight Loss %

- **FAA test results using the NexGen sonic burner configured with the igniterless stator resulted in weight loss % approximately half of expected result**
- **This may be due to less turbulent airflow using an igniterless stator and lack of internal ignition wires**
- **Testing will be repeated with another oil burner supplied by Marlin Engineering**

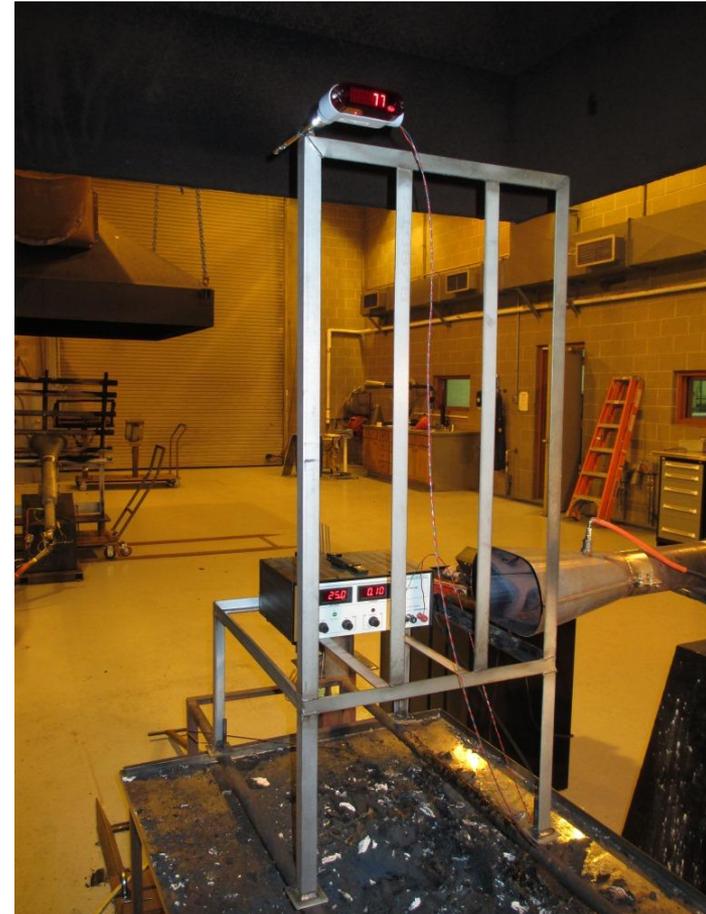
- A pair of NIST certified hot-wire anemometers were recently acquired by the FAA Fire Safety Branch
- The new equipment will be used for an in-depth study of how test cell configuration and ventilation airflow may affect test results related to oil burner test methods

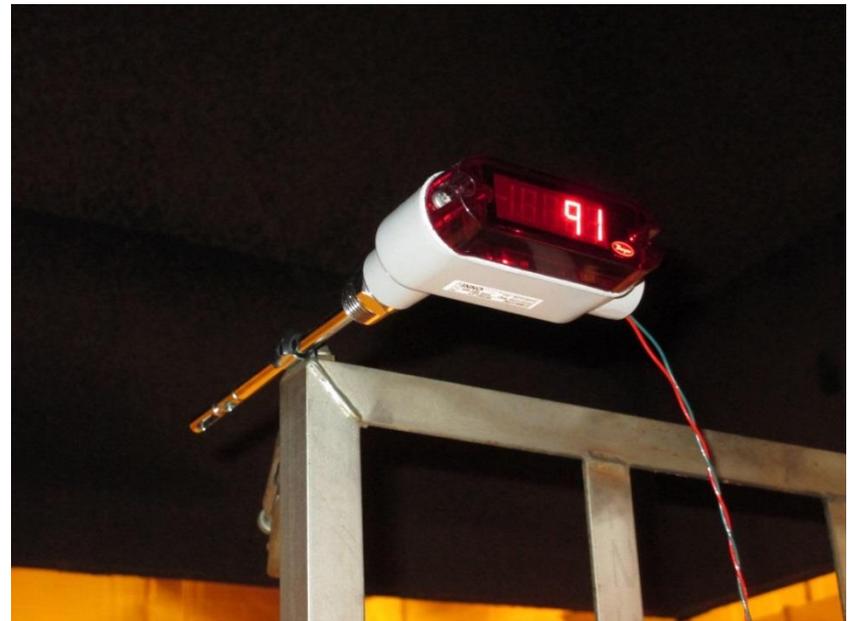
- Initial testing was performed with one anemometer attached to the seat cushion test frame
- The hot-wire portion of the measurement device was located 3 inches forward from the upper corner of the seat test frame, and approximately centered under the ventilation hood
- Airflow measurements were taken in the vertical direction

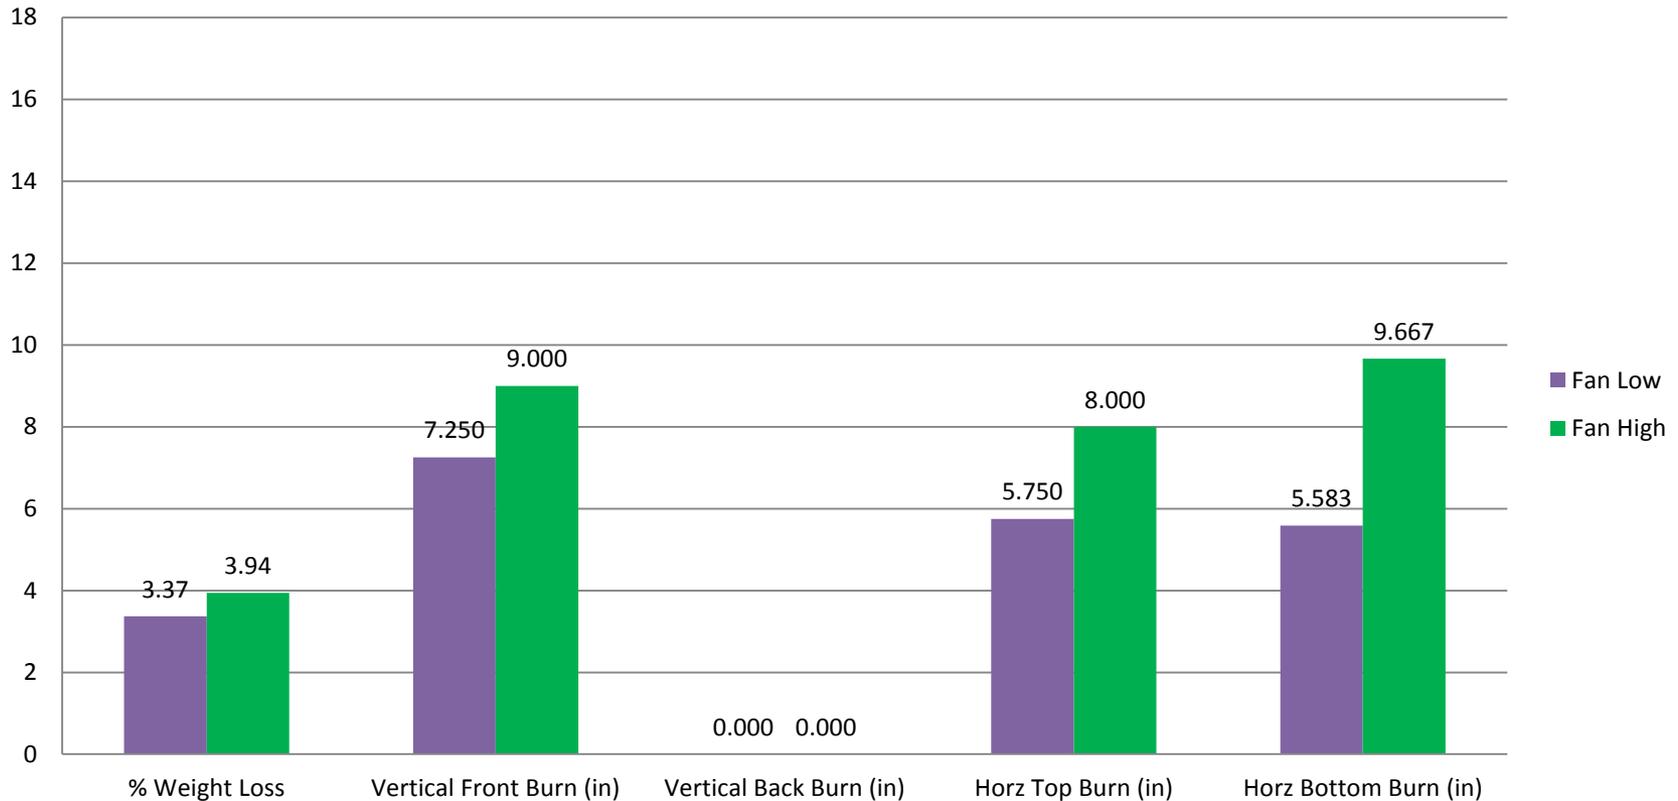
Average Fireblocked Cushion Test Results

Fan Low = ~75 ft/min
Fan High = ~125 ft/min

- **Test results for seat cushion indicate increased weight loss and burn lengths when airflow is increased**
- **Test results for cargo liner indicate decreased temperatures measured 4-inches above the liner sample**
- **These test results suggest ventilation airflow may significantly impact test results for oil burner test methods**

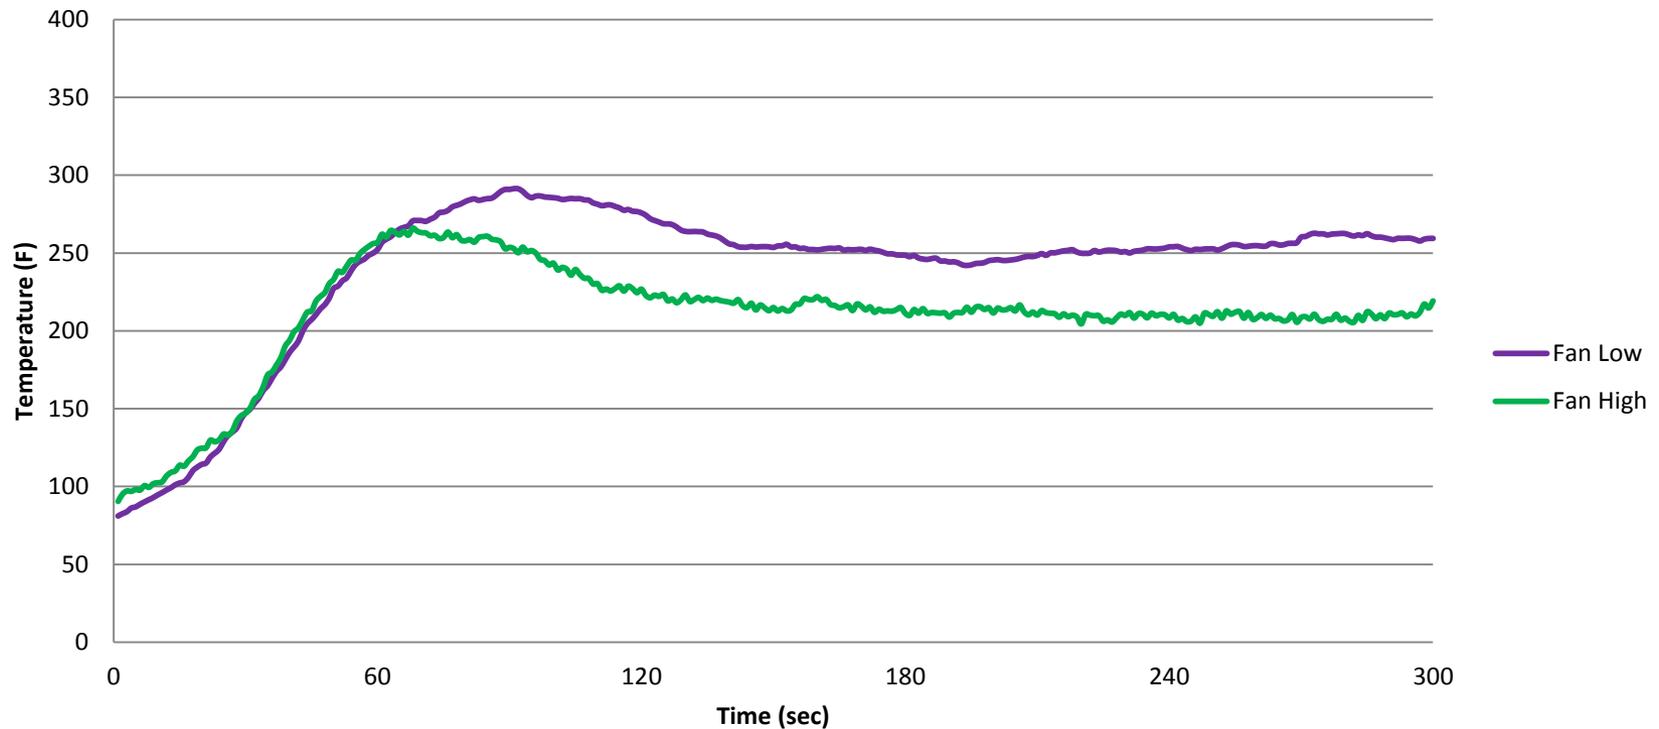
Airflow in the cargo liner test cell has not yet been measured using the hot-wire anemometers

Average Temperature Measured 4-Inches above 0.035" Woven Fiberglass Polyester Reinforced Cargo Liner Samples
