Burnthrough Round Robin

Update

Presented to: IAMFTWG

Date: March 6-7, 2018, Savannah, Georgia

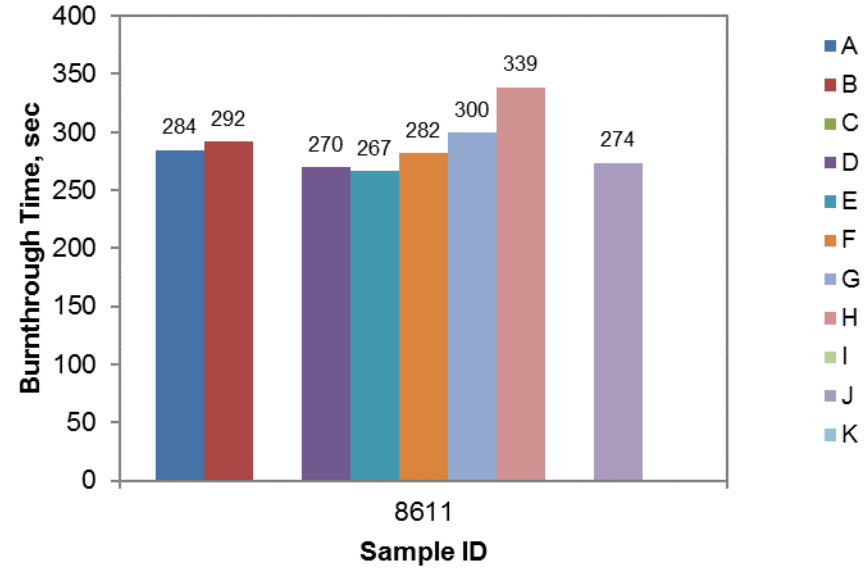
8611 Average Burnthrough Times

Note: Lab H results 325, 325, n/a, 318, 386

- **8 out of 11 labs have submitted results**
- **Data looks good**
 - ~7% Std Dev for 8579
 - ~9% Std Dev for 8611
 - Burnthrough blankets below 2.0 BTU/ft²s during 4-minute test at all labs (depending on slit in back blanket)

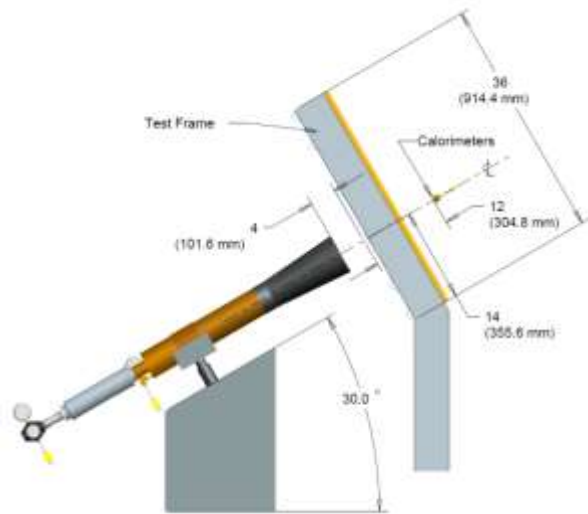
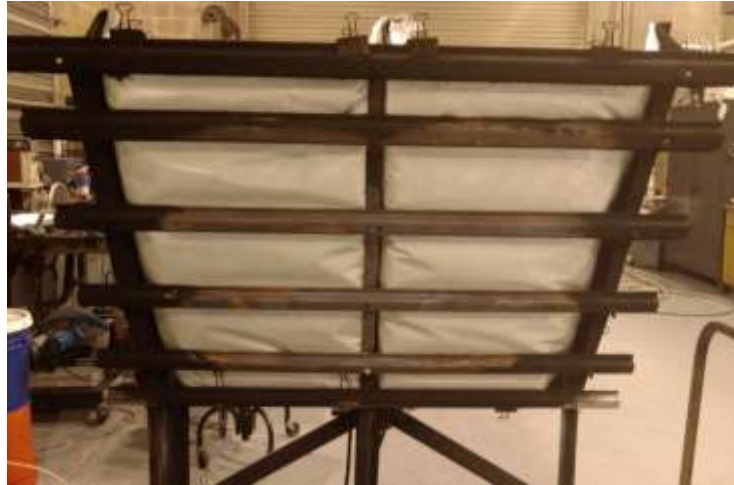
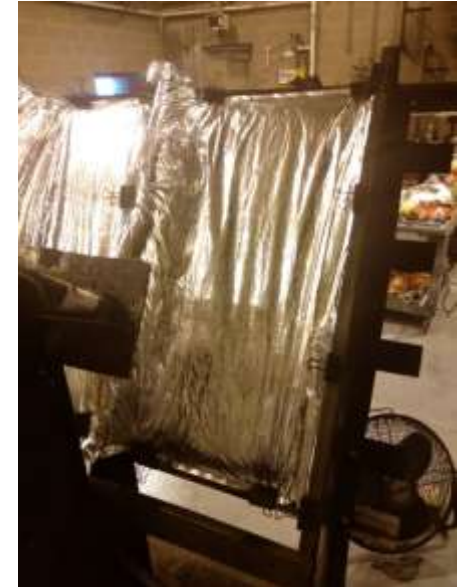
Insulation Blanket Burnthrough Tests

Brook One BO856B-II Thermal Acoustic Insulation Blankets

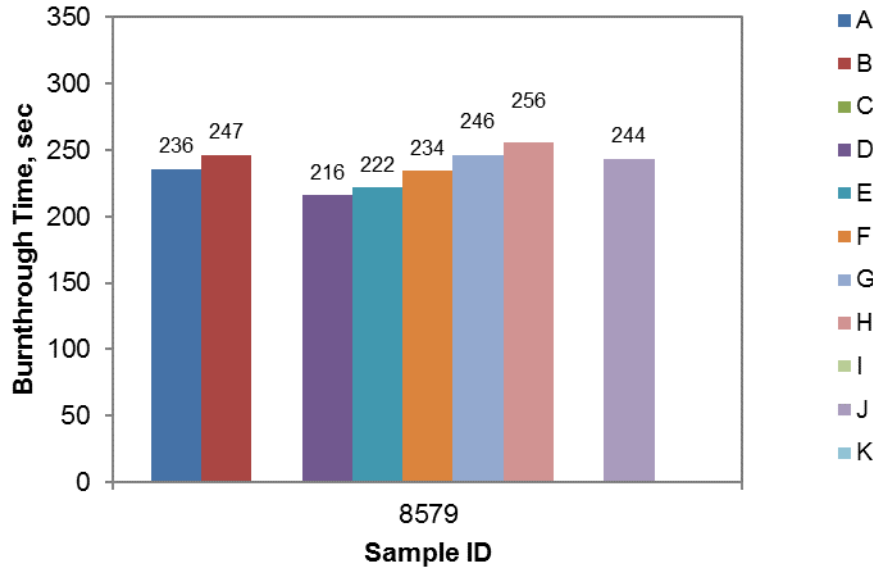
8579 Average Burnthrough Times

Overall Average BT: 237.5 s
 Std Dev: 15.9 s
 % Std Dev: 6.7%

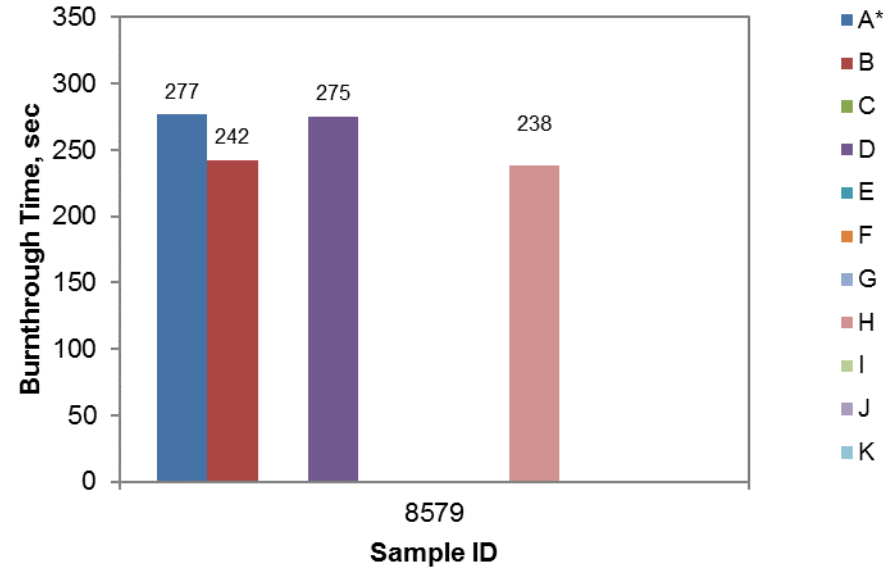
8579 Average Burnthrough Times

Overall Average BT: 256.2 s
 Std Dev: 20.1 s
 % Std Dev: 7.8%

- 4 labs have submitted results
- Some labs don't have necessary equipment (new stator)
- One lab (A*) ran at 60 psig instead of 65 psig by accident
- Comparing Phase 1 & 2 shows that the new configuration is trending towards longer burnthrough times
 - More evident with 8611

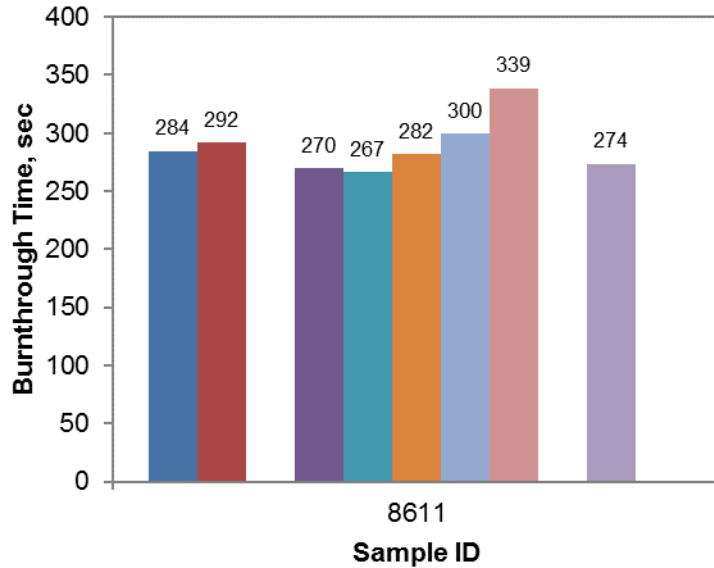
8611 Average Burnthrough Times

Overall Average BT: 287 s
 Std Dev: 25.2 s
 % Std Dev: 8.8%

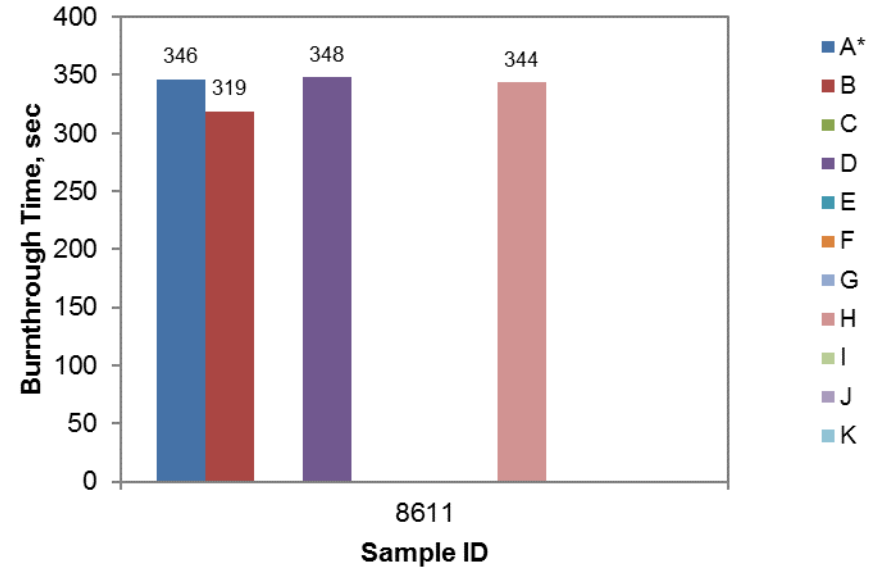
8611 Average Burnthrough Times

Overall Average BT: 337.8 s
 Std Dev: 18.8 s
 % Std Dev: 5.6%
