Report No. NA-68-31
(DS-68-21)

FINAL REPORT

FRICTION EFFECTS OF RUNWAY GROOVES, RUNWAY 18-36 WASHINGTON NATIONAL AIRPORT

DEPARTMENT OF TRANSPORTATION
FEDERAL AVIATION ADMINISTRATION
National Aviation Facilities Experimental Center
Atlantic City, New Jersey 08405

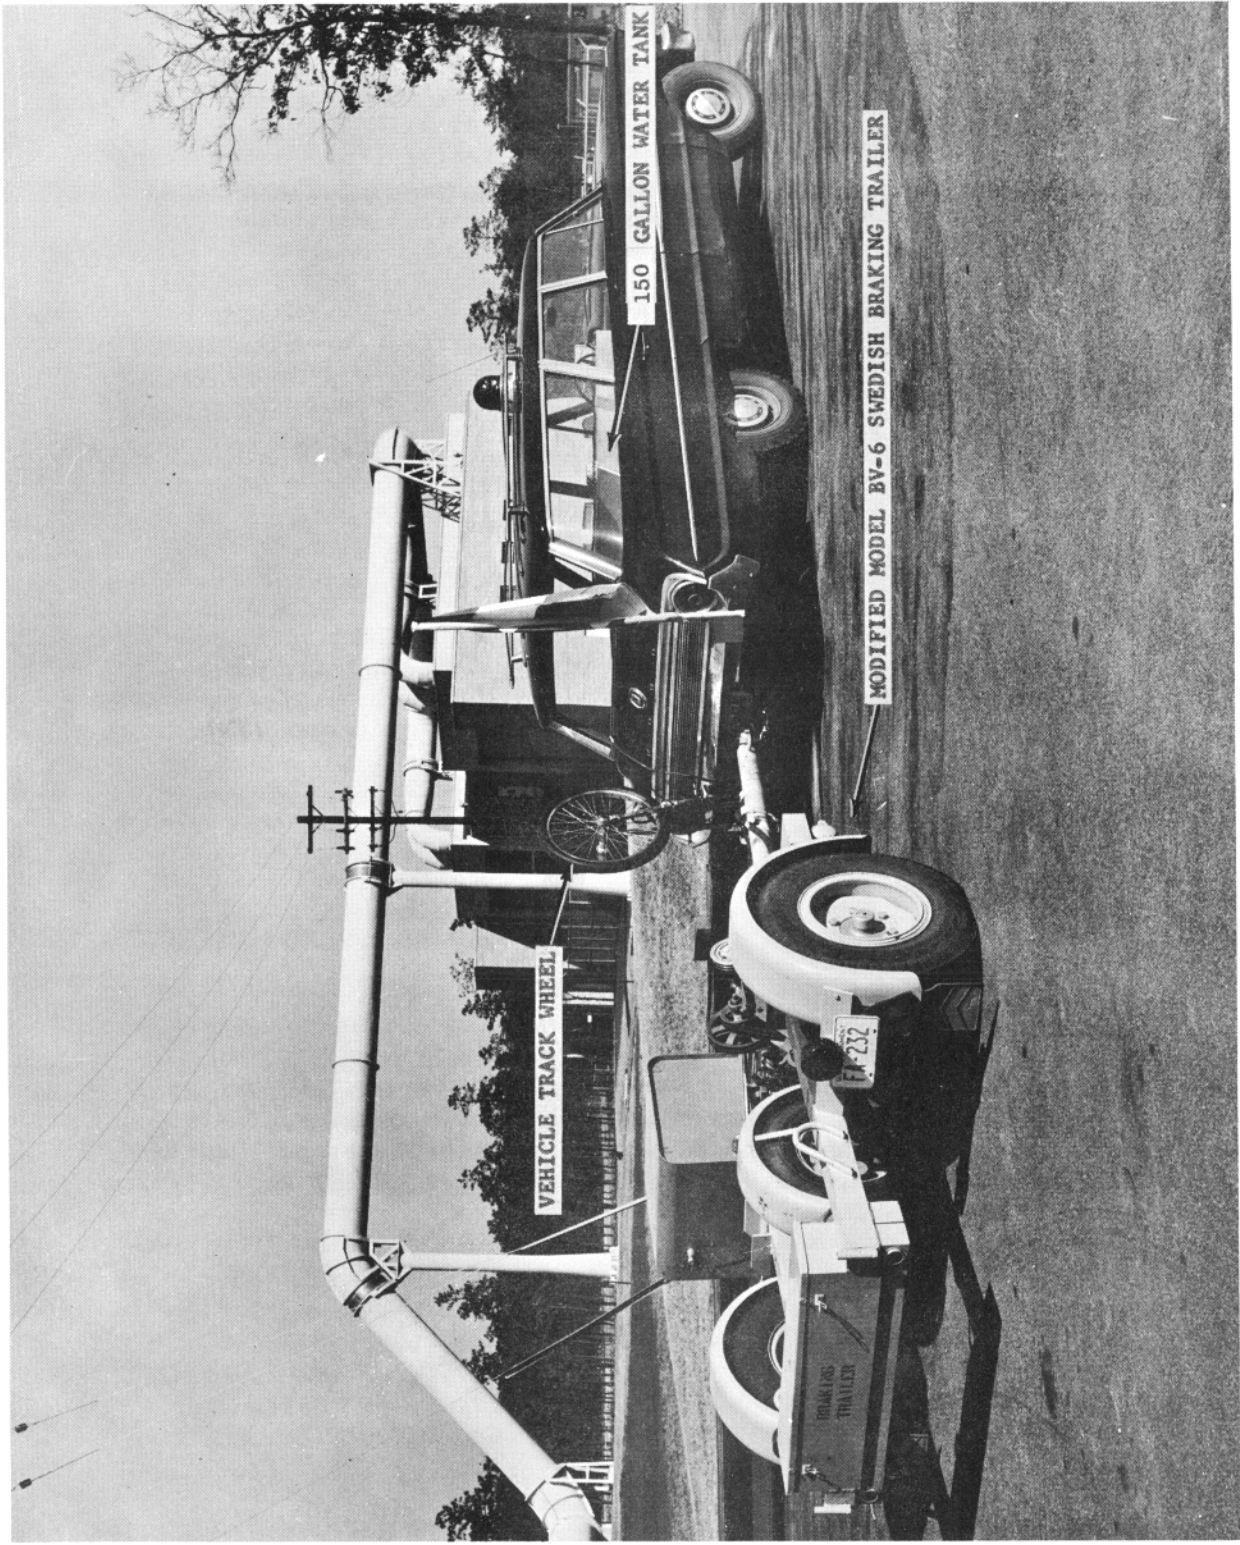
FIG. 1 FAA'S FIXED SLIP RUNWAY FRICTION TESTER AND TOWING VEHICLE

Friction Tester - The equipment used to measure runway friction was the FAA's FSRFT, Figure 1, which is a modified Swedish Skiddometer, Model BV-6. The Skiddometer operates in a fixed slip mode and was originally conceived by the Swedish Road Institute for the purpose of measuring the friction values of snow and ice-covered runways. This friction tester utilizes the standard automotive test tire and loading, specified by the American Society of Testing Material (ASTM) for friction testing.

This tester was used in a different manner than that prescribed by the Swedish Road Institute; namely, to measure friction of wet and dry runway surfaces. To accomplish this, the project engineering personnel designed and installed a special water dispensing system, Figure 2. This design incorporated a belt-driven constant displacement water pump coupled to the axle of the FSRFT. The output of the pump varies directly with speed, thereby providing a constant water thickness independent of vehicle speed. A water thickness of approximately .020 inch was obtained, meeting the ASTM Specification E-274

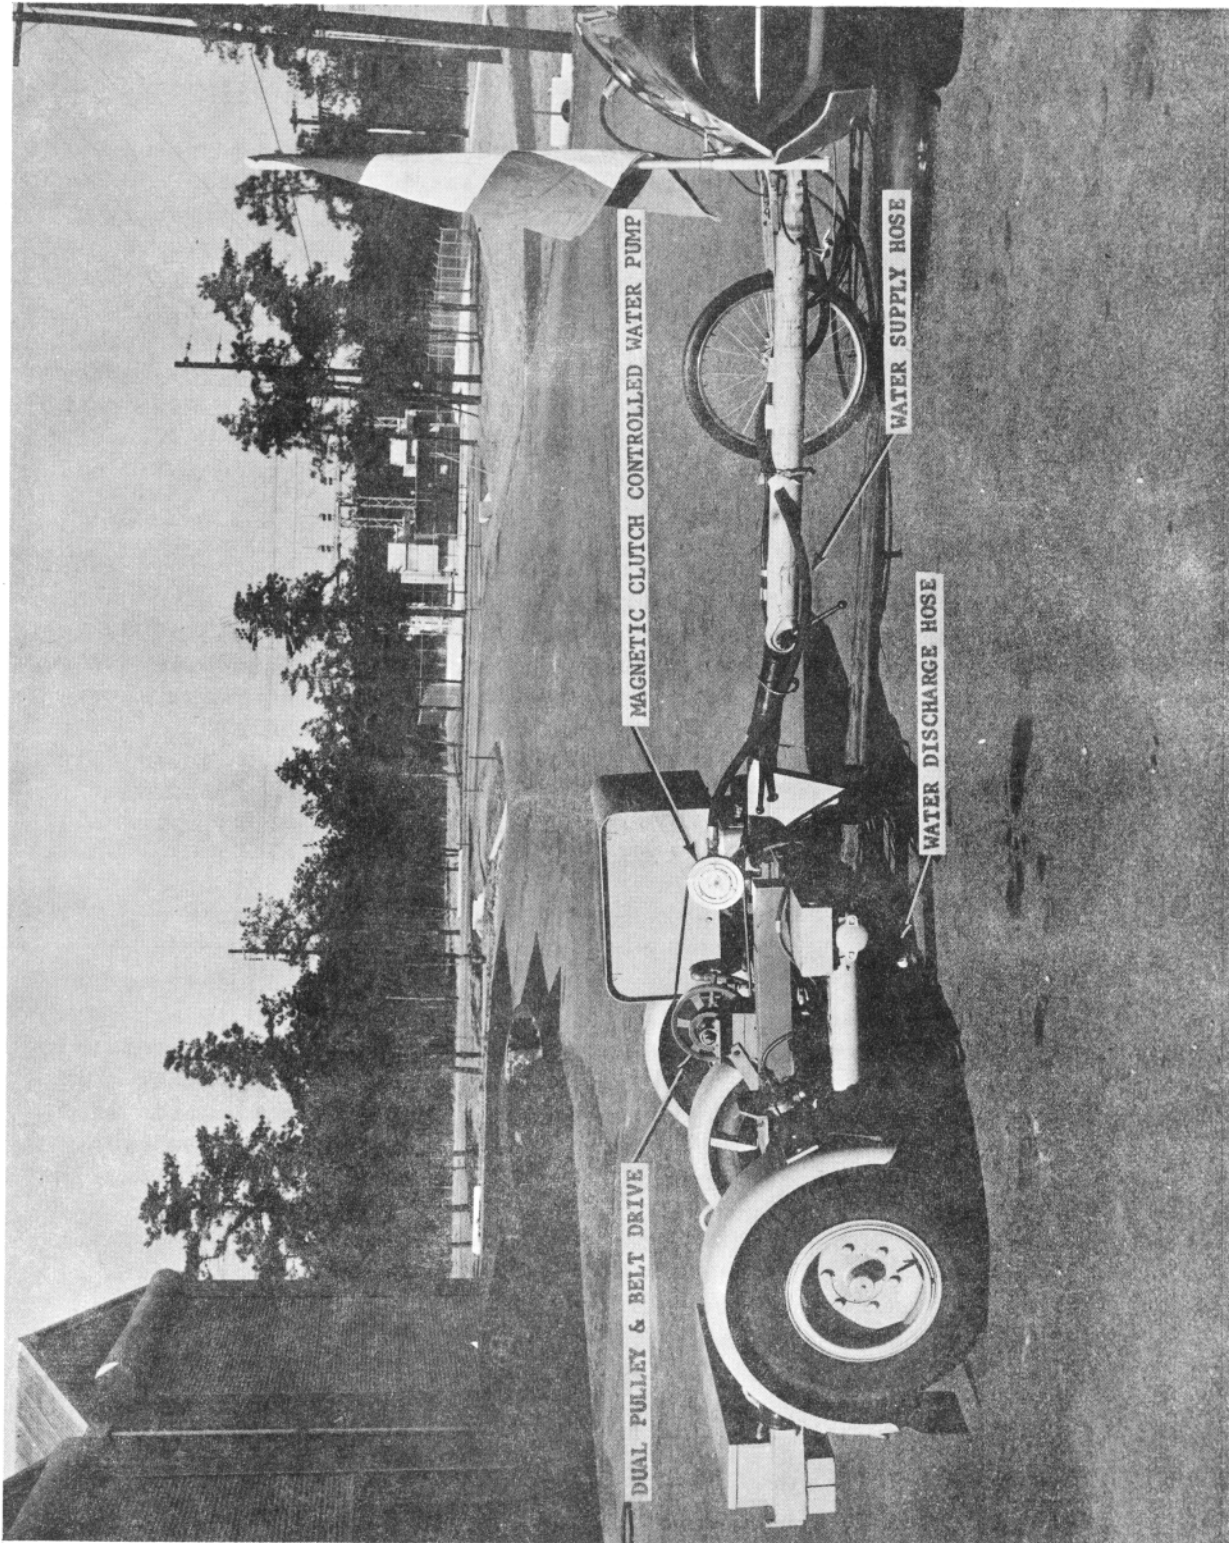
FIG. 2 WATER DISPENSING SYSTEM

which states that a water depth of $.020 \pm .005$ inch be used when measuring wet pavement friction. The pump is operated by means of a magnetic clutch, powered and controlled from the tow vehicle. During friction measuring operations, the magnetic clutches of the three-wheel axle are engaged (locked) thus forcing the test wheel to rotate with the same angular speed as the two outer wheels. Since the diameter of the test tire is smaller than the diameter of the outer tires, the peripheral speed of the test tire becomes less than that of the outer tires. Thus, the design causes the test tire to be retarded, generating a tire/pavement slipping action. This action produces a constant slip ratio of approximately 13 percent. The torque of the test wheel, generated by friction forces between the test tire and pavement, is measured by a strain gage force transducer.

The water dispensing system and friction recording system are separately and remotely controlled by the operator in the tow vehicle enabling, first, dry testing, followed by wet testing over the same path. When the water dispensing system is activated, a water film approximately .020-inch thick is deposited on the pavement surface 18 inches ahead of the test tire, thus providing conditions for wet testing.

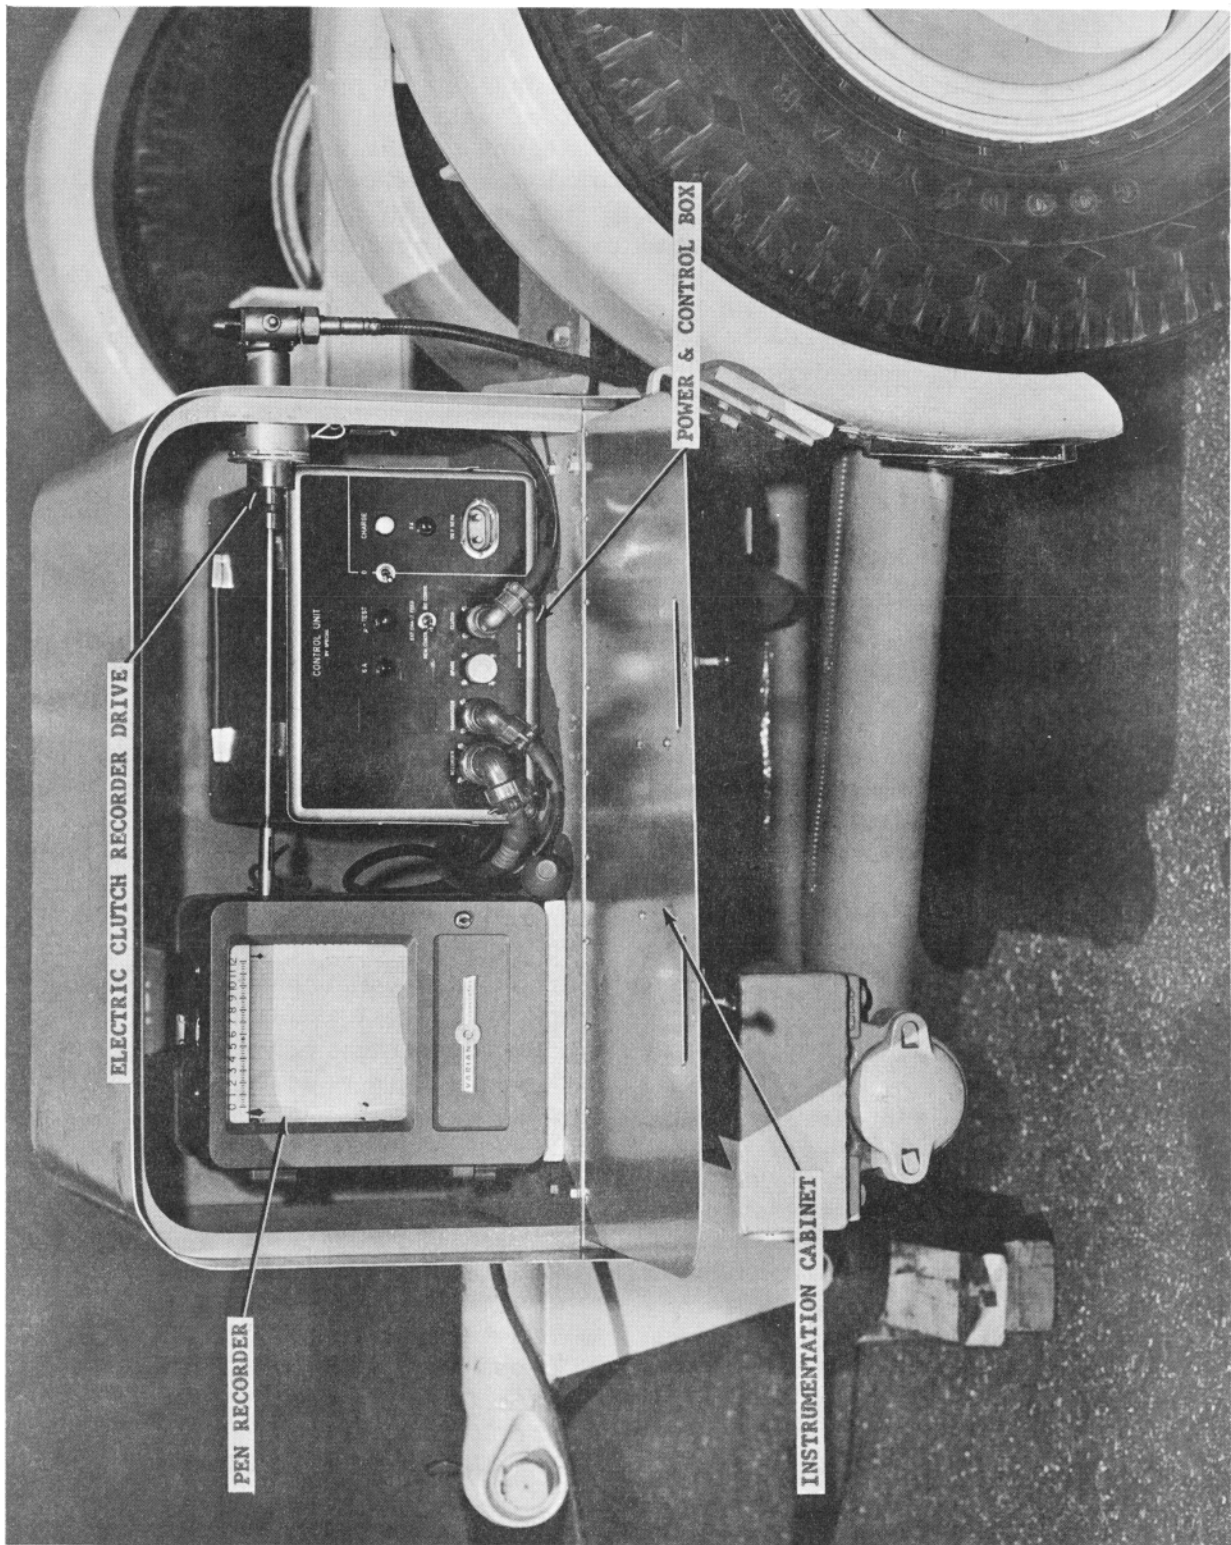
FIG. 3 INSTRUMENTATION CABINET AND RECORDER

Instrumentation - The friction forces exerted on the test wheel are registered by a pen recorder, Figure 3. The recorder and associated electrical equipments are located in an instrument cabinet mounted on the frame of the trailer. The readout on the chart paper is traced in analog format and the displacement of the pen provides a numerical value known as "Brake Friction Number" (BFN_{13}). This value is the measured coefficient of friction times 100, obtained by testing in the brake slip mode at 13 percent slip. The recorder has a combination electric chart paper drive which is used during calibration, and a mechanical external chart paper drive for recording friction.

The mechanical drive consists of a flexible cable connected to the left outer trailer wheel. This arrangement produces chart paper lengths proportional to the distance tested - independent of test speed. Each distance subdivision of chart paper length is equal to approximately $77 \frac{2}{3}$ feet of runway distance and each friction subdivision represents an uncorrected BFN_{13} value of 1, full scale representing a BFN_{13} value of 120. The recorder is also equipped with an electric timer which provides a pip at 1-second intervals. This pip is recorded by a pen on the margin of the chart paper. The distance between pips facilitates verifying the speed of the tester.

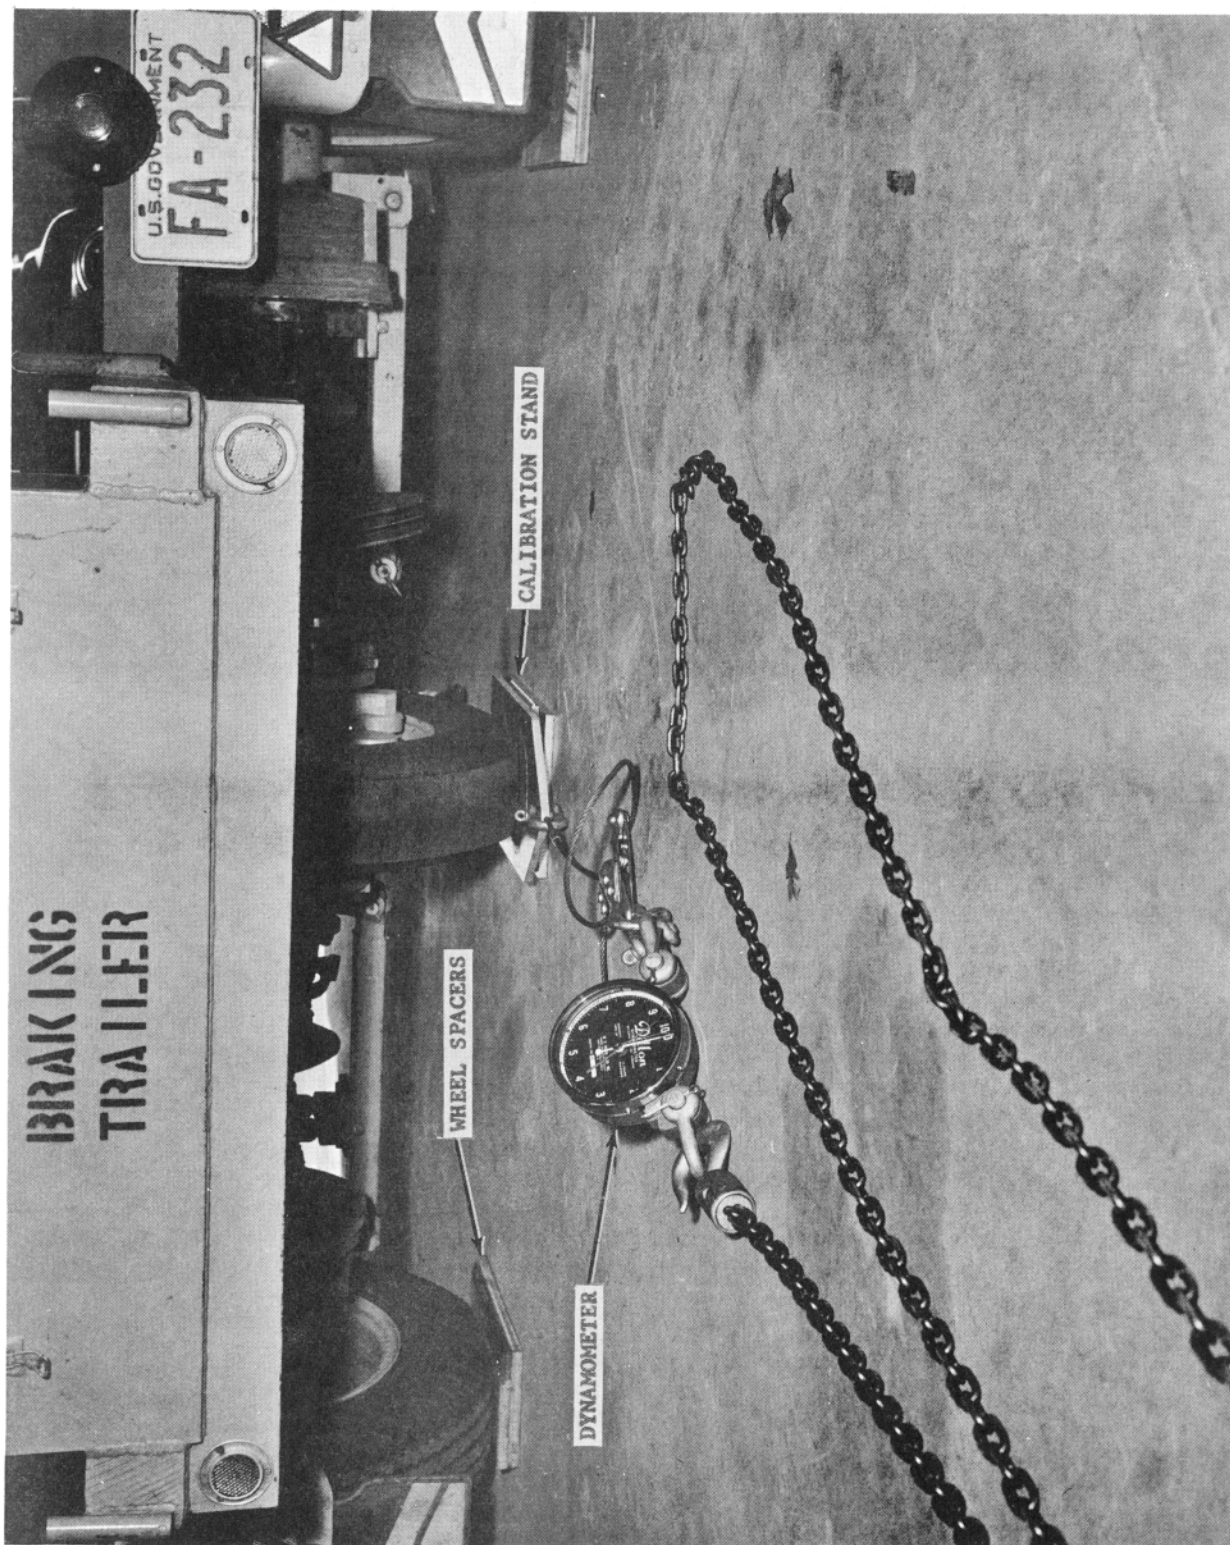
FIG. 4 CALIBRATION EQUIPMENT

Calibration - Prior to each series of test runs, the FSRFT was calibrated, Figure 4. This calibration was accomplished by applying known horizontal loads to the platform of the calibration stand. The horizontal forces are transmitted to the contact area of the tire resting on the platform. The dynamometer reading was related to the displacement of the recorder pen which recorded the uncorrected coefficient of friction (BFN). Repeated calibrations provided information from which system accuracy and/or deterioration would be observed.

The analysis of the calibration records made prior to each series of tests and past records indicate that this tester produces calibration results of less than ± 3 percent deviation.

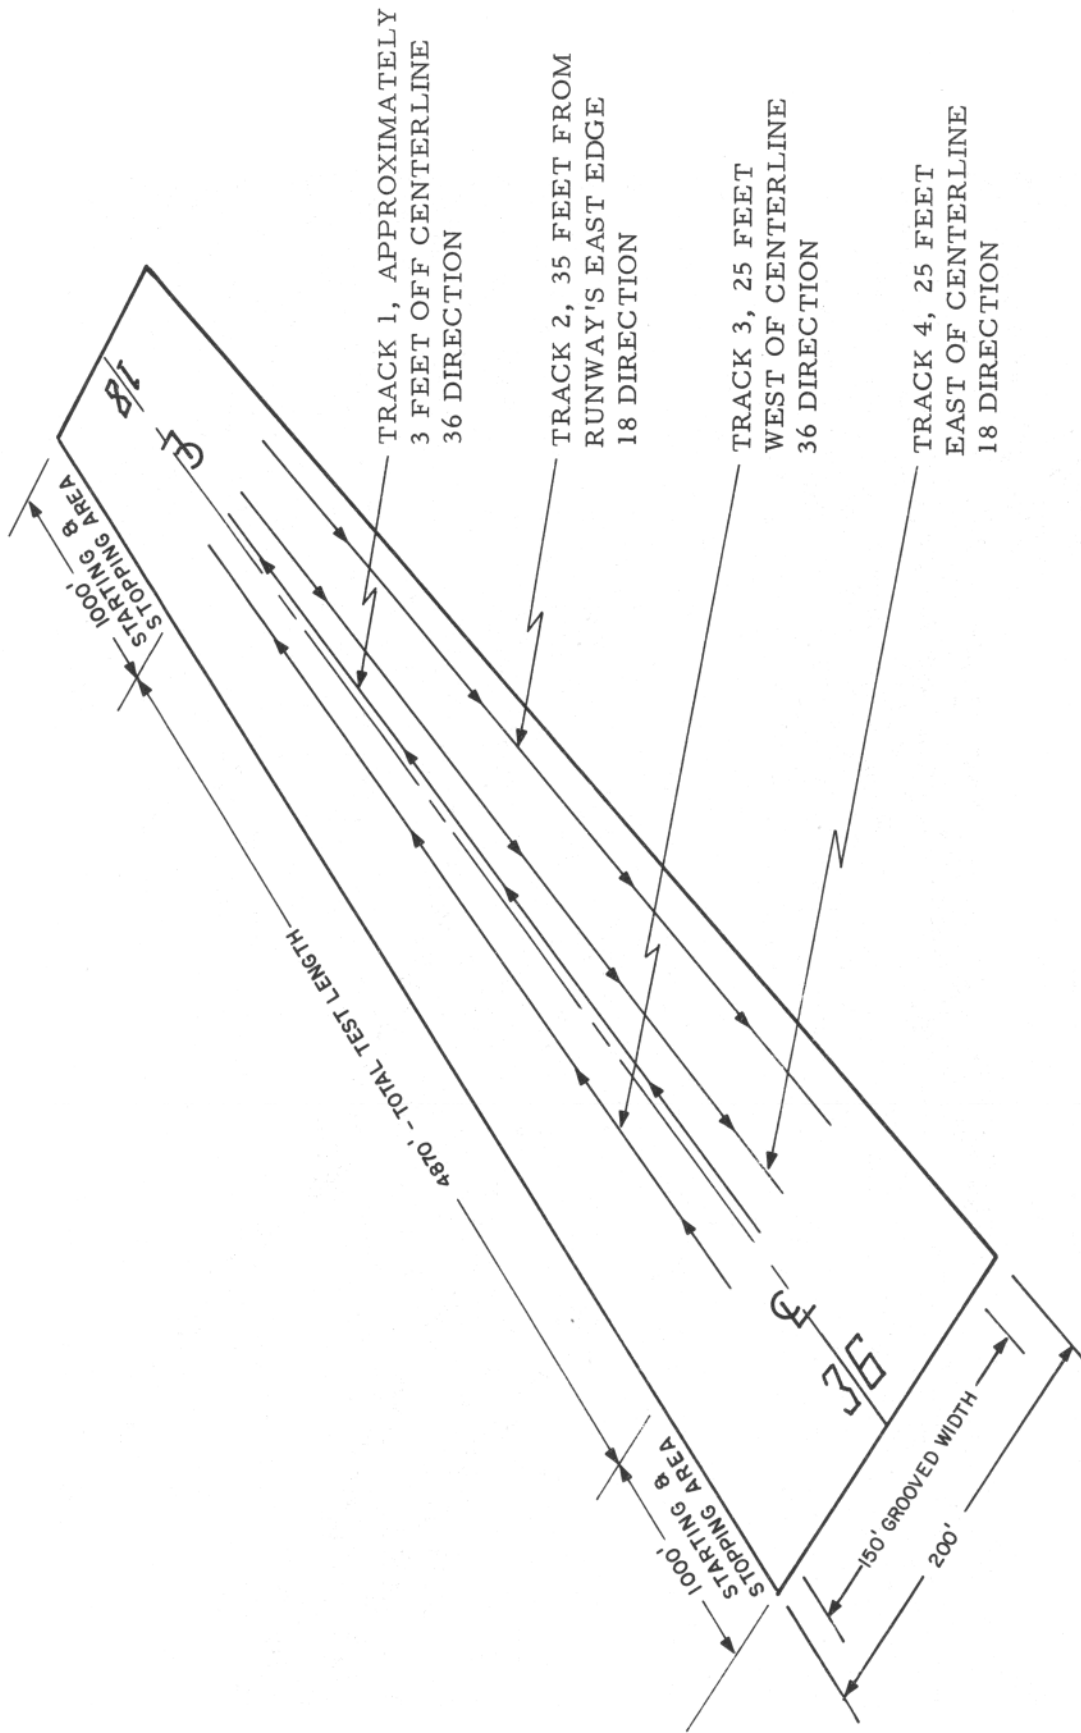
FIG. 5 RUNWAY 18-36 TEST TRACK CONFIGURATION

Runway Pattern and Nomenclature - The test pattern used on the 6870-foot runway consisted of four test tracks or paths shown in Figure 5. One thousand feet at each end of the runway were reserved for accelerating and stopping; the remaining 4870 feet were friction-tested. Track No. 1 is located 3 feet east of the runway centerline, to clear centerline paint marks, and all runs on Track No. 1 were made in the 36 or north direction. Track No. 2 is located 35 feet from the east edge of the runway, and tests on this track were conducted in the 18 or southerly direction. Test runs on Track No. 3 were conducted in the 36 direction, 75 feet from the west edge of the runway (25 feet west of the centerline), while tests on Track No. 4 were made in the 18 direction and 75 feet from the east edge of the runway (25 feet east of centerline). Tracks Nos. 1, 3, and 4 provided data of the most contaminated portion of the runway, while Track No. 2 (runway edge) provided data on the least contaminated portion of the runway. This test design allows a comparison to be made between the rubber-contaminated (touchdown and rollout area) portions of the runway and the relatively uncontaminated portion along the runway edge.

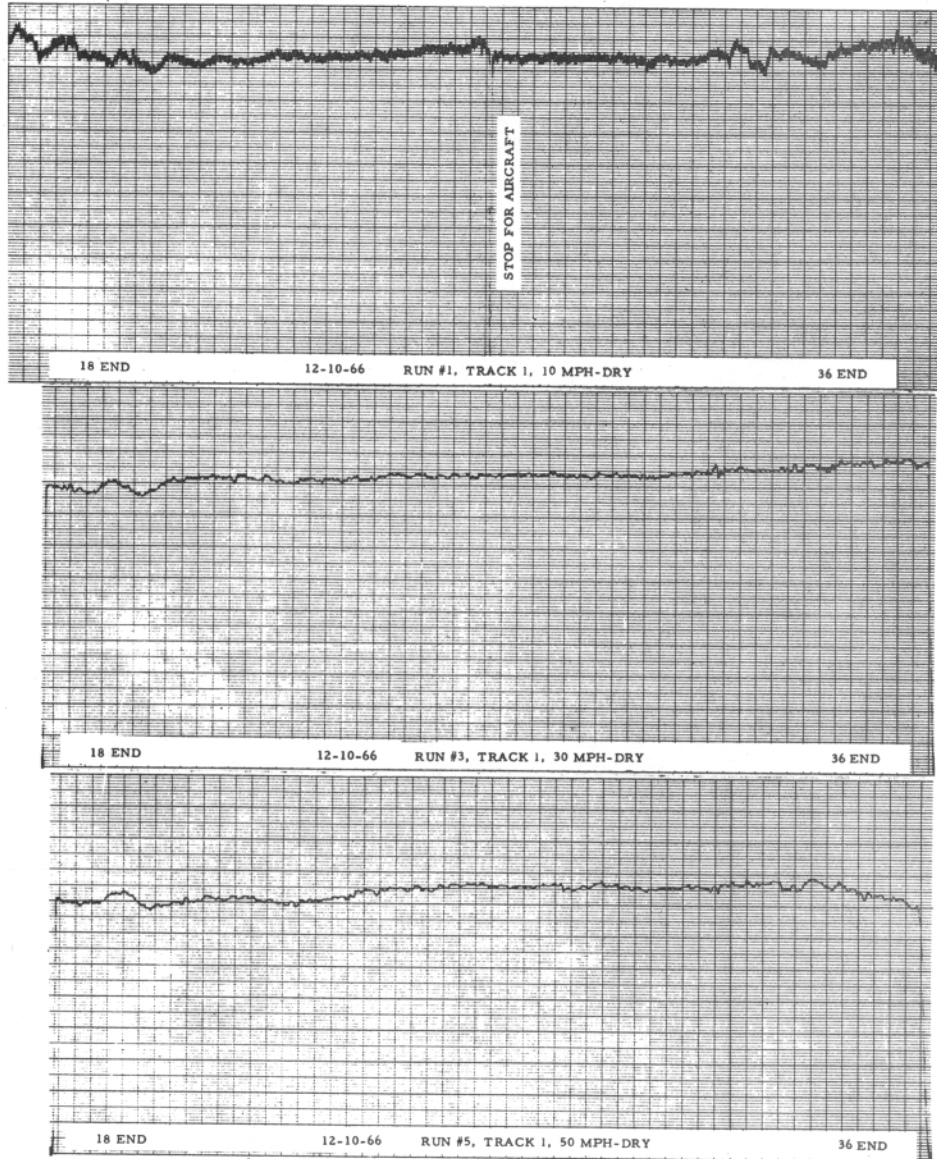
BEFORE GROOVING - TRACK 1, CENTERLINE
DRY TESTS

Track 1 (centerline) - There is no significant change either in BFN_{13} or curve shape for the dry tests, pages 1-1, and 1-2. In the wet test configuration, however, pages 1-3 and 1-4, there is noticeable and measurable differences in the BFN_{13} values, favoring the after-grooving condition. The BFN_{13} values are generally increased and the overall analog traces are markedly smoother.

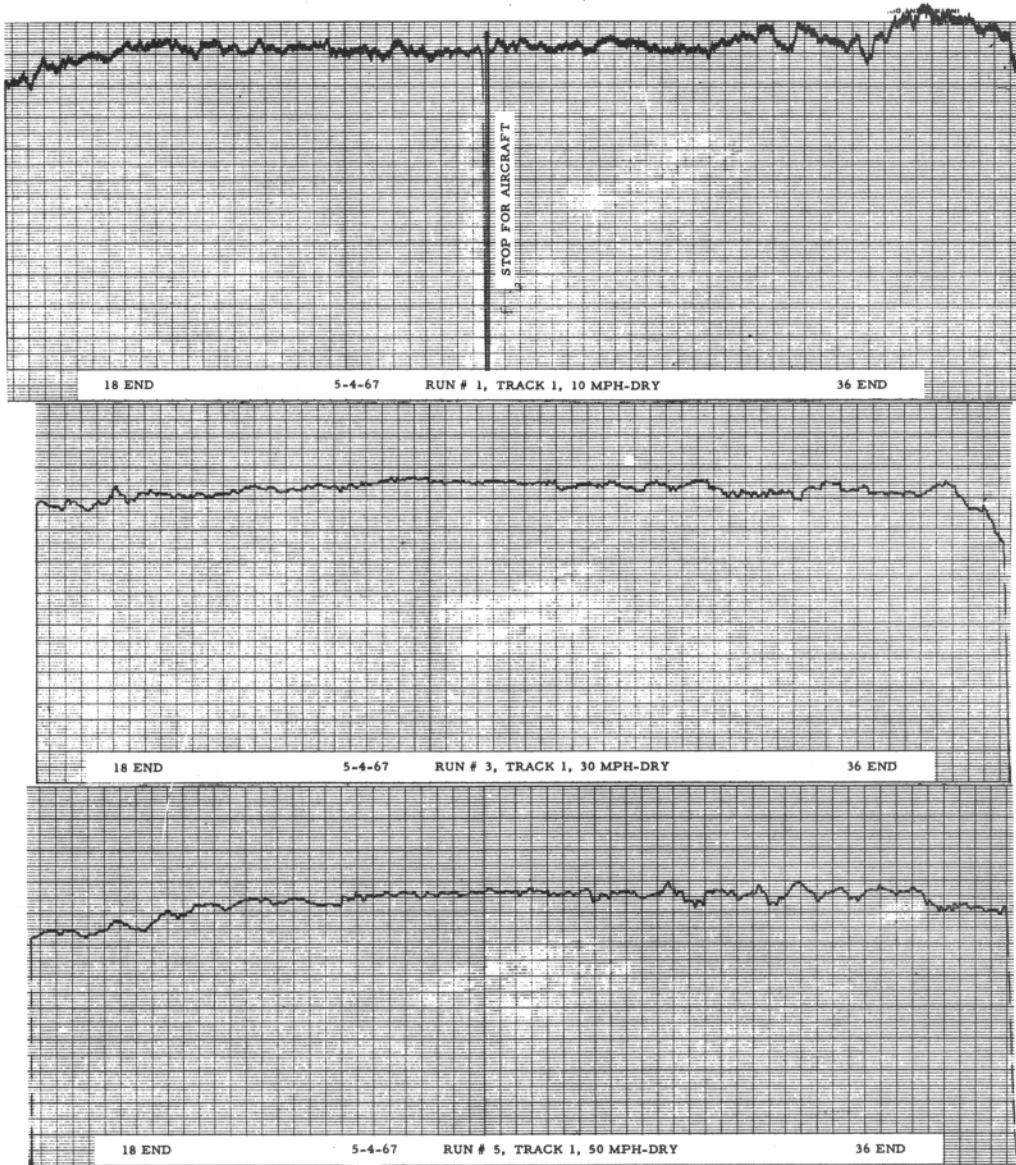
AFTER GROOVING - TRACK 1, CENTERLINE
 DRY TESTS

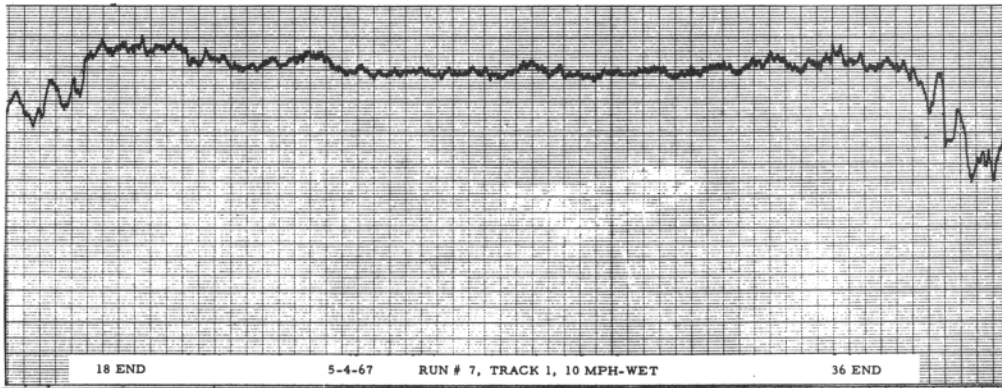
AFTER GROOVING - TRACK 1, CENTERLINE
WET TESTS

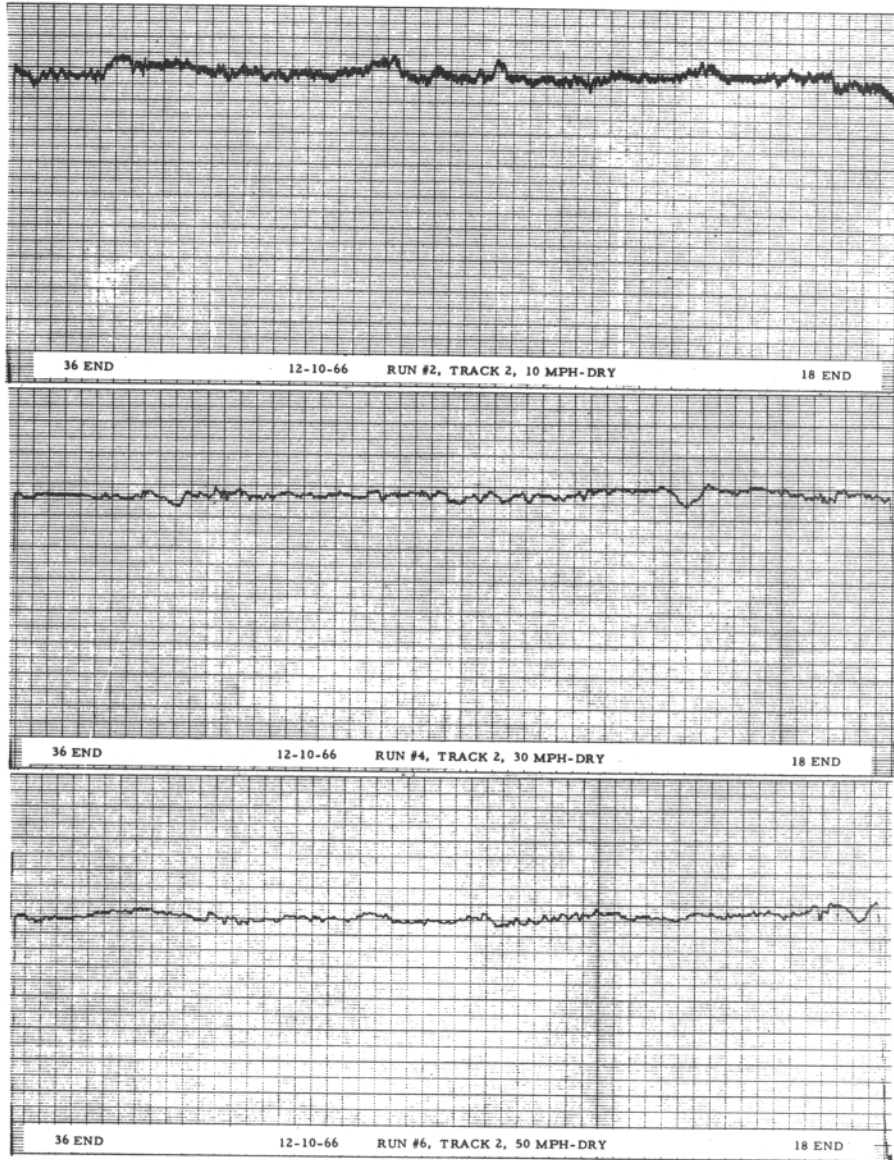
BEFORE GROOVING - TRACK 2, EAST RUNWAY EDGE
DRY TESTS

Track 2 (runway edge) - Since this track is near the edge of the runway and relatively free of rubber deposits and the polishing action of traffic, it would be expected that any friction value changes would be caused mainly by the grooves. The rough trace of the 10 mph after-grooving dry test is unexplainable; otherwise, the dry tests are almost identical before and after grooving, pages 1-5 and 1-6. In the wet tests, pages 1-7 and 1-8, the before- and after-grooving traces of the 10- and 60-mph tests are very similar, whereas a definite

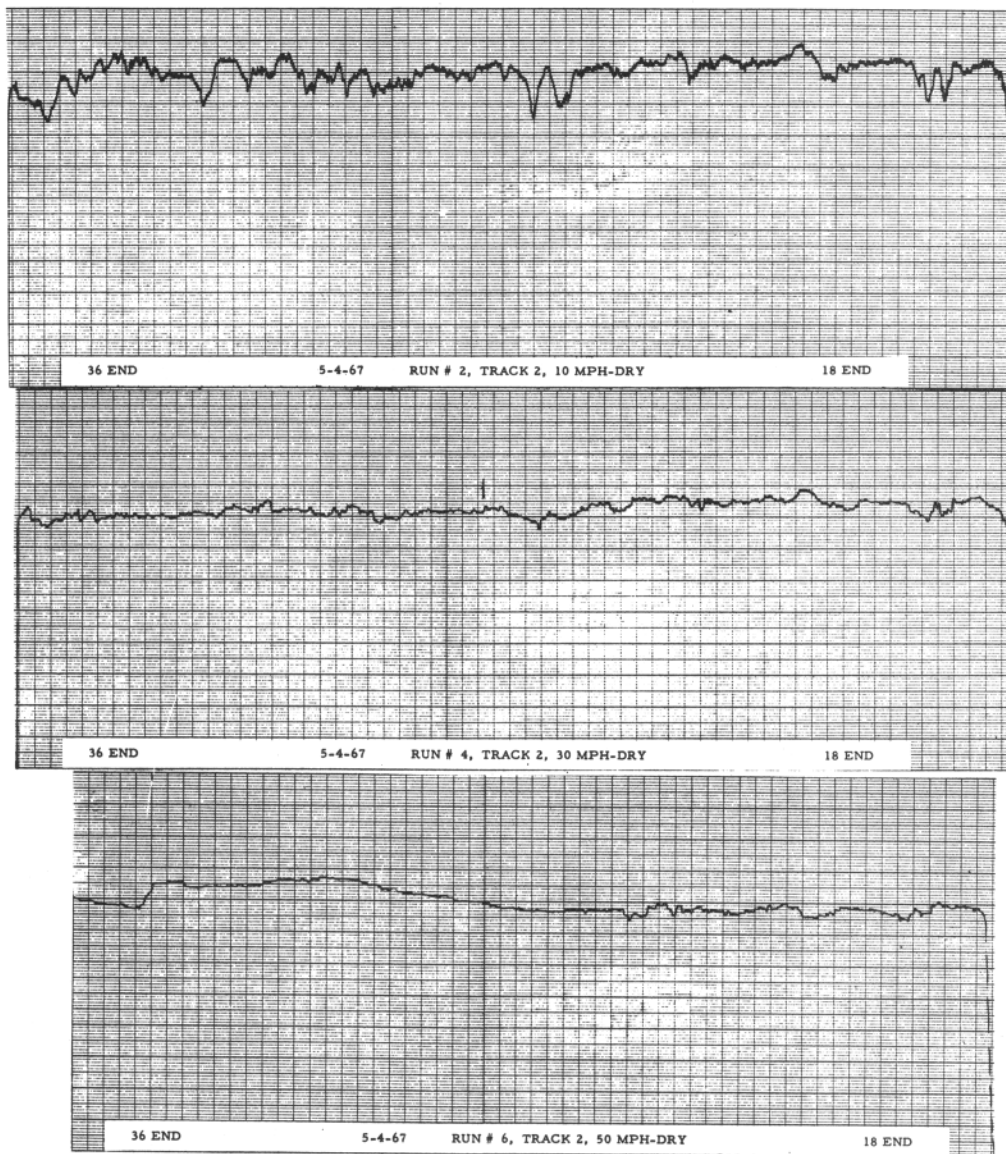
AFTER GROOVING - TRACK 2, EAST RUNWAY EDGE
DRY TESTS

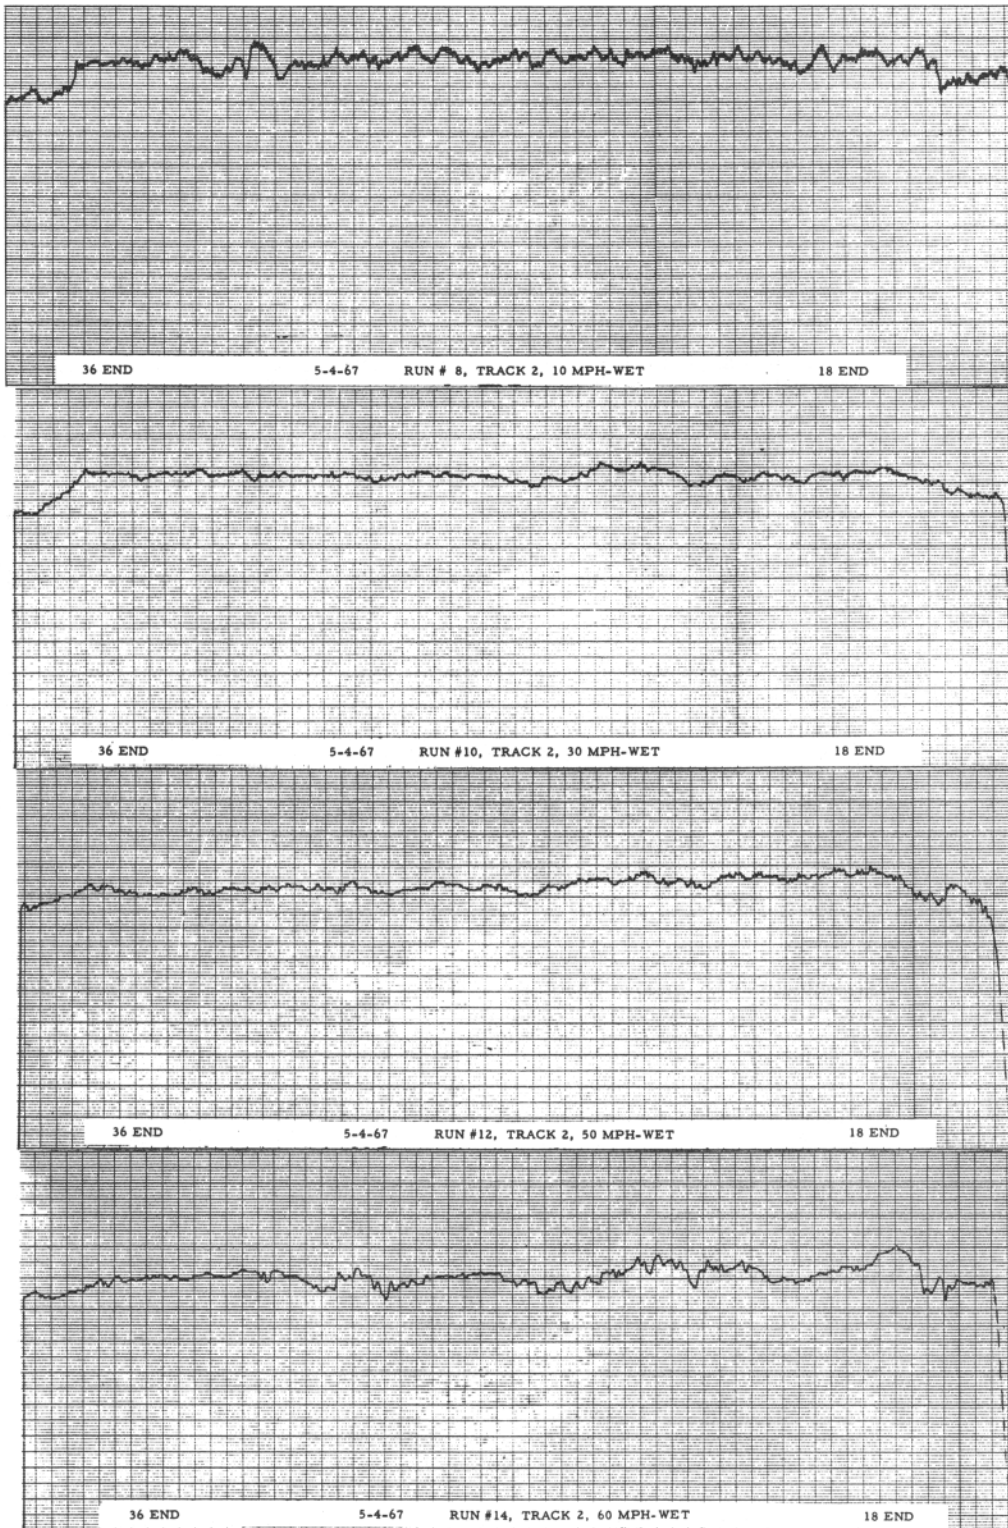
AFTER GROOVING - TRACK 2, EAST RUNWAY EDGE
WET TESTS

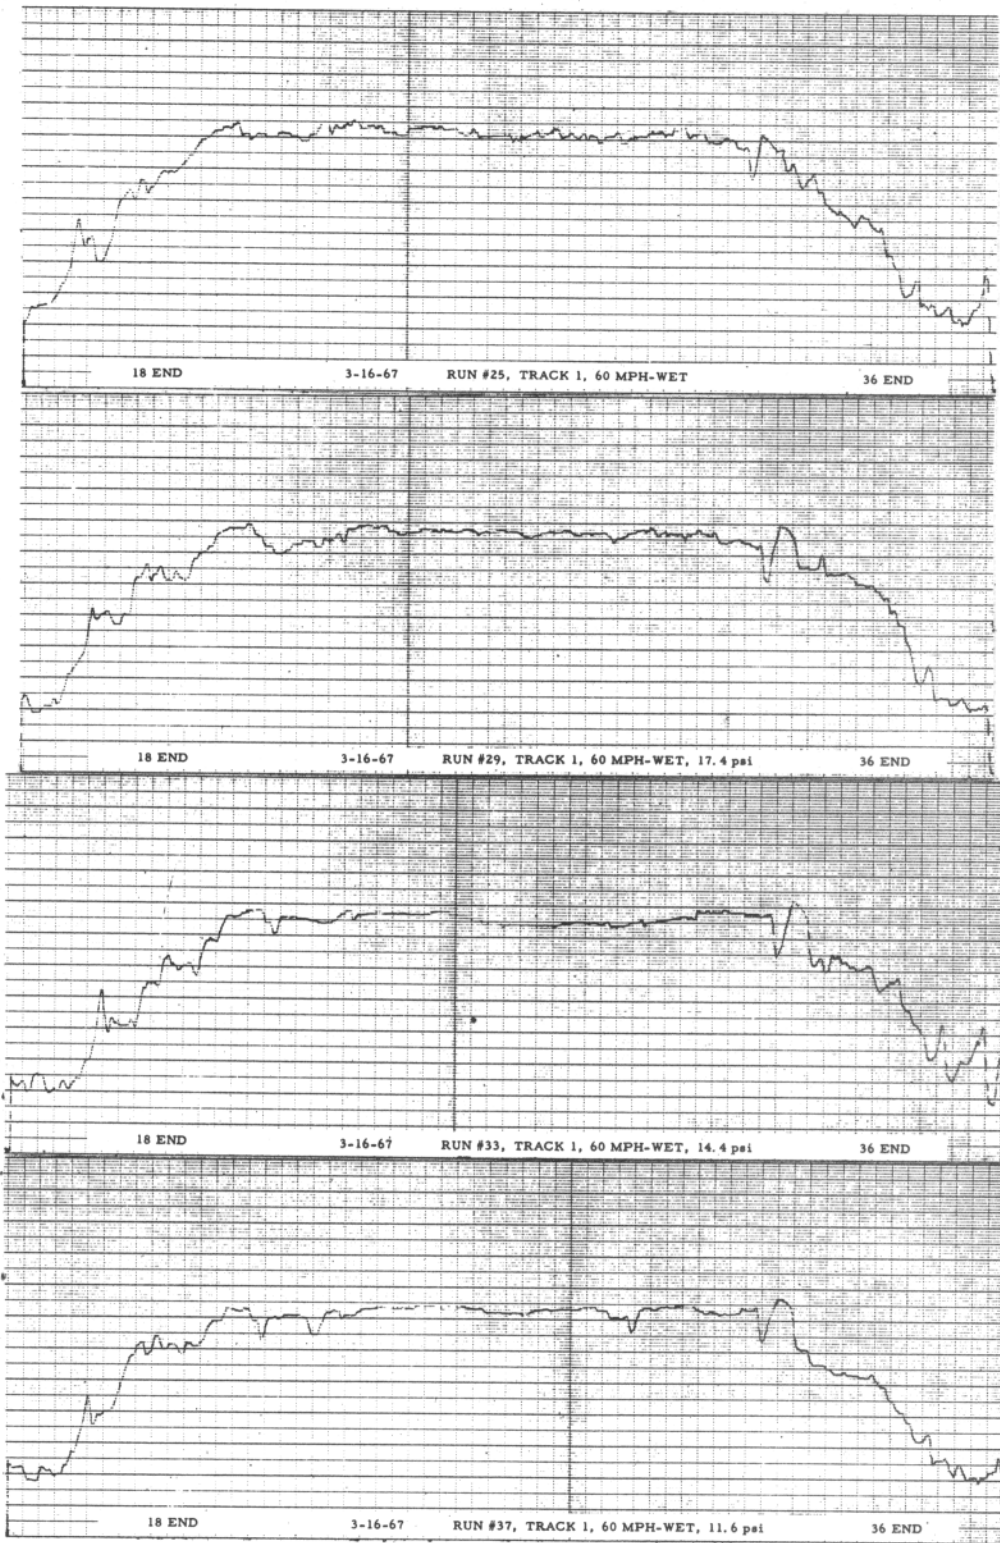
BEFORE GROOVING - TRACK 1, CENTERLINE
WET TESTS

It will be noted from the oscillograph records in Appendix IV that the friction force traces did not indicate low friction values associated with hydroplaning either before or after grooving. The analog curves are very similar both in shape and magnitude for the various tire pressures, and if hydroplaning or partial hydroplaning had occurred, lower BFN_{13} values would have been recorded. Decreasing tire pressure or increasing speed are the only two factors governing hydroplaning that could be readily controlled during the tests. There are other important factors, however, which govern hydroplaning and which have to be taken into consideration; such as, ample water depth and surface drainage. After the first attempt to achieve hydroplaning by lowering tire pressure failed (February 3, 1967), it was indicated by the data that sufficient water depth was not present. The output of the water dispensing system was then approximately doubled by changing pump drive pulleys. This small increase in water depth, however, still did not provide any evidence of hydroplaning.

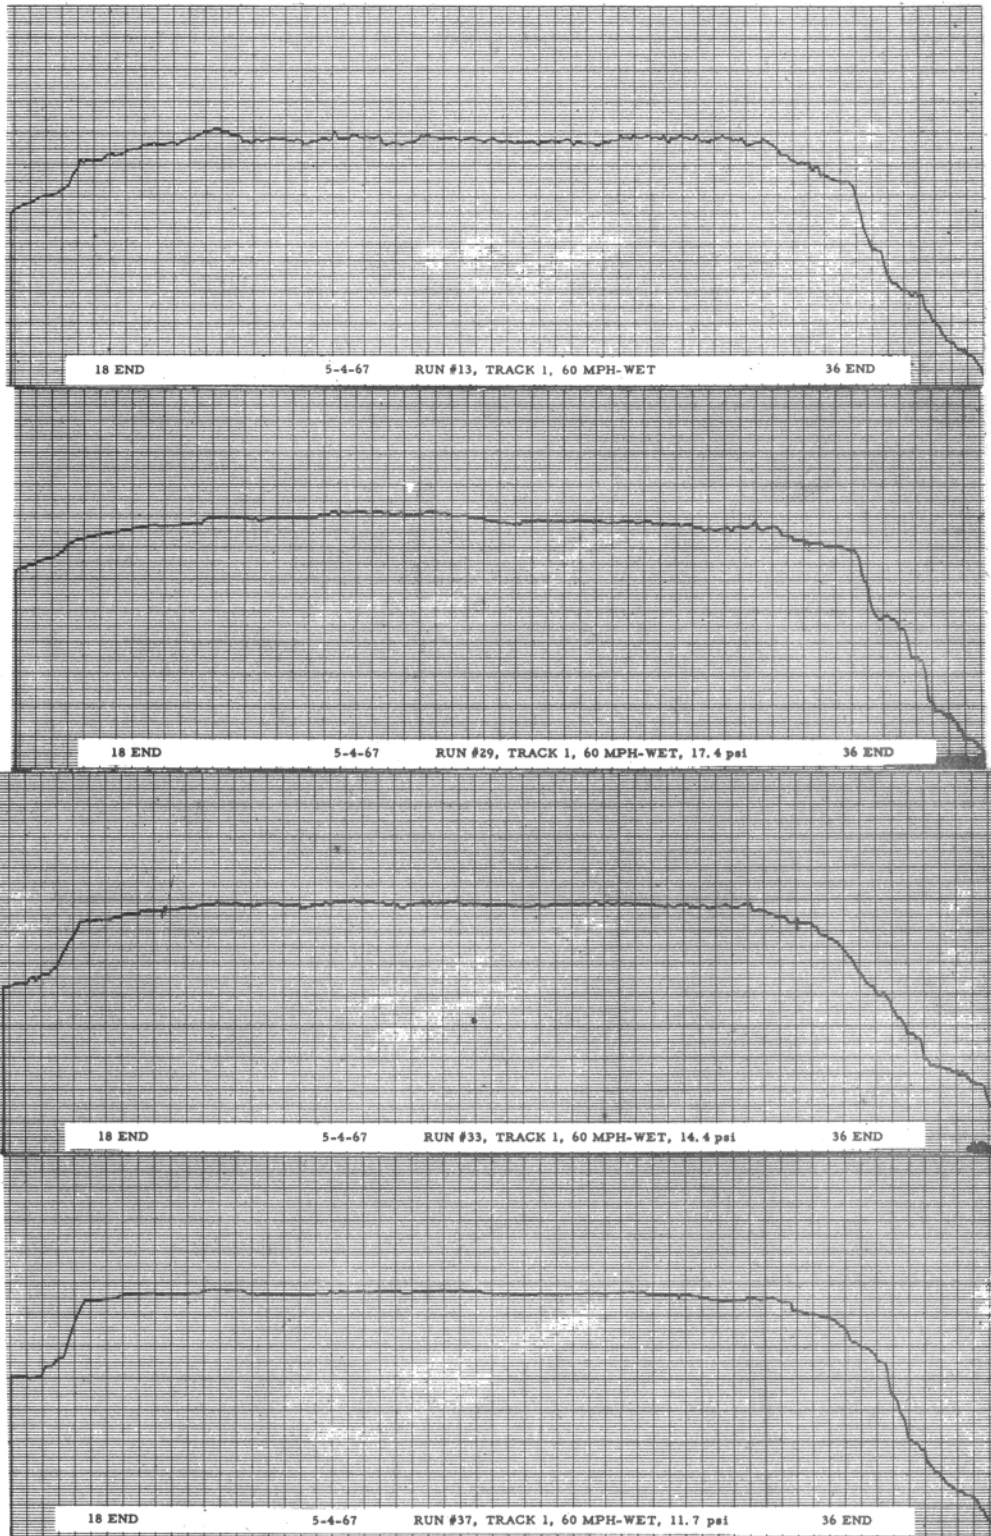
AFTER GROOVING - TRACK 1, CENTERLINE
WET TESTS
