Report No. RD-65-50

**FINAL REPORT**

**POST-CRASH FIRE-FIGHTING STUDIES  
ON  
TRANSPORT CATEGORY AIRCRAFT**

**FEDERAL AVIATION AGENCY**  
Systems Research & Development Service  
Atlantic City, New Jersey

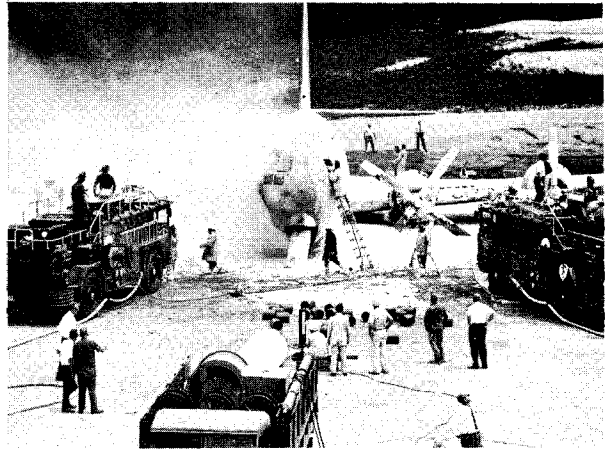
FIG. 4 BURN SCENES FROM TEST 3B

t = 58 SEC.

t = 150 SEC.

t = 200 SEC.

t = 565 SEC.

POST BURN SCENE

INTERIOR SCENE  
STA. 1010

Post-fire examination of the C-97 used in Test 3B presented the following results. First, the fuselage skin was in very good condition, indicating an effective job of maintaining fuselage integrity by the crash crew. Upon entering the forward area of the passenger compartment, the first impression was that there had been no serious thermal environment inside the C-97. However, upon further and closer examination, it was observed that the vinyl covering of the fiberglass insulation had partially burned between Fuselage Stations 710 and 1166 (Fig. 4, Appendix 2). The more pronounced burning took place near the emergency hatches and simulated rear exit doors on both sides of the fuselage. Analysis of the globe calorimeter plots indicate that ignition of the vinyl was caused by radiant heat passing through the rear emergency hatch on the left side of the fuselage (The radiant heat intensity is directly proportional to the slope of the globe temperature plots). This suggests a need for more suitable interior materials for passenger cabins.

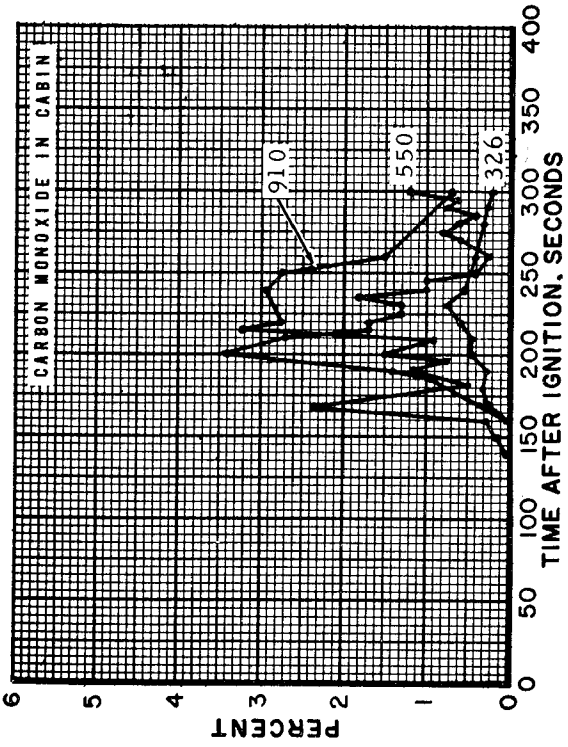
FIG. 5 CARBON MONOXIDE CONCENTRATIONS RECORDED IN THE C-97 FUSELAGE CABIN; TESTS 1, 2, 3A AND 3B

FIG. 5A TEST 1 DATA

FIG. 5B TEST 2 DATA

FIG. 5C TEST 3A DATA

FIG. 5D TEST 3B DATA

NOTE: GRAPHS IDENTIFIED BY FUSELAGE STATION NUMBERS

Of the three human tolerance parameters used in the determination of escape time, unbearable pain due to heat exposure proved to be the controlling parameter in all tests except Test 2B (air temperature of 390°F yielded the shortest time for 2B). Carbon monoxide was found not to be a principal factor in limiting escape on any test (Fig. 5, Appendix 3). No measurable carbon monoxide concentration was recorded during Tests 2B and 3, and the gas analyzer equipment was inoperative during Test 4.

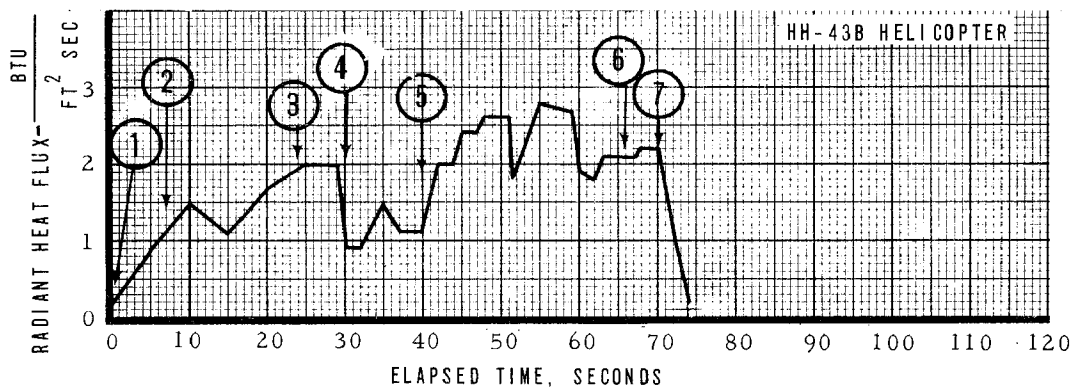
FIG. 6 RADIANT HEAT INCIDENT UPON FIREMAN STANDING ON UPWIND SIDE OF A FIRE, WITH AND WITHOUT HELICOPTER DOWNWASH

1. Fireman holding radiometer approaches fire at a distance of about 40 feet.
2. Fireman standing fixed next to fire at about 3-foot distance.
3. Helicopter approaching (200-yard distance).
4. Helicopter approaching (35-yard distance).
5. Fireman turns around.
6. Helicopter hovering at a distance of about 15 yards.
7. Fireman backs out away from fire.

1. Fireman holding radiometer approaches fire.
2. Fireman stops at about 6-foot distance from fire.
3. Owing to discomfort to hands, fireman backs up about 3 feet.
4. Owing to discomfort, fireman backs out away from fire to a distance of about 12 feet.
5. Helicopter arrives and hovers at a distance of about 10 yards from fire.
6. Fireman backing out away from fire.
7. Fireman turns away from fire.

The helicopter was unable to cut a rescue path through flames from a completely fuel-wetted area. Measurements taken on the upwind side of the fire area indicate that downwash increased the intensity of radiant heat (Fig. 6, Appendix 3).
