Icing in Aircraft Fuel Lines

Presented to: Systems Meeting

By: Thomas Maloney, Rutgers Graduate Student Rutgers Advisors: Professor Rossmann, Professor Diez Date: 11-16-2011

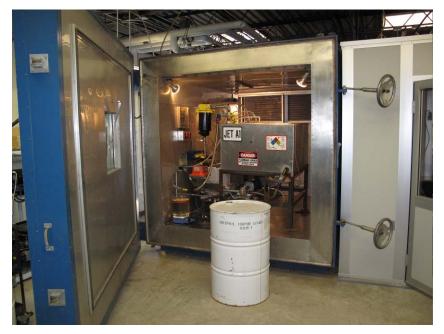
Test Facility (Altitude Chamber)

- Temperature Potential: -51.1C
- Pressure Potential: 2.73psi (40,000ft)
- Humidity Control
- Current fuel storage within the chamber: 135 gal.
