Icing in Aircraft Fuel Lines

Presented to: Systems Meeting Fall, 2012

By: Thomas Maloney, FAA Engineer

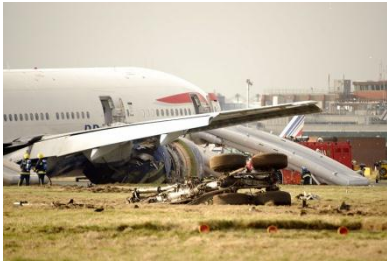
[4]

- **B52 accident (1958)** ^[3]
 - Fuel pump screen clogged with ice.
 - Over 200 previous “cause unknown” accidents later attributed to fuel icing.
 - Fuel Heaters and Icing Inhibitors were introduced
- **Boeing 777 engine rollback (2008)** ^[2]
- **Boeing 777 accident (2008)** ^[2]
 - Blockage of the FOHE from ice.
- **A330 engine rollback (2009)**

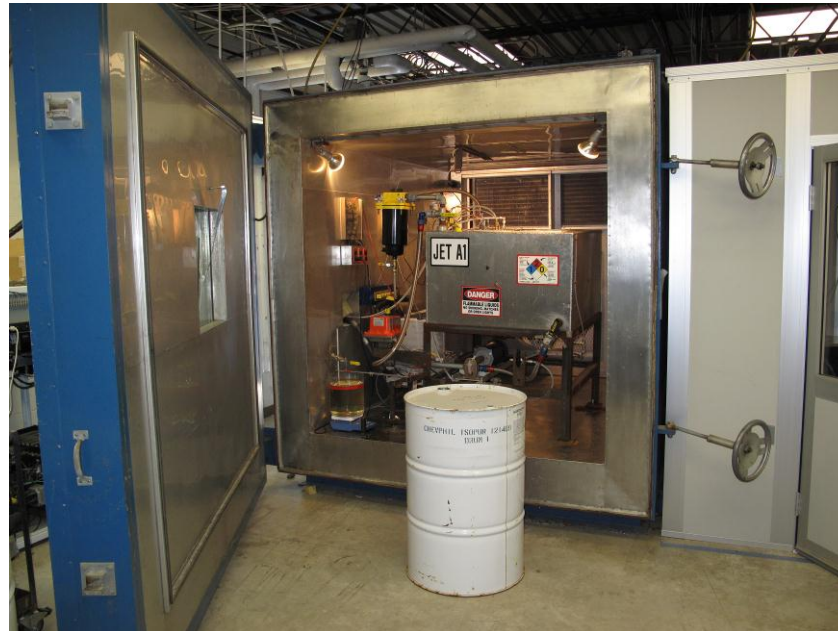
Altitude Chamber

- **Temperature Potential: -51.1C**
- **Current fuel storage within the chamber: 115 gal.**
- **Pressure Potential: 2.73psi (40,000ft)**
- **Humidity Control**

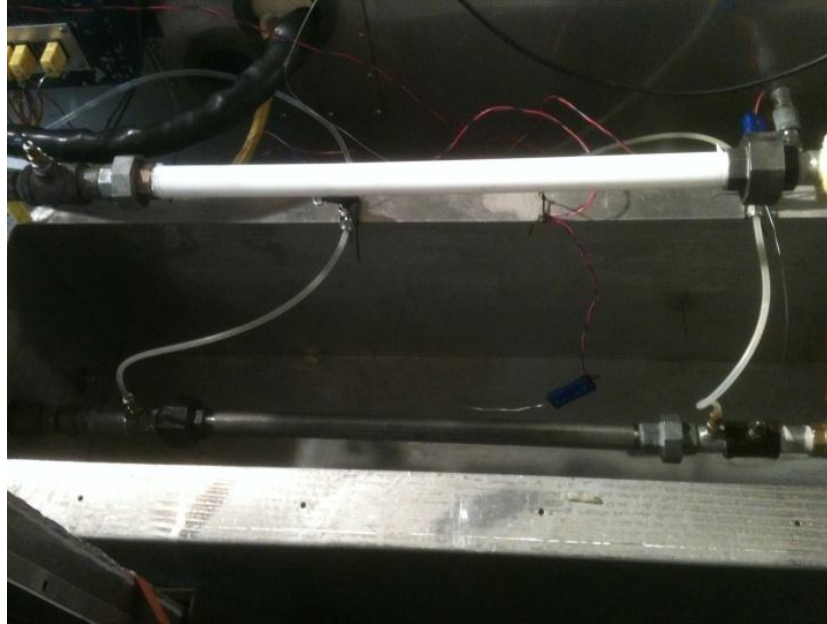
- Each test pipe was fitted with ports for differential pressure measurement.
- Each pipe had a type T thermocouple port downstream of the test area.
- Each test pipe was easily removable for visual observation and ice quantity measurement.

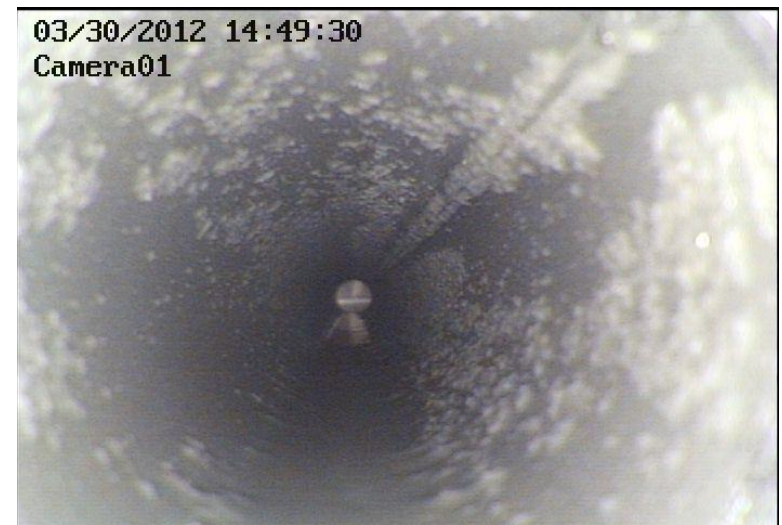
Reynolds Number:.....2031.3346
 Test Temperature:.....-9.3119 °C [-6.38 -13.14]
 Initial Temperature:.....21.405 °C[22.905 18.905]
 Test Duration:.....2.4714 hrs
 Flow is diverted prior to: -9.3119 °C
 Pressure Increase:.....0.0063987 $\frac{Pa}{m \cdot sec}$ [0.0064308 0.0063667]
 H_2O collected from pipe: 0.25 mL [0.25097 0.24903]

Note: The figures displayed here do not necessarily correspond to a single test

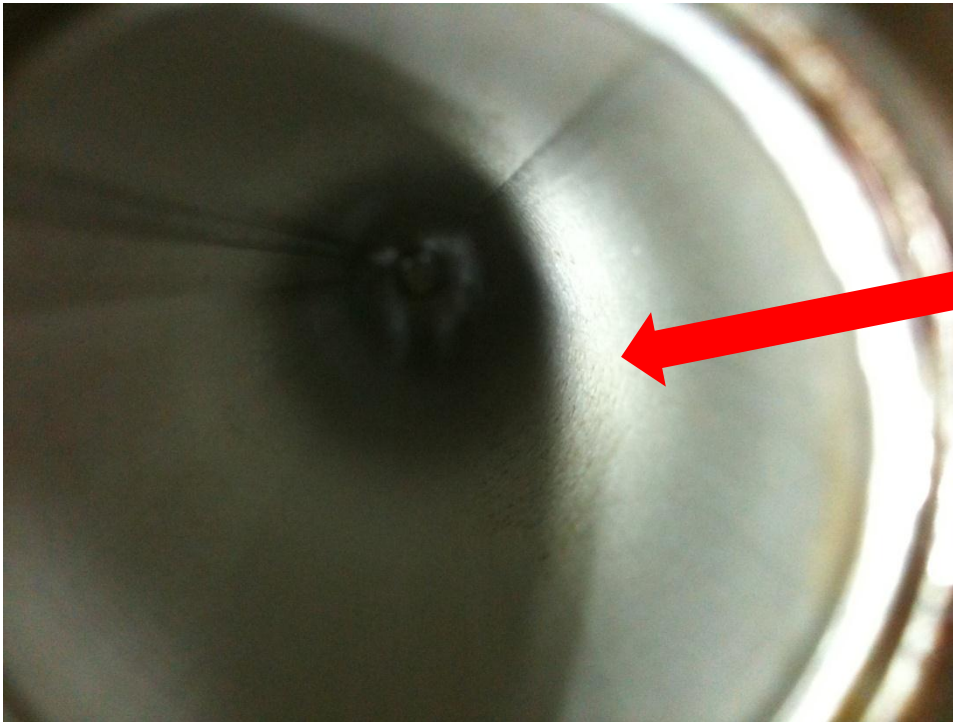
- Air in the test pipe as the fuel cooled to the test temperature.

A noticeable amount of ice but less than the previous condition.

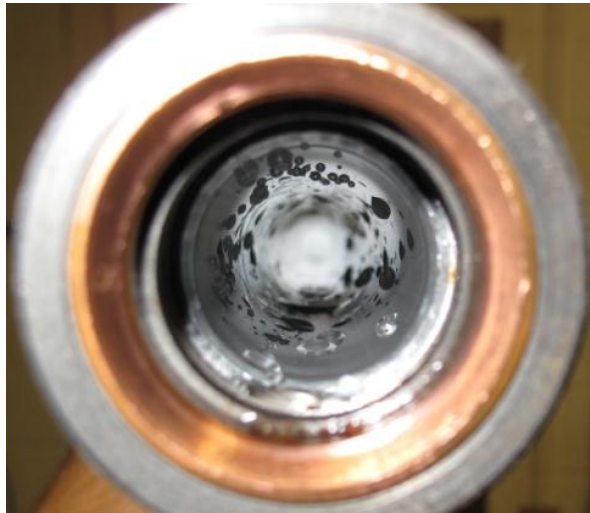
Before

- Air in test pipe except for a defined region that was sprayed with water

Note: A clear image of the other side of the pipe was not taken after the test where water was not sprayed but it had a lack of ice accumulation

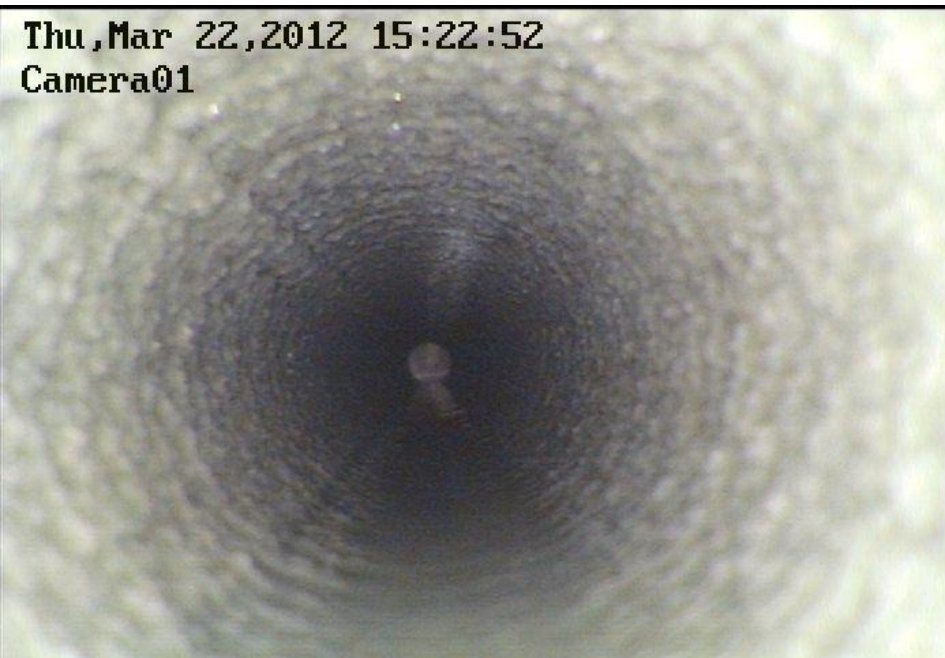
Test 1

- **Repeatability**
 - Repeatability tests were done at a Reynolds number of 8362 and temperature of -11 °C
- **Variation of Reynolds Number**
 - ≈ 3150 to ≈ 13000
 - This Re regime covered the range that a commercial airliner may typically encounter.
- **Variation of Temperature**
 - ≈ -7 °C to ≈ -20 °C
 - Boeing attributed -5 °C to -20 °C to be the temperature range that had sticky ice. [2]
- **Variation of Heat Transfer from the Pipe**
 - Insulated pipe or not insulated pipe
 - This variation was done because of what was unintentionally found in earlier tests.
- **Fuel Contaminants** (Each previous contaminant wasn't completely removed before adding the next one)
 - Dust
 - Excess water
 - Ground up aluminum
 - Ground up steel
 - Ground up Polyurethane insulation

- Repeatability was shown to exist visually with the pipe images and quantitatively with pressure increase.
- Higher Re decreased total accumulation because of an increase in shear stress
- The ice accumulated the most at -11 °C.
- A greater heat transfer from the pipe increased ice accumulation.
- Fuel contaminants contribute to ice accumulation.

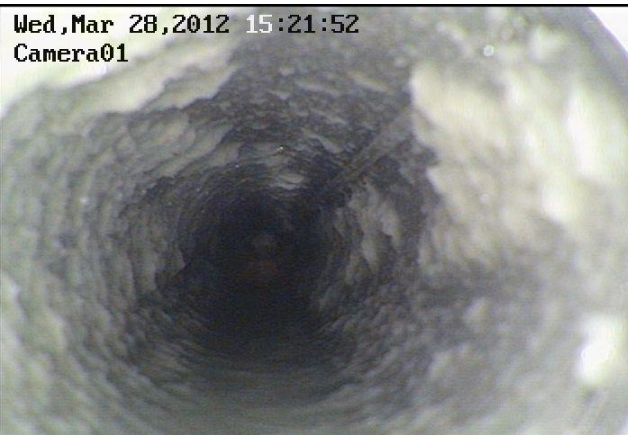
Re: 4000

Thicker
ice

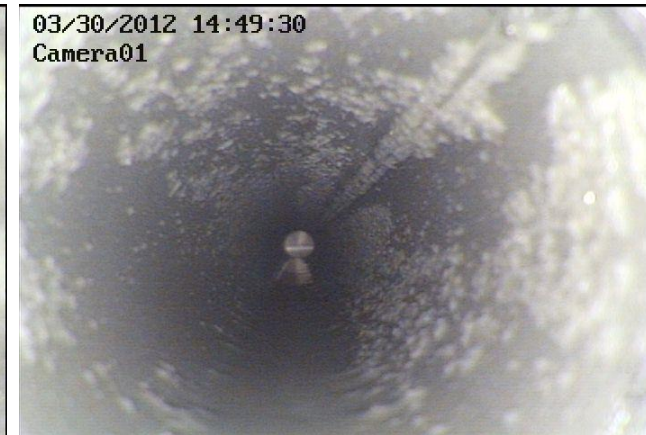
Re: 12922

Thinner
ice

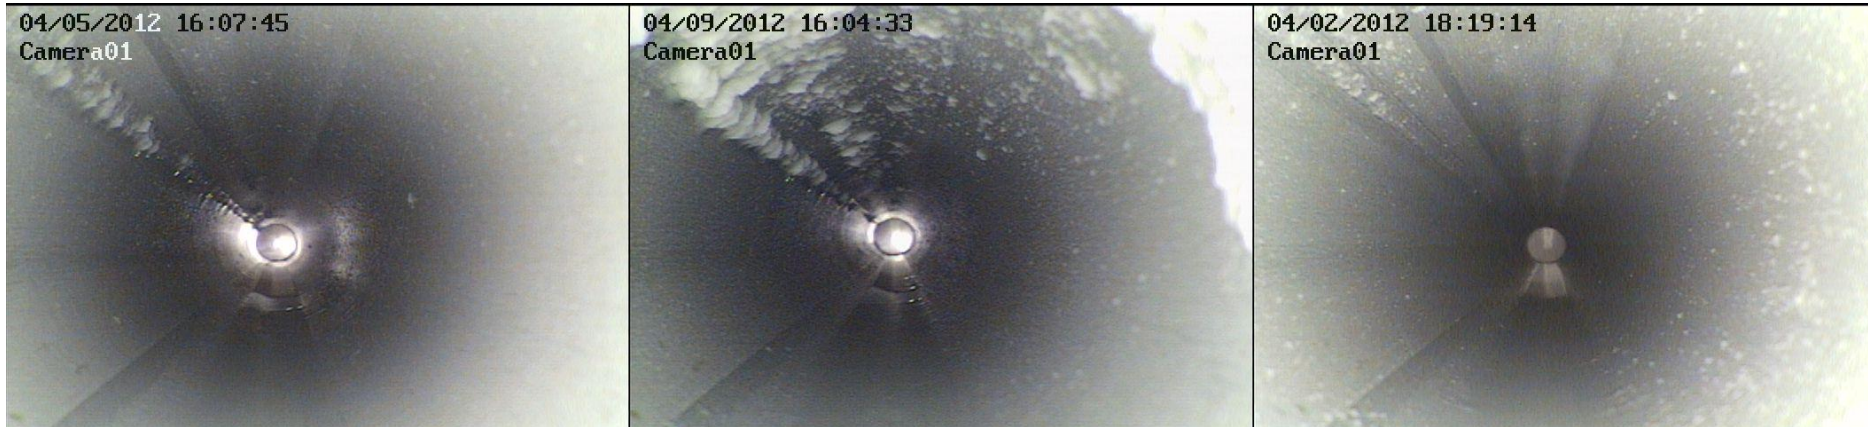
-7.4 °C

-11.24 °C

-19.35 °C

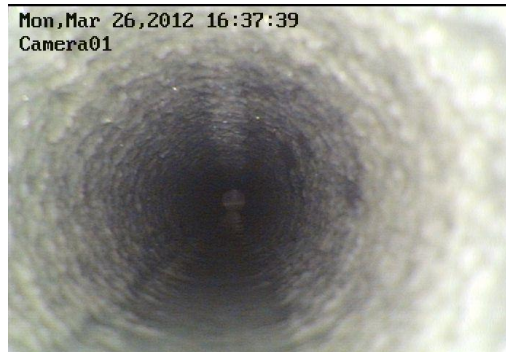
Fuel with the mystery
contaminant

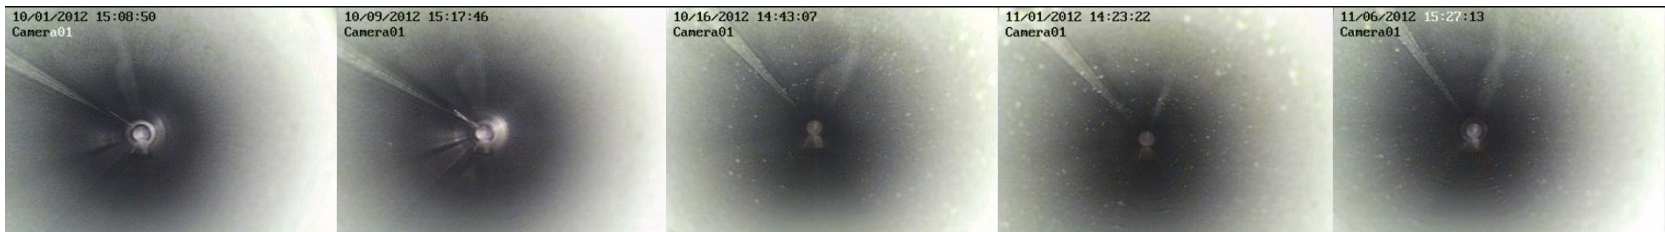
Dust

Excess Water

Ground
Aluminum

Ground Steel

Ground
Polyurethane
Insulation

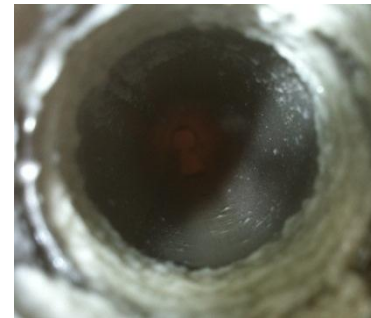
Stainless Steel

- **Contamination increases ice accumulation.**
- **Ice accumulated more on pipe welds than elsewhere in the pipe**

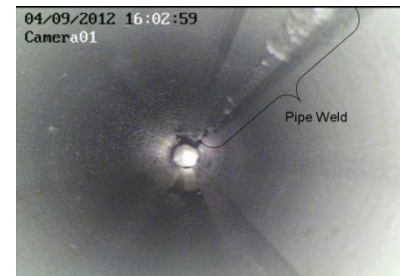
Pipe Oriented right-side-up
