**AFAPL AIRCRAFT FIRE TEST  
PROGRAM WITH FAA 1967-1970**

**D. E. Sommers      J. H. O'Neill**  
**DEPARTMENT OF TRANSPORTATION**  
**FEDERAL AVIATION ADMINISTRATION**  
National Aviation Facilities Experimental Center  
Atlantic City, New Jersey 08405

**FINAL REPORT**

AFAPL-TR-70-93

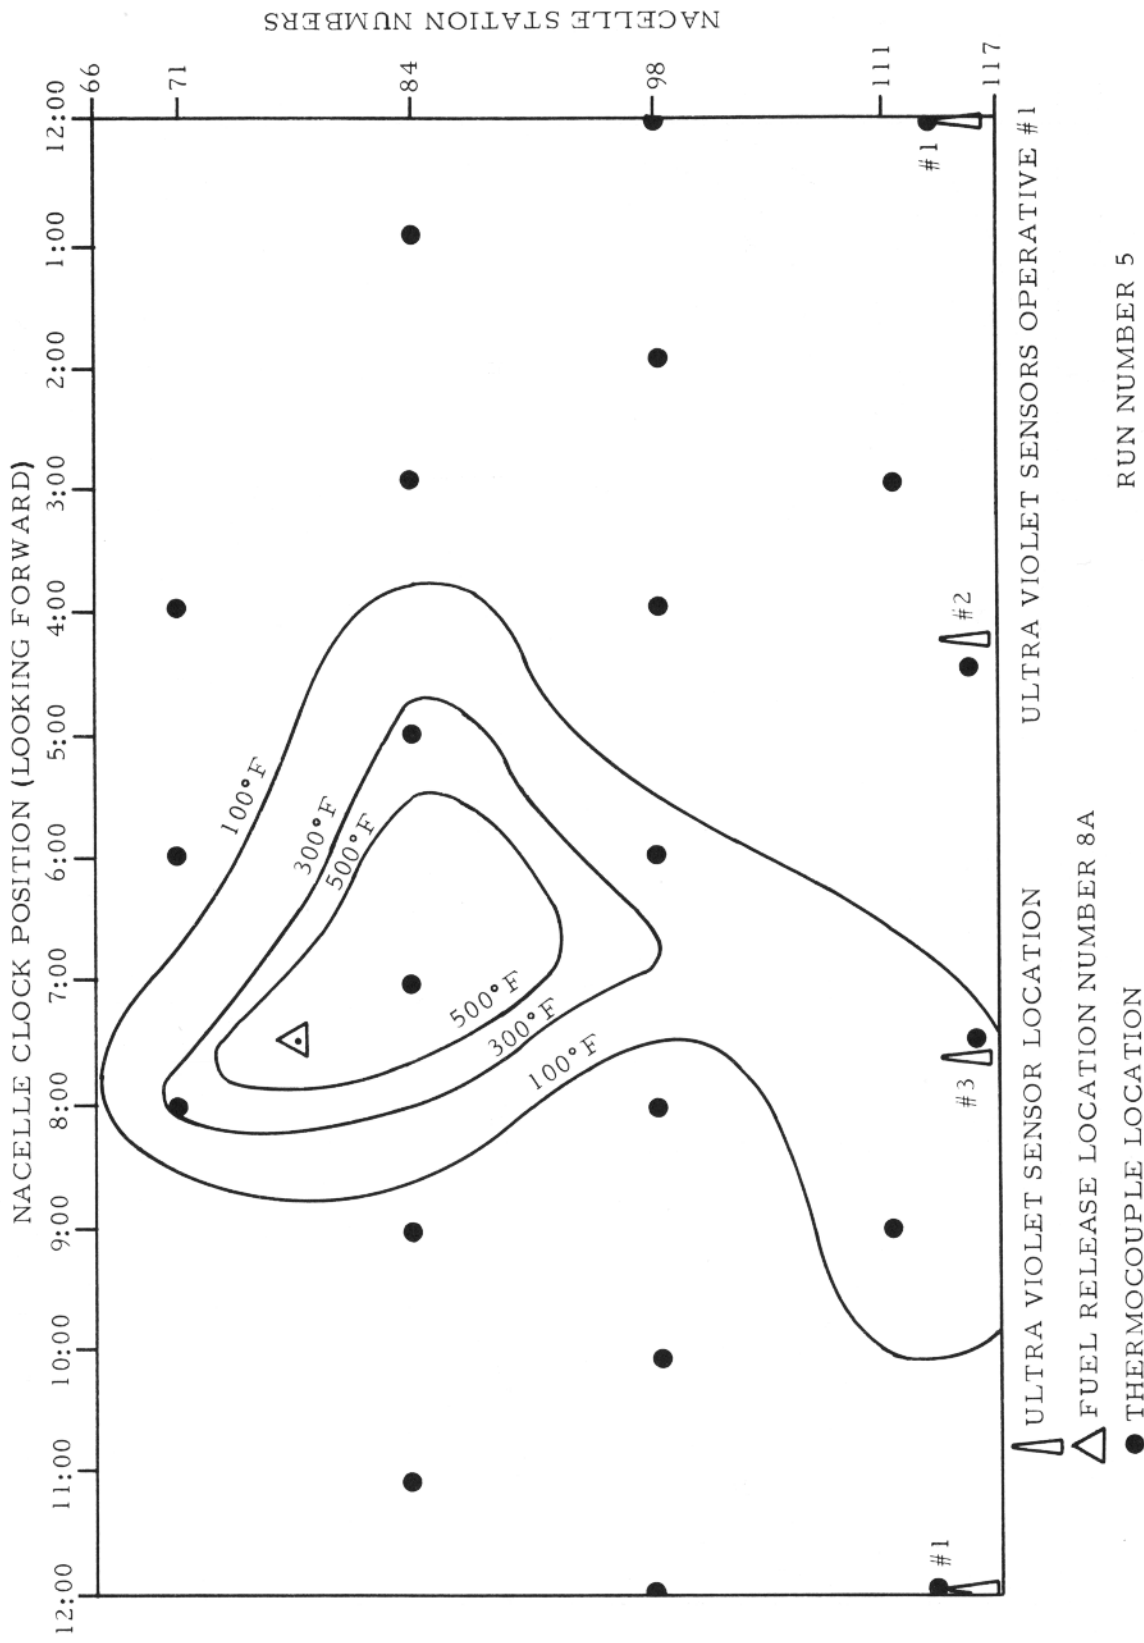
FIGURE 8 - STABILIZED AIR TEMPERATURE RISE IN COMPRESSOR COMPARTMENT

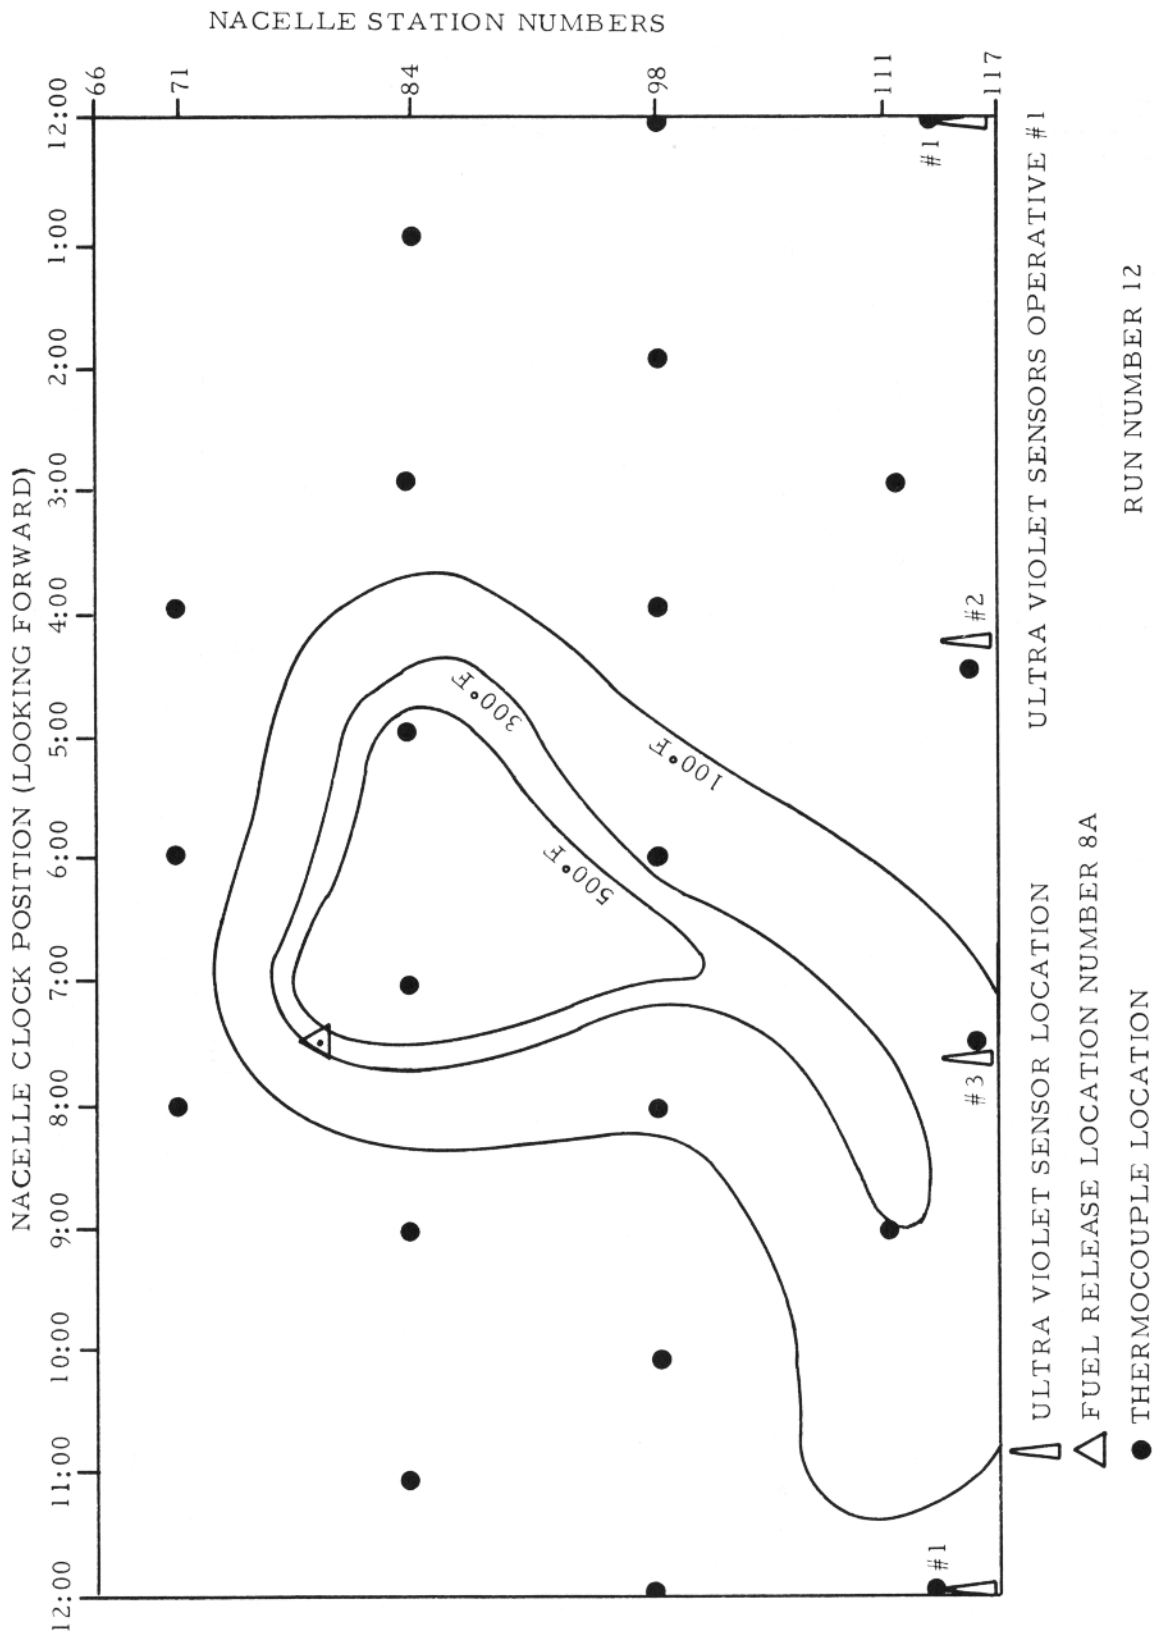
FIGURE 9 - STABILIZED AIR TEMPERATURE RISE IN COMPRESSOR COMPARTMENT

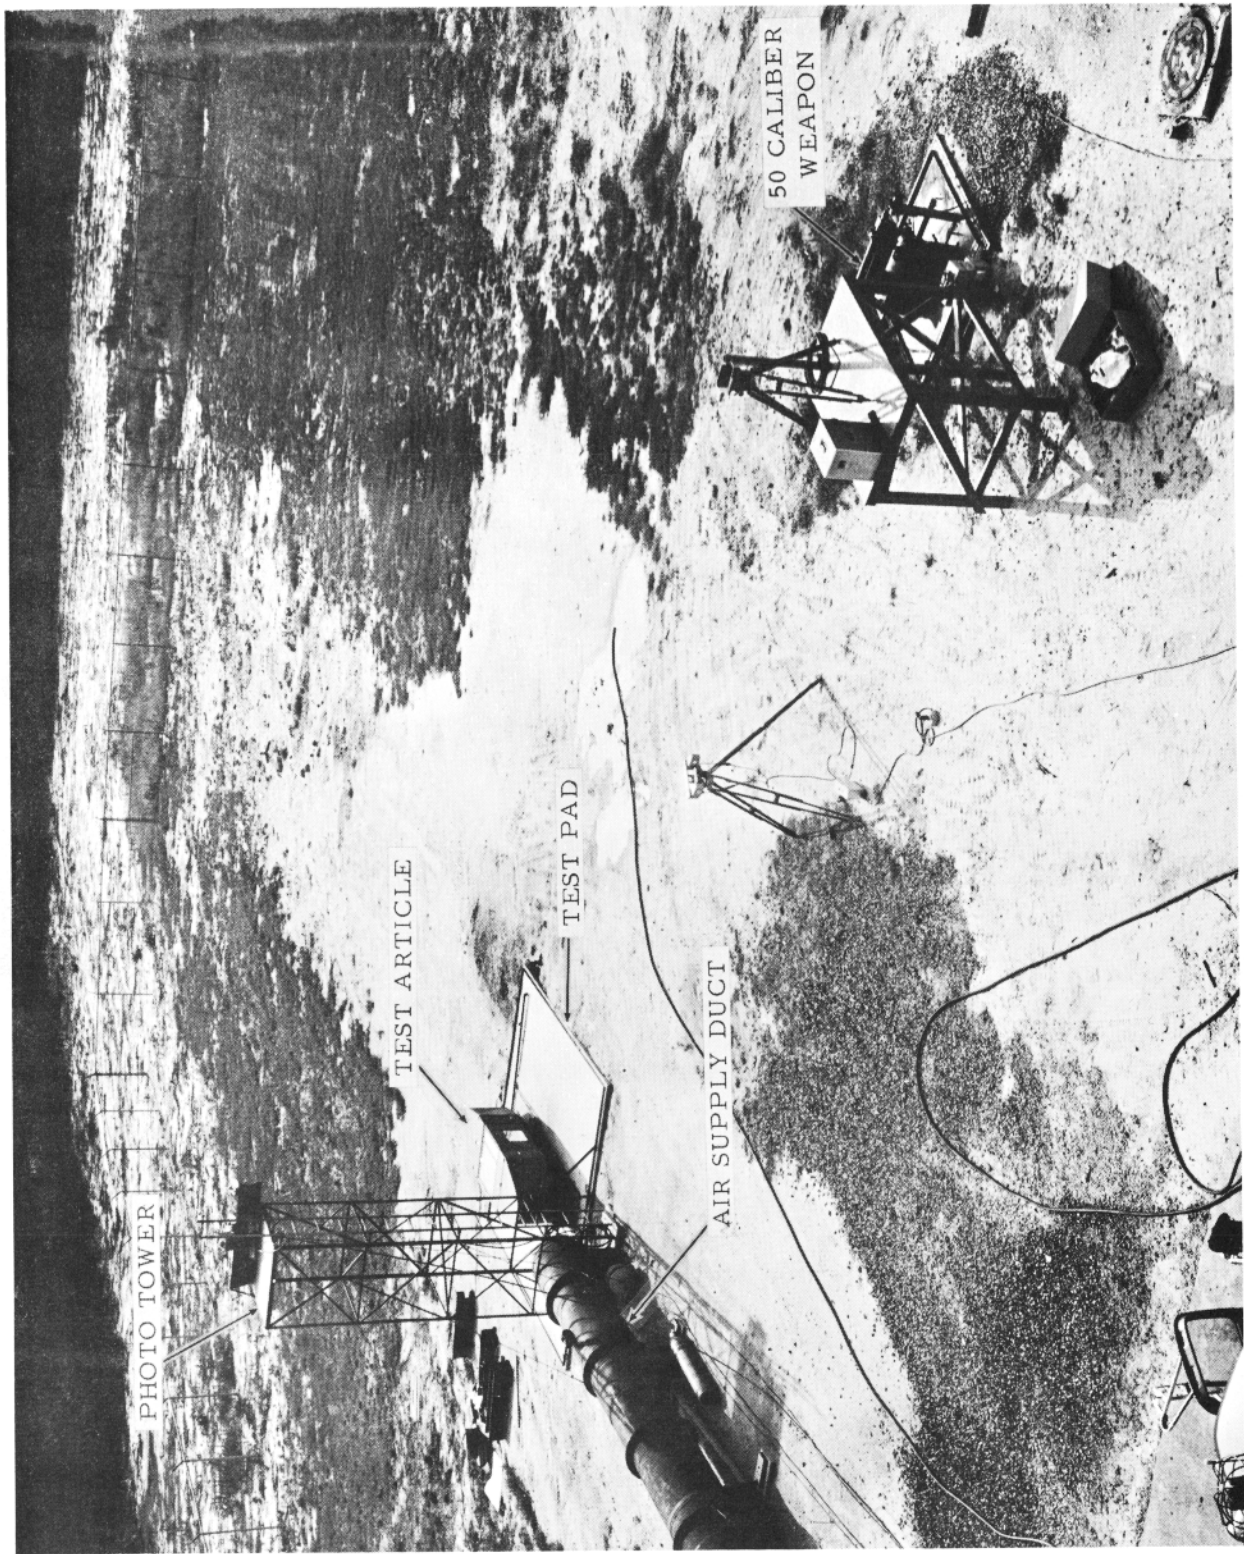
FIGURE 31 - OVERALL VIEW SHOWING THE TEST PAD

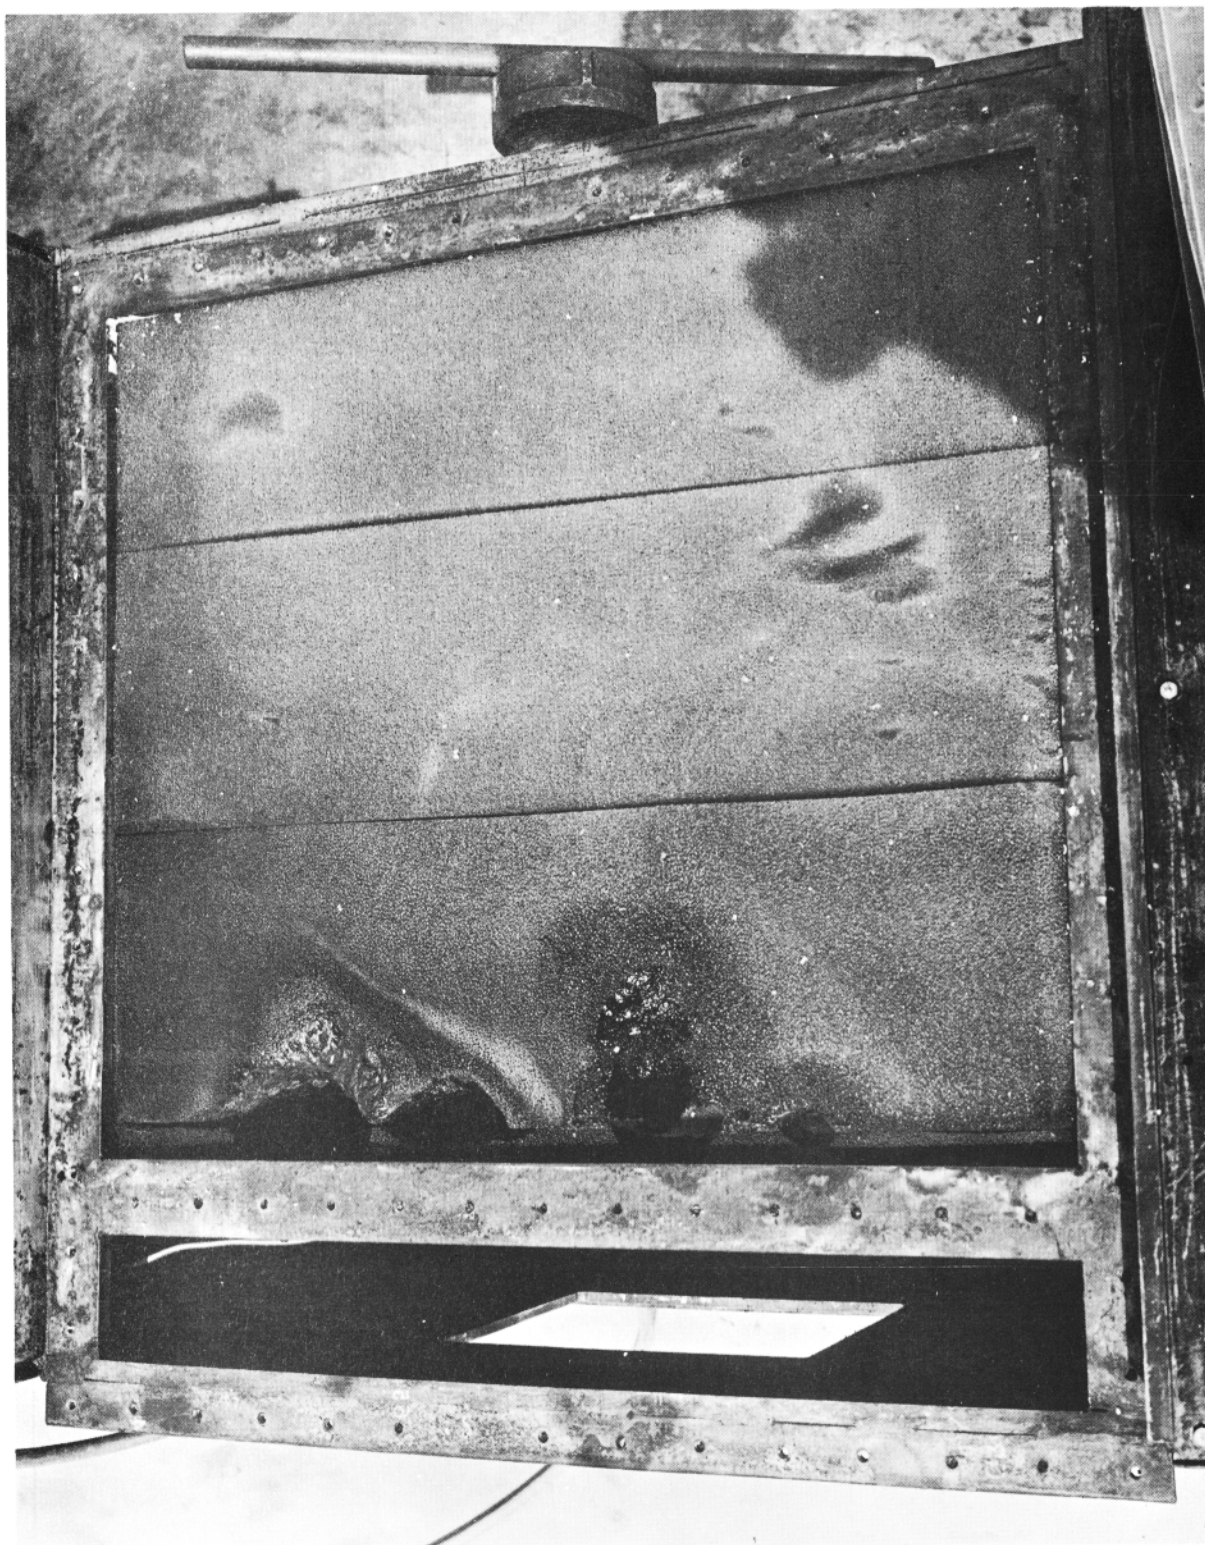
FIGURE 42 - DAMAGE TO POLYURETHANE FOAM IN TANK AREA  
4" TEST ARTICLE AND JP-4
