**EFFECTIVENESS OF FLIGHT ATTENDANTS ATTEMPTING
TO EXTINGUISH FIRES IN AN ACCESSIBLE CARGO COMPARTMENT.**

David Blake
Fire Safety Section
Federal Aviation Administration
William J. Hughes Technical Center
Atlantic City Airport, NJ 08405

International Aircraft Fire and Cabin Safety Research Conference
November 16-20, 1998
Atlantic City, NJ

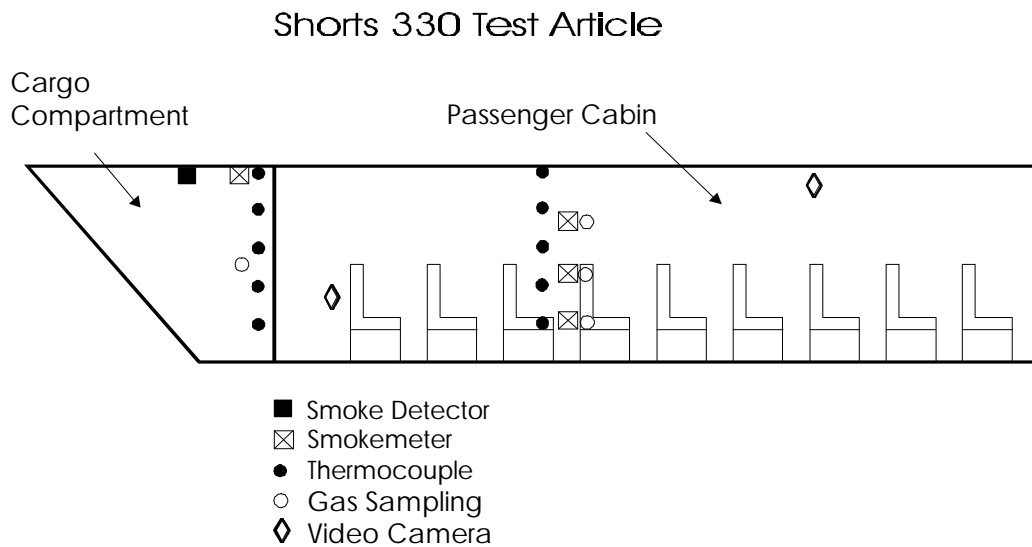
A modified Shorts 330 aircraft was used as the test article for this project. A door opening was cut into the aft cabin bulkhead to allow access to the aft cargo compartment. This compartment is located on the same level as the passenger cabin and is normally inaccessible in flight. The volume of the original cargo compartment was approximately 175 ft³. An aircraft approved photoelectric smoke detector was installed on the ceiling of the cargo compartment. The alarm point of the detector was 94 percent light transmission per foot. The interior of the passenger cabin as well as the cargo compartment was instrumented with thermocouples, smoke meters, gas analyzers and video cameras. Figure 1 shows the test article and instrumentation. A fan was mounted externally and ducted into the existing aircraft ventilation ducts. The airflow into the cabin was 280 ft³/min. This airflow provided one change of cabin air approximately every 4.5 minutes. The airflow provided a slight positive pressure in the cabin relative to the cargo compartment. This was verified by generating a small amount of smoke from a theatrical smoke generator in the cargo compartment and then opening the door from the smoke in the cargo compartment. The airflow into the cabin was sufficient to contain the smoke in the cargo compartment.
