Evaluation of Means Adopted To Provide Fire Protection in B-36 Aircraft Powerplants

By
Lyle E. Tarbell
Aircraft Division

TECHNICAL DEVELOPMENT REPORT NO. 366

December 1958

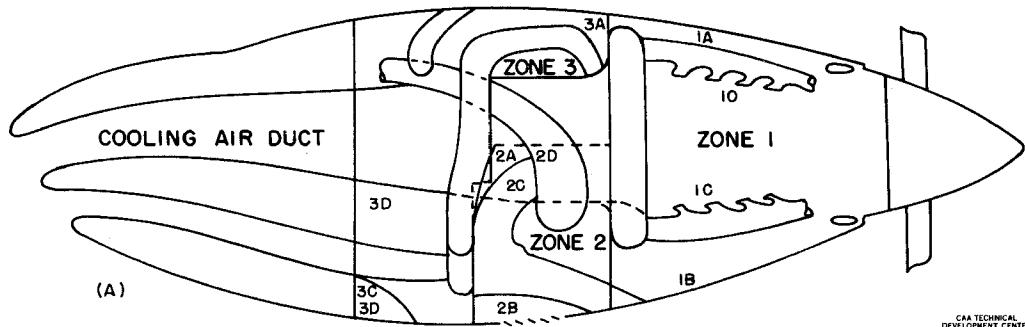
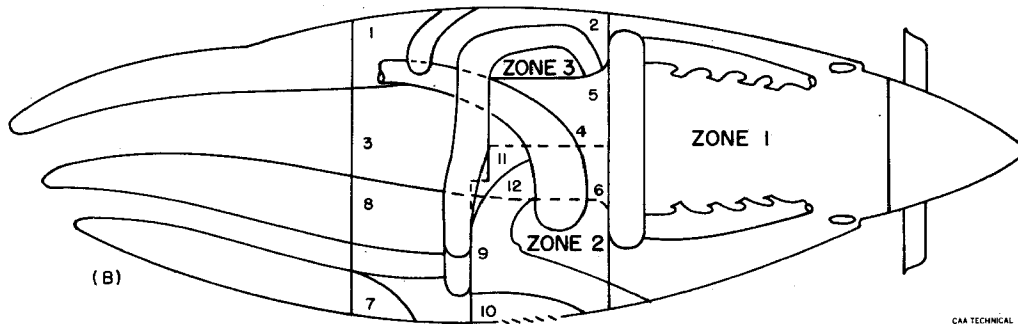
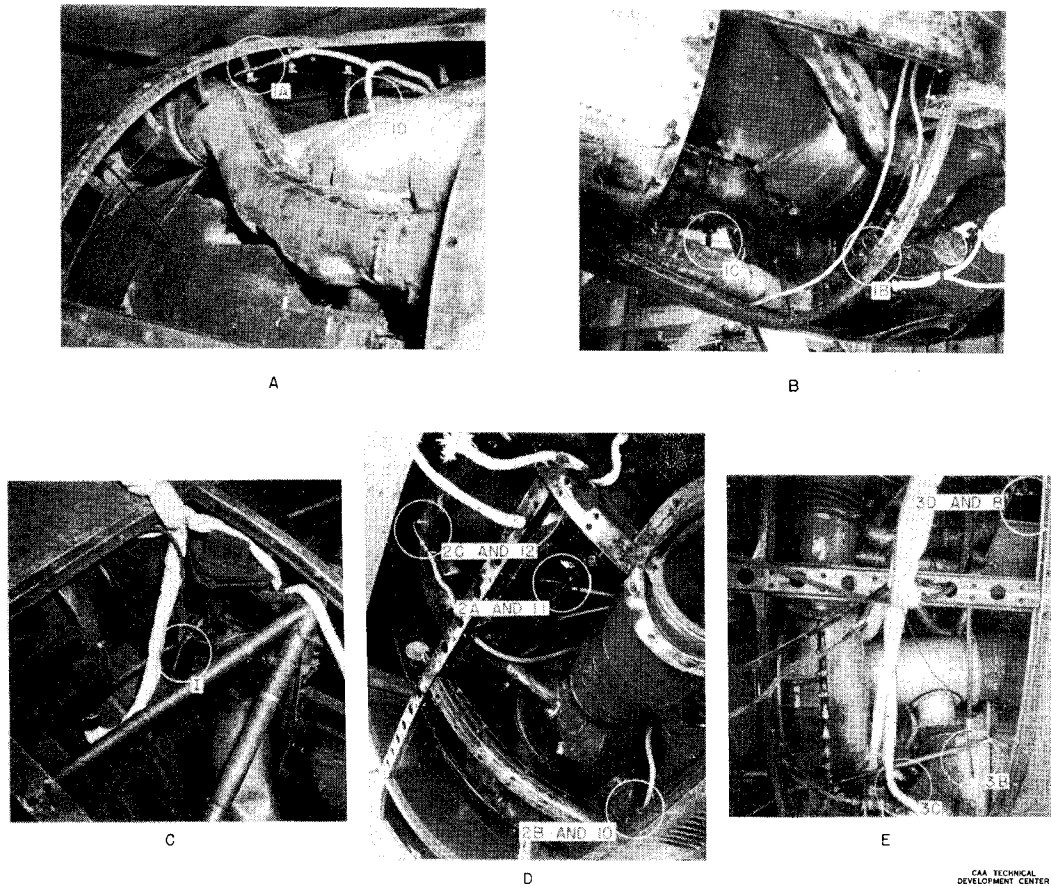
Fig. 6A Probe Locations for Preliminary Sampling of Agent Concentrations Using System A

Fig. 6B Probe Locations Used for Flight and Later Laboratory Investigations

In Zone 1, the concentrations were relatively low at all points and insufficient to produce extinguishment of fire. In Zone 2, concentrations were appreciably higher than in Zone 1 although at probe location 2C insufficient agent vapor was indicated. However, this probe was located inside the shroud on the downstream side of the heat exchanger and the reading did not portray conditions within the zone proper. In Zone 3, some concentration of agent was recorded. This resulted from leakage of agent from Zone 2 as no agent was released directly into Zone 3.

Fig. 7 Probes in B-36 Test Nacelle - A and B, Zone 1, D, Zone 2, and C and E, Zone 3

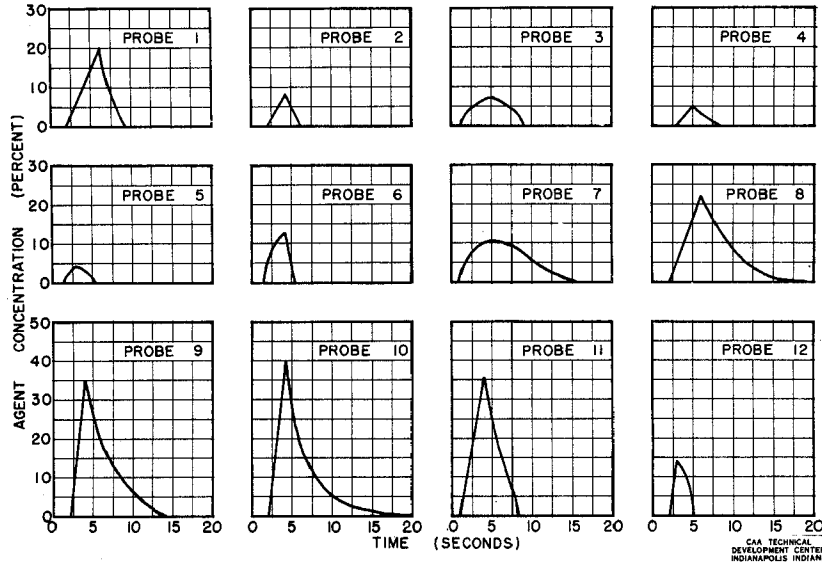
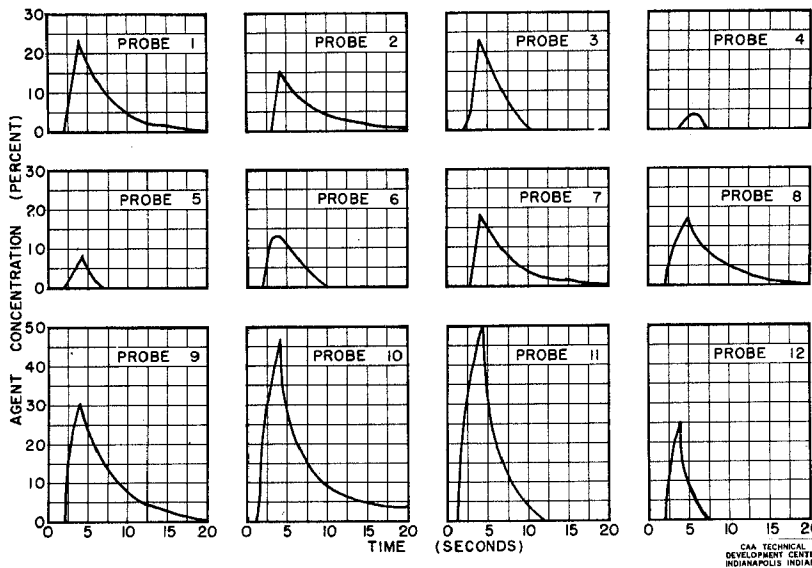
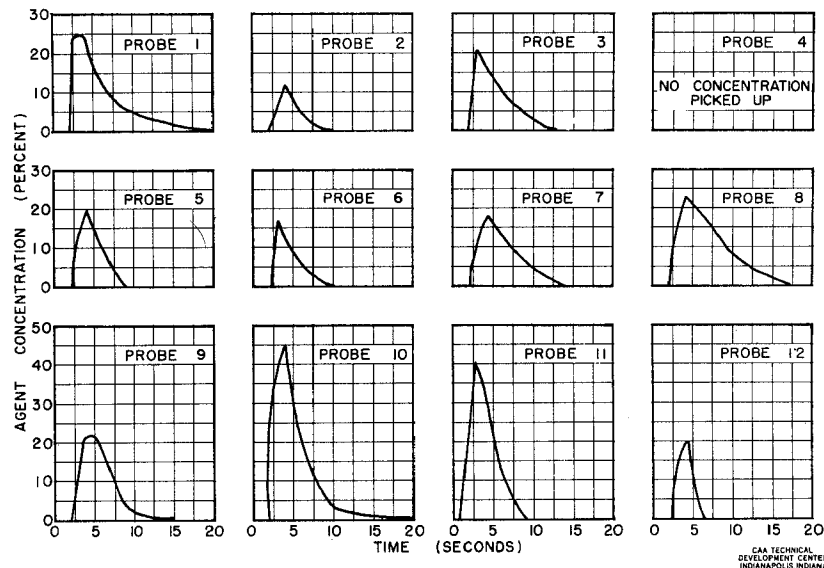
Fig. 9 CB Concentrations at 2,000 Feet Altitude Produced by System C and Using 33 Pounds of Agent, 425 PSI Container Pressure

Fig. 10 CB Concentrations at 5,000 Feet Altitude Produced by System C and Using 33 Pounds of Agent, 425 PSI Container Pressure

Fig. 11 CB Concentrations at 20,000 Feet Altitude Produced by System C and Using 33 Pounds of Agent, 425 PSI Container Pressure

In general, the CB concentrations resulting from the discharge of 33 pounds of agent appeared to be adequate in Zone 2 but low to marginal in the other zones. A slight improvement was evident when the discharge was measured at higher altitudes although the average condition still would be considered marginal. There appeared to be no advantage in closing the air plug prior to discharge, nor was there any advantage in increasing the volume of propellant gas in the container and reducing the agent to 25 pounds.

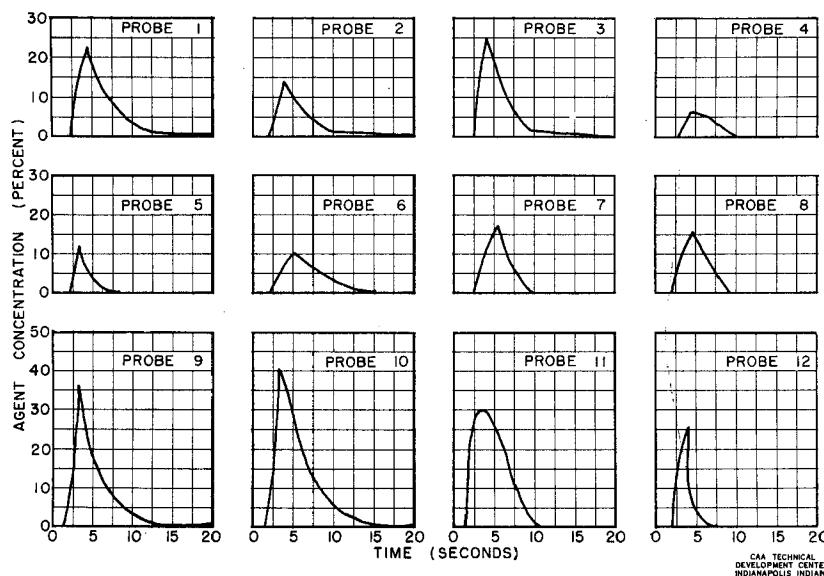
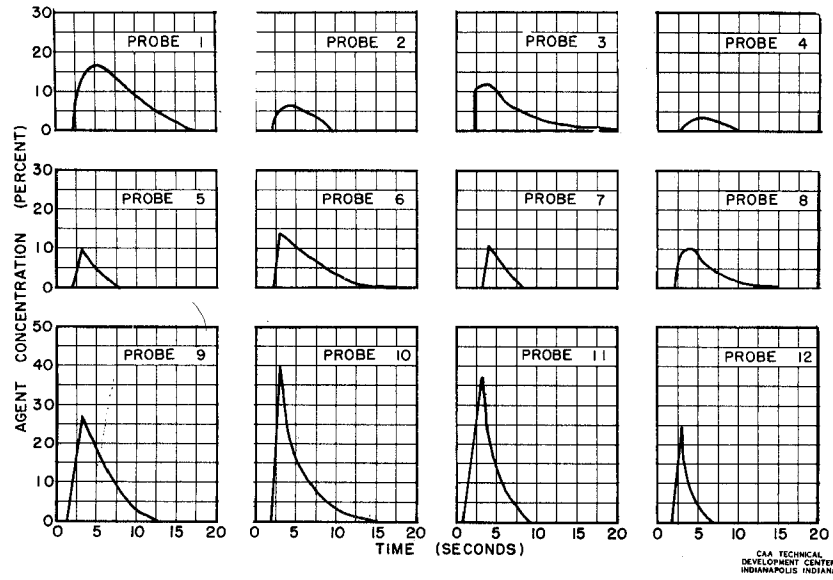
Fig. 12 CB Concentrations at 20,000 Feet Altitude Produced by System C and Using 33 Pounds of Agent, 425 PSI Container Pressure, and with Air Plug Closed

Fig. 13 CB Concentrations at 20,000 Feet Altitude Produced by System C and Using 25 Pounds of Agent, 425 PSI Container Pressure

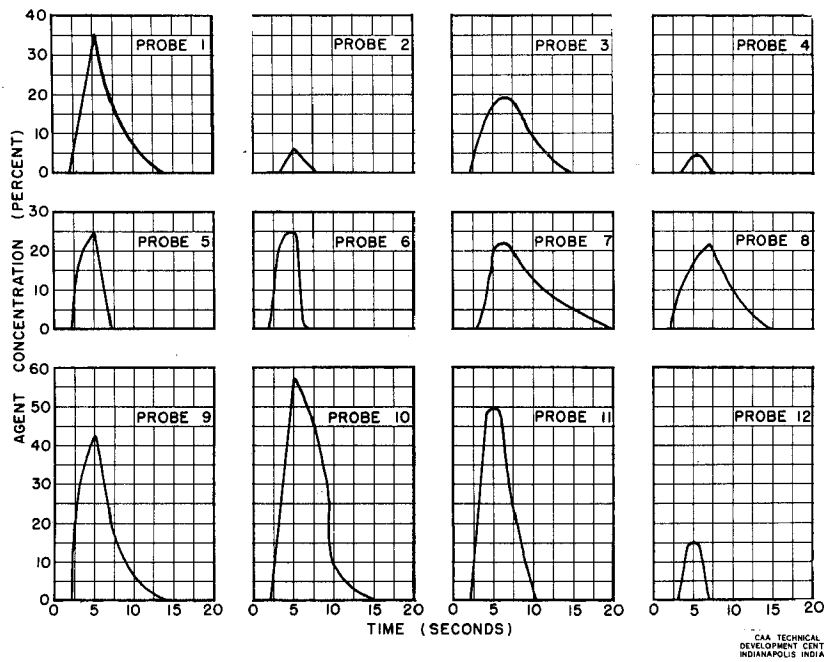
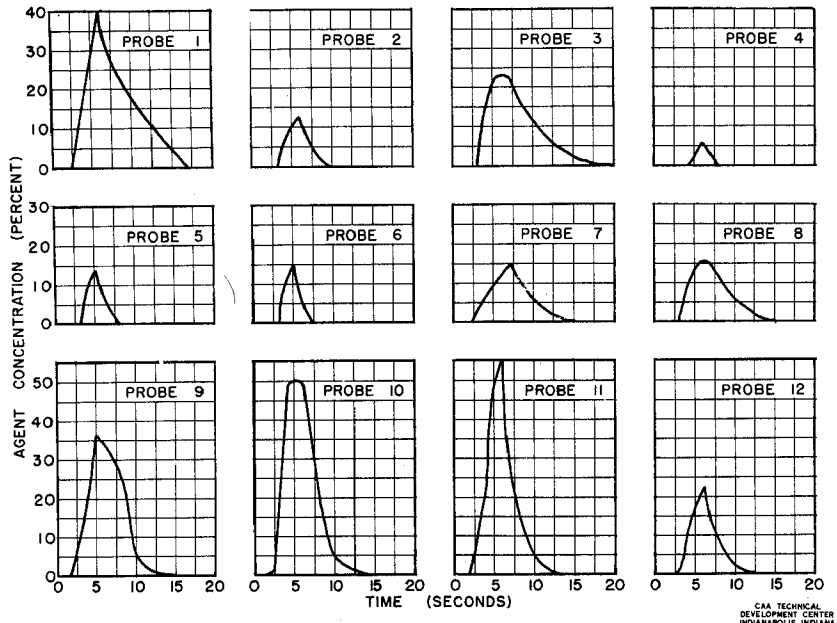
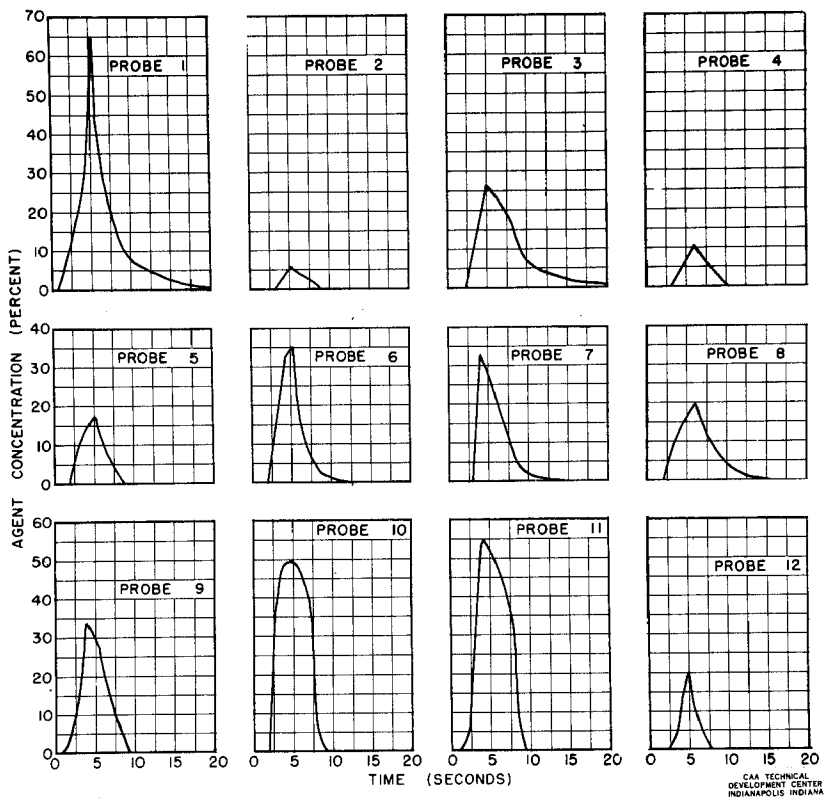
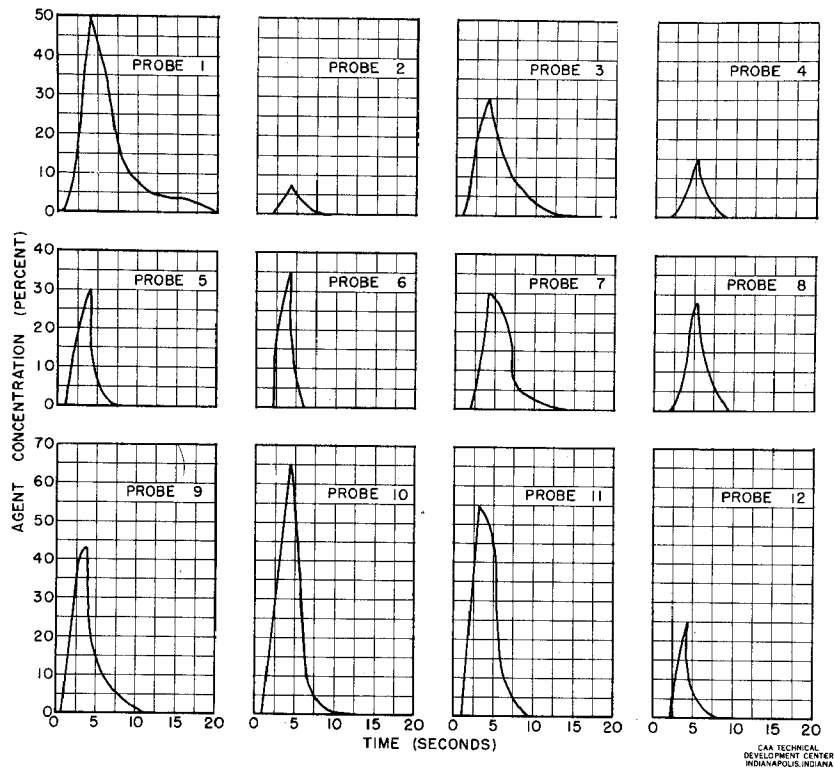
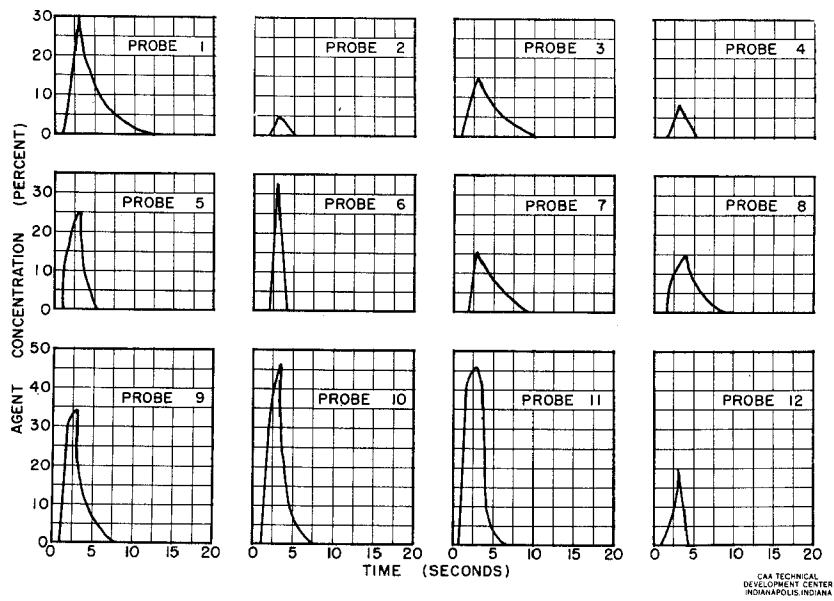
Fig. 14 DB Concentrations at 2,000 Feet Altitude Produced by System C and Using 39 Pounds of Agent, 425 PSI Container Pressure

Fig. 15 DB Concentrations at 5,000 Feet Altitude Produced by System C and Using 39 Pounds of Agent, 425 PSI Container Pressure

Fig. 16 DB Concentrations at 20,000 Feet Altitude Produced by 39 Pounds of Agent, 425 PSI Container Pressure

Fig. 17 DB Concentrations at 20,000 Feet Altitude Produced by System C and Using 39 Pounds of Agent, 600 PSI Container Pressure

Fig. 18 Concentrations at 20,000 Feet Altitude Produced by System C and Using 18.8 Pounds of Agent, 600 PSI Container Pressure

Using DB instead of CB, the concentrations produced by discharging 39 pounds of agent again were apparently adequate in Zone 2. In Zone 3, concentrations were not uniform, and since some were rather low, the protection for the zone appeared inadequate. At the low altitude of 2,000 feet, the concentration appeared to be adequate near the engine accessories but at higher altitudes protection also was considered marginal. The use of a higher propellant gas pressure of 600 psi instead of 425 psi raised the peak concentrations in most cases, but a reduction in the quantity of agent to 18.8 pounds was not compensated for by the increased pressure.

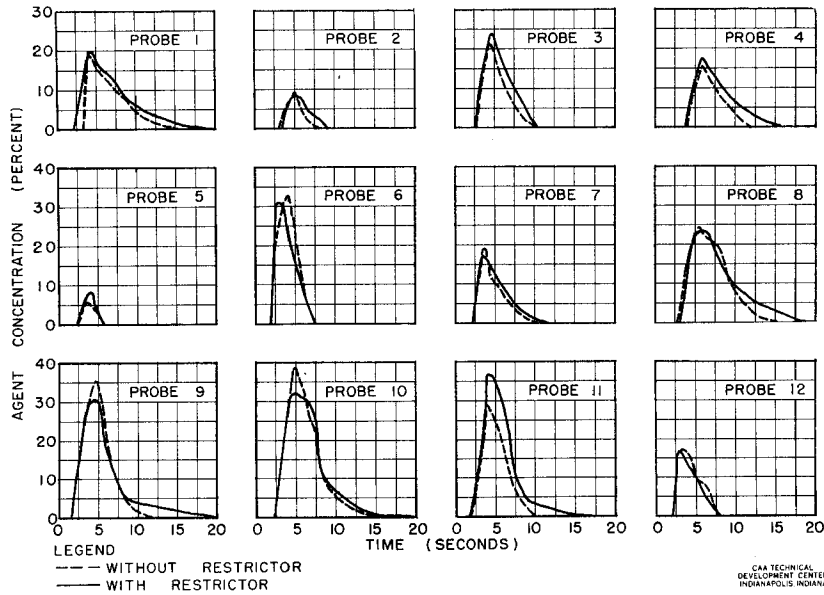
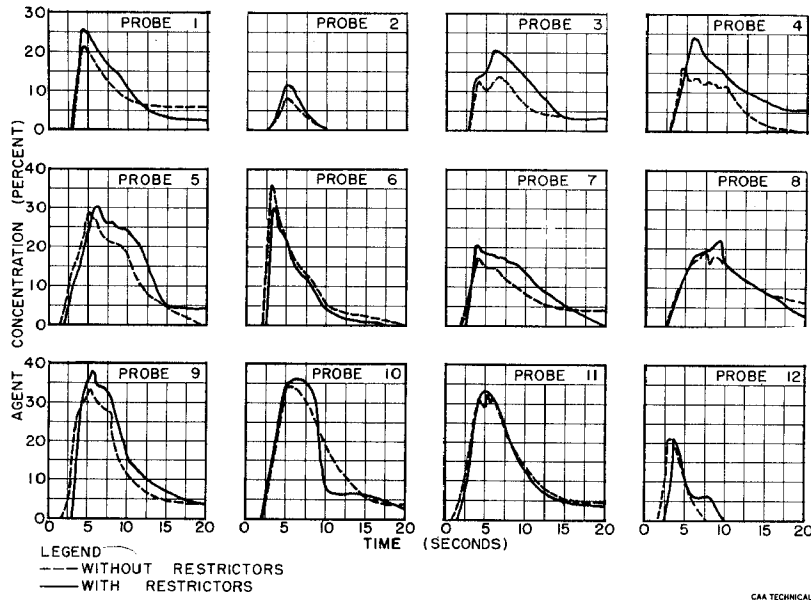
When 33 pounds of CB were discharged, the concentrations produced with and without the restrictor were shown in Fig. 20 for simulated low-altitude, and in Fig. 21 for simulated high-altitude operation. The effect of the restrictor under low-altitude conditions was negligible in all zones. Under simulated high-altitude conditions, it appeared to increase the concentrations by a moderate amount in Zone 3 and had little effect on Zones 1 and 2. When 39 pounds of DB were discharged at simulated high-altitude conditions, using 425 and 600 psi agent container pressure, use of the restrictor increased concentrations in Zone 3 in both

Fig. 20 CB Concentrations at Simulated Low Altitude Produced by System D

Fig. 21 CB Concentration at Simulated High Altitude Produced by System D

A comparison of the results shown in Figs. 20 and 21 show that agent concentrations in Zone 1 were considerably higher under simulated high-altitude conditions than under simulated low-altitude conditions. Concentrations in Zones 2 and 3 essentially were the same under the two conditions.

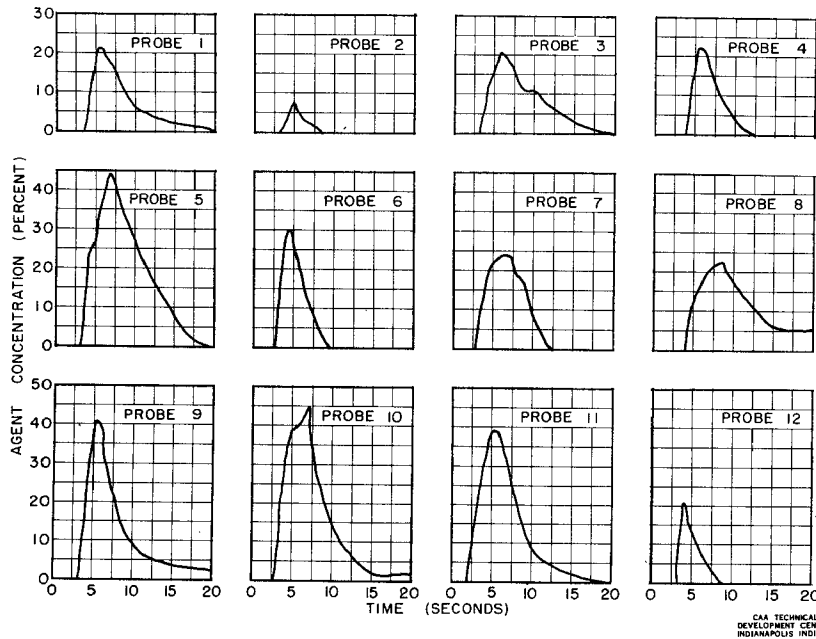
Results of the test conducted with the air plug closed are shown in Fig. 22. A comparison of these with the results in Fig. 21 (without restrictor) indicates that closing the air plug increased concentrations in all zones to some extent.

Fig. 22 CB Concentrations Without Restrictor and with Air Plug Closed Using Extinguishing System D

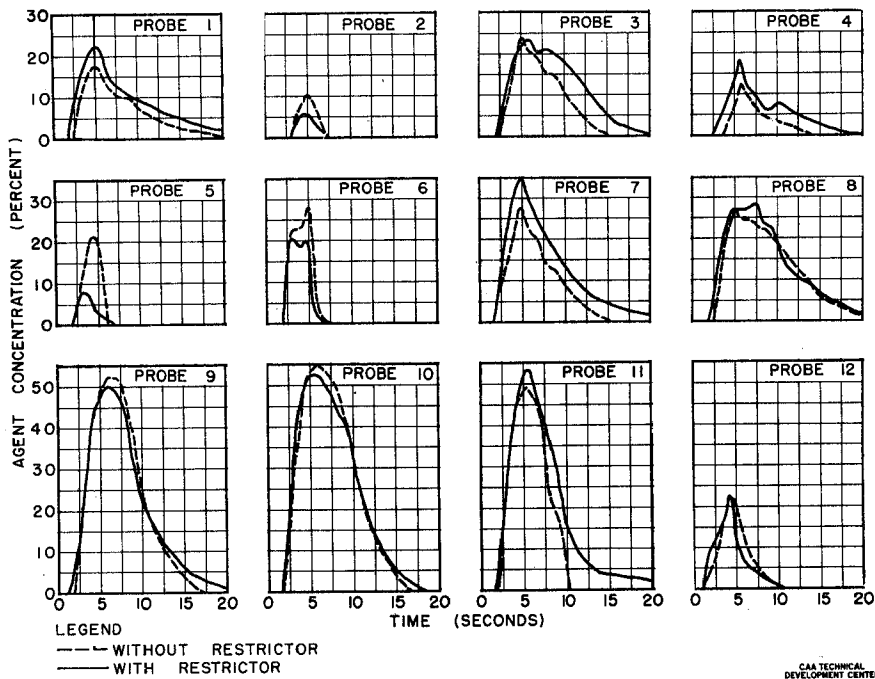
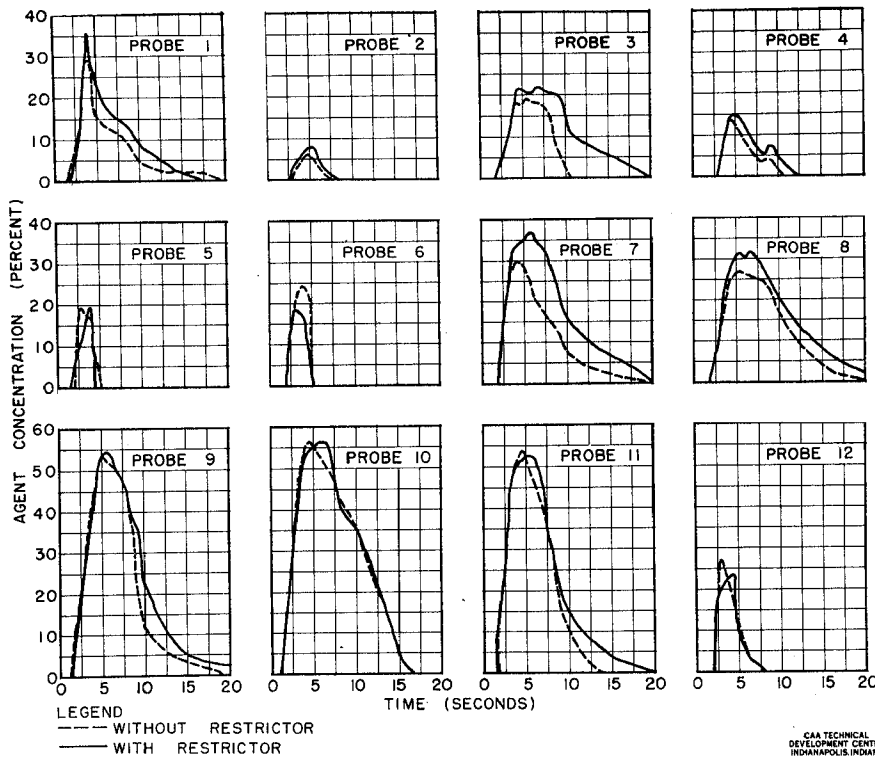
instances and caused slight reductions in concentration of agent in Zones 1 and 2. These results are shown in Figs. 23 and 24. In summation, the restrictor provided a slight improvement in Zone 3 and a slight decrease in concentrations in Zones 1 and 2.

Fig. 23 DB Concentration at Simulated High Altitude (425 PSI) Using Extinguishing System D

Fig. 24 DB Concentrations at Simulated High Altitude (600 PSI) Extinguishing System D

The graphs in Figs. 23 and 24 provide a comparison of concentrations produced by DB agent container pressures of 425 psi and 600 psi. These results show that the higher pressure produced a negligible increase in concentrations.
