DOT/FAA/AR-95/49

A Study of the Continued Fire Worthiness of Aircraft Seat Cushion Fire-Blocking Layers

March 1997

Final Report

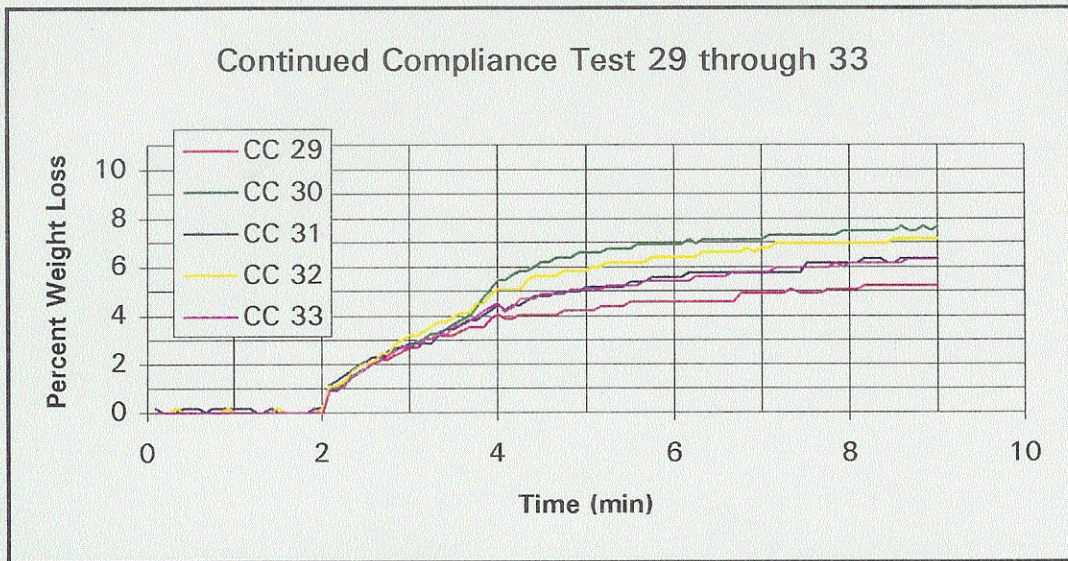
FIGURE 8. PERCENT WEIGHT LOSS PROFILES, TESTS 29 THROUGH 33

The percent weight loss was 10.87 for test number 36. This test was one of the final four tests performed which had reused vertical cushions. In review of this test, the final weight loss was mainly affected by the involvement of the reused vertical cushion. Had the vertical cushion been in an untested condition, the entire cushion set would have been expected to pass in the same manner as the other 29 tests.
