DOT/FAA/AR-96/48

Fuel Fire Penetration Test and Destruction of a Transport Aircraft

December 1996

Final Report

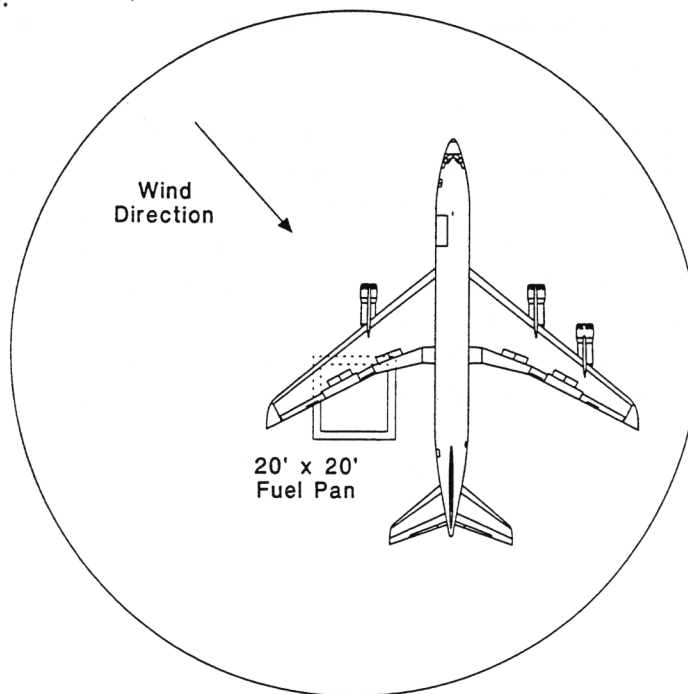
FIGURE 1. TEST CONFIGURATION

The test site was a graded 200-foot-diameter circle in an area where there were no vertical wind obstructions. The aircraft was positioned 15 feet downwind of a 20- by 20-ft fuel pan such that the prevailing wind would blow across the pan 60° left of the aircraft nose. This fuel pan was located inside of a larger 30- by 30-ft pan to reduce the possibility of fuel spillage contaminating the ground (figure 1).

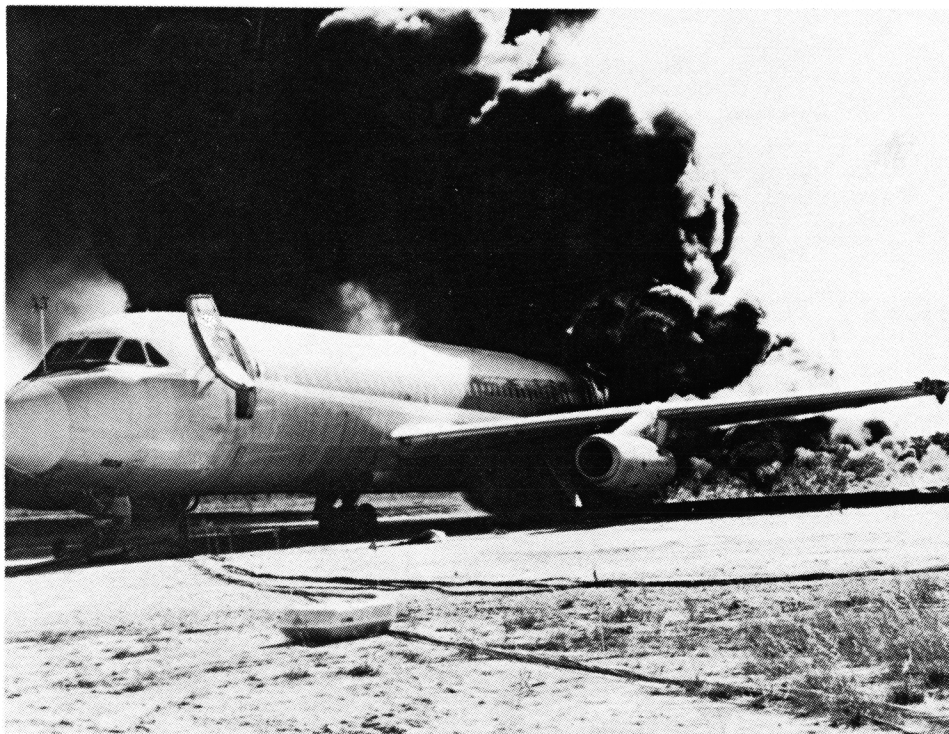
FLAME IMPINGEMENT. The pool fire became fully developed 20 seconds after ignition. The wind driven flame (60° left of the nose at an average speed of 12 knots) struck the fuselage between stations 1070 and 1300 trailing towards the rear of the aircraft and covering the top of the fuselage from station 1200 aft (figures 2, 3). A small amount of flame blew under the fuselage aft of the right rear door from station 1294 aft. A relatively large amount of flame blew over the fuselage from station 1220 aft to the vertical stabilizer. Occasionally, the flame from under the fuselage and the flame from over the fuselage combined in the vicinity of the right rear door, station 1262. The fire remained fairly constant for approximately 8 minutes then diminished as the fuel was exhausted until it was out at 11 minutes.

FIGURE 2. FLAME IMPINGEMENT ON PORT AFT FUSELAGE

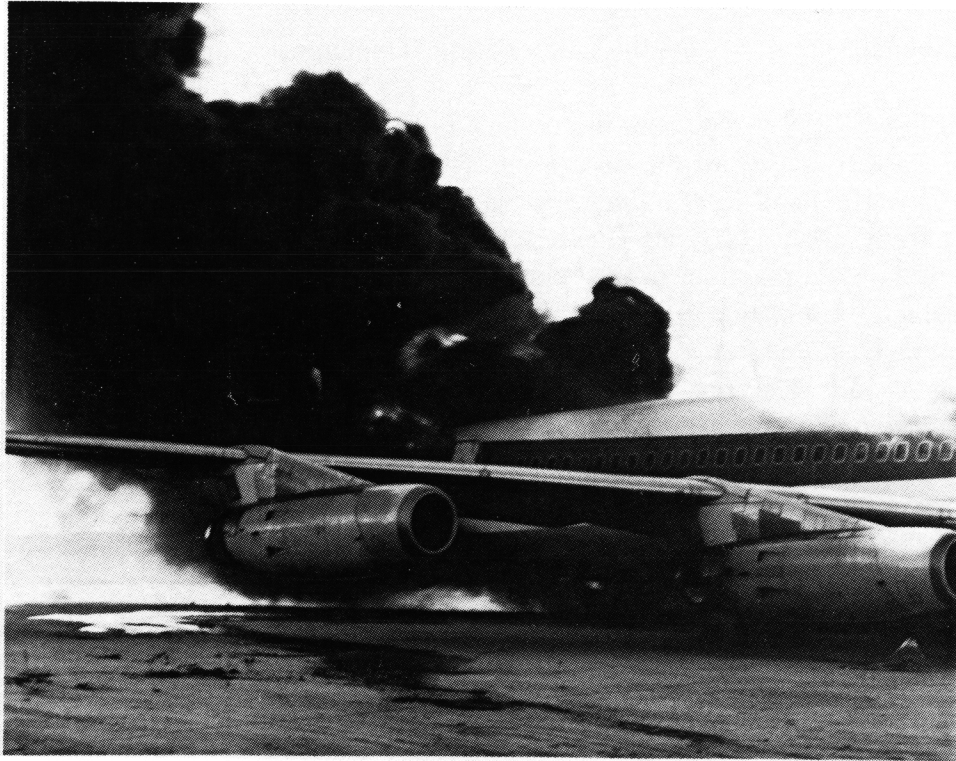
FIGURE 3. FLAME IMPINGEMENT ON STARBOARD AFT FUSELAGE

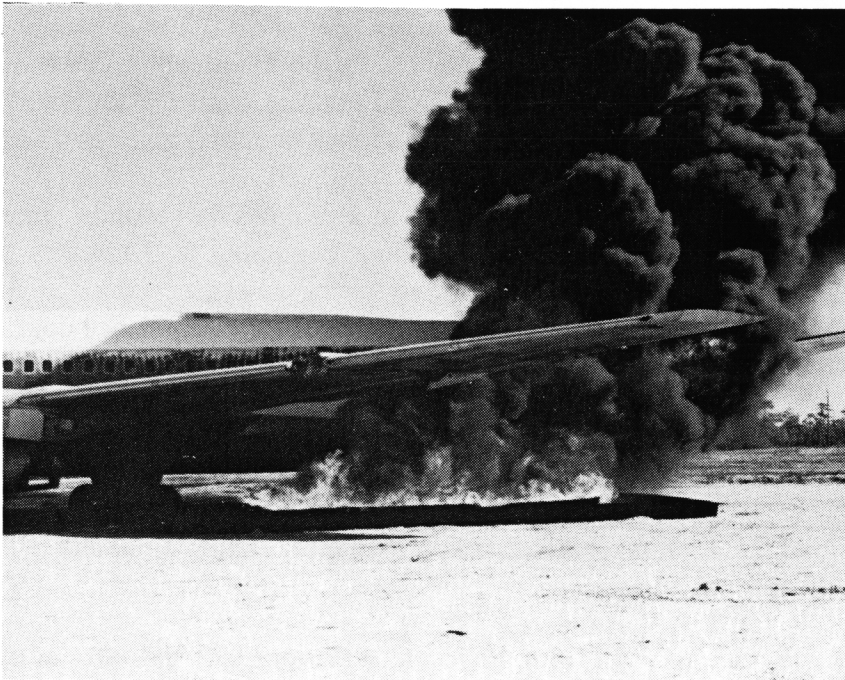
The external fuel fire burned steadily for 8 minutes and did not self-extinguish from lack of fuel until 11 minutes 15 seconds had elapsed. The fire plume was blown by the 12-knot wind against and over the rear fuselage (figures 4 and 5). However, long before the pool fire was out, the interior of the aircraft supported a self-sustaining cabin fire. Two minutes twenty-five seconds after the pool ignition a visible seat fire was observed in the main cabin. Two minutes thirty seconds into the test, heavy black smoke was observed pouring from the starboard rear service door. A small fireball erupted from the starboard rear service door at 2 minutes 47 seconds.

FIGURE 5. FULLY DEVELOPED FUEL FIRE, 20 SECONDS AFTER IGNITION

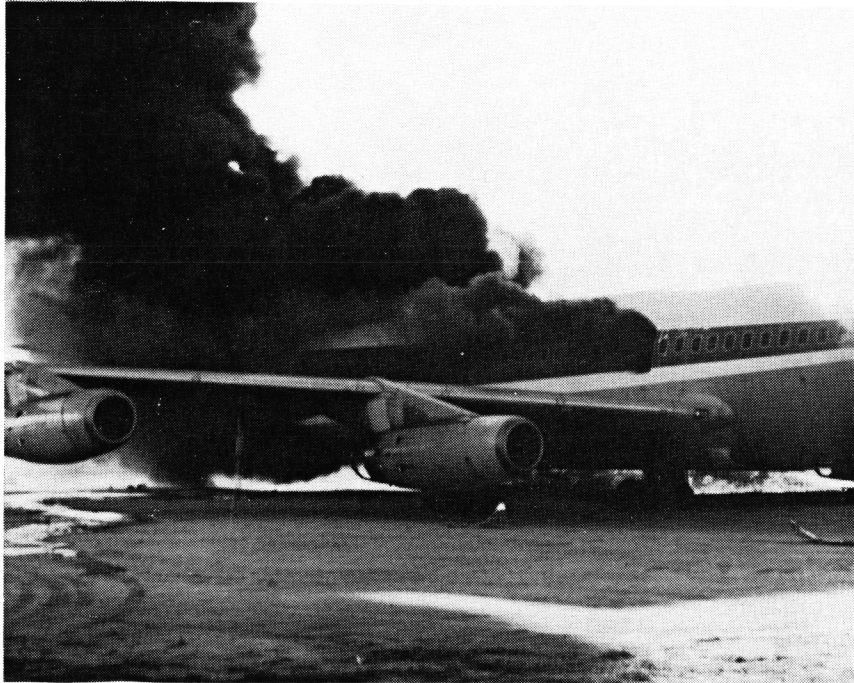
A flash fire occurred in the empennage crawlthrough at 2 minutes 51 seconds. Intermittent fire was observed coming out of the right rear service door beginning at 3 minutes 30 seconds. Heavy black smoke began to pour from the right overwing emergency door at 3 minutes 35 seconds (figure 6). White smoke began to pour from the right forward service door at 3 minutes 58 seconds. This quickly changed to heavy black smoke at 4 minutes 20 seconds.

FIGURE 6. SMOKE POURS FROM STARBOARD OVERWING EXIT, 3 MINUTES 35 SECONDS AFTER IGNITION

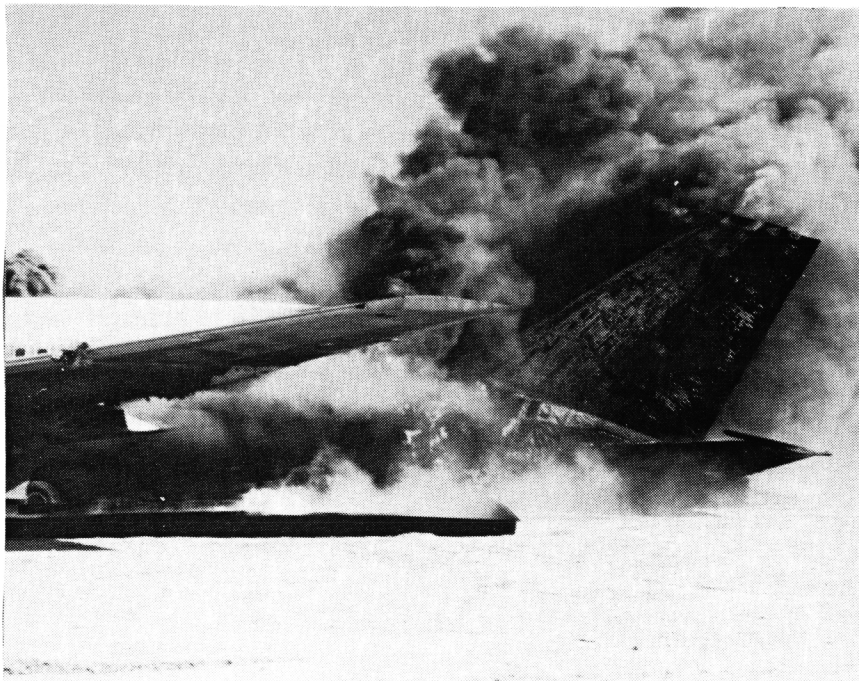
The entire tail section of the aircraft separated at approximately station 1264 and collapsed to the ground at 8 minutes 12 seconds (figure 7).

FIGURE 7. TAIL SEPARATES FROM FUSELAGE, 8 MINUTES 12 SECONDS AFTER IGNITION

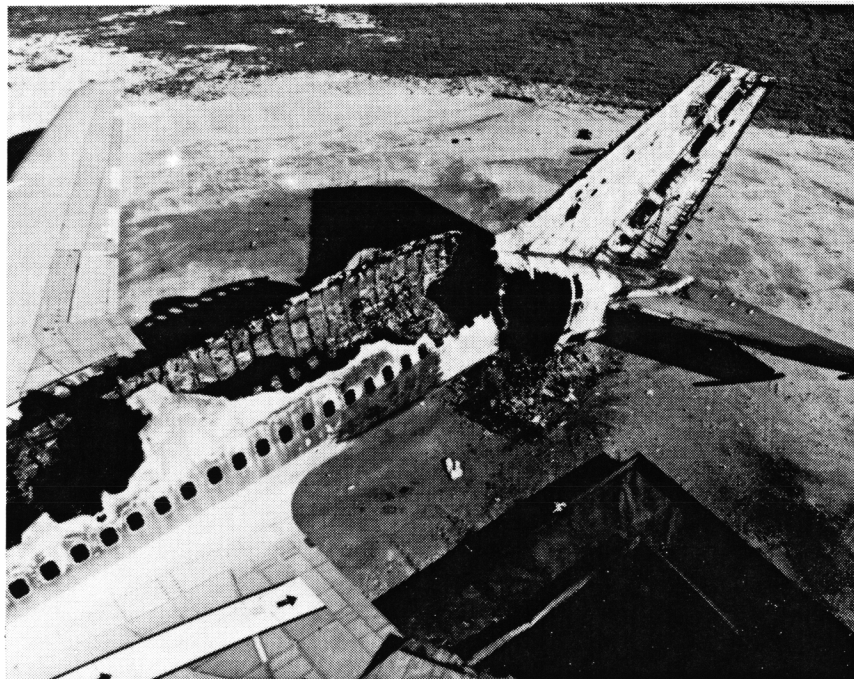
The entire interior of the aircraft was completely gutted. There were no recognizable interior furnishings. All of the windows, with the exception of those on the flight deck, were consumed. The top of the fuselage was burned down to just above the windows (figures 12 and 13). The entire empennage assembly was separated from the fuselage at station 1264 (figure 14). The cabin floor was consumed aft of the main wing spar. Forward of the main wing spar, the floor was intact as well as the forward cargo compartment. The remaining floor support beams were weakened, twisted, and sagging.

FIGURE 13. AERIAL VIEW OF CABIN AFT AFTER FIRE

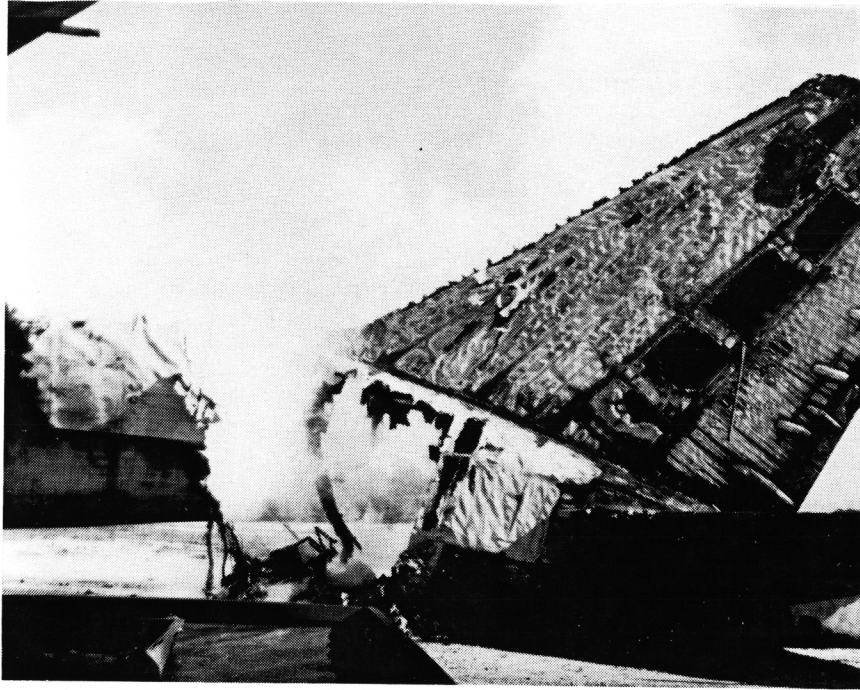
FIGURE 14. THE EMPENNAGE SEPARATED FROM THE FUSELAGE AT STATION 1264

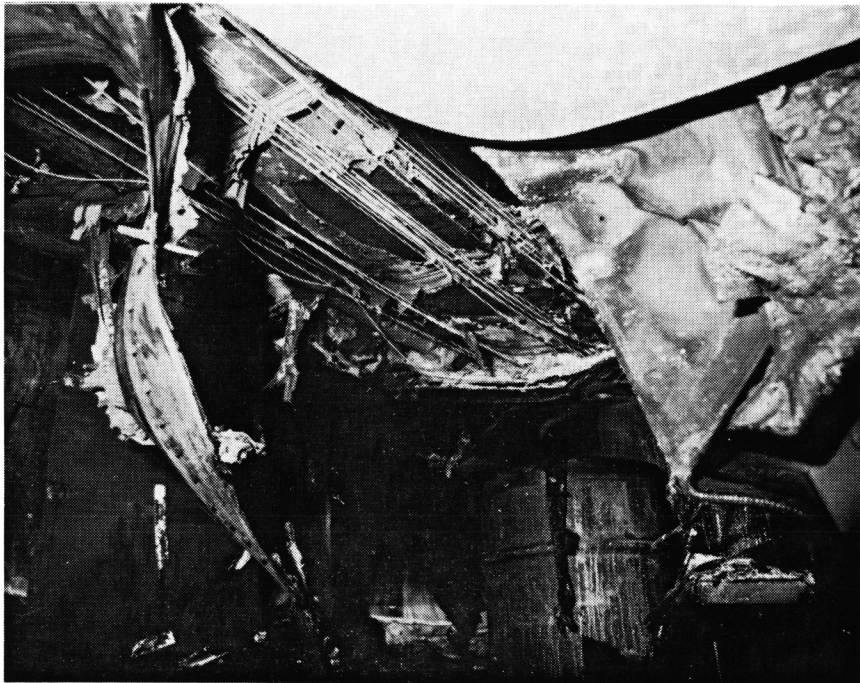
The forward cargo compartment ceiling liners were pulled away and charred (figure 15). The forward cargo compartment door was operational.

FIGURE 15. FORWARD CARGO COMPARTMENT CEILING LINERS ARE PULLED AWAY AND CHARRED

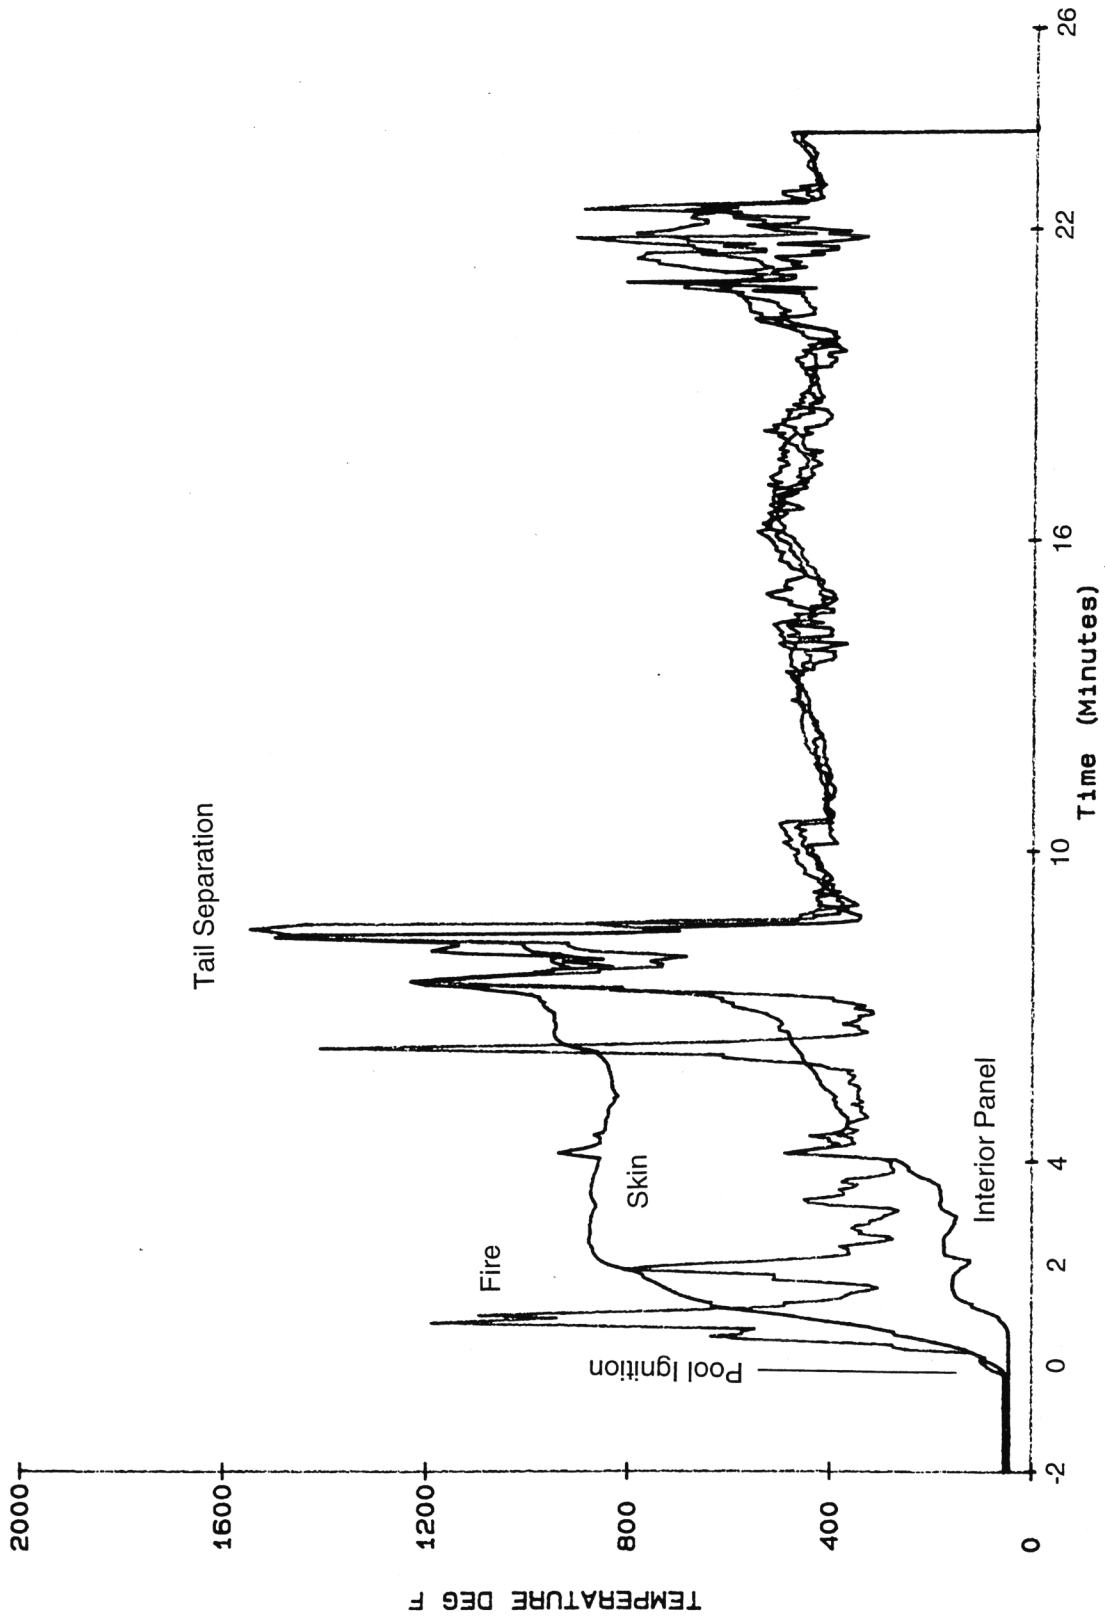
Thermocouple temperatures recorded outside the fuselage at station 1192 measured just below the base of the window peaked at 1200°F 1 minute after pool ignition then subsided to an average of 400°F until the 8-minute mark when the temperature again peaked at 1400 and 1600°F at the 9-minute mark (figure B-1). The heat flux at this location peaked at 19 BTU/ft²-sec but averaged 5 BTU/ft²-sec (figure B-2). These measurements were 2 to 3 feet forward of the flame plume. The flame temperature at the cheek area, also at station 1192, followed the same trend as figure B-1 (figure B-3).

Figure B-1 shows the temperature profile on the port side just below the window. The skin temperature reached 900°F, which is the approximate incipient melt point for aluminum, in 2 minutes. The cabin sidewall, however, stayed relatively cool reaching only 150°F in this period. It should be noted that this skin location was only in the fuel fire for a very short period of time.

FIGURE B-1. TEMPERATURE PROFILE THROUGH FUSELAGE SKIN AT STATION 1192, BELOW THE WINDOW, PORT SIDE

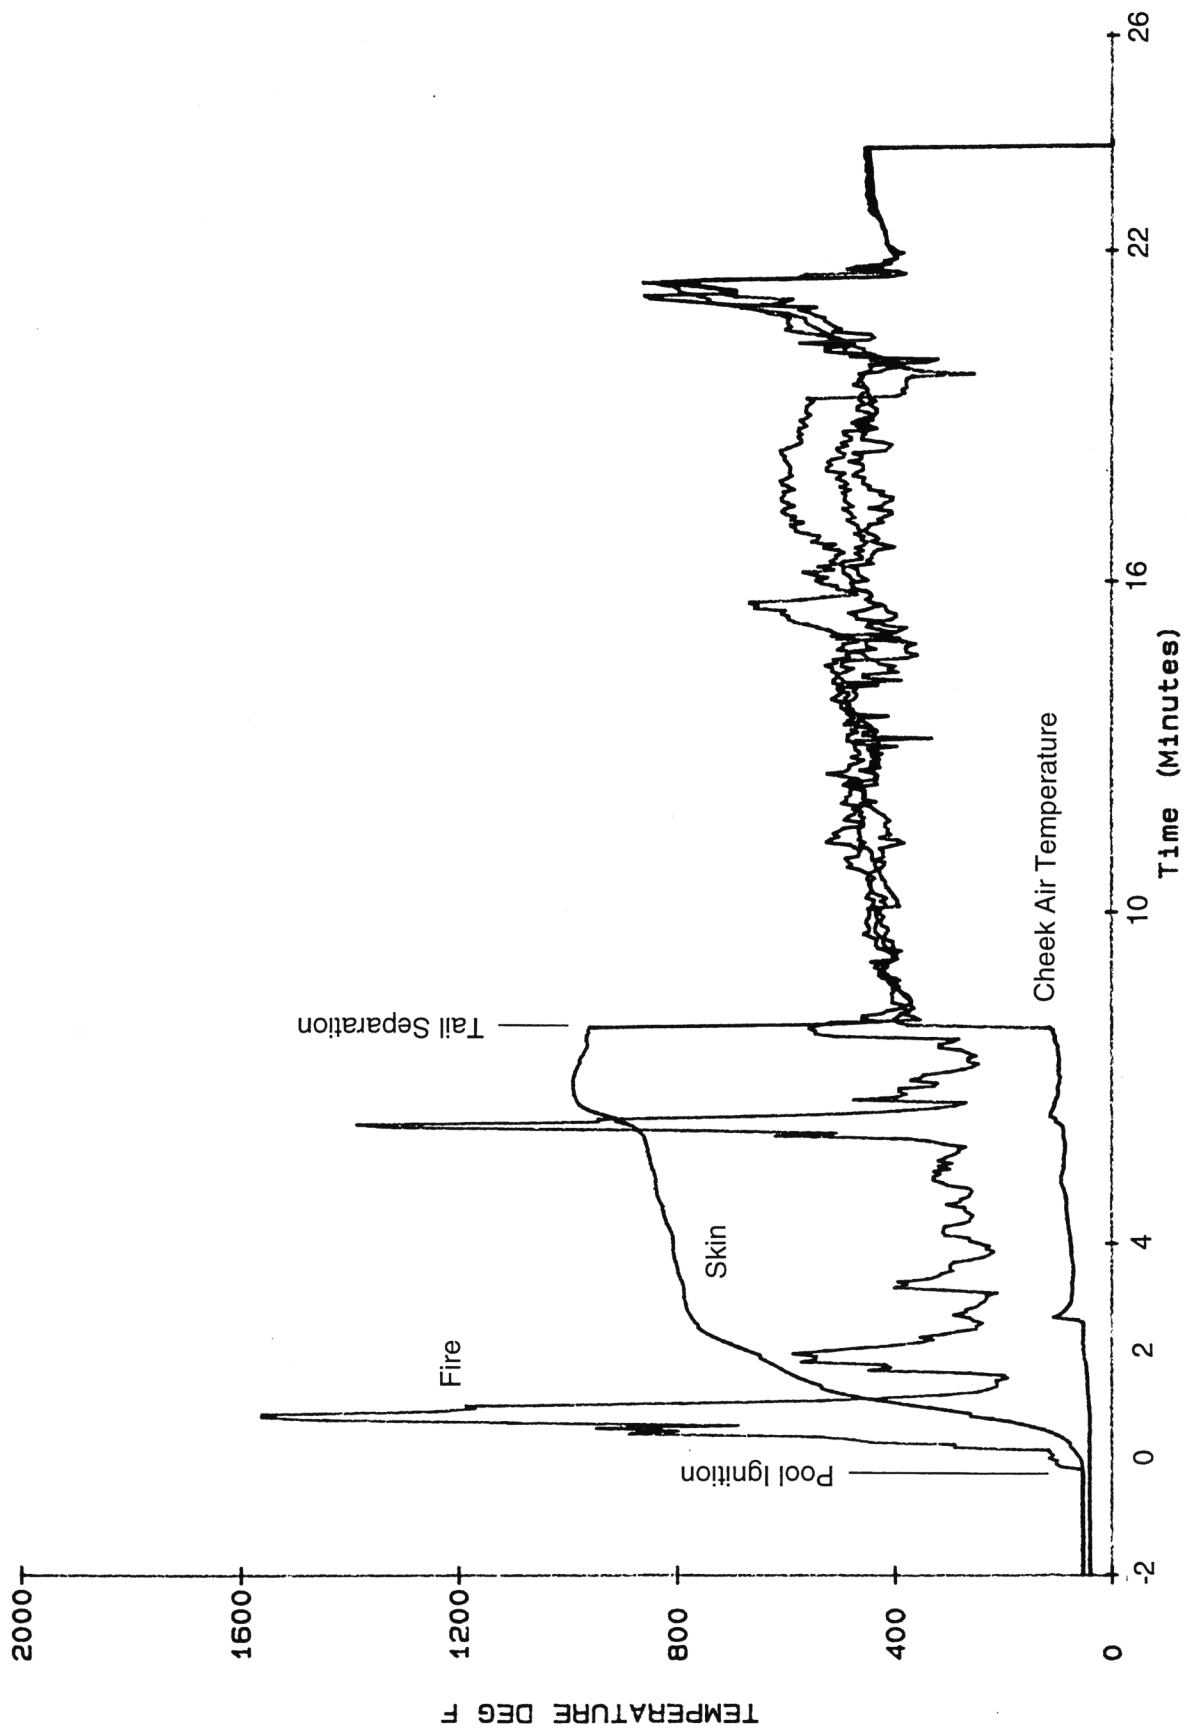
FIGURE B-3. TEMPERATURE PROFILE THROUGH FUSELAGE SKIN AT STATION 1192, CHEEK AREA, PORT SIDE

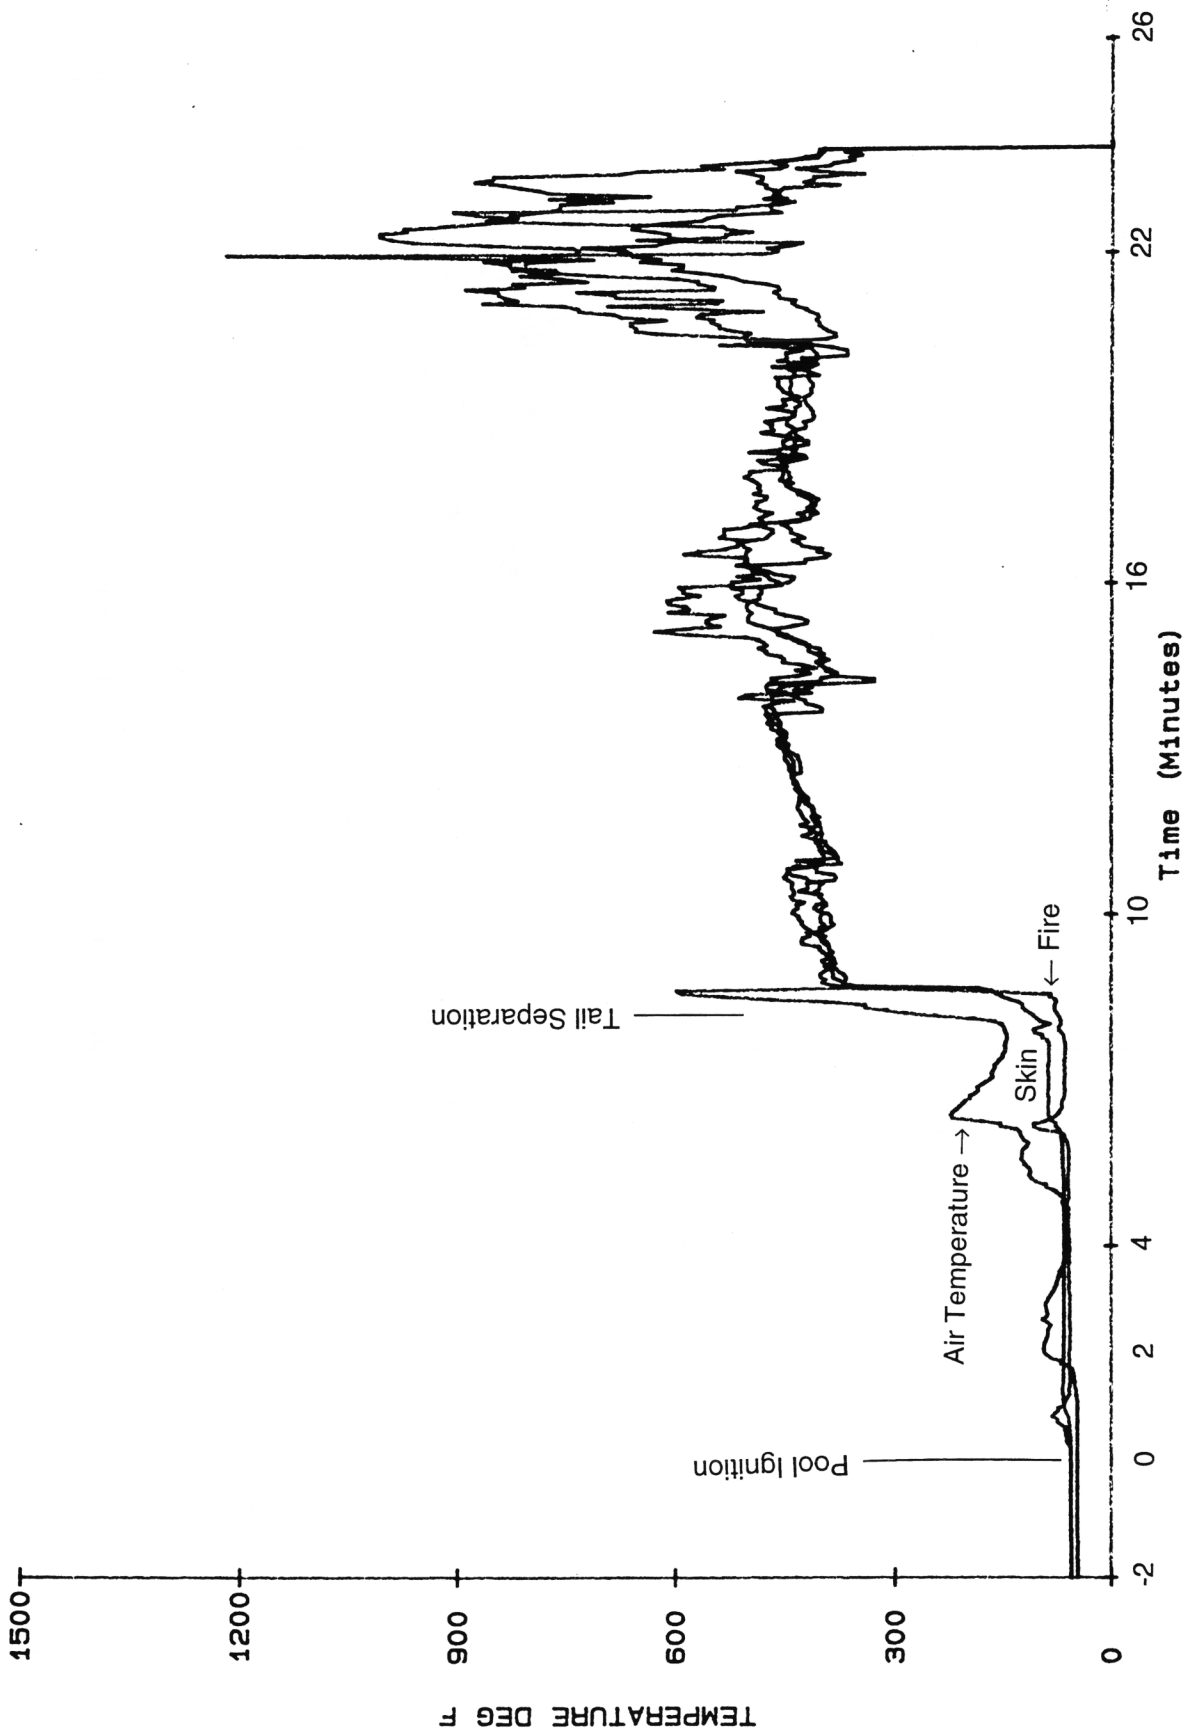
The thermocouples installed on the starboard side at both the cheek area and the window level were not directly impinged by the fuel fire plume. The external air temperature at both locations remained quite low until the tail separated from the aircraft at the 8-minute mark. This exposed the thermocouples to the diminishing pool fire (figures B-4 and B-5).

FIGURE B-4. TEMPERATURE PROFILE THROUGH FUSELAGE SKIN AT STATION 1192, CHEEK AREA, STARBOARD SIDE

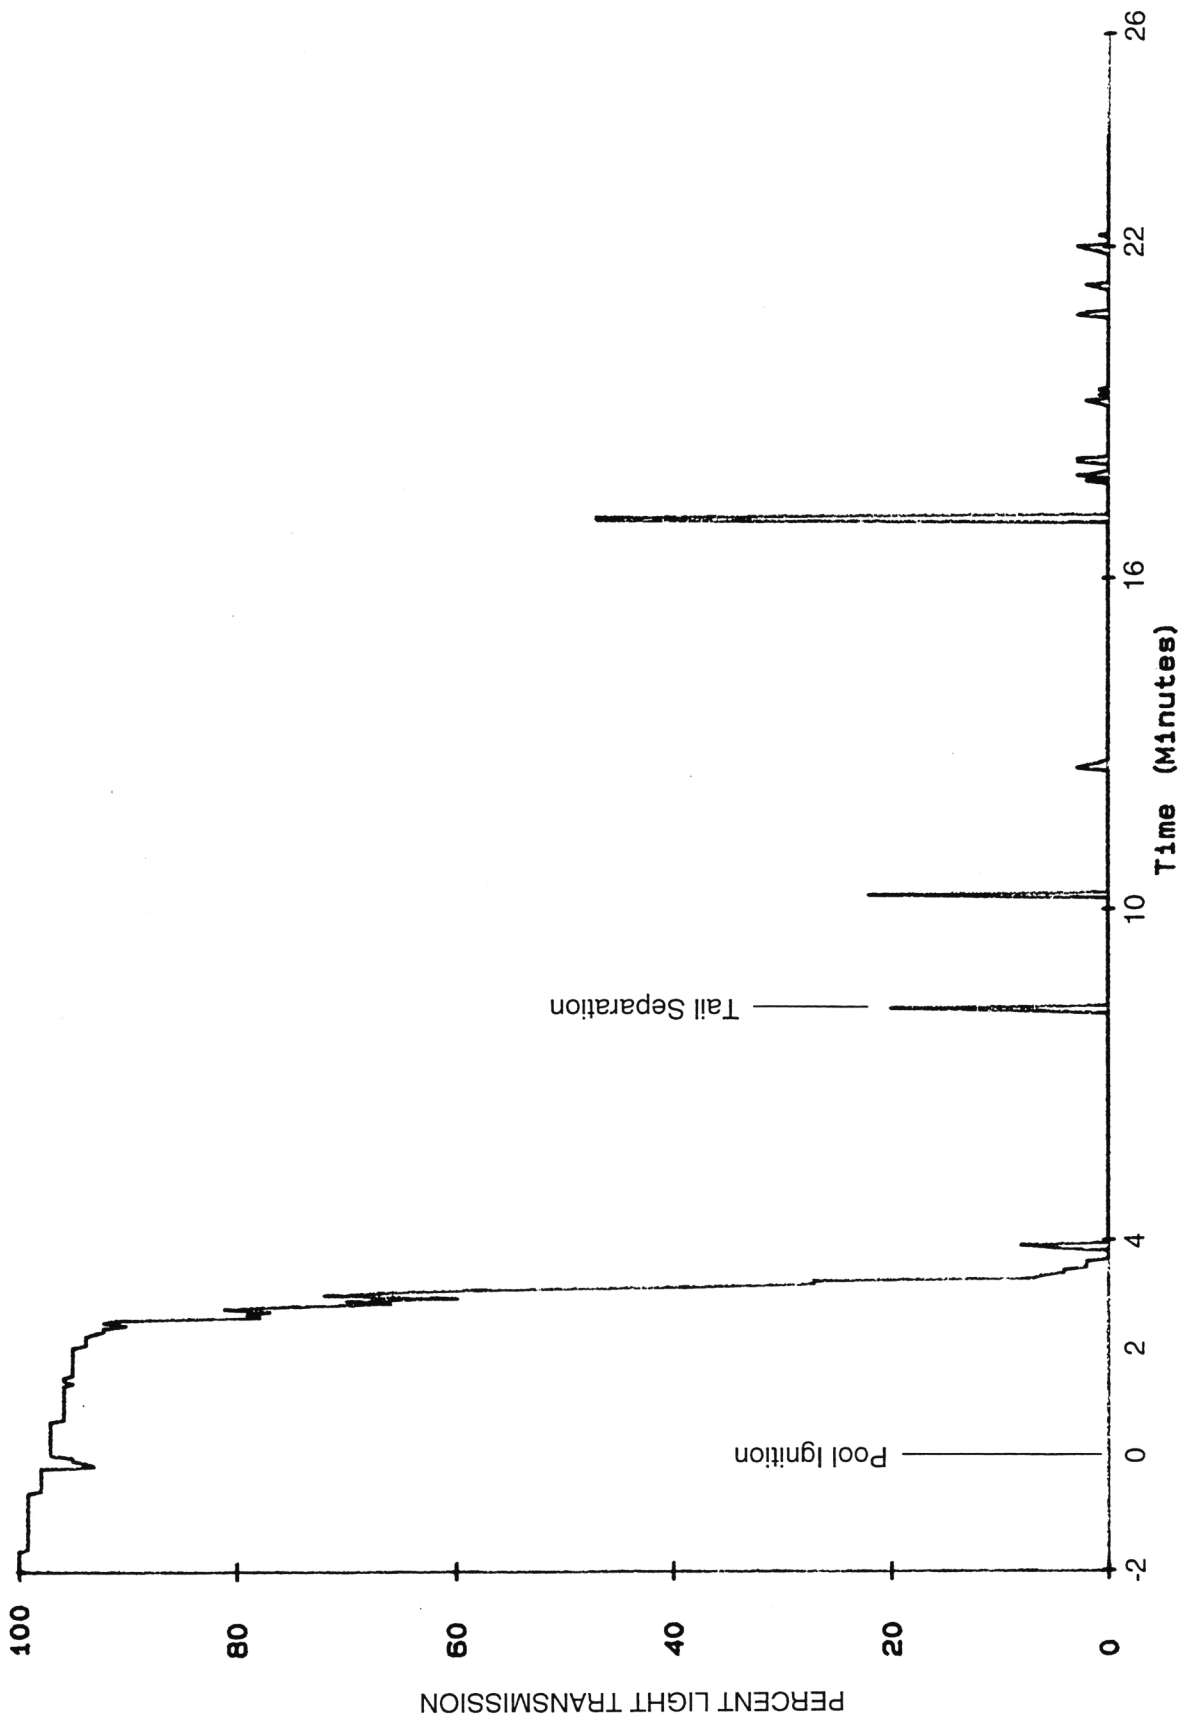
FIGURE B-13. SMOKE DENSITY AT STATION 1106
