**CIVIL AERONAUTICS ADMINISTRATION  
TECHNICAL DEVELOPMENT CENTER  
INDIANAPOLIS, INDIANA**

TECHNICAL DEVELOPMENT REPORT NO. 327

INVESTIGATION OF FIRES ORIGINATING  
FROM AN AIRCRAFT OXYGEN SYSTEM

October 1957

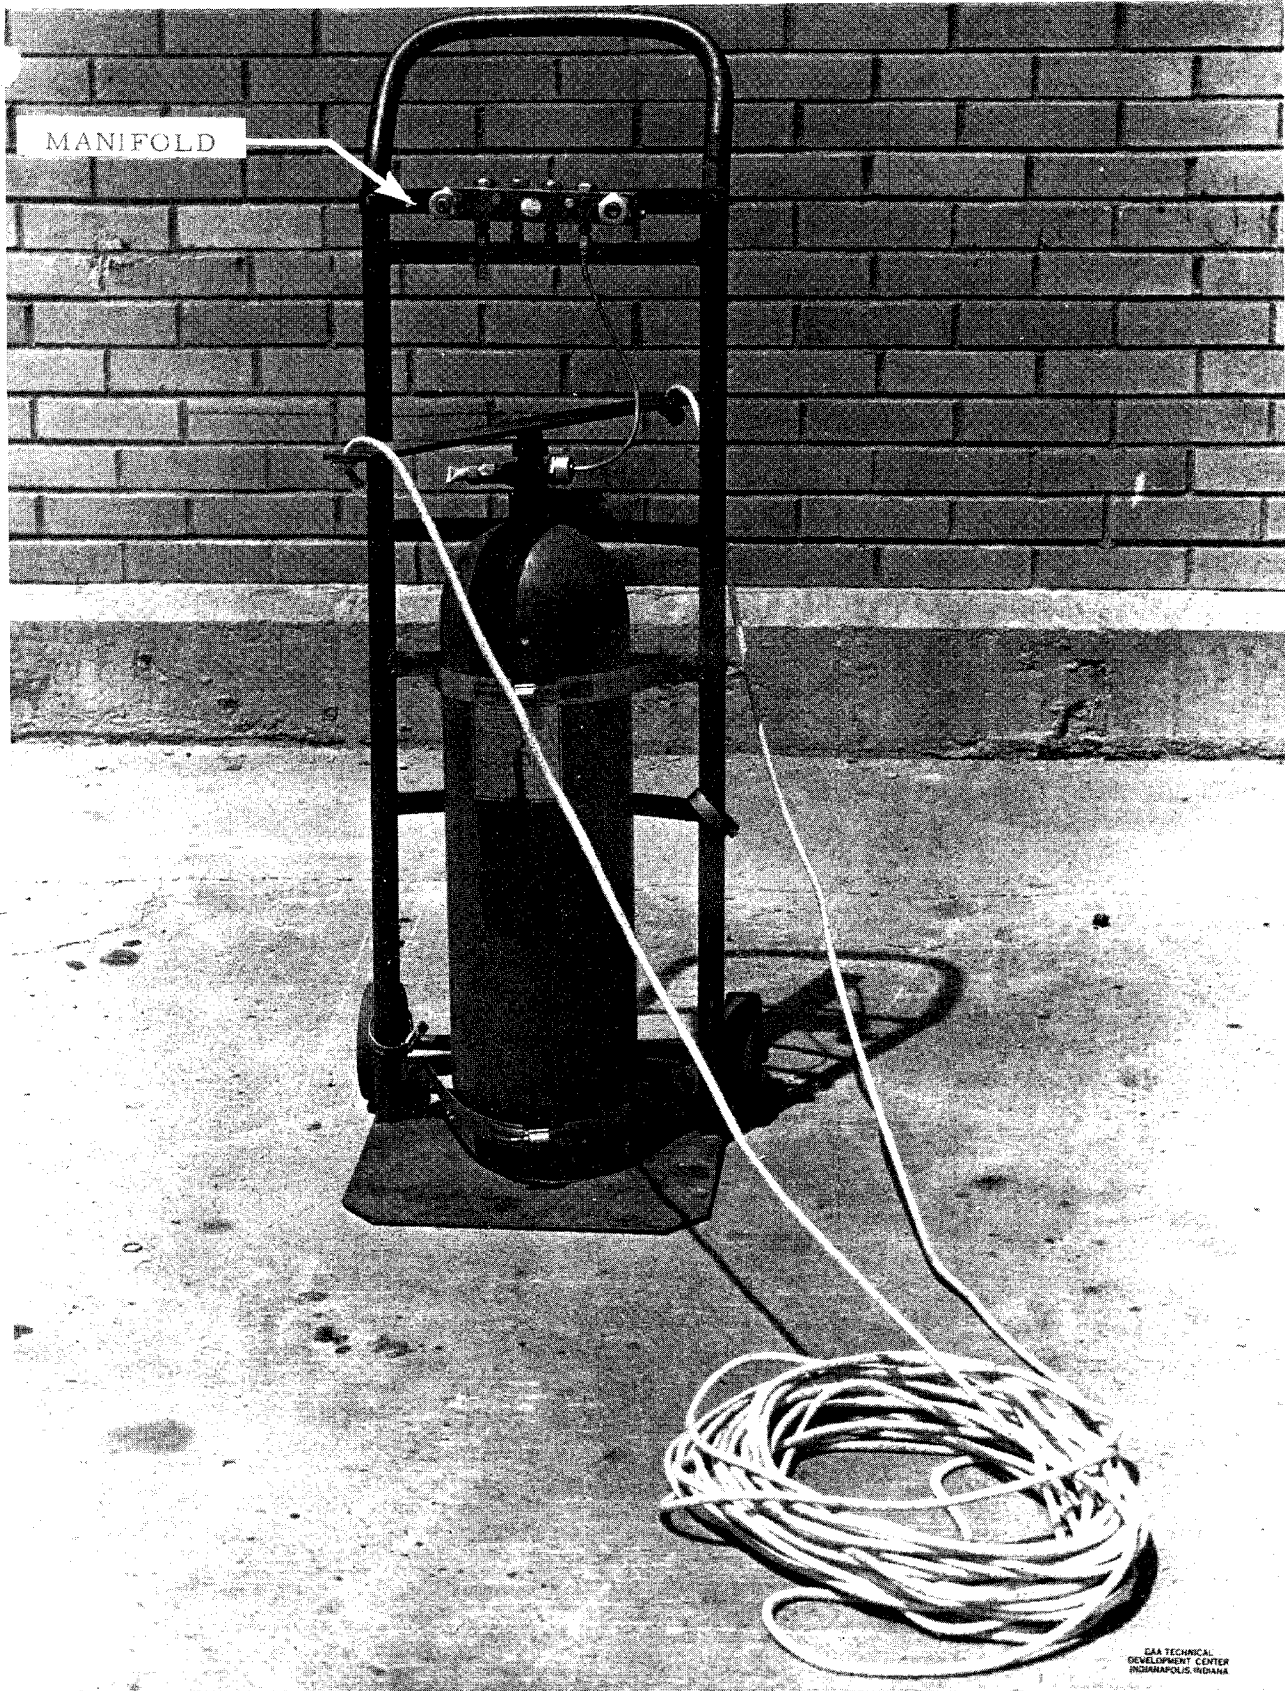
FIG. 1 OXYGEN EQUIPMENT IN POSITION FOR TESTS.

The test equipment was set up to conform as nearly as possible to the actual airplane installation. A means was provided for rapidly opening and closing the cylinder valve from a remote position. The two regulator outlet connections and the three inlet fittings not connected to cylinders were blocked off. The arrangement of the test equipment is shown in Fig. 1.

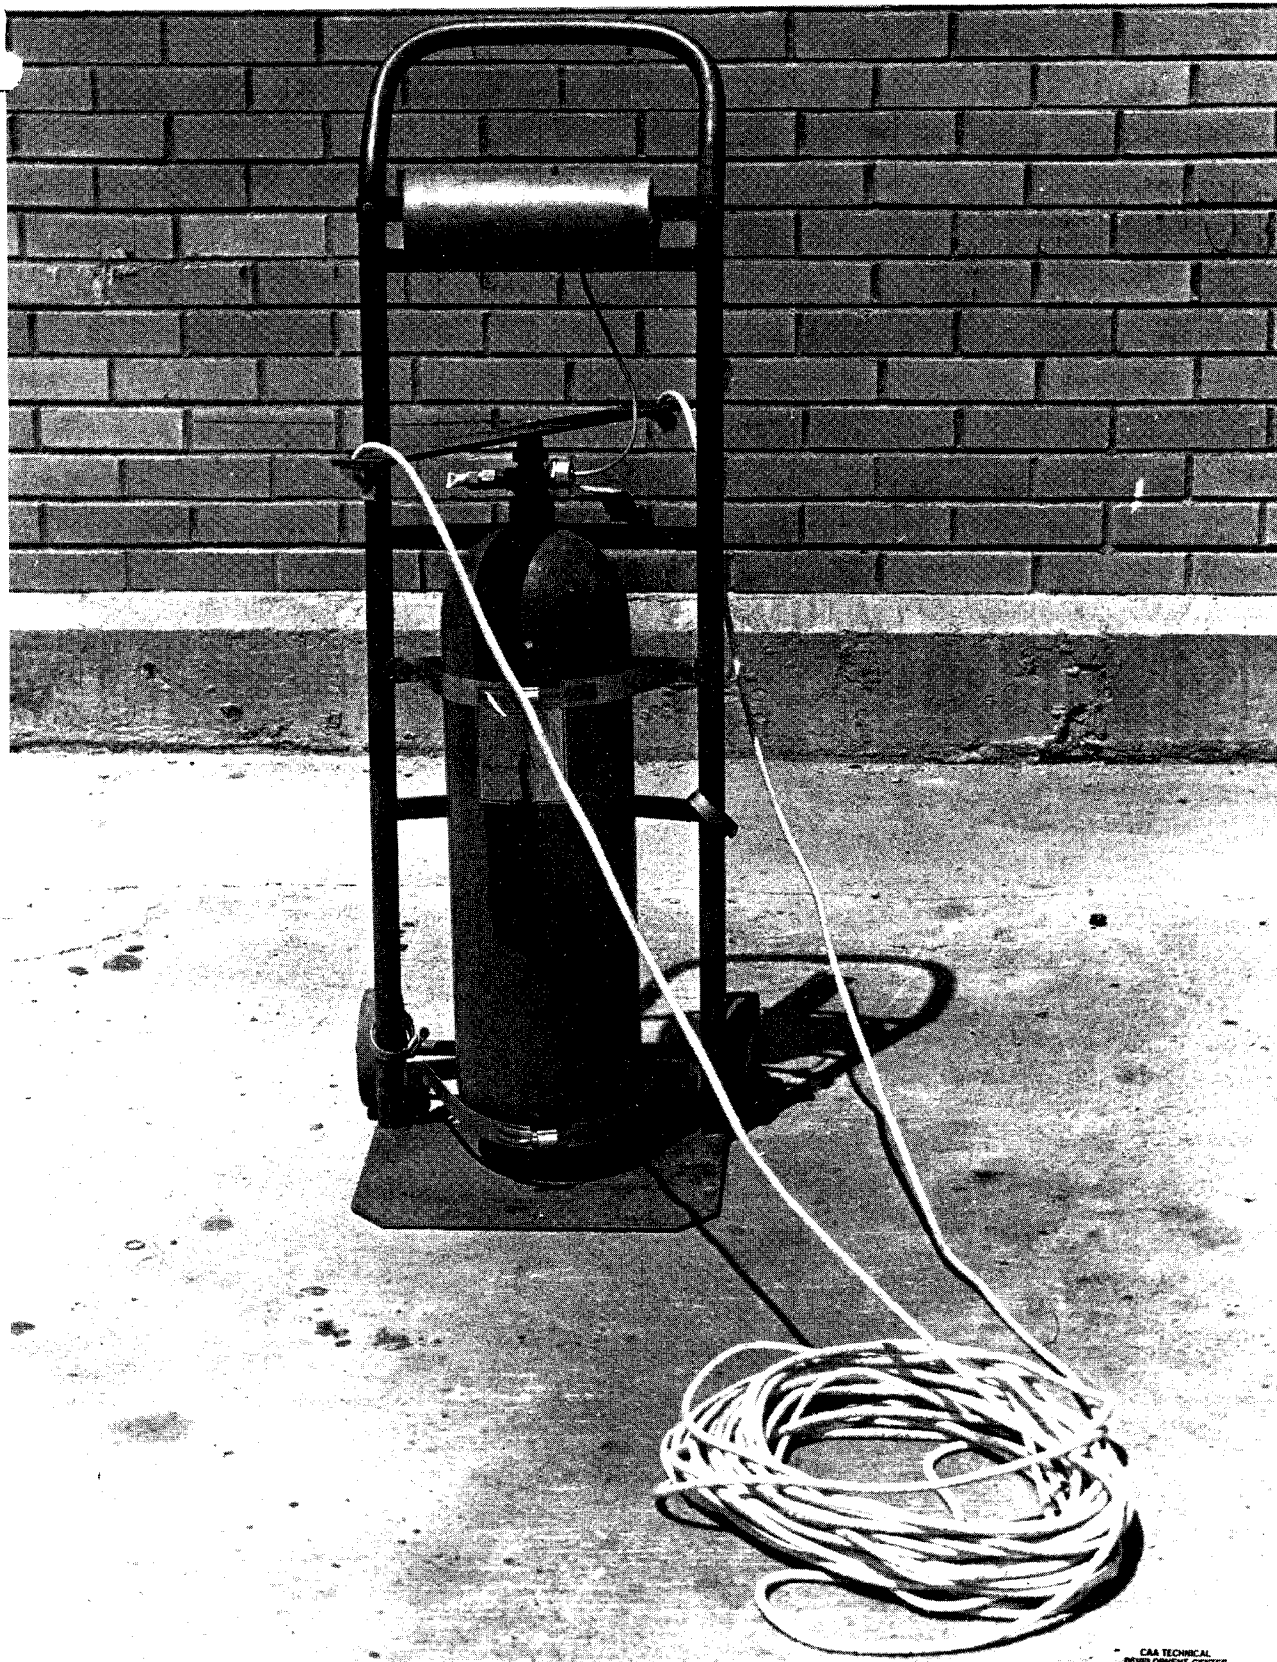
FIG. 2 OXYGEN SYSTEM MANIFOLD ENCLOSED IN SHIELD

In the third series, the manifold was completely enclosed in a protective shield made from a piece of Johns-Manville Style 89 firewall material formed into a closed cylinder approximately 3 1/2 inches in diameter shown in Fig. 2. This material will withstand a 2,000° F flame for 15 minutes without flame penetration and is considered to be fireproof. The tubing connecting the cylinder to the manifold passed through a narrow slit in the shield. The 1/4-inch pipe plugs which close the main passage through the manifold were left accessible through the ends of the shield. A wad of oil-soaked cotton was placed outside the manifold in the protective shield. One of the regulator outlet connections was allowed to leak slightly to increase the probability of fire burning through and igniting the cotton in the shield. Ignition was accomplished in the same manner as in the previous tests.
